| | <p><b>PCB Contamination Remaining on Site - Rear Parking Lot (0-2 ft bgs)</b></p> <p>Former Sperry Remington - North Portion #808022</p> <p>Elmira, New York</p> | | | |
| | <p>Beech and Bonaparte<br/>engineering p.c.<br/><i>an affiliate of Geosyntec Consultants</i></p> | | <p>Figure<br/><b>Q-1</b></p> | |

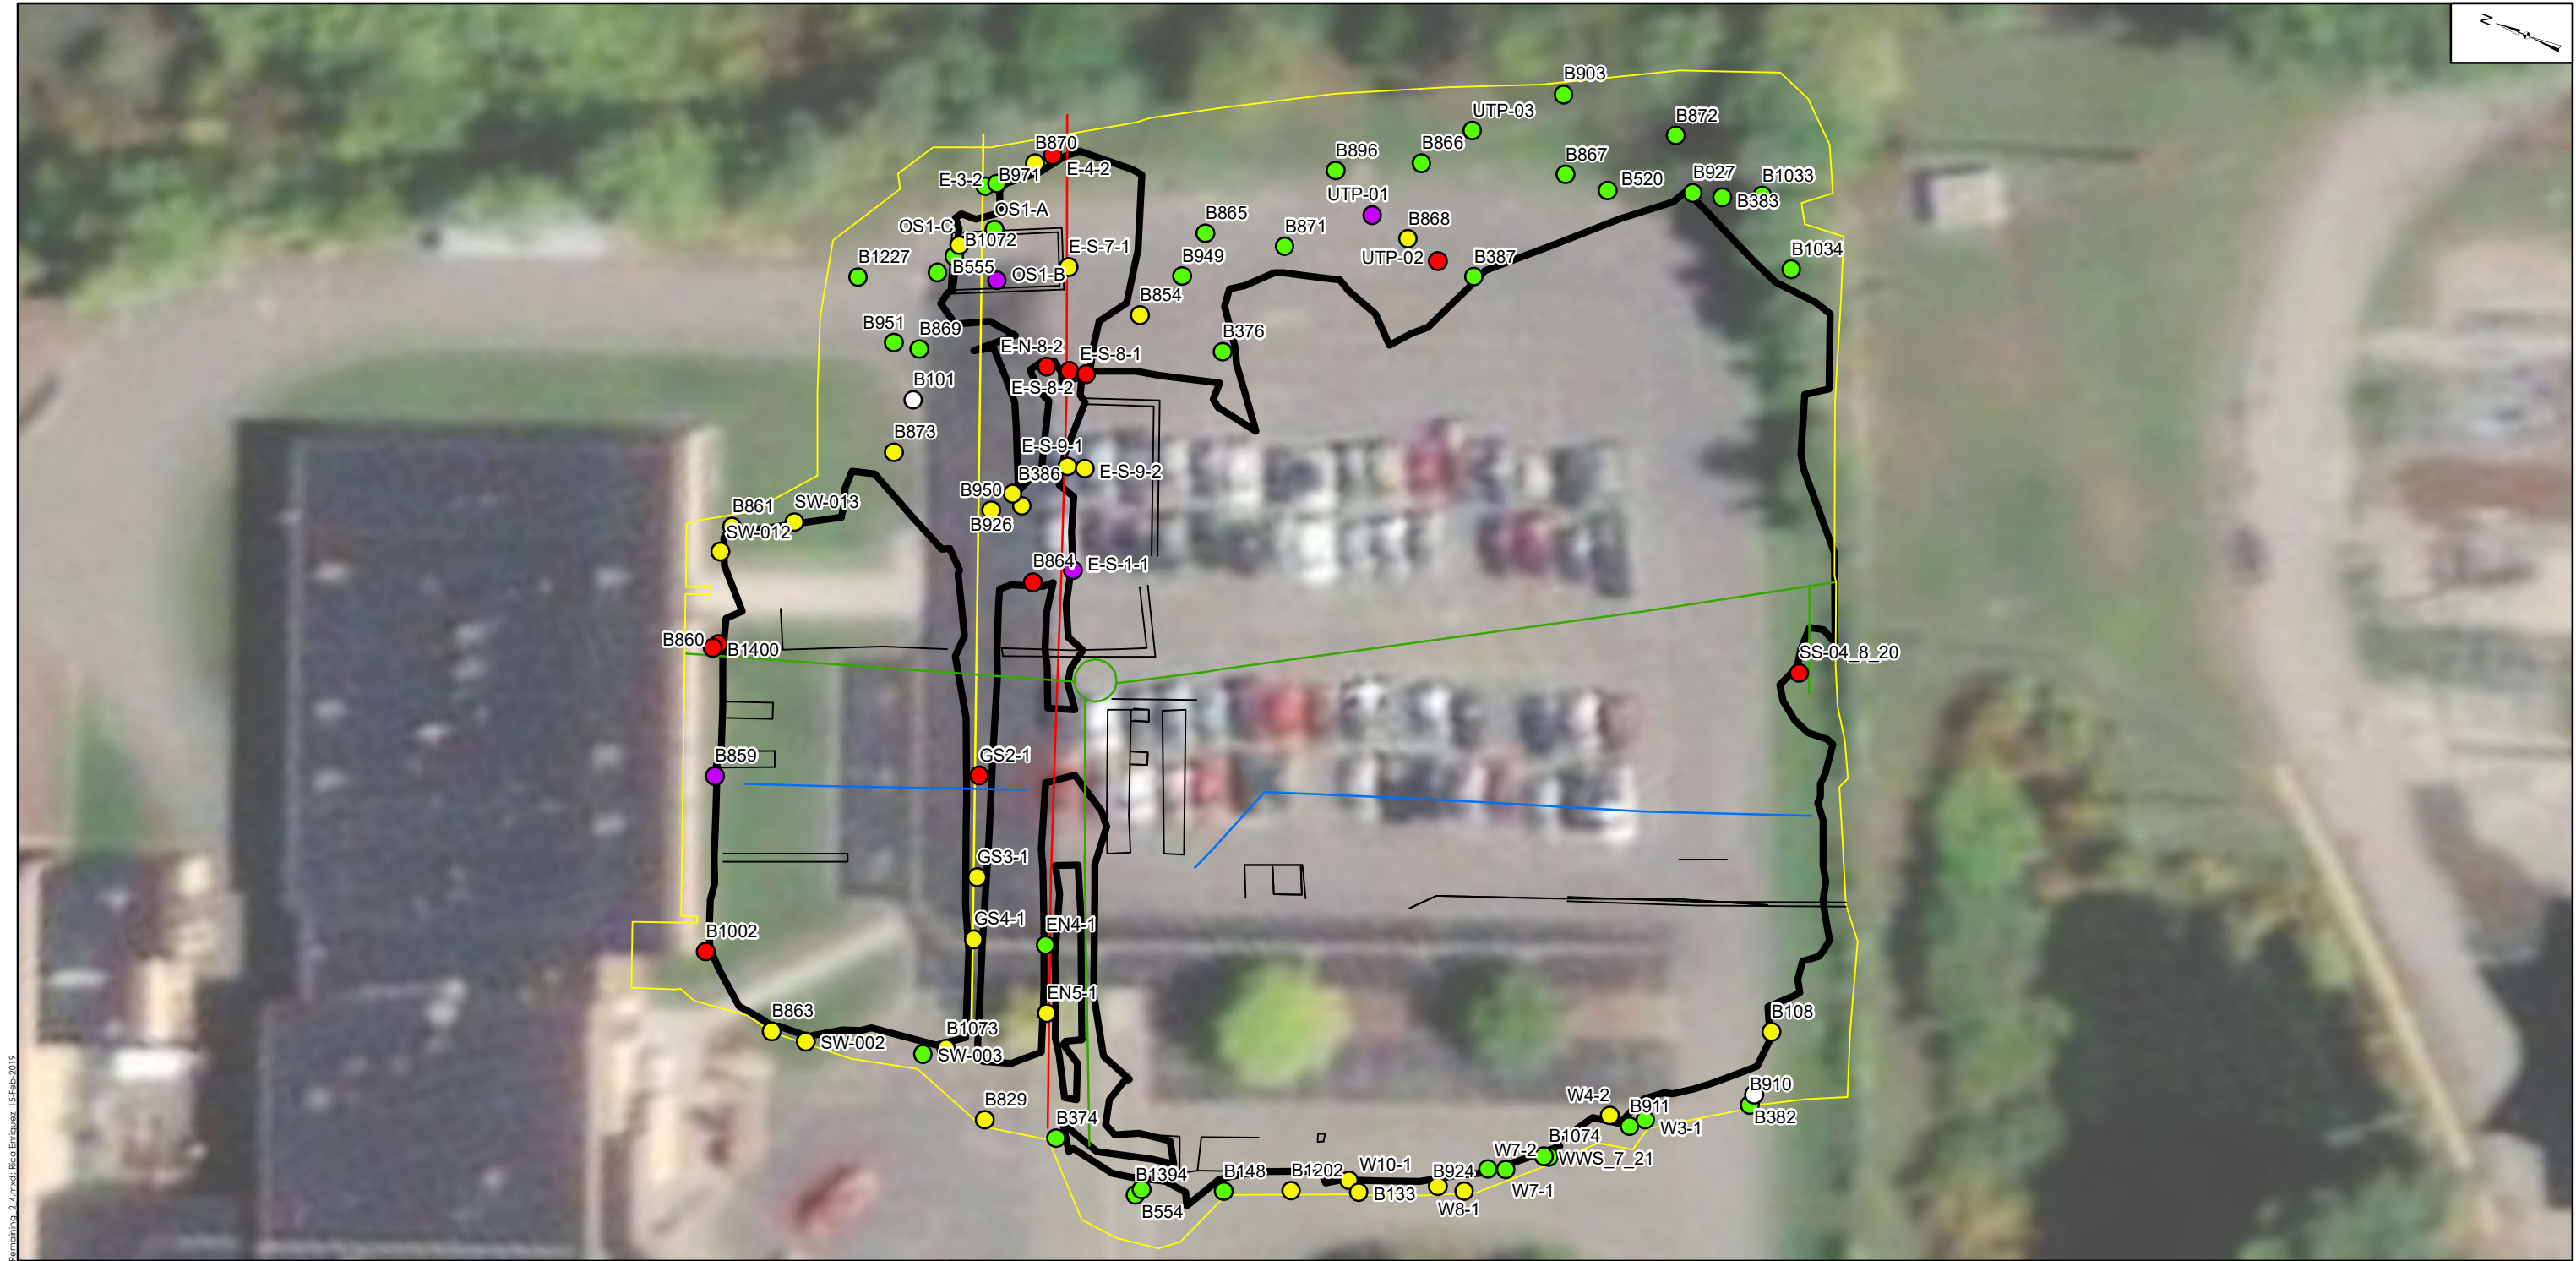
| <b>Total PCB Concentration</b> | | | <b>PCB Contamination Remaining on Site - Rear Parking Lot (2-4 ft bgs)</b><br>Former Sperry Remington - North Portion #808022<br>Elmira, New York | | |

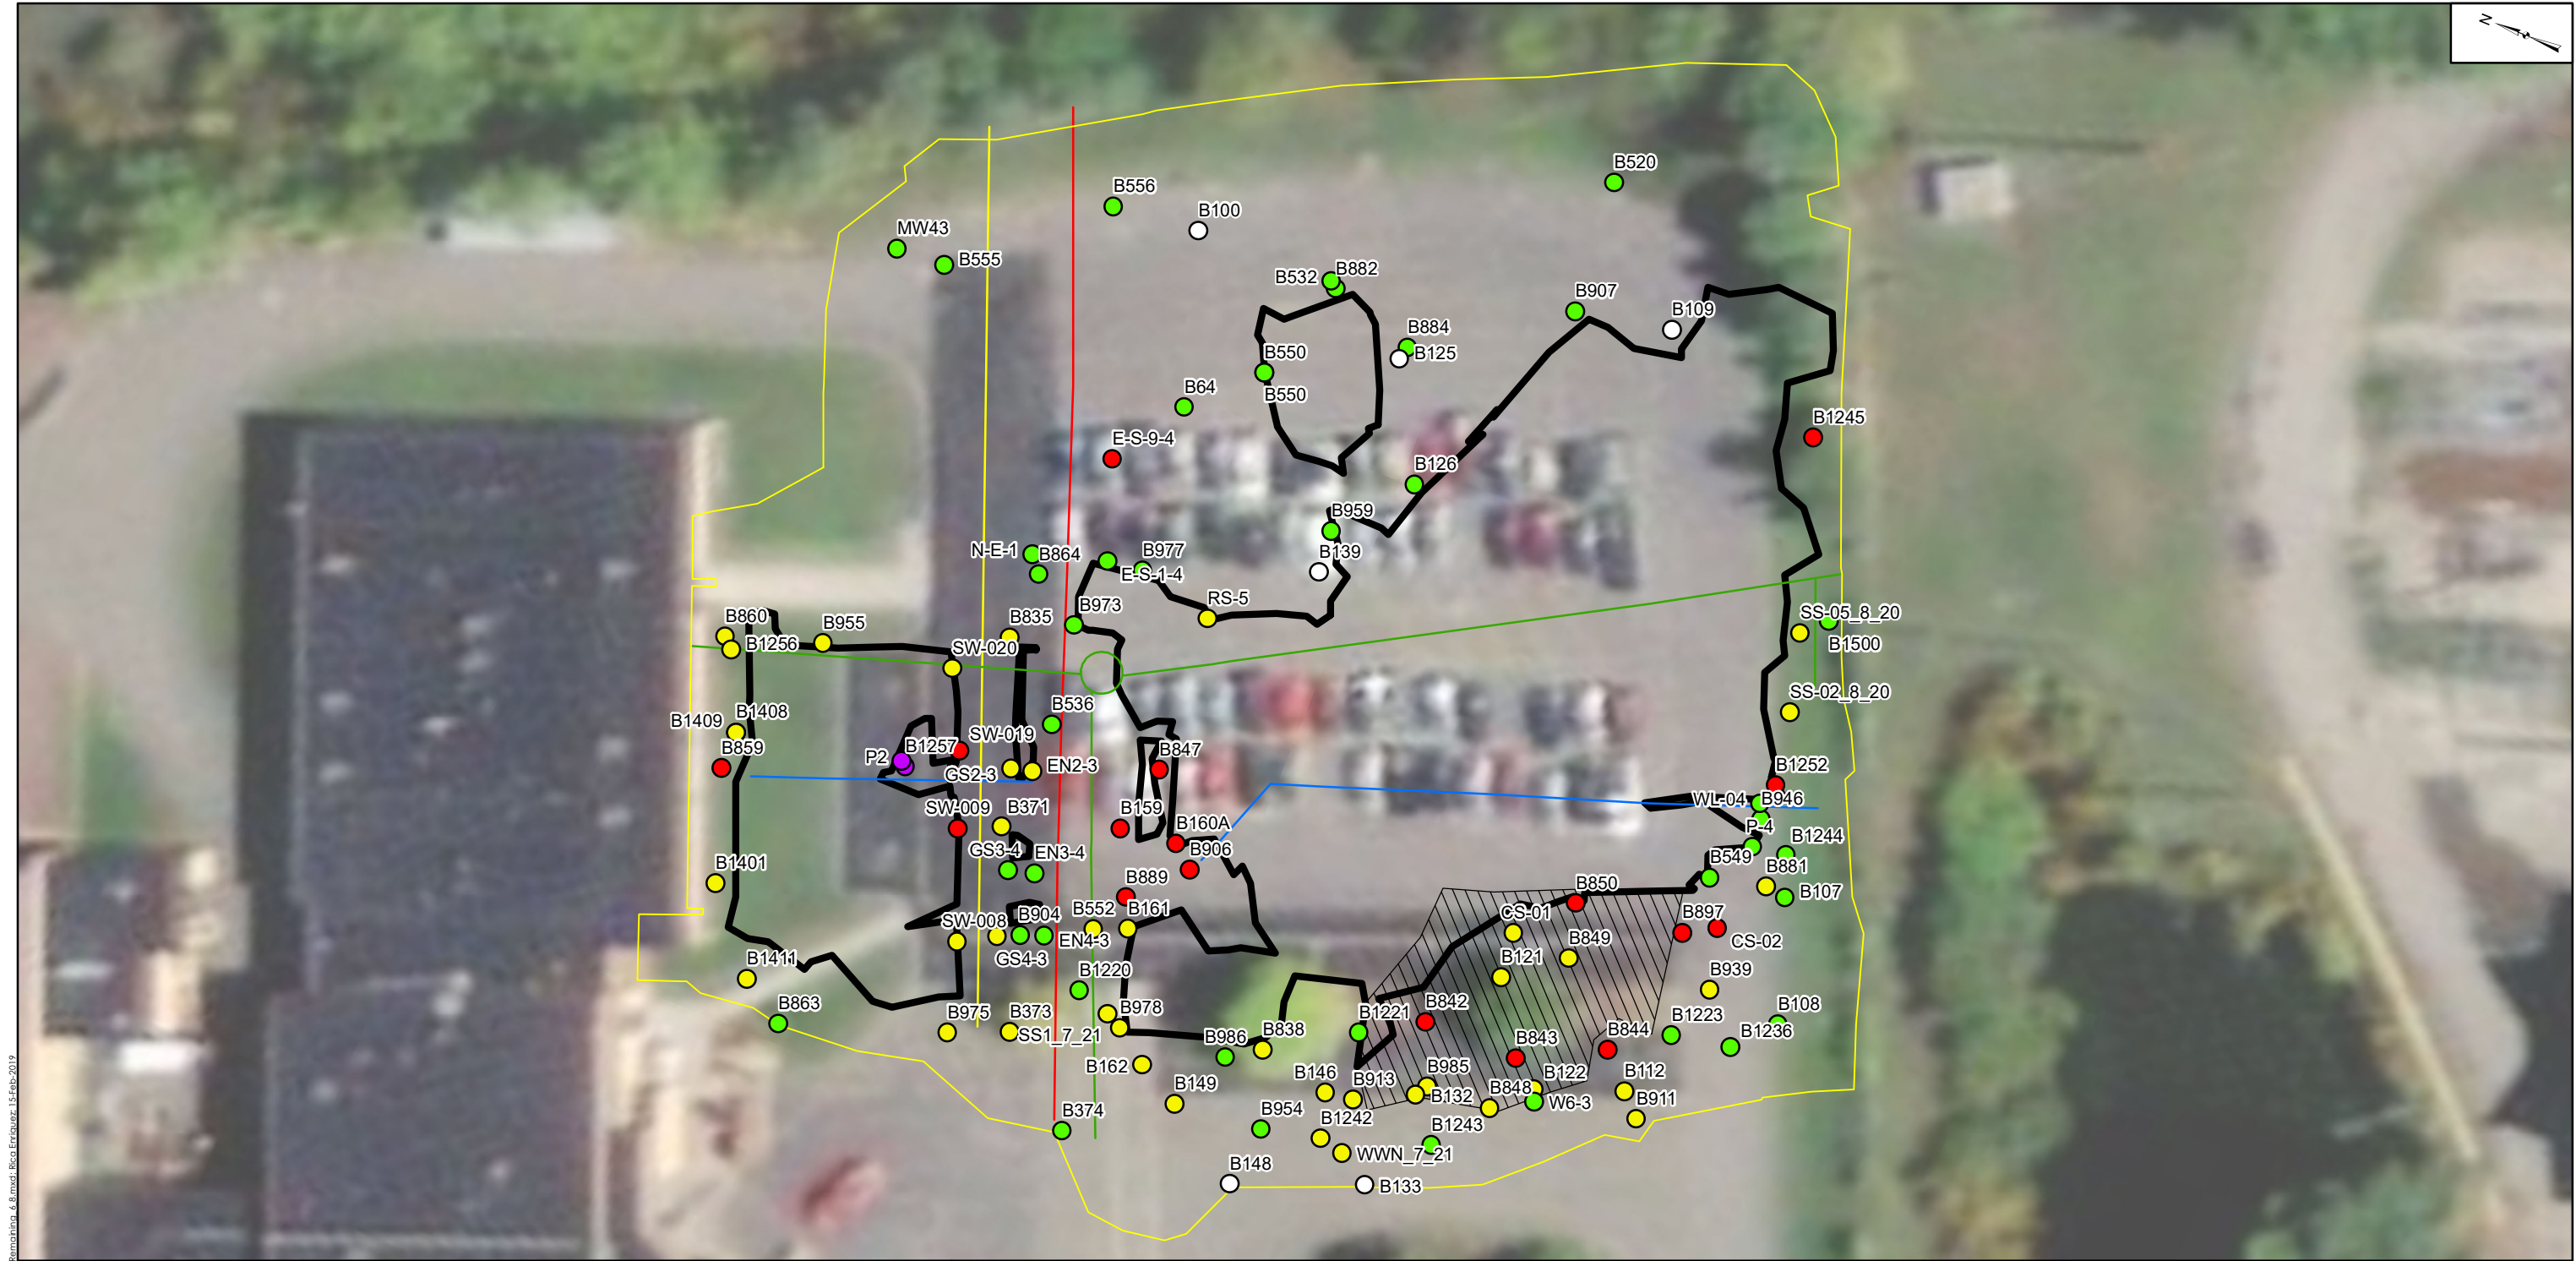
| <b>Total PCB Concentration</b> | | | | <b>PCB Contamination Remaining on Site - Rear Parking Lot (6-8 ft bgs)</b><br>Former Sperry Remington - North Portion #808022<br>Elmira, New York | |

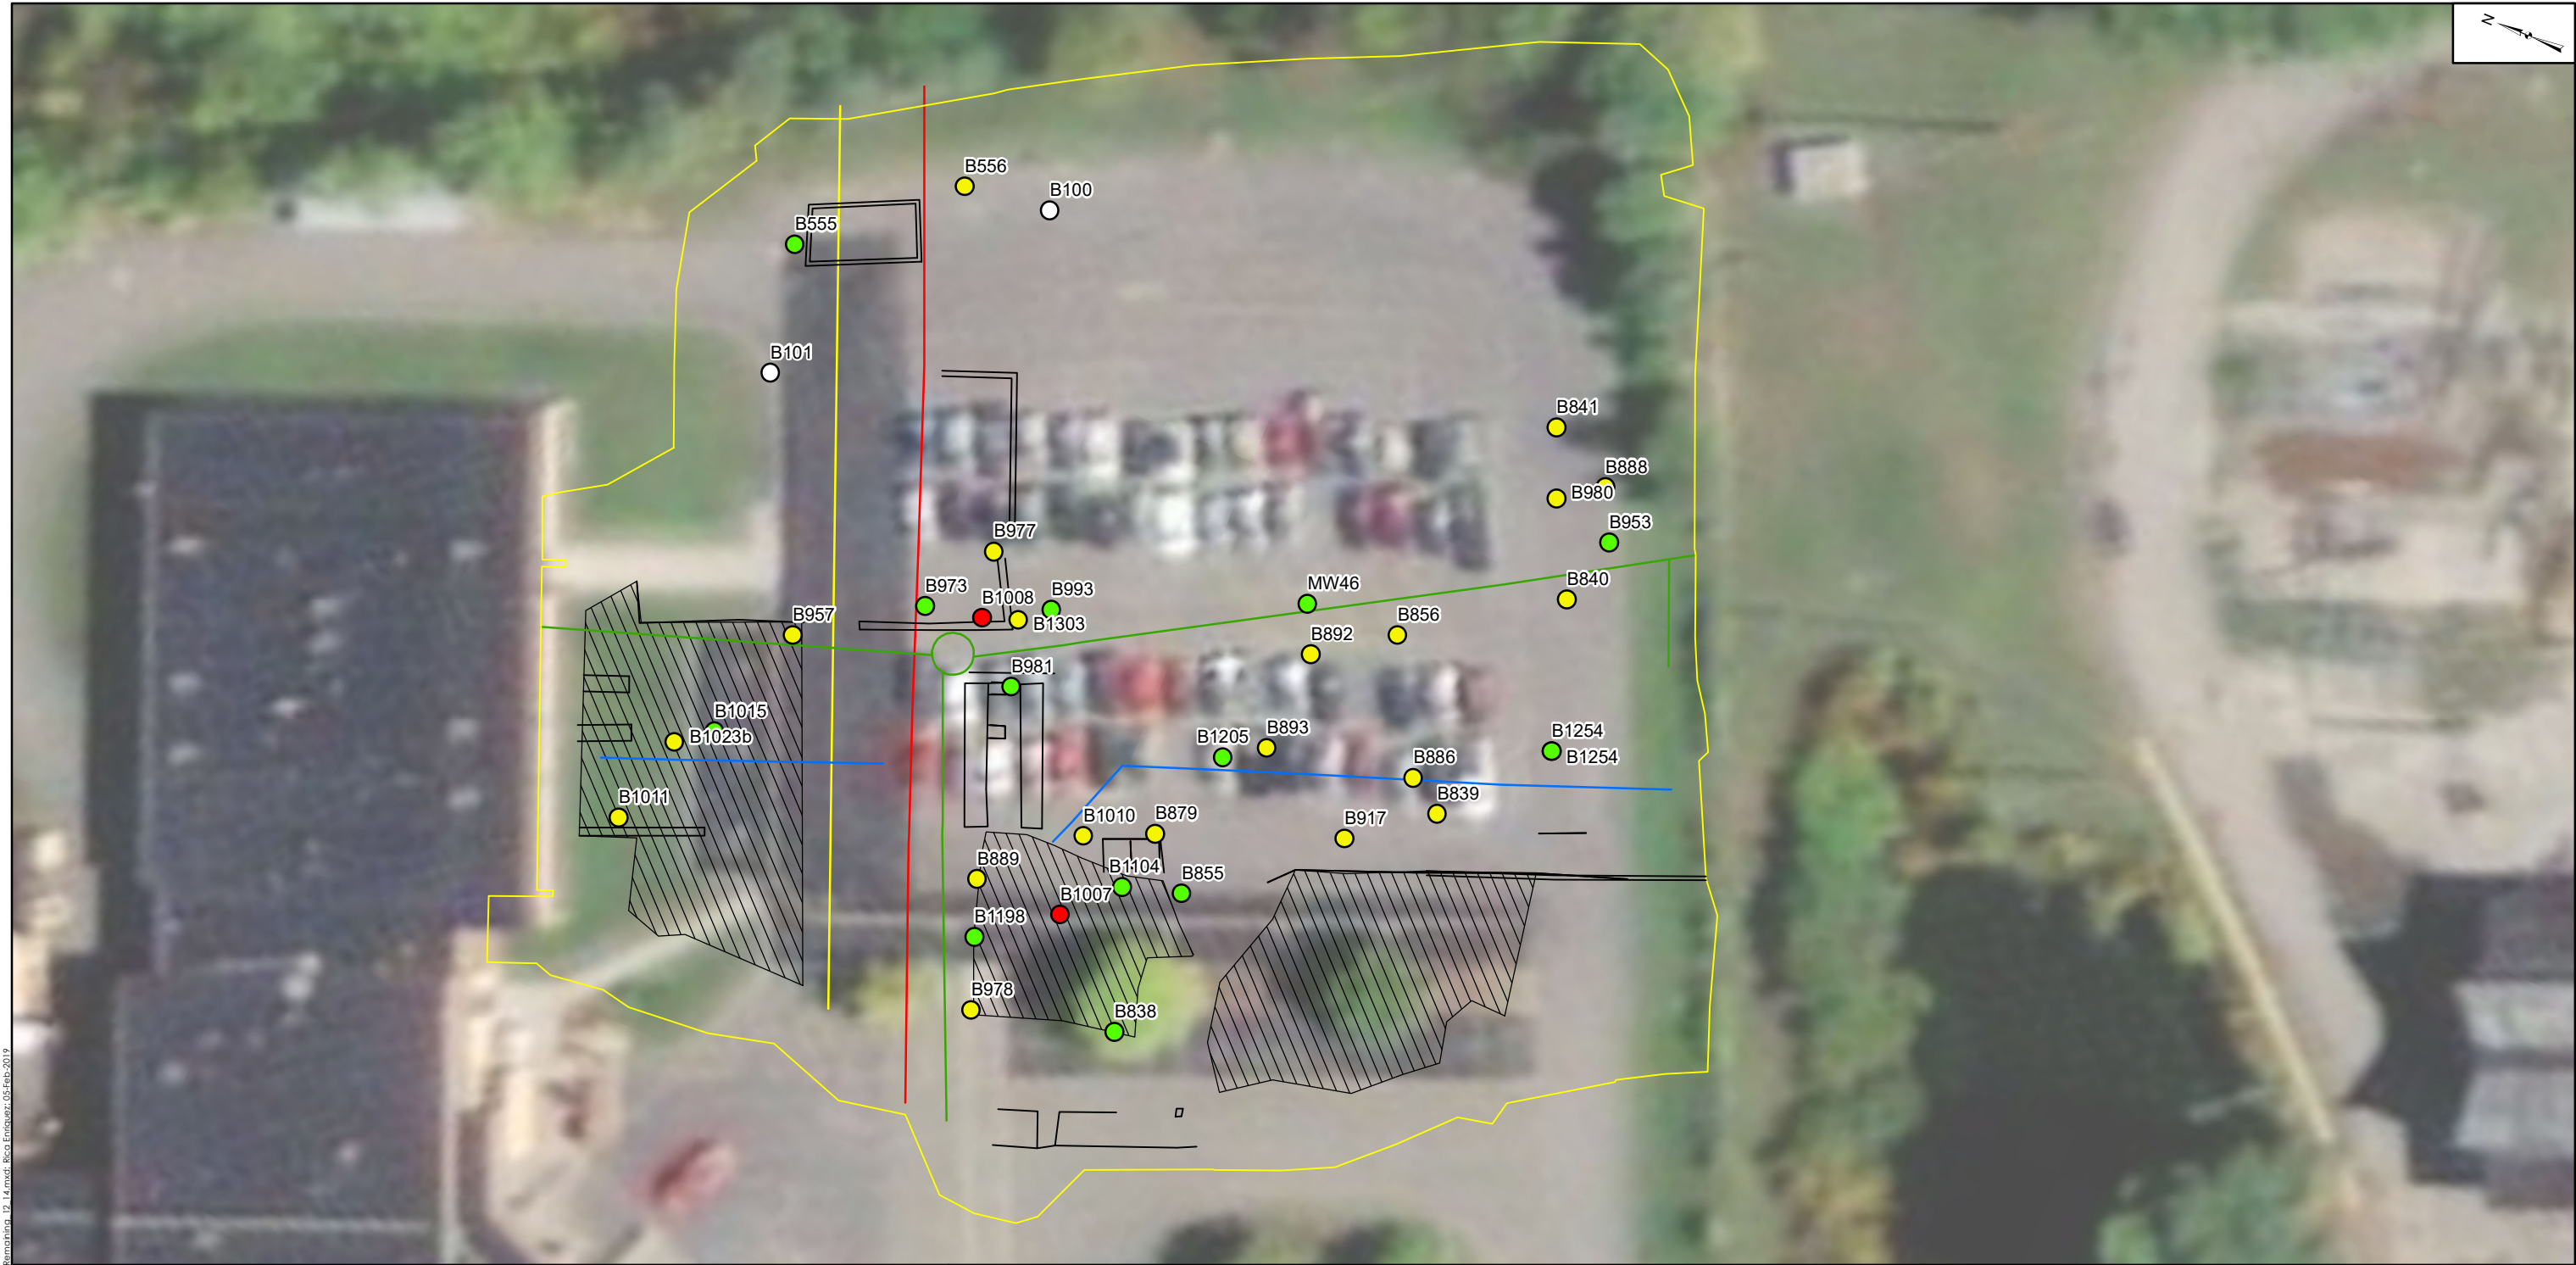
| <div>Legend</div> <div>Total PCB Concentration</div> <div><div><div></div>Non-Detect</div><div><div></div>&lt; 1 mg/kg</div><div><div></div>1-10 mg/kg</div><div><div></div>10-50 mg/kg</div><div><div></div>&gt; 50 mg/kg</div></div> <div><div>Concrete Feature</div><div>Overall Extent of Excavation (As-Built)</div><div><div>Limit of excavation (As-Built)</div><div>Concrete</div></div><div>Utilities (As-Built)</div><div><div>Electric</div><div>Gas</div><div>Storm</div><div>Water</div></div></div> | | | <div>Notes:</div> <div>PCB - Polychlorinated Biphenyl</div> <div>ft bgs - Feet below ground surface</div> <div>mg/kg - milligram per kilogram</div> <div>"SSHS-" prefix removed from locations.</div> <div>Aerial imagery accessed via ArcGIS Online on 05 February 2019.</div> | | <div>4020040 Feet</div> <div>PCB Contamination Remaining on Site - Rear Parking Lot (12-14 ft bgs)</div> <div>Former Sperry Remington - North Portion #808022</div> <div>Elmira, New York</div> | |

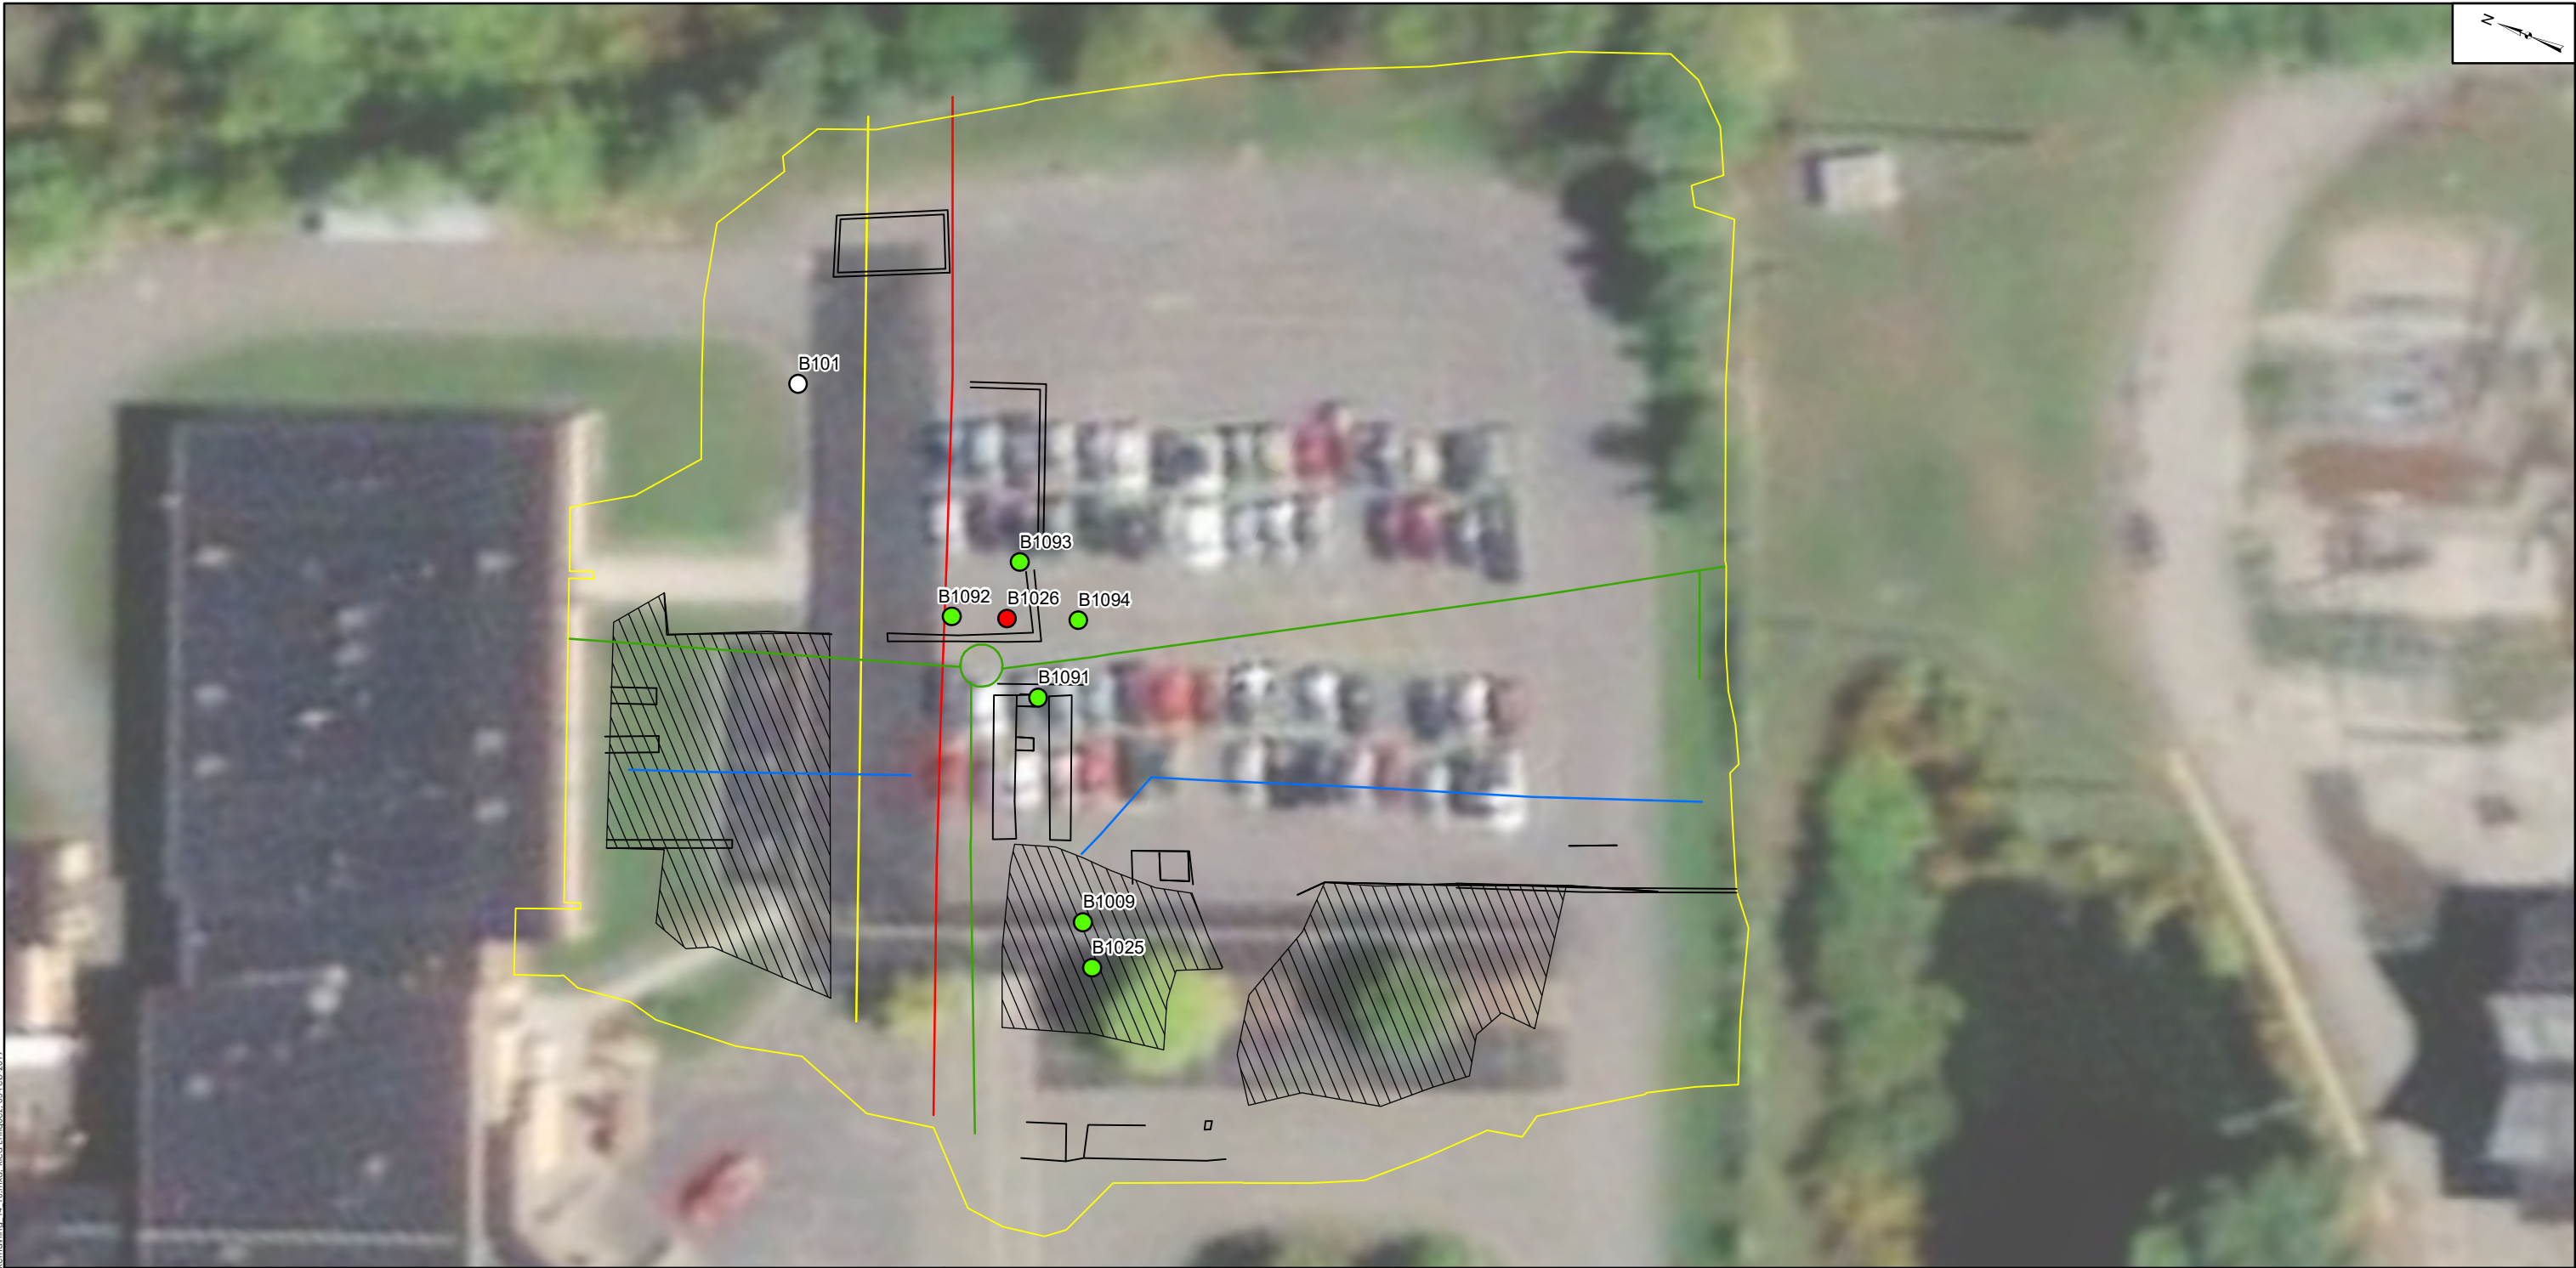
| <div>Legend</div> <div><div>Total PCB Concentration</div><div><div><div>○</div>Non-Detect</div><div><div><div>●</div>&lt; 1 mg/kg</div><div><div><div>●</div>1-10 mg/kg</div><div><div><div>●</div>10-50 mg/kg</div><div><div><div>●</div>&gt; 50 mg/kg</div></div></div></div><div><div>Concrete Feature</div><div><div>Overall Extent of Excavation (As-Built)</div><div><div>Concrete</div></div></div></div><div><div>Utilities (As-Built)</div><div><div>Electric</div><div>Gas</div><div>Storm</div><div>Water</div></div></div></div></div></div> | | <div>Notes:</div> <div>PCB - Polychlorinated Biphenyl</div> <div>ft bgs - Feet below ground surface</div> <div>mg/kg - milligram per kilogram</div> <div>"SSHS-" prefix removed from locations.</div> <div>Aerial imagery accessed via ArcGIS Online on 05 February 2019.</div> | <div>4020040 Feet</div> <div><div>PCB Contamination Remaining on Site - Rear Parking Lot (14-16 ft bgs)</div><div>Former Sperry Remington - North Portion #808022</div><div>Elmira, New York</div></div> | |

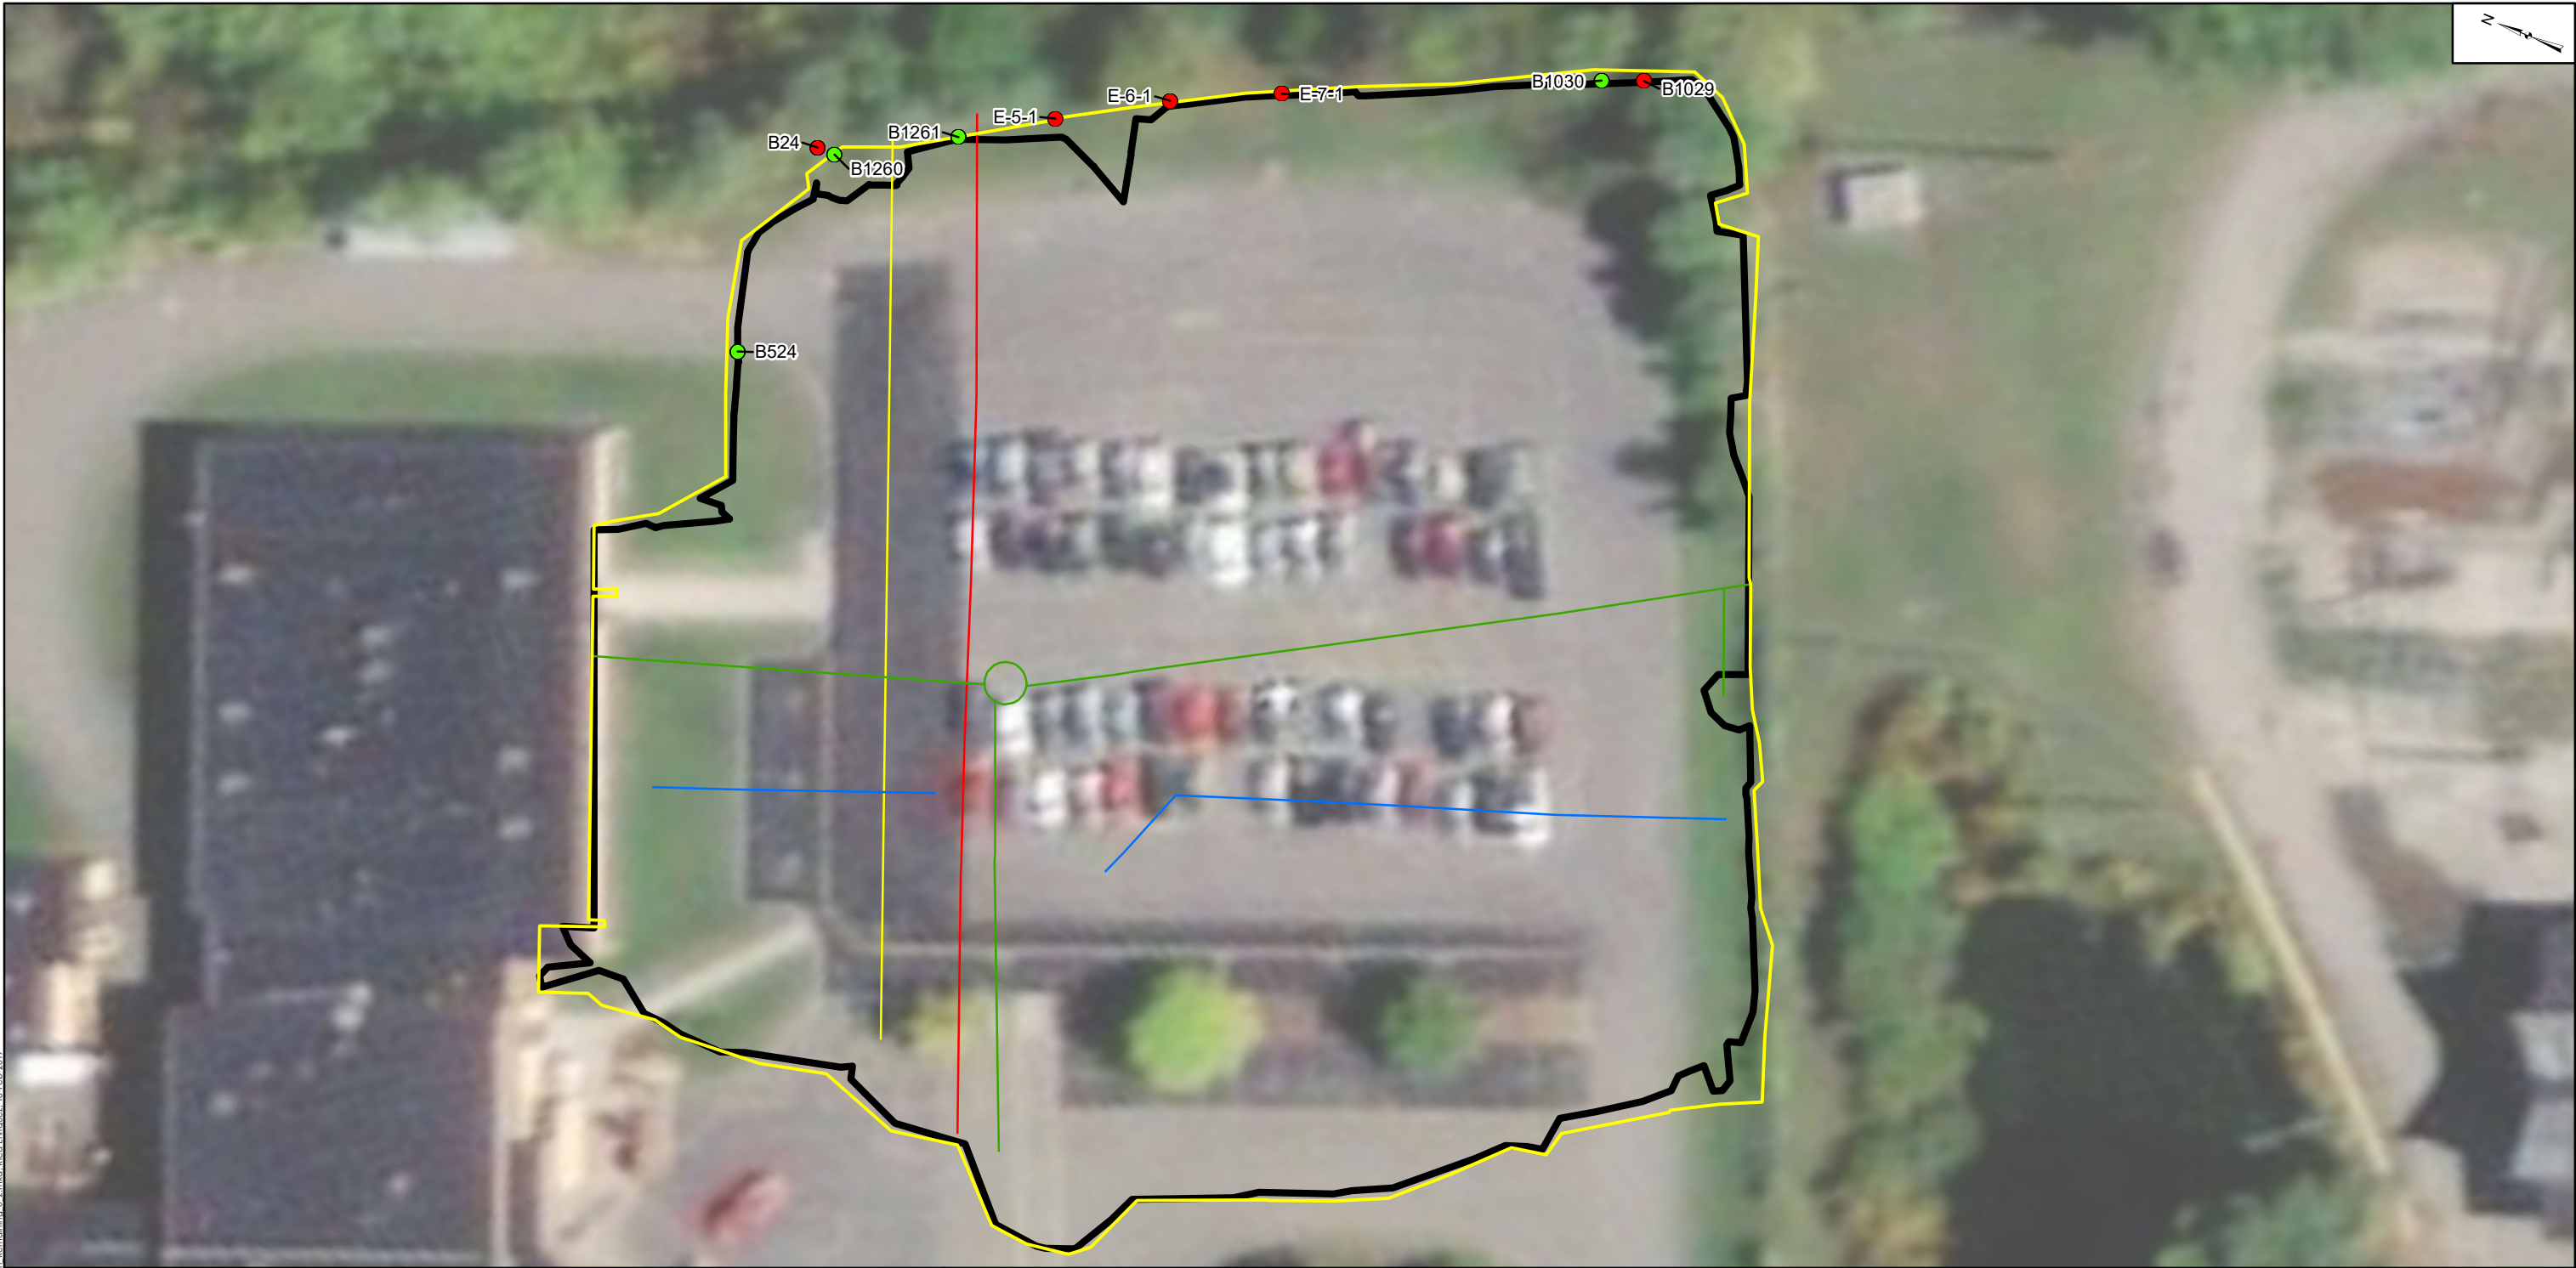
| <b>Overall Extent of Excavation (As-Built)</b><br>—<br><b>Limit of excavation (As-Built)</b><br>— | | | | <b>Metals Contamination Remaining on Site - Rear Parking Lot (0-2 ft bgs)</b><br>Former Sperry Remington - North Portion #808022<br>Elmira, New York | |

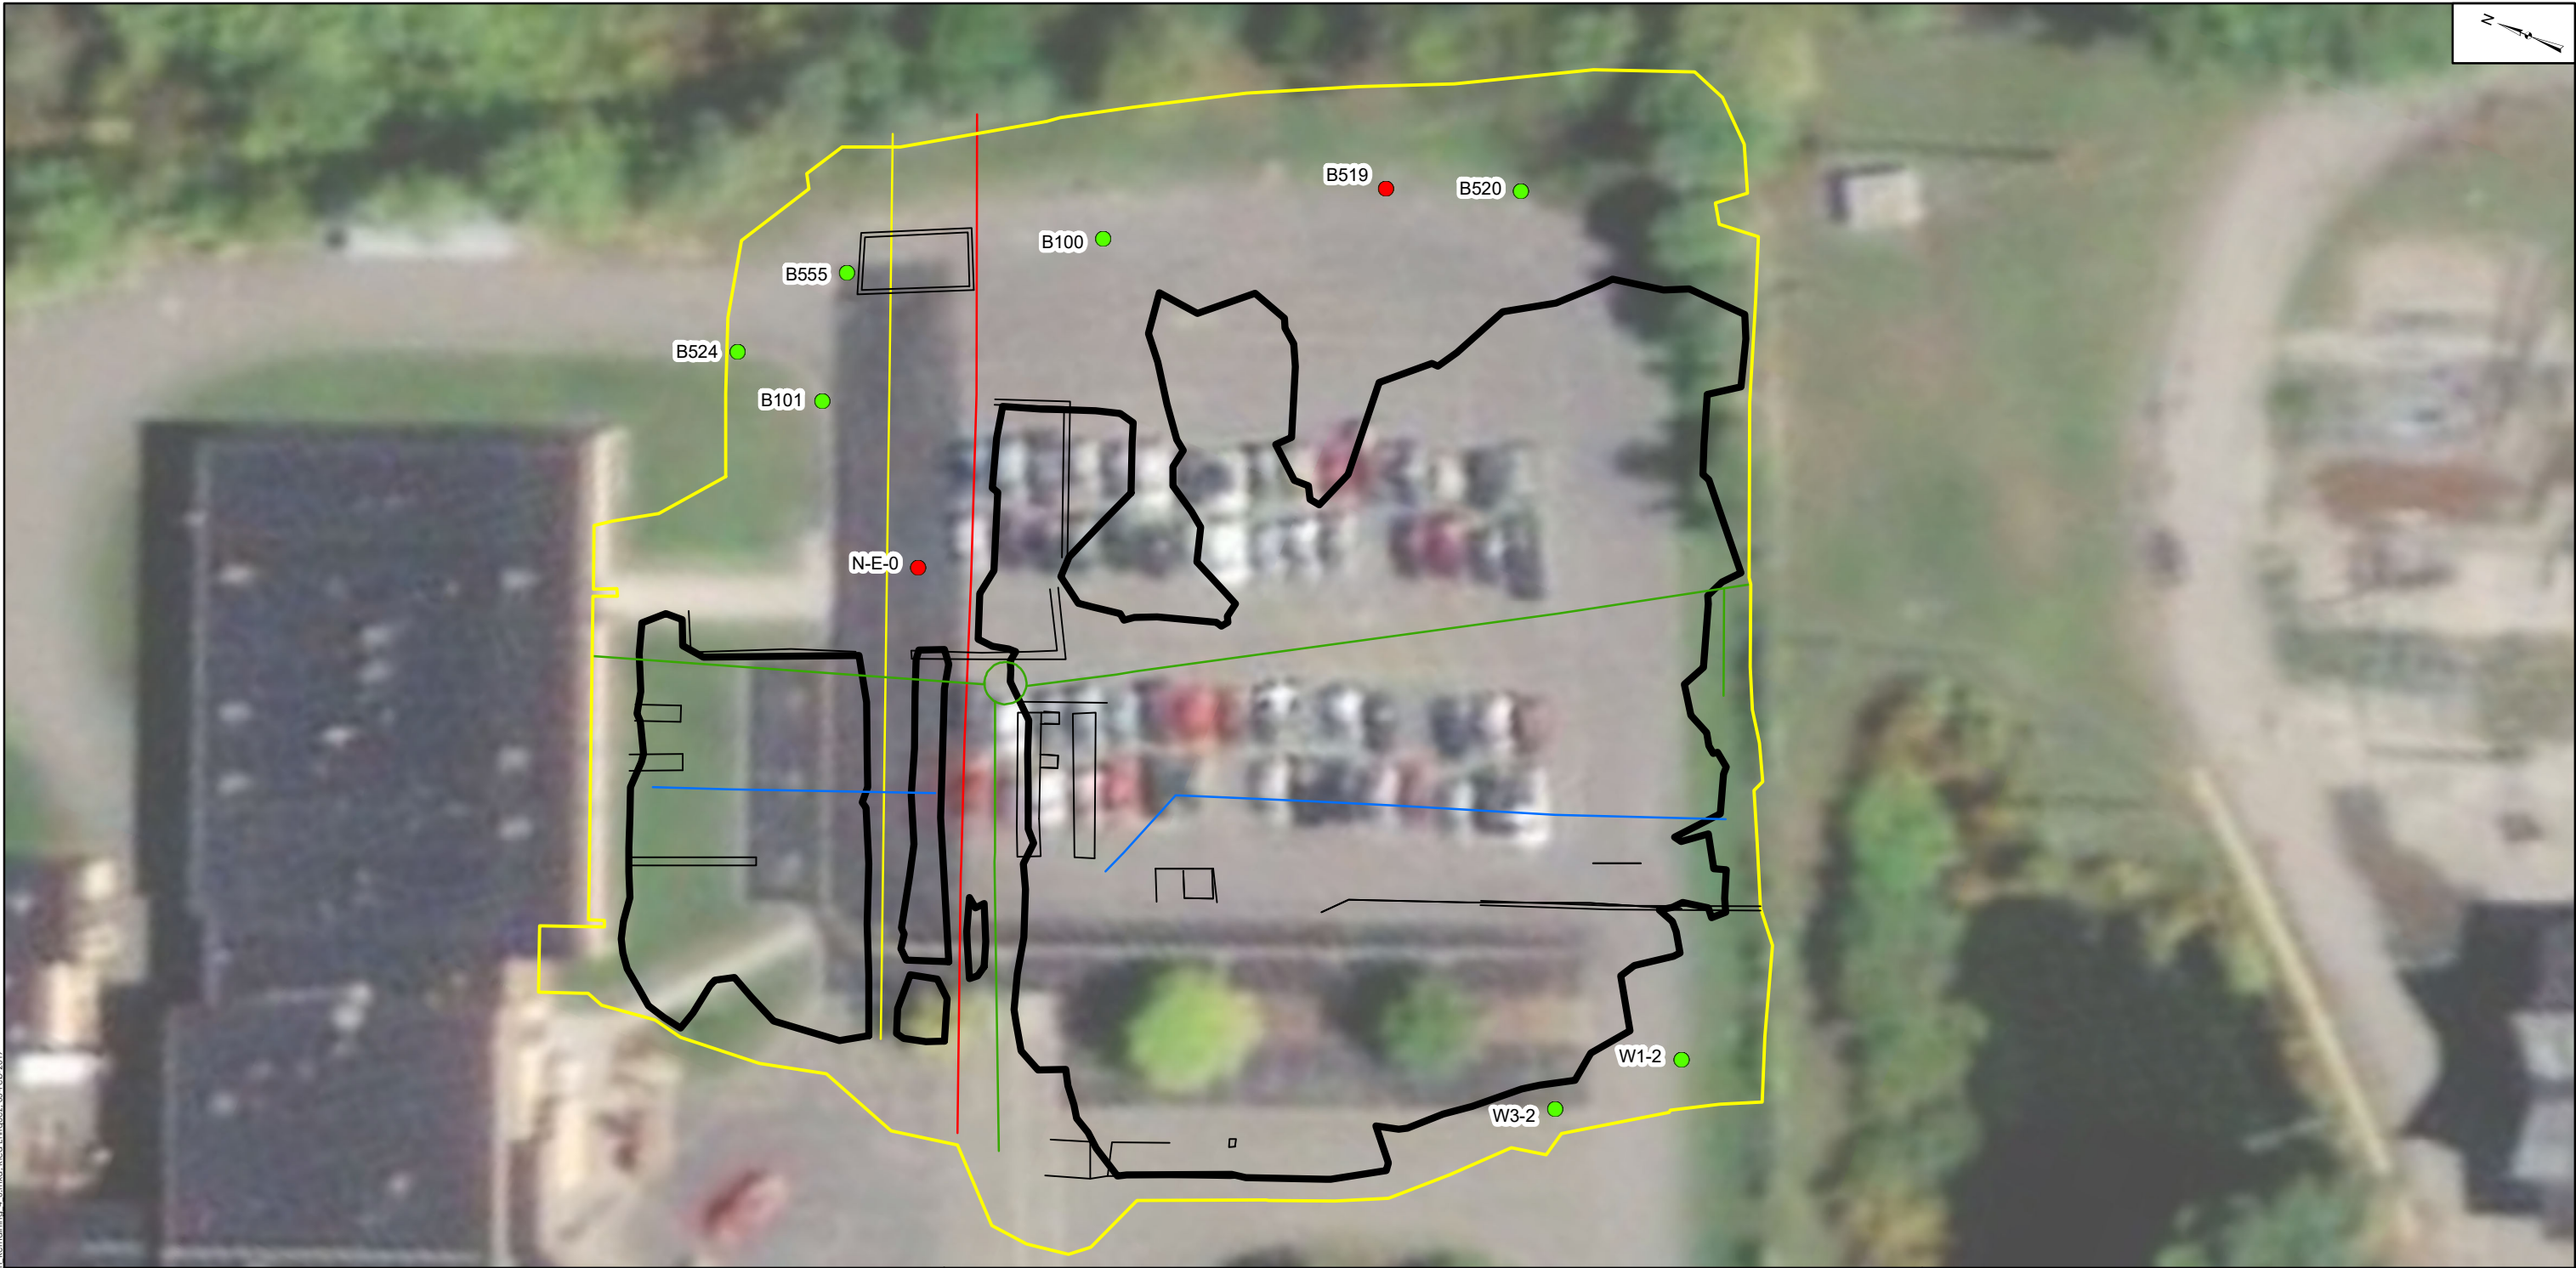
| Concrete Feature<br>Overall Extent of Excavation (As-Built)<br>Limit of excavation (As-Built) | | | | <b>Metals Contamination Remaining on Site - Rear Parking Lot (4-6 ft bgs)</b><br>Former Sperry Remington - North Portion #808022<br>Elmira, New York | |
