| | <p><b>PCB Contamination Remaining on Site - Rear Parking Lot (0-2 ft bgs)</b></p> <p>Former Sperry Remington - North Portion #808022</p> <p>Elmira, New York</p> | | | |
| | <p>Beech and Bonaparte<br/>engineering p.c.<br/><i>an affiliate of Geosyntec Consultants</i></p> | | <p>Figure<br/><b>Q-1</b></p> | |

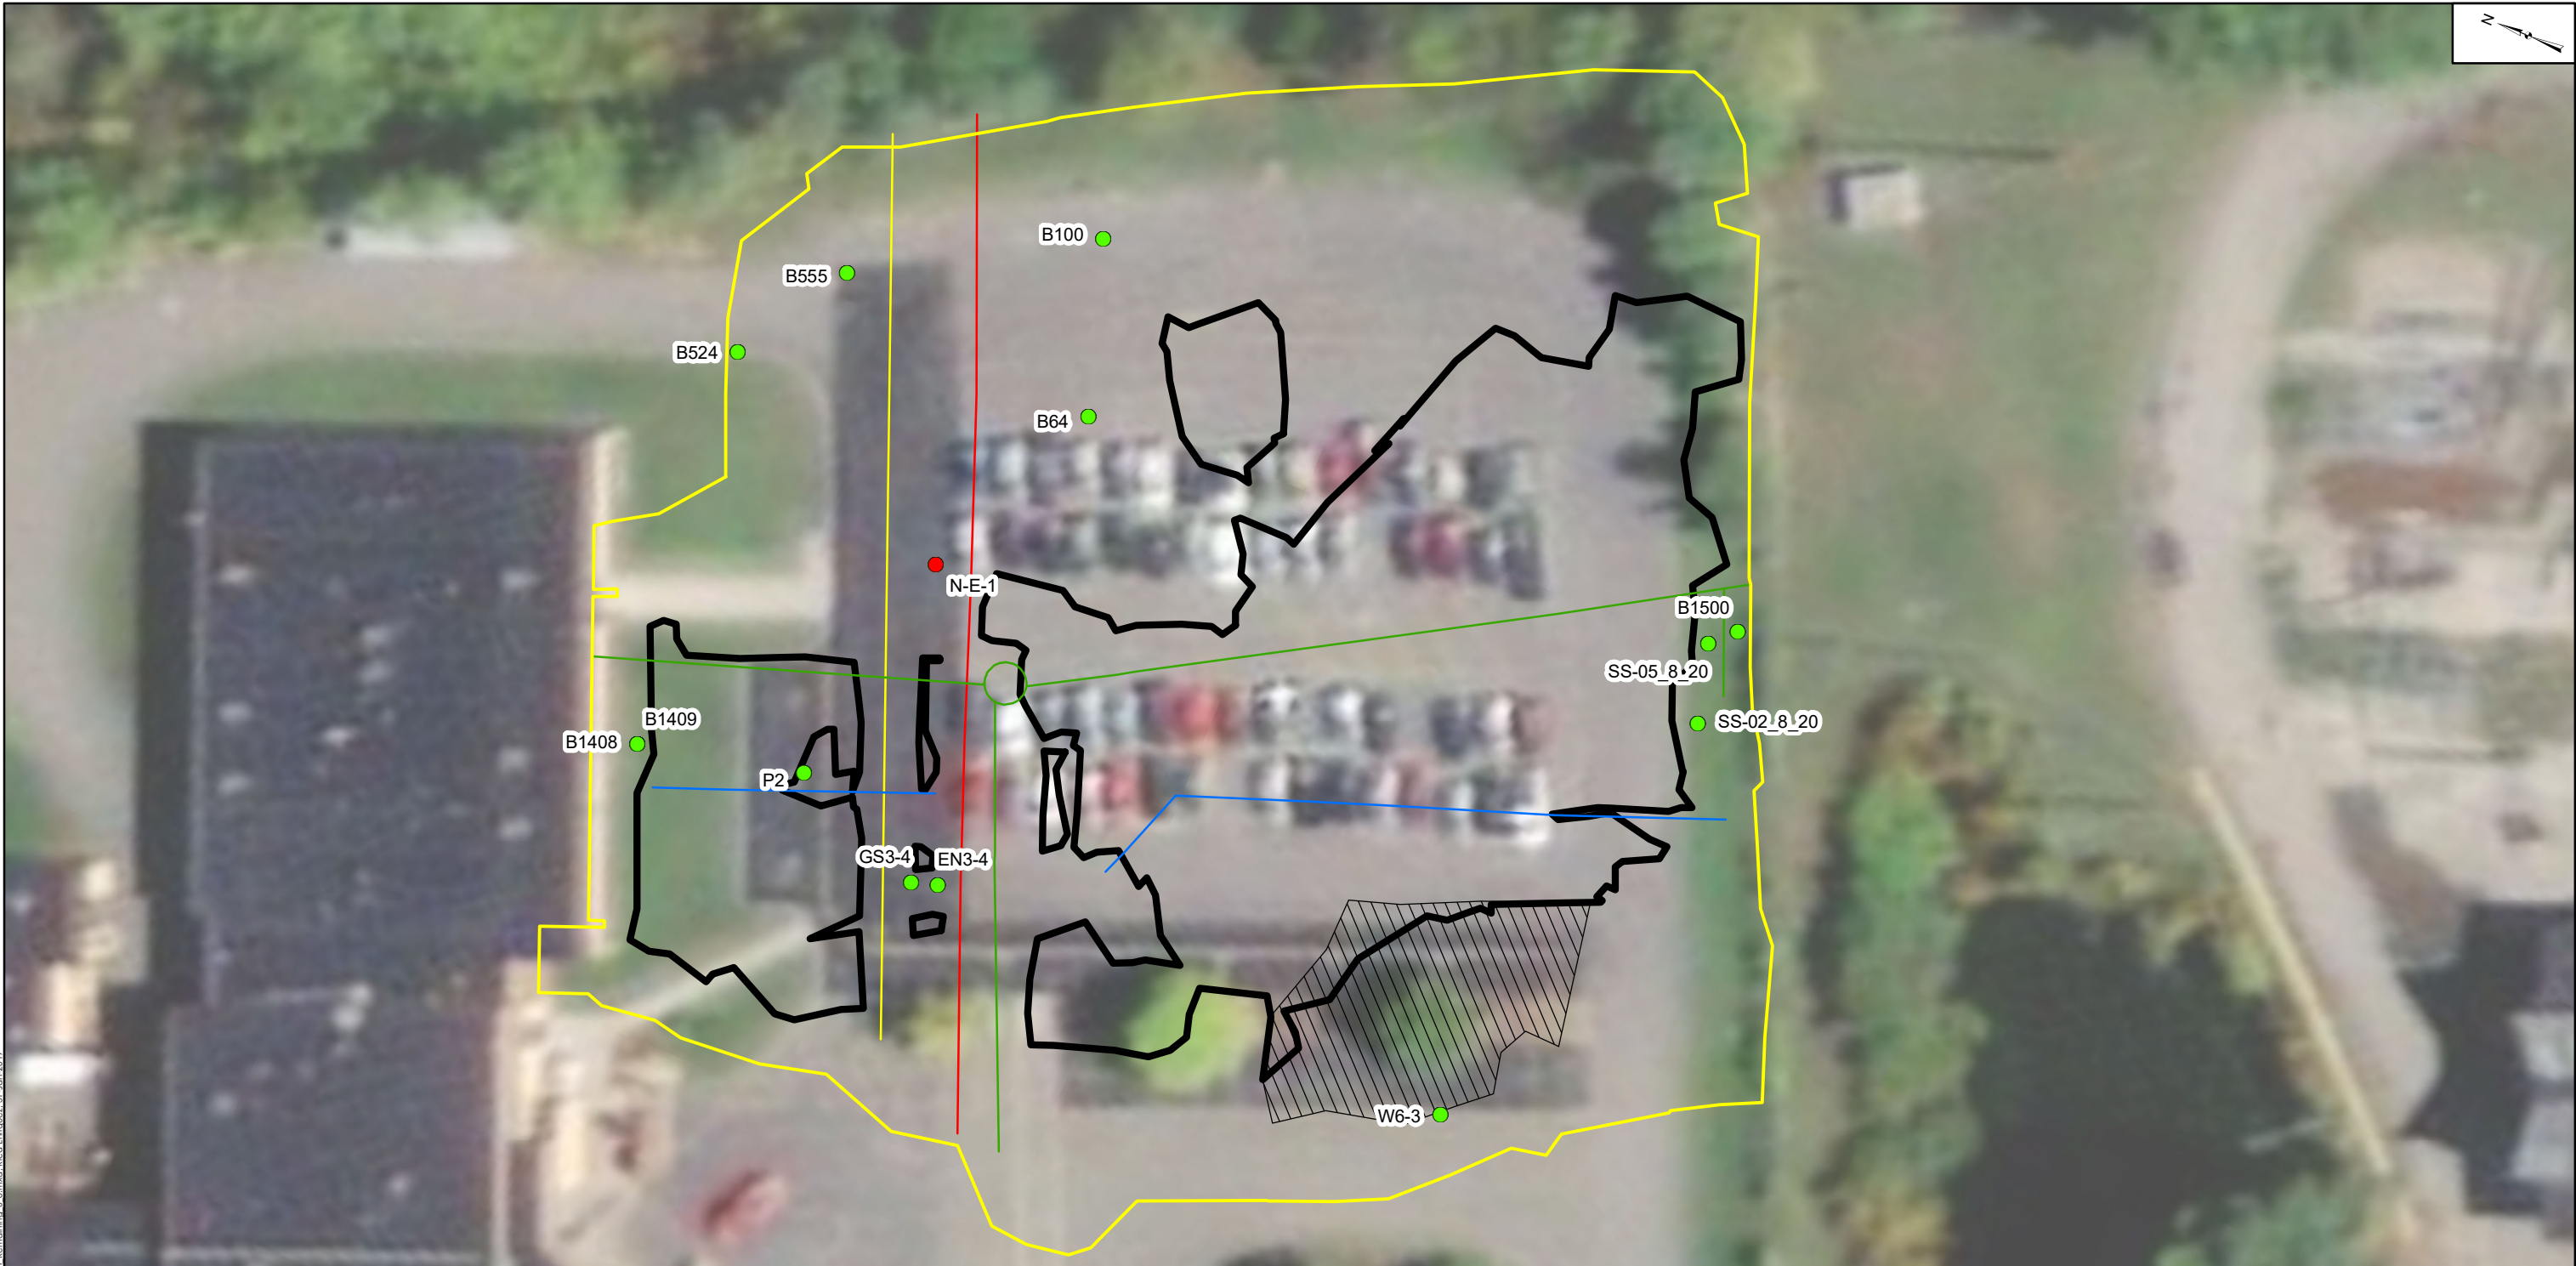
| <div>Legend</div> <div><div>Metals in Soils</div><div><div><div>○</div>Non-Detect</div><div><div>●</div>Detected, Below SCO</div><div><div>●</div>Exceeds SCO</div></div></div> <div><div><div>Overall Extent of Excavation (As-Built)</div><div>Limit of excavation (As-Built)</div><div>Concrete</div></div></div> <div><div>Utilities (As-Built)</div><div><div>Electric</div><div>Gas</div><div>Storm</div><div>Water</div></div></div> | | <div>Notes:</div> <div>ft bgs - Feet below ground surface</div> <div>"SSHS-" prefix removed from locations.</div> <div>SCO - Soil Cleanup Objective (Table 375-6.8(b) in 6 NYCRR PART 375)</div> <div>"SSHS-" prefix removed from locations.</div> <div>Aerial imagery accessed via ArcGIS Online on 31 January 2019.</div> | <div><div>4020040 Feet</div><div><div>Metals Contamination Remaining on Site - Rear Parking Lot (6-8 ft bgs)</div><div>Former Sperry Remington - North Portion #808022</div><div>Elmira, New York</div></div></div> |

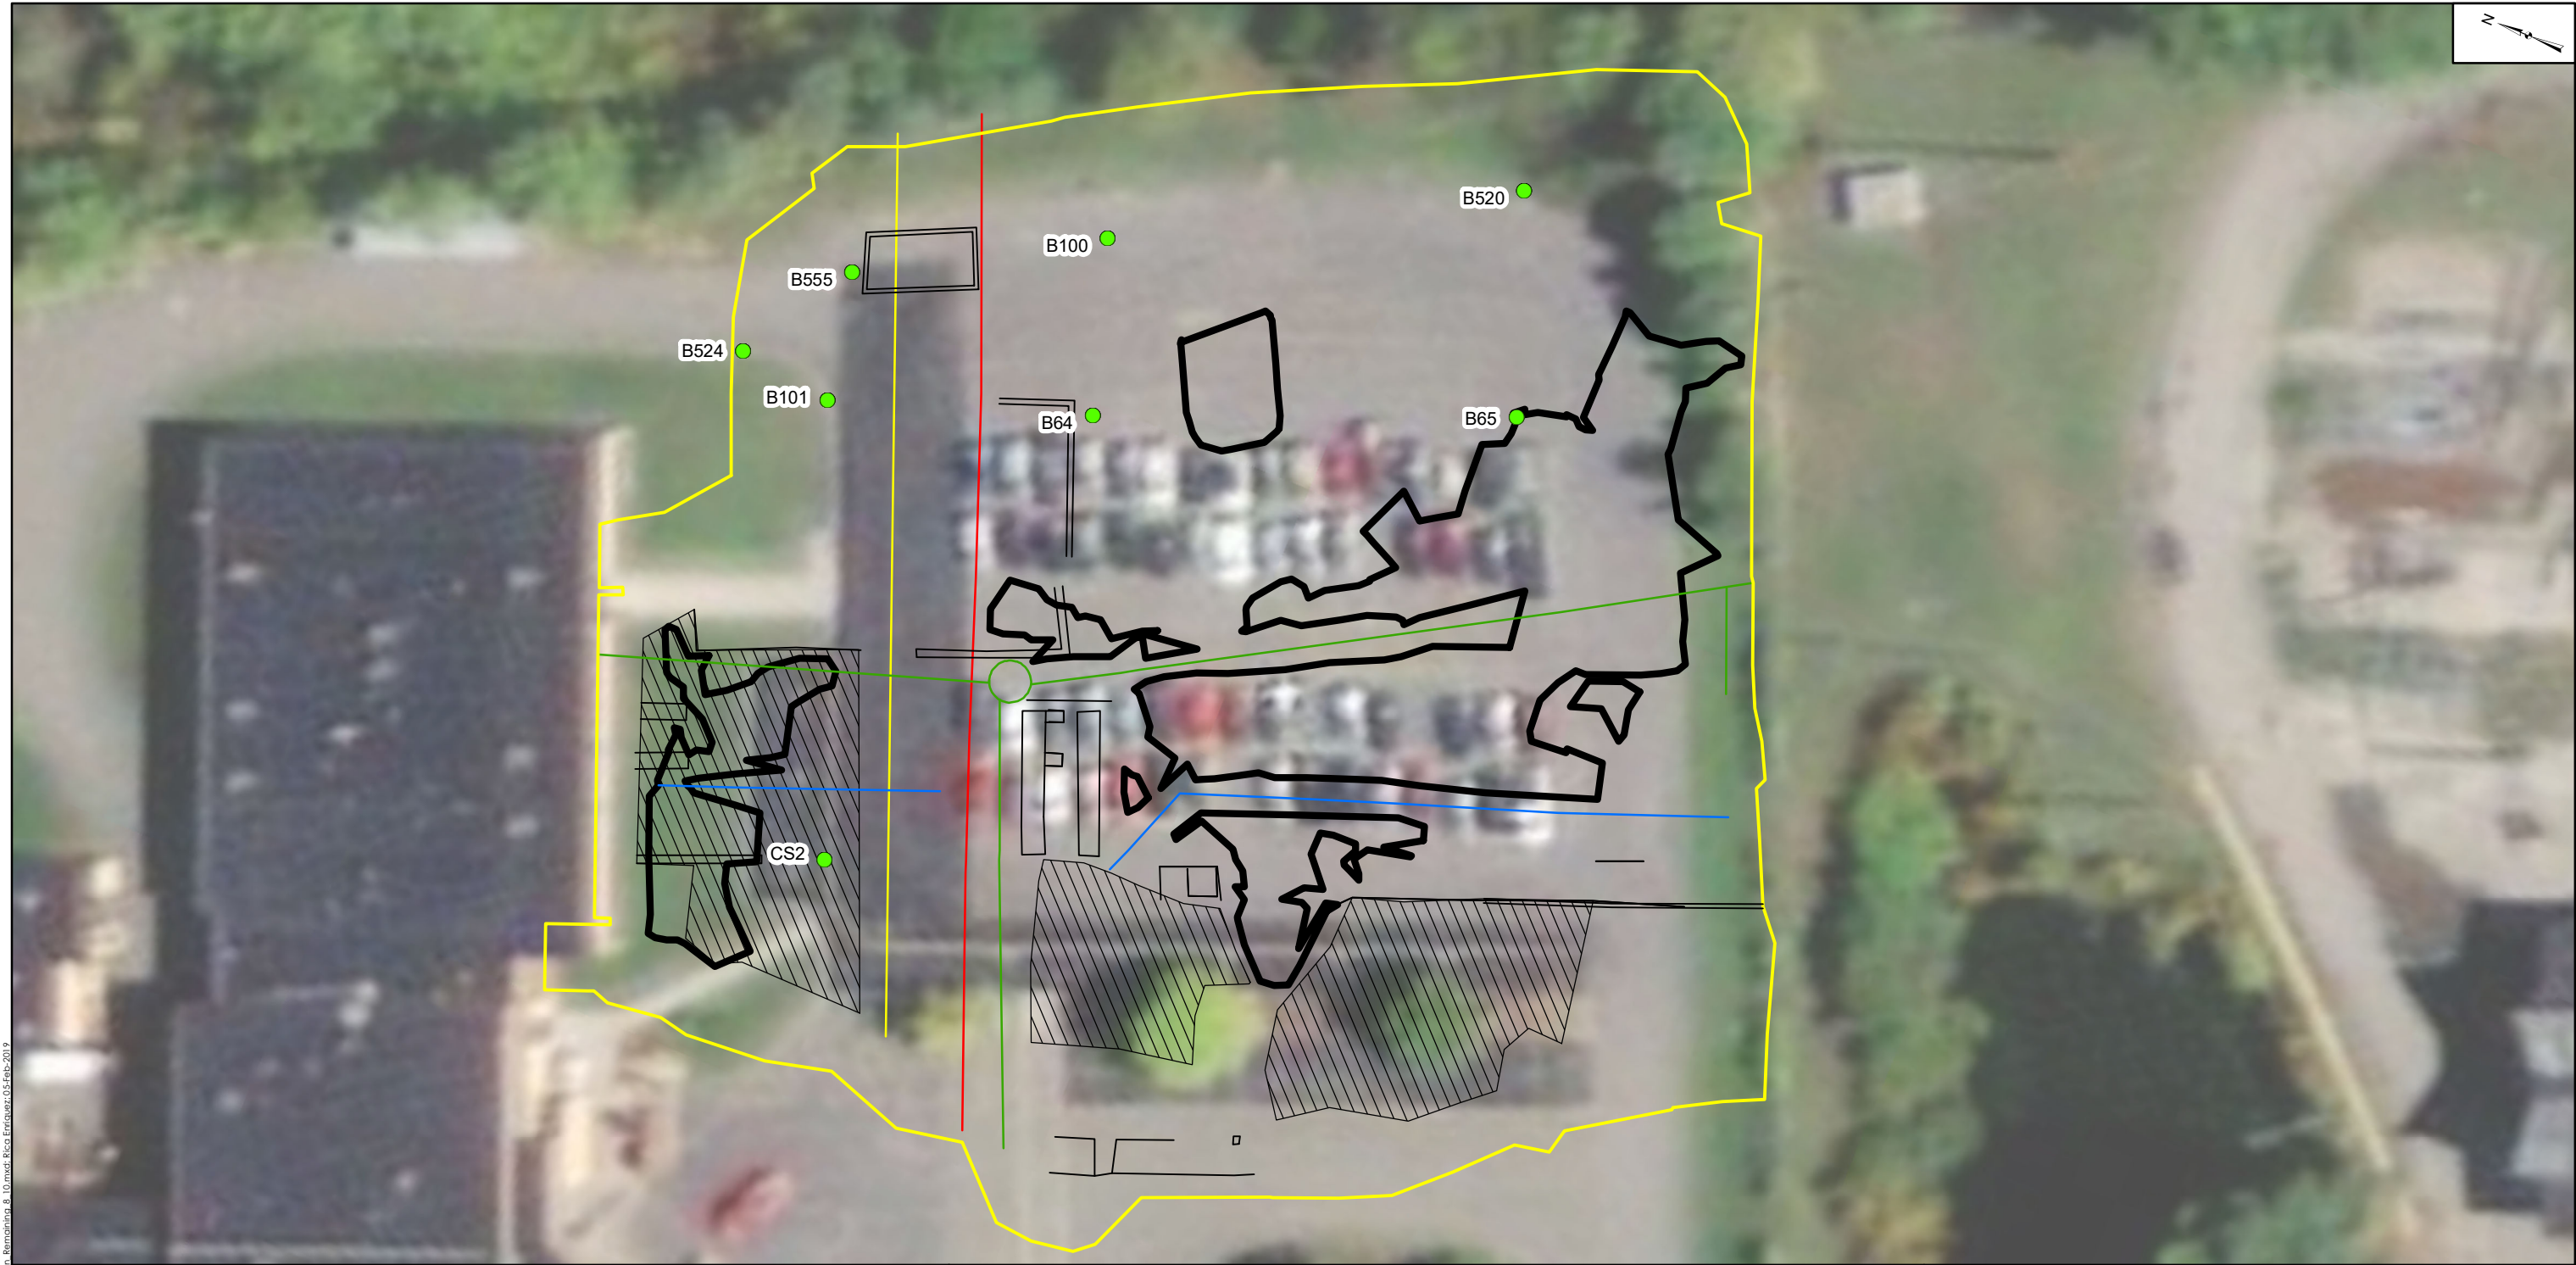
| <div>Legend</div> <div>Metals in Soils</div> <div><div><div></div><div>Non-Detect</div></div><div><div></div><div>Detected, Below SCO</div></div><div><div></div><div>Exceeds SCO</div></div></div> <div><div><div></div><div>Concrete Feature</div></div><div><div></div><div>Overall Extent of Excavation (As-Built)</div></div><div><div></div><div>Limit of excavation (As-Built)</div></div><div><div></div><div>Concrete</div></div></div> <div><div>Utilities (As-Built)</div><div><div></div><div>Electric</div></div><div><div></div><div>Gas</div></div><div><div></div><div>Storm</div></div><div><div></div><div>Water</div></div></div> | | | <div>Notes:</div> <div>ft bgs - Feet below ground surface</div> <div>"SSHS-" prefix removed from locations.</div> <div>SCO - Soil Cleanup Objective (Table 375-6.8(b) in 6 NYCRR PART 375)</div> <div></div> <div>"SSHS-" prefix removed from locations.</div> <div></div> <div>Aerial imagery accessed via ArcGIS Online on 05 February 2019.</div> | | | <div><div>4020040</div><div>Feet</div></div> <div></div> <div><div>Metals Contamination Remaining on Site - Rear Parking Lot (8-10 ft bgs)</div><div>Former Sperry Remington - North Portion #808022</div><div>Elmira, New York</div></div> <div><div><div>Beech and Bonaparte</div><div>engineering p.c.</div><div>an affiliate of Geosyntec Consultants</div></div><div><div>Columbia, Maryland</div><div>February 2019</div></div><div><div>Figure</div><div>Q-13</div></div></div> | | |

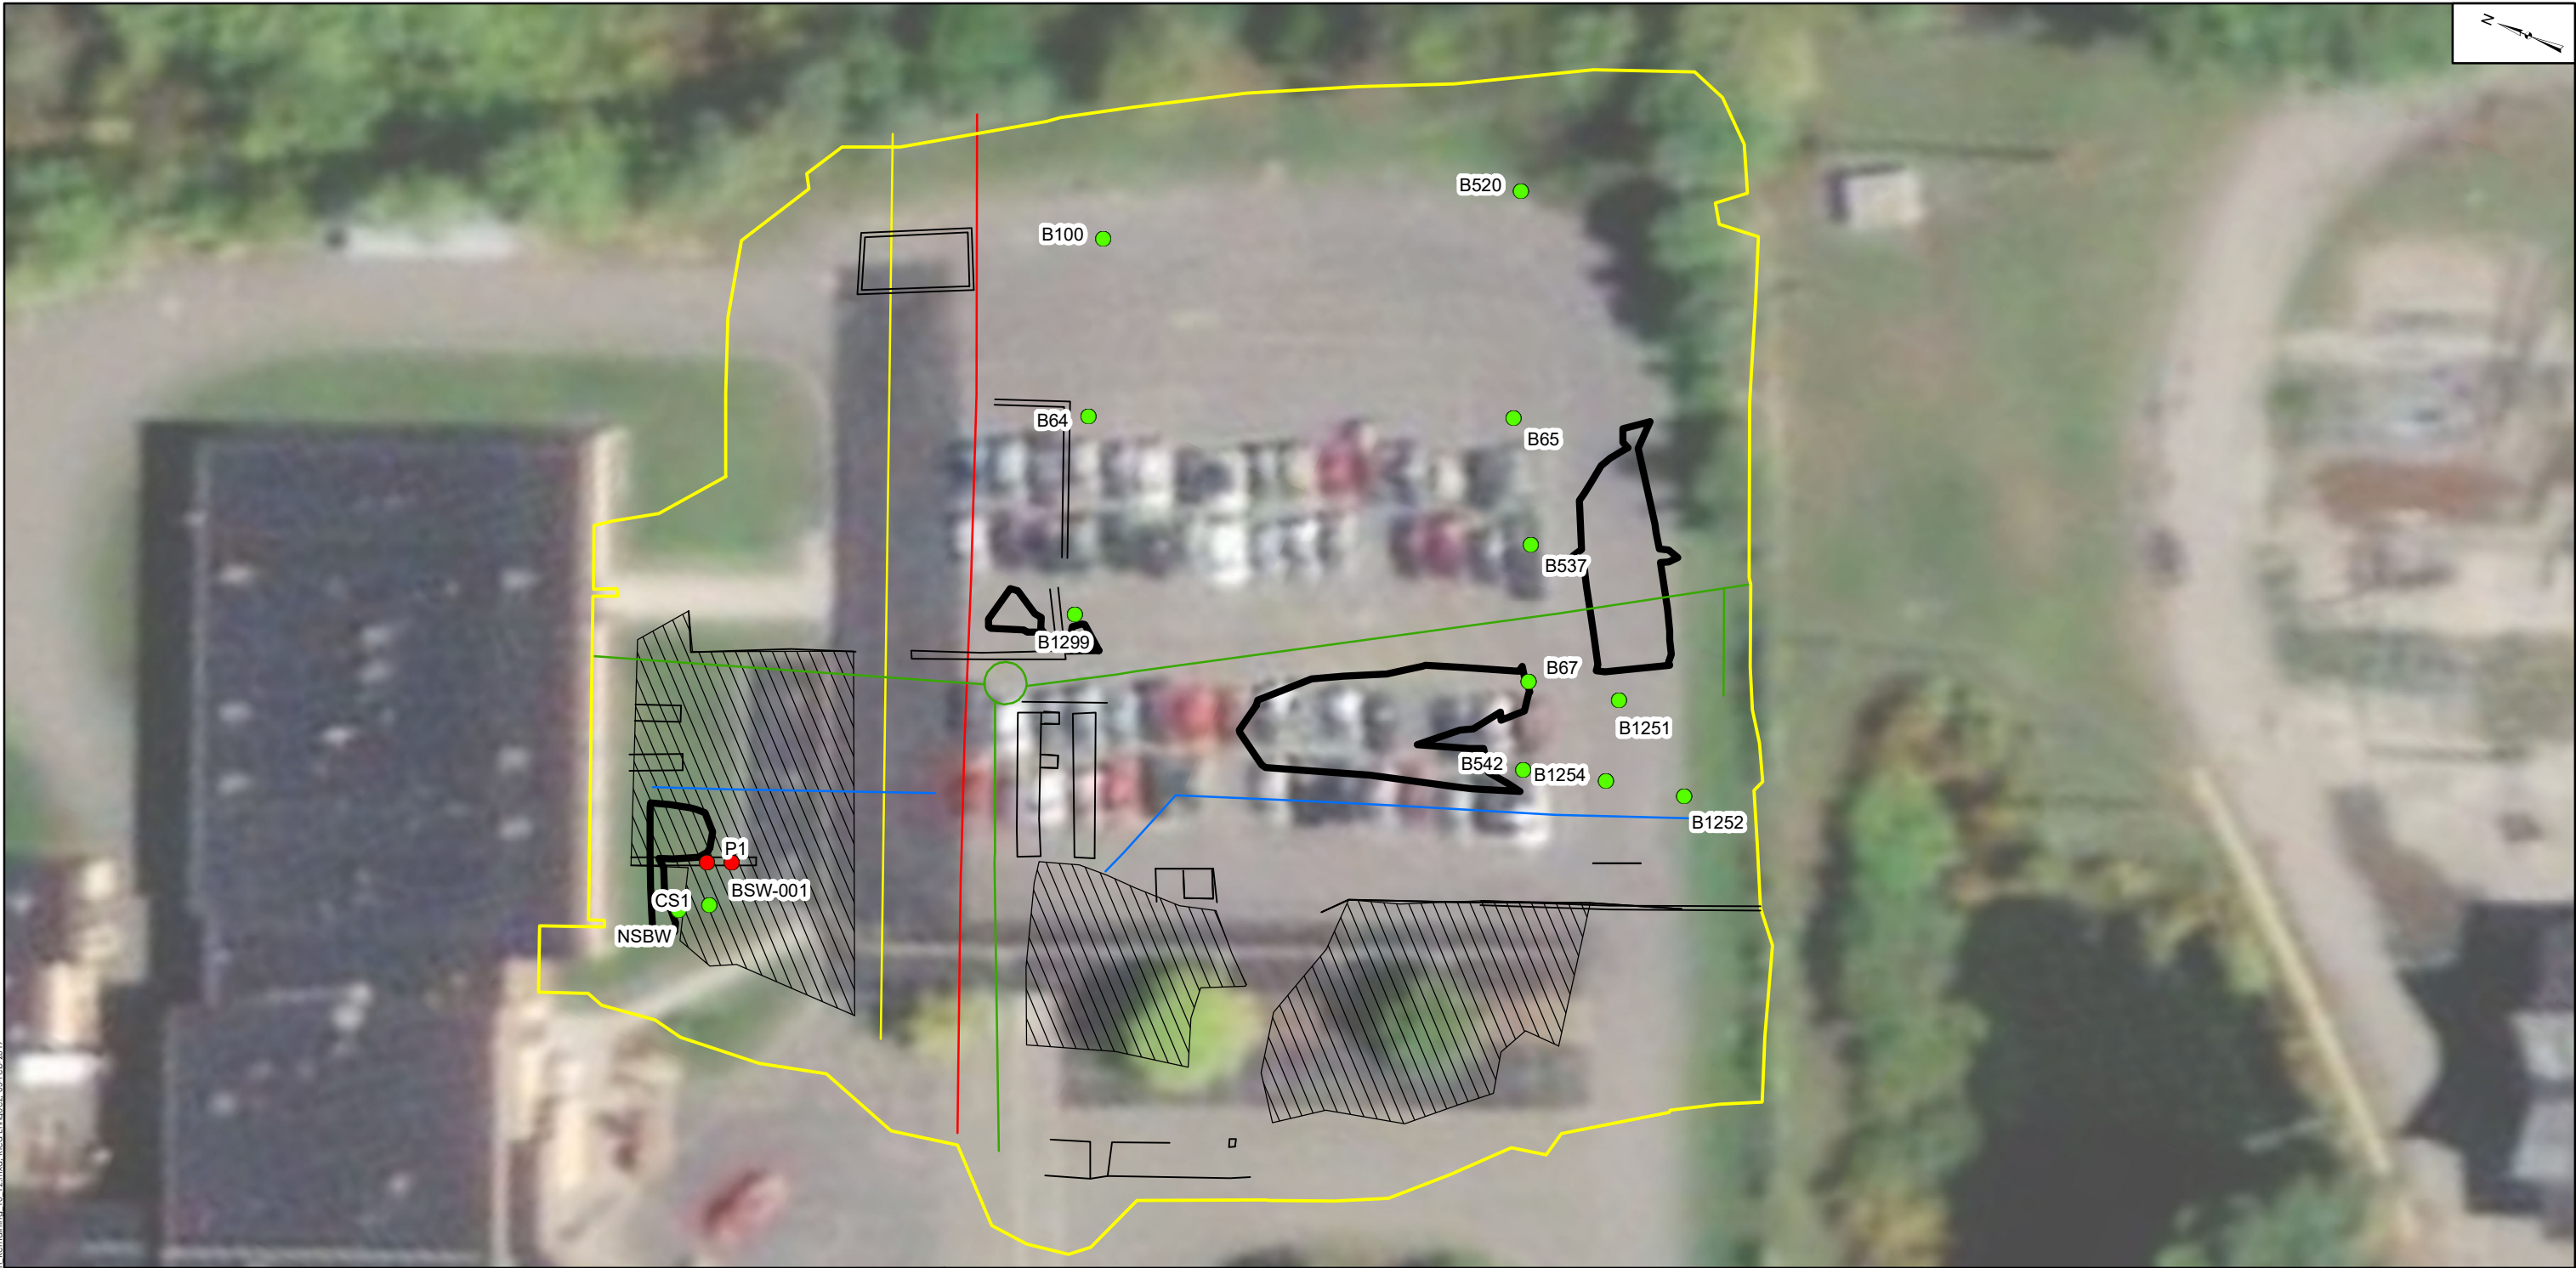
| <b>Metals in Soils</b><br><br>○ Non-Detect<br>● Detected, Below SCO<br>● Exceeds SCO | | | | <b>Metals Contamination Remaining on Site - Rear Parking Lot (10-12 ft bgs)</b><br>Former Sperry Remington - North Portion #808022<br>Elmira, New York | | |

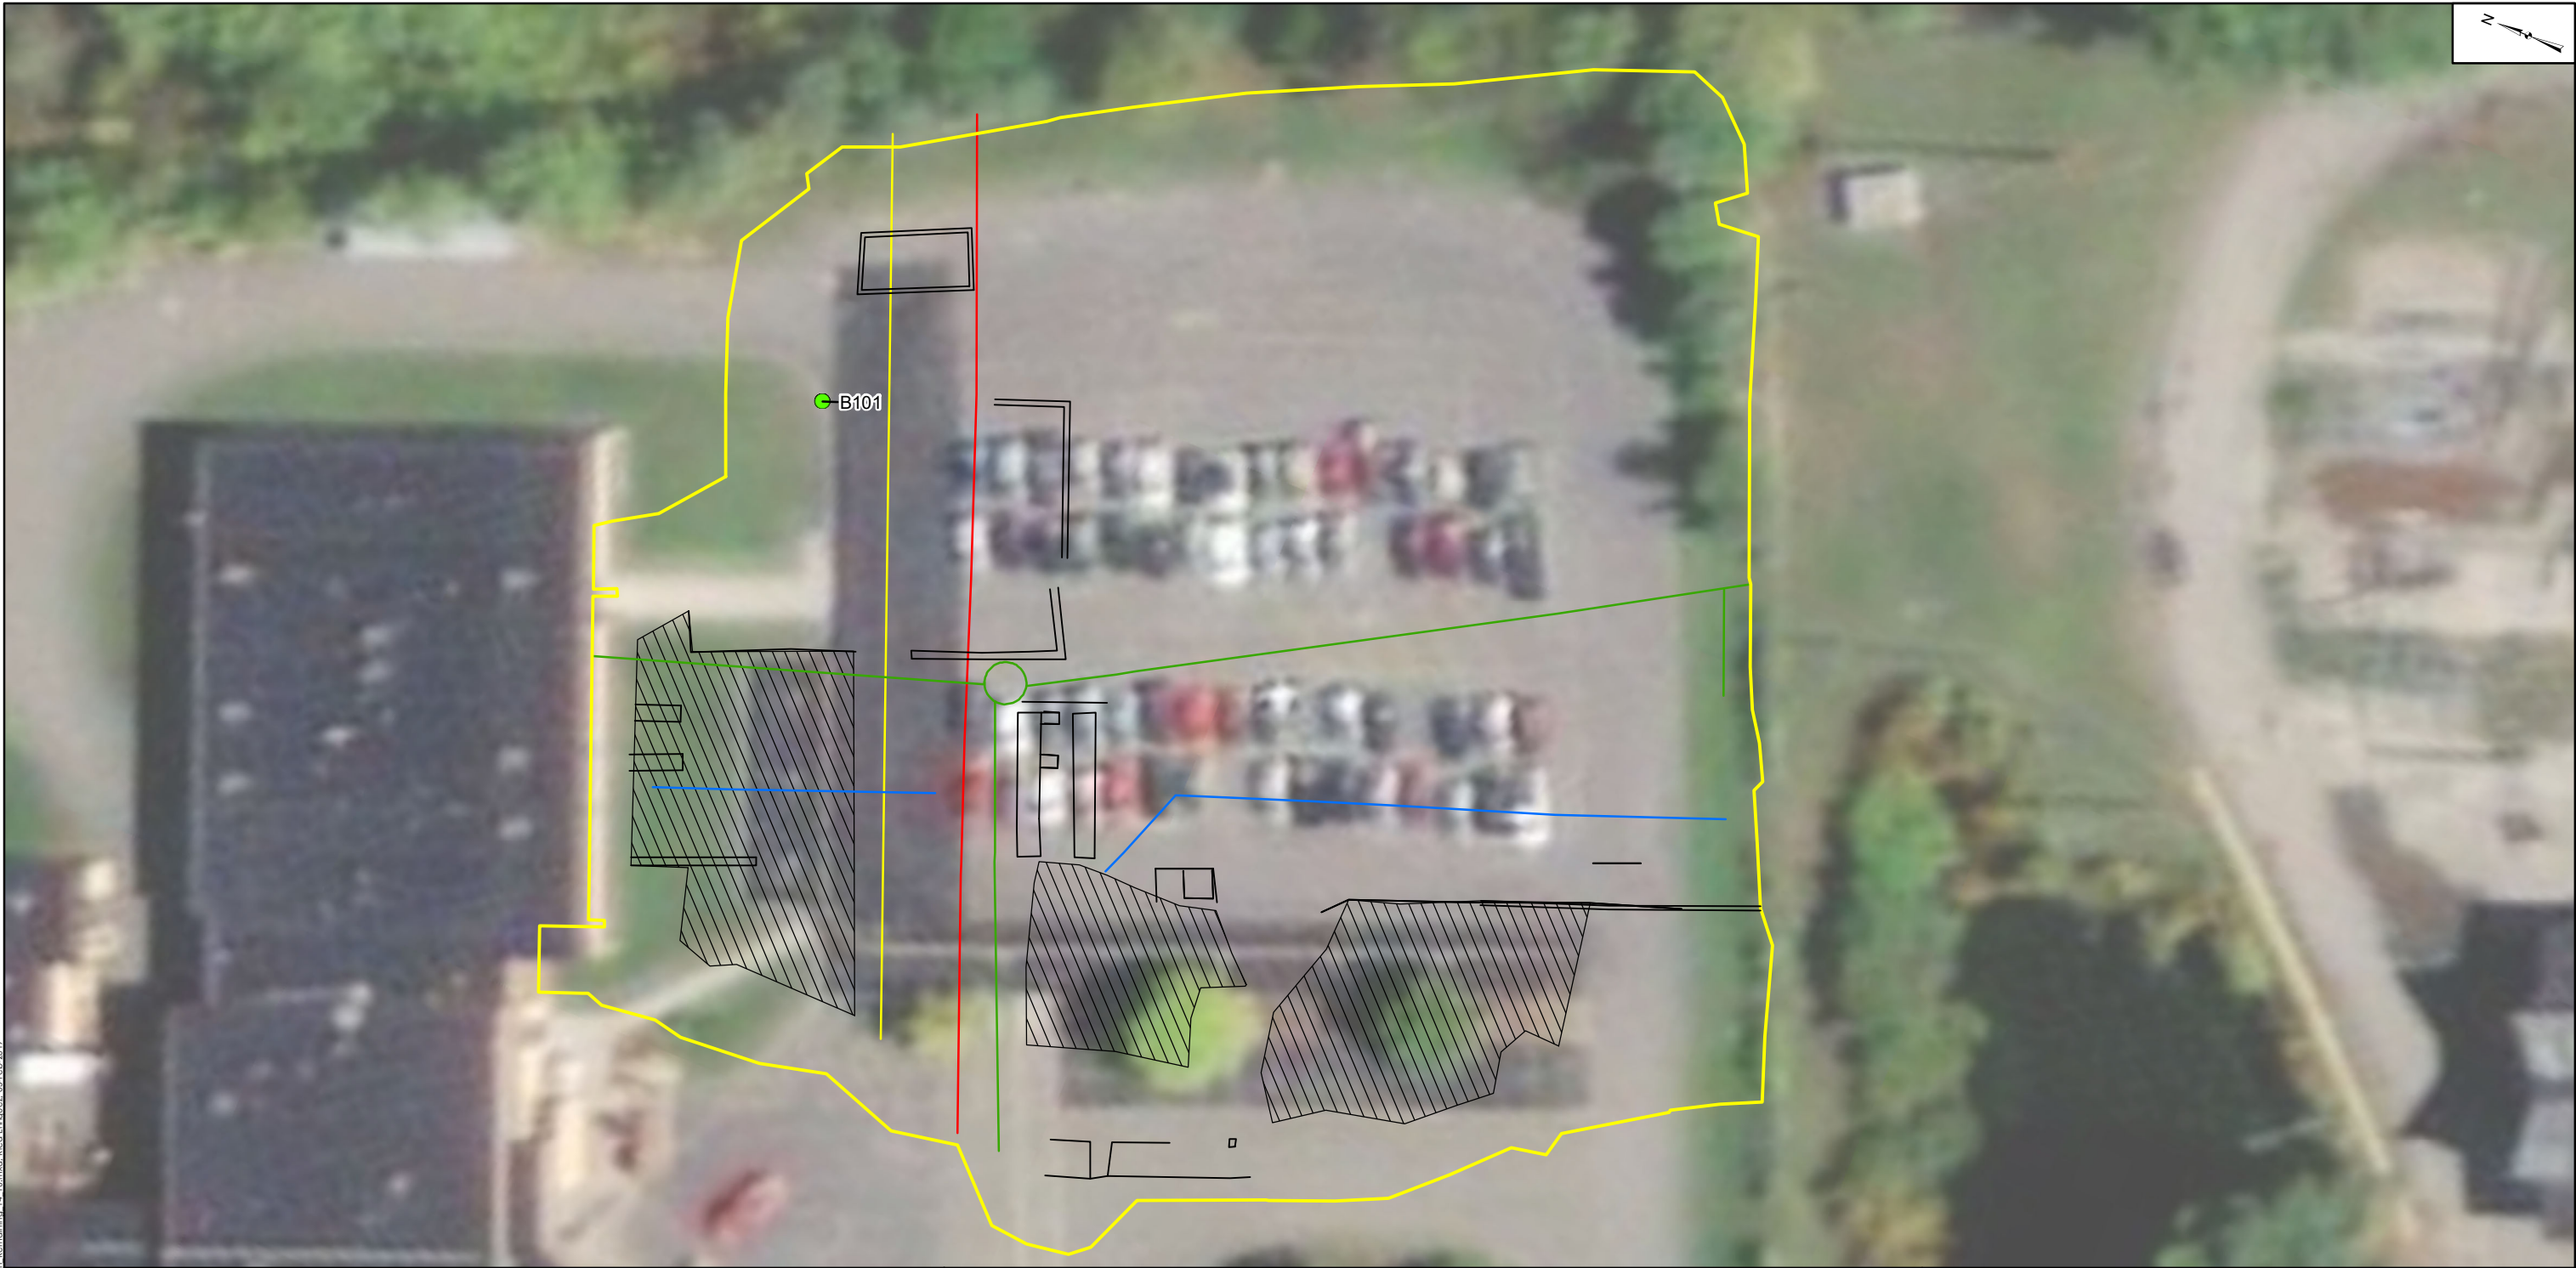
| <b>Metals in Soils</b><br><br><div><div></div>Non-Detect</div> <div><div></div>Detected, Below SCO</div> <div><div></div>Exceeds SCO</div> | | | <div>Concrete Feature</div> <div>Overall Extent of Excavation (As-Built)</div> <div>Limit of excavation (As-Built)</div> <div>Concrete</div> | | | <b>Utilities (As-Built)</b><br><div>Electric</div> <div>Gas</div> <div>Storm</div> <div>Water</div> | | | <b>Metals Contamination Remaining on Site - Rear Parking Lot (14-16 ft bgs)</b><br>Former Sperry Remington - North Portion #808022<br>Elmira, New York | |
