Re: Site Management
Periodic Review Report
Former Griffin Technology Site
Site No.: C835008
Farmington (T), Ontario (C)

The New York State Department of Environmental Conservation (Department) and the New York State Department of Health (NYSDOH) have completed a review of the Periodic Review Report (PRR) dated September 4, 2025, and IC/EC Certification for following period: April 30, 2024, to April 30, 2025, for the *Former Griffin Technology site* (Site) located at 6132 Victor Manchester Road, the Town of Farmington, Ontario County. Based on the information presented, the PRR is conditionally approved with the clarifications and modifications presented below.

Project:
Former Griffin Technology Site (#C835008)
Periodic Review Report 2023

Project: Former Griffin Technology Site (#C835008)
Periodic Review Report 2025

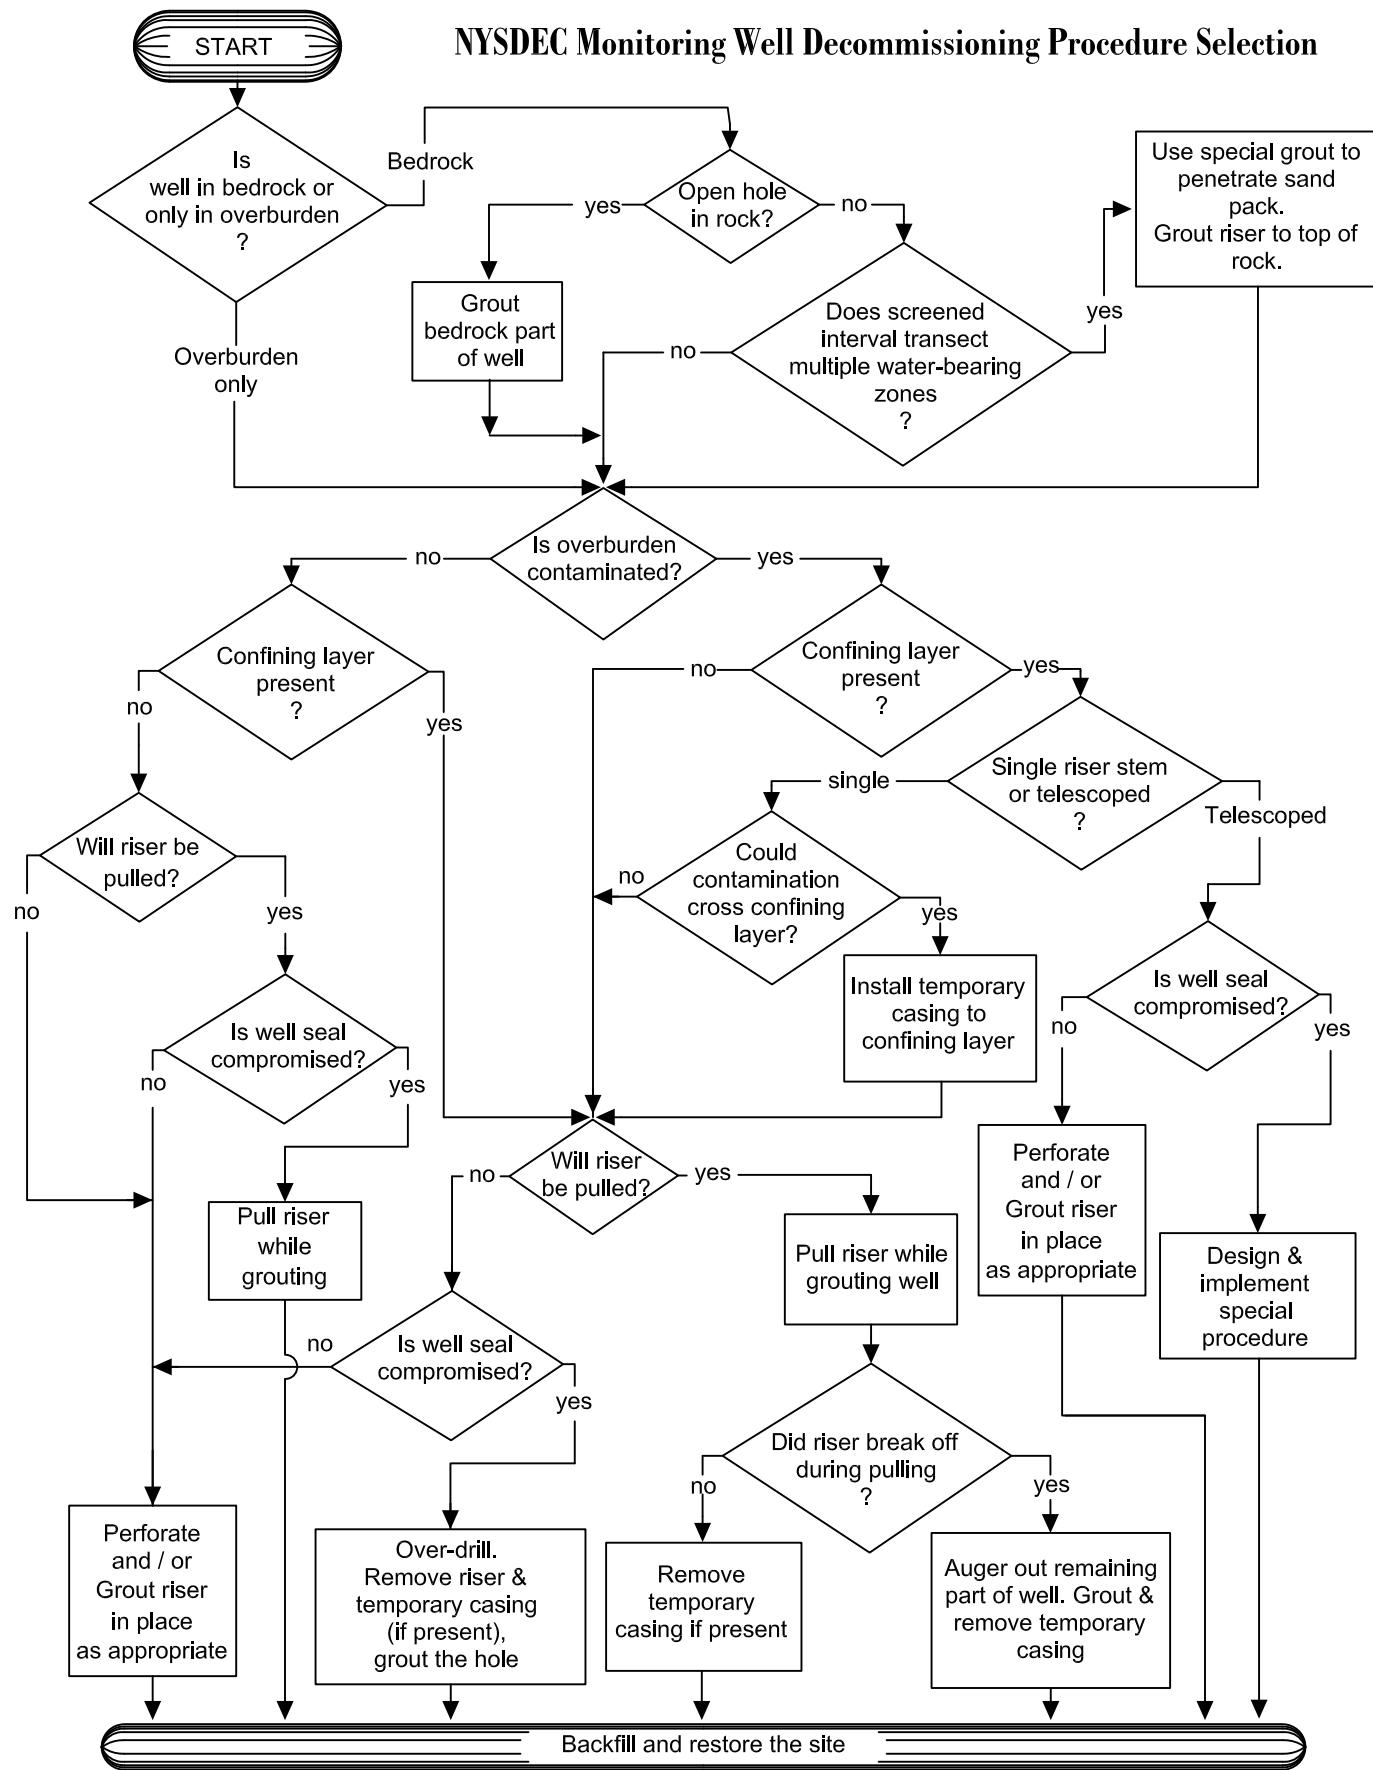
FIGURE 2
DECOMMISSIONING PROCEDURE SELECTION

The decommissioning procedure selection flow chart, Figure 2, is to be used to select decommissioning methods. The selection process first identifies the basic monitoring well type. There are only two types of monitoring wells described in this guidance, overburden wells and bedrock wells. Bedrock wells typically have an overburden portion which in the selection process is to be treated as an overburden well. Techniques are specified for wells based upon their type and the other physical conditions present. Decommissioning techniques called for by the selection process have their practical limits; construction details dictate when a well stem can be pulled without breaking and when it cannot be pulled. The DEC project manager has the discretion to deviate from the flow chart, (Figure 2), based on site conditions, budgetary concerns and professional judgment. The remainder of this section will discuss types of monitoring wells in various settings along with recommended decommissioning techniques.

Referring to Figure 2 and Section 2.1, if the well extends into bedrock, the rock hole portion of the well is to be grouted in-place to the top of the rock. The grout mix, however, may vary according to the conditions. A thicker grout may be required to fill voids and a thinner grout may be necessary to penetrate well screen and sand pack. Refer to the grout mixture specifications given in Section 6.1 and 6.2.

One should select a decommissioning procedure that takes into account the geologic and hydrogeologic conditions at the well site; the presence or absence of contamination in the groundwater; and original well construction details. The selection process for well decommissioning procedures is provided by the flow chart, Figure 2. Answers to the questions

The remainder of Section 2 discusses the well decommissioning methods and the selection process. Refer to Figure 2 for a flow chart diagram of the complete procedure selection process. The DEC Project Manager has the discretion to deviate from the flow chart, (Figure 2), based on site conditions and professional judgment.

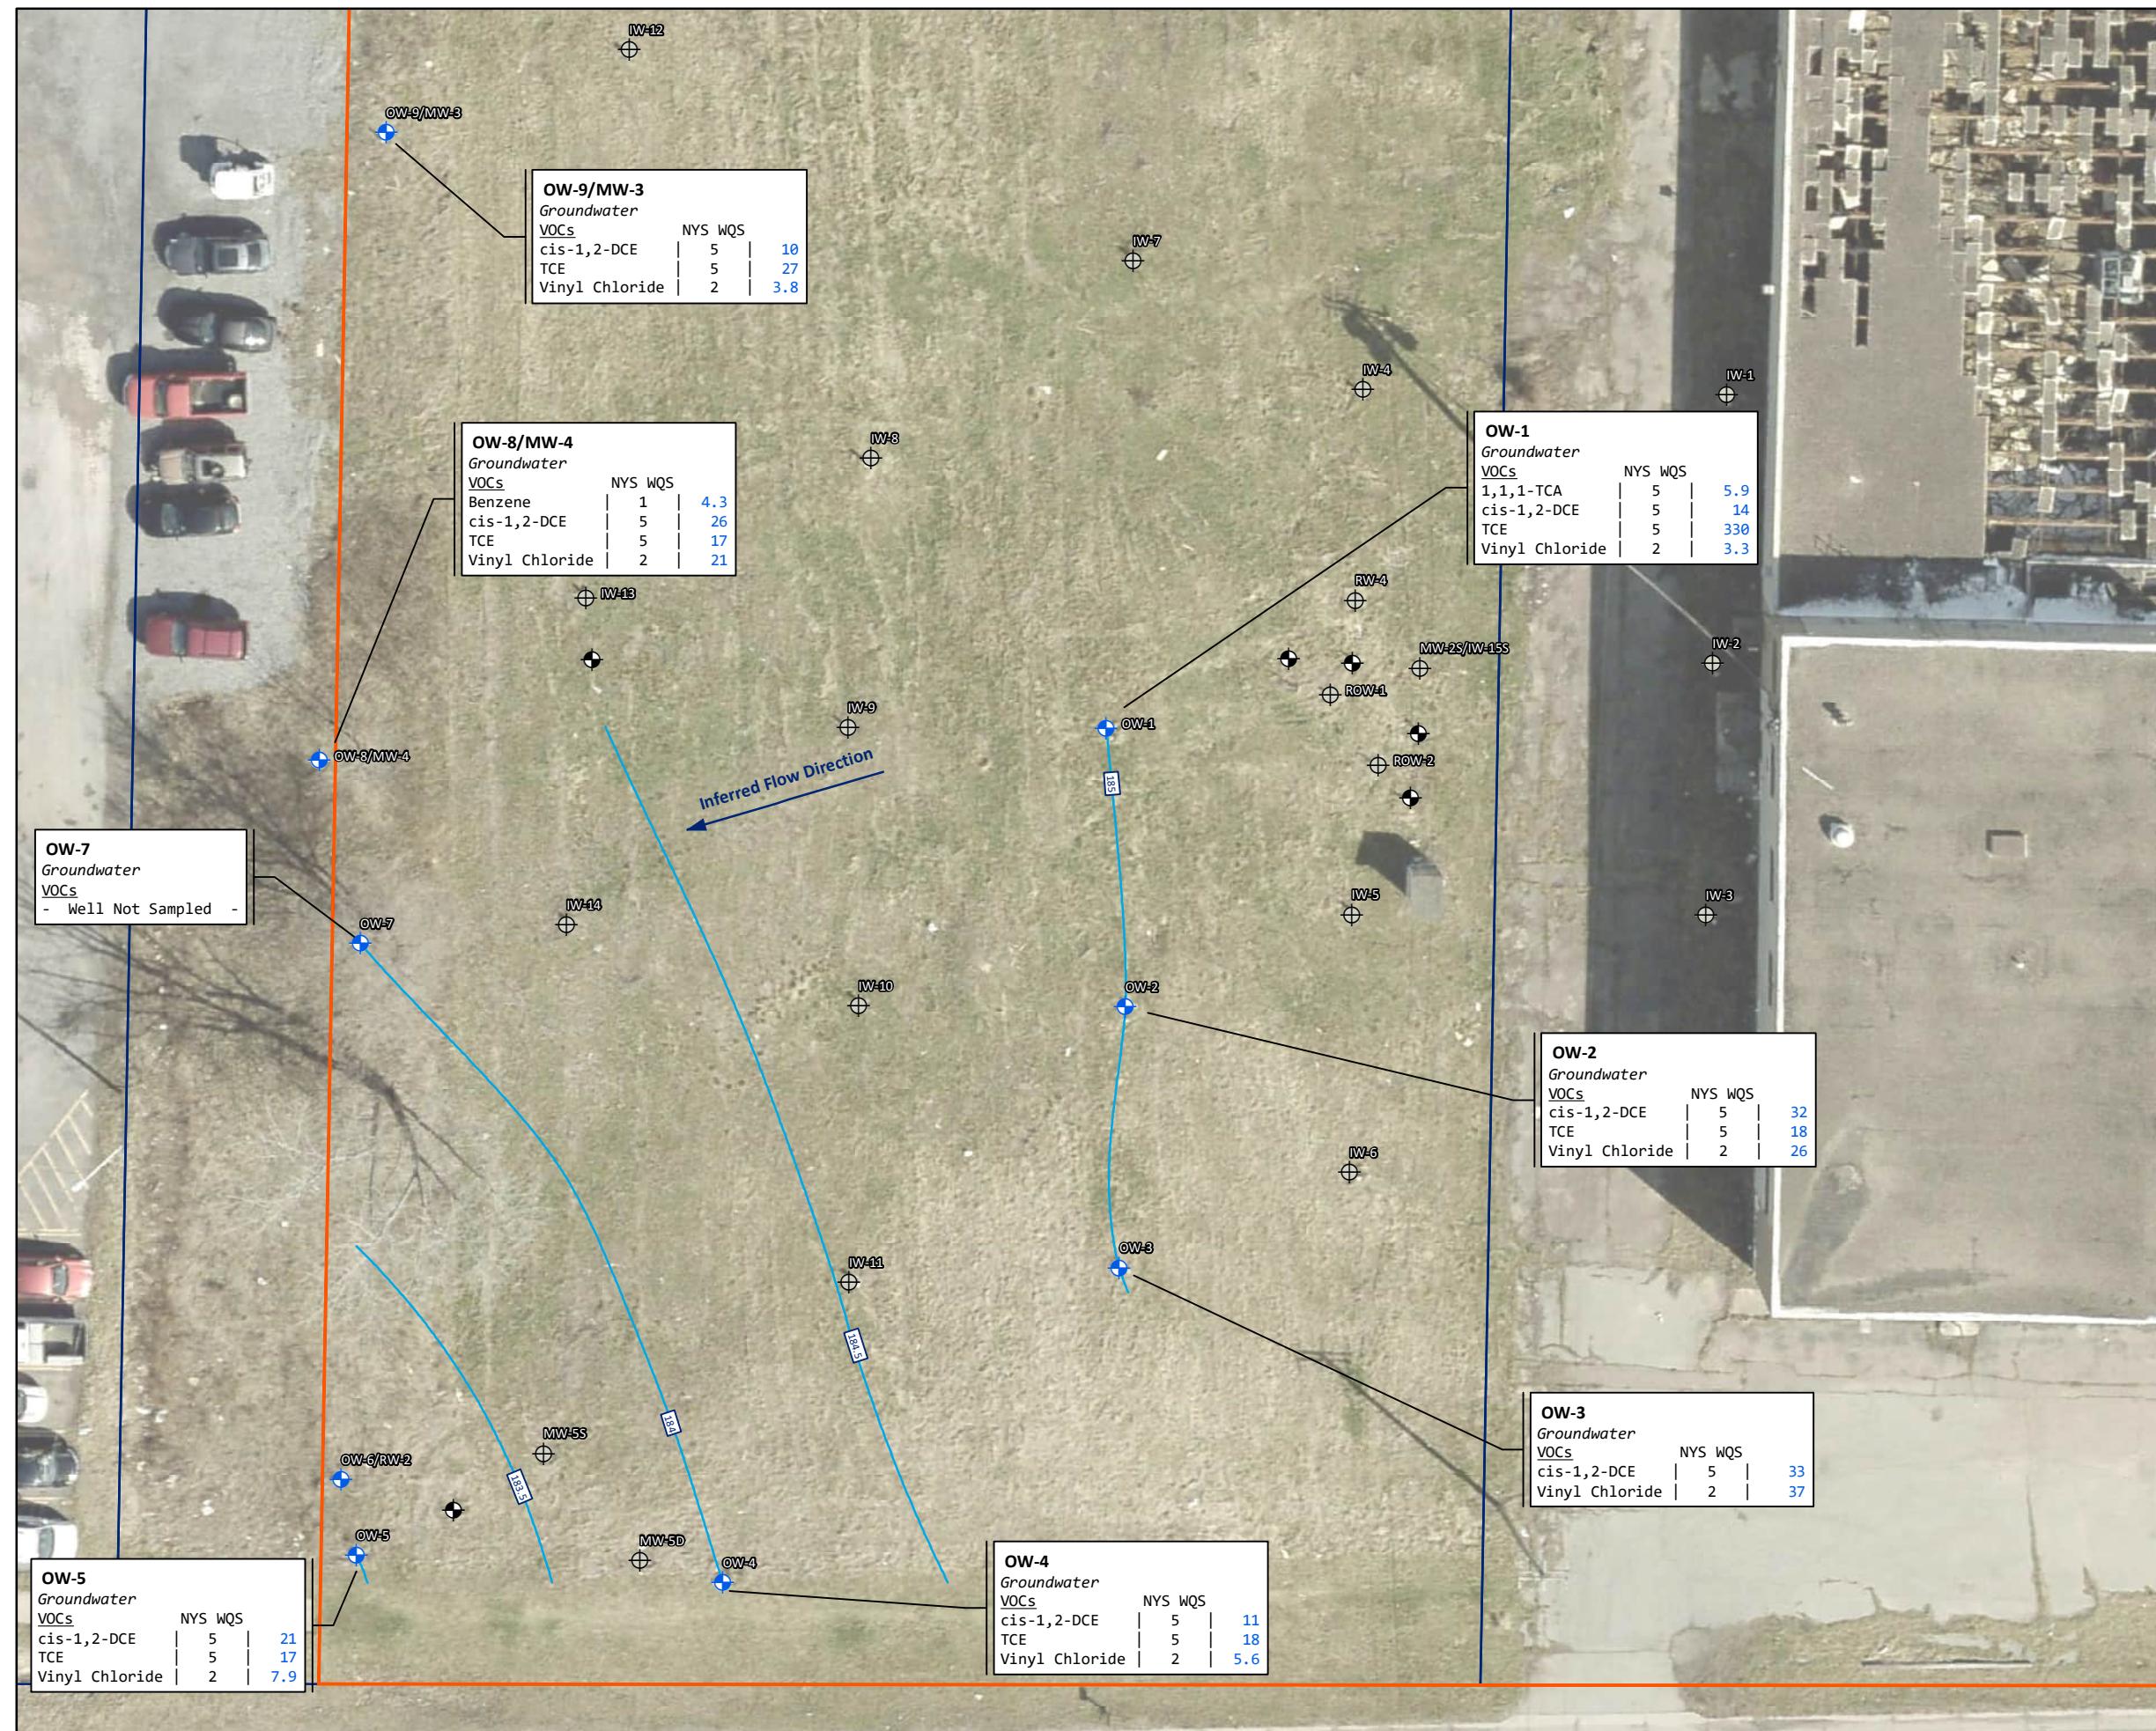
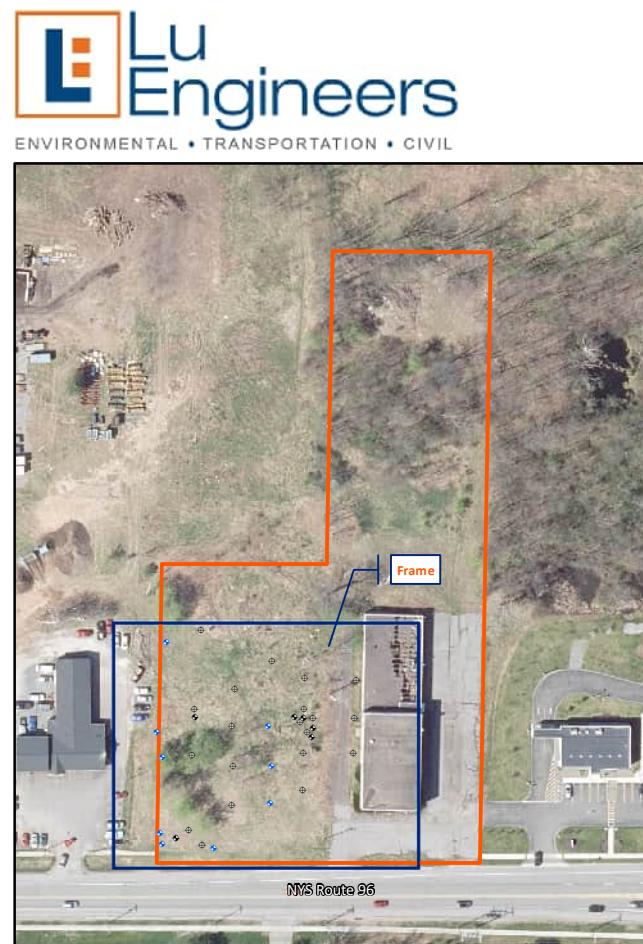
Figure 3:
July 2025 Groundwater Analytical Results

Cis-1,2-DCE concentrations decreased at OW-1, 2, 4, 5, and 9 with respect to the November 2024 sampling event. It is noted that concentrations in OW-3 remained unchanged and concentrations at OW-8/MW-4 have increased with respect to the previous sampling event. Cis-1,2-DCE concentrations remain in exceedance of NYSDEC 6NYCRR Part 703.5 Class GA groundwater standards at: OW-1 (14 ppb), OW-2 (32 ppb), OW-3 (33 ppb), OW-4 (11 ppb), OW-5 (21 ppb), OW-8/MW-4 (26 ppb) and OW-9/MW-3 (10 ppb).

Vinyl chloride concentrations decreased at OW-1, 2, 3, 4, 5, 8 and 9 with respect to the November 2024 sampling event. It is noted that concentrations in OW-8/MW-4 remained unchanged from the previous sampling event. Vinyl chloride concentrations remain in exceedance of NYSDEC 6NYCRR Part 703.5 Class GA groundwater standards at: OW-1 (3.3 ppb), OW-2 (26 ppb), OW-3 (37 ppb), OW-4 (5.6 ppb), OW-5 (7.9 ppb), OW-8/MW-4 (21 ppb) and OW-9/MW-3 (3.8 ppb).

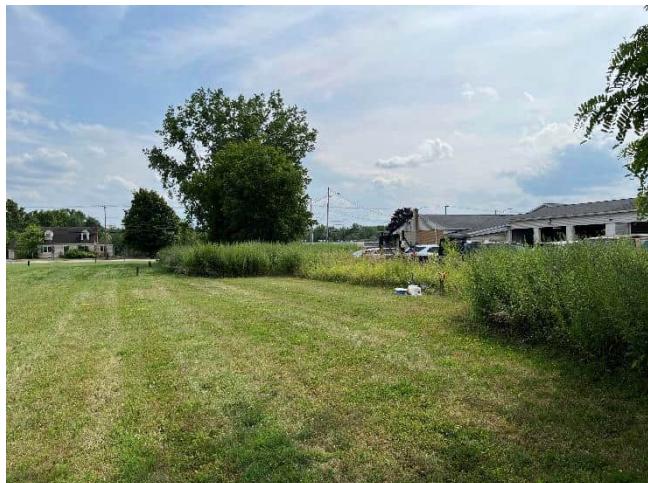
Photo No. 6 Purging of groundwater at OW-9.

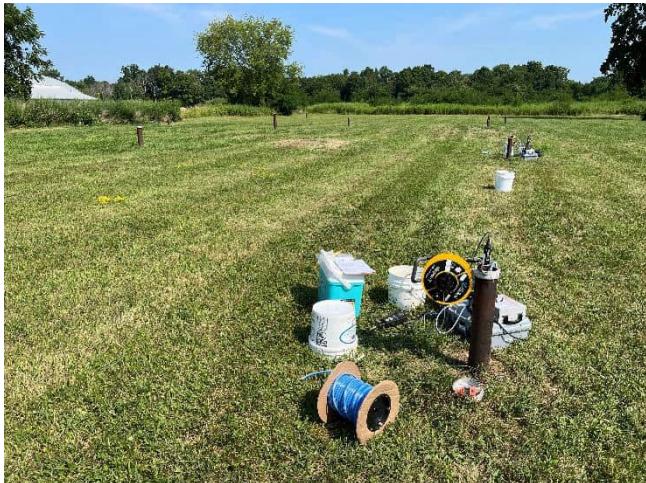
Photo No. 7 Purguing of groundwater at OW-3 using low flow.

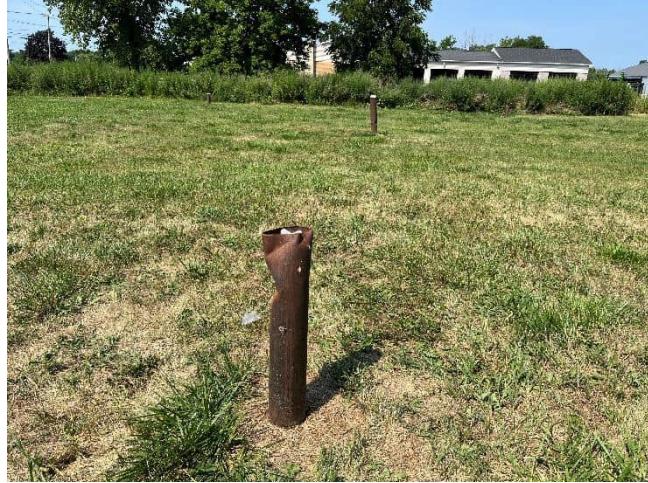
Well ID	Notes	Recommendation
OW-1	Protective casing damaged; lock and cover missing; limited access for sampling.	Repair protective casing and replace lock.
OW-2	Generally in good condition; missing lock.	Replace lock.
OW-3	Generally in good condition; missing lock.	Replace lock.
OW-4	Well casing upheaved; lock and cover missing.	Repair protective casing and replace lock.
OW-5	Missing lock and cover.	Replace lock and cover.

Photo No. 8 OW-1 damaged from lawn mower.

1. The Department understands that the scheduled maintenance for Site's groundwater monitoring wells will be completed and reported in the subsequent PRR, and that maintenance will include the following for each well:
 - Repair Protective Casings: OW-1, OW-4, IW-2, IW-4, IW-11, IW-13, and IW-14.
 - Replace Locks: OW-1, OW-2, OW-3, OW-4, OW-5, OW-7, OW-8/MW-4, OW-9/MW-3, IW-2, IW-4, IW-11, IW-13, and IW-14.
 - Replace Cover: OW-5.
 - Decommission: IW-9.

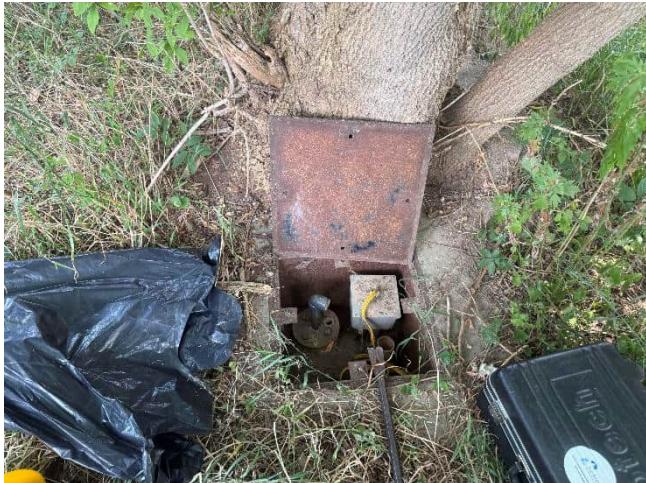
Well ID	Notes	Recommendation
OW-7	Missing lock	--
OW-8/MW-4	Generally in good condition; missing lock.	Replace lock and clear vegetation.
OW-9/MW-3	Generally in good condition; missing lock.	Replace lock.
IW-1	Good condition.	--
IW-2	Protective casing uplifted; lock and cover broken off.	Repair protective casing.
IW-3	Good condition.	--
IW-4	Lock and cover broken off.	Repair protective casing.
IW-5	Good condition.	--
IW-6	Good condition.	--
IW-7	Good condition.	--
IW-8	Good condition.	--
IW-9	Surface completion destroyed.	Decommission to extent practicable.
IW-10	Good condition.	--
IW-11	Lock and cover broken off.	Repair protective casing.
IW-12	Good condition.	--
IW-13	Protective casing damaged; limited access for sampling.	Repair protective casing and replace lock.
IW-14	Lock and cover broken off.	Repair protective casing.

Photo No. 9 The interior of OW-7.

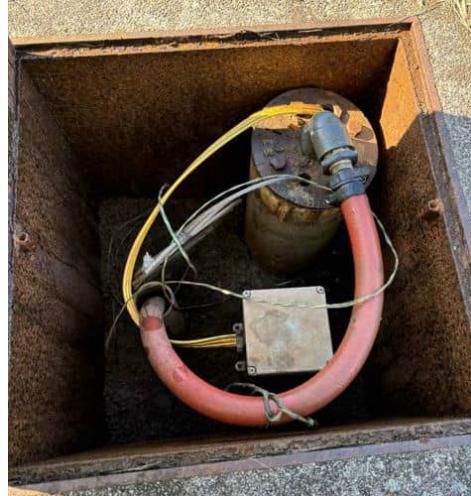
Photo No. 10 interior of injection well pump.

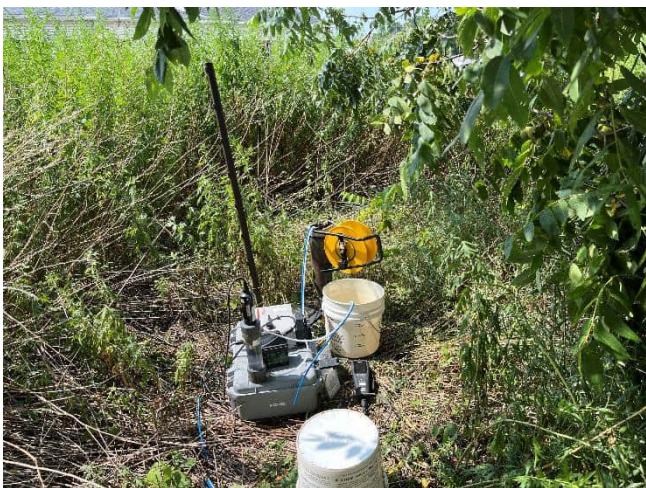
Photo No. 11 OW-8/MW-4
