FACT SHEET

Brownfield Cleanup Program

Site Name: Allegany Bitumens Belmont Asphalt Plant

Allegany Bitumens Update: Proposed Decision Document Recommends No Further Action at Brownfield Site; Public Comment Period 9/28 – 11/13/12

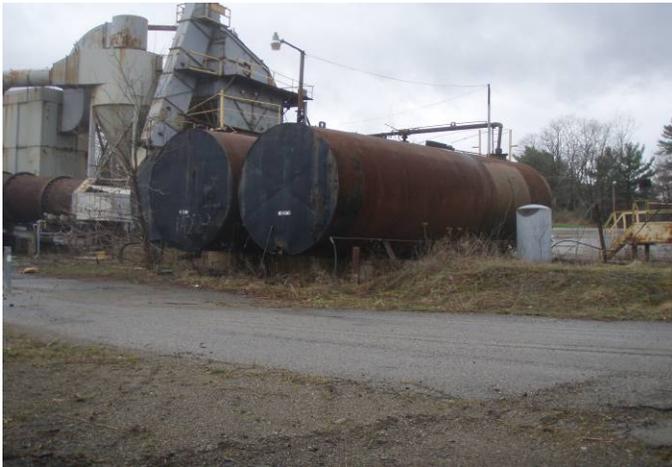
Before remediation: Allegany Bitumens site pre-remediation

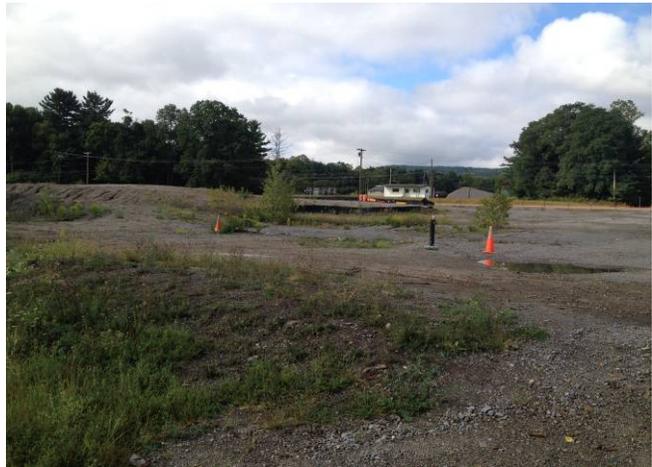
After remediation: Allegany Bitumens site after remediation

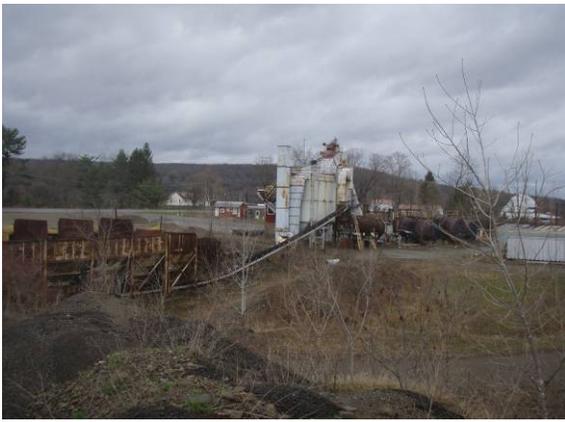
Before remediation: Allegheny Bitumens site pre-demolition

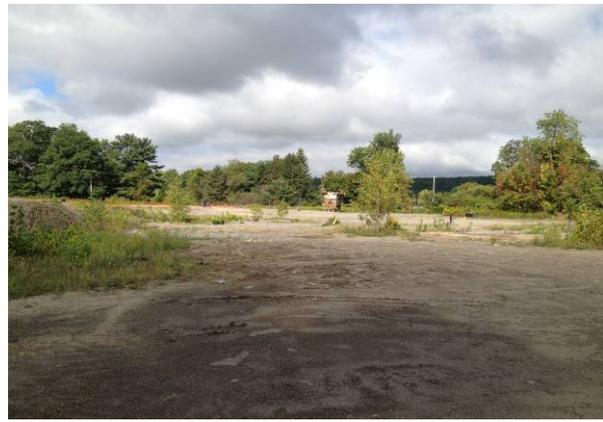
After remediation: Allegheny Bitumens site after

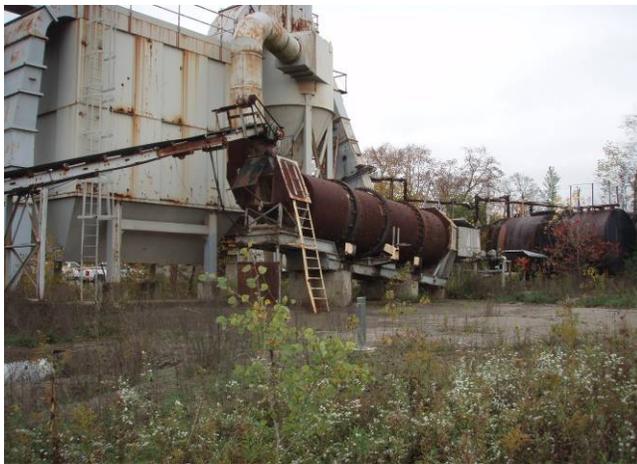
Before remediation: Allegheny Bitumens site pre-demolition

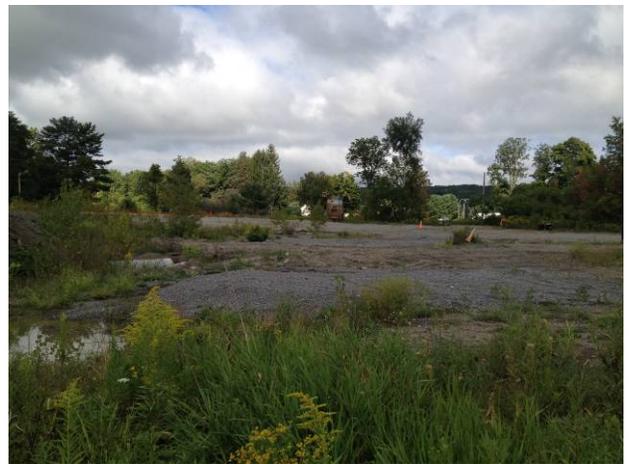
After remediation: Allegheny Bitumens site after

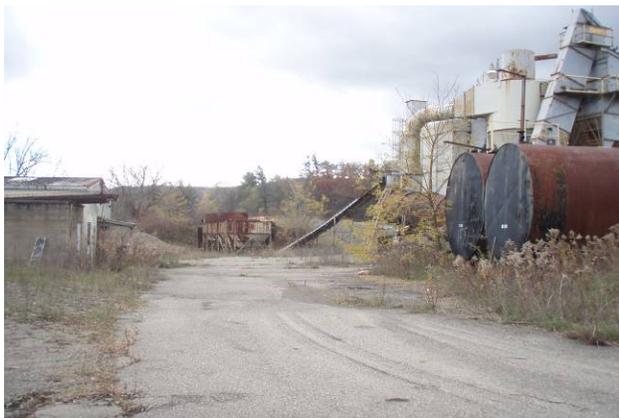
Before remediation: Allegany Bitumens site pre-demolition

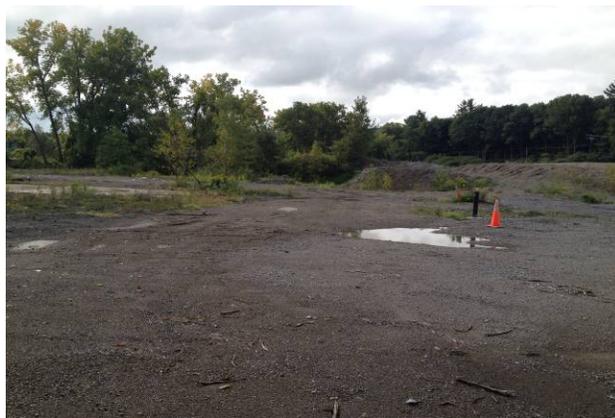
After remediation: Allegany Bitumens site after
