**Remedial Alternatives Analysis Report and
Remedial Action Work Plan
Former Allegany Bitumens Belmont Asphalt Plant
Brownfield Cleanup Program Site # C902019
5392 State Route 19
Amity, Allegany County, New York**

June 11, 2012
File: 190500593

**RE: Remedial Alternative Analysis Report and
Remedial Action Work Plan
Brownfield Cleanup Program Site # C902019
Former Allegany Bitumens Belmont Asphalt Plant
5392 State Route 19, Amity, New York**

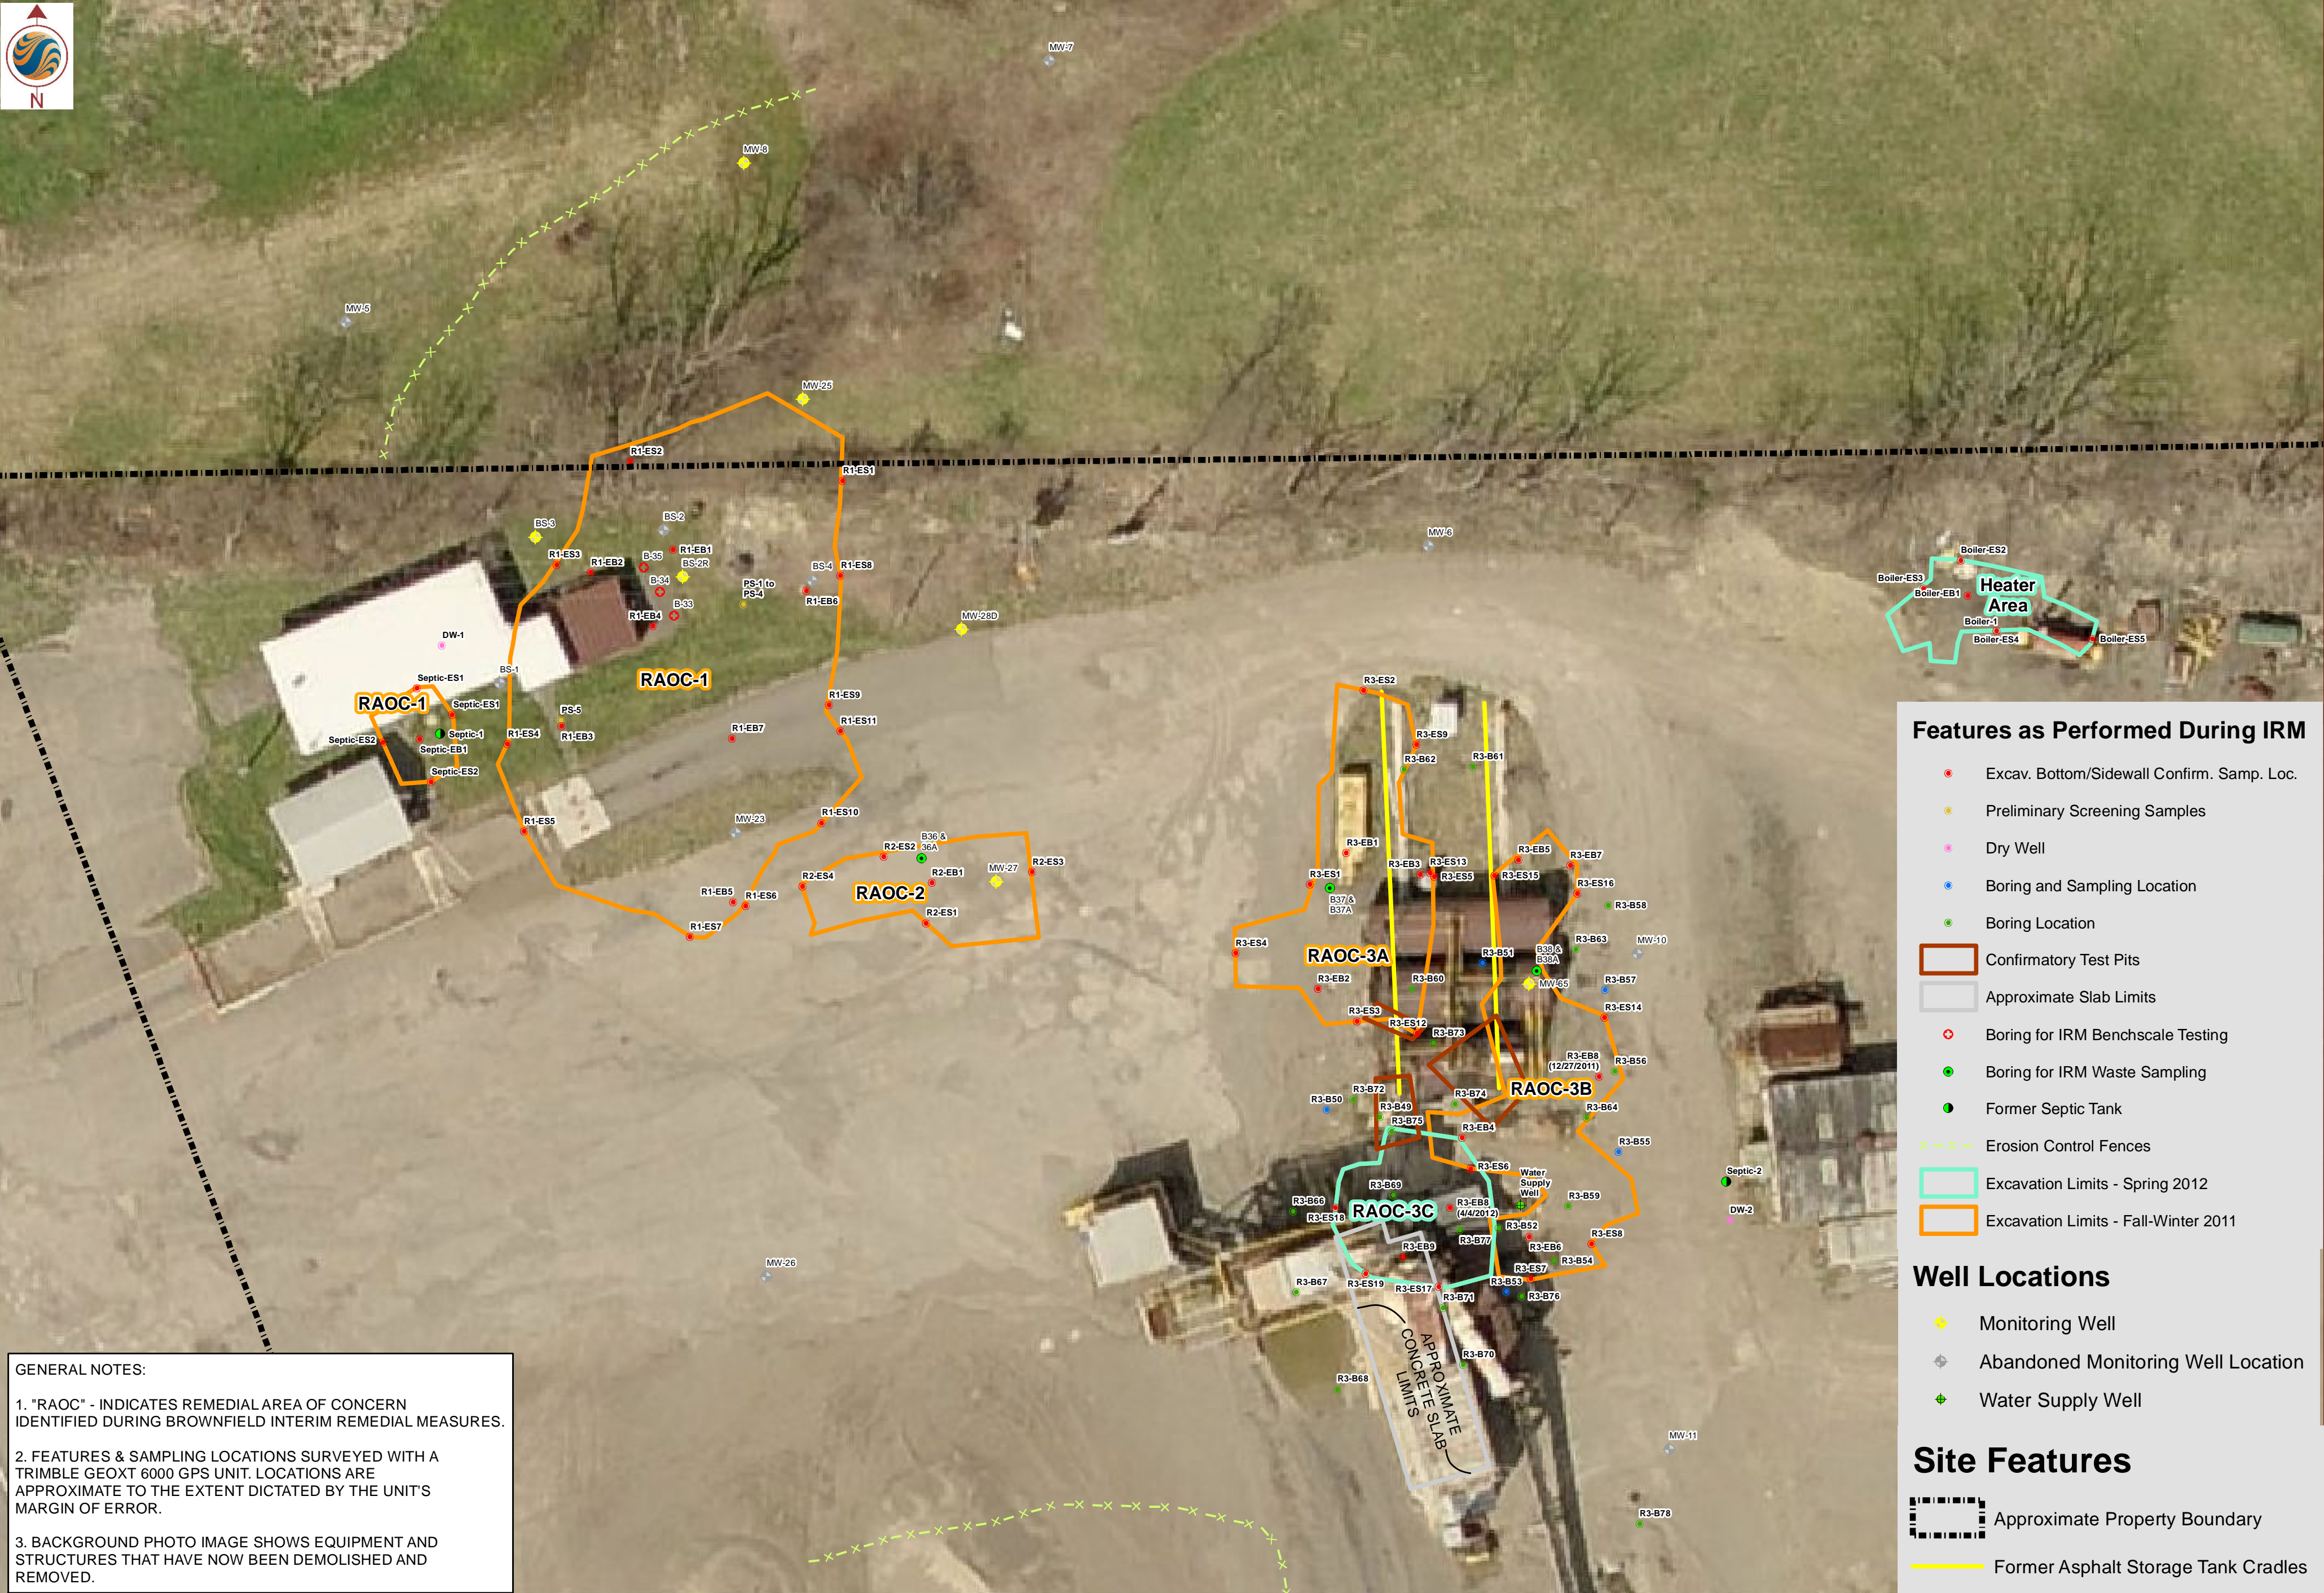
During excavation of the impacted soil in RAOC-3, it became evident that two distinct areas of impacted soil existed: a western portion (RAOC-3A), and an eastern portion (RAOC-3B & 3C) (see Figure 5). Impacts at RAOC-3A included those originally observed at TP-14. Elevated PID readings, staining and petroleum product odors were observed at depths ranging down to approximately 4.5 ft bgs. Groundwater was not encountered within the excavation depth at RAOC-3A.

Approximately 1,635 tons of chlorinated VOC-impacted soil was excavated from the source area and disposed offsite. The excavation limits are shown on Figure 5. The mapped excavation extended up to approximately eight ft below the water table. Excavation sidewall and bottom confirmatory samples indicated that the excavation sufficiently removed impacted soil, i.e. no exceedences of POGW, Commercial, or Industrial Use SCOs were observed in the analyzed samples.

Excavation at RAOC-3B was temporarily halted in December 2011 while a direct-push boring drilling program was conducted to more thoroughly delineate the apparent extent of the petroleum product. Sixteen borings (B-49 to B-64; see Figure 5) were completed. Evidence of petroleum product was observed in several borings. Five apparently "clean" soil samples were submitted for analysis to confirm the limits of the impact.

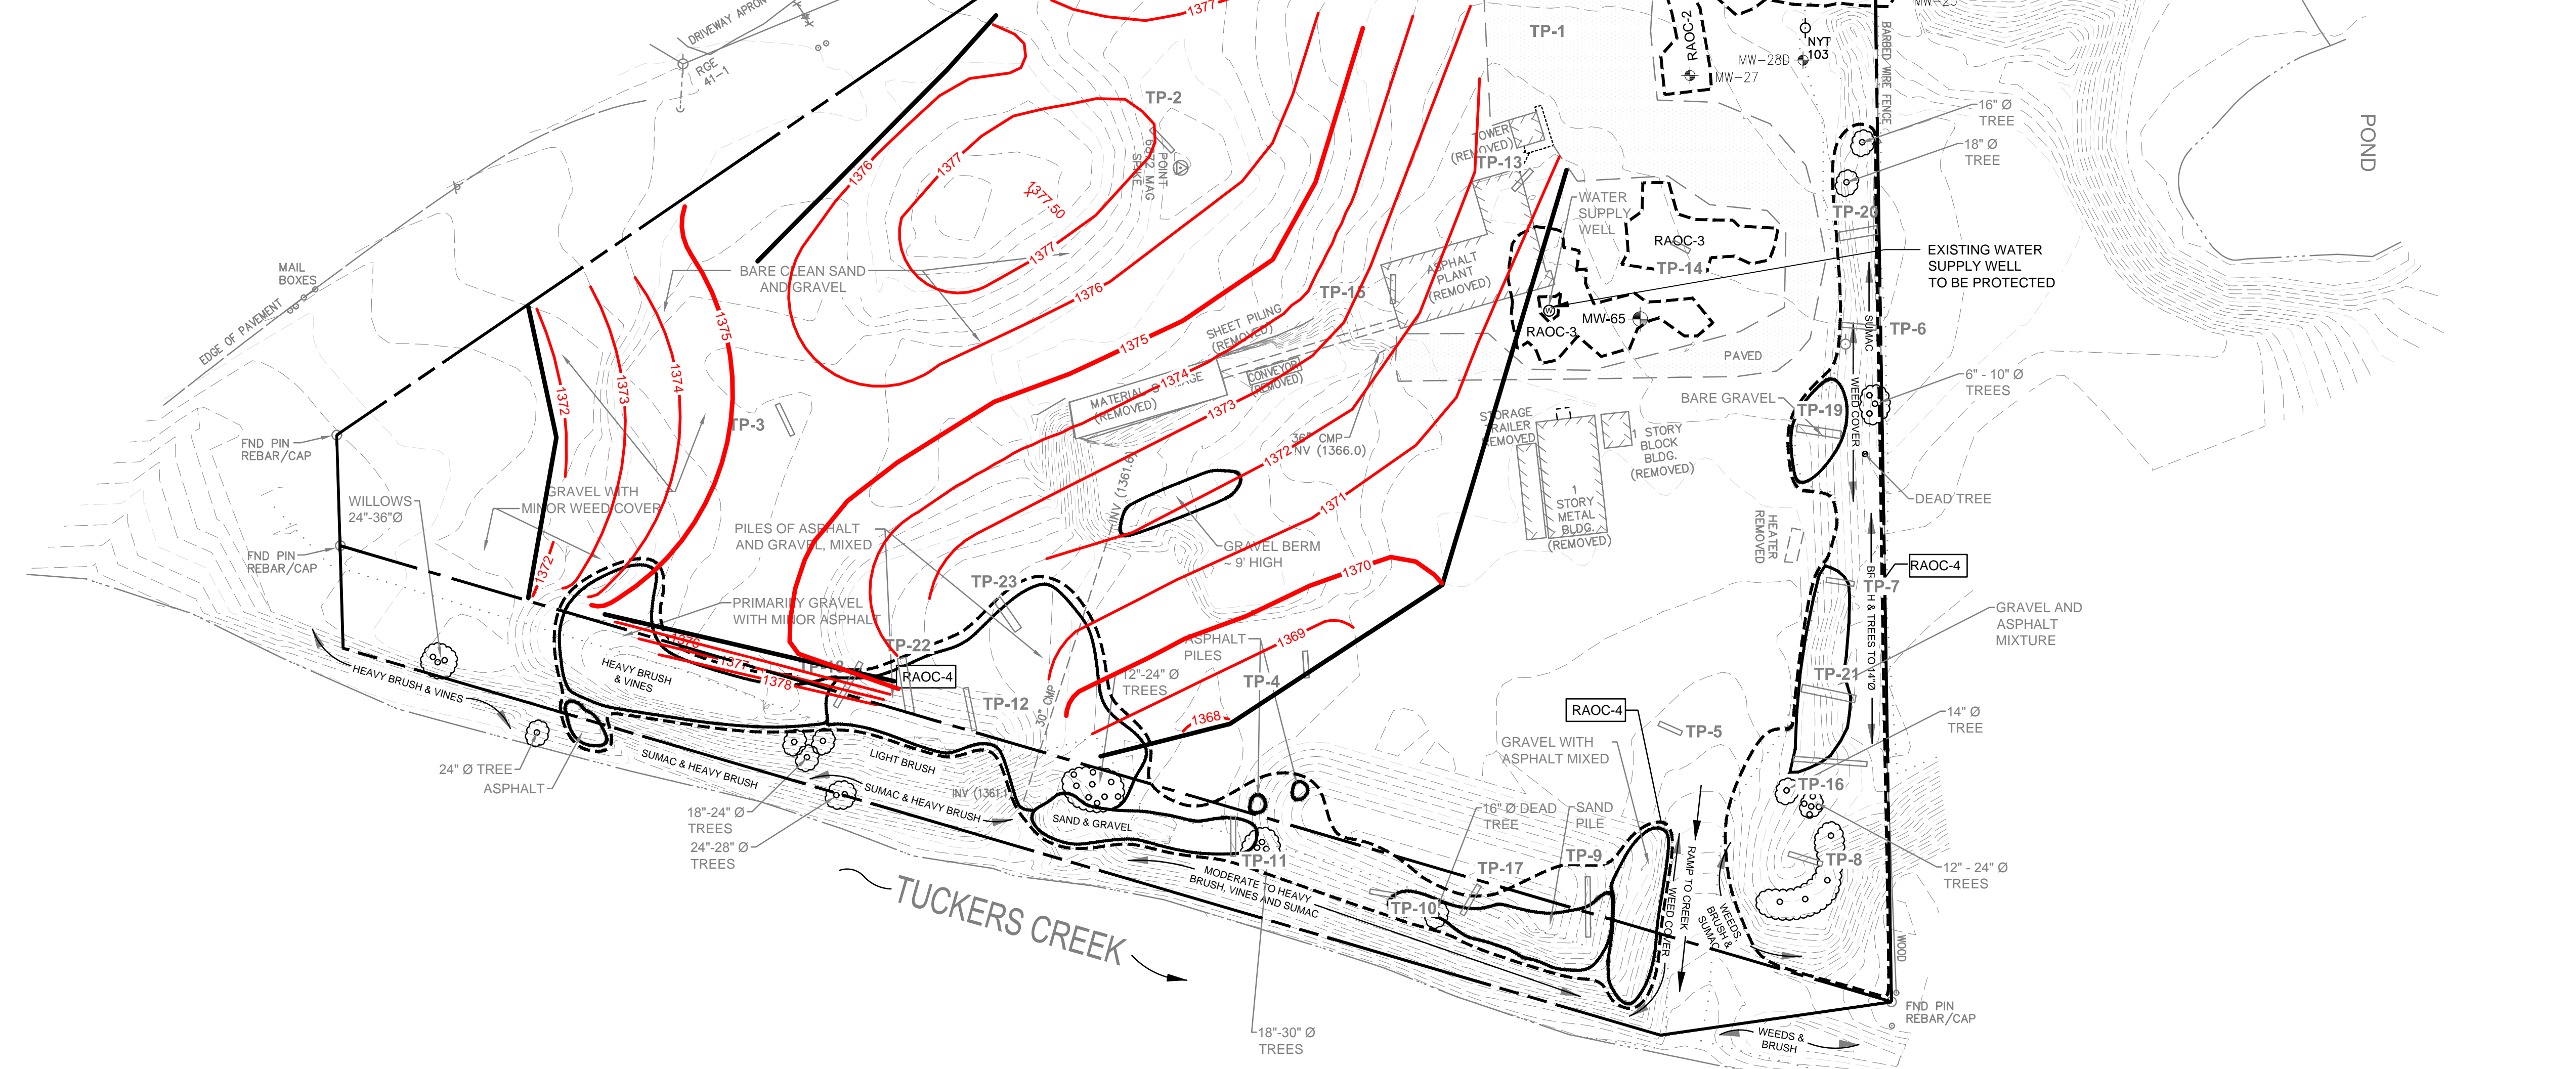
NOTE TO CONTRACTOR:
 1. EXISTING CONTOURS SHOWN ON THE BASEMAPPING DEPICT PROPOSED PHASE I EARTHWORK (SEE FIGURE 7).
 2. MAINTAIN EROSION AND SEDIMENTATION CONTROL FEATURES UNTIL STABILIZED.
 3. SEE FIGURE 9 FOR ADDITIONAL NOTES AND DETAILS

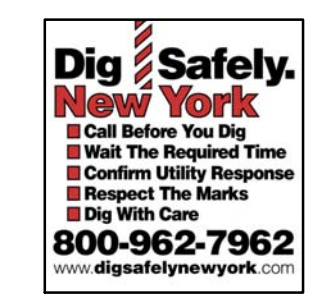
ENVIRONMENTAL NOTES:

1. WORK TO BE PERFORMED PURSUANT TO A NYSDEC BROWNFIELD CLEANUP AGREEMENT (BCA) AND THE NYSDEC APPROVED REMEDIAL WORK PLAN (RWP). ALL PROVISIONS OF THE NYSDEC APPROVED RWP WILL NEED TO BE FOLLOWED INCLUDING, BUT NOT LIMITED TO, HEALTH AND SAFETY, COMMUNITY AIR MONITORING PLAN, PROPER DISPOSAL AND DOCUMENTATION OF ALL WASTES TAKEN OFF SITE, AND PLACEMENT OF A ONE FOOT CAP CONSISTING OF SIX INCHES OF CLEAN ON SITE SOIL AND SIX INCHES OF IMPORTED CLEAN TOPSOIL IN DESIGNATED AREAS.

1. CONTRACTOR TO CONSTRUCT PHASE I BERMS TO PROPOSED FINISHED GRADE EXCLUDING ONE FOOT CAP. UPON COMPLETION OF PHASE II SITE GRADING, CONSTRUCT ONE FOOT CLEAN SOIL CAP ON BERMS AND ALL DESIGNATED AREAS AS SHOWN ON FIGURE 7.

1. ALL DEFINED CAP AREAS SHOWN ON FIGURE 7 SHALL BE GRADED AND BROUGHT TO WITHIN ONE (1) FOOT OF THE PROPOSED FINISHED GRADE ELEVATION THEN RECEIVE SIX (6) INCHES OF CLEAN ON-SITE SOIL AND SIX (6) INCHES OF CLEAN IMPORTED TOPSOIL. SEED, MULCH AND WATER UNTIL A HEALTHY STAND OF GRASS IS OBTAINED. ACTUAL LIMITS OF AREAS REQUIRING CLEAN SOIL CAP MAY VARY FROM THE LIMITS SHOWN ON FIGURE 7. CONTRACTOR SHALL COORDINATE WITH THE OWNER/OWNER'S REPRESENTATIVE ON LIMITS OF CLEAN FILL CAP.

Figure 8 depicts the proposed final site grades. Figure 9 provides Notes and Details related to the proposed berm construction (Figure 7) and final site grading (Figure 8).
