**REMEDIAL ACTION SELECTION REPORT
FOR THE PRODUCT RECOVERY
INTERIM REMEDIAL MEASURE IN THE
EASTERN TANK YARD AREA**

**Buffalo Terminal
625 Elk Street
Buffalo, New York**

January 5, 2005

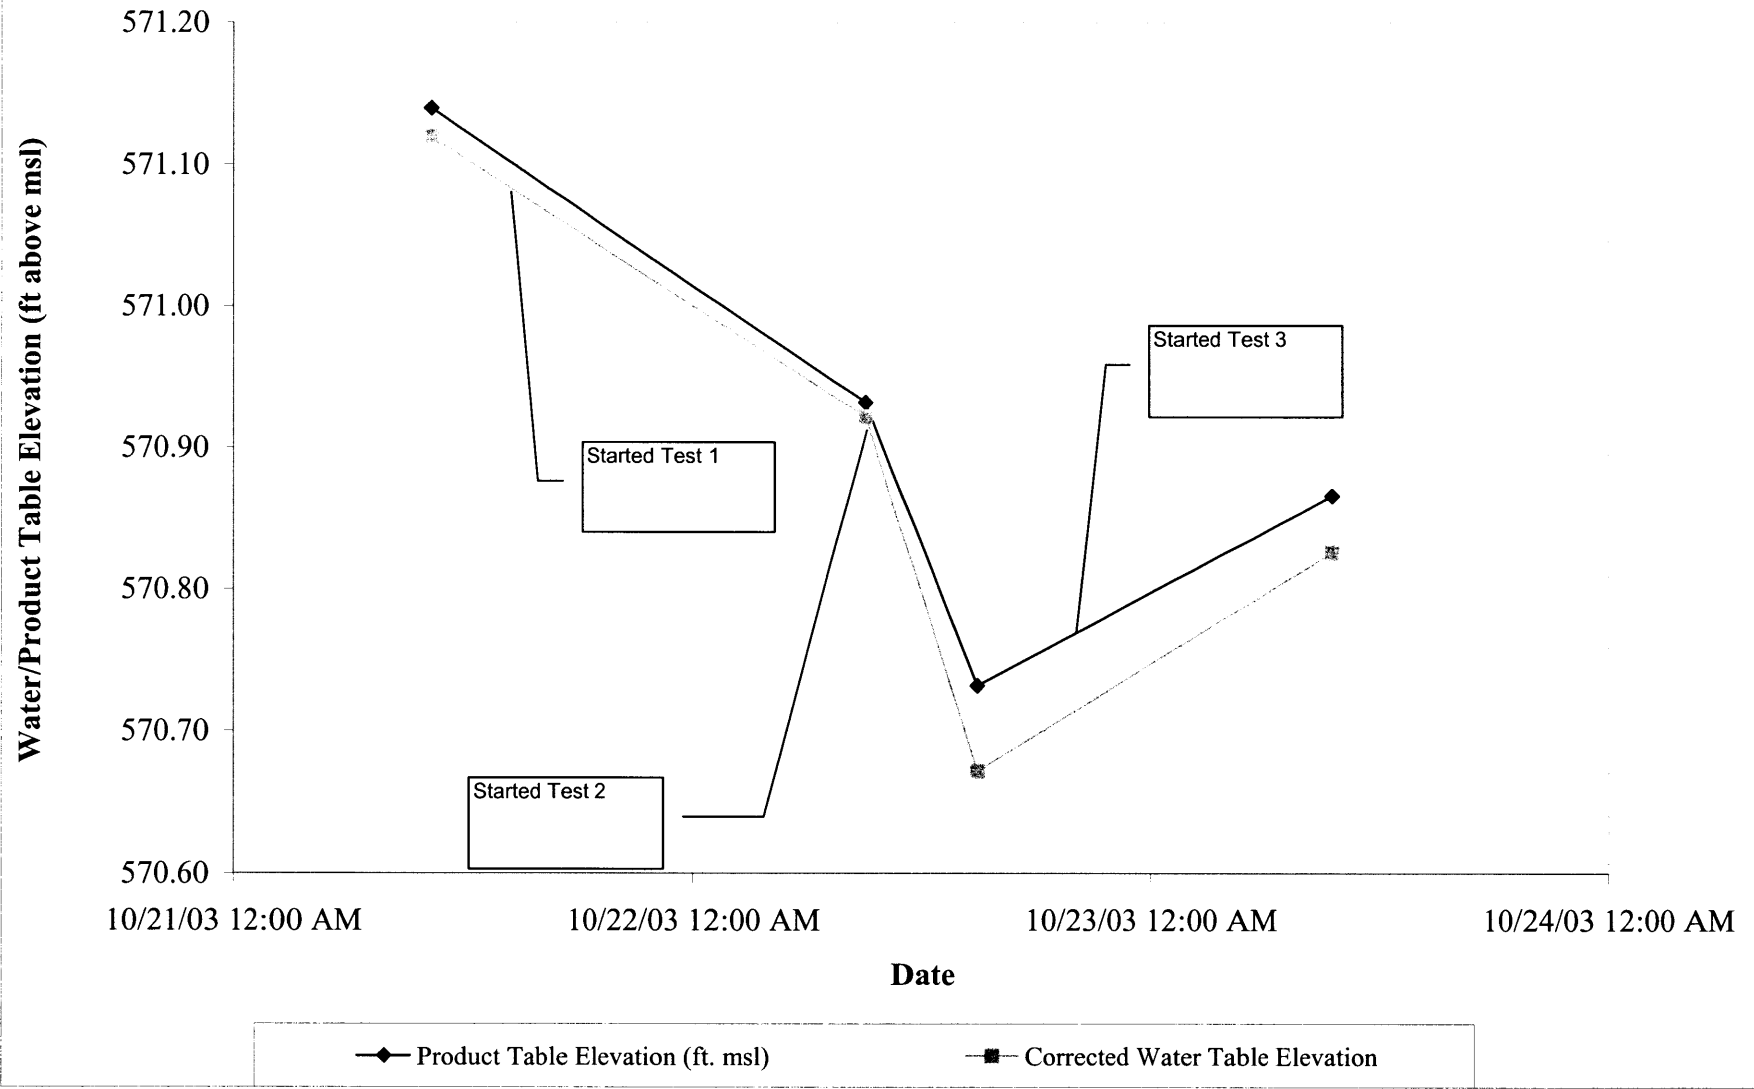
Hydrograph During VER Pilot Test, Monitoring Well RW-8R

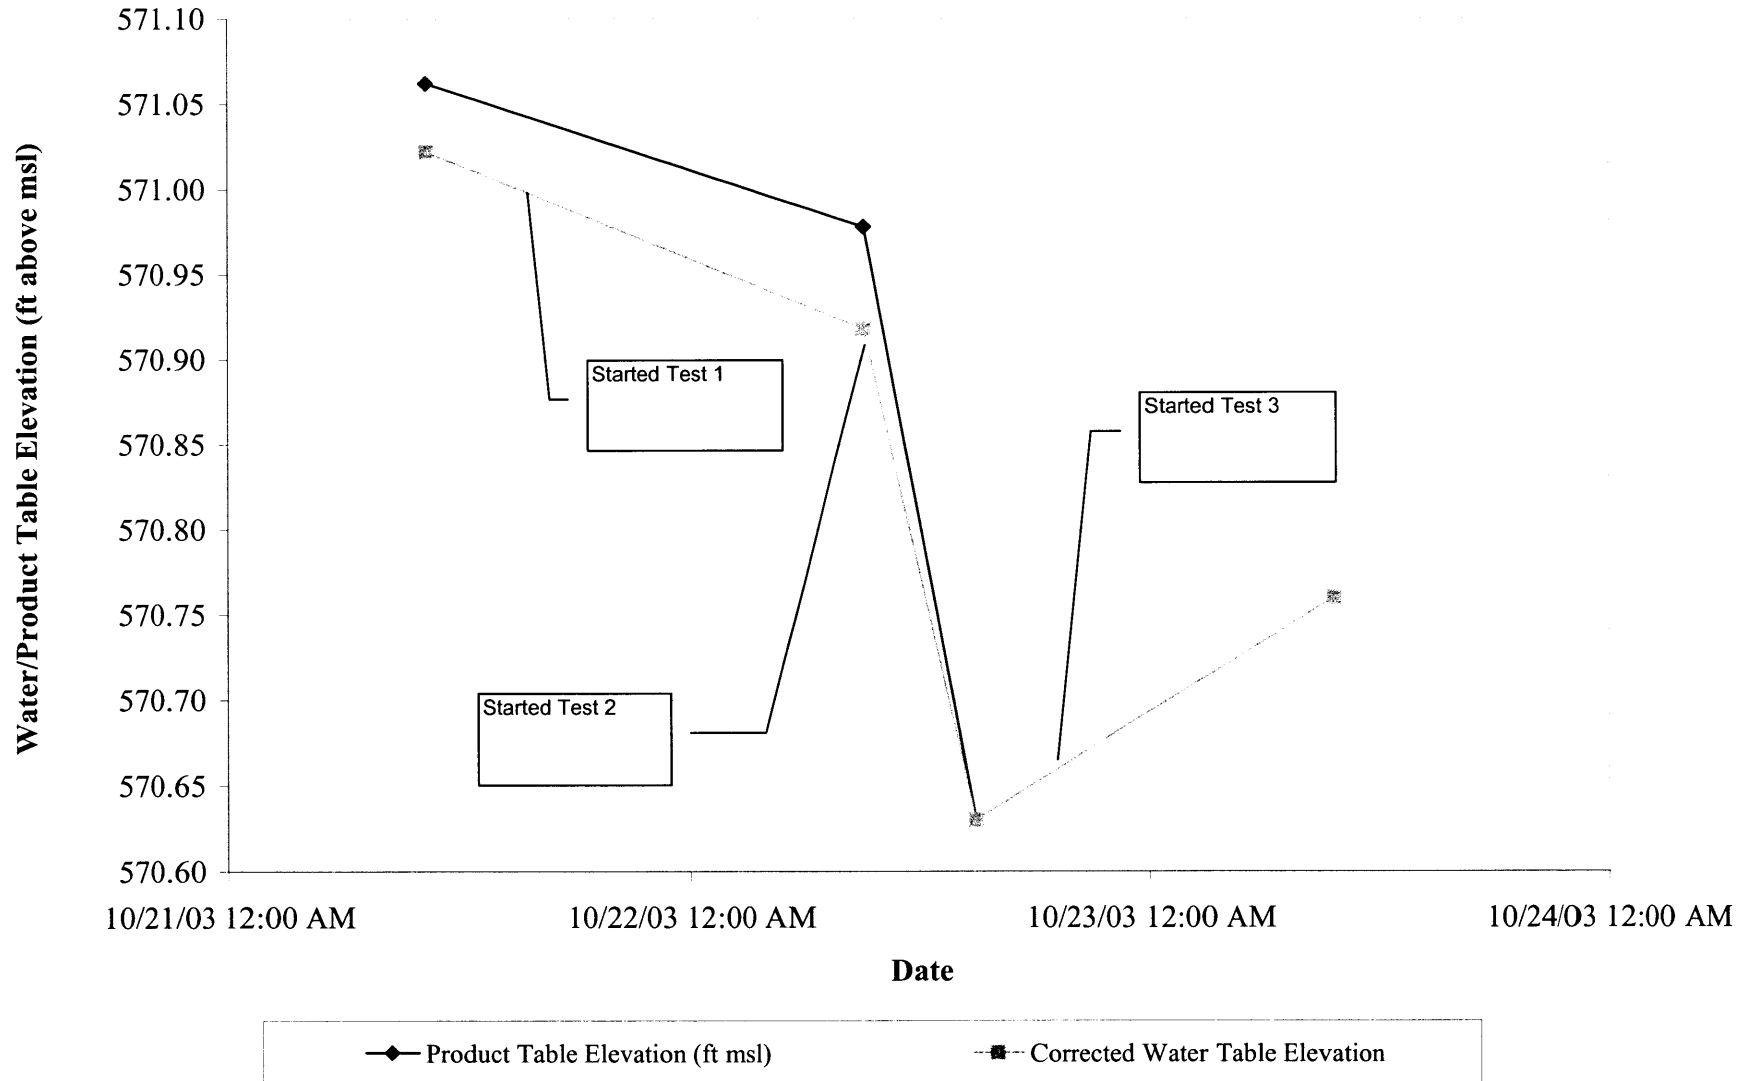
Hydrograph During VER Pilot Test, Monitoring Well LF-1S

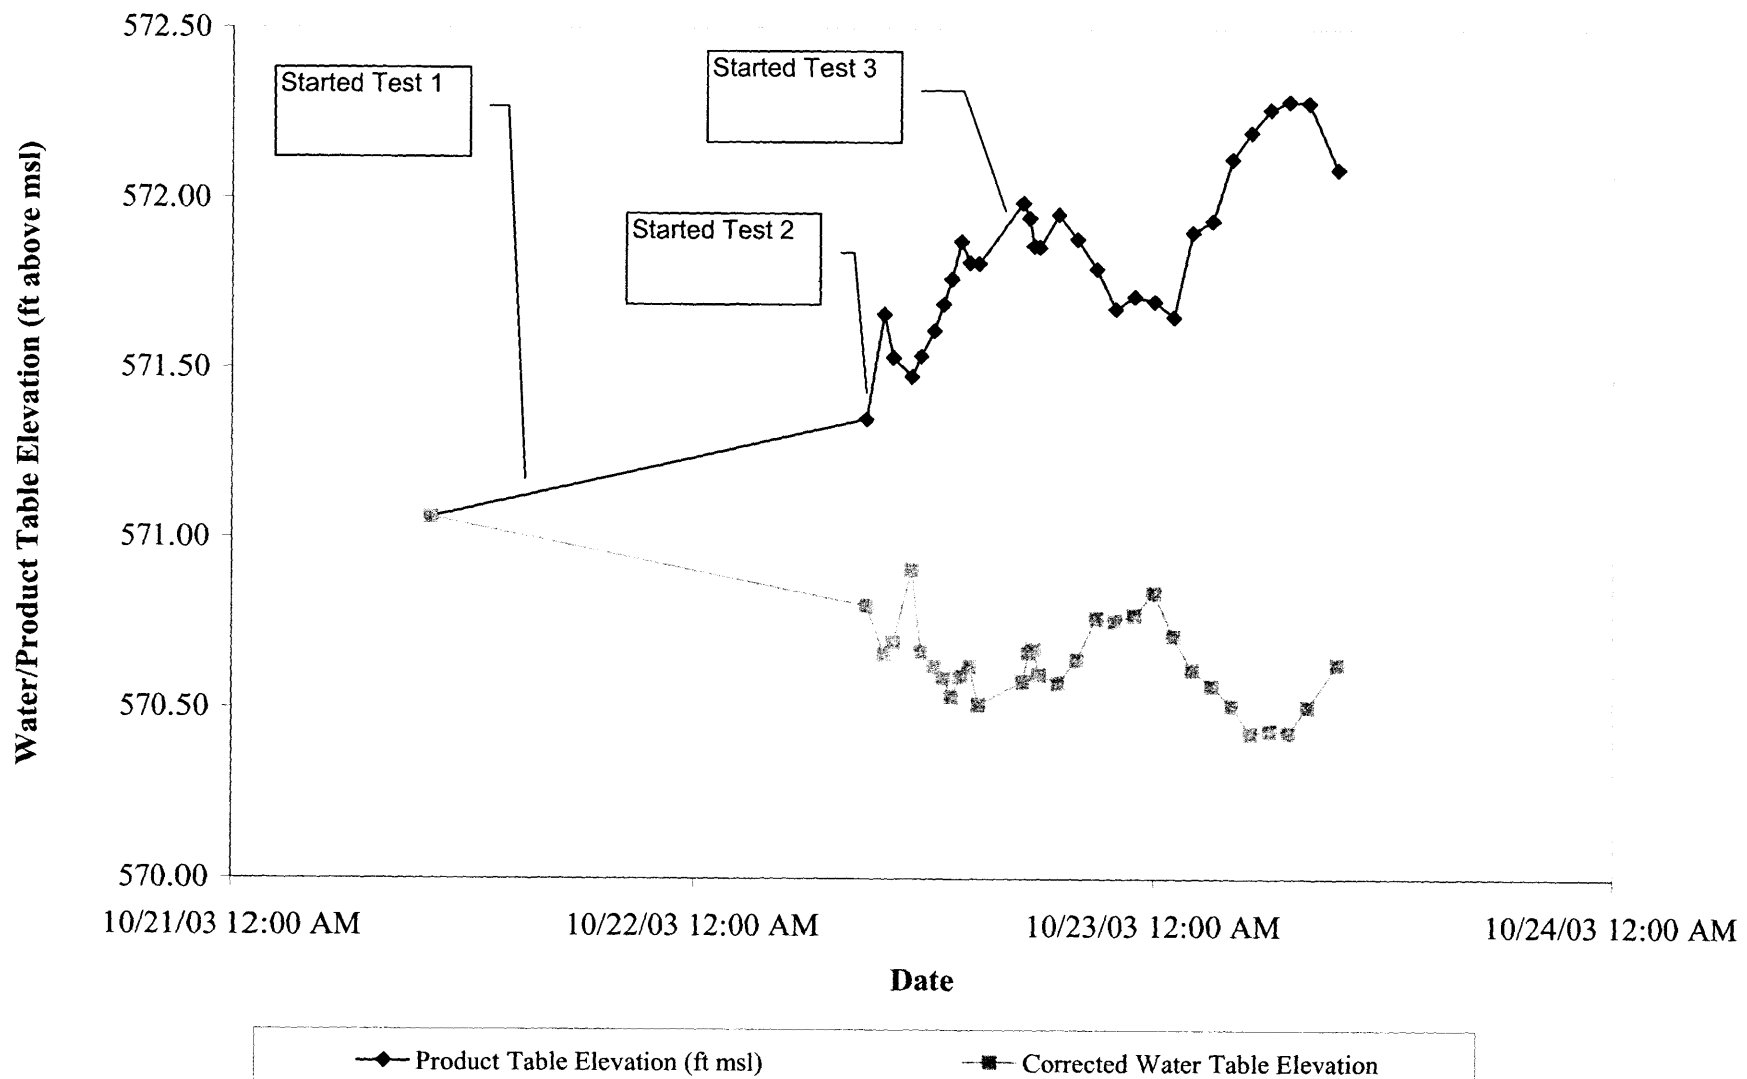
Hydrograph During VER Pilot Test, Monitoring Well VERMW-2

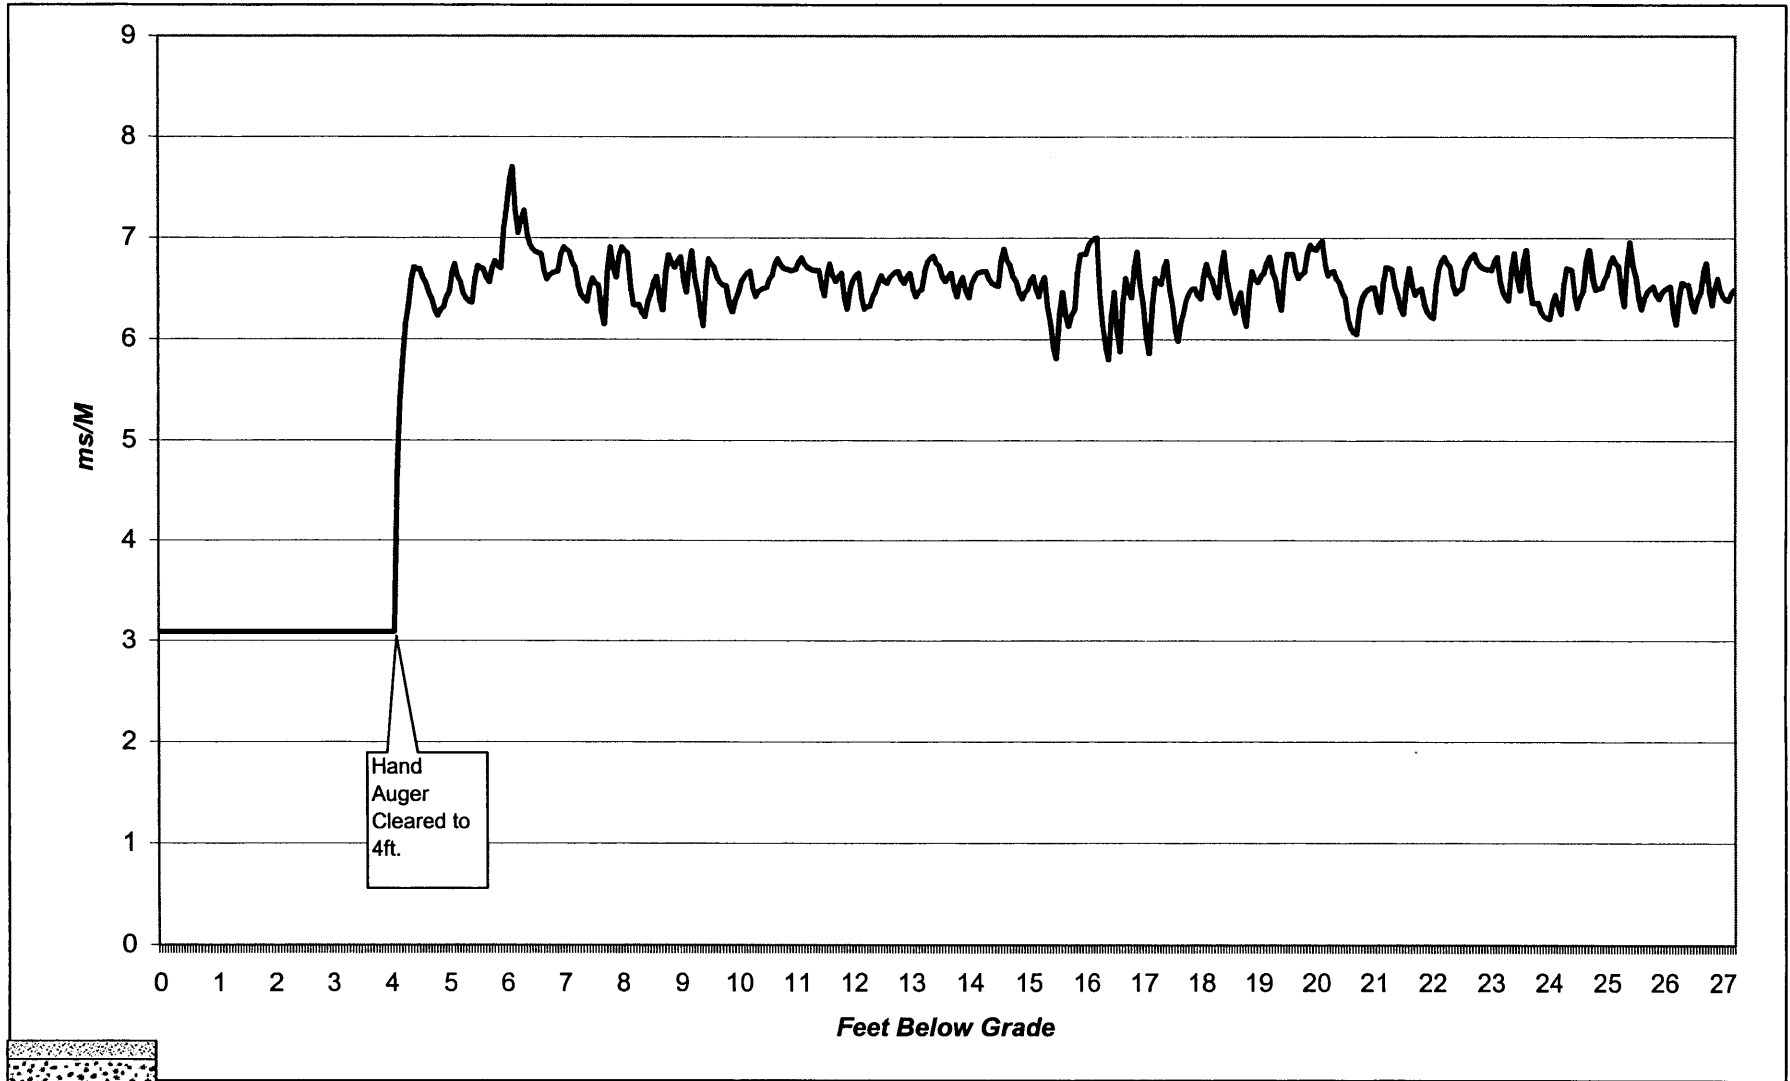
Soil Conductivity - MIP3
