# ALTERNATIVES ANALYSIS REPORT FOR OPERABLE UNIT 4

ExxonMobil Former Buffalo Terminal  
Buffalo, New York

BCP Site C915201E

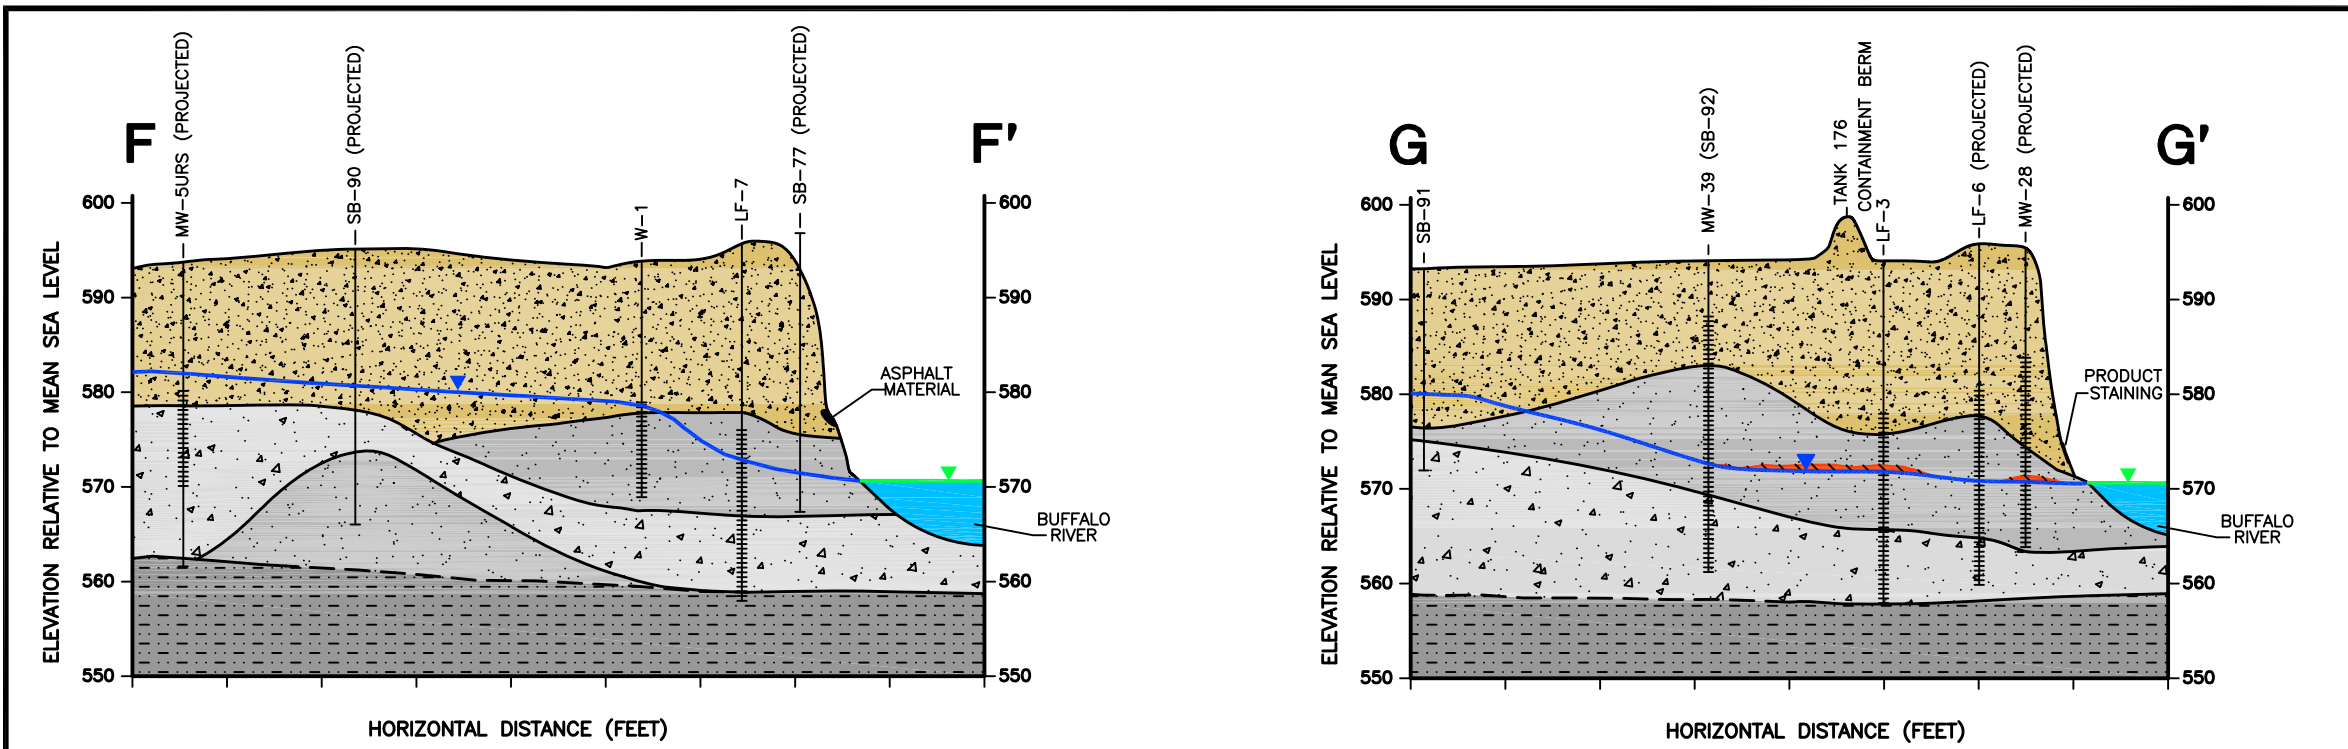
ROUX ASSOCIATES, INC. <i>Environmental Consulting &amp; Management</i>	Compiled by: N.C.	Date: 22JUNE09	FIGURE <b>8</b>
	Prepared by: J.A.D.	Scale: AS SHOWN	
	Project Mgr: N.C.	Office: NY	
	File No: MC5238307	Project: 17252Y11

- BUFFALO RIVER ELEVATION IN FEET ABOVE MEAN SEA LEVEL, JANUARY 2002
- WATER-TABLE ELEVATION IN FEET ABOVE MEAN SEA LEVEL, JANUARY 2002
- INDICATES MONITORING WELL SCREENED INTERVAL
- INDICATES SOIL BORING
- FILL MATERIAL CONSISTING OF BLACK CINDERS, CONCRETE, BRICK, GLASS, SLAG, WOOD, SILT, GRAVEL AND SAND
- ALLUVIAL DEPOSITS (SAND, SAND AND SILT, SAND AND GRAVEL, SILTY SAND, SILT)
- ALLUVIAL DEPOSITS (SAND AND GRAVEL)
- CLAY (INCLUDES CLAY AND SAND AND CLAY)
- SEPARATE-PHASE PRODUCT

- NOTES**
1. FOR LOCATION OF SECTION LINES SEE PLATE 1.
  2. LAND SURFACE SHOWN IS ALONG THE SECTION CUT LINE, NOT NECESSARILY AT THE WELL/BORING LOCATIONS IF WELL/BORING IS PROJECTED ONTO THE LINE.
  3. MW-28 HAS A SOLAR POWERED PRODUCT RECOVERY PUMP INSTALLED SINCE APRIL 5, 2001.
  4. LINES SEPARATING CLAY LAYER FROM SAND AND GRAVEL LAYER ARE SHOWN DASHED WHERE INFERRED.
  5. GEOTECHNICAL BORINGS ADVANCED IN APRIL 2009 INDICATE A SILTY SAND AND CLAYEY SAND LAYER FROM 54 TO 77 FEET BELOW GRADE, UNDERLAIN BY BEDROCK.

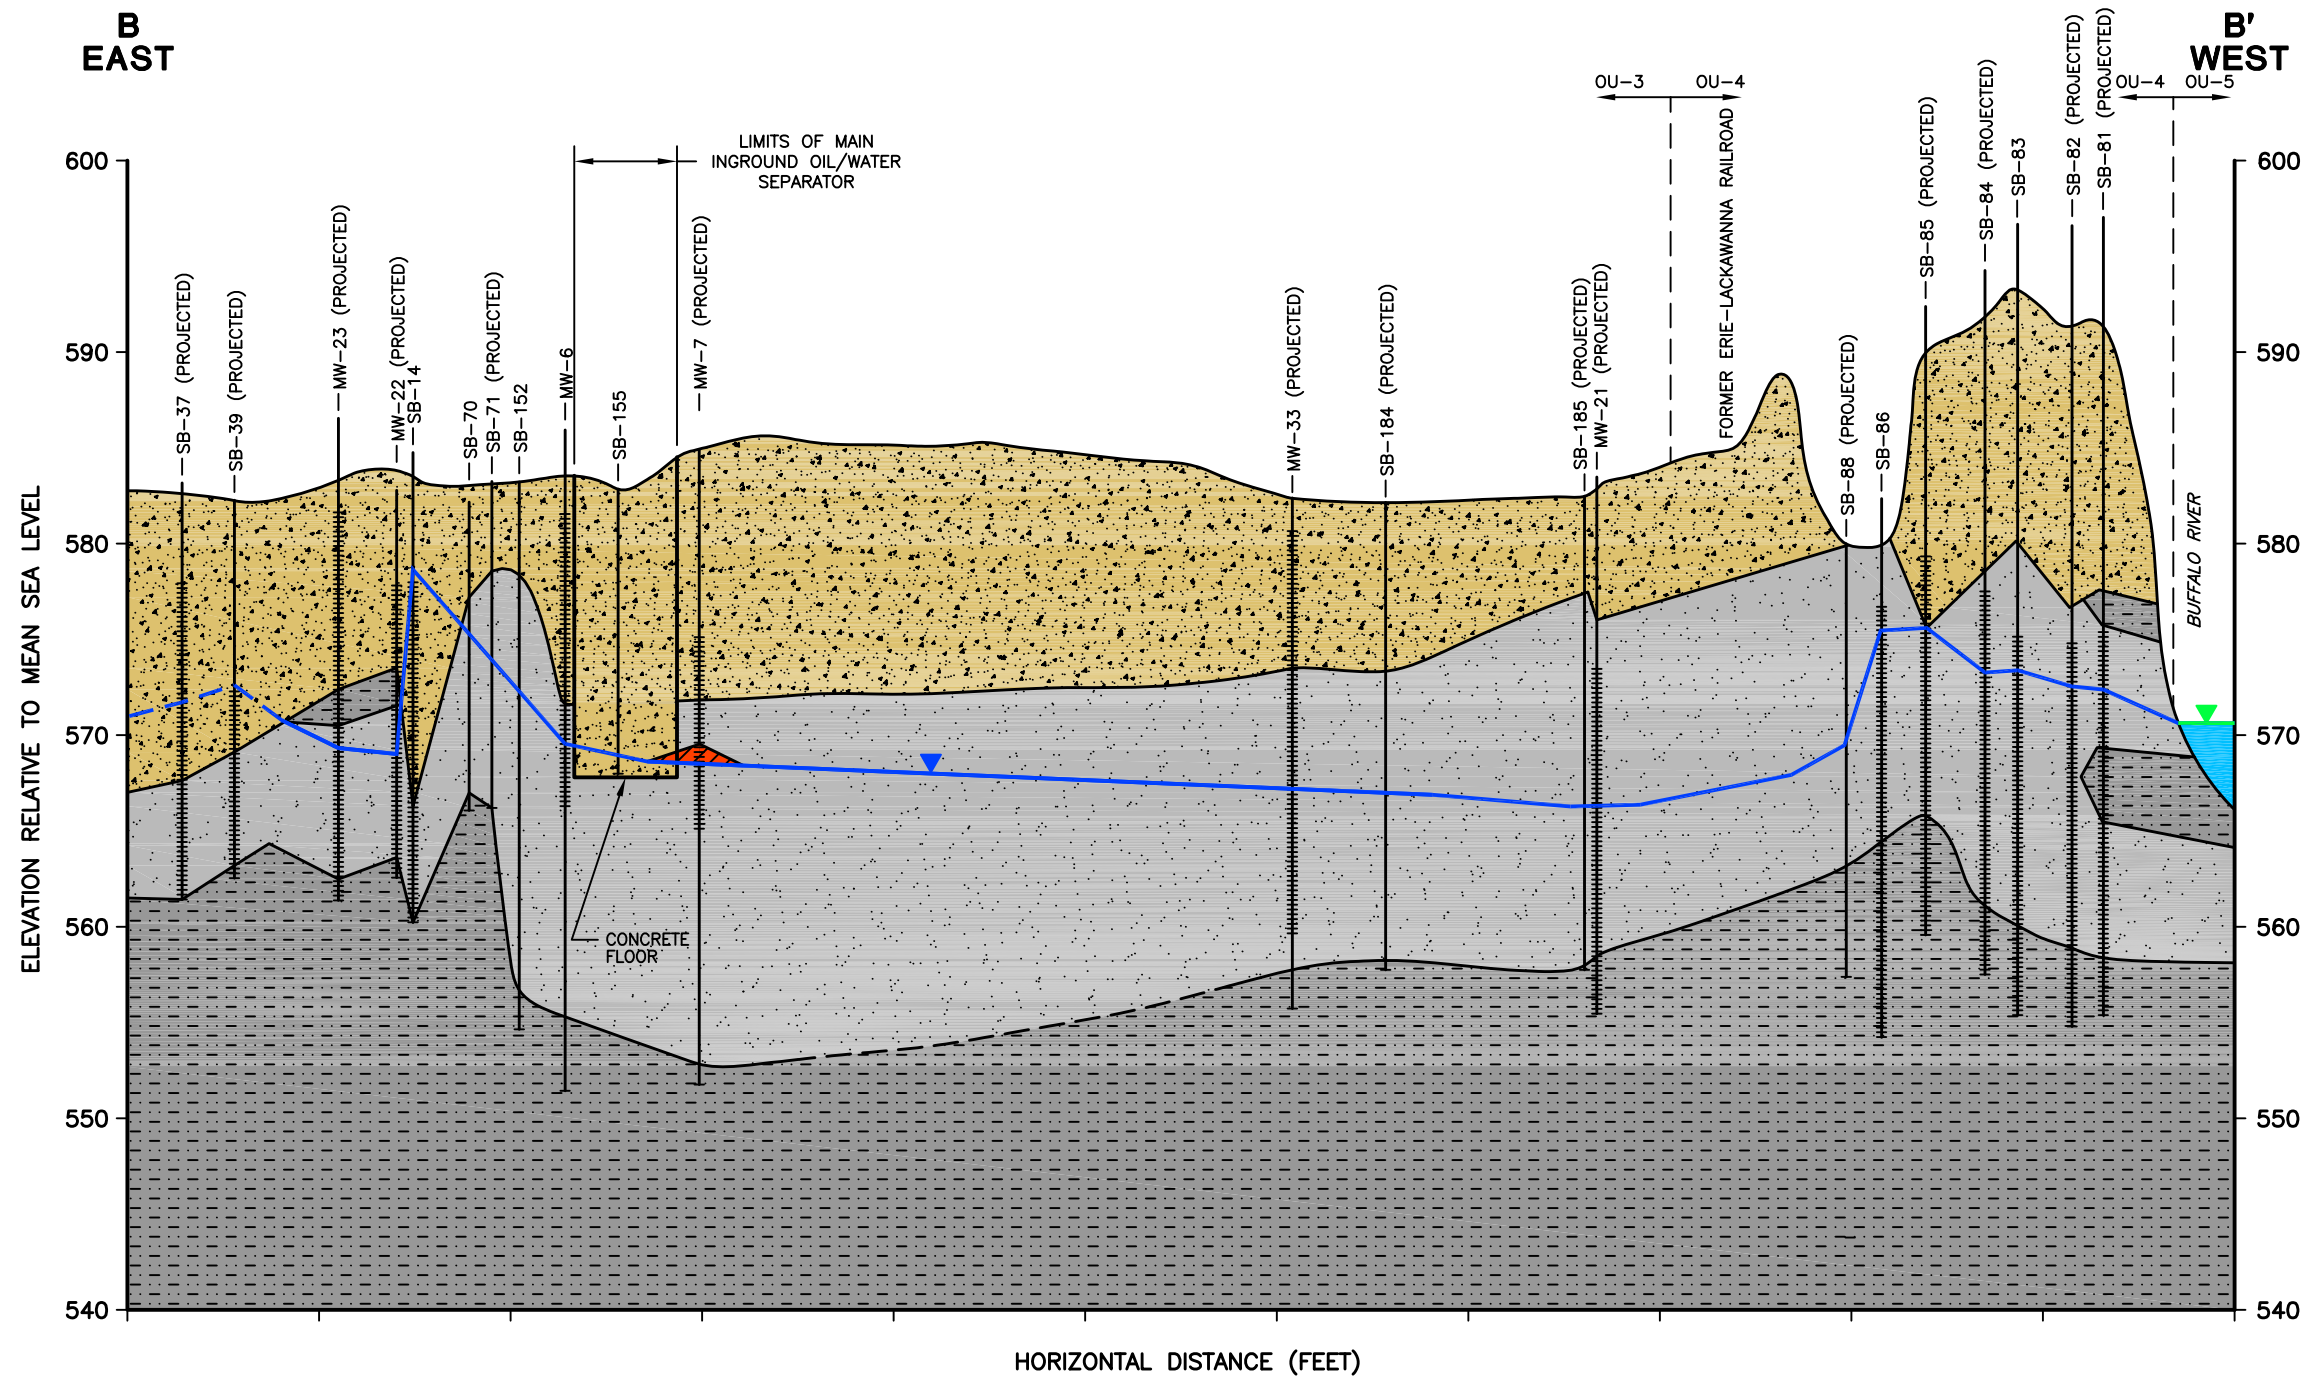
Title: **GENERALIZED HYDROGEOLOGIC CROSS SECTION B-B'**

- INDICATES MONITORING WELL SCREENED INTERVAL
- INDICATES SOIL BORING
- GROUNDWATER TABLE ELEVATION IN FEET ABOVE MEAN SEA LEVEL, (DASHED WHERE INFERRED)
- BUFFALO RIVER ELEVATION IN FEET ABOVE MEAN SEA LEVEL
- FILL MATERIAL CONSISTING OF BLACK CINDERS, CONCRETE, BRICK, GLASS, SLAG, WOOD, SILT, GRAVEL AND SAND
- ALLUVIAL DEPOSITS (SAND, SAND AND SILT, SAND AND GRAVEL, SILT AND SILTY SAND)
- CLAY (INCLUDES CLAY AND SAND AND CLAY)
- SEPARATE-PHASE PRODUCT

- NOTES**
1. FOR LOCATION OF SECTION LINES SEE PLATE 1.
  2. LAND SURFACE SHOWN IS ALONG THE SECTION CUT LINE, NOT NECESSARILY AT THE WELL/BORING LOCATIONS IF WELL/BORING IS PROJECTED ONTO THE LINE.
  3. WATER/PRODUCT LEVEL DATA SHOWN WAS COLLECTED ON JANUARY 17 AND 18, 2002.
  4. WATER LEVEL AND SEPARATE PHASE PRODUCT THICKNESS SHOWN AT MW-7 WAS ESTIMATED BECAUSE PRODUCT WAS TOO THICK FOR PROBE TO PASS.
  5. LINES SEPARATING CLAY LAYER FROM ALLUVIAL DEPOSITS IS SHOWN DASHED WHERE INFERRED.
  6. THE ALLUVIAL DEPOSITS PRESENT AT THE WELL LOCATIONS SHOWN IN THE ETYA EAST OF THE FORMER ERIE-LACKAWANNA RAILROAD ARE PRIMARILY COMPRISED OF SAND AND GRAVEL.
  7. GEOTECHNICAL BORINGS ADVANCED IN APRIL 2009 INDICATE A SILTY SAND AND CLAYEY SAND LAYER FROM 54 TO 77 FEET BELOW GRADE, UNDERLAIN BY BEDROCK.

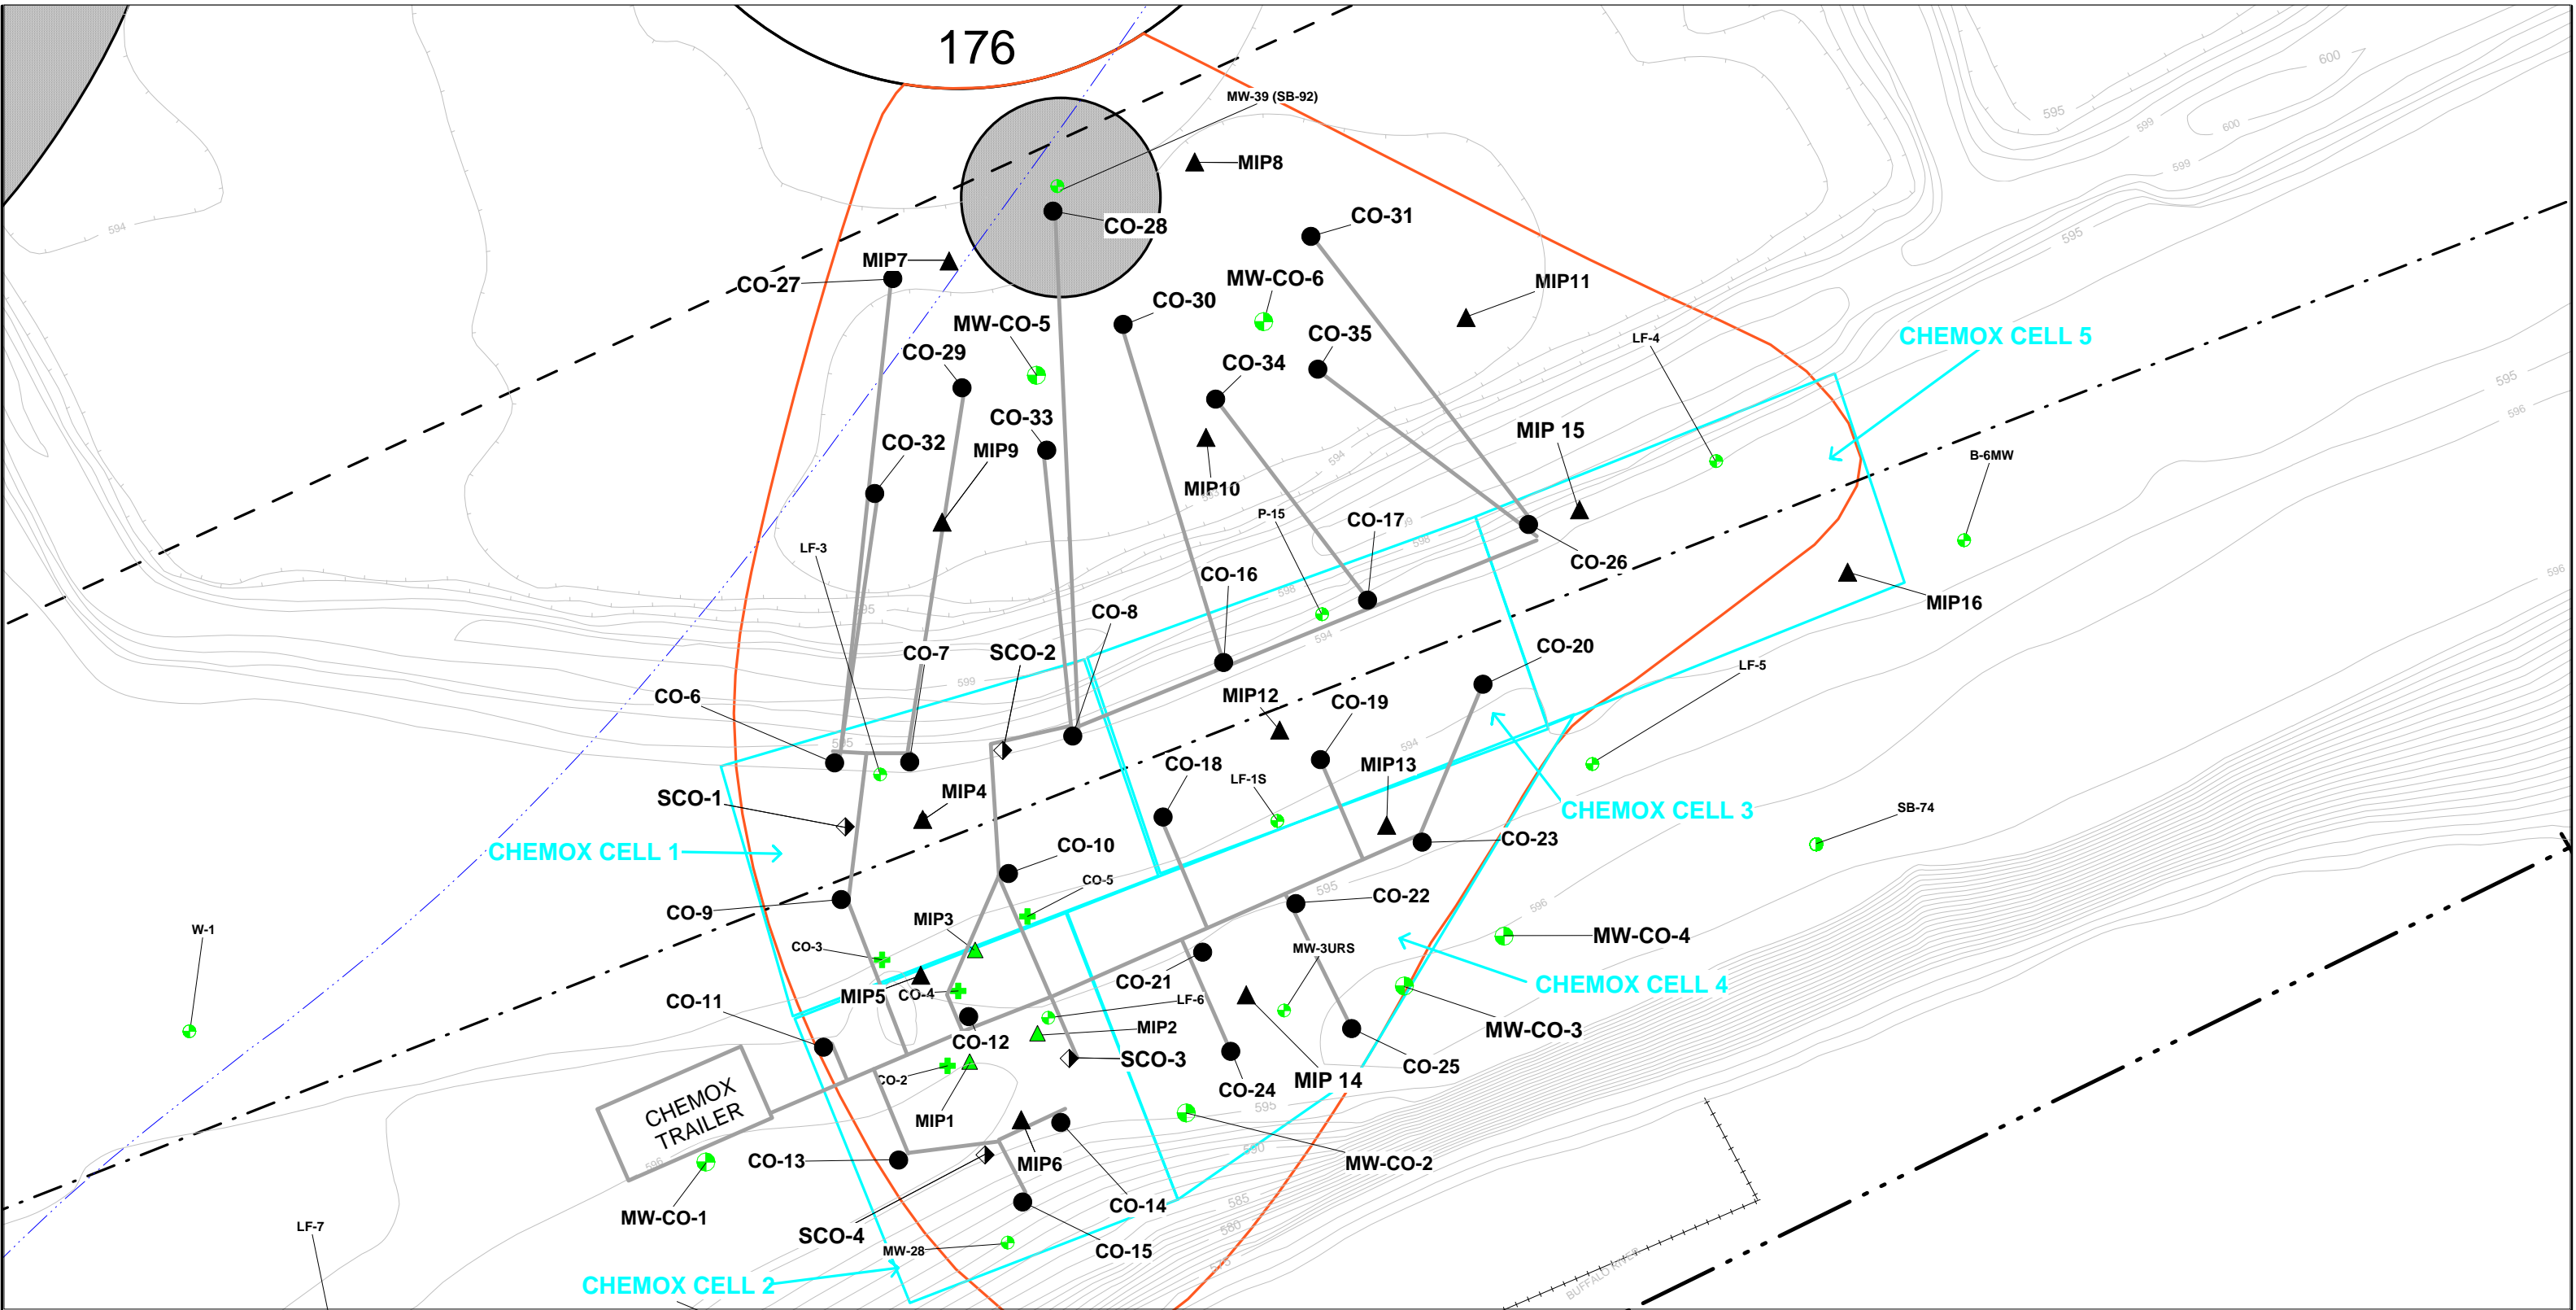
- ◆ SUPPLEMENTAL HYDROGEN PEROXIDE INJECTION WELL  
INSTALLED BETWEEN DEC. 2006 AND JAN. 2007  
(ONE HYDROGEN PEROXIDE POINT JUST BELOW THE WATER TABLE)
- ▲ MEMBRANE INTERFACE PROBE LOCATION  
INSTALLED BETWEEN DEC. 2006 AND JAN. 2007
- NESTED CHEMOX INJECTION WELL  
INSTALLED BETWEEN DEC. 2006 AND JAN. 2007  
(ONE OZONE AND ONE HYDROGEN PEROXIDE POINT)
- ⊕ CHEMOX PILOT TEST NESTED INJECTION WELL INSTALLED FOR CHEMOX PILOT TEST  
(ONE OZONE AND ONE HYDROGEN PEROXIDE POINT).
- ⊕ MONITORING WELL
- ⊕ SOIL BORING/ MONITORING WELL

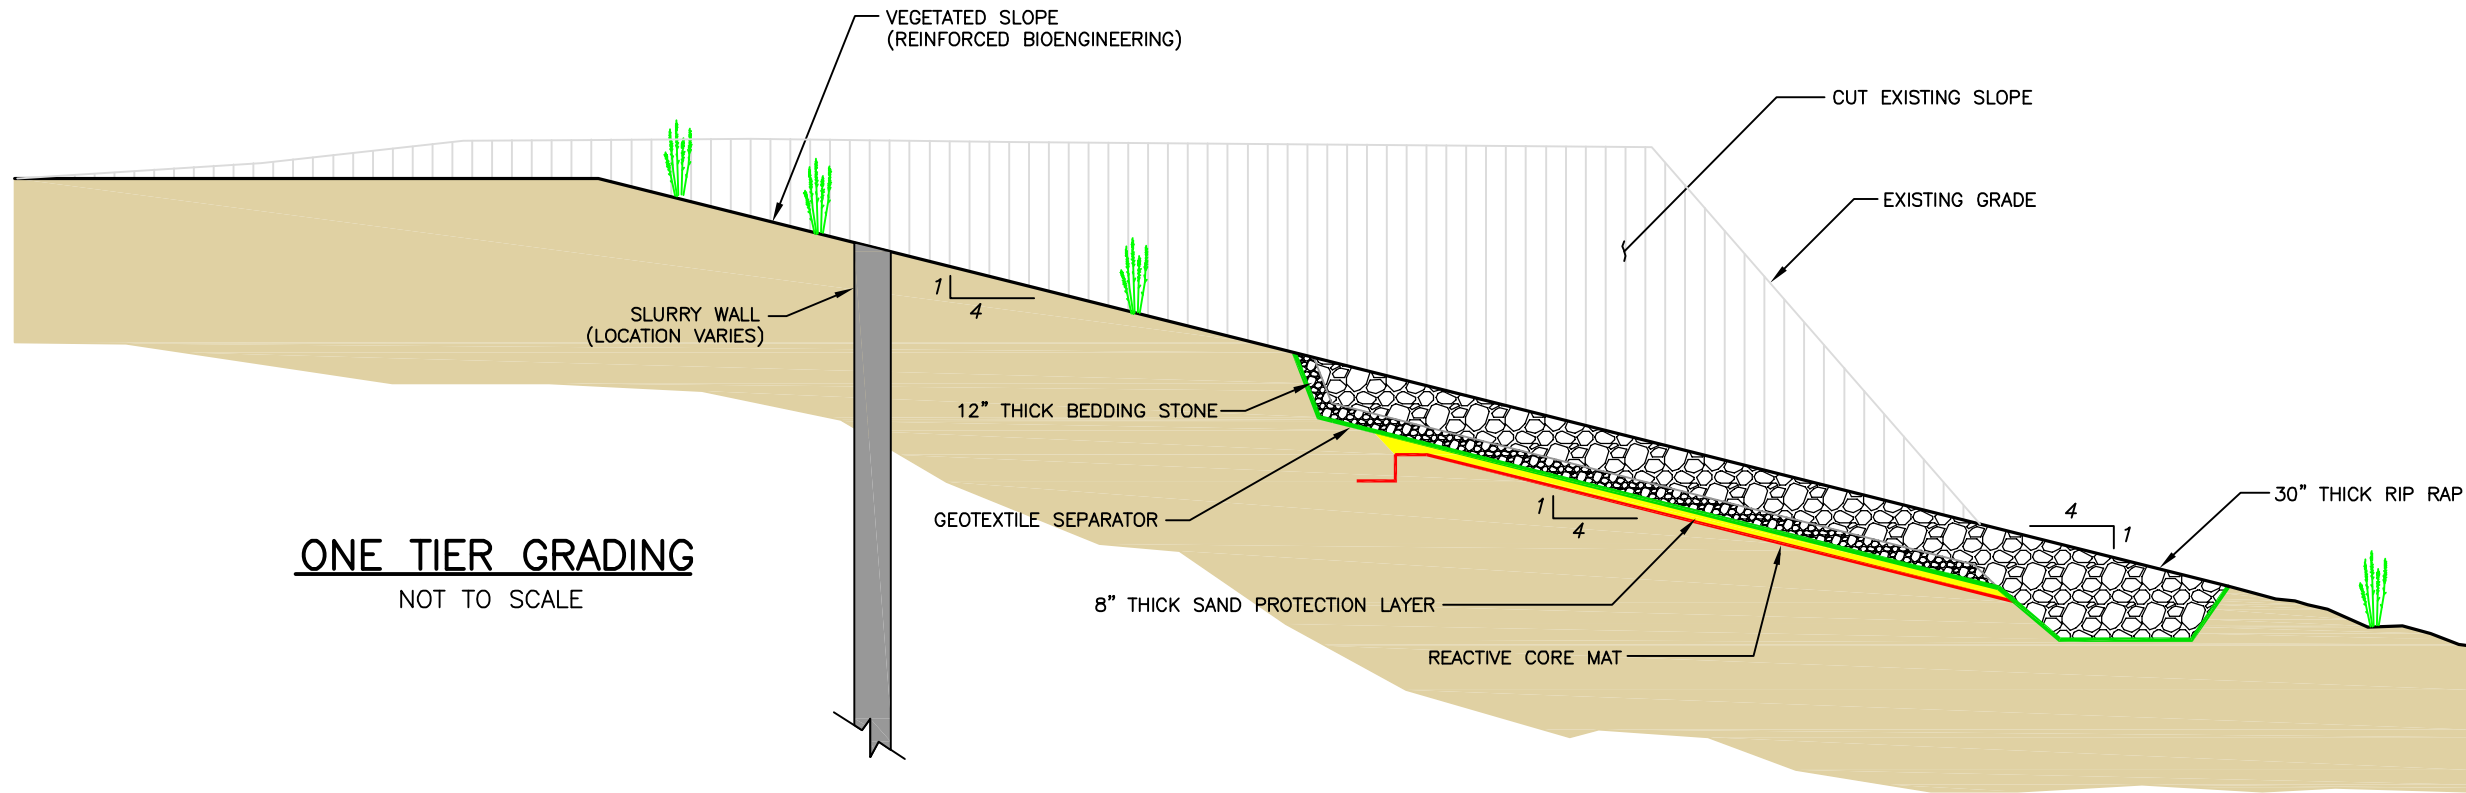
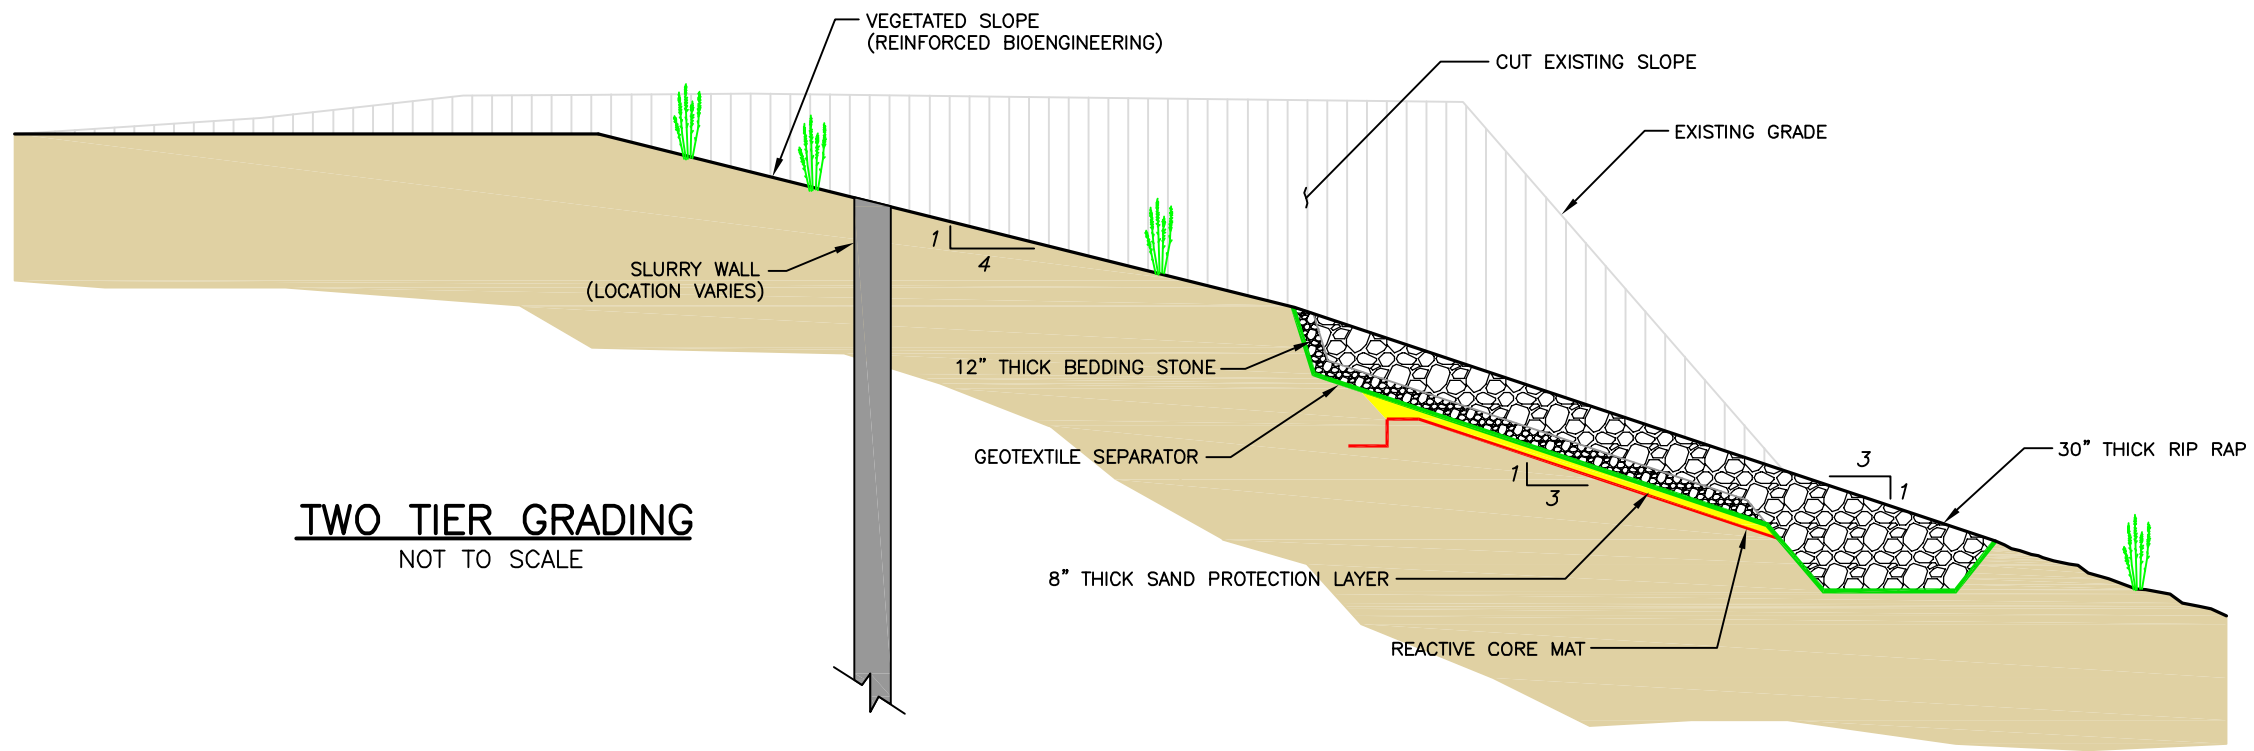
**ONE TIER GRADING**  
NOT TO SCALE

**TWO TIER GRADING**  
NOT TO SCALE

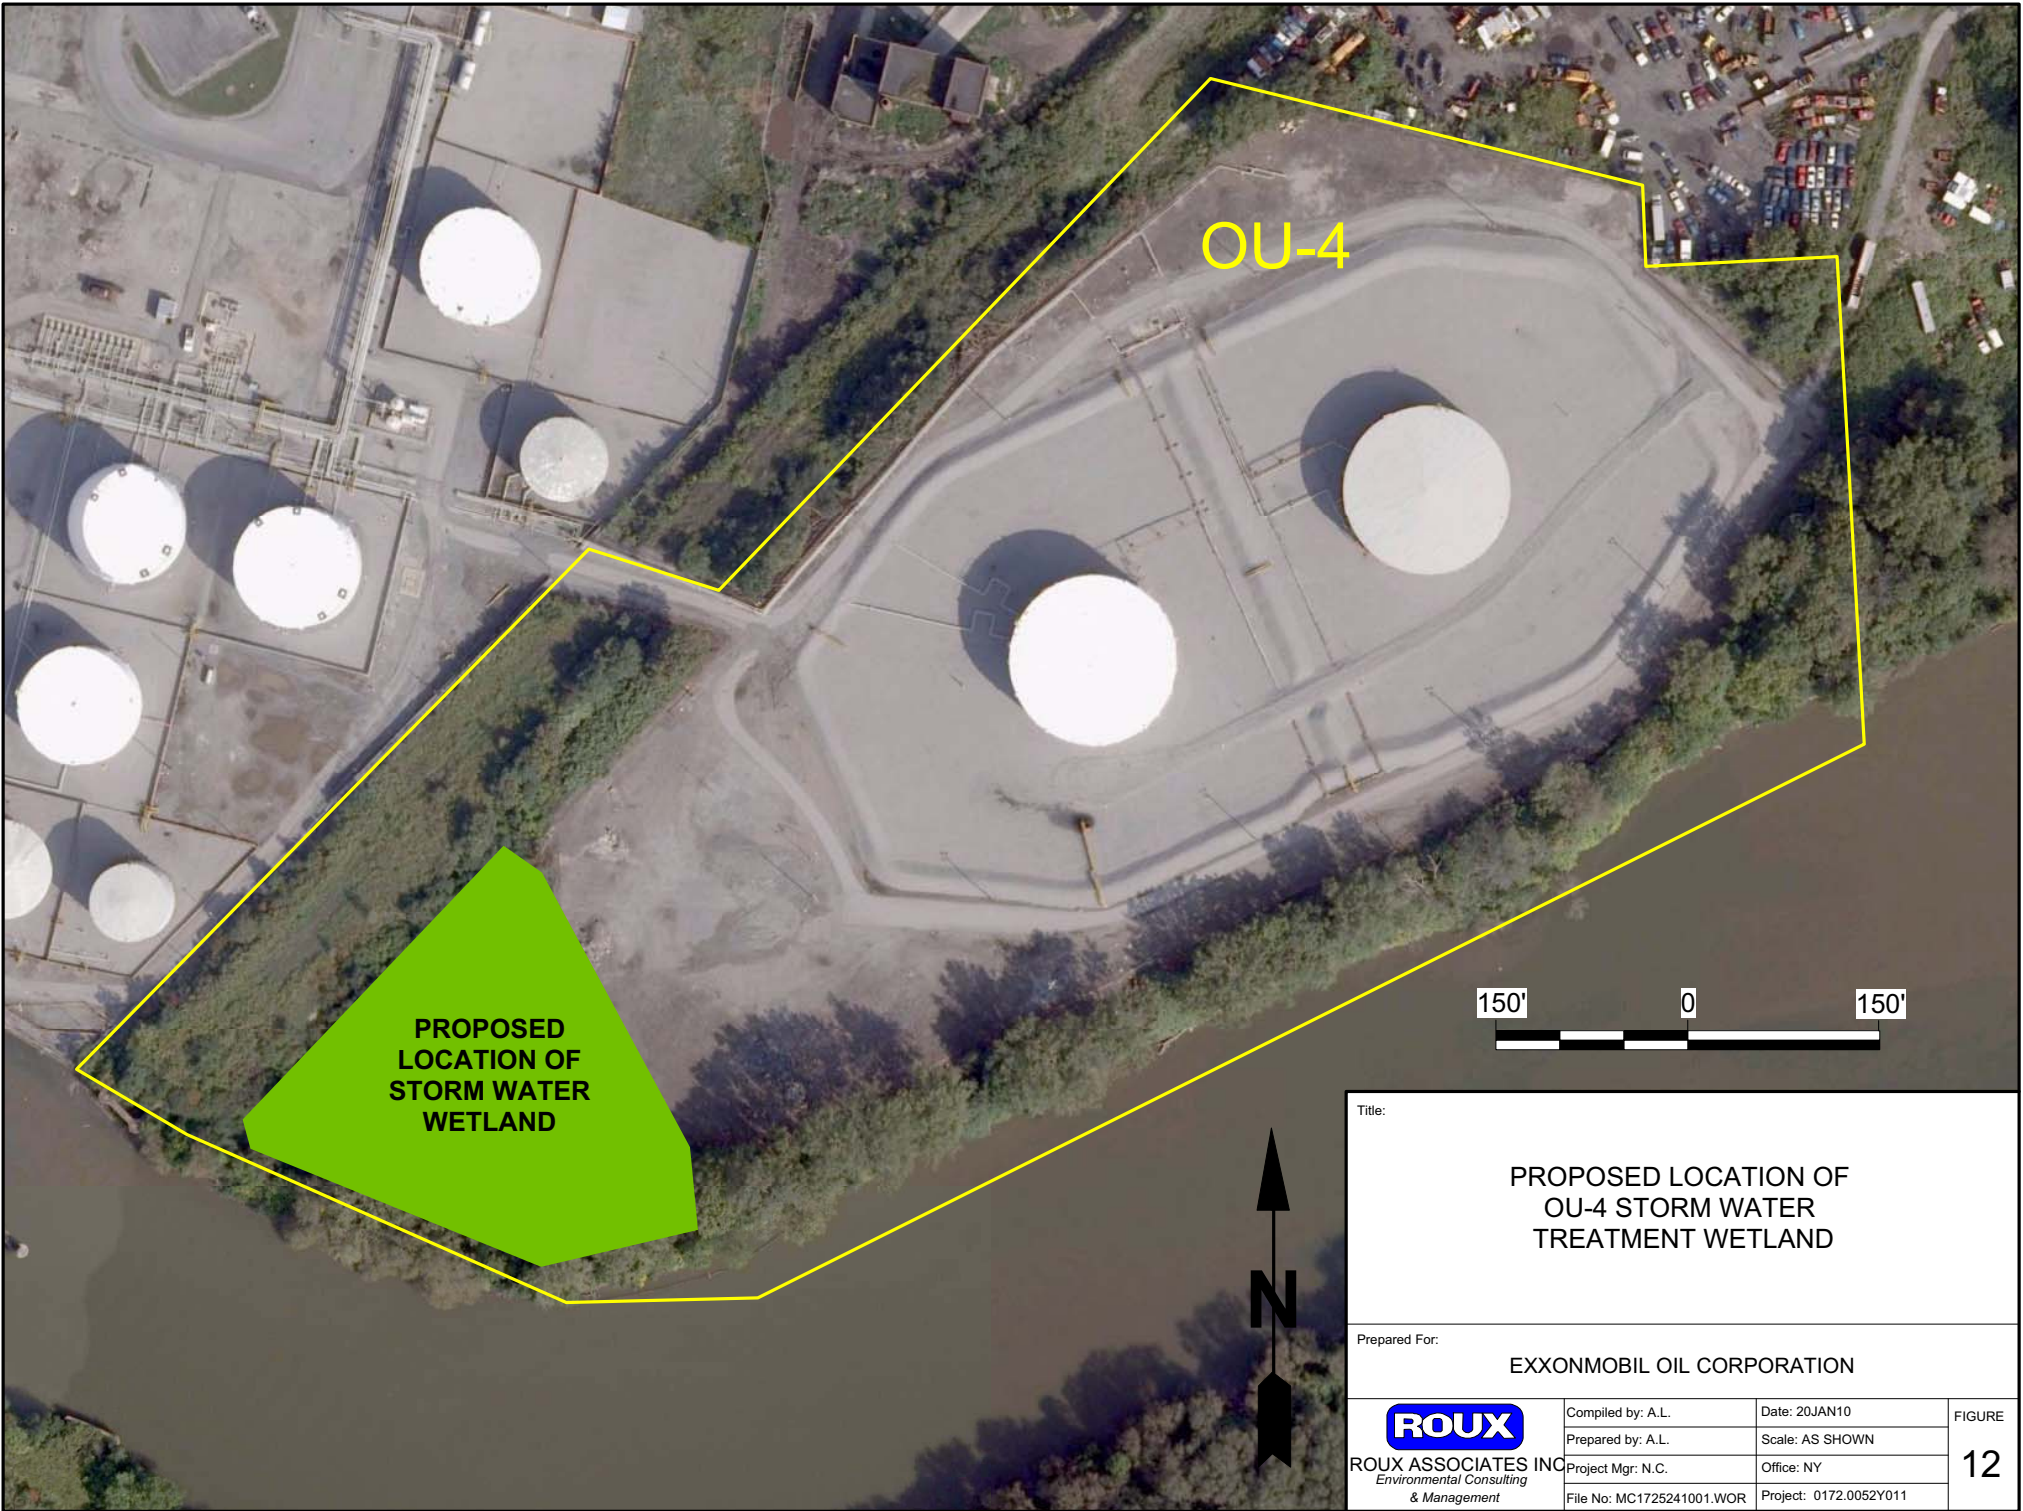
PROPOSED  
LOCATION OF  
STORM WATER  
WETLAND

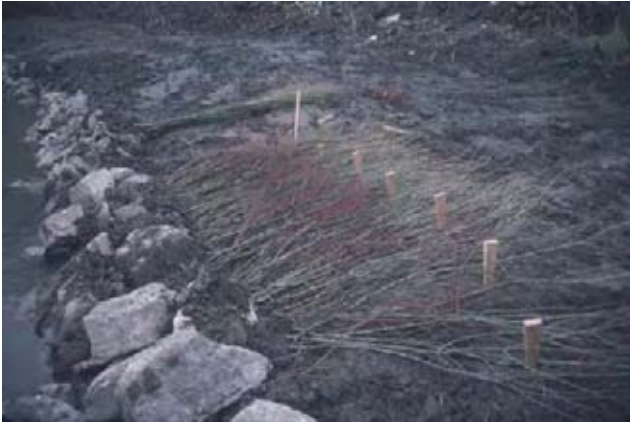
# STANDARD AND SPECIFICATIONS FOR BRUSH MATTRESS

A mulch or mattress of brush laid on a slope and fastened down with stakes and wire.

Brush mattresses are used primarily on streambanks where the velocity is less than 6 feet per second and excessive runoff from streamflow has created erosive conditions. This practice can resist temporary inundation, but not scour or undercutting.

Scheduled inspections the first year are necessary to make sure the anchoring system is sound. Broken wire or missing stakes shall be replaced immediately. Any missing toe material missing shall be replaced.

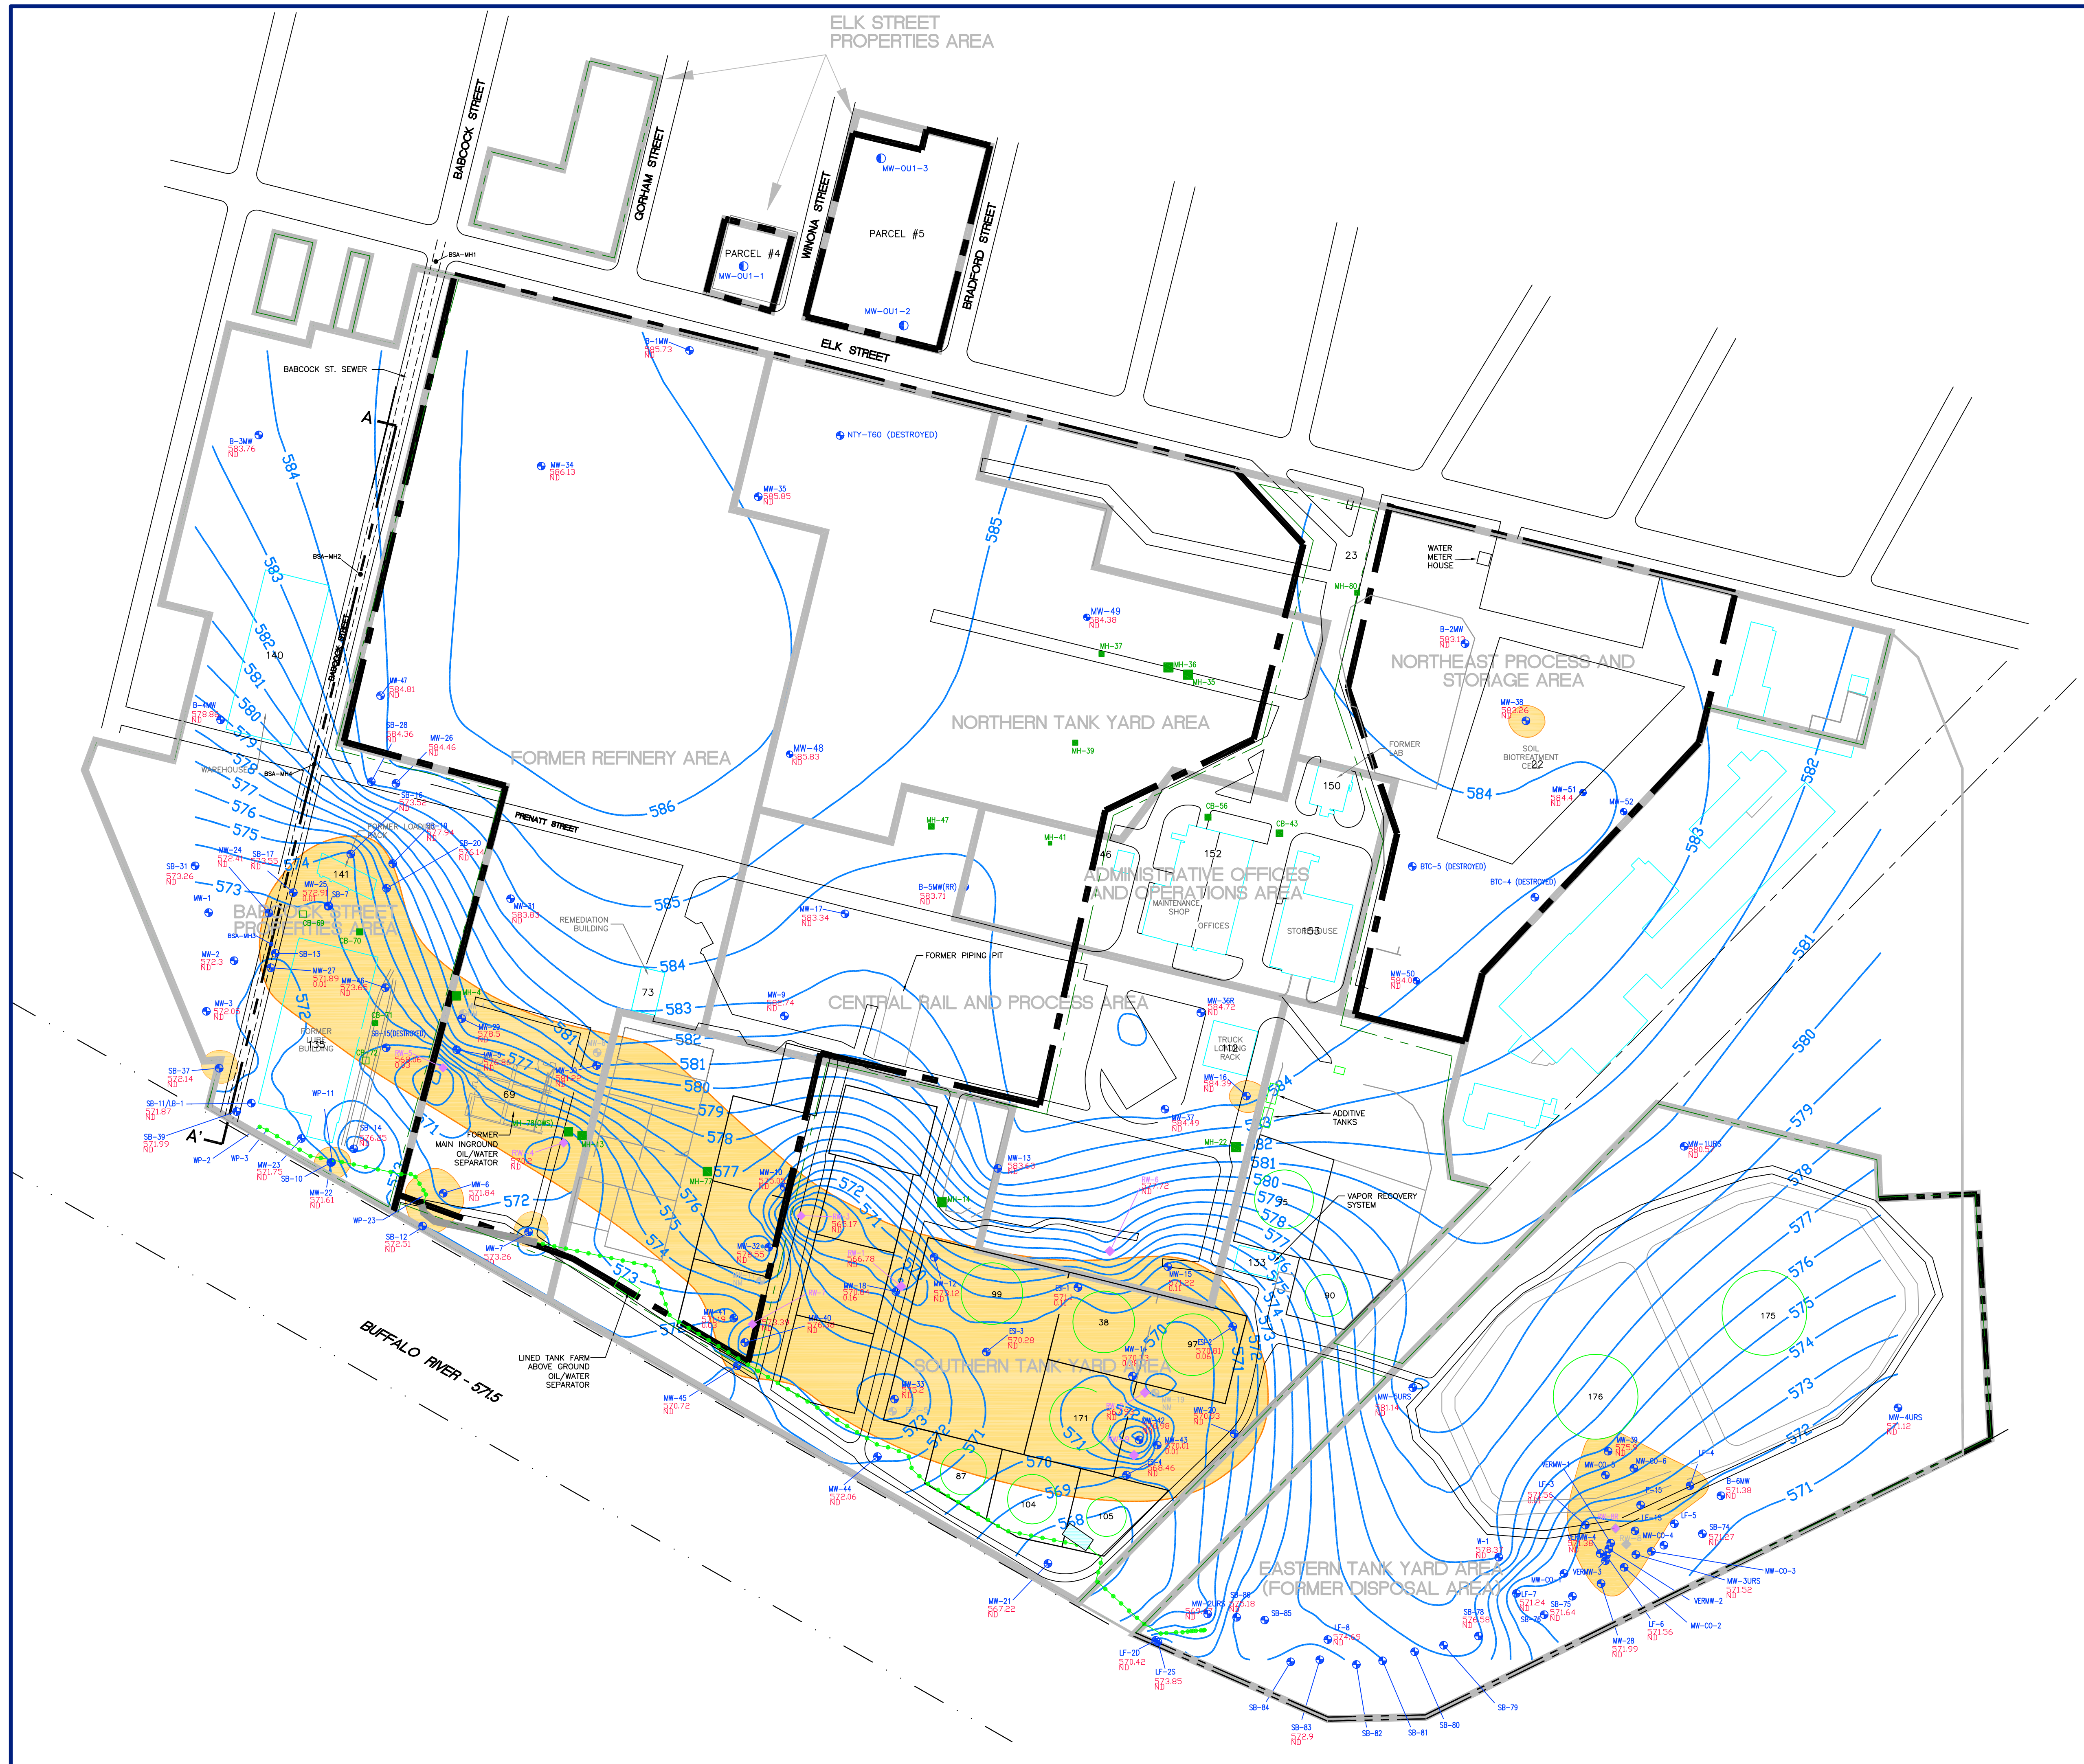
DRAFTED BY: AM	<b>GROUNDWATER POTENTIOMETRIC MAP</b> APRIL 5, 2010	
CHECKED BY: MAP		
REVIEWED BY: AJ	<b>FORMER XOM TERMINAL</b> BUFFALO, NEW YORK	
NORTH		
<b>Groundwater &amp; Environmental Services, Inc.</b> 158 SONWIL DRIVE CHEEKTOWAGA, NEW YORK 14225		
	DATE 5-21-10	PLATE 2

WELL DESIGNATION	AVERAGE FLOW RATE FOR WELLS (GALLONS PER MINUTE)
MW-1	NOTE 1) 1.0
MW-2	2.2
MW-3	2.2
MW-4	3.5
MW-5	2.9
EASTERN WIS	26.9
WESTERN WIS	NOTE 1)

NOTES:  
1. FLOW METER NOT OPERATING PROPERLY

Based upon the water level and separate-phase product thickness data collected during prior investigations and recent quarterly groundwater monitoring (Table 3), the groundwater flow direction is generally south-southeast across OU-4 towards the Buffalo River. The most recent groundwater flow map is provided in Plate 2.

The historical and current extent of separate-phase product within monitoring wells is limited to the area south of Tank 176 shown on Plate 2. In addition to existing wells that currently have measurable separate-phase product present, separate-phase product was noted at or near the water table interface during the completion of borings/wells SB-82 and SB-84 during December 2000. However, none of the wells installed in December 2000 have indicated the presence of measurable separate-phase product during ongoing water/product level gauging and/or groundwater sampling. Sheen was present at SB-80 during only one gauging round in January 2004. Above the water table, heavier black product was observed at SB-82 (7 to 9 ft bls) and

The ongoing groundwater monitoring data demonstrates that groundwater flow is southward to the Buffalo River (Plate 2). This would limit any potential for offsite migration to the north or east. In addition, the long term groundwater quality data from the northernmost (upgradient) well (MW-1URS) and easternmost (cross gradient) well (MW-4URS) indicate non-detect to low (below NYSDEC criteria) concentrations of VOCs and SVOCs. Based upon the groundwater flow and quality data described above, there has been no offsite migration to the north or east of OU-4.
