# ALTERNATIVES ANALYSIS REPORT FOR OPERABLE UNIT 4

ExxonMobil Former Buffalo Terminal  
Buffalo, New York

BCP Site C915201E

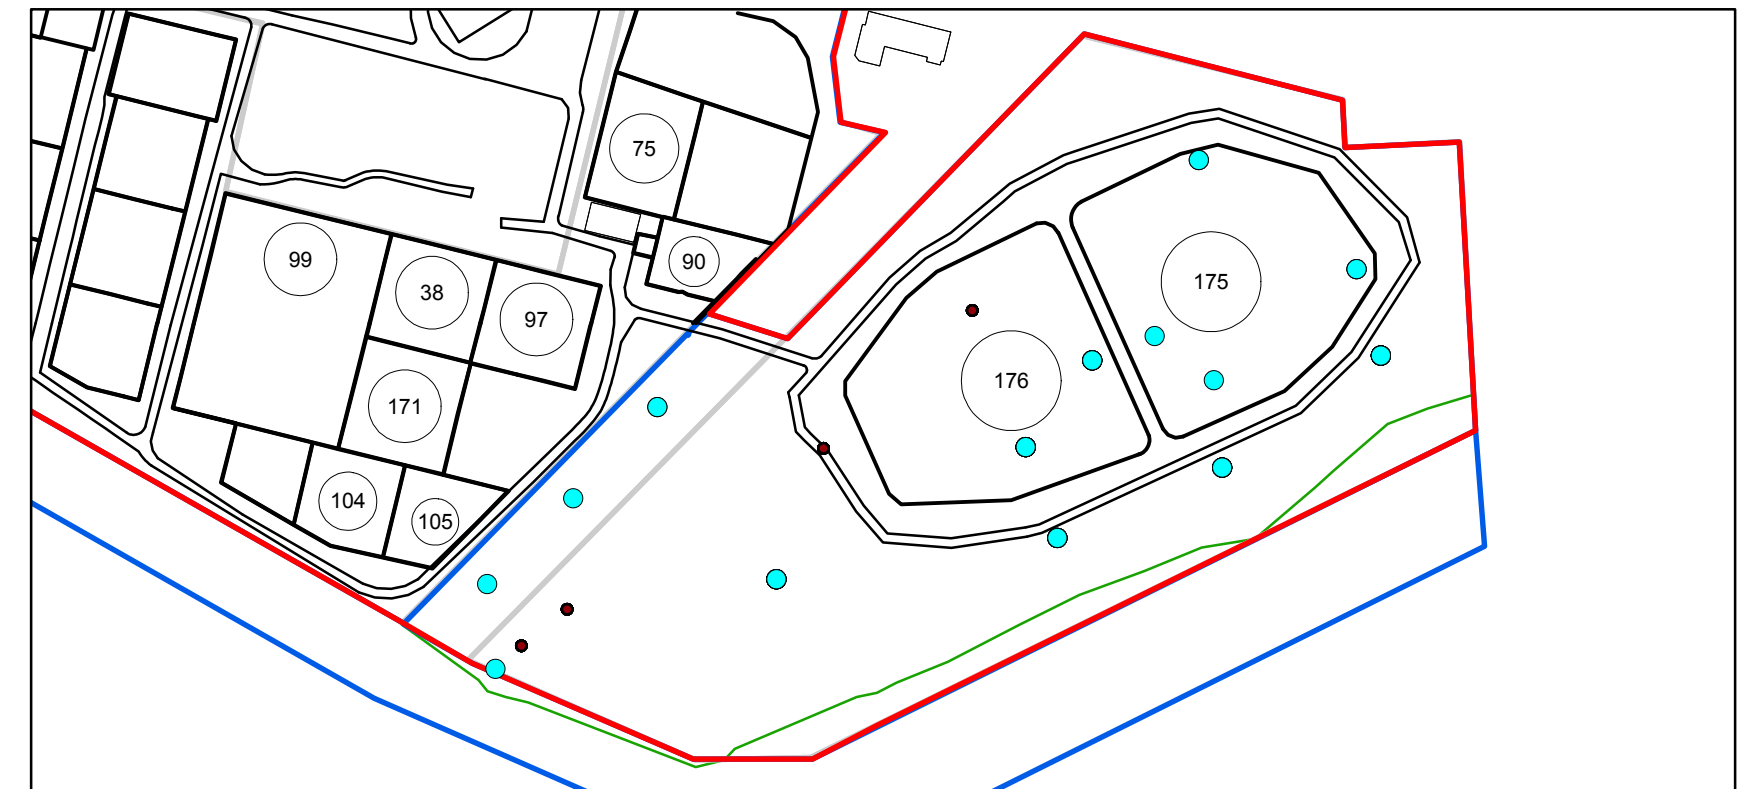
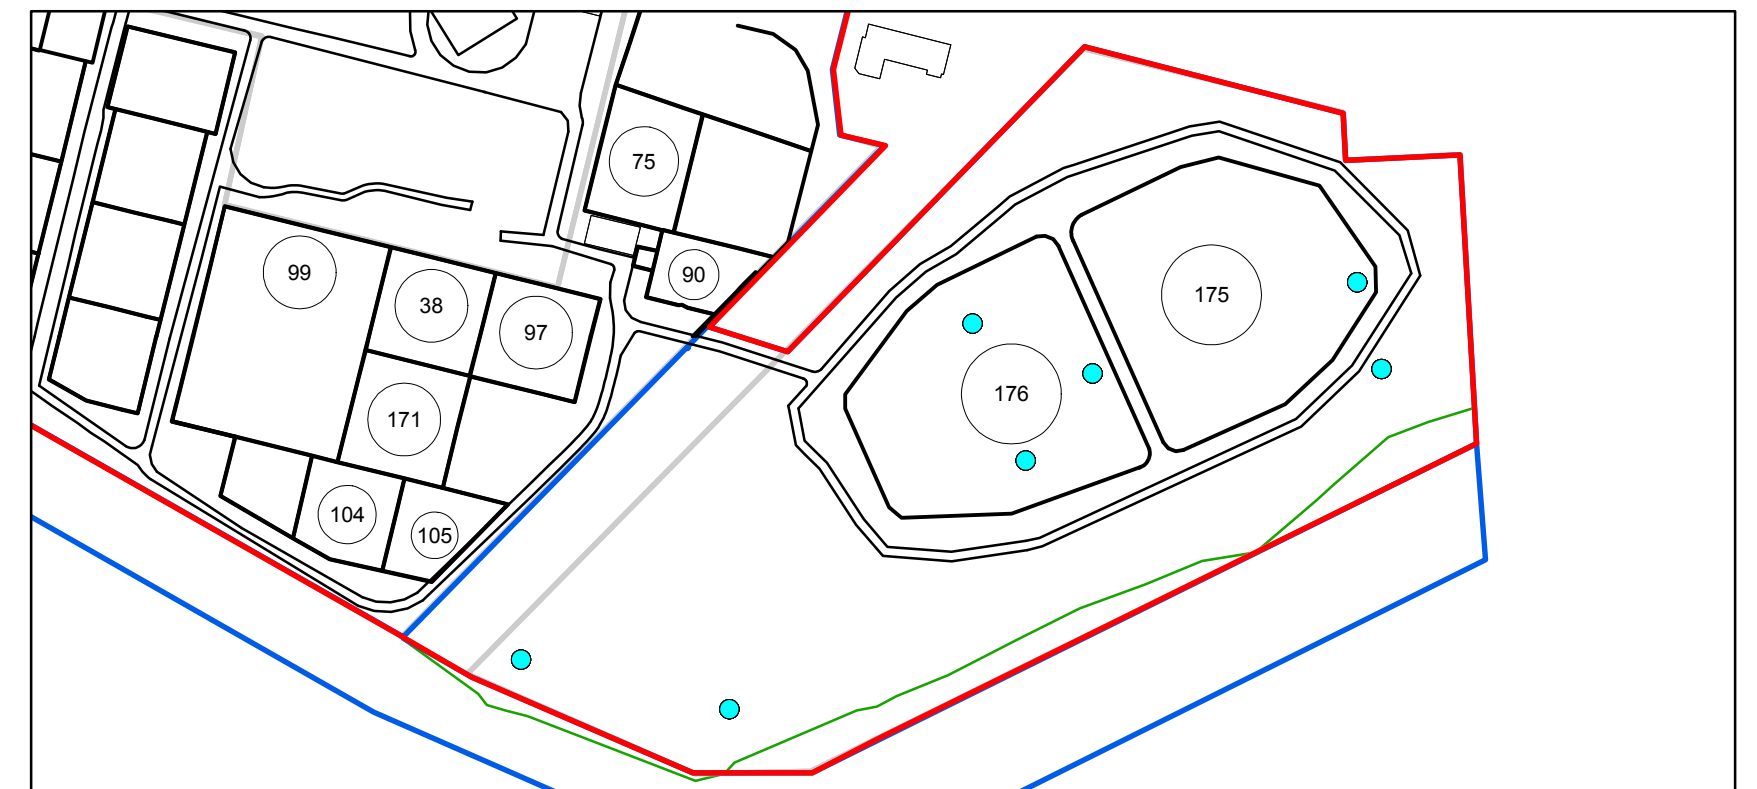
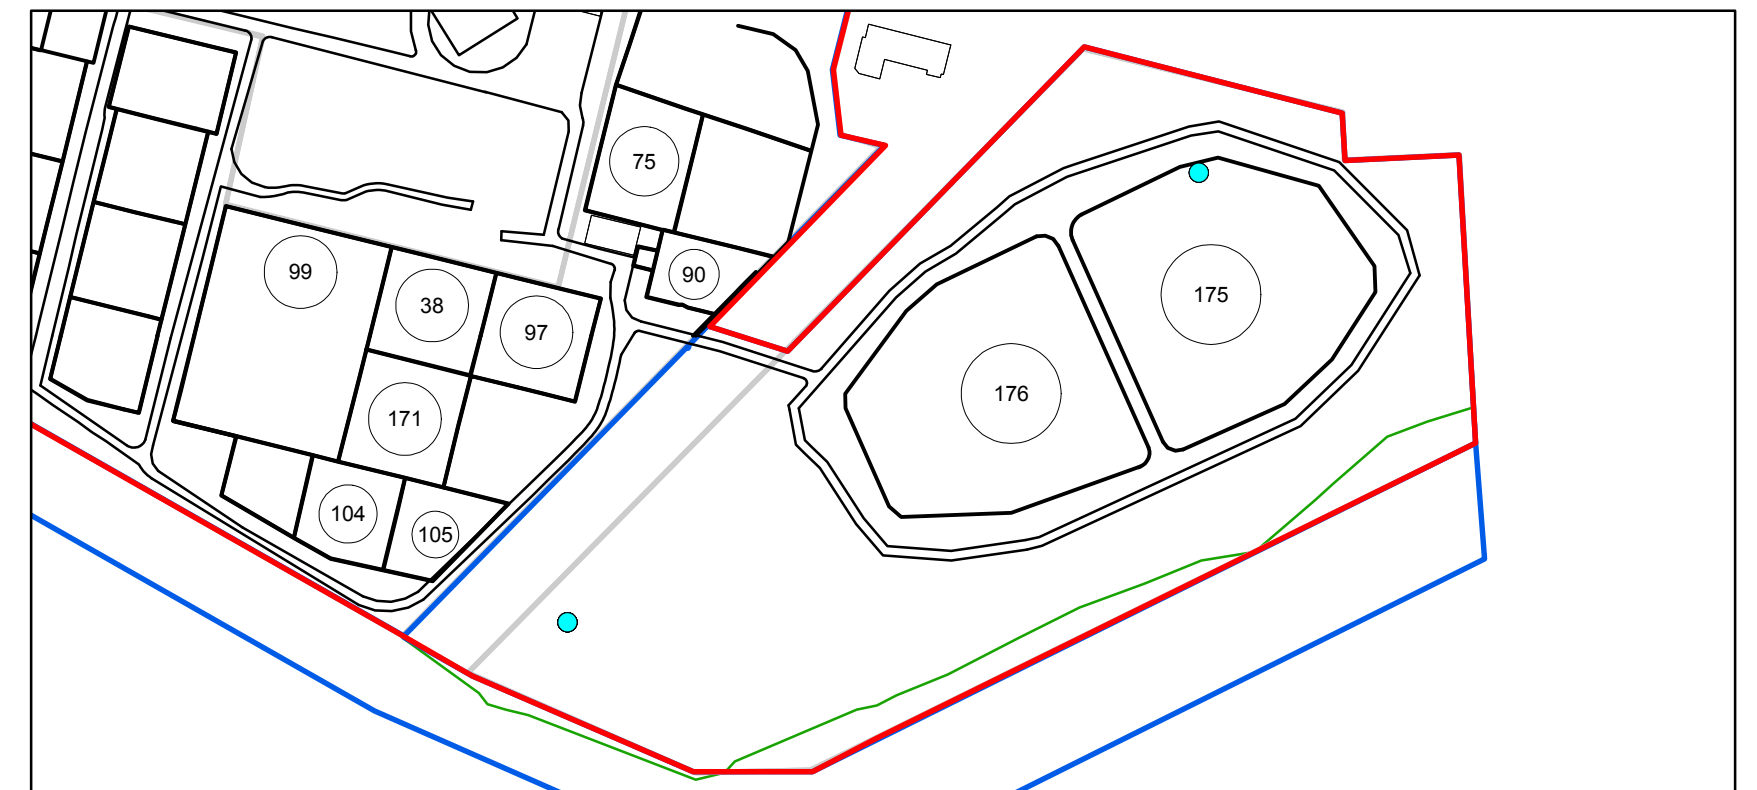
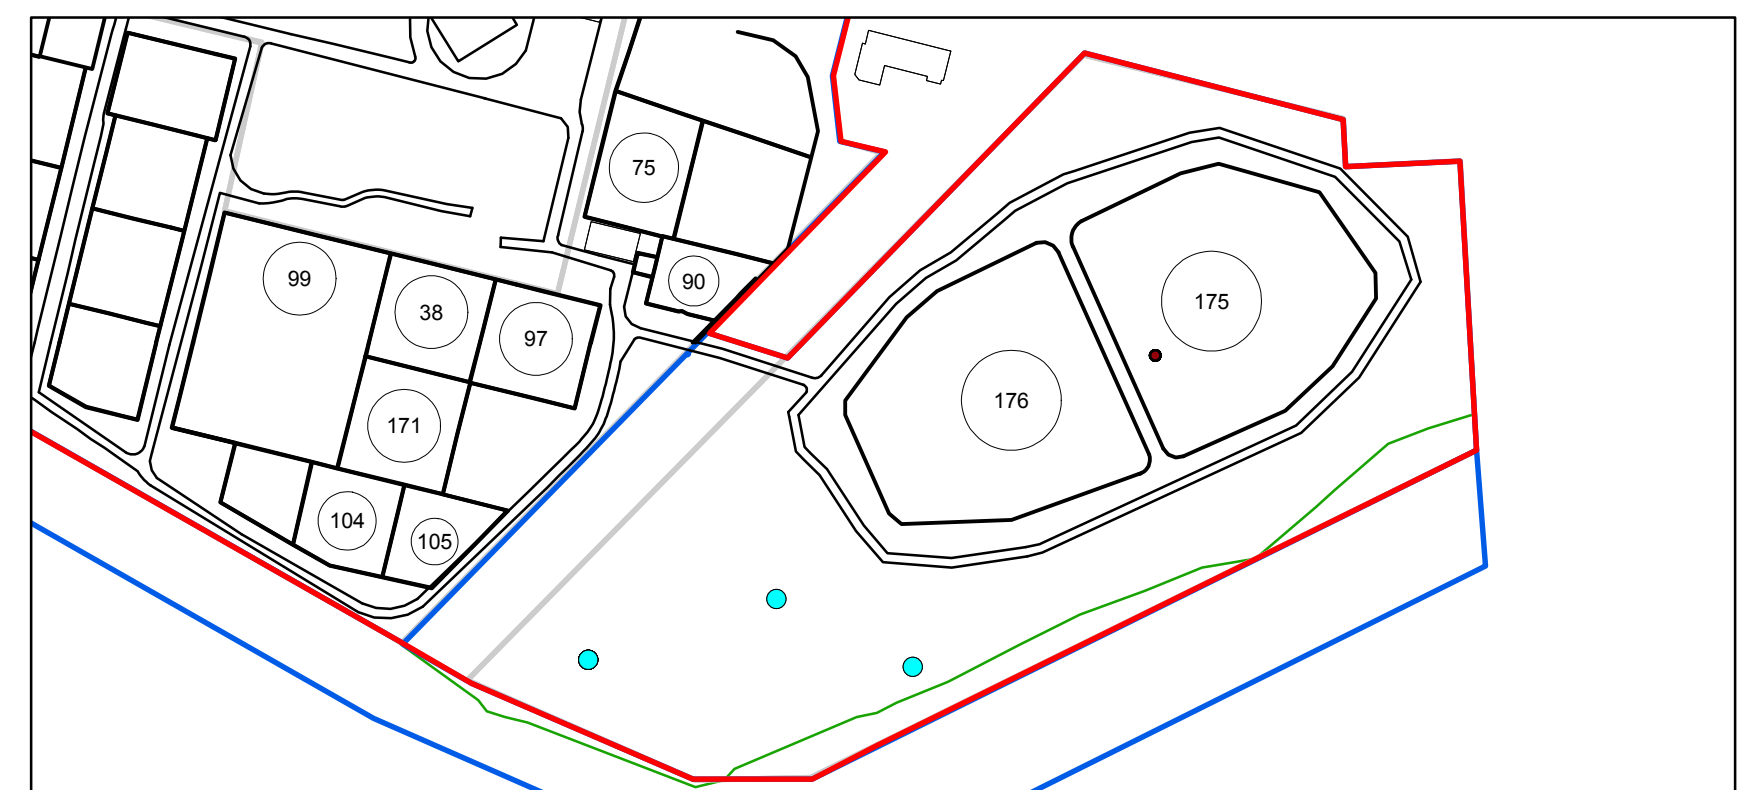
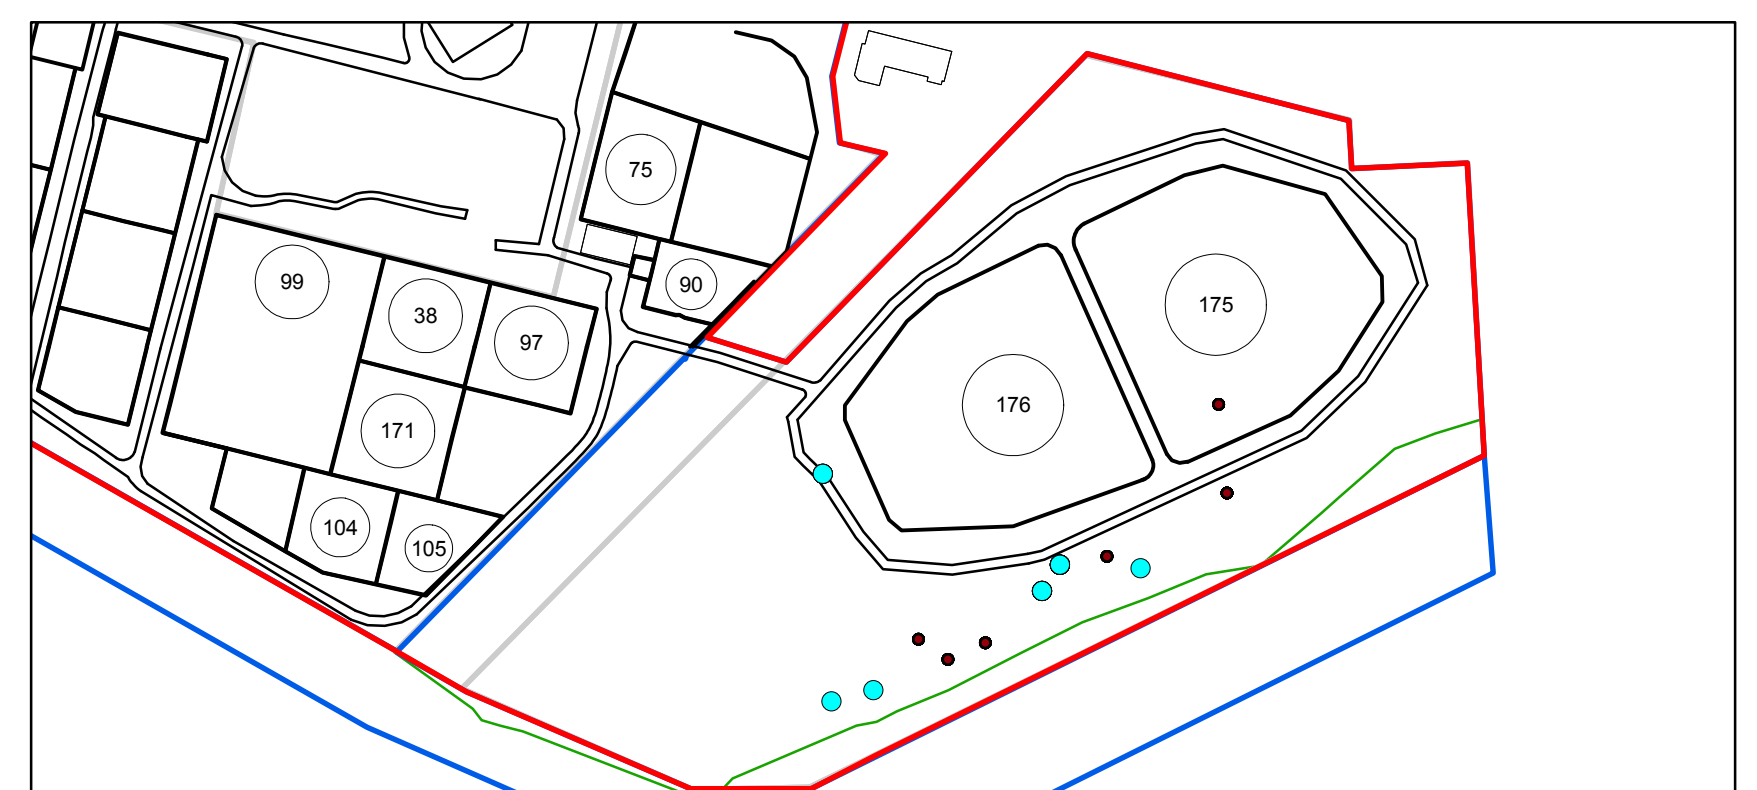
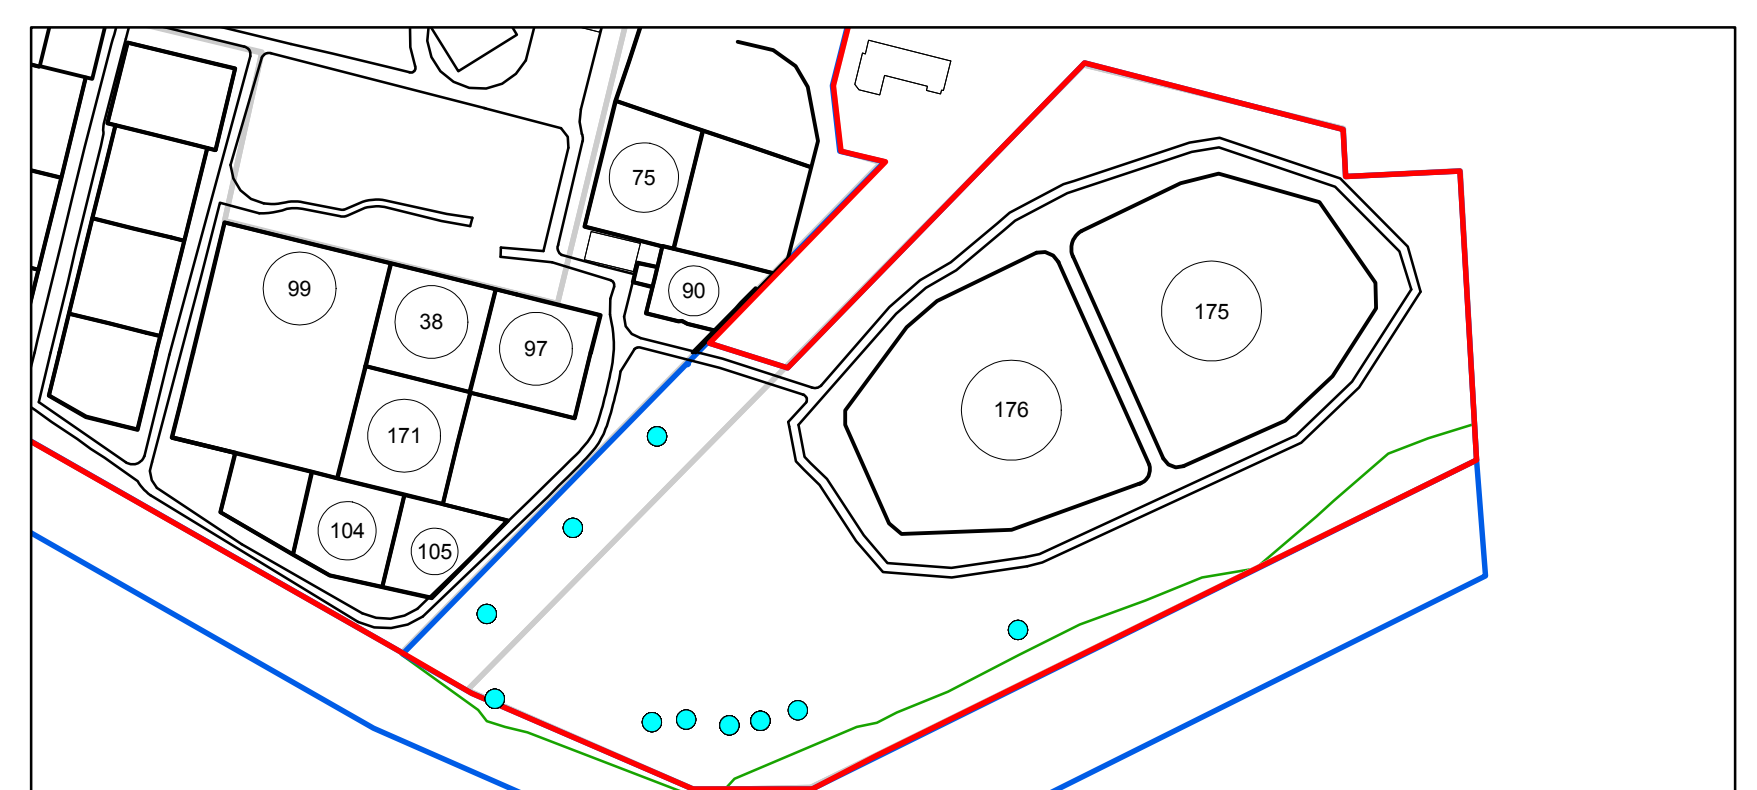
<p>ROUX ASSOCIATES, INC. Environmental Consulting &amp; Management</p>	Compiled by: F.C.	Date: 29JUL10	<p style="font-size: 24pt; font-weight: bold;">3</p>
	Prepared by: F.C.	Scale: AS SHOWN	
	Project Mgr: N.C.	Office: NY	
	File No: MCS2383010R.MXD	Project: 0172.052Y013

DISTRIBUTION OF VOCs RELATIVE TO PART 375 UNRESTRICTED CRITERIA

DISTRIBUTION OF VOCs RELATIVE TO PART 375 INDUSTRIAL CRITERIA

As shown on Plate 3, exceedances of the unrestricted use criteria were observed:

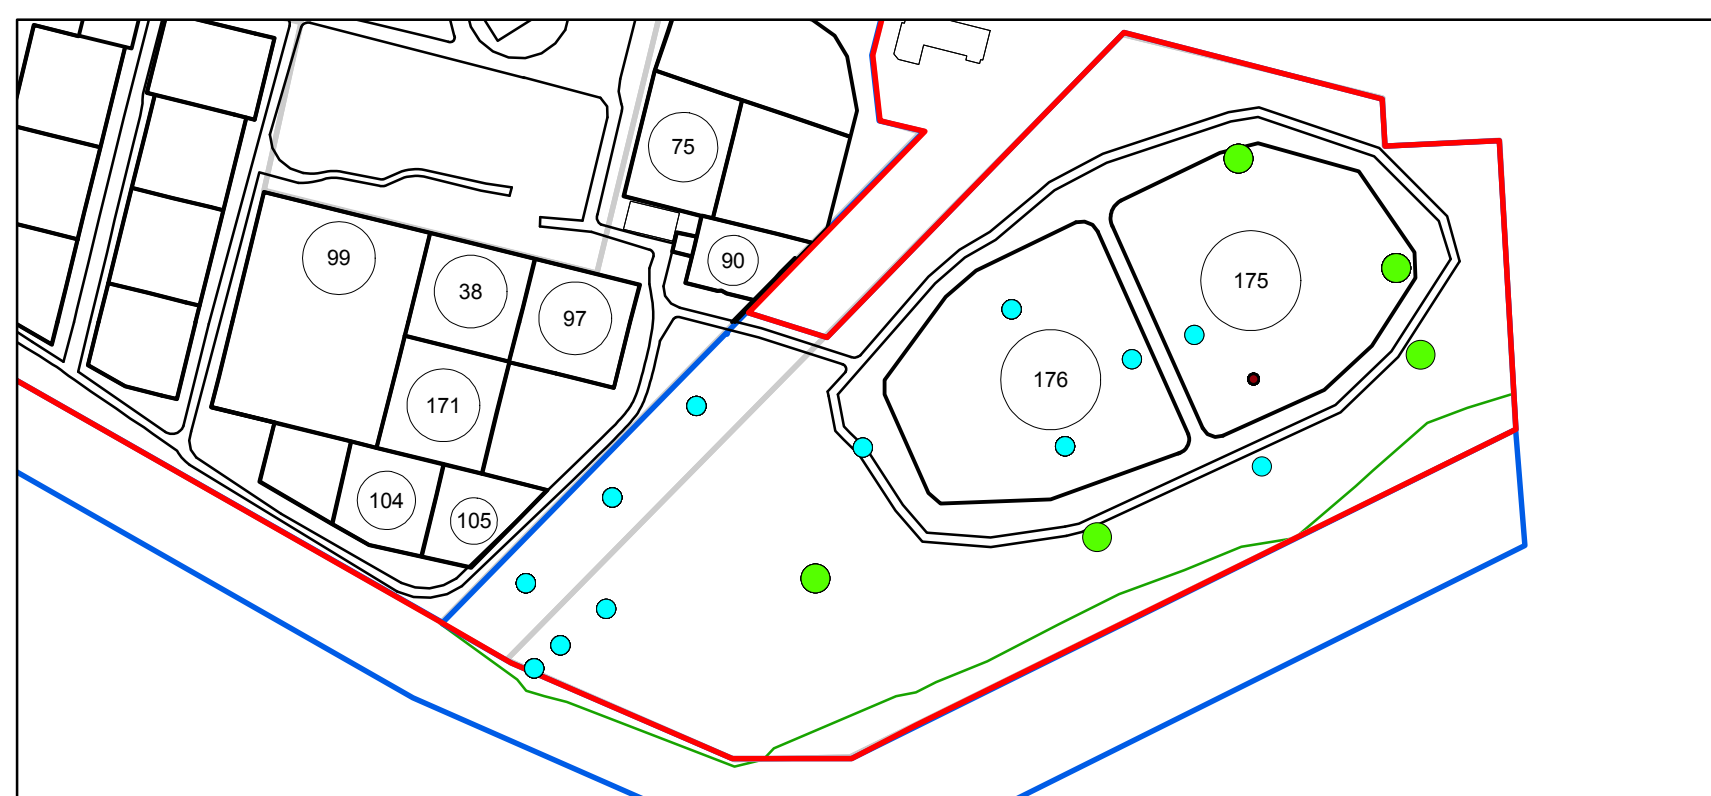
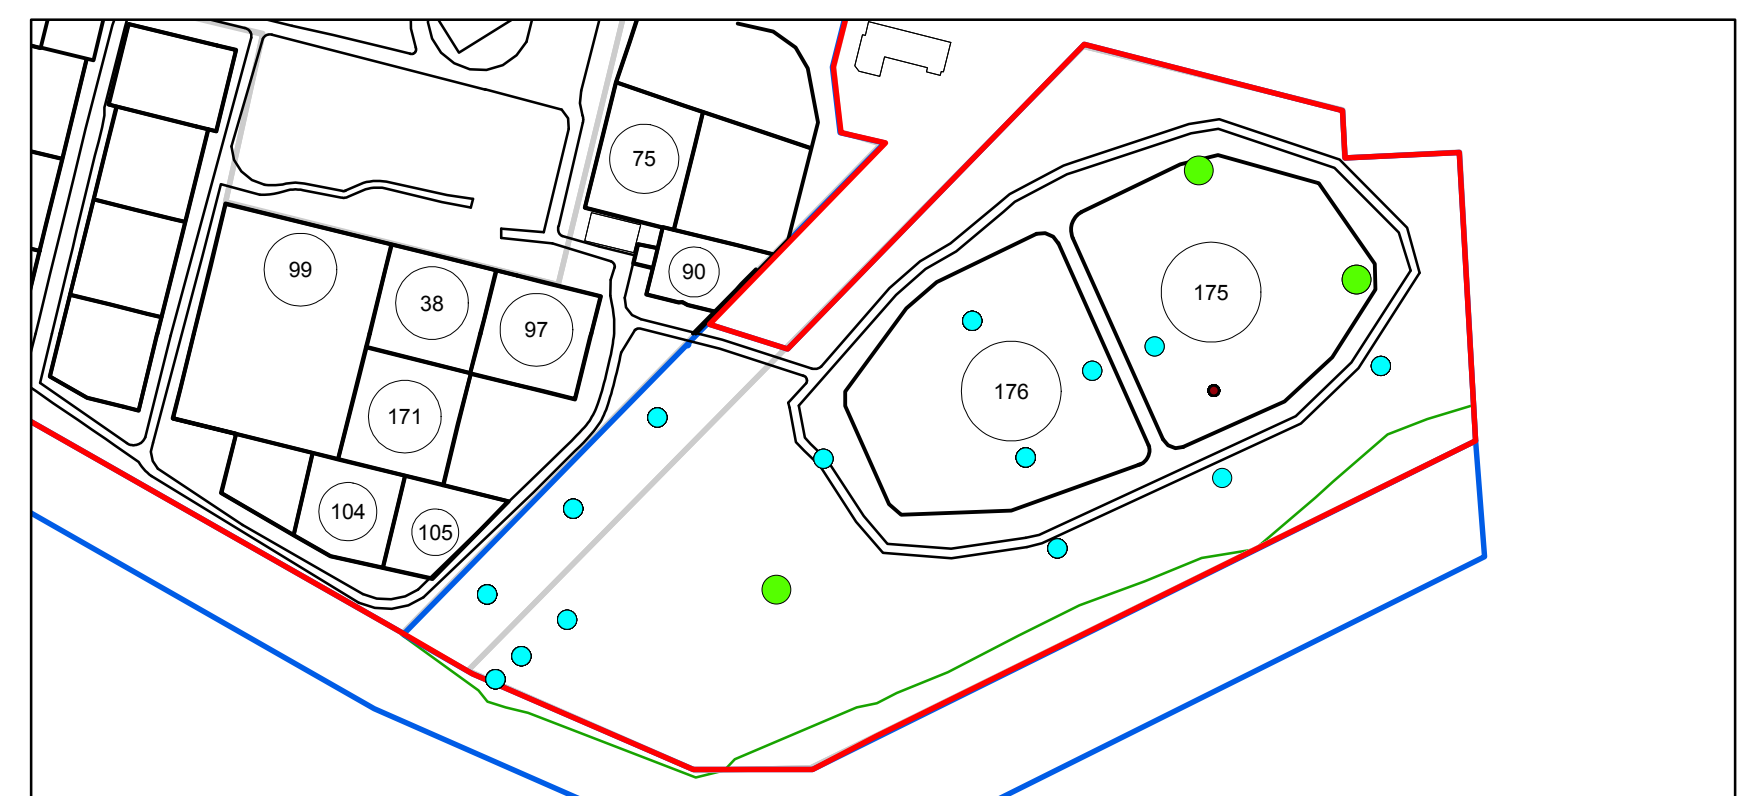
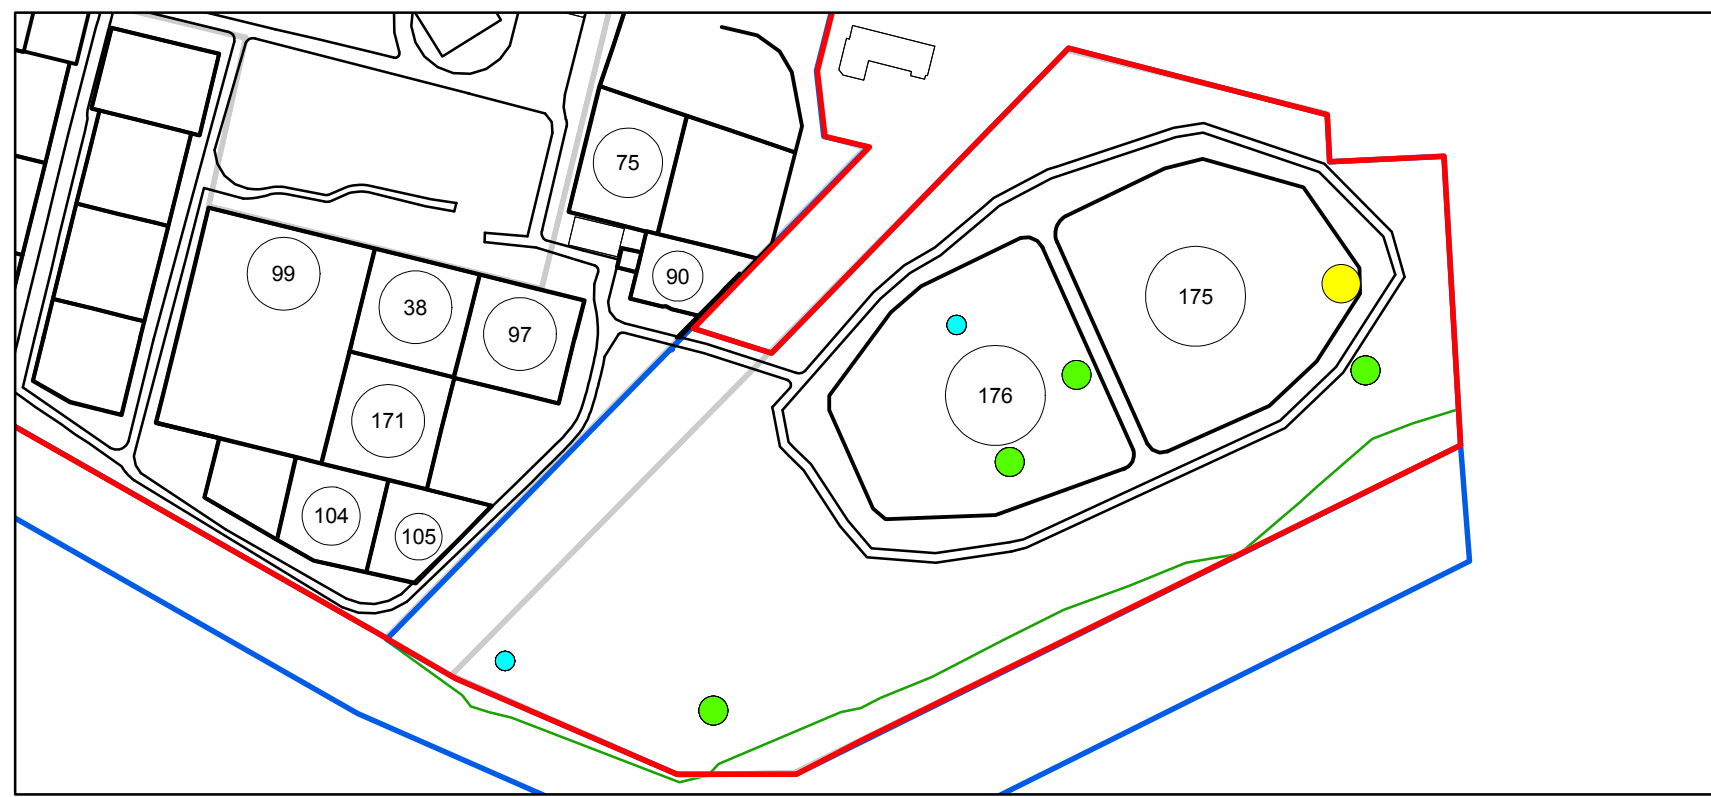
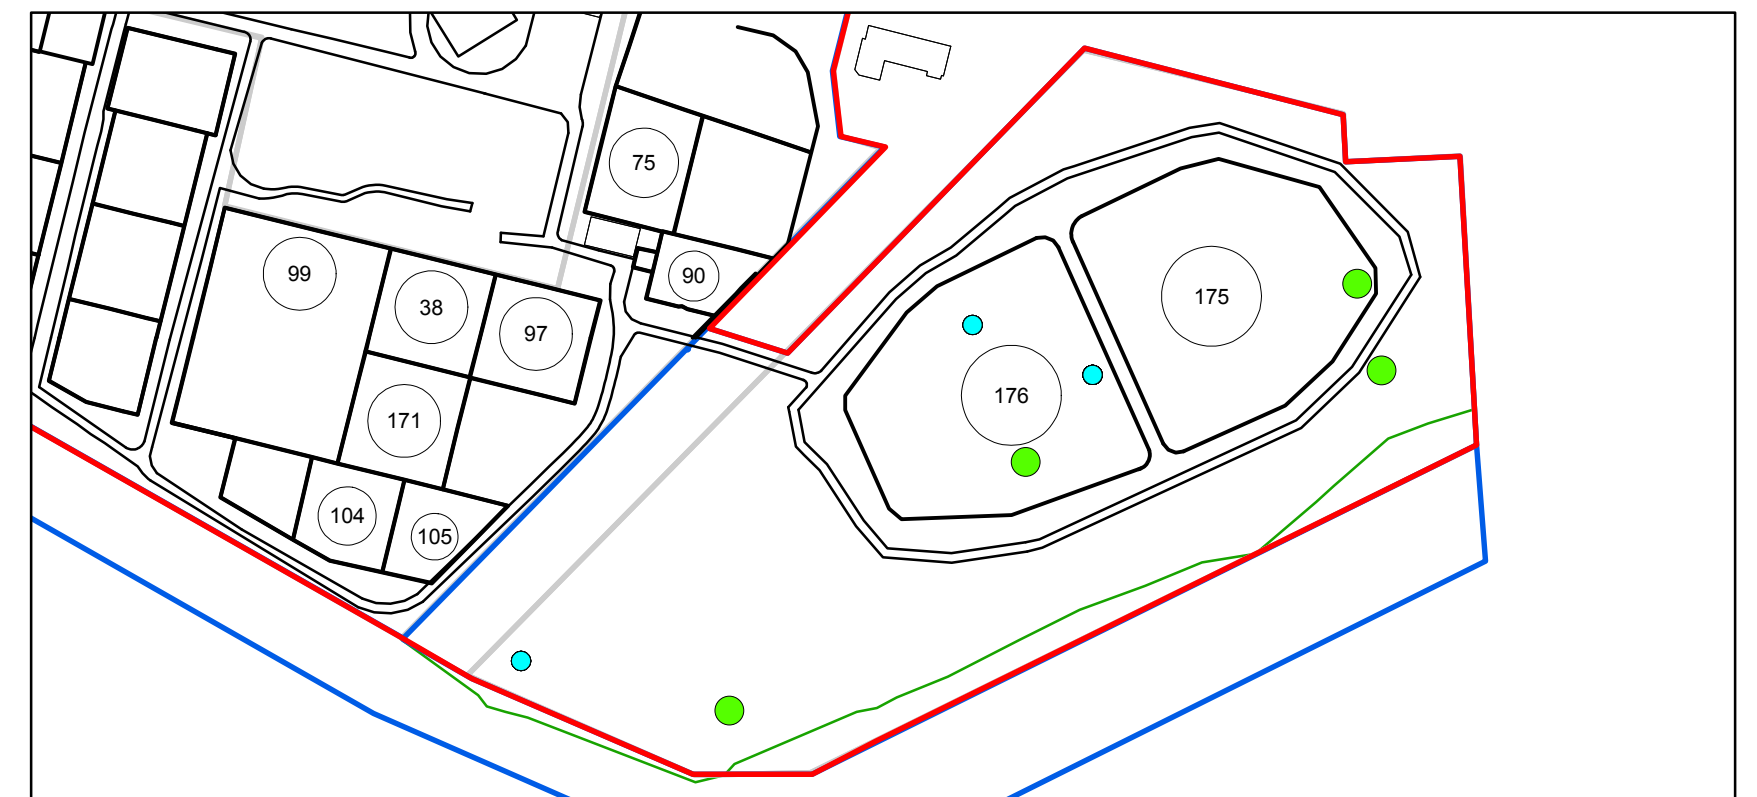
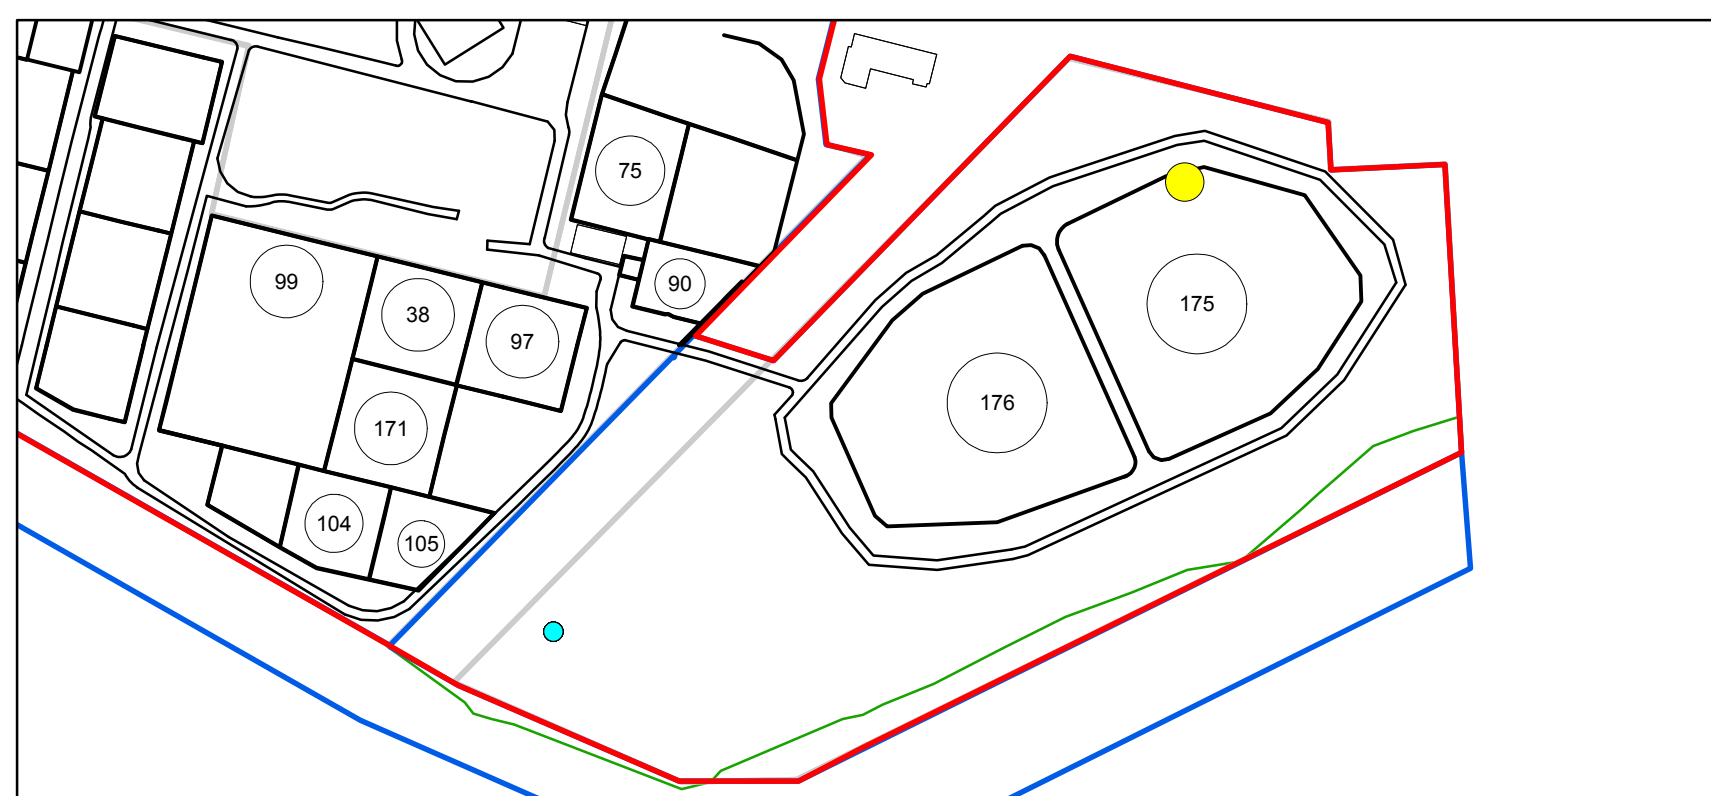
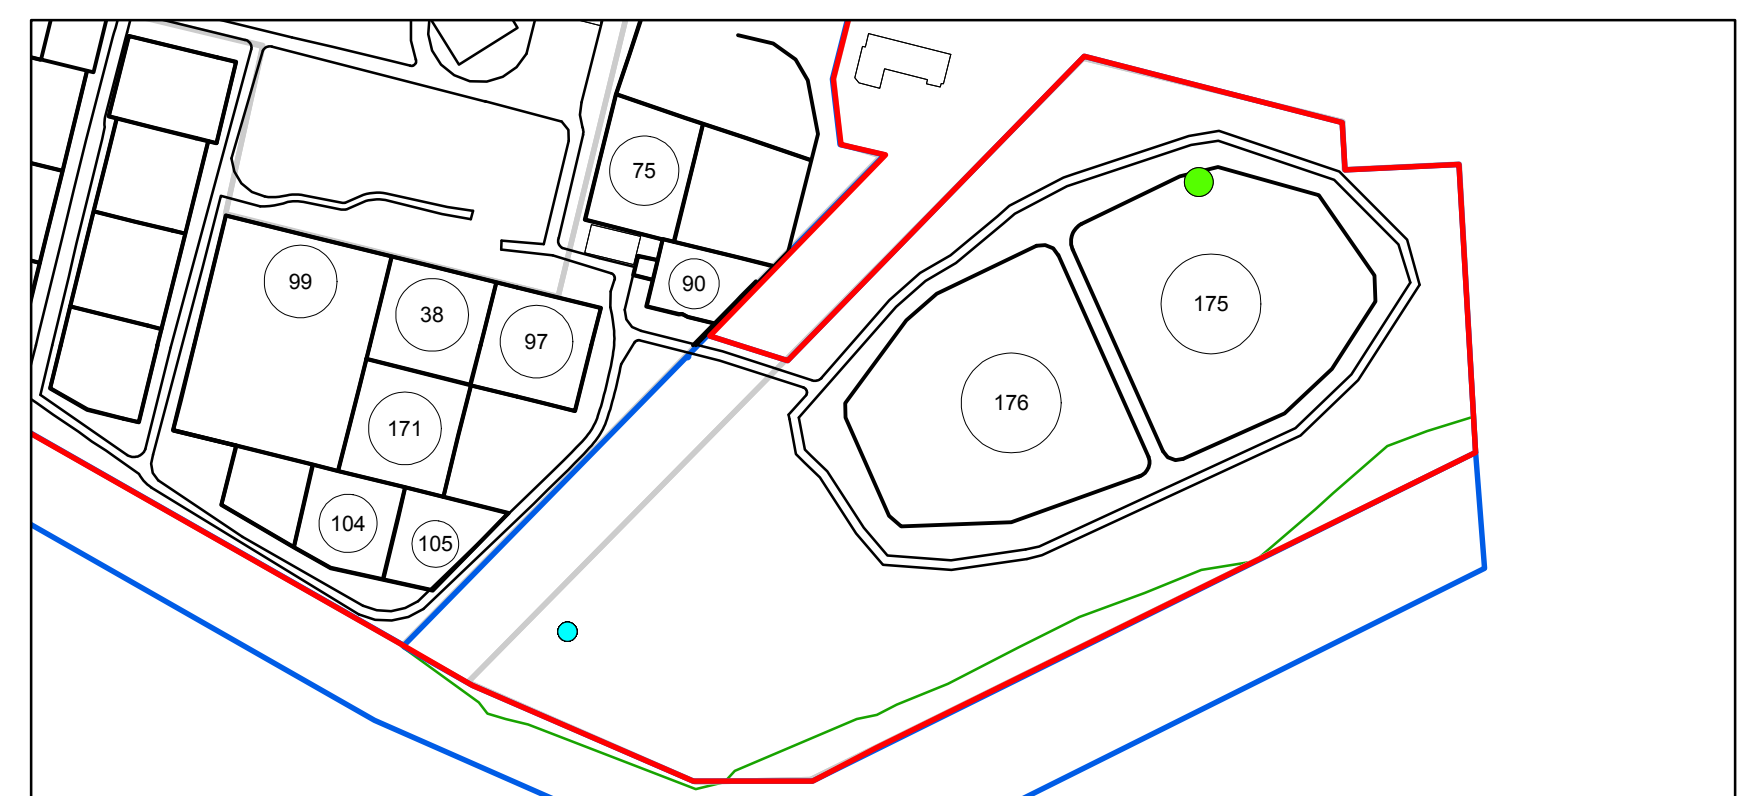
<p>ROUX ASSOCIATES, INC. Environmental Consulting &amp; Management</p>	Compiled by: F.C.	Date: 29JUL10	<p>PLATE</p> <p style="font-size: 24pt; font-weight: bold;">4</p>
	Prepared by: F.C.	Scale: AS SHOWN	
	Project Mgr: N.C.	Office: NY	
	File No: MCS2383011.MXD	Project: 0172.052Y013

DISTRIBUTION OF SVOCs RELATIVE TO PART 375 UNRESTRICTED CRITERIA

DISTRIBUTION OF SVOCs RELATIVE TO PART 375 INDUSTRIAL CRITERIA

As shown on Plate 4, exceedances of the industrial criteria were observed:
