# ALTERNATIVES ANALYSIS REPORT FOR OPERABLE UNIT 4

ExxonMobil Former Buffalo Terminal  
Buffalo, New York

BCP Site C915201E

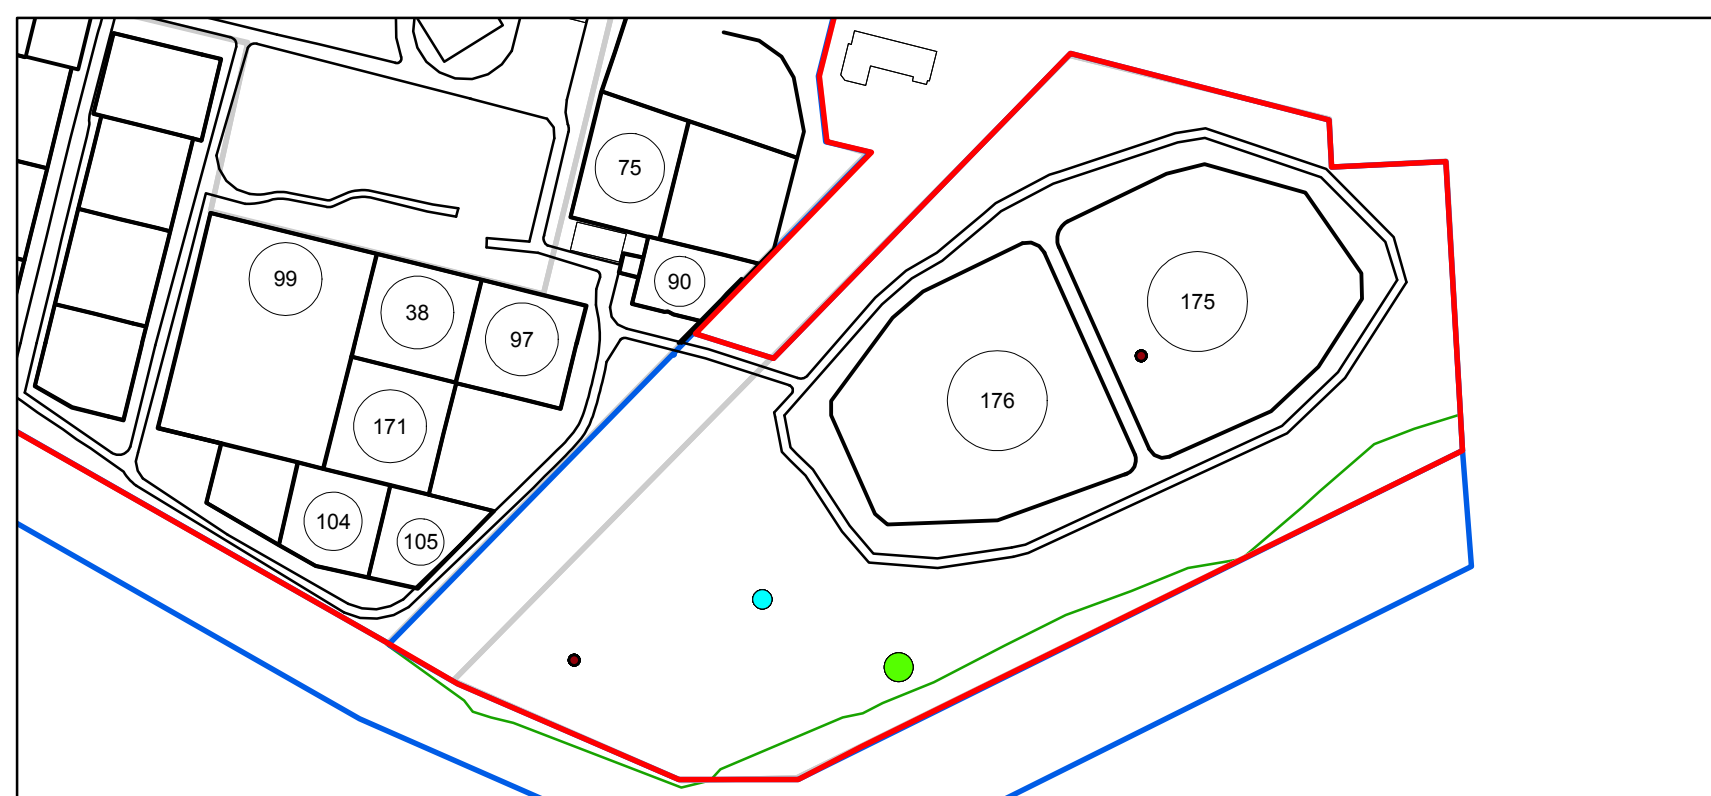
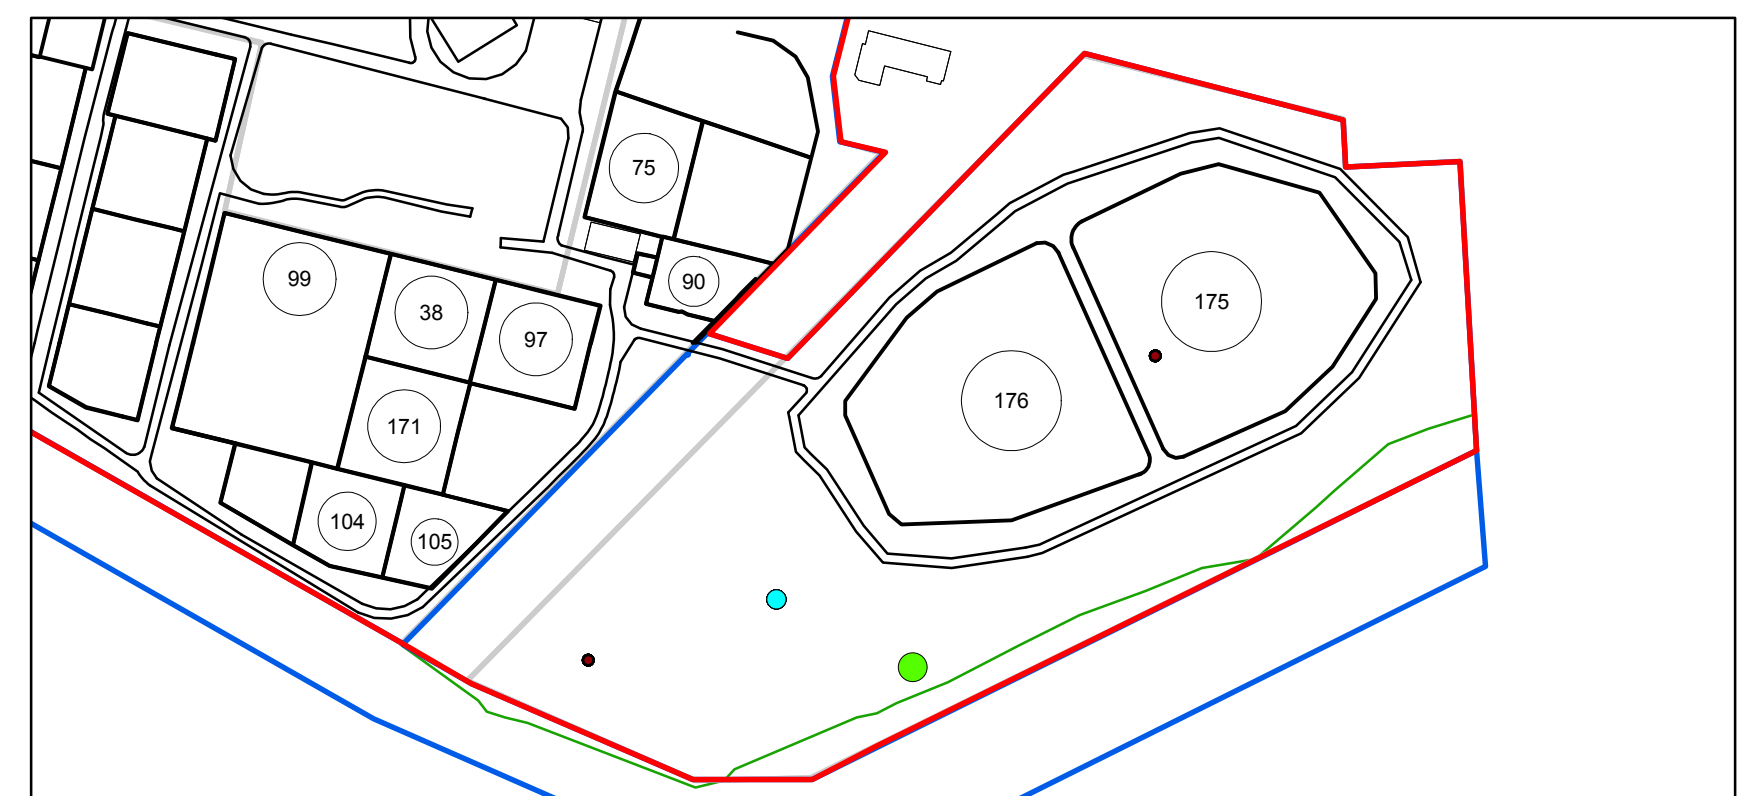
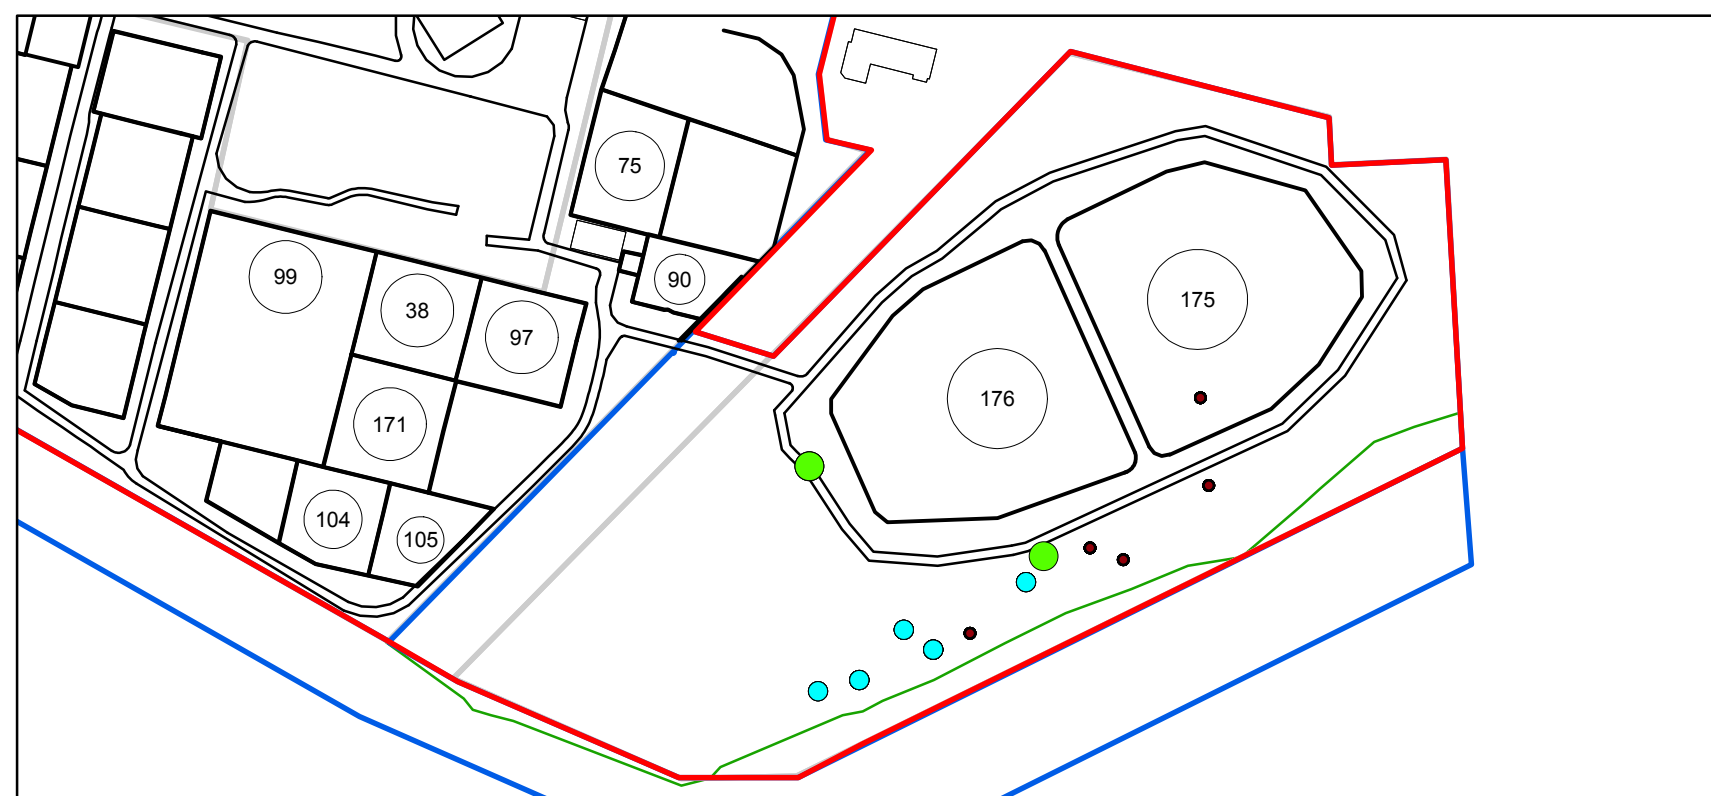
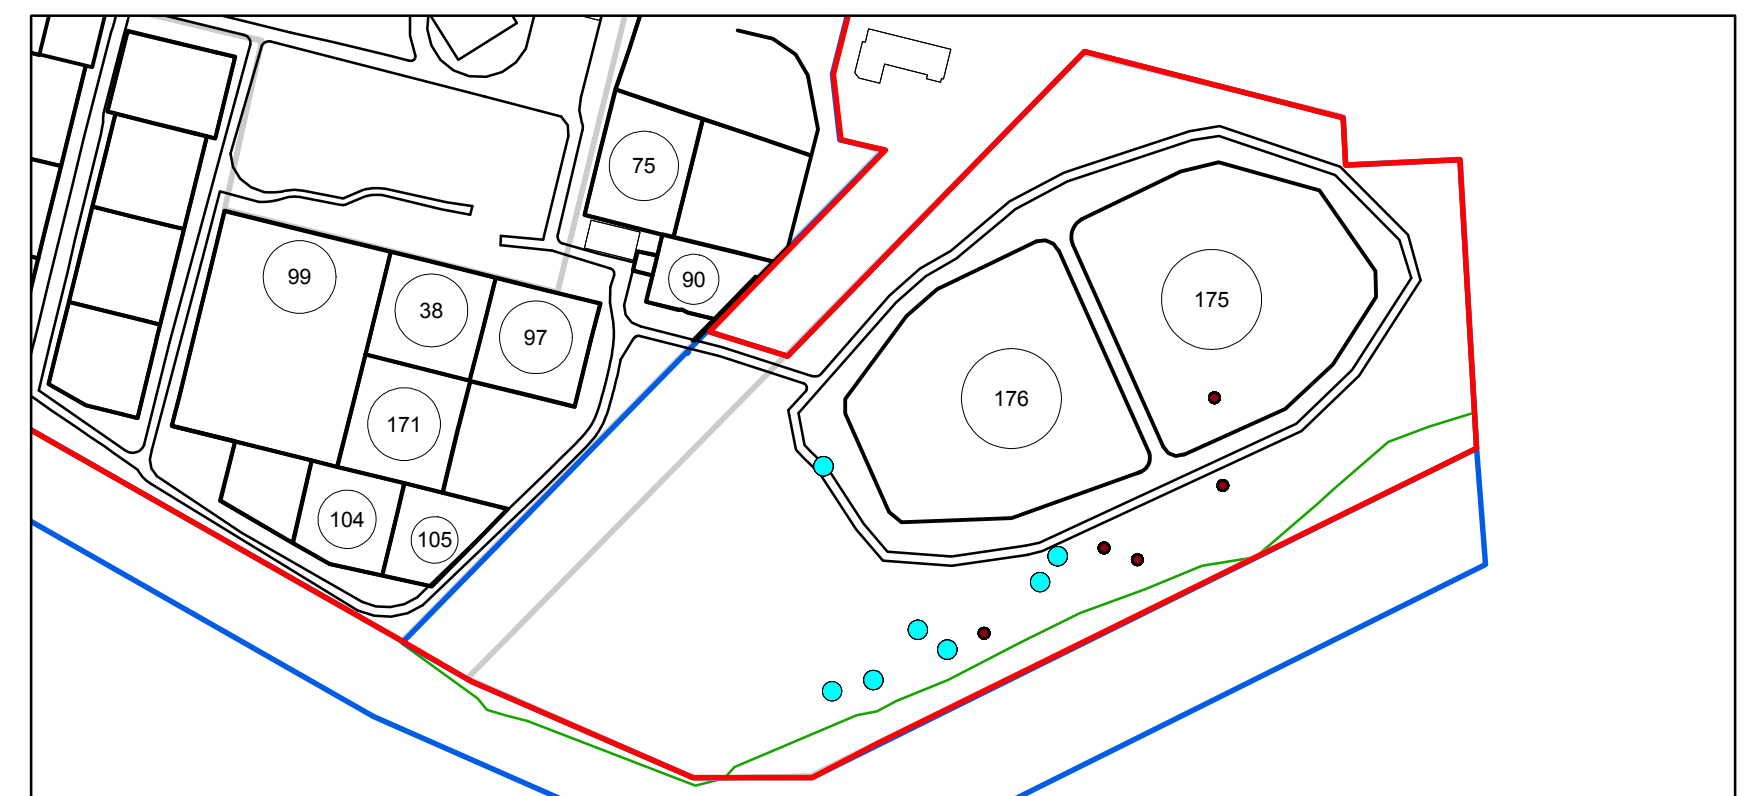
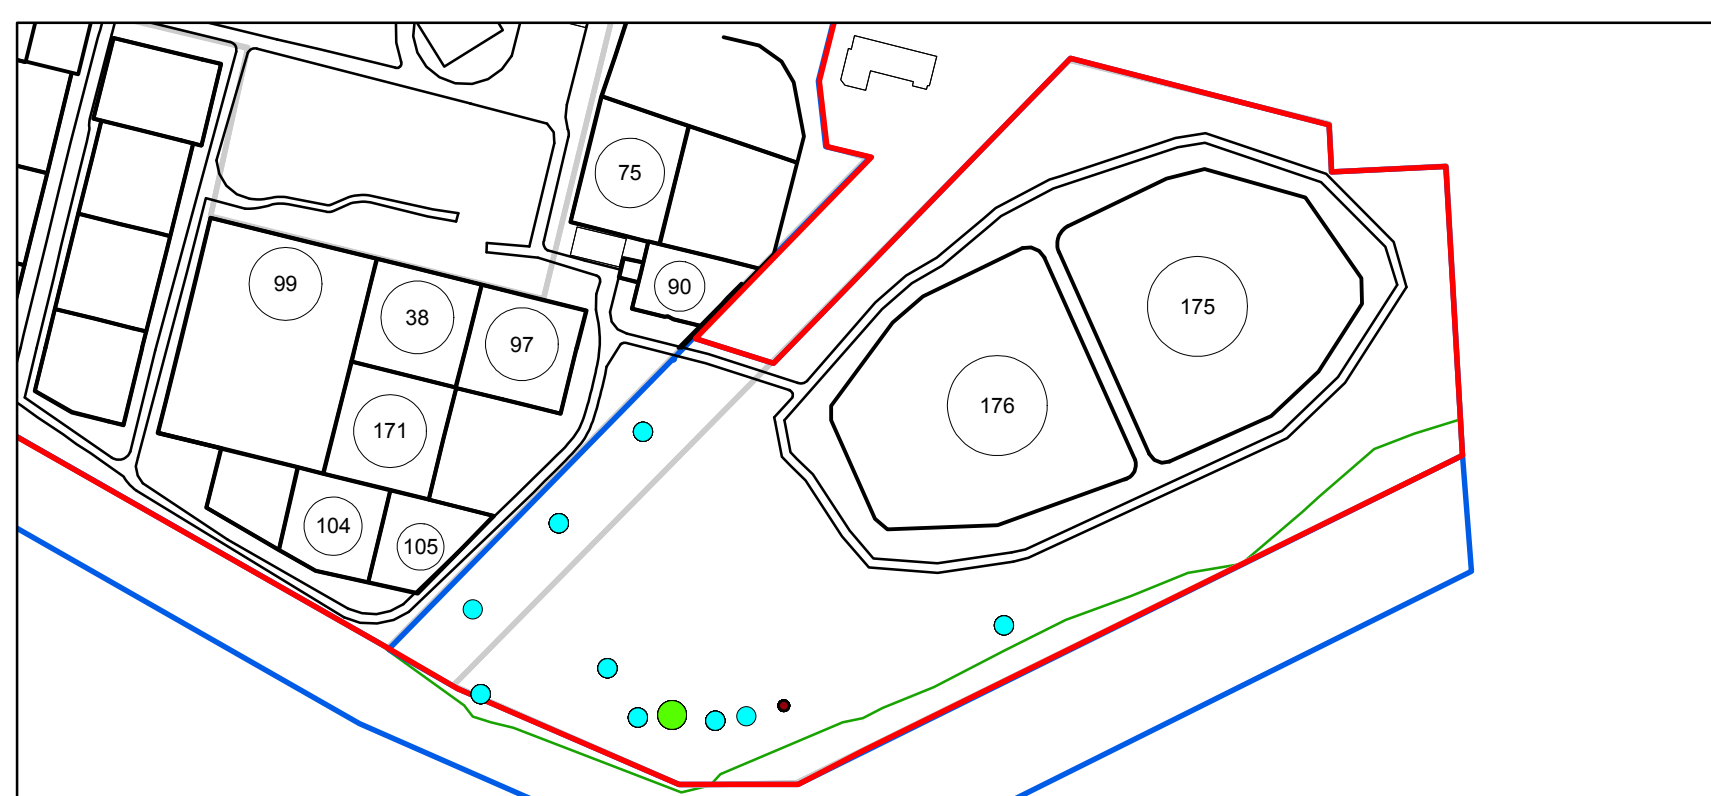
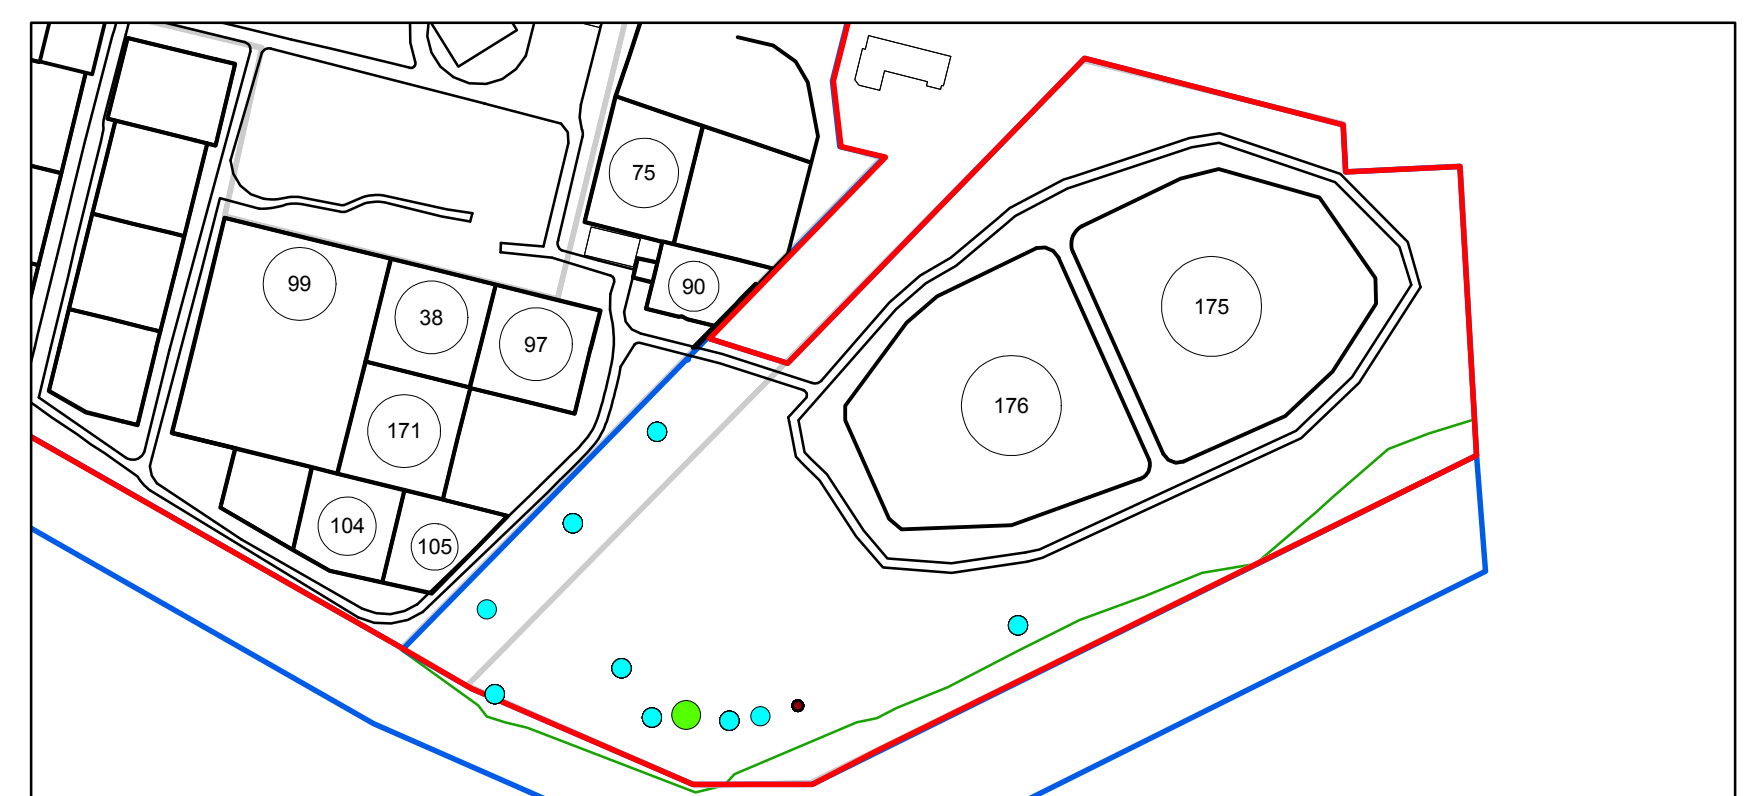
DISTRIBUTION OF SVOCs RELATIVE TO PART 375 UNRESTRICTED CRITERIA

DISTRIBUTION OF SVOCs RELATIVE TO PART 375 INDUSTRIAL CRITERIA

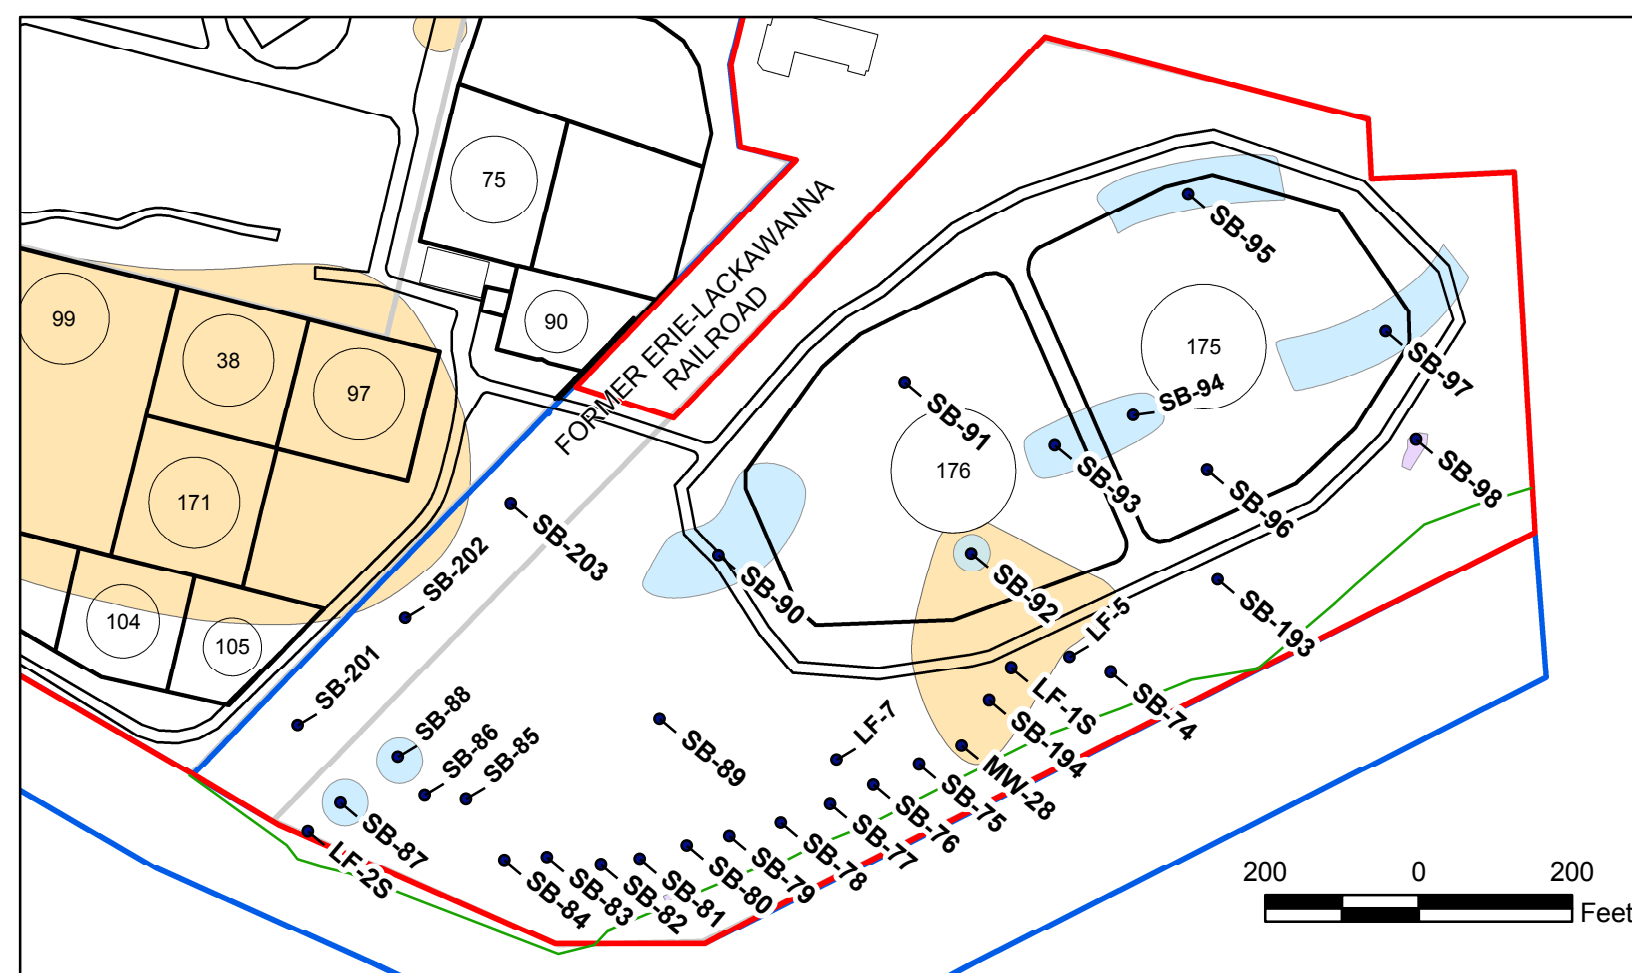
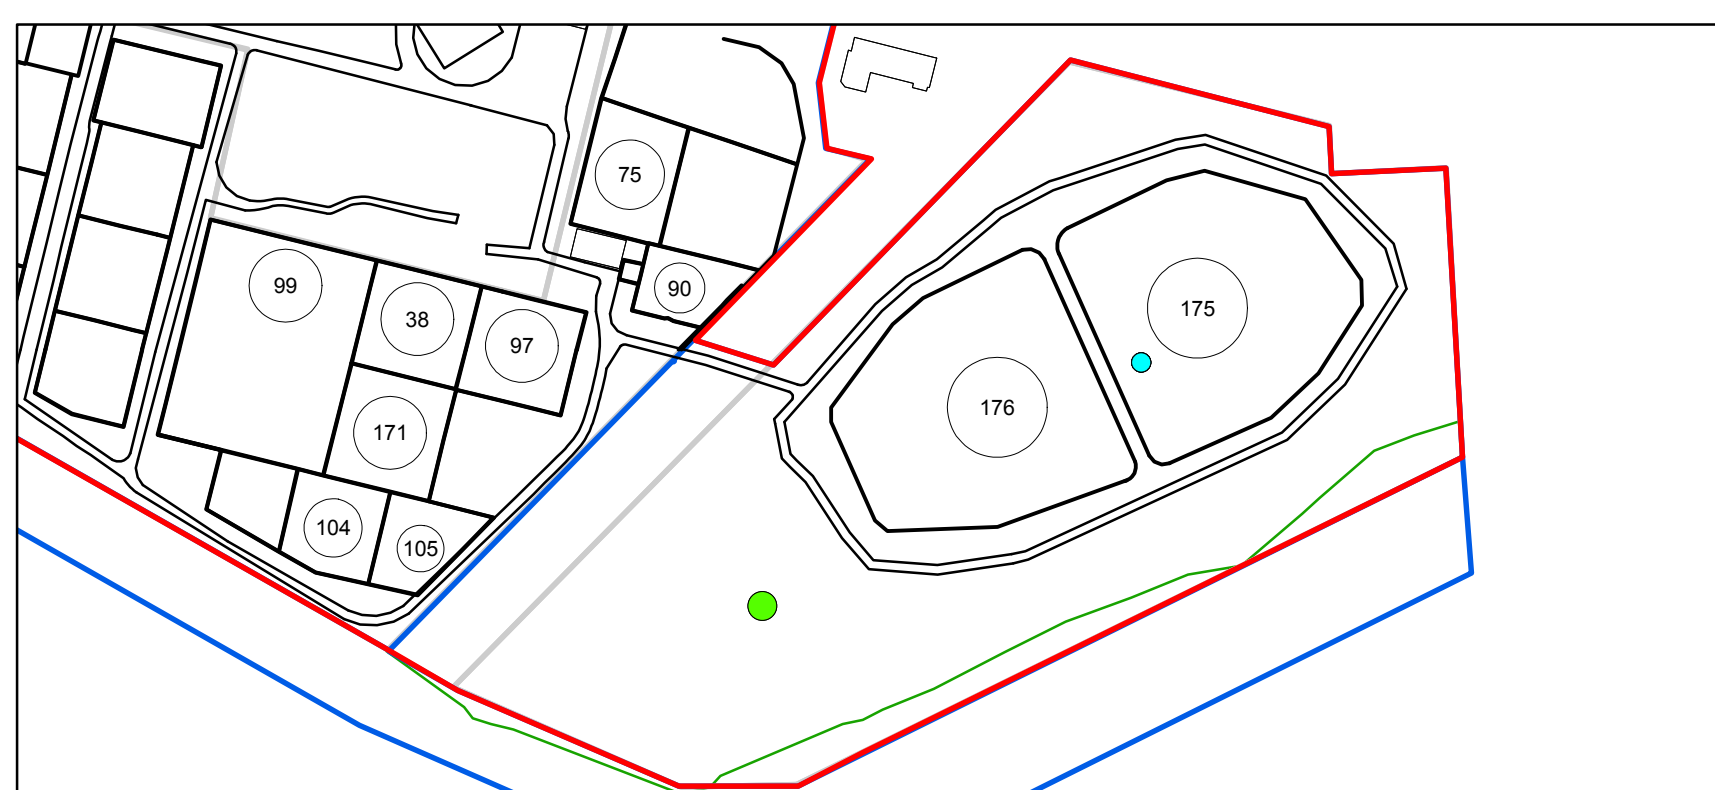
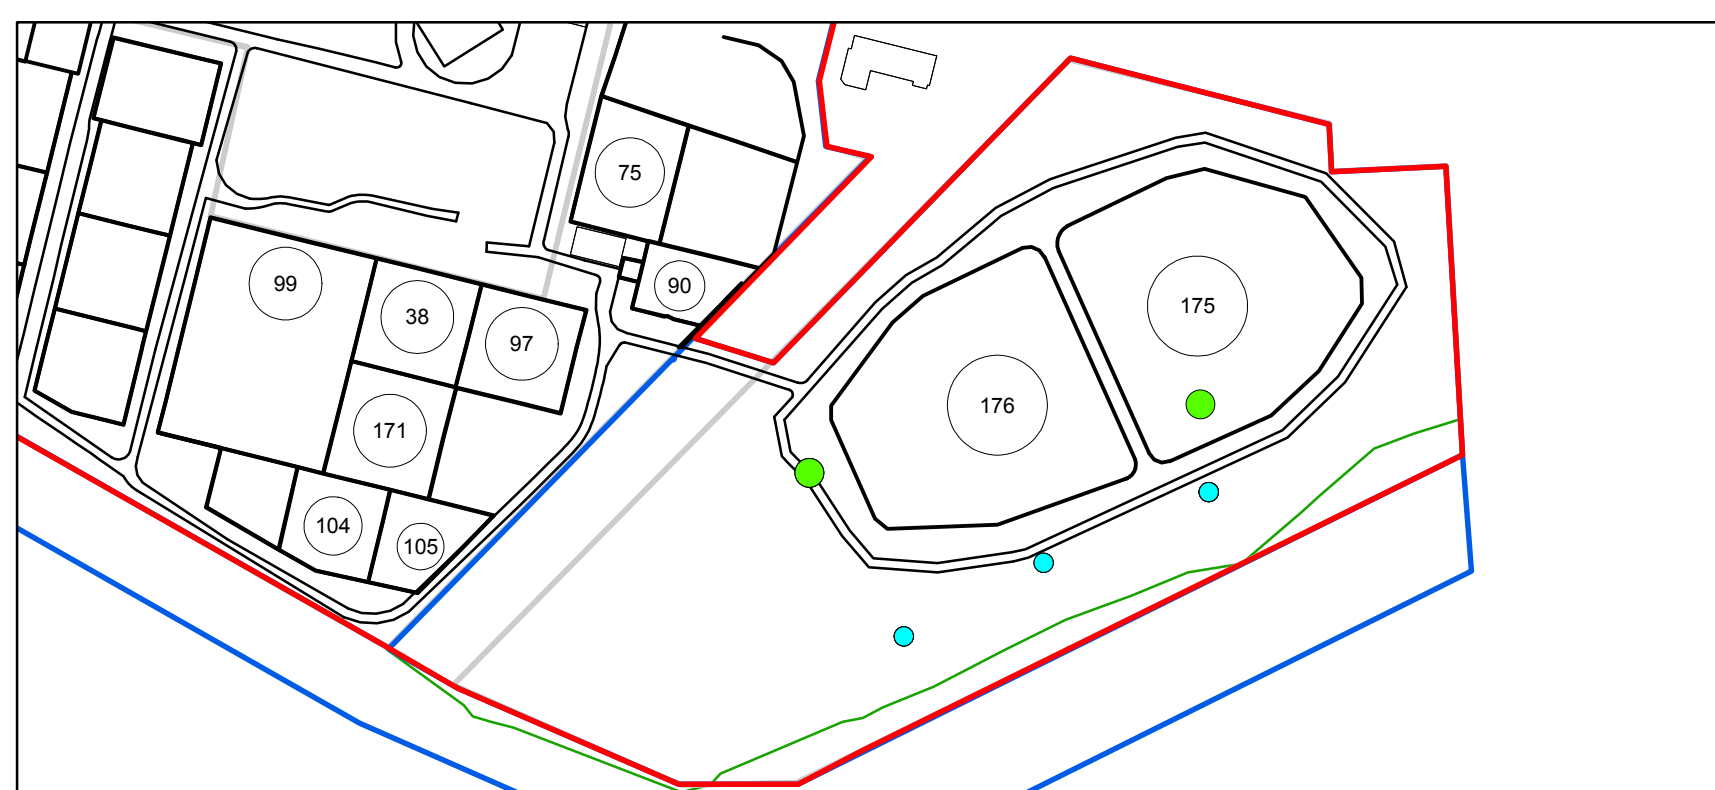
Compiled by: F.C.	Date: 29JUL10	PLATE
Prepared by: F.C.	Scale: AS SHOWN	<b>5</b>
Project Mgr: N.C.	Office: NY	
File No: MCS2383012r.MXD	Project: 0172.052Y013

DISTRIBUTION OF METALS RELATIVE TO PART 375 UNRESTRICTED CRITERIA

DISTRIBUTION OF METALS RELATIVE TO PART 375 INDUSTRIAL CRITERIA

As shown on Plate 5, exceedances of the unrestricted use criteria were observed:

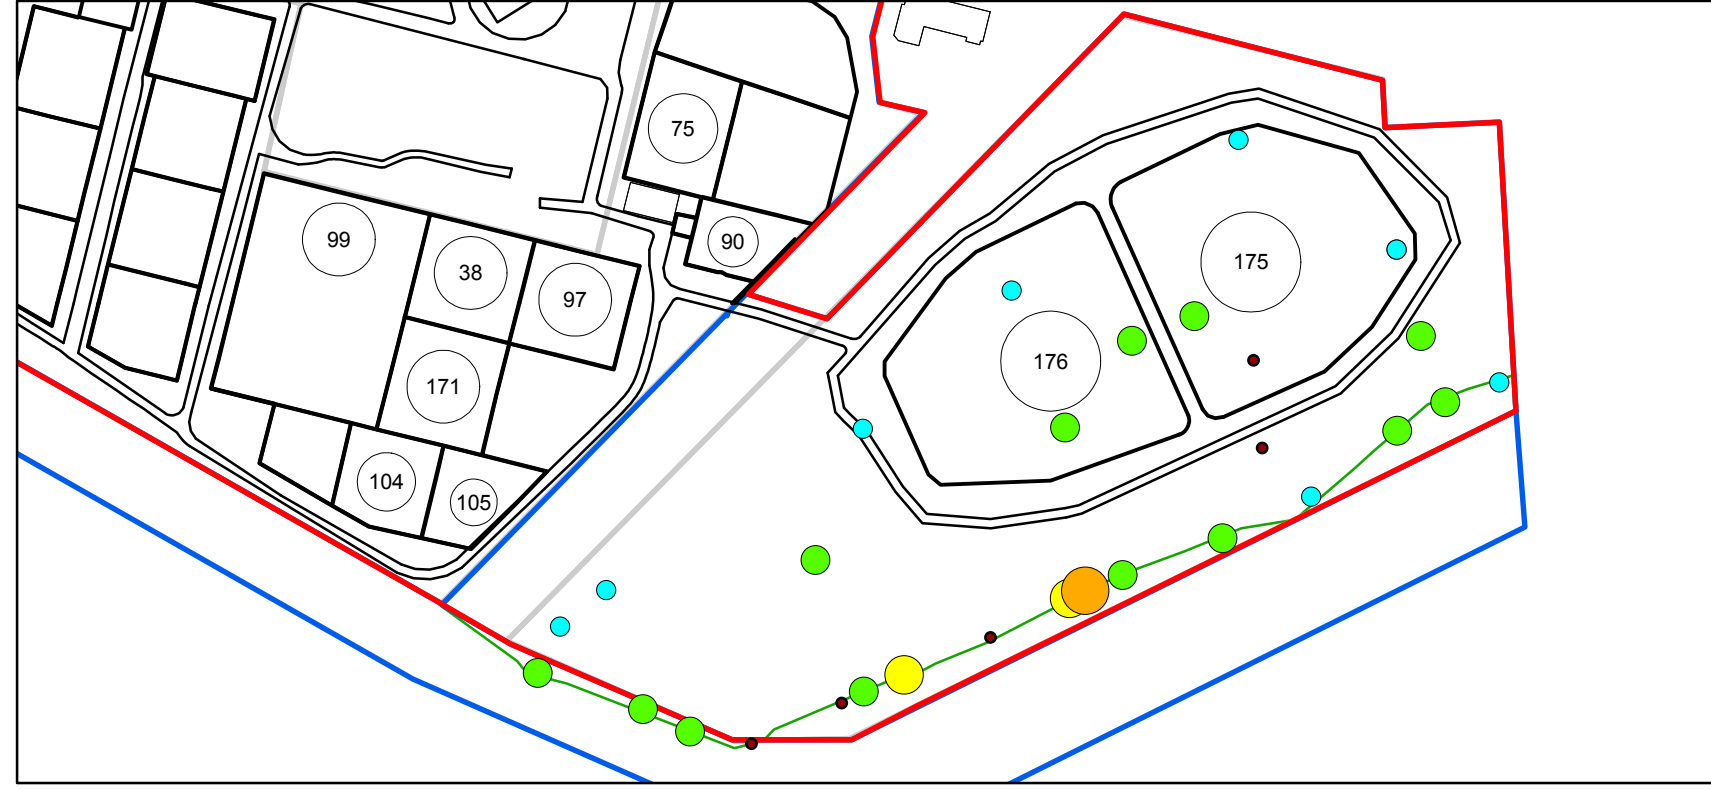
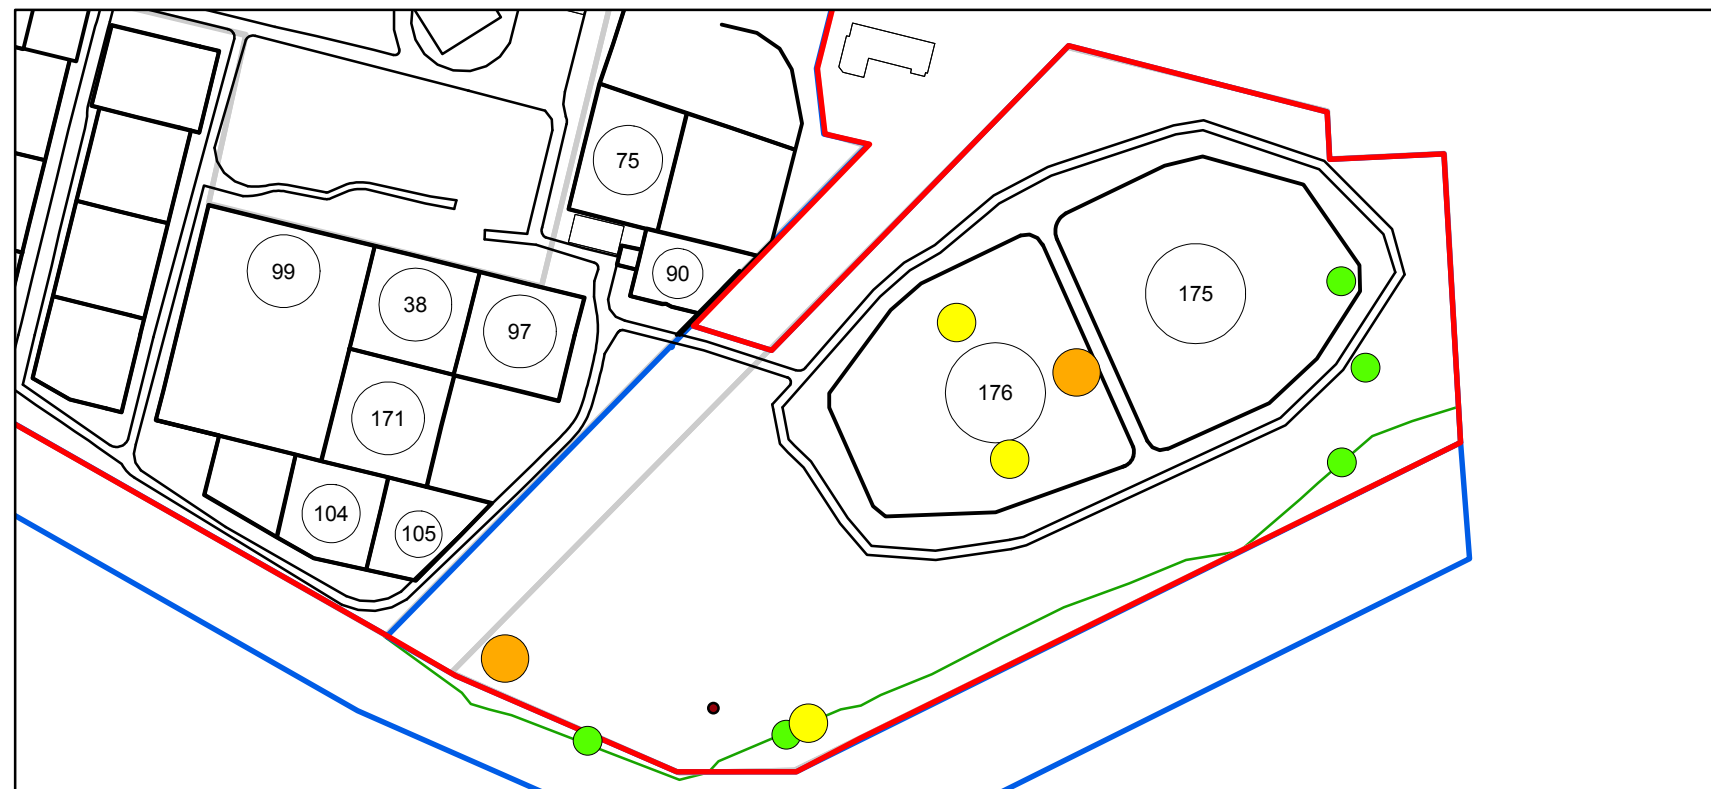
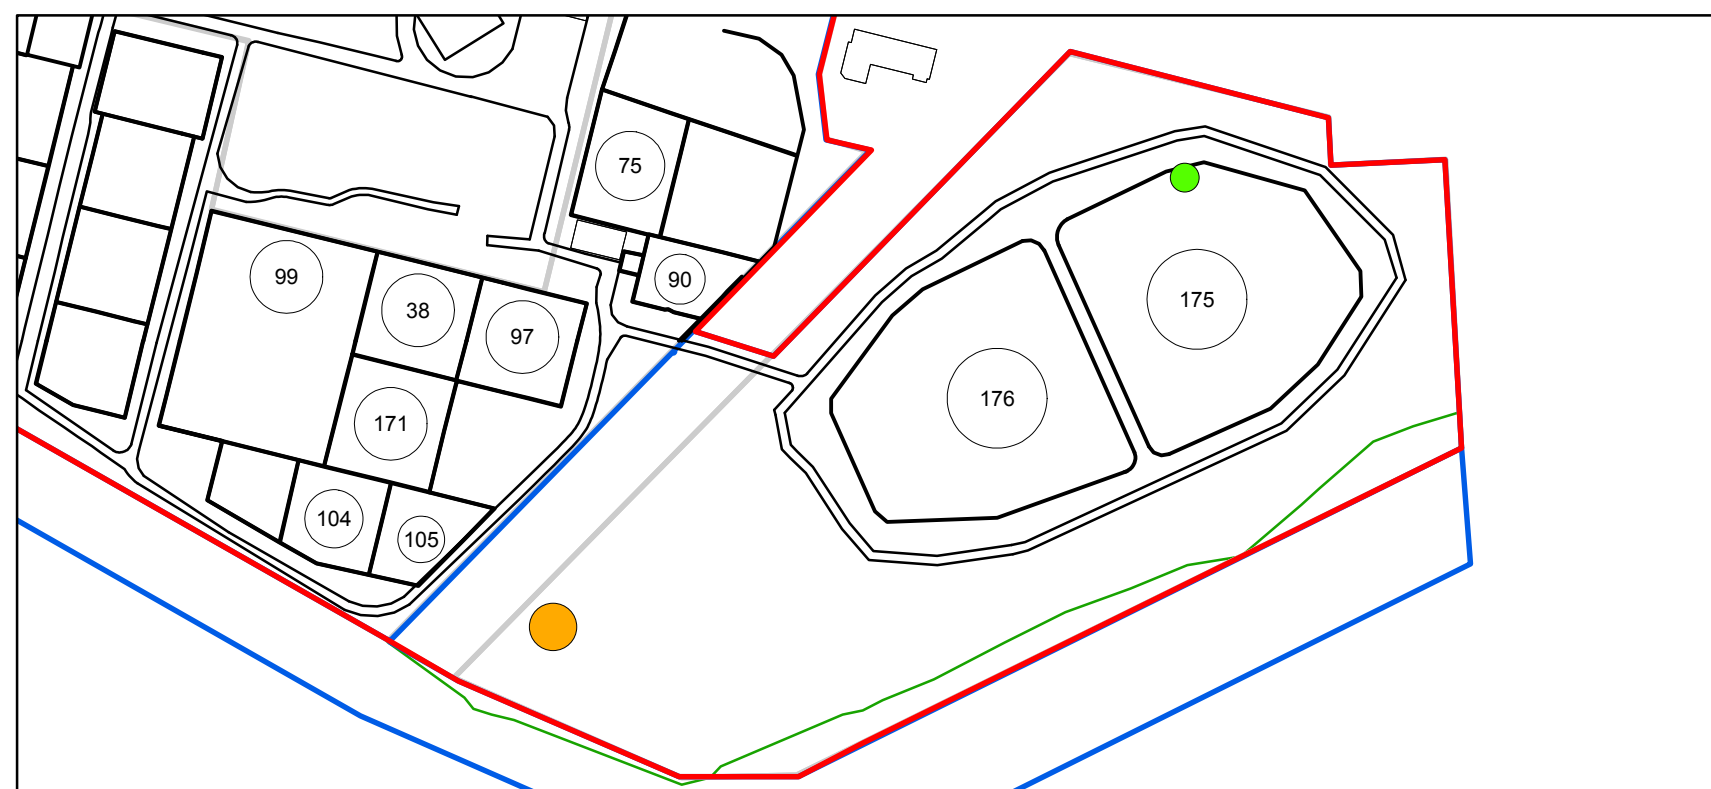
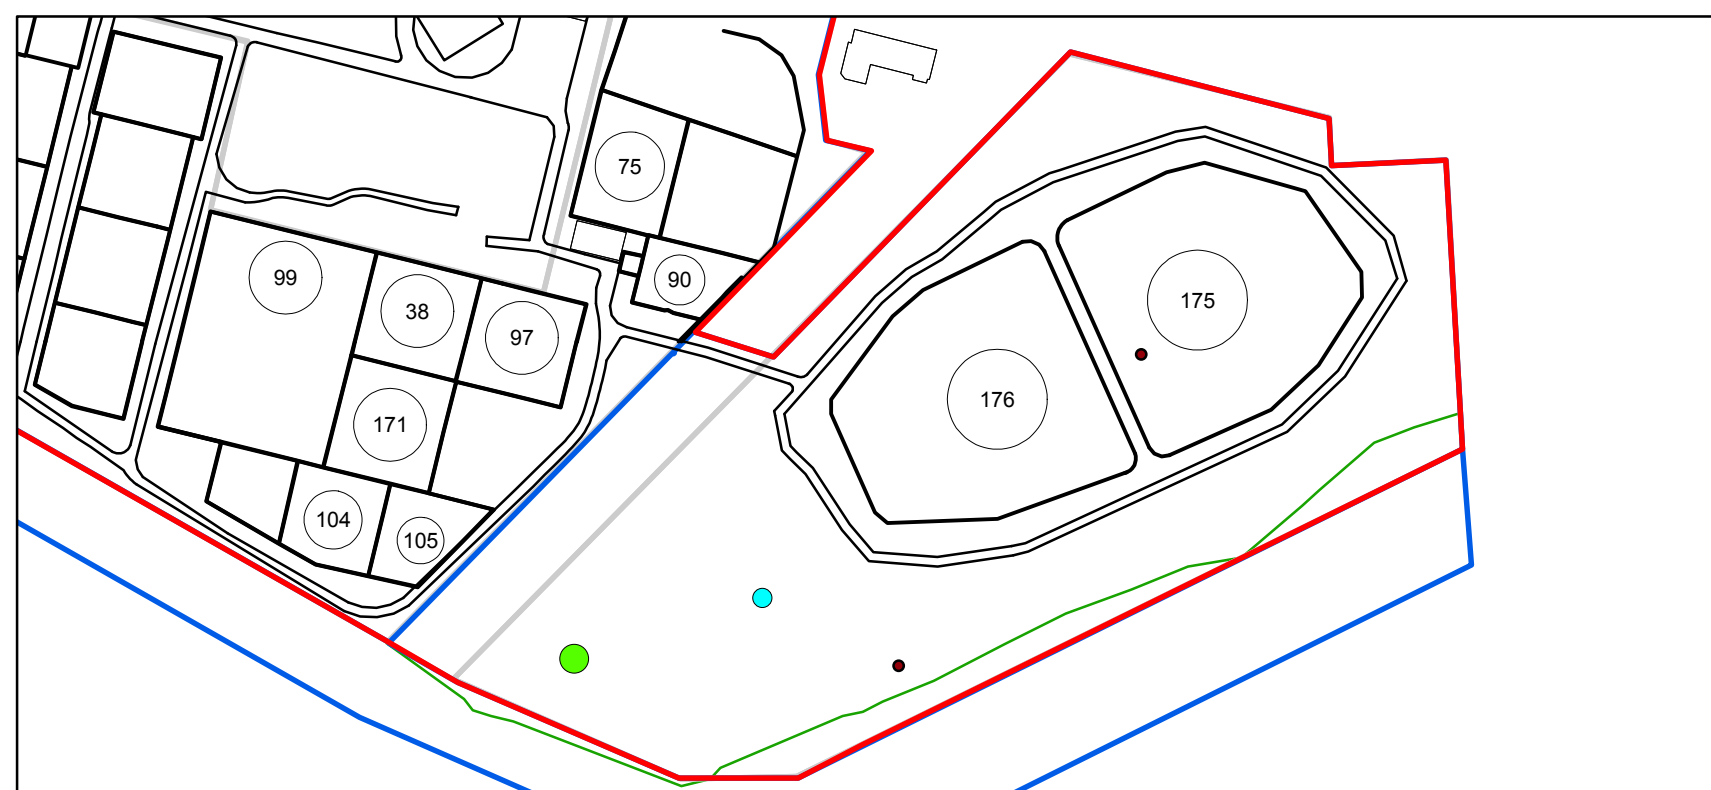
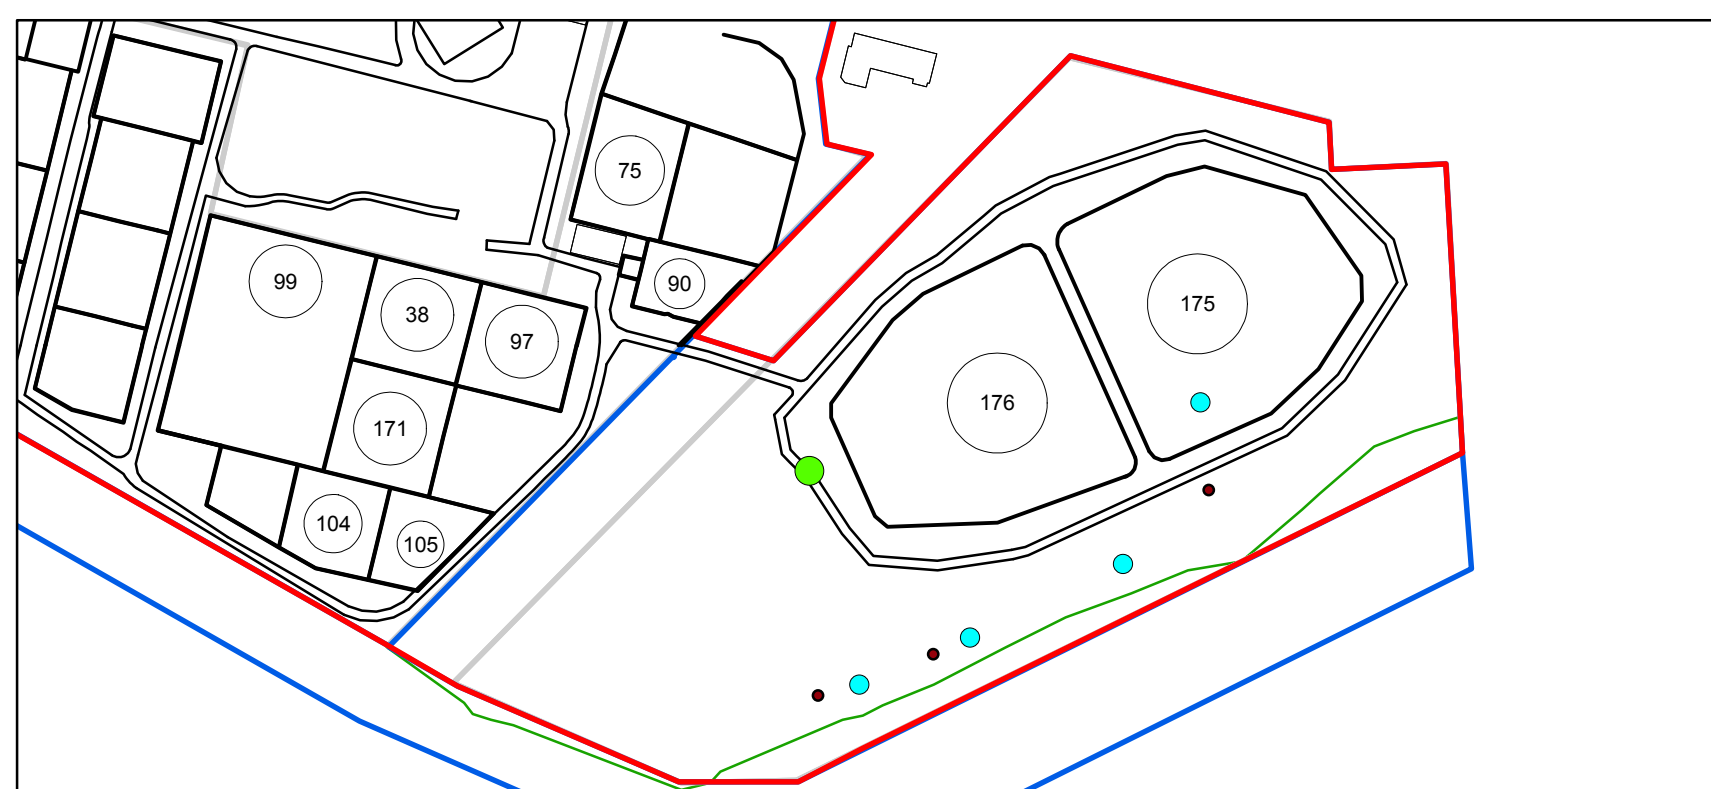
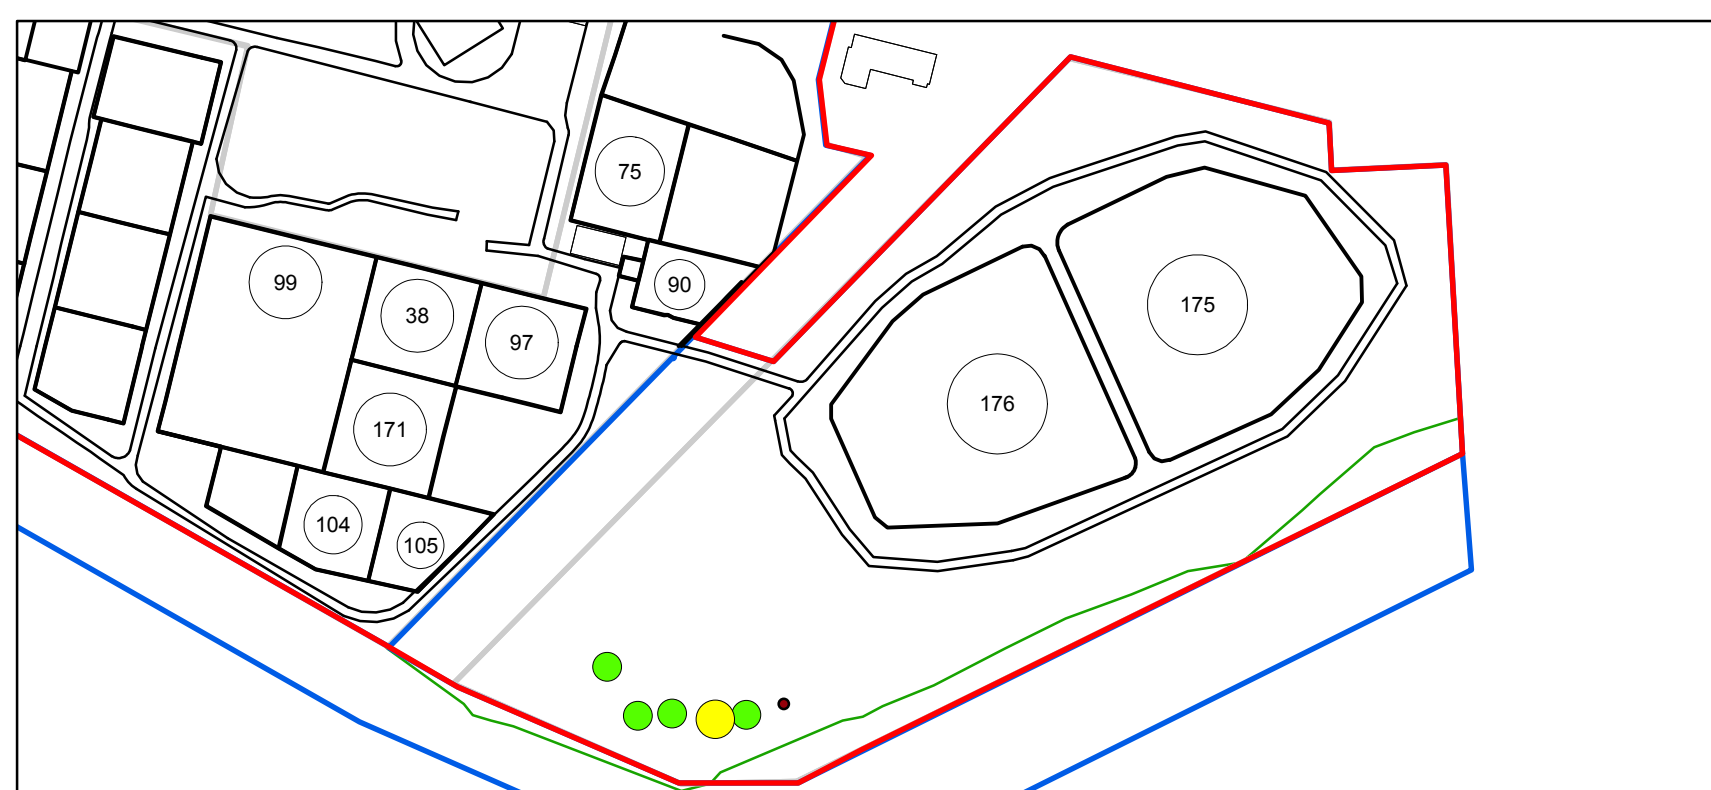
DISTRIBUTION OF TPH-GRO CONCENTRATIONS
