# ALTERNATIVES ANALYSIS REPORT FOR OPERABLE UNIT 4

ExxonMobil Former Buffalo Terminal  
Buffalo, New York

BCP Site C915201E

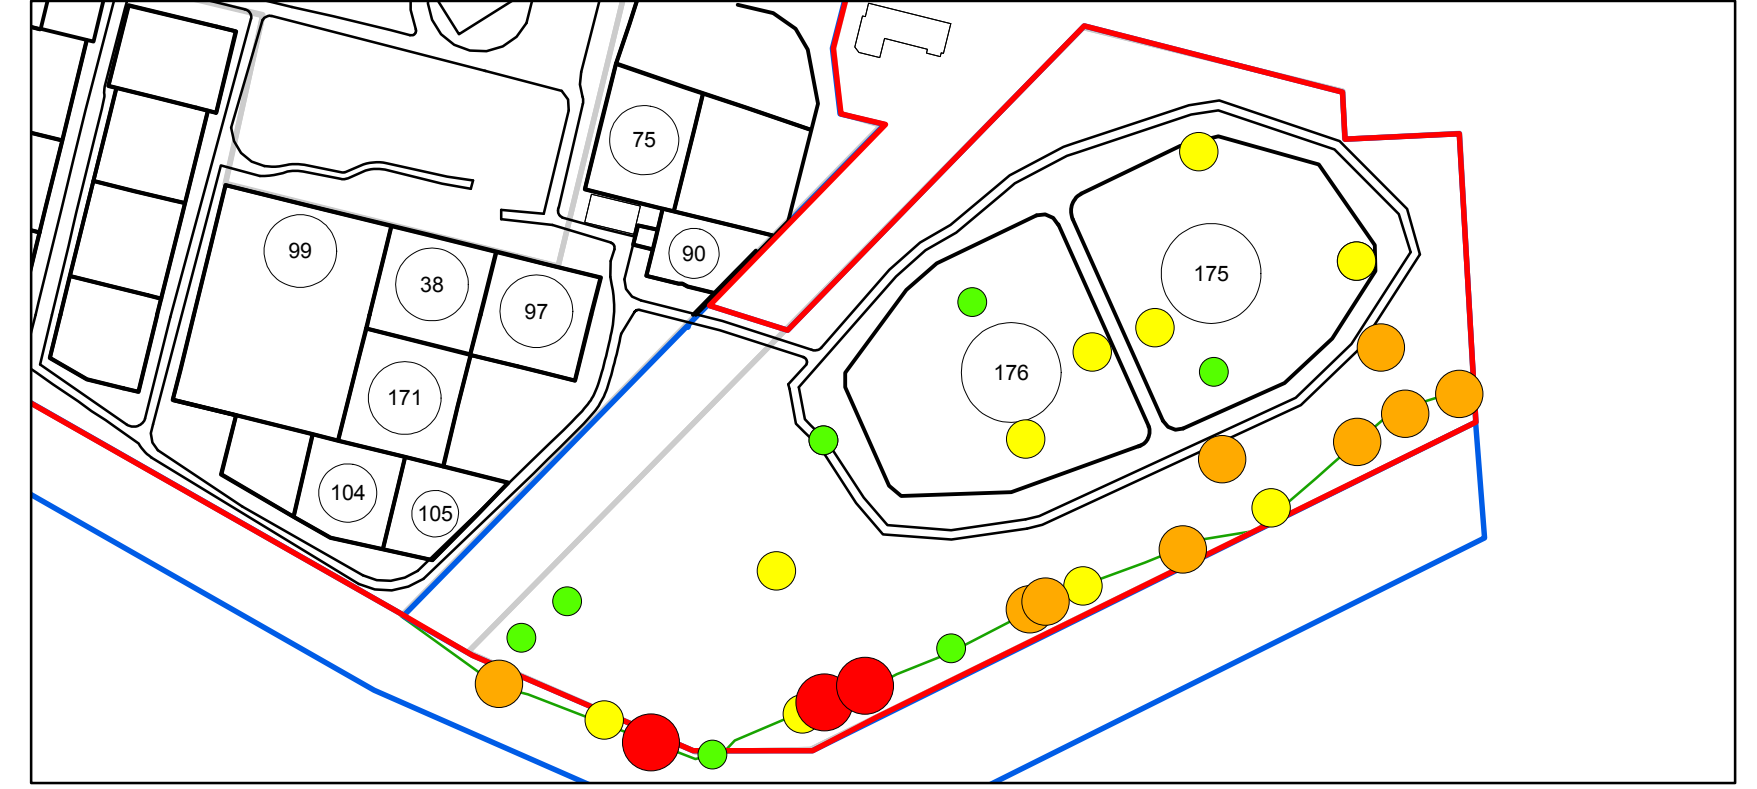
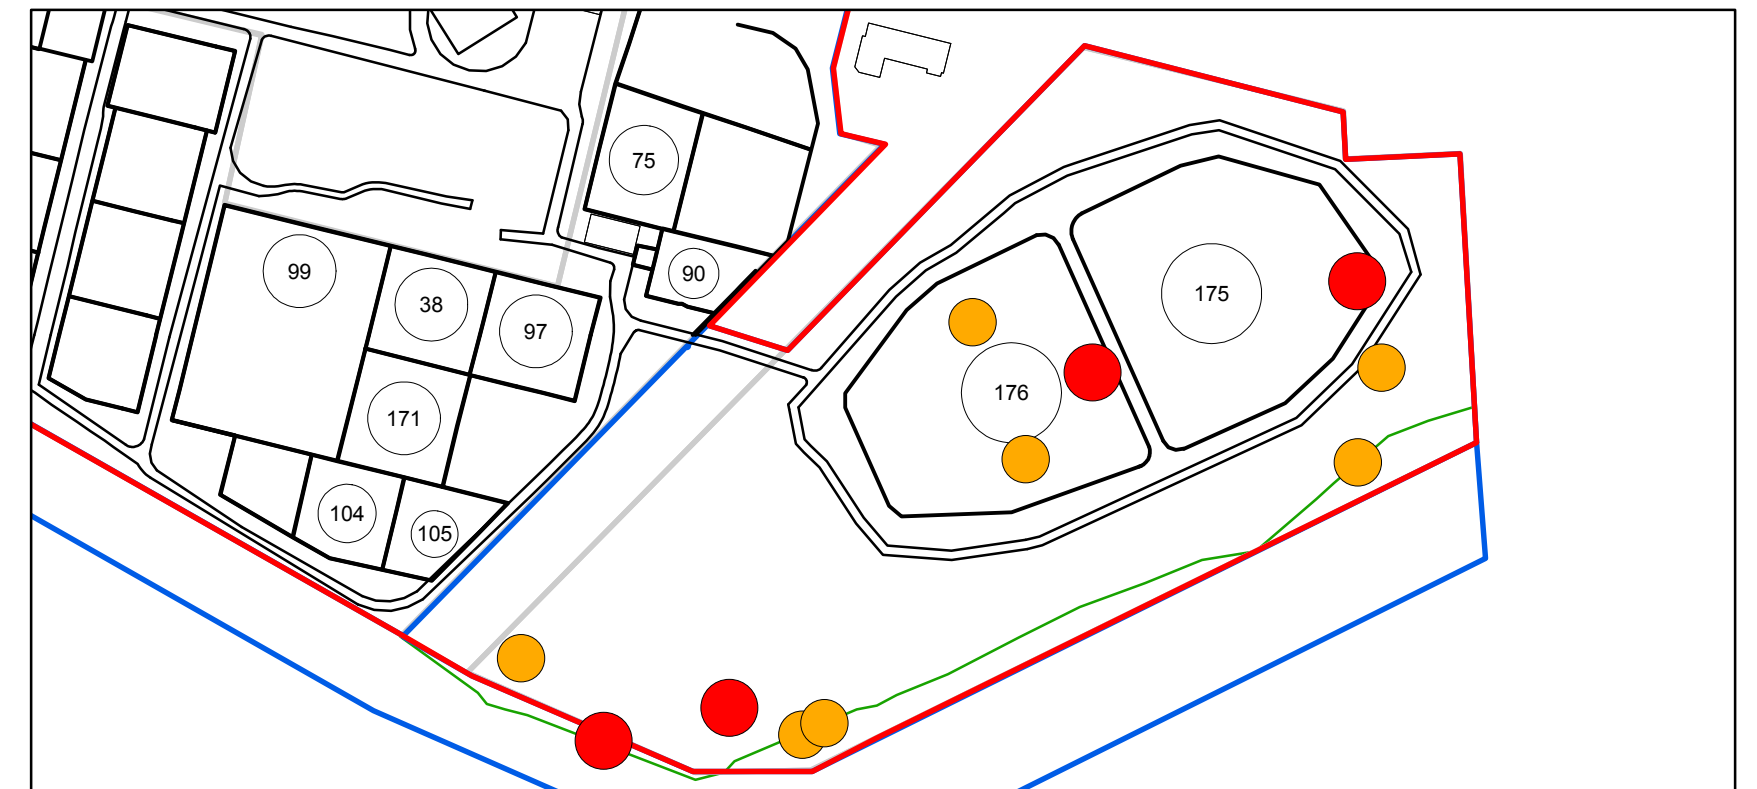
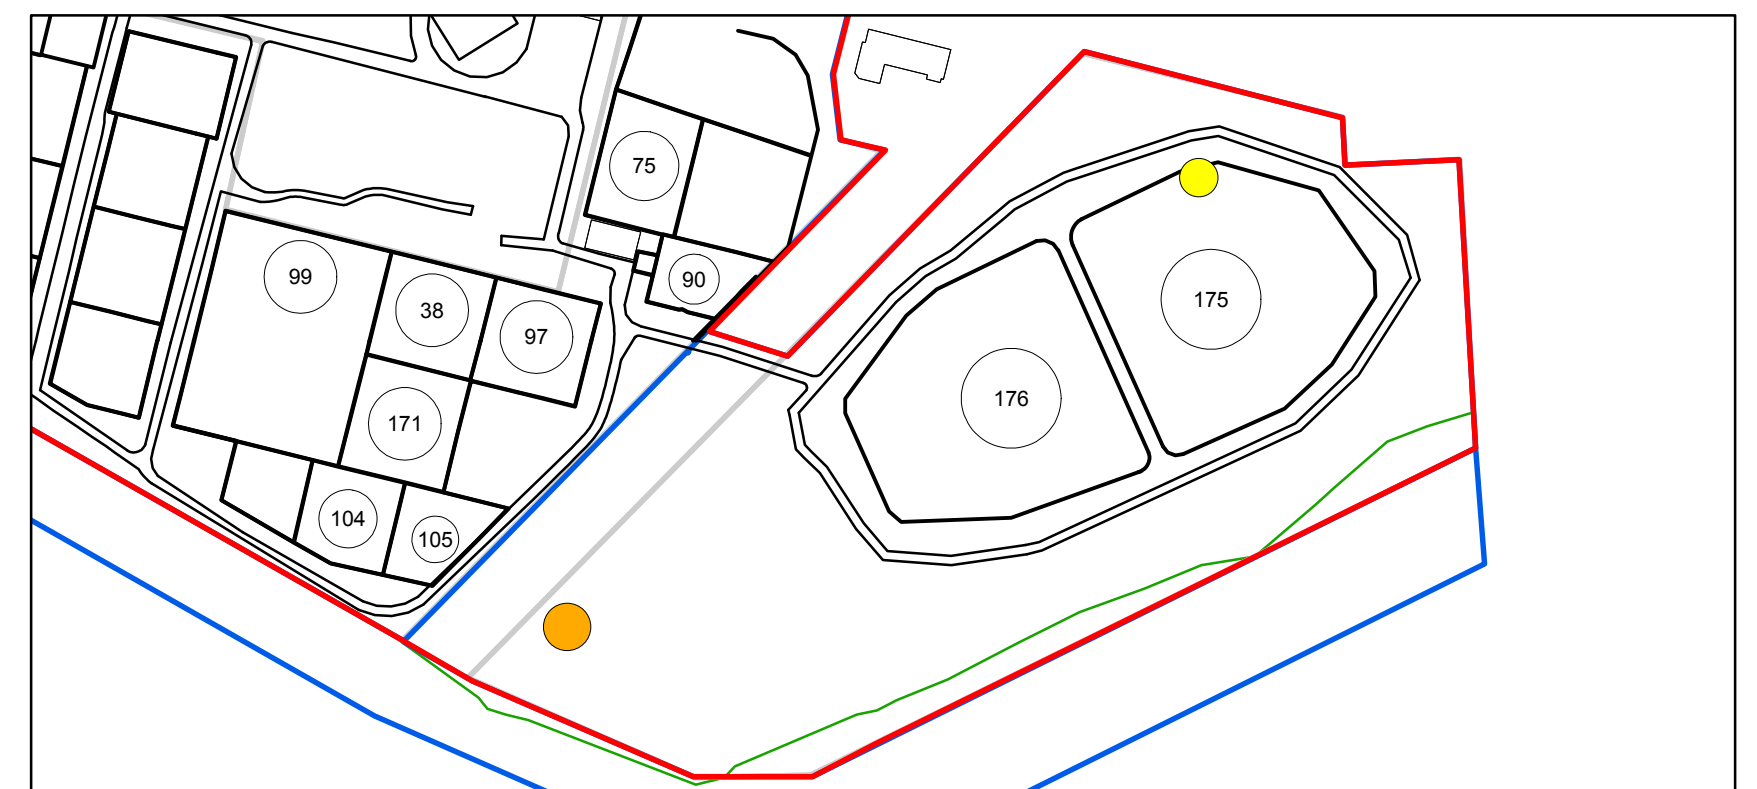
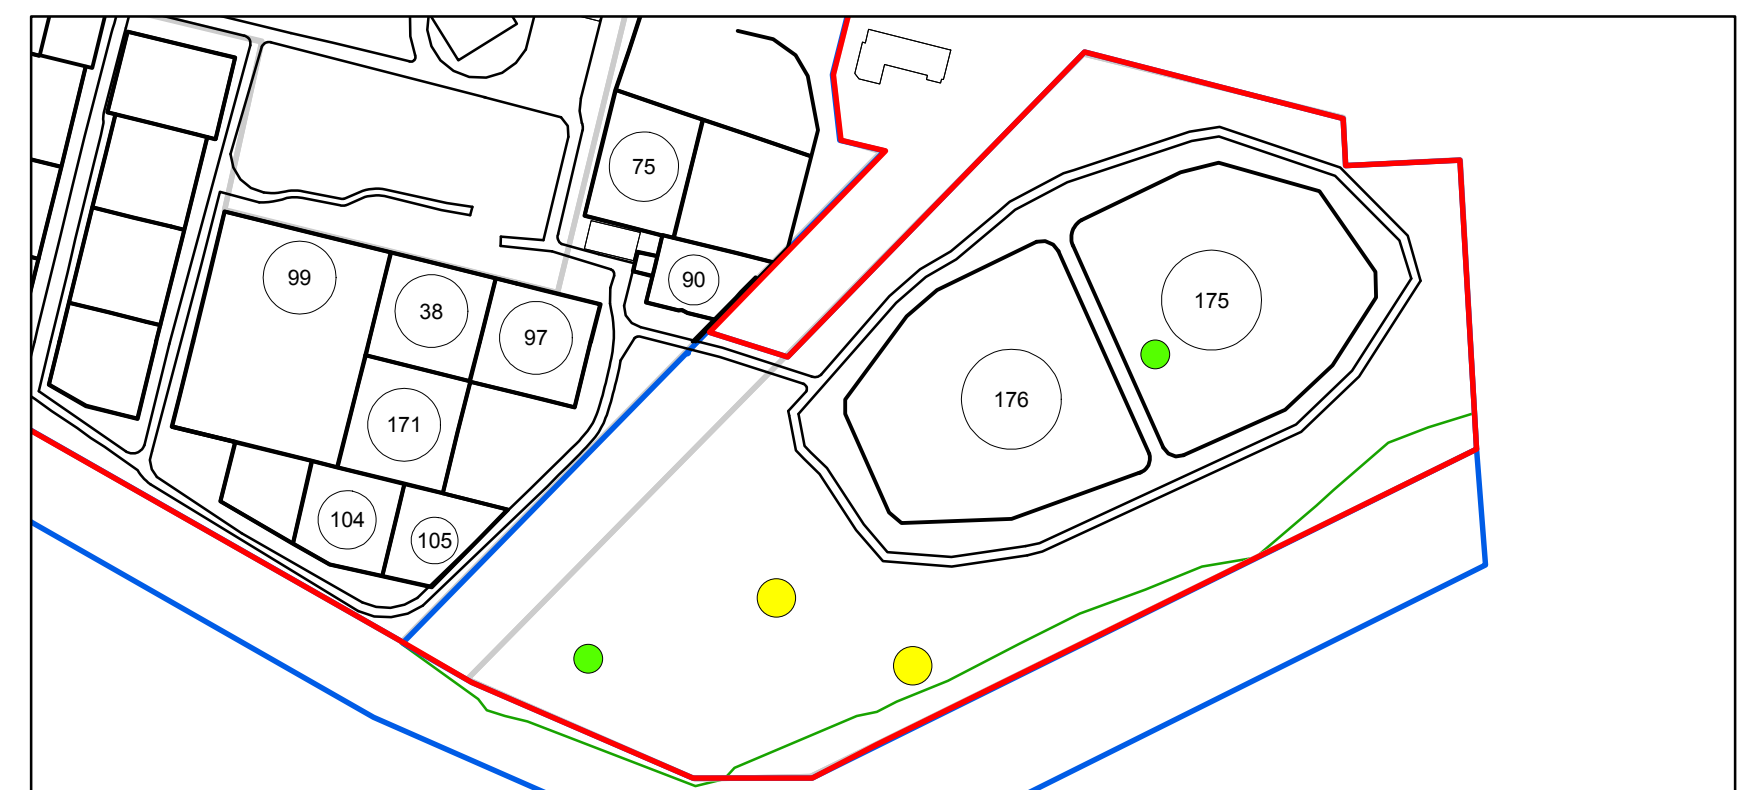
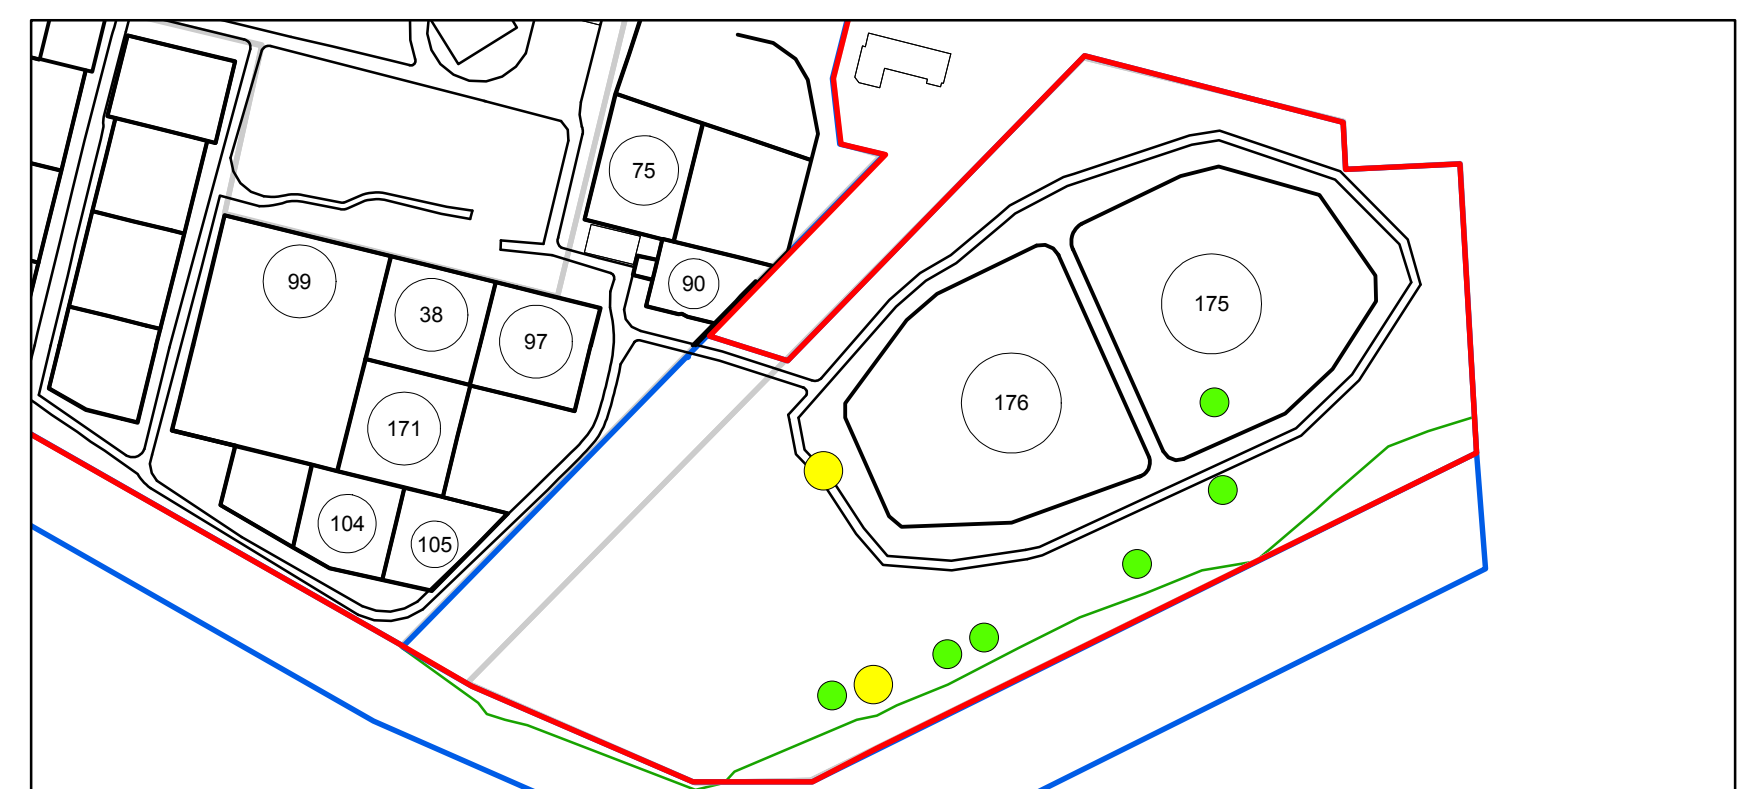
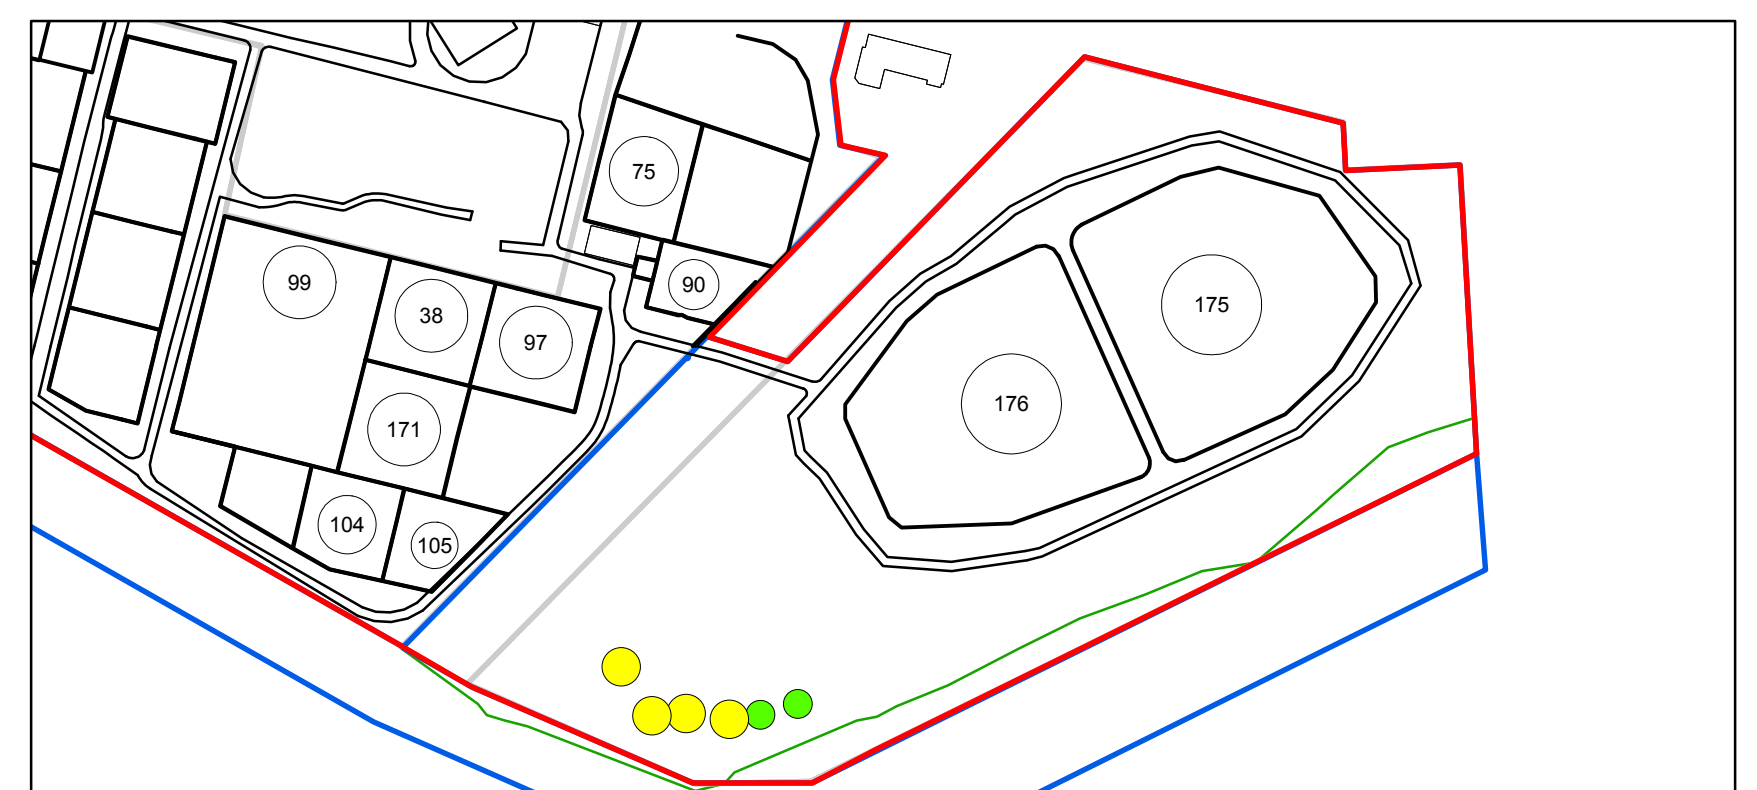
ROUX ASSOCIATES, INC. Environmental Consulting & Management	Compiled by: F.C.	Date: 03AUG10	<b>6</b> PLATE
	Prepared by: F.C.	Scale: AS SHOWN	
	Project Mgr: N.C.	Office: NY	
	File No: MCS2383013R.MXD	Project: 0172.052Y013

DISTRIBUTION OF TPH-GRO CONCENTRATIONS

DISTRIBUTION OF TPH-DRO CONCENTRATIONS

highest exceedance of a particular criteria is shown at each sample location at different depth intervals, even though more than one constituent may have exceeded the criteria. Plates 6 and 8 present the available data in the following depth intervals in order to provide an indication of the depth at which impacts were observed along the shoreline of OU-4:

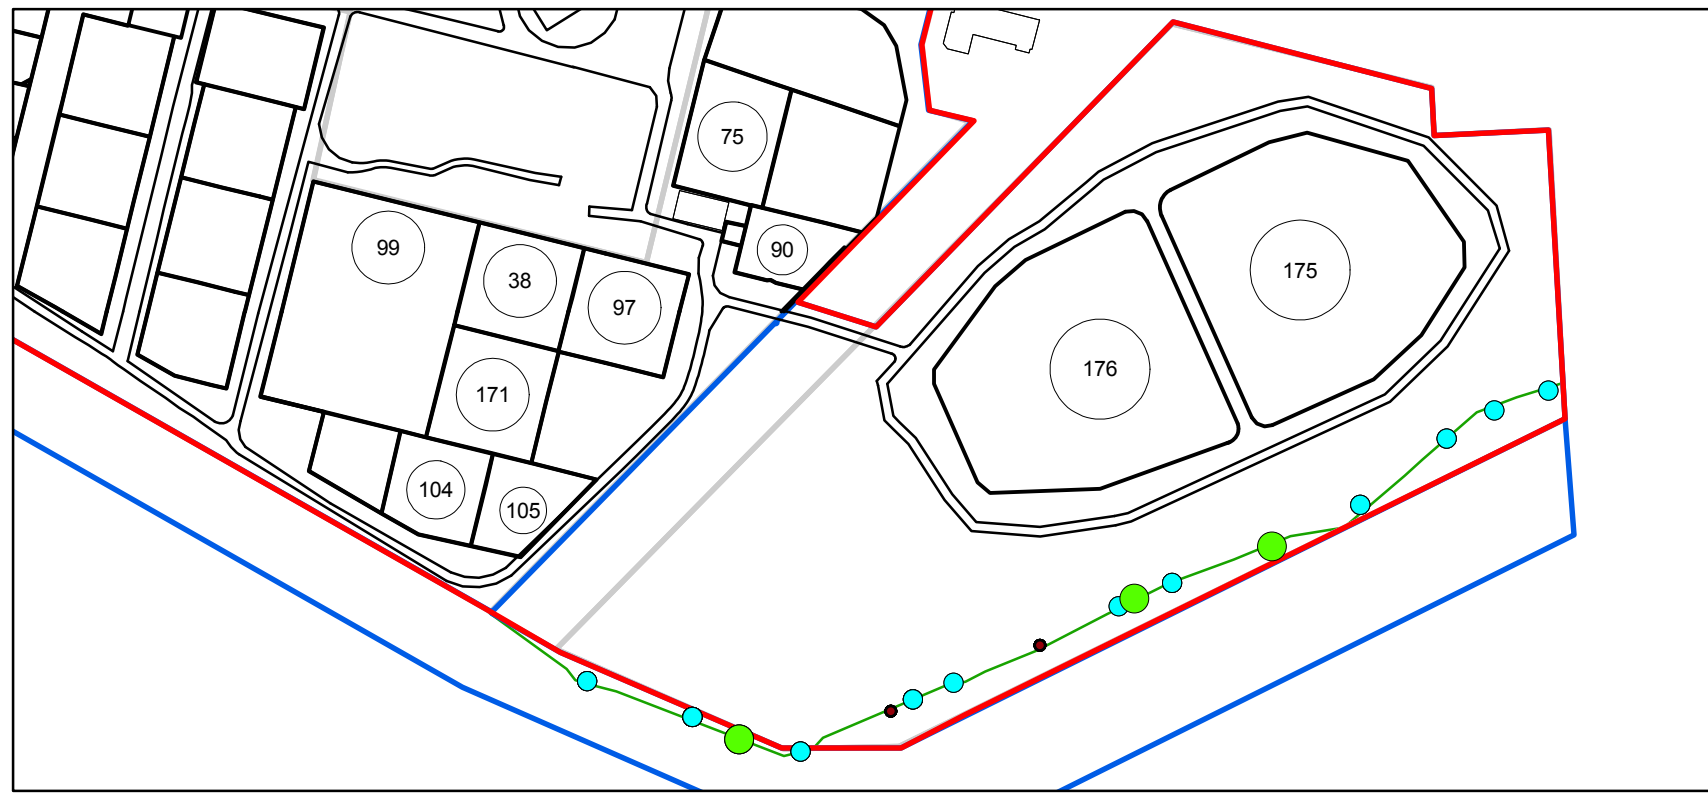
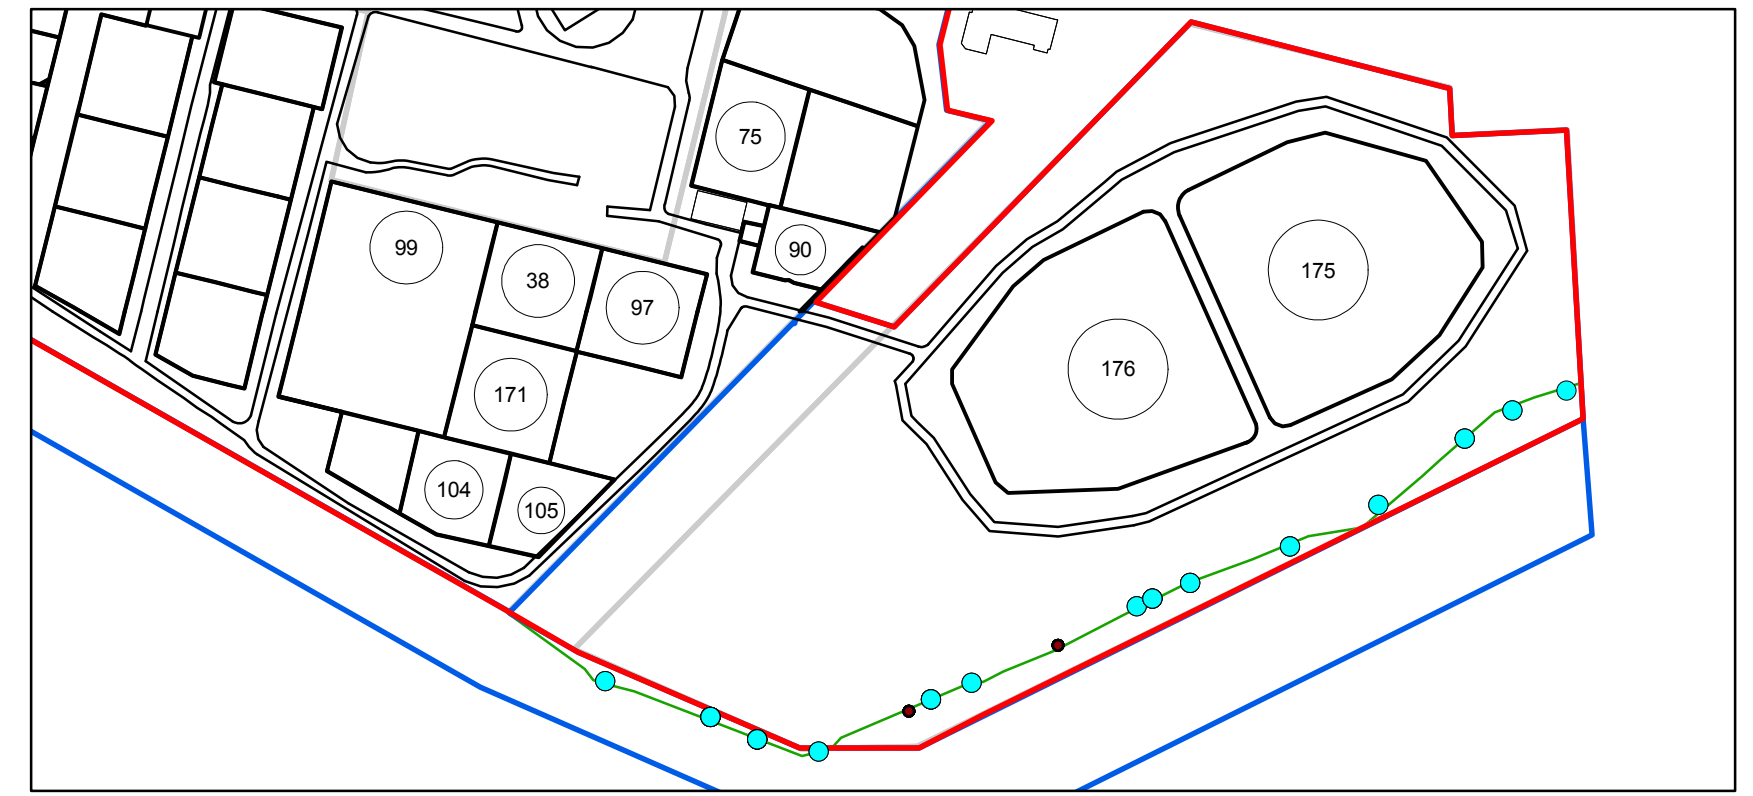
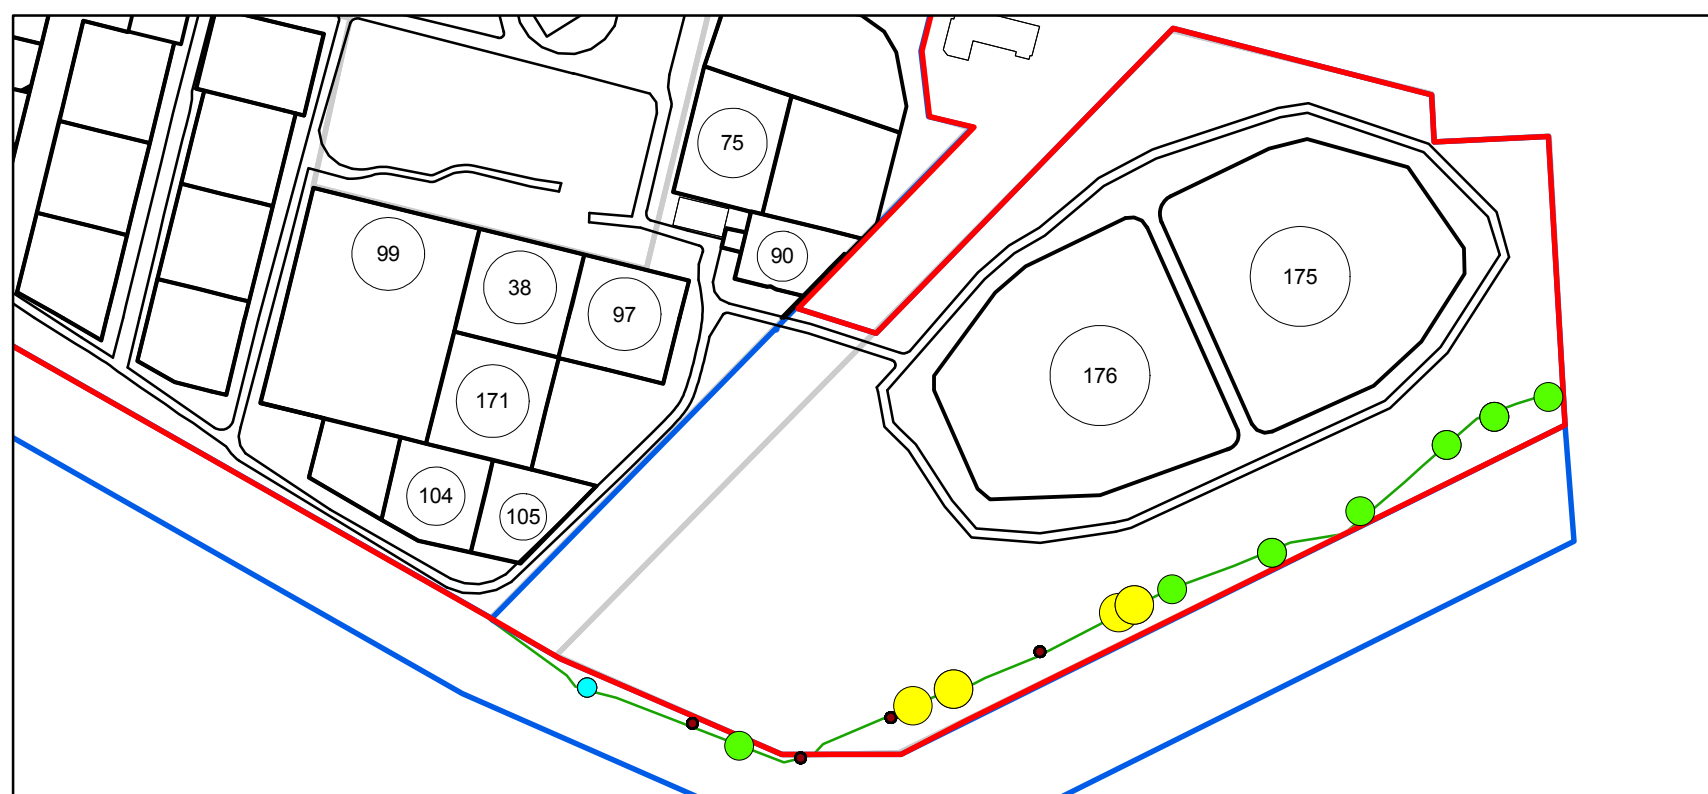
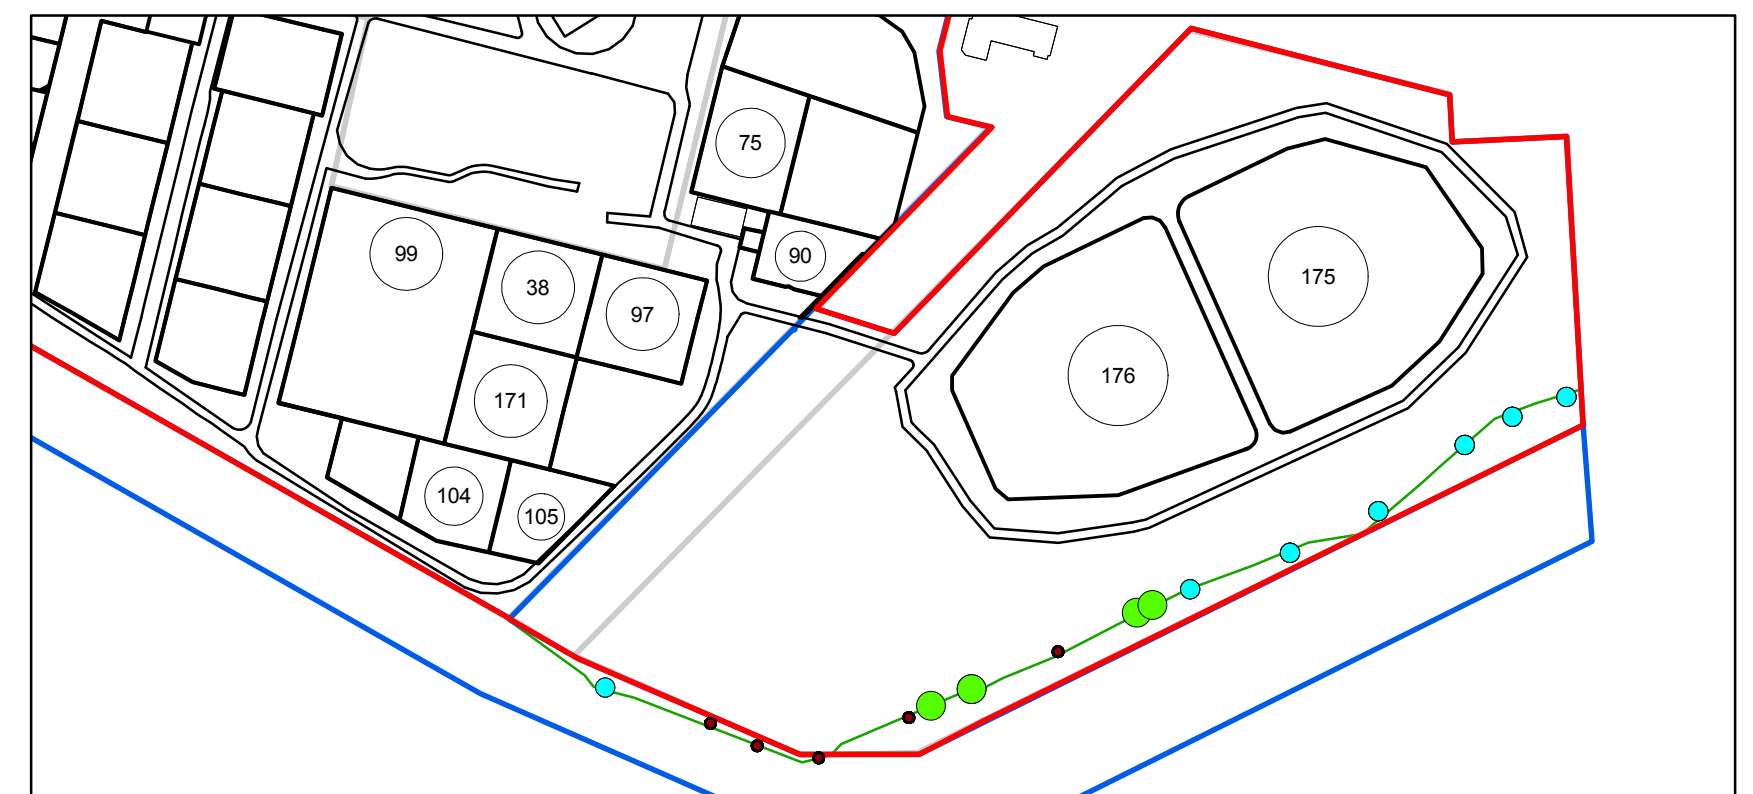
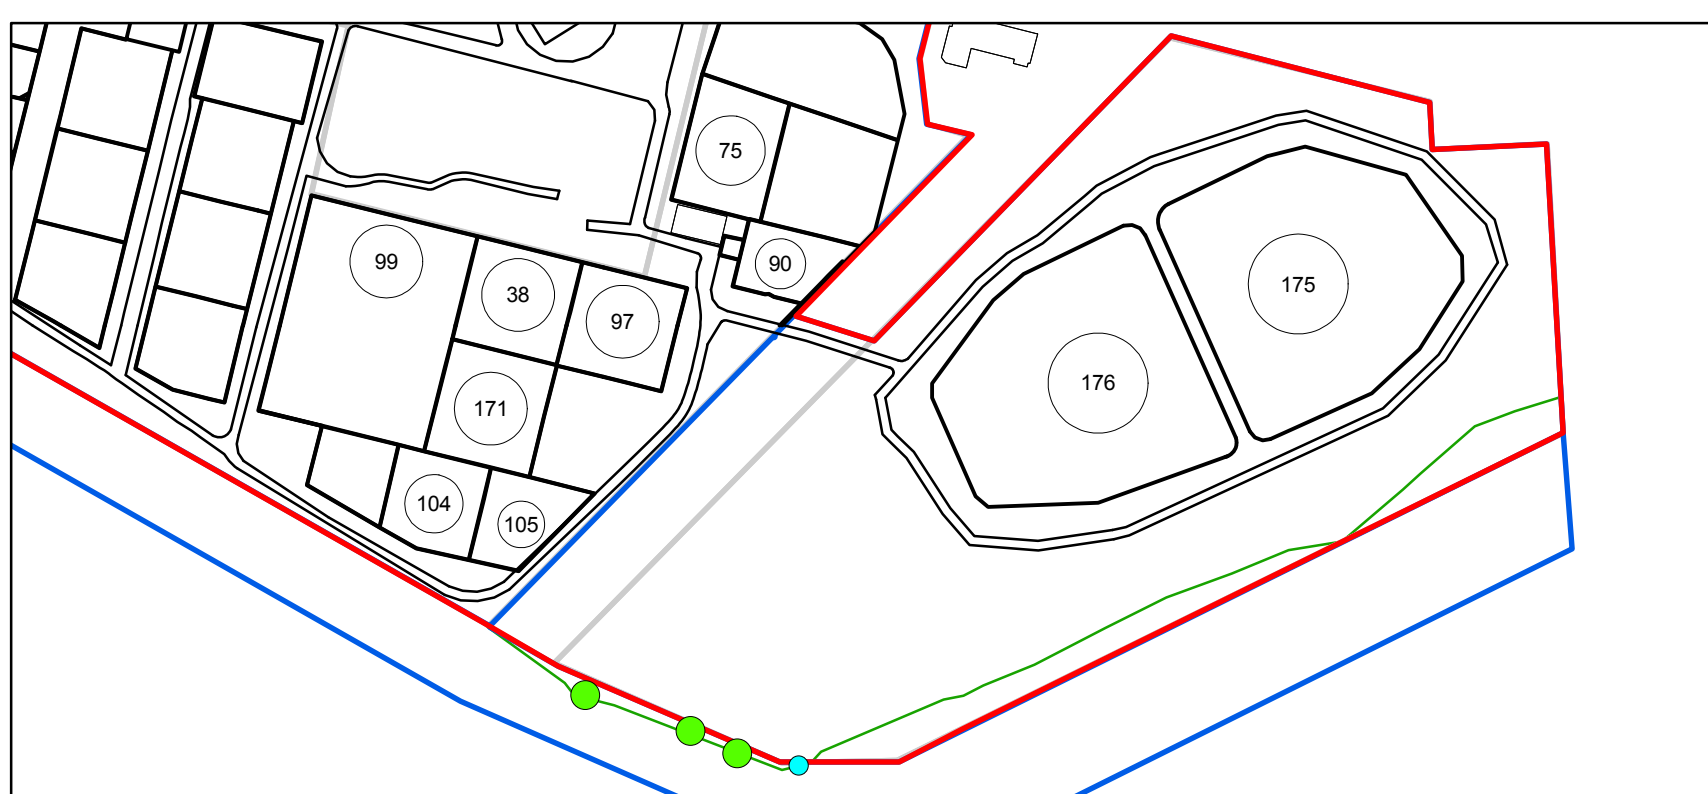
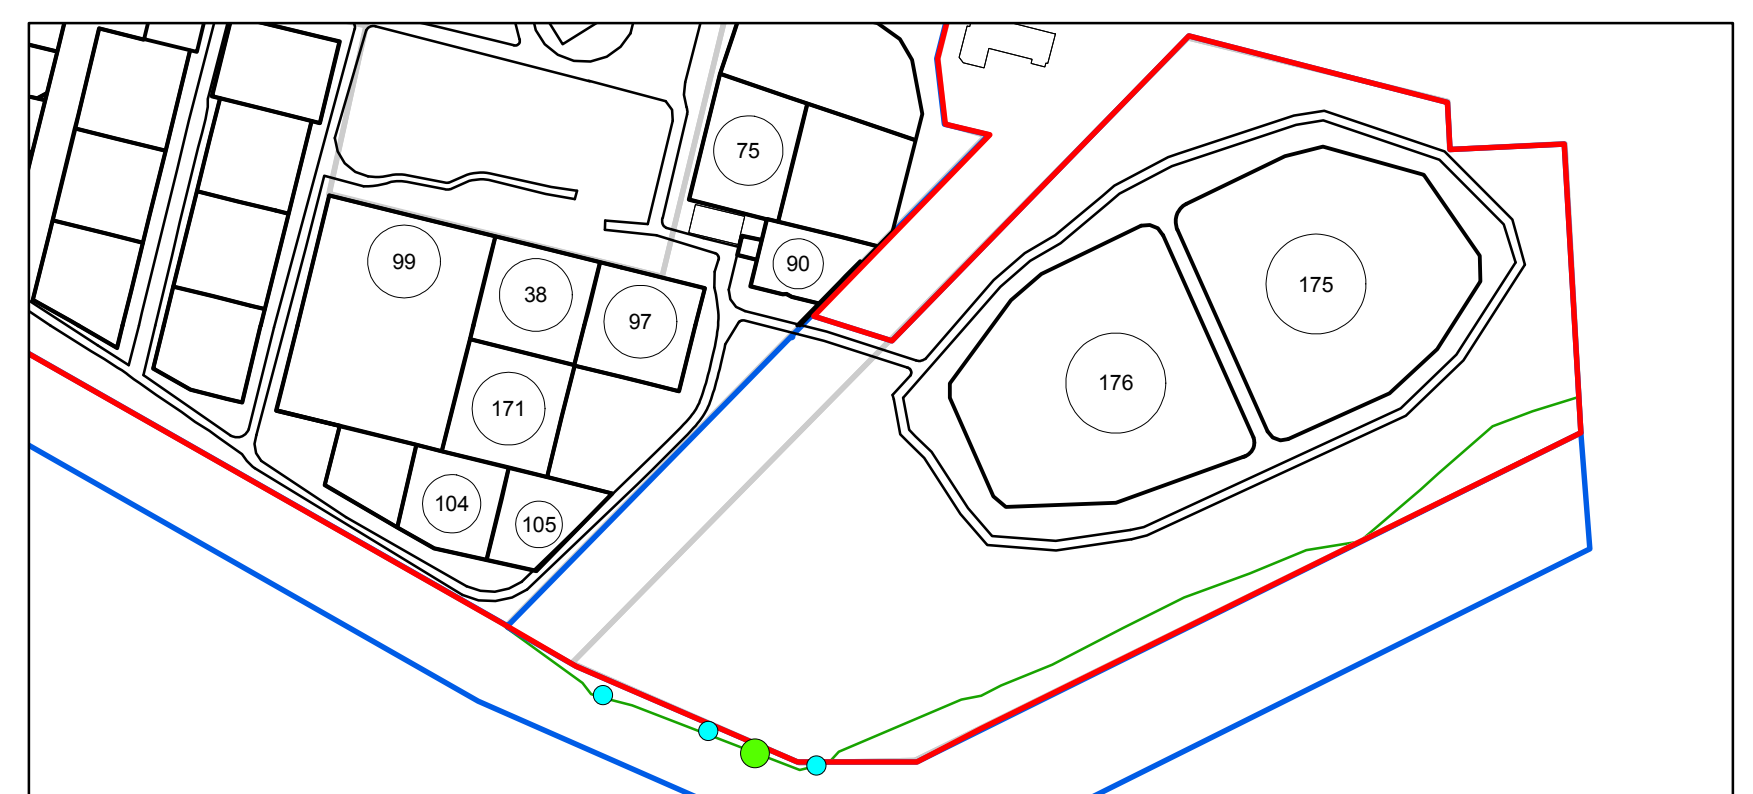
DISTRIBUTION OF CONCENTRATIONS RELATIVE TO BENTHIC AQUATIC LIFE CHRONIC TOXICITY FRESH WATER CRITERIA

DISTRIBUTION OF CONCENTRATIONS RELATIVE TO BENTHIC AQUATIC LIFE ACUTE TOXICITY FRESH WATER CRITERIA

DISTRIBUTION OF CONCENTRATIONS RELATIVE TO LOWEST EFFECT LEVEL

DISTRIBUTION OF CONCENTRATIONS RELATIVE TO SEVERE EFFECT LEVEL

As shown on Plate 8, exceedances of SVOCs relative to the benthic aquatic life chronic toxicity fresh water criteria in the shallow interval were detected at 11 of the 16 locations sampled. Six SVOCs were detected above the benthic aquatic life chronic toxicity fresh water criteria (acenaphthene, anthracene, benzo[a]anthracene, fluorene, naphthalene, and phenanthrene). The higher concentrations were generally observed within the seepage areas of OU-4.

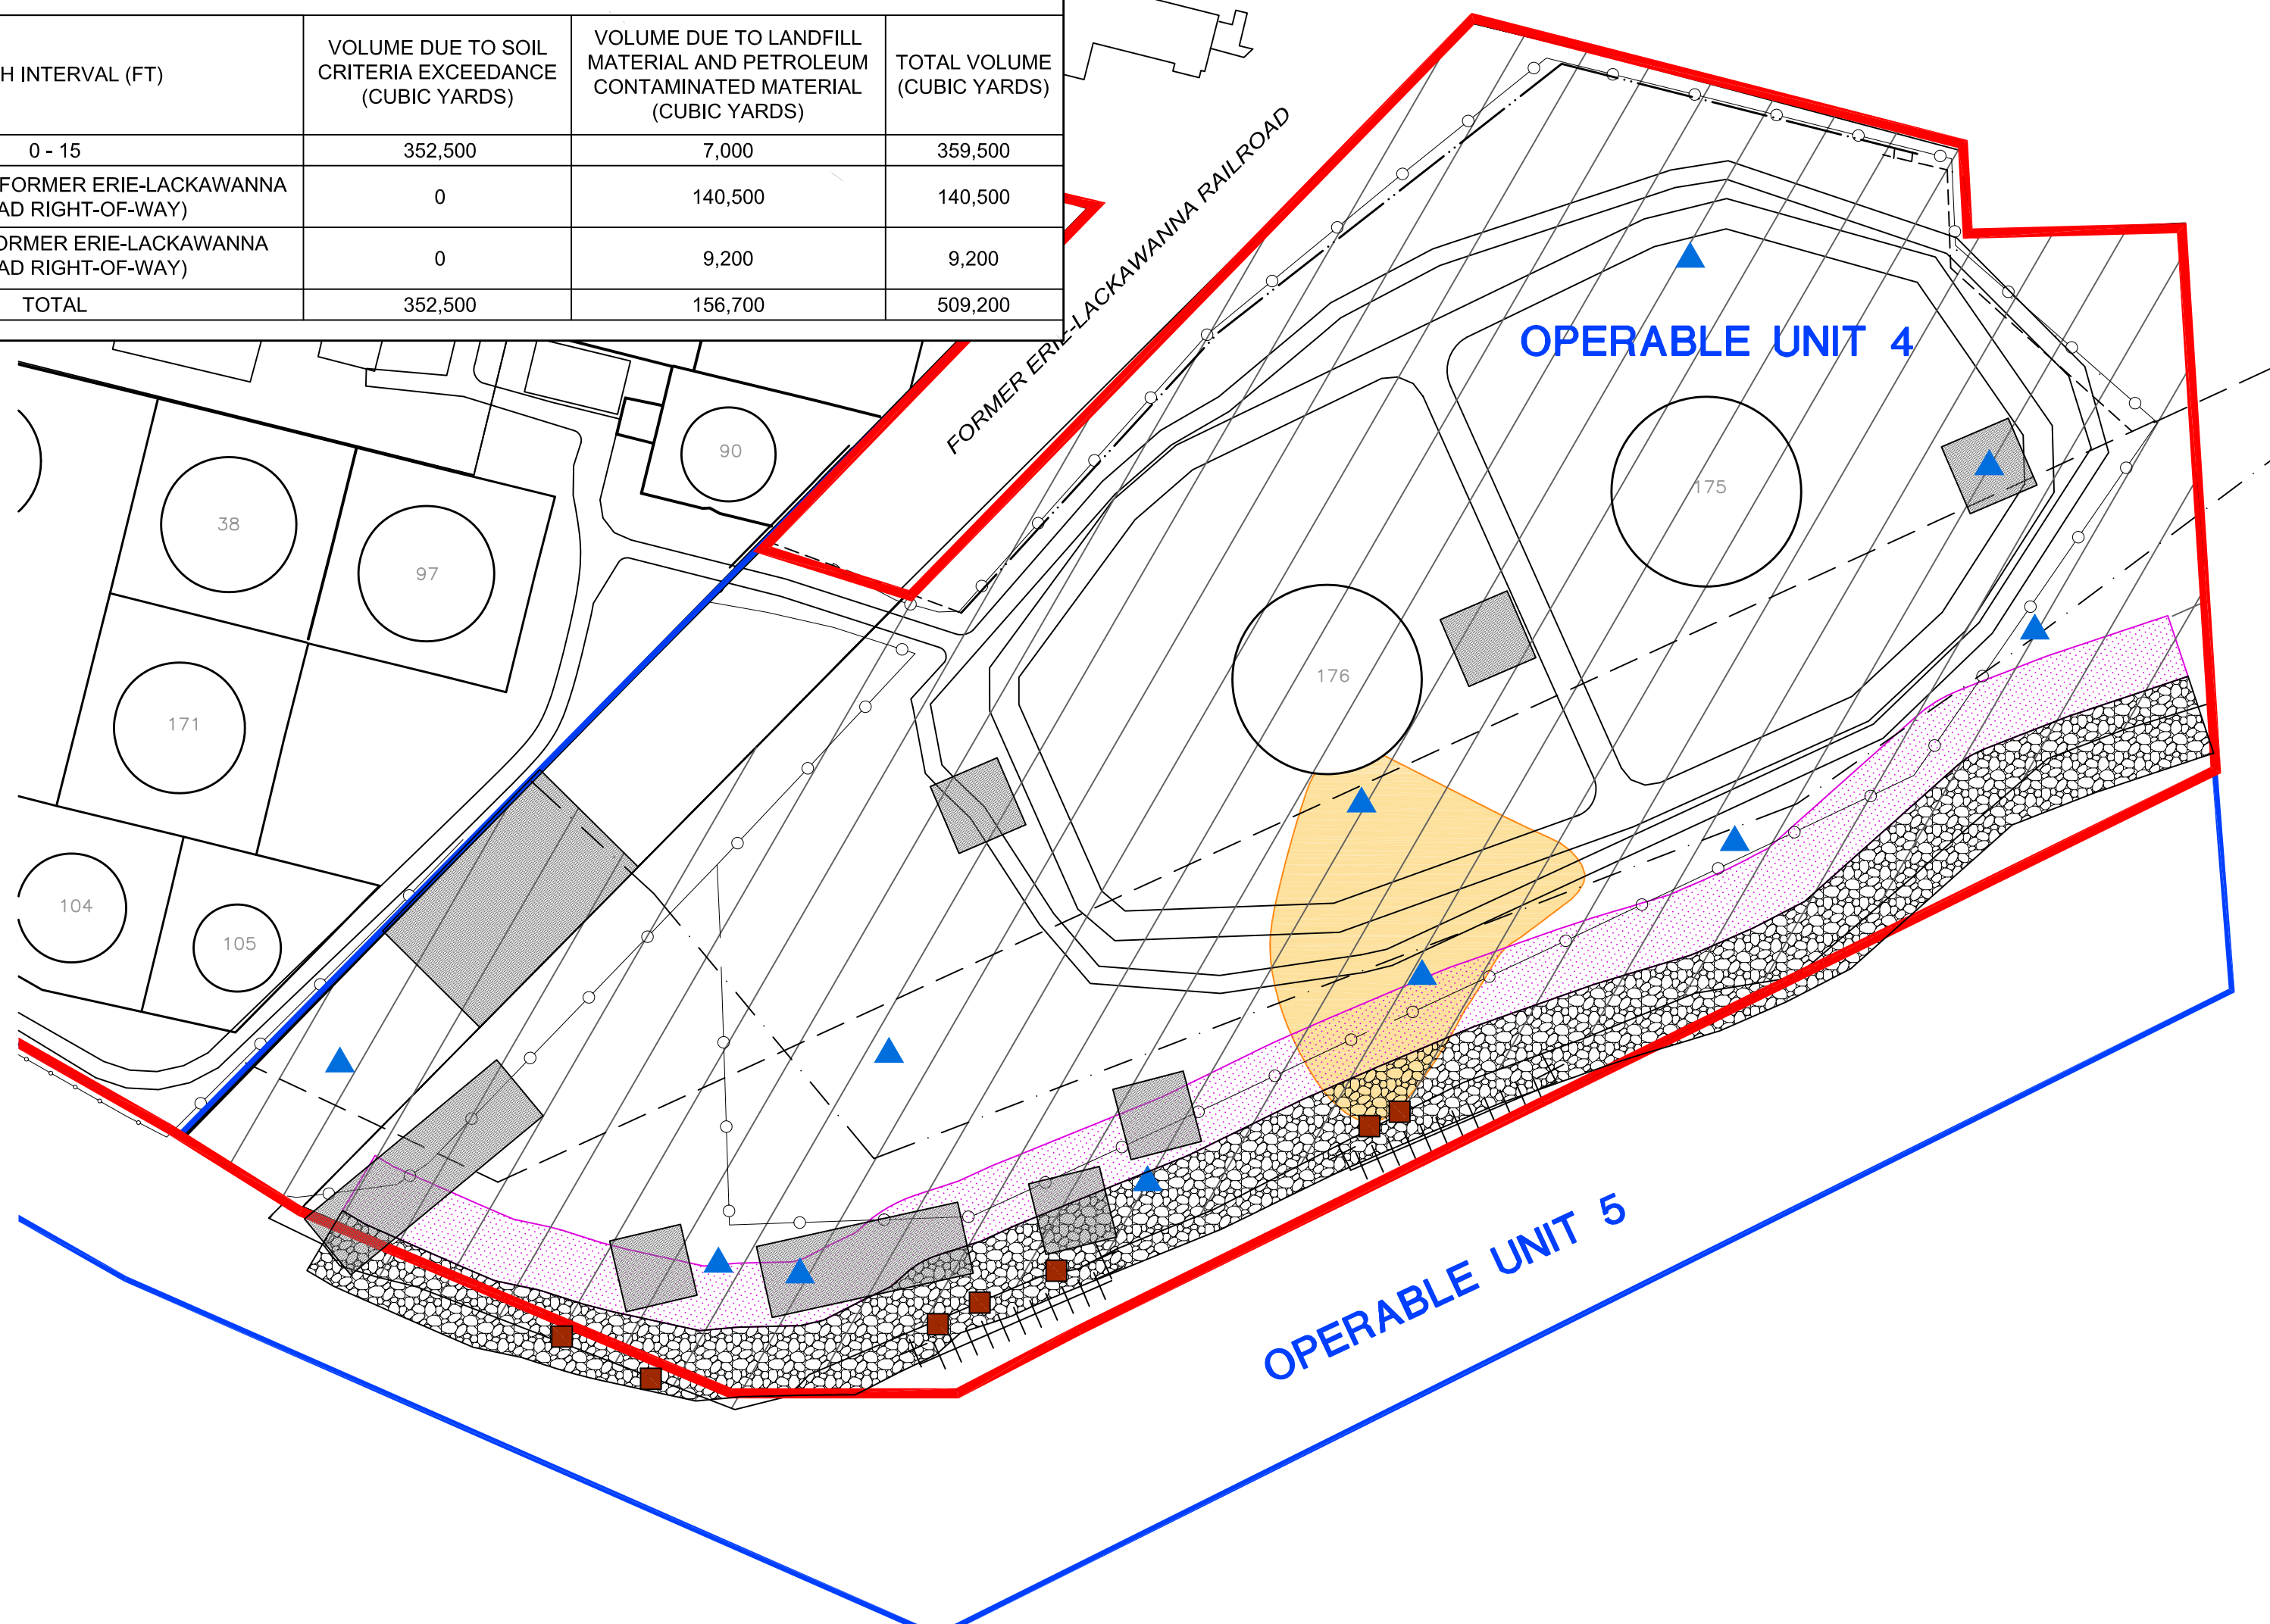
- LIMITS OF EXCAVATION
- LIMITS OF PROPOSED 4-ON-1 VEGETATED EMBANKMENT
- LIMITS OF PROPOSED 3-ON-1 RIP RAP EMBANKMENT
- HISTORICAL AND CURRENT EXTENT OF SEPARATE-PHASE PRODUCT
- PETROLEUM CONTAMINATED MATERIAL
- SOIL SAMPLE EXCEEDING INDUSTRIAL CRITERIA
- SEDIMENT SAMPLE EXCEEDING BENTHIC AQUATIC LIFE ACUTE TOXICITY FRESH WATER CRITERIA OR SEVERE EFFECT LEVEL
- FENCELINE
- LIMITS OF CONTAINMENT BOOMS
- PORTION OF BUCKEY'S PRODUCT PIPELINE THAT IS ABANDONED (LINE PURGED AND ABANDONED IN PLACE)
- PORTION OF BUCKEY'S BURIED PRODUCT PIPELINE THAT IS ACTIVE
- BUCKEY'S ACTIVE ABOVE GROUND PRODUCT PIPELINE
- ENBRIDGE PIPELINES INC.'S BURIED PRODUCT PIPELINE (LINE REPORTEDLY PURGED AND FILLED WITH NITROGEN IN 1982)
- BCP SITE BOUNDARY
- OPERABLE UNIT BOUNDARY
