Phase I Environmental Site Assessment

**1132 and 1146 Seneca Street
Buffalo, NY 14240**

September 2007

Malcolm Pirnie, Inc.

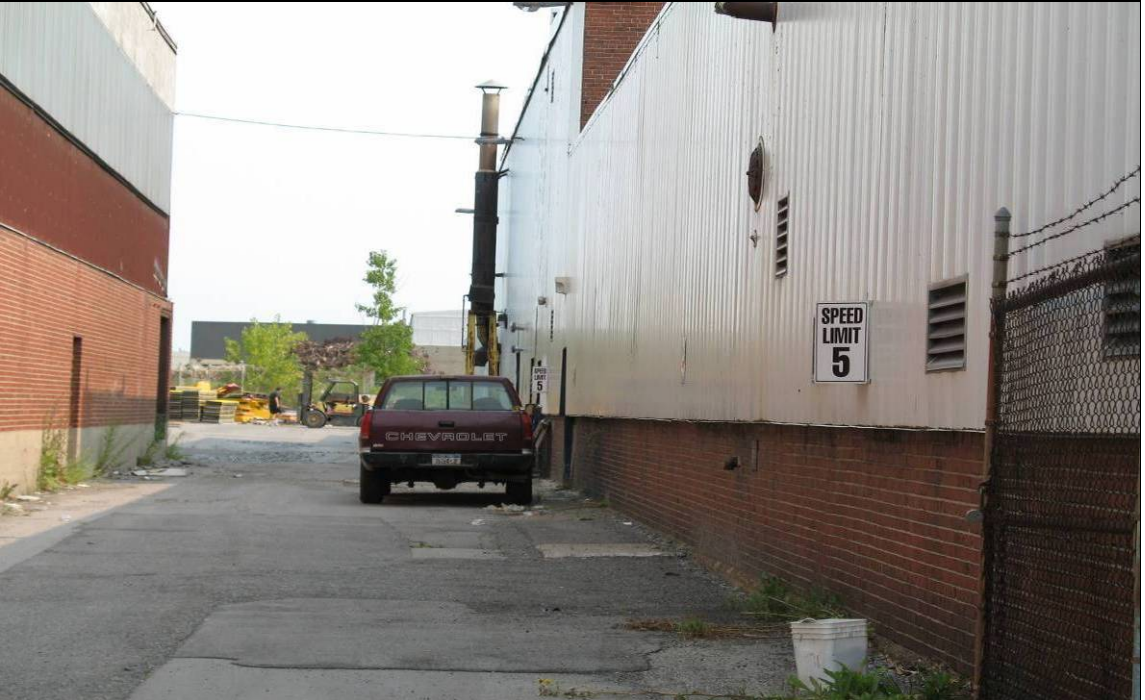
Project: 1132 Seneca Street		Location: Buffalo, NY	Project No. 6105-001
Photo No. 1	Date: 8/14/07

Direction Photo Taken: North			
Description: Paved access road located along the western property boundary

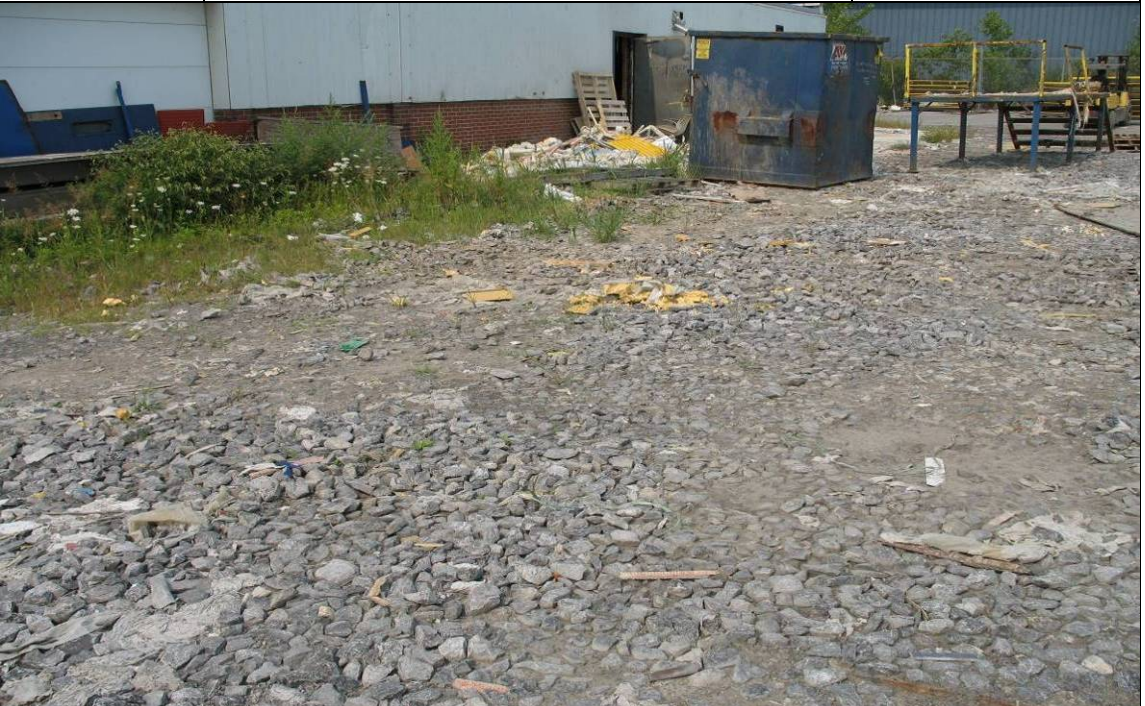
Project: 1132 Seneca Street		Location: Buffalo, NY	Project No. 6105-001
Photo No. 8	Date: 8/14/07

Direction Photo Taken: South			
Description: Unpaved area located north of the manufacturing building

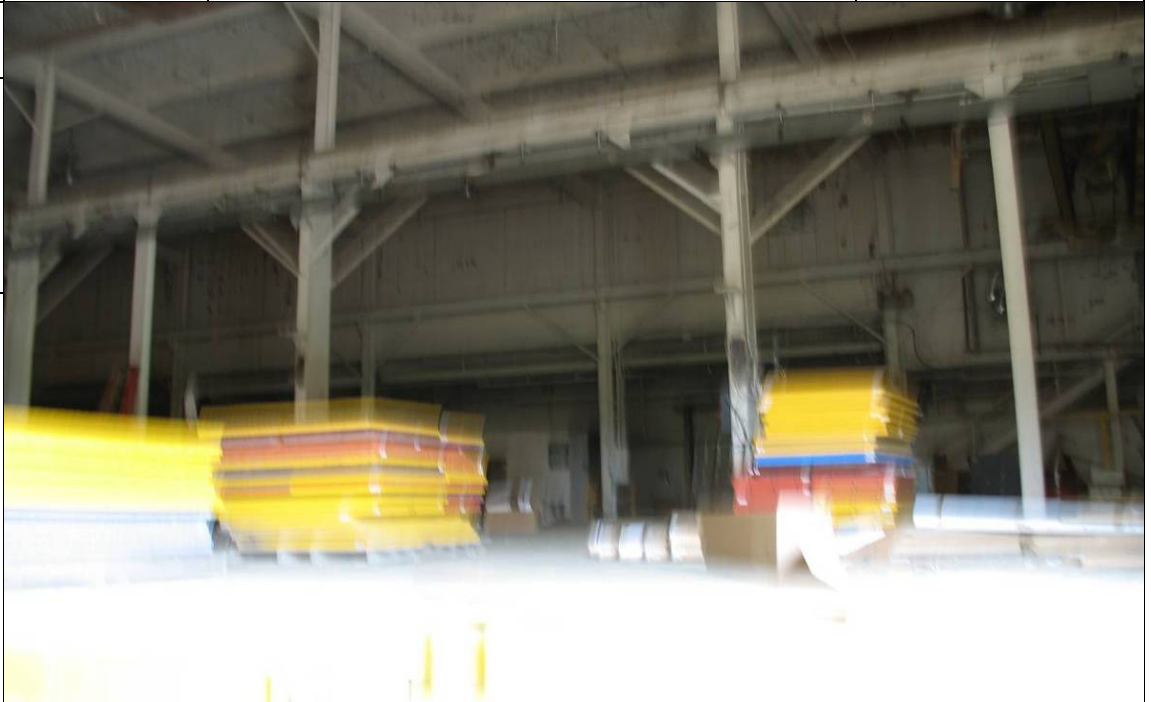
**Direction Photo
Taken:****Description:**Inside manufacturing
building

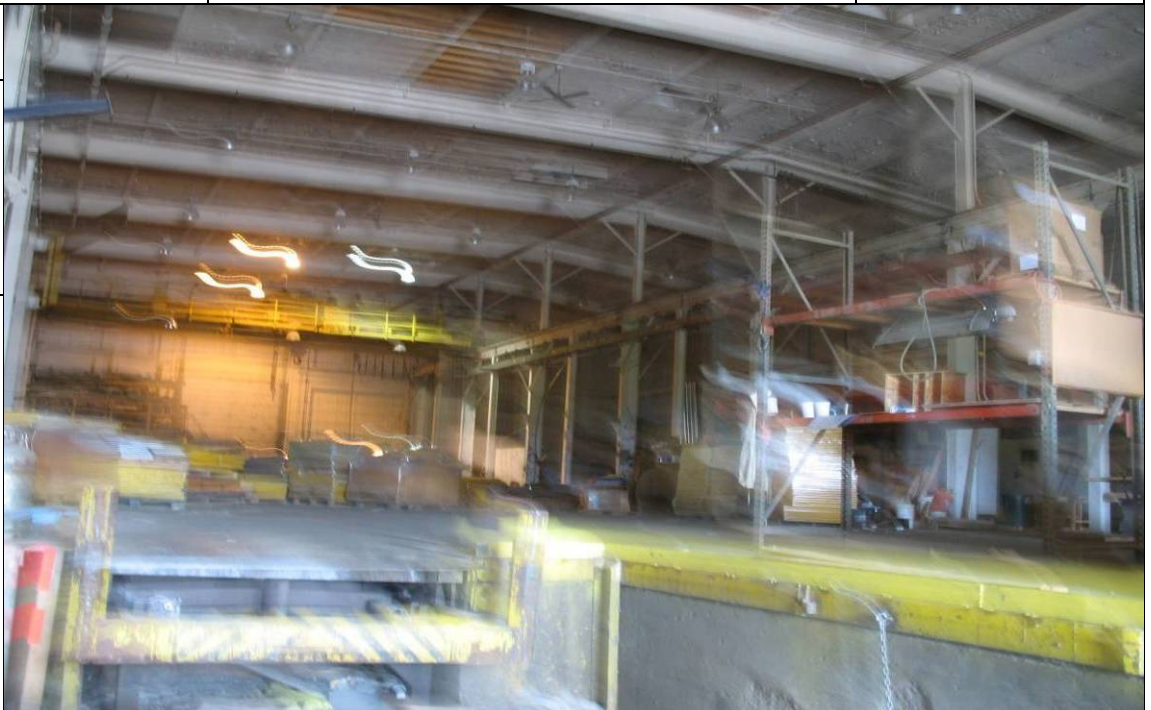
**Direction Photo
Taken:****Description:**Inside manufacturing
building

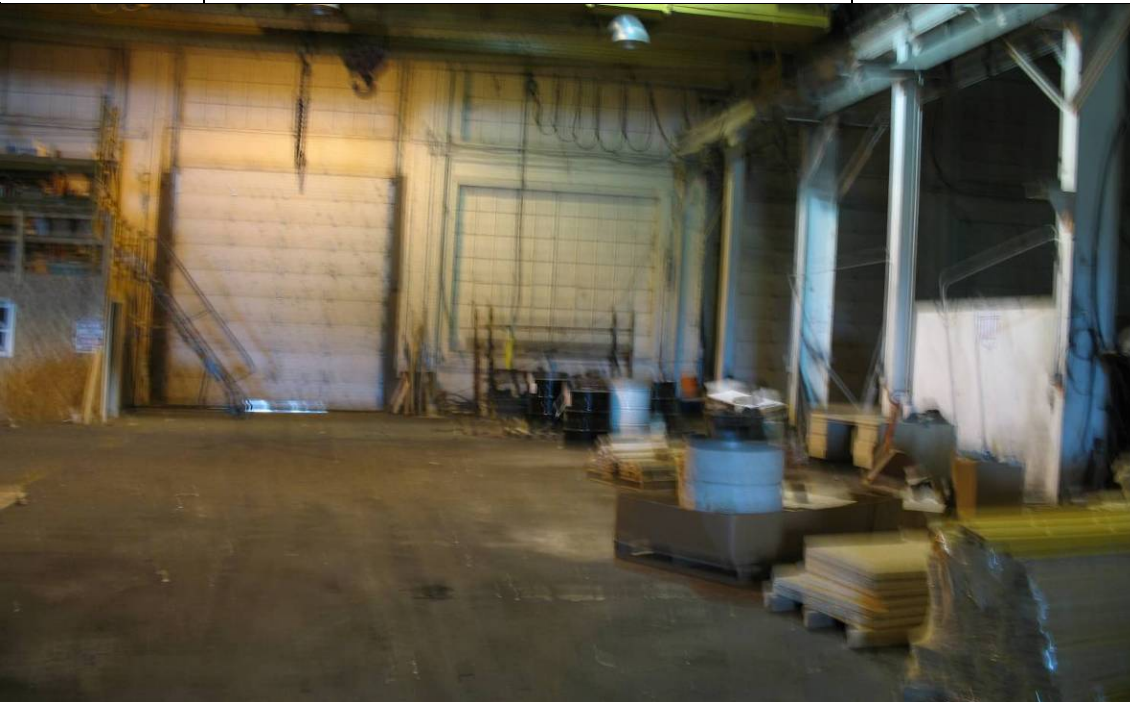
Project: 1132 Seneca Street		Location: Buffalo, NY	Project No. 6105-001
Photo No. 13	Date: 8/14/07

Direction Photo Taken:			
Description: Inside manufacturing building

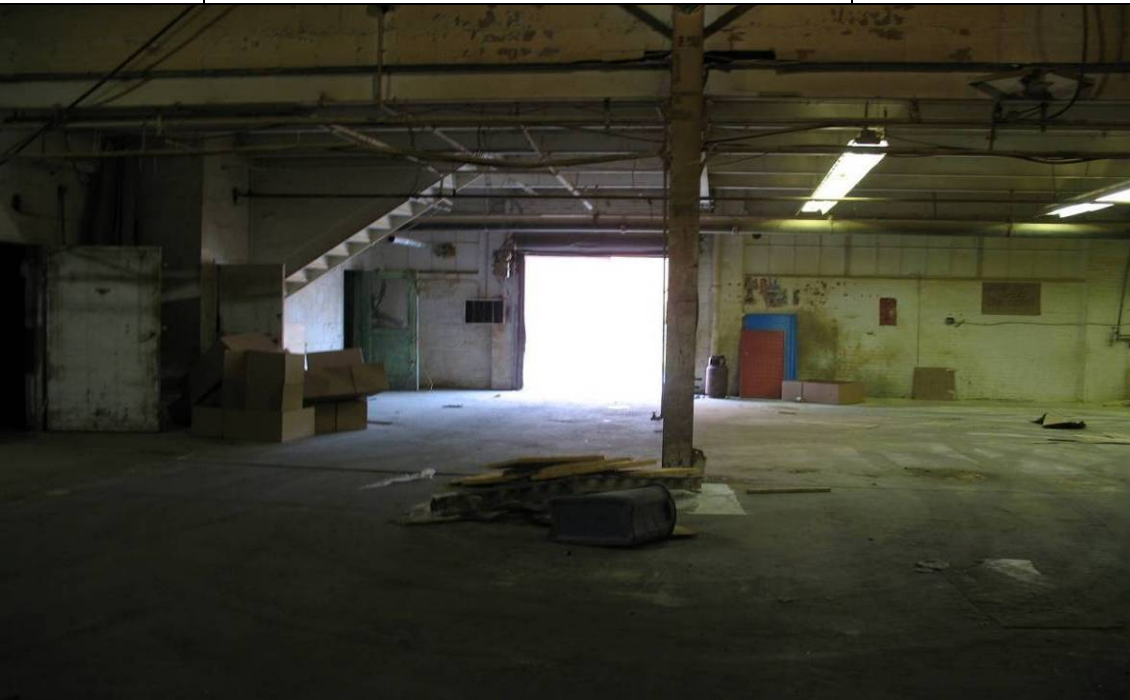
Project: 1132 Seneca Street		Location: Buffalo, NY	Project No. 6105-001
Photo No. 18	Date: 8/14/07

Direction Photo Taken:			
Description: Inside the manufacturing building

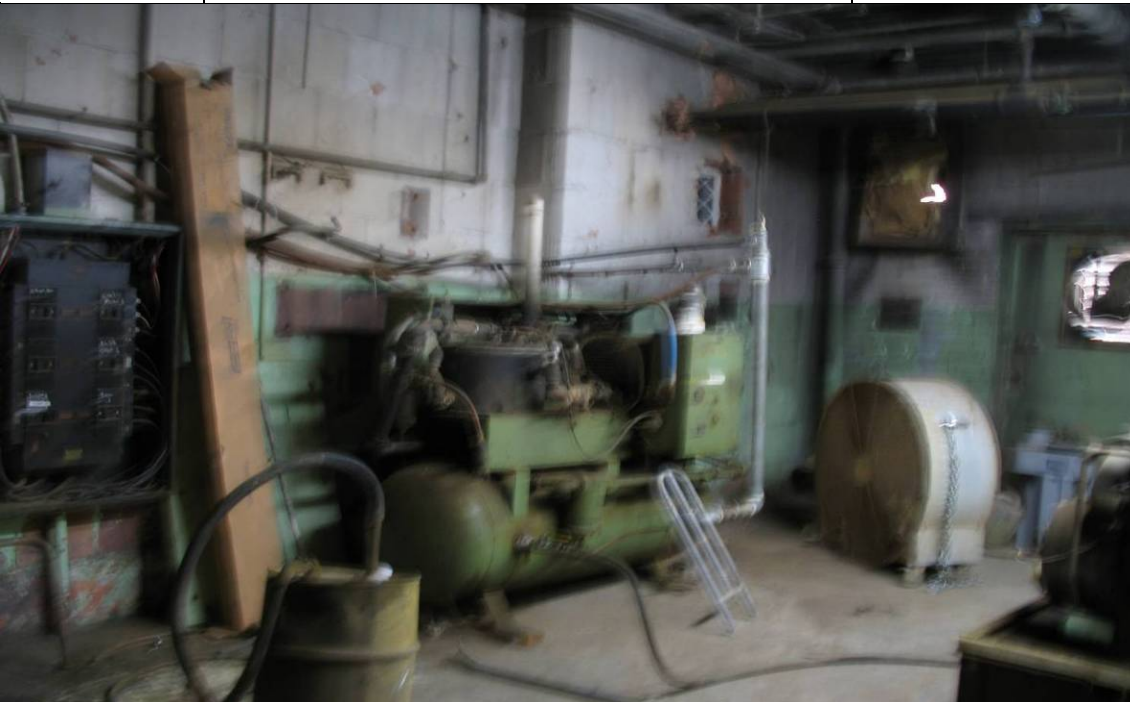
Project: 1132 Seneca Street		Location: Buffalo, NY	Project No. 6105-001
Photo No. 19	Date: 8/14/07

Direction Photo Taken:			
Description: Inside the manufacturing building

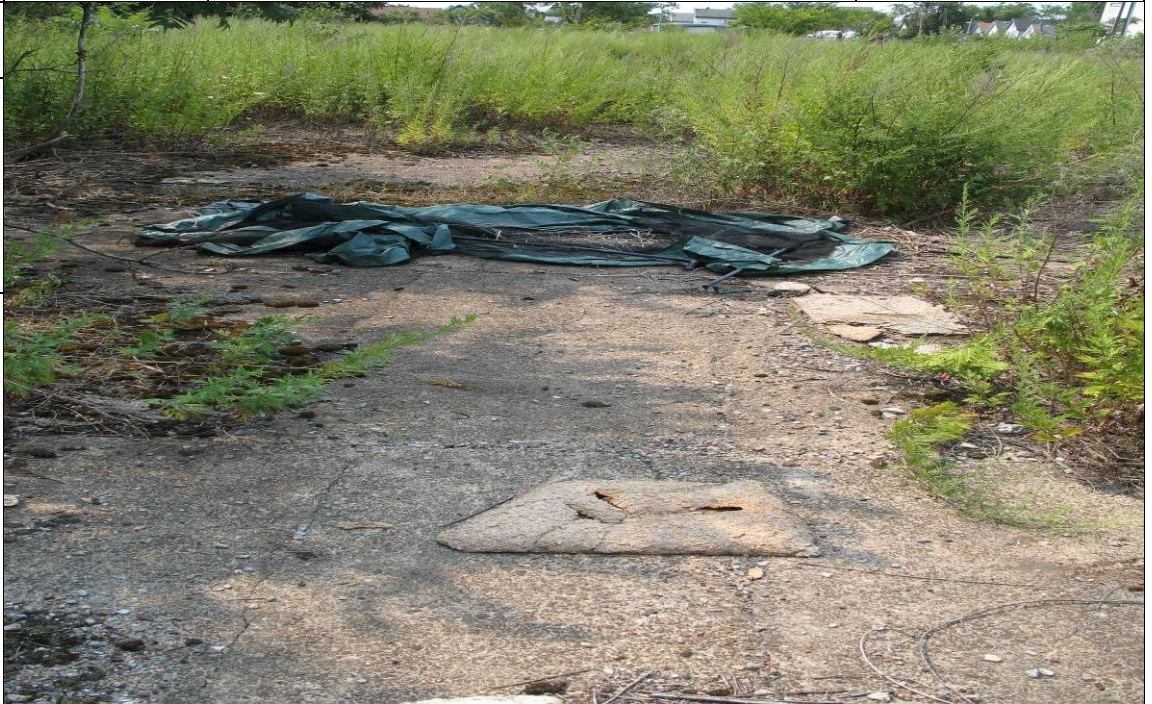
Concrete Pad
