## MEMORANDUM

| <b>Re:</b> | Area A Slope Stability and Revised Dredge Prism | | |

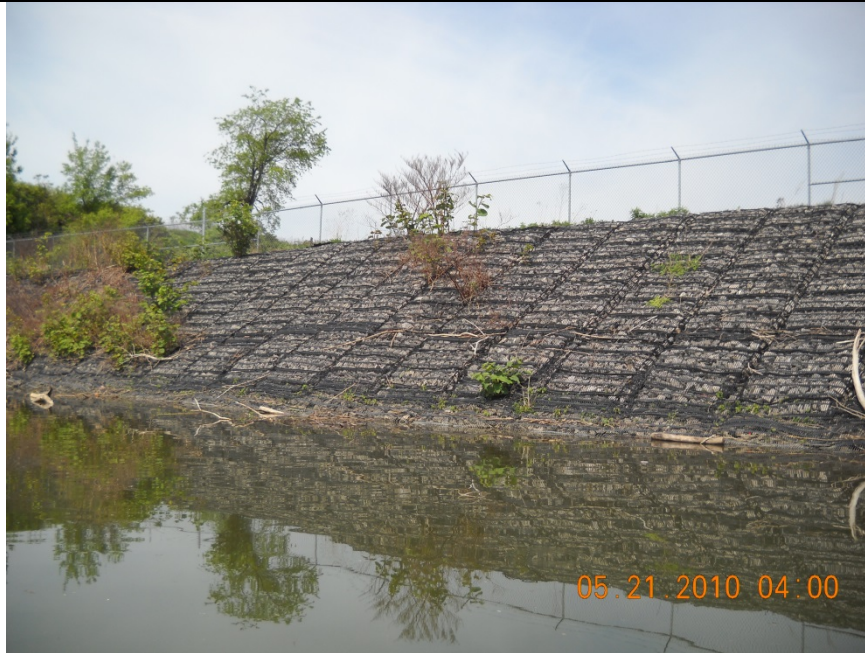
Photo 1: Marine mattress segment at Area A

Area A, located adjacent to DMUs 9 & 10, was identified as a critical structure during the design phase for the Buffalo River Remediation Project. This area contains a segment of shoreline protected by a marine mattress, approximately 120 feet long along the shoreline, extending from top of bank down to approximately elevation +553.5 IGLD 85. The mattress is anchored at the top of the slope, and is comprised of stone gabions reinforced with geogrid. Upland from the marine mattress is a slurry wall that was constructed as part of the brownfield cleanup operations for the former Buffalo Color site. Dredging within DMUs 9 & 10 is anticipated to be necessary immediately adjacent to the toe of the mattress, raising concerns over the stability of the shoreline mattress and slope, both during and following dredging activities.

Anchor QEA performed a series of slope stability analyses to evaluate potential effects of the dredging project on the stability of the marine mattress. Early modeling results indicated the existing condition of the mattress was stable; however, it was below factors of safety that are typically utilized for design or new construction. Planned vertical dredge cuts at the toe of slope showed potential to lower the factor of safety below 1.0, potentially indicating an unstable slope condition. Depending on the size and shape of the failure mass and the upland slurry wall configuration, impacts could extend to those areas.

Additional slope stability modeling was performed more recently to update the initial evaluations based on new data that was provided to Anchor QEA. The extents of the marine mattress were updated based on diver verification data locating the as-built toe of the mattress, which extended further into the river than what was initially envisioned. In addition, geotechnical information along the slope was updated utilizing recent borings advanced within the river near the toe of the slope. The revised evaluation indicated that although a reduced dredge prism might be anticipated due to the mattress extending further into the river than previously anticipated, the low-strength clay strata was found to be thicker than what upland borings previously had illustrated. These changes resulted in an overall result similar to preliminary model predictions, indicating that slope stability is still a concern at the site if dredging is conducted as envisioned.
