REMEDIAL ACTION WORK PLAN

FORMER PILGRIM VILLAGE SENIOR APARTMENTS
TAX MAP ID NO.: 100.71-3-1.11 (PORTION OF)
BUFFALO, NEW YORK 14209
NYSDEC SITE NO.: C915363

MAY 2021

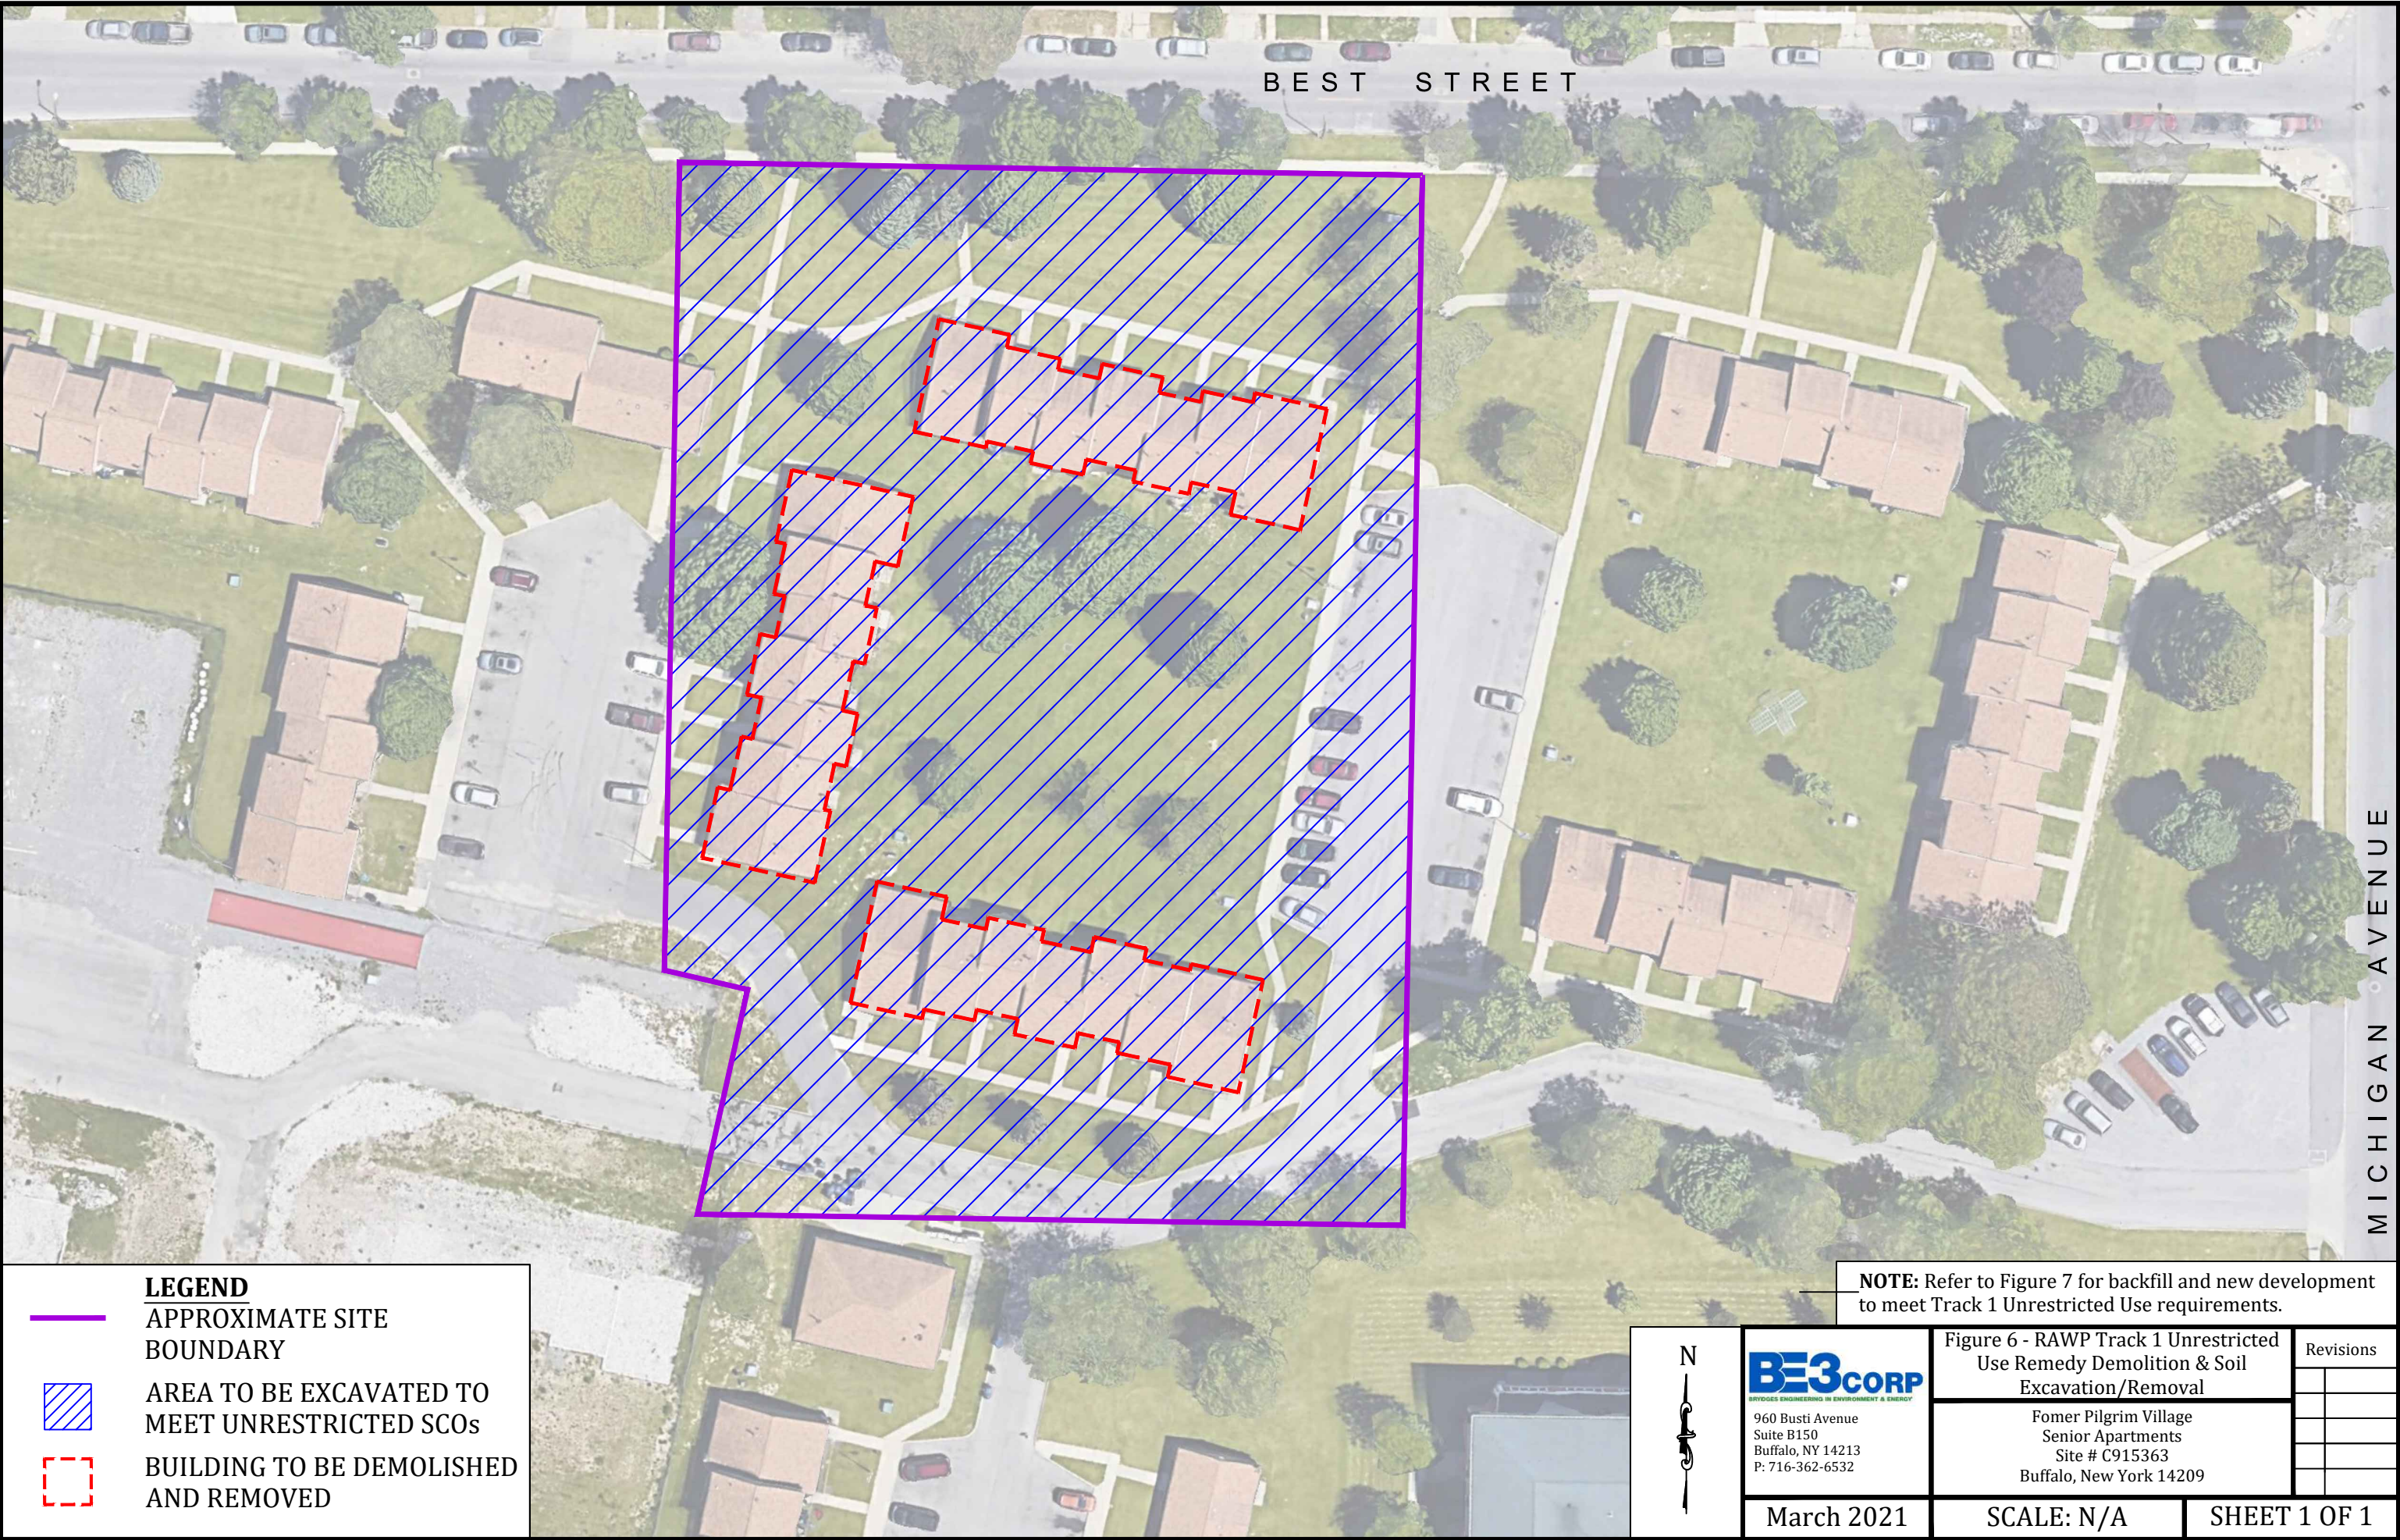
Figure 6	RAWP Track 1 Unrestricted Use Remedy – Demolition & Soil Excavation/Removal
Figure 7	RAWP Track 1 Unrestricted Use Remedy – Clean Backfill for New Development

Monitoring wells installed during the RI will be decommissioned/removed in accordance with NYSDEC's CP-43: Groundwater Monitoring Well Decommissioning Policy. Buildings as noted on **Figure 6** will be demolished and floor slabs/foundations removed and, after examination/testing, will be sent to either a landfill or recycler.

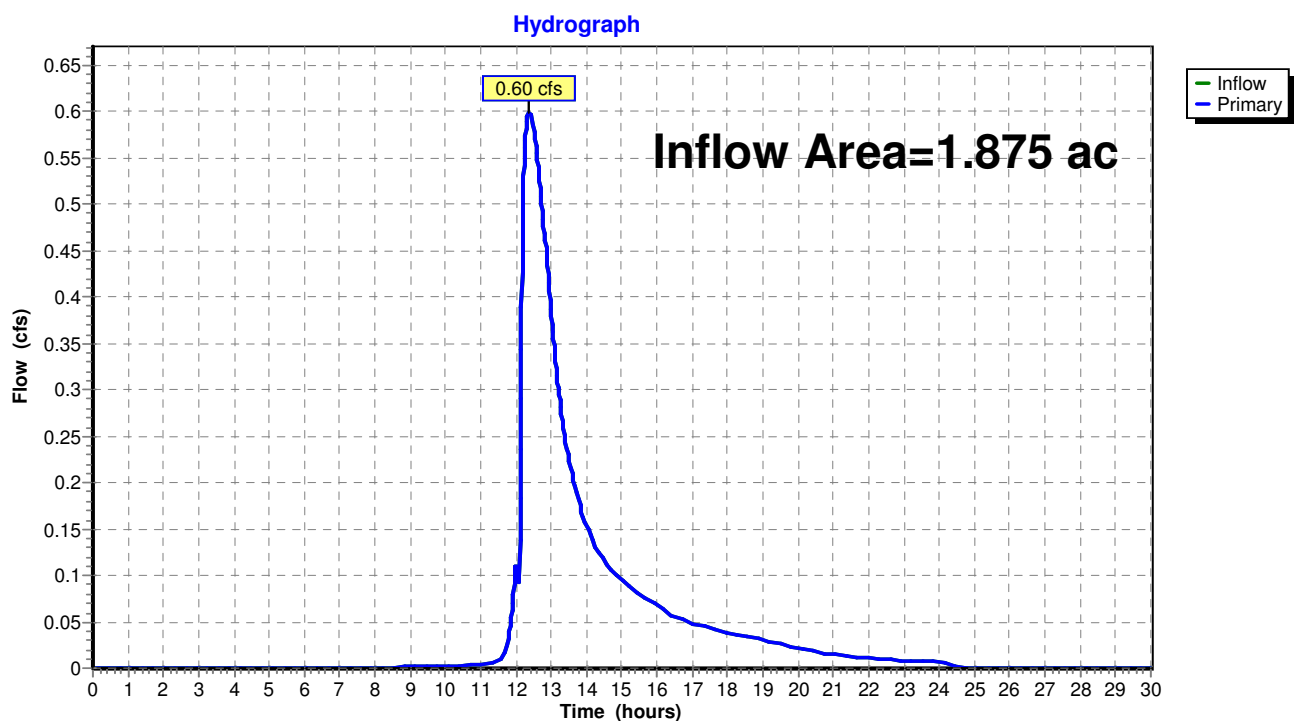
Pond 2P: Discharge to Best Street

Routing by Stor-Ind method, Time Span= 0.00-30.00 hrs, dt= 0.01 hrs

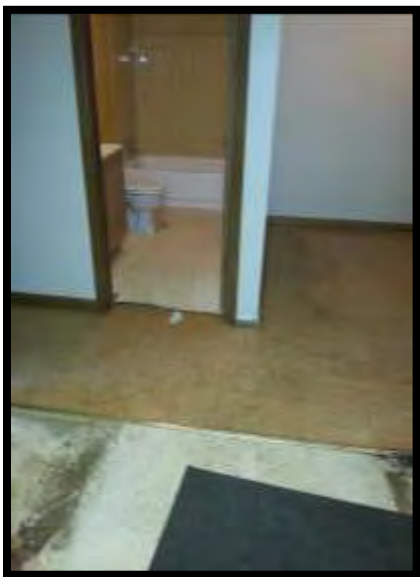
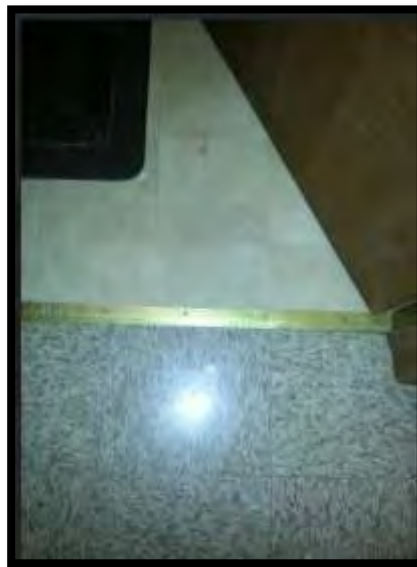
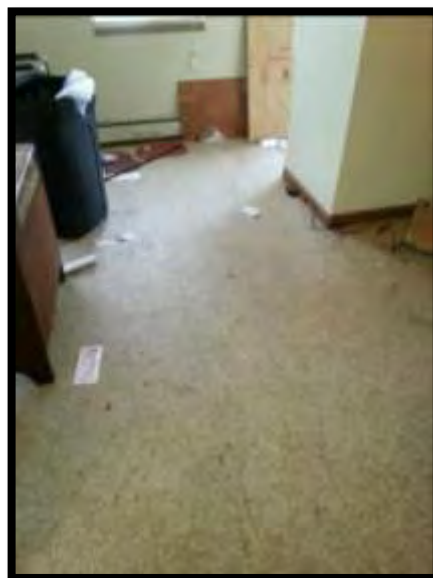
Appendix B: Site Pictures

Representative Linoleum, Floor Tiles and Mastic under flooring found in Buildings 1,2,3,4,6.
