Environmental Advantage

Environmental Advantage, Inc. 3636 N. Buffalo Road Orchard Park, New York 14127
Industrial Compliance, Hazardous Materials Management, Site Assessment/Remediation

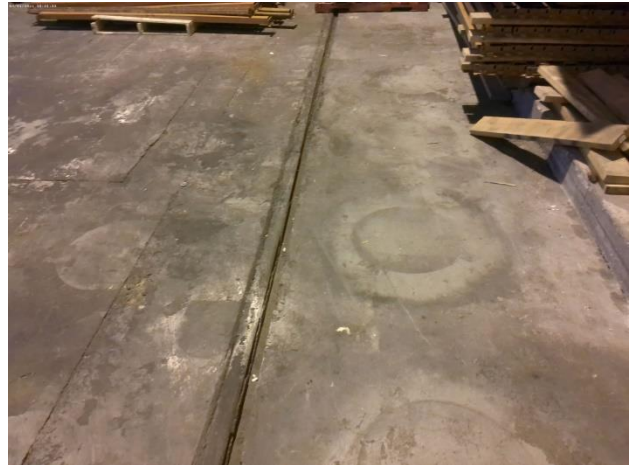
22. Sections of rail tracks transect the interior of the structure. There is staining throughout the area.

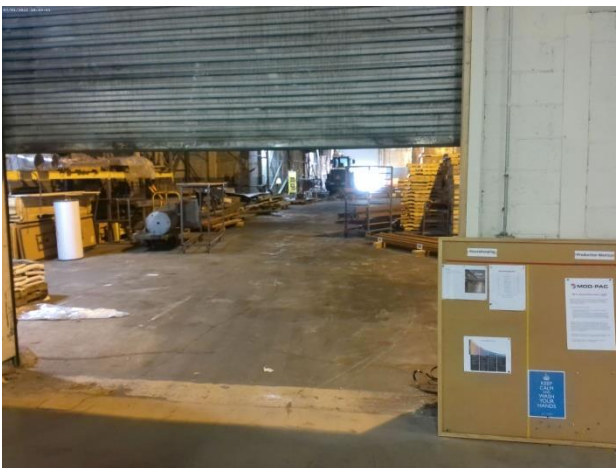
23. View of overhead door leading off-site along the northern wall of the structure looking south.

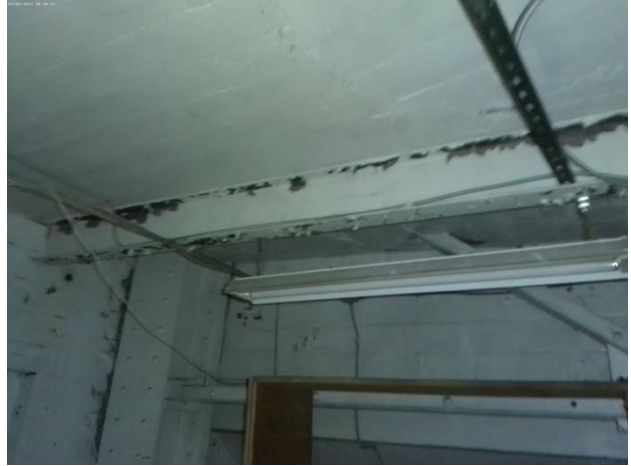
26. Extensive peeling and chipping paint was observed within the office/break room.

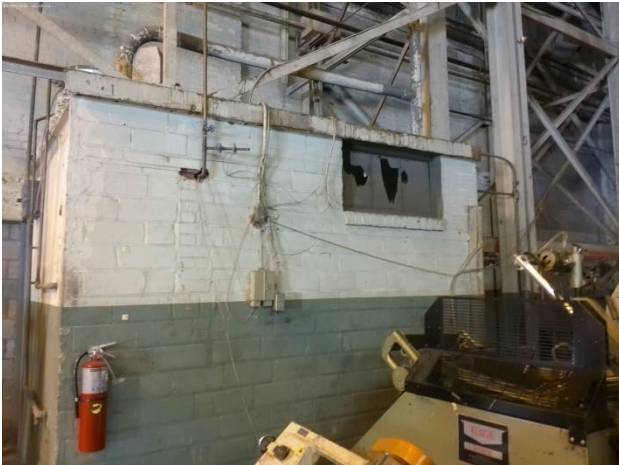
27. Exterior of the bathroom along the western interior of the structure.

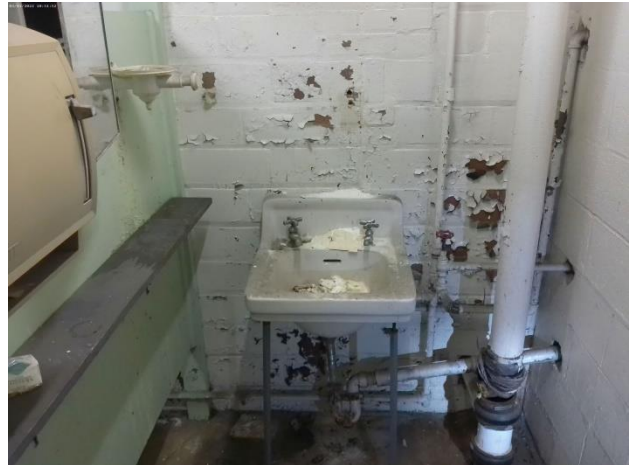
28. Extensive peeling and chipping paint was observed within the bathroom.

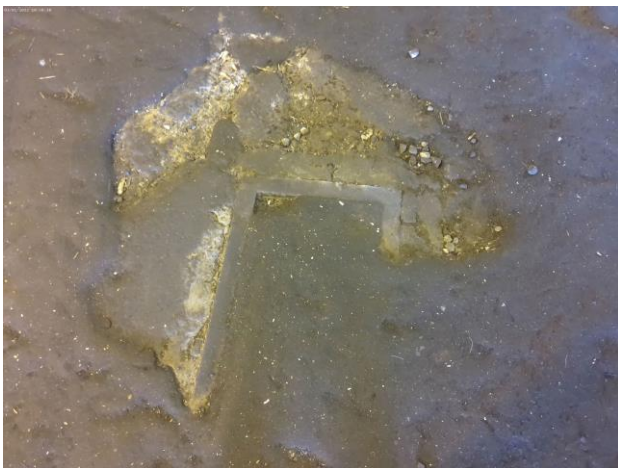
35. Steel supports cut flush to the floor were observed throughout the interior of the structure.

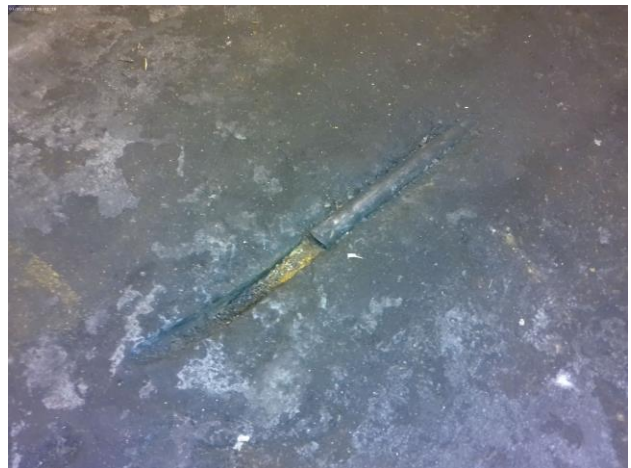
36. View of an exposed utility pipe in the floor of the structure near the north wall.

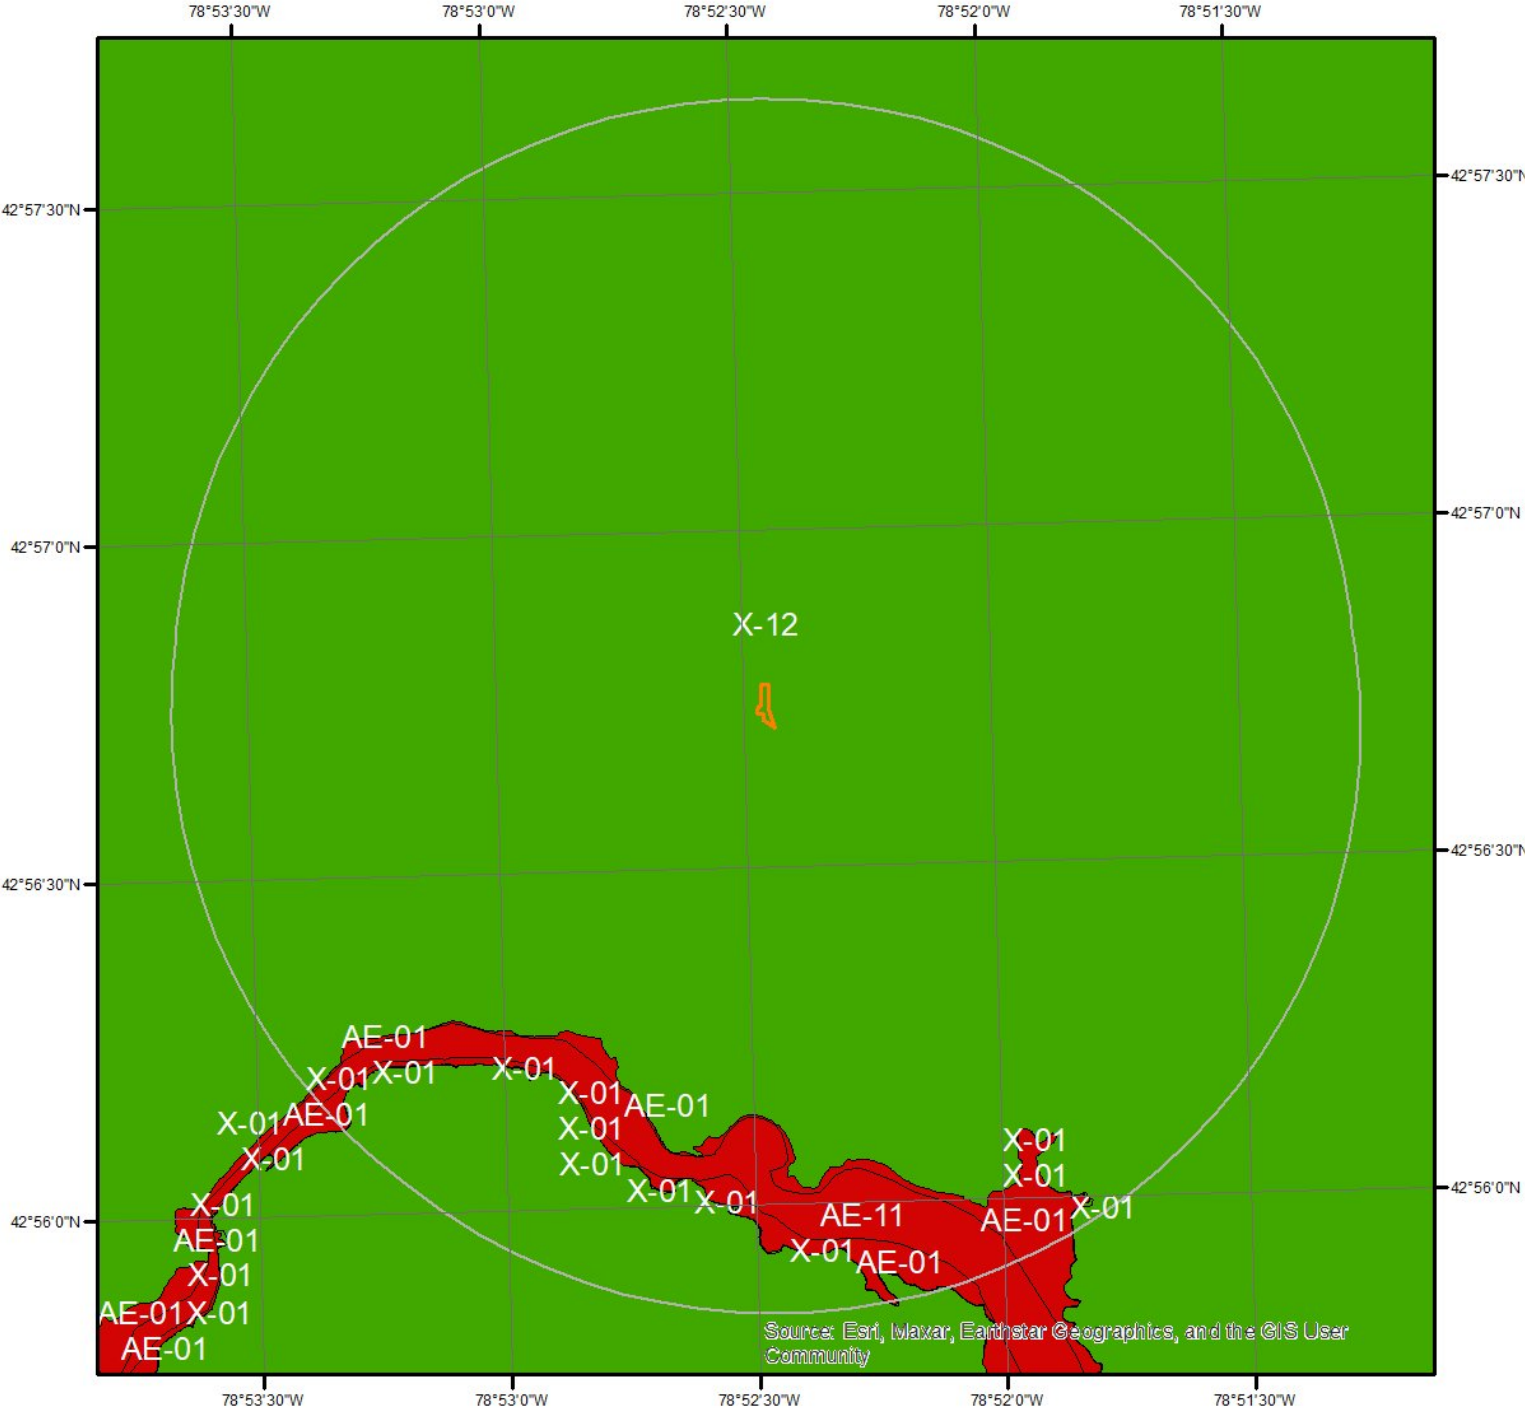
Hydrologic Information
