# FINAL REPORT PHASE I ENVIRONMENTAL SITE ASSESSMENT

## 4435 – 4445 MILITARY ROAD PAUL GRENGA PROPERTY

Town of Niagara, NY 14305

Re: Final Report - Phase I Environmental Site Assessment Paul Grenga Property, 4435-4445 Military Rd, Town of Niagara, NY 14305

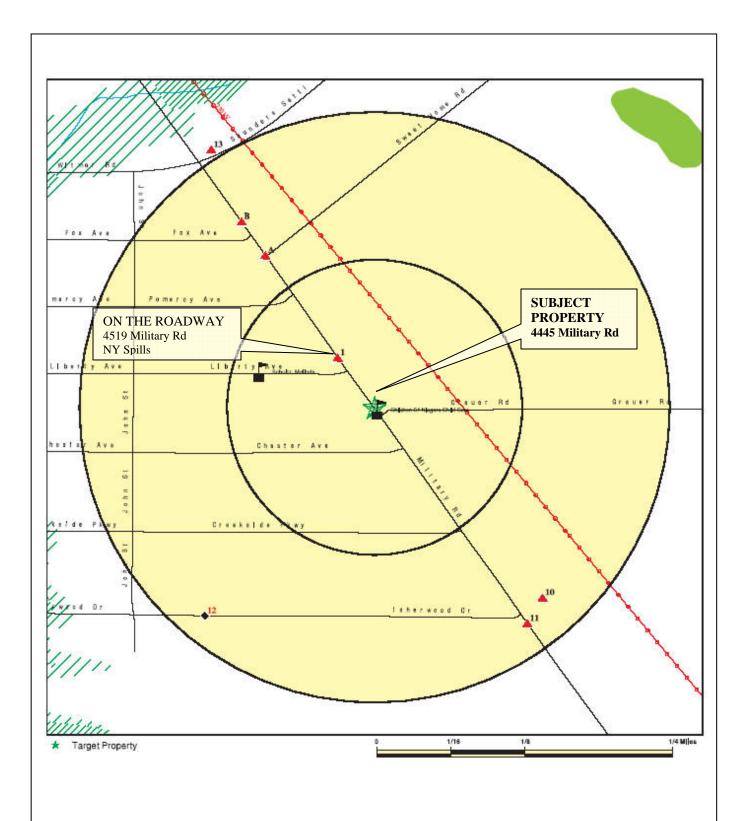
FIGURE 3

RECOGNIZED ENVIRONMENTAL CONDITIONS 4445 Military Rd, Town of Niagara, NY

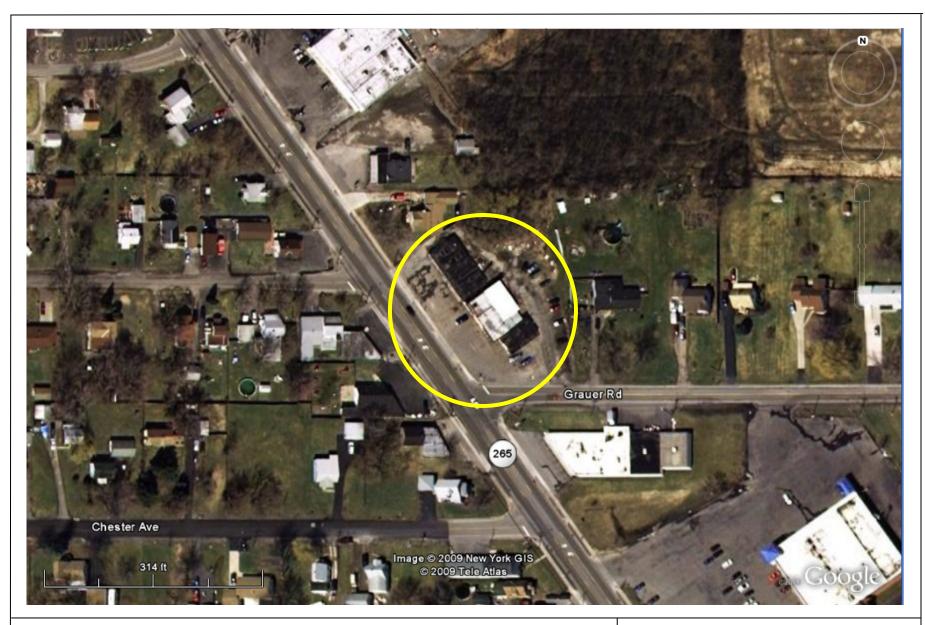
FIGURE 6

4435-4445 Military Road, Town of Niagara, NY 14305 AERIAL PHOTO

IEG conducted a reconnaissance of the Site on August 10, 2009 to identify potential recognized environmental conditions in connection with the Site. A layout of the Site and surrounding properties is attached as Figure 2. Selected photographs taken during the Site reconnaissance are included as Appendix A. An aerial photo showing buildings on the property is included in Appendix H.
