Remedial Investigation Work Plan

Building #42
2001 and 2011 Main Street
Niagara Falls, New York 14305

LaBella Project No. 2201378.02

August 20, 2020

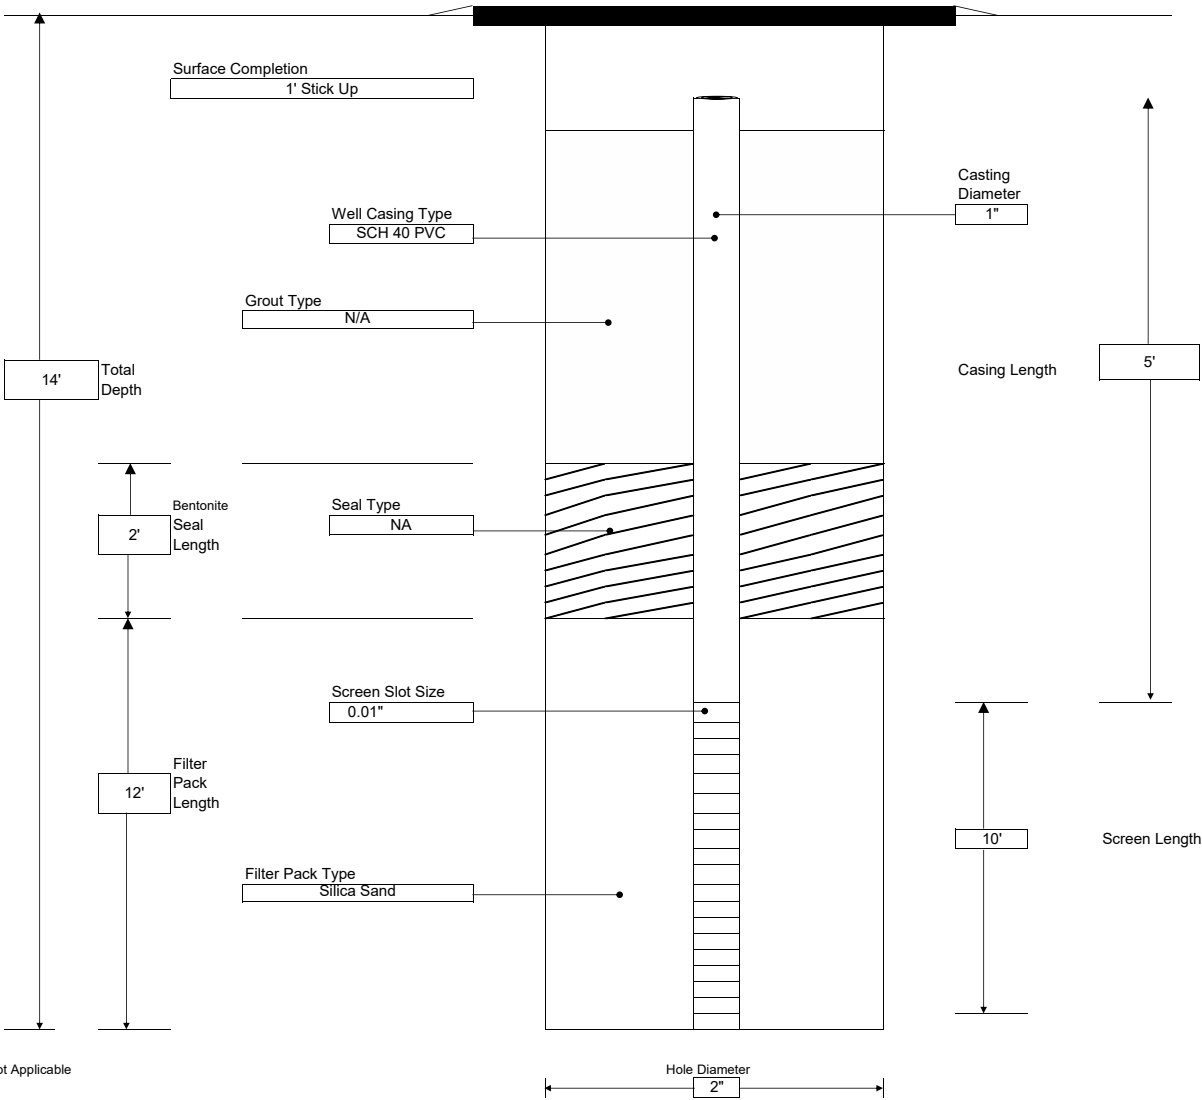
Surface Completion
1' Stick Up

Well Casing Type
SCH 40 PVC
