**Environmental Restoration
Record of Decision
Willsboro Black Ash Pond Site
Willsboro, Essex County, New York
Site Number E516009**

March 2007

DECLARATION STATEMENT ENVIRONMENTAL RESTORATION RECORD OF DECISION

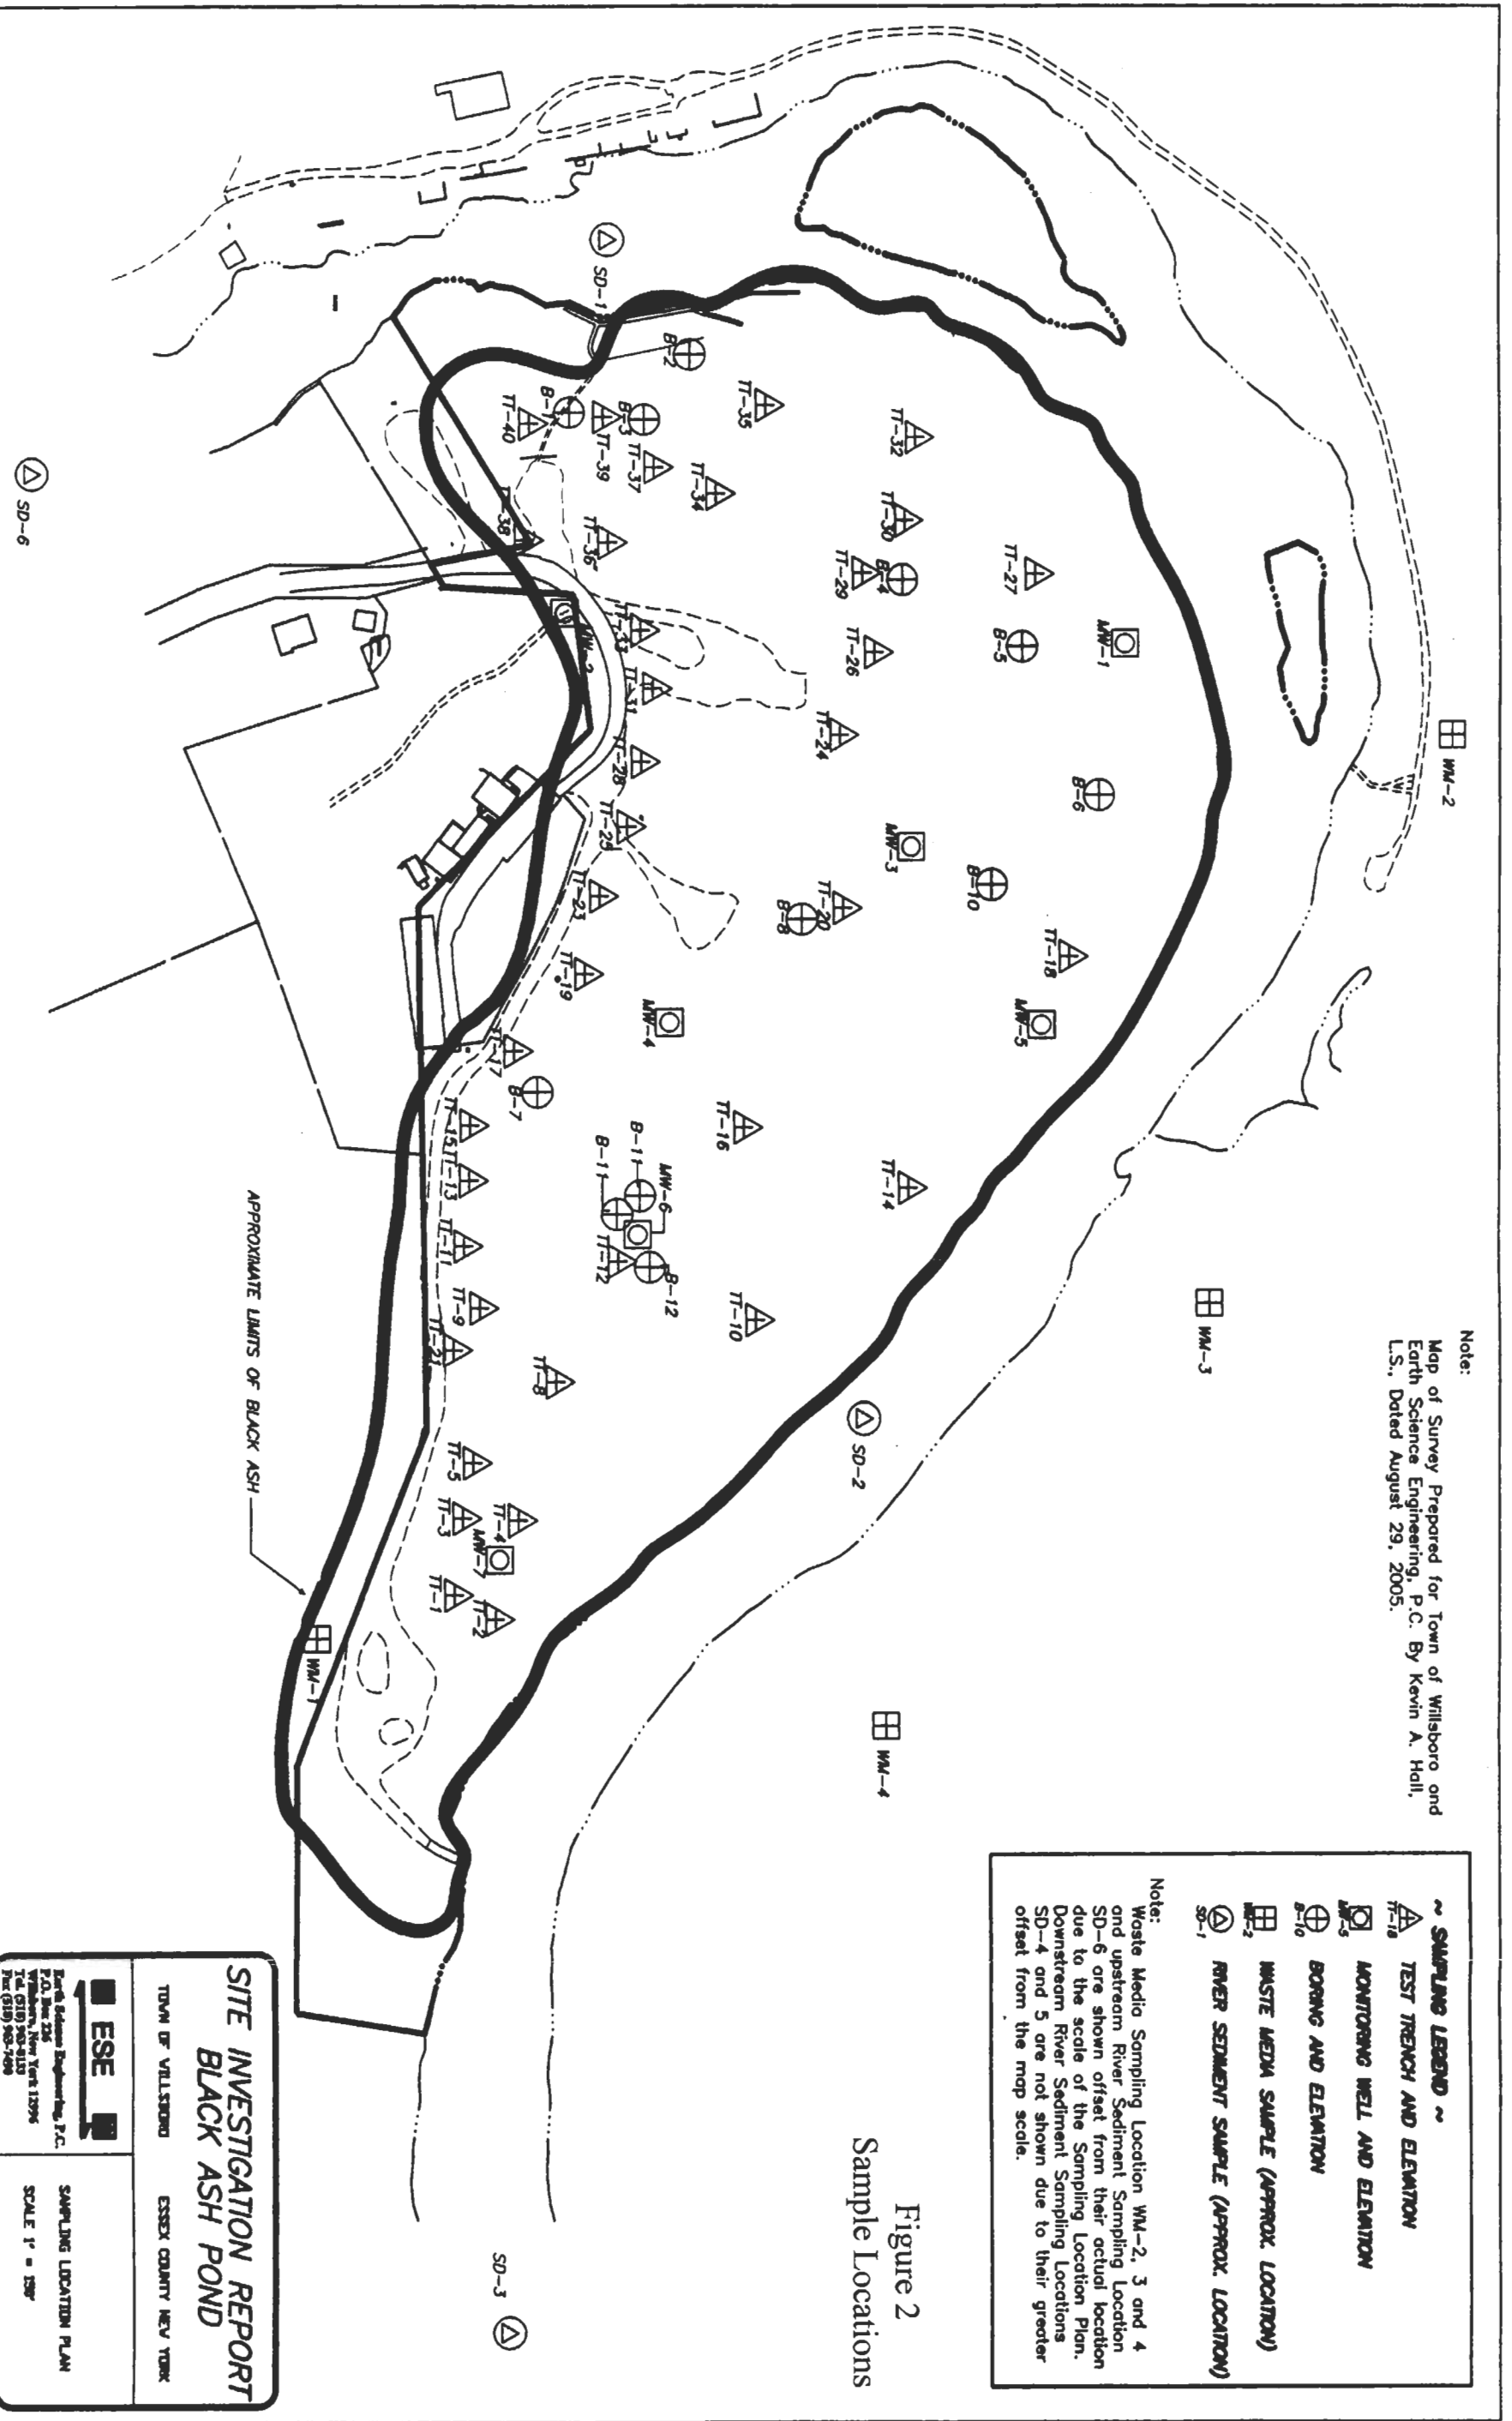
Note:
 Waste Media Sampling Location WM-2, 3 and 4
 and upstream River Sediment Sampling Location
 SD-6 are shown offset from their actual location
 due to the scale of the Sampling Location Plan.
 Downstream River Sediment Sampling Locations
 SD-4 and 5 are not shown due to their greater
 offset from the map scale.

Figure 2
 Sample Locations

The Site Investigation included a review of existing information and interviews with numerous residents of the area. Subsurface test trenches were completed within the site to identify areas of environmental concern. Soil borings were completed to define the vertical limits of the black ash and or sludge material. Samples of the waste were collected for laboratory analysis. A number of borings were completed as groundwater monitoring wells to assess potential impacts to the shallow groundwater. Sediment samples were collected from the Boquet River to assess potential impacts from the black ash. Test trench, monitoring well, and sample locations are presented on Figure 2.

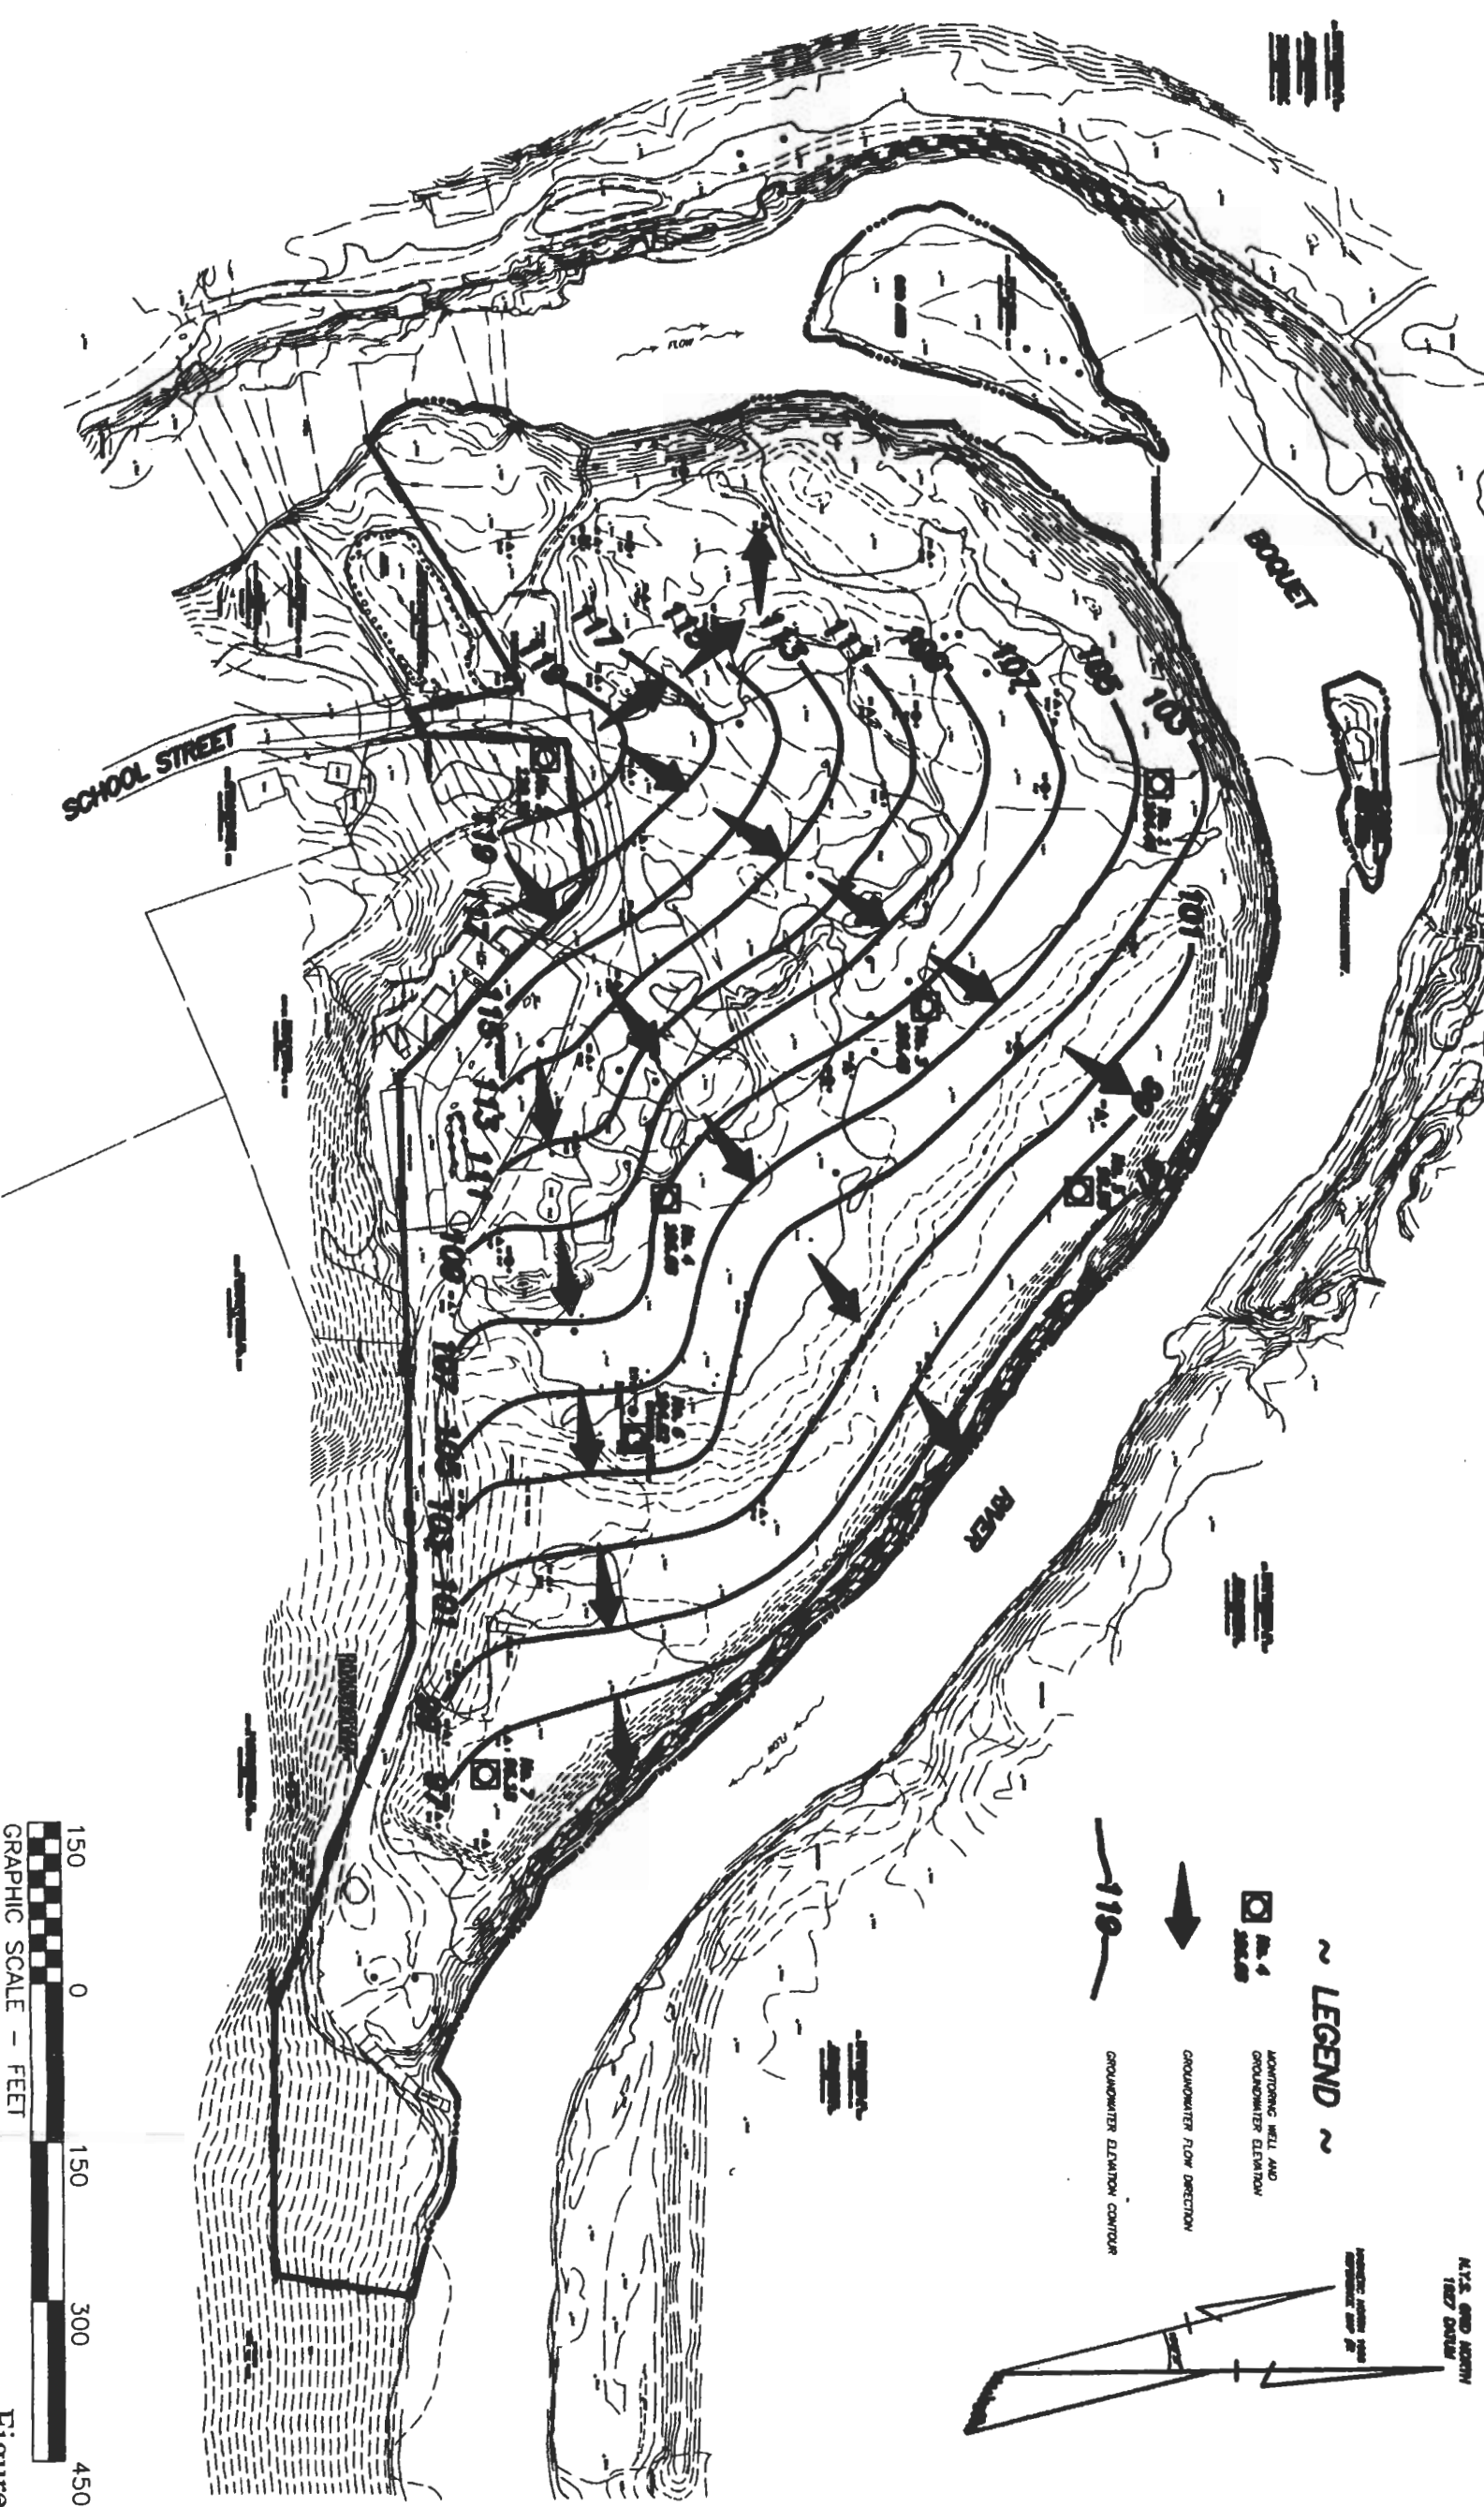
Figure 3
Groundwater Flow Direction

Within the 25 acres of the site, water was found in the monitoring wells at various depths ranging from 7 to 16 feet. In general, the flow of groundwater in the vicinity of the site is from the higher elevations south of the site toward the Boquet River. See Figure 3.

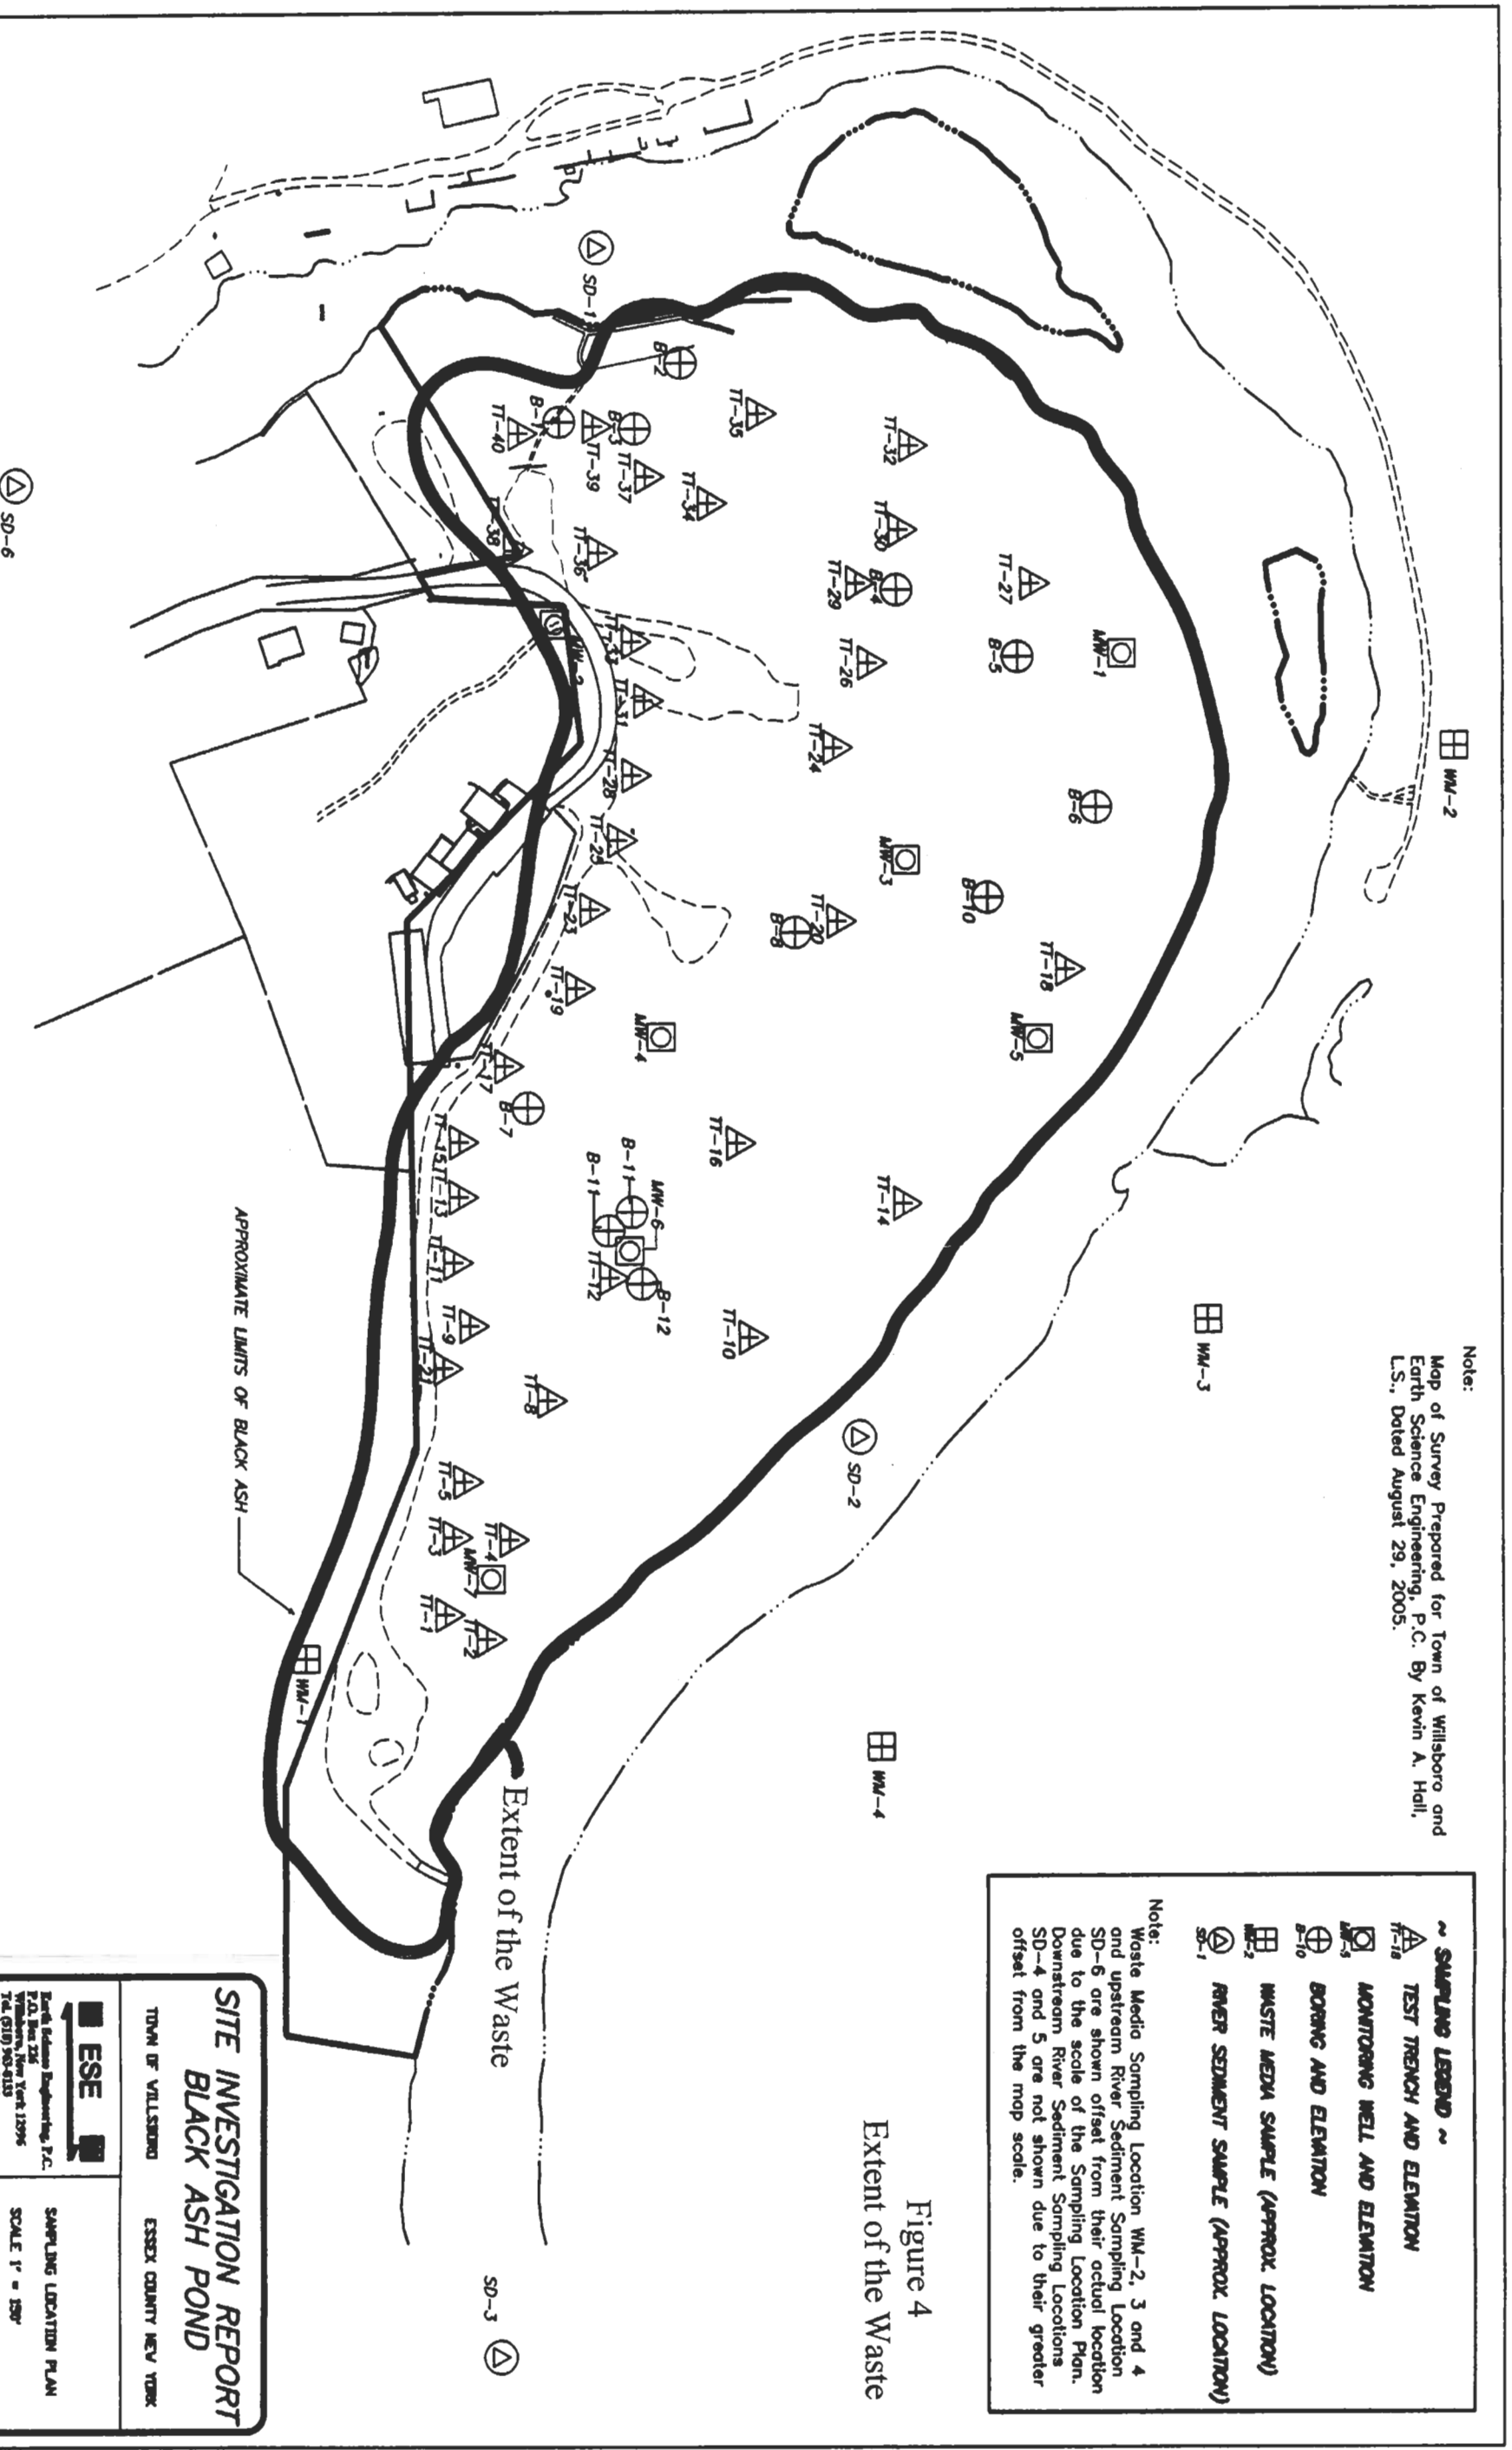
Figure 4
 Extent of the Waste

Figure 4 shows the extent of the black ash waste on the property. The waste contains levels of metals which exceed the clean up goals established in TAGM 4046. For metals, the clean up goal is often established as equivalent to site background levels. The following are the media which were investigated and a summary of the findings of the investigation.

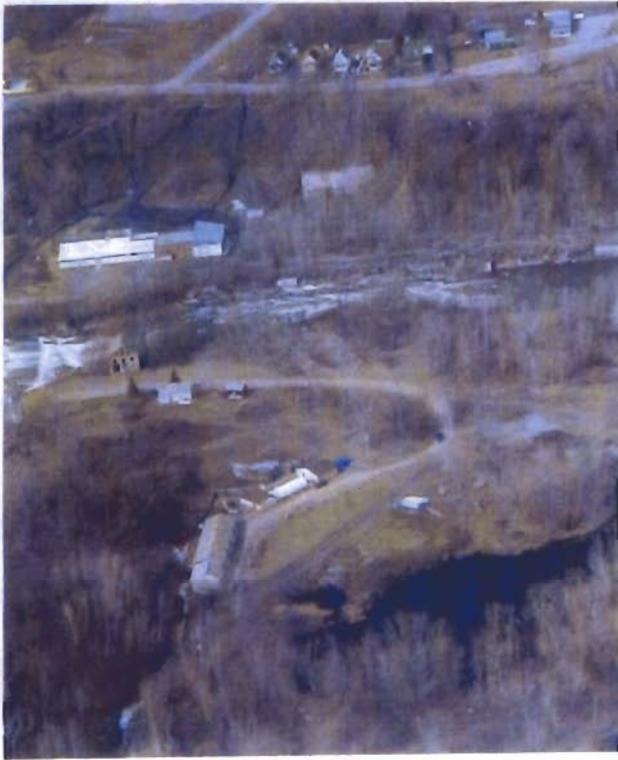
Black Ash Pond, looking west

As described in the SI report, many soil, groundwater and sediment samples were collected to characterize the nature and extent of contamination. Images of the Black Ash Pond site can be found on Photo Page 1. A photo of the ash exposed to the River can be found on Photo Page 2. The main categories of contaminants that exceed their SCGs are inorganics (metals). For comparison purposes, where applicable, SCGs are provided for each medium.

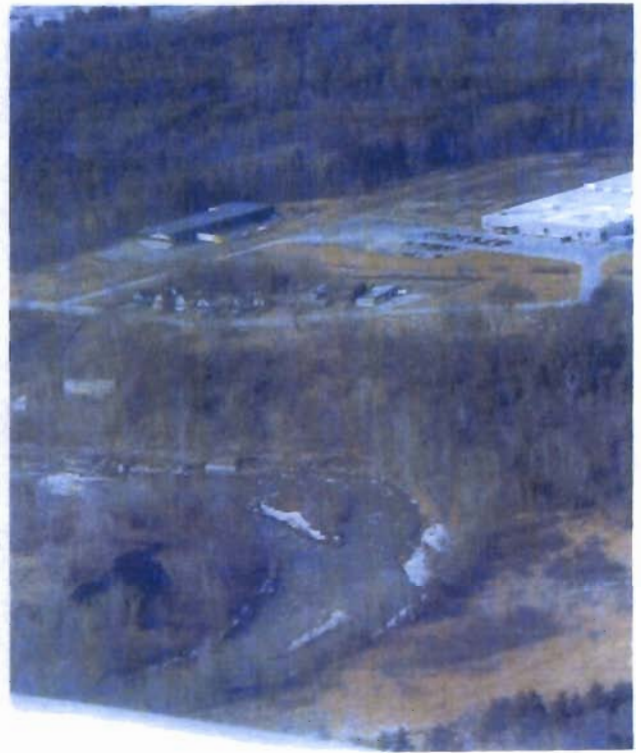
Black Ash Pond and Sludge Lagoon, looking west

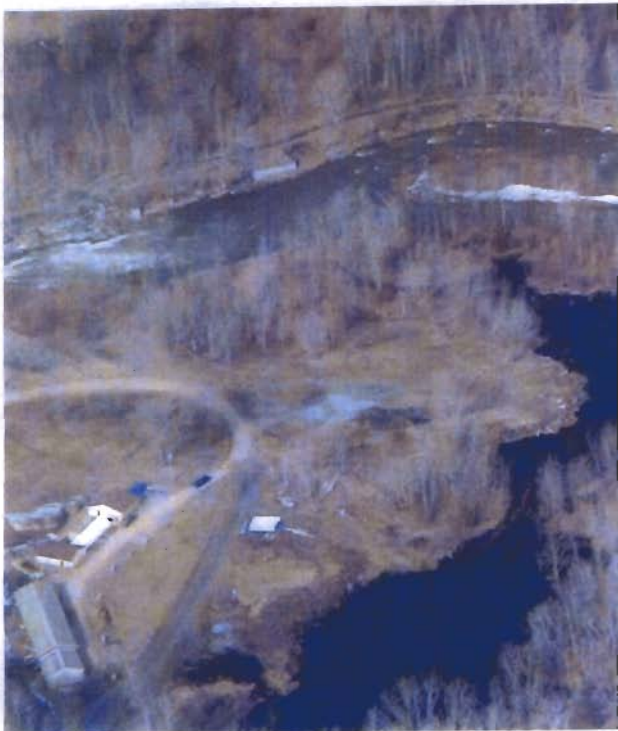
Town Waste Water Treatment Plant with Black Ash Pond in foreground

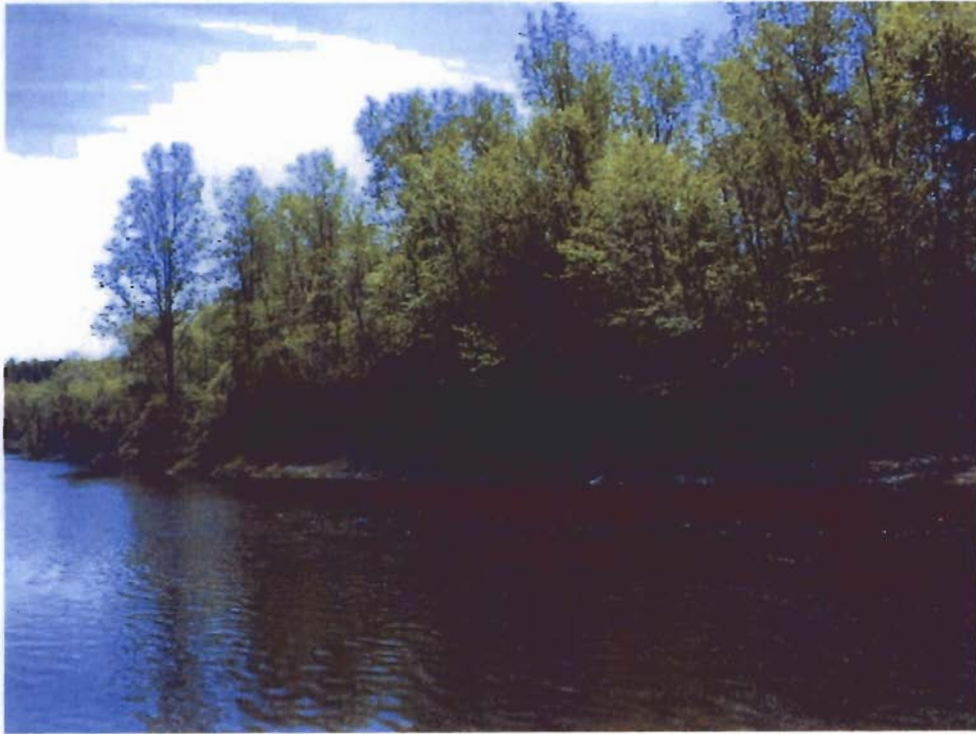
View from the river of the eroded bank

The wastes disposed of within the former black ash lagoon can be characterized as metal contaminated industrial wastes. The berm which used to separate the wastes from the river has deteriorated and no longer functions to contain the waste mass. The black ash is directly exposed to the river and erosion of the material is impacting the river. The extremely fine grained nature of the waste makes it readily subject to transport and erosion.

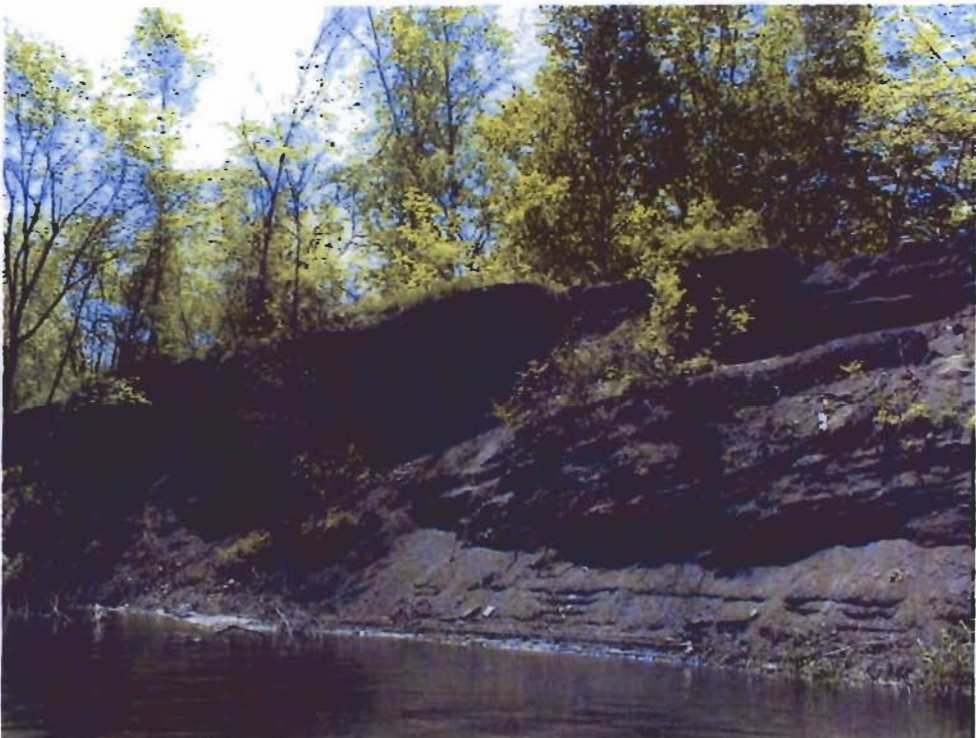
Black ash collapsing into the river

The black ash pond area was used as a deposition area for spent black liquor used in the making of paper pulp. The black liquor was a combination of soda ash, chemical lime, wood fiber and soft coal. The black ash is the residue of spent black liquor combustion dumped in a basin area approximately 900 ft long and 400 ft wide. The waste accumulated to a depth of up to 16 feet within the basin during the years of paper mill operation. Over time, the dike constructed to retain the waste has eroded away in some locations exposing the ash to the river. The ash is eroding directly into the river.
