# RECORD OF DECISION

Utica St. / Hamilton  
Environmental Restoration Project  
Hamilton, Madison County  
Site No. E727011  
March 2014

Prepared by  
Division of Environmental Remediation  
New York State Department of Environmental Conservation

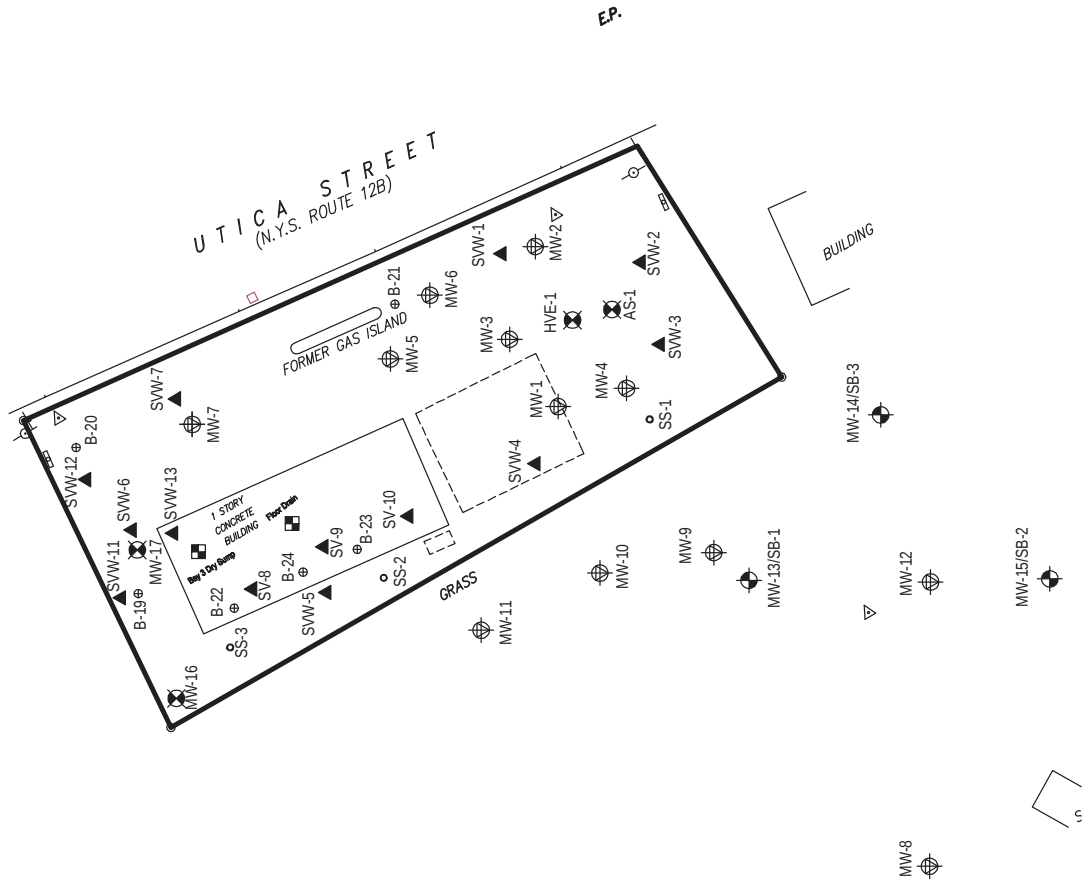
- GROUNDWATER MONITORING WELL (2006)
- GROUNDWATER MONITORING WELL (2002)
- SOIL VAPOR MONITORING WELL (2006)
- SOIL BORING (2006)
- SURFACE SOIL SAMPLE (2006)
- FLOOR DRAIN AND DRY SUMP SAMPLE
- LOCATION OF FORMER USTs (APPROXIMATE)
- SITE BOUNDARY (APPROXIMATE)

Wastes are defined in 6 NYCRR Part 375-1.2(aw) and include solid, industrial and/or hazardous wastes. Source areas are defined in 6 NYCRR Part 375(au). Source areas are areas of concern at a site where substantial quantities of contaminants are found which can migrate and release significant levels of contaminants to another environmental medium. Wastes and source areas were identified at the site include a gasoline underground storage tank (UST), a waste oil tank (UST), the former gasoline pump island as well as areas inside the repair shop such as the service bays. Please refer to Figure 2 for reference.

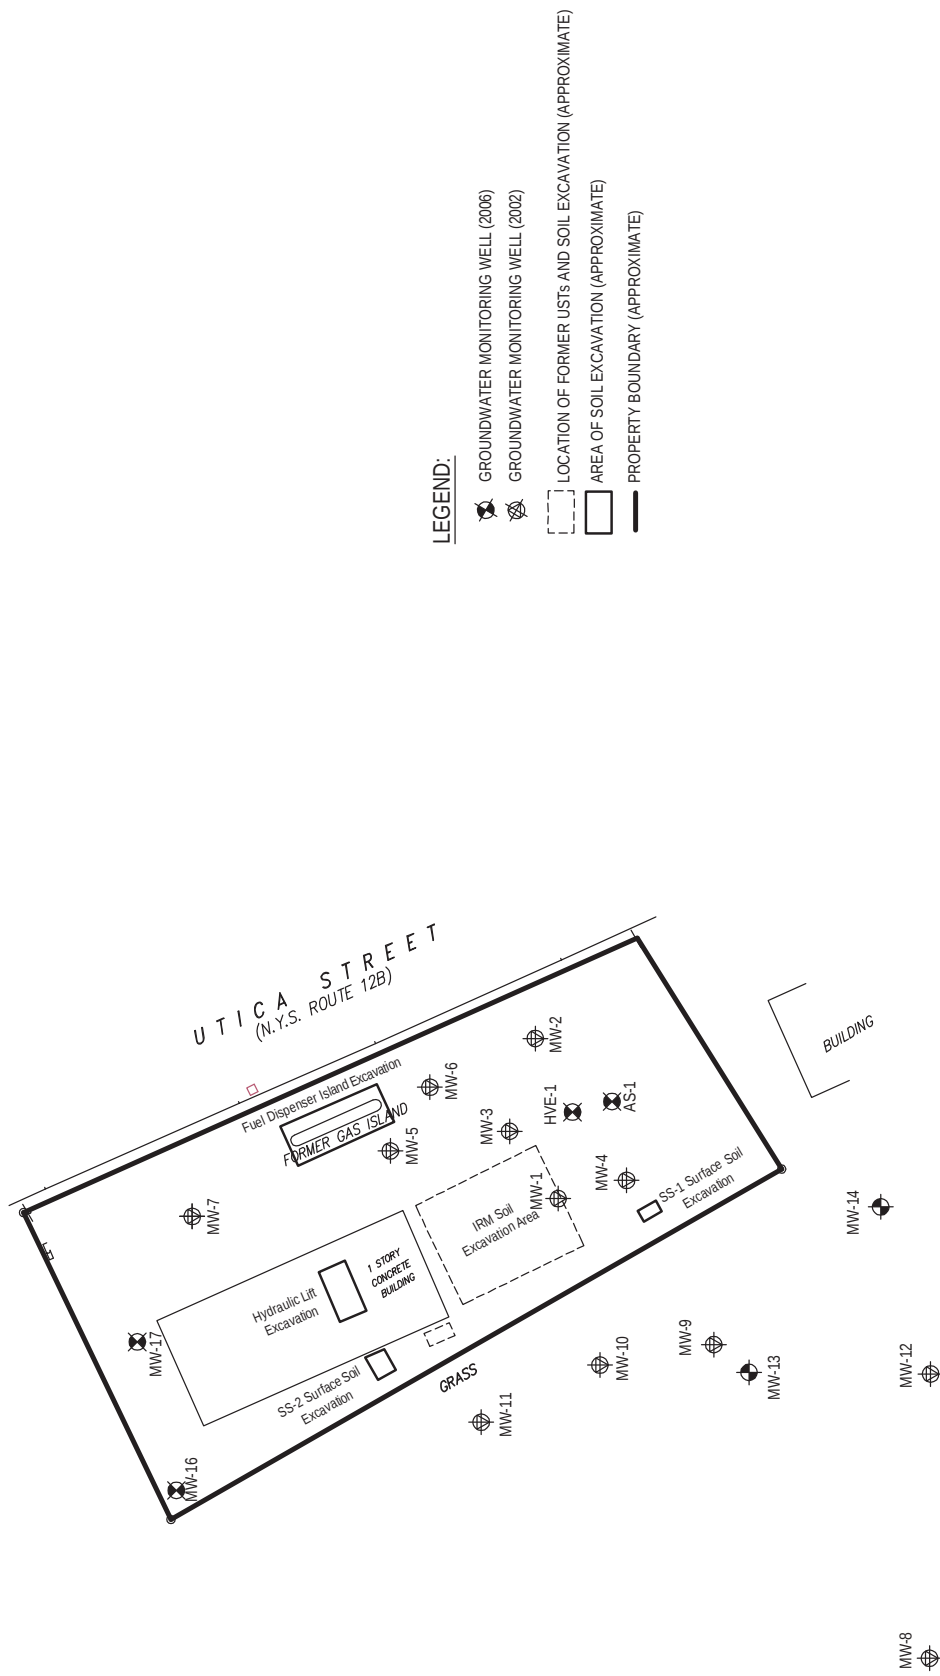
- GROUNDWATER MONITORING WELL (2006)
- GROUNDWATER MONITORING WELL (2002)
- LOCATION OF FORMER USTs AND SOIL EXCAVATION (APPROXIMATE)
- AREA OF SOIL EXCAVATION (APPROXIMATE)
- PROPERTY BOUNDARY (APPROXIMATE)

Approximately 60 tons of visibly contaminated soil and debris were excavated and properly disposed off-site; two underground storage tanks (a 550 gallon petroleum and a 275 gallon waste oil tank) were removed; and a 275 gallon fuel oil above ground storage tank; a hydraulic lift and its hydraulic fluid contents, a gasoline pump island; debris from two floor sumps inside the repair garage bays, surface soil from two discrete areas outside the site's building, nine 55 gallon drums of various petroleum waste, and petroleum contaminated debris were also removed.

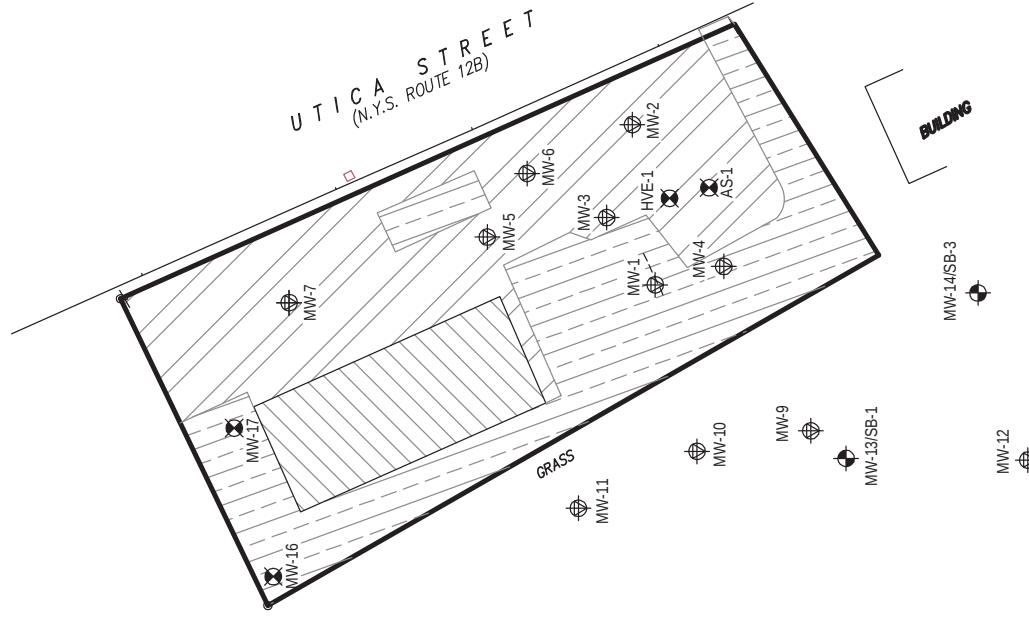
- GROUNDWATER MONITORING WELL (2006)
- GROUNDWATER MONITORING WELL (2002)
- LOCATION OF SOIL/GRANULAR FILL COVER (APPROXIMATE)
- LOCATION OF PAVEMENT (APPROXIMATE)
- LOCATION OF BUILDING SLAB (APPROXIMATE)
- PROPERTY BOUNDARY (APPROXIMATE)

1. A site cover currently exists and will be maintained to allow for commercial use of the site. Any site redevelopment will maintain a site cover, which may consist either of the structures such as buildings, pavement, sidewalks comprising the site development or a soil cover in areas where the upper one foot of exposed surface soil will exceed the applicable soil cleanup objectives (SCOs). Where a soil cover is required it will be a minimum of one foot of soil, meeting the SCOs for cover material as set forth in 6 NYCRR Part 375-6.7(d) for commercial use. The soil cover will be placed over a demarcation layer, with the upper six inches of the soil of sufficient quality to maintain a vegetation layer. Any fill material brought to the site will meet the requirements for the identified site use as set forth in 6 NYCRR Part 375-6.7(d).
