Subject: NYSDEC Site #E828144 - Andrews St 11/12/10 through 11/15/10 demolition progress **Attachments:** Figure 3, Andrews St NYSDEC Site # E828144, Demolition Progress 11-11-10 thorugh 11-15-10.pdf; 11-12-10 P 008.jpg; 11-12-10 P 001.jpg; 11-12-10 P 004.jpg; 11-15-10 P 010.jpg; 11-15-10 P 005.jpg

Subject: NYSDEC Site #E828144 - Andrews St 11/16/10 demolition progress

DAY ENVIRONMENTAL, INC.DAILY SITE OBSERVATION REPORT

CLIENT: City of Rochester		DATE: 11/10/10
PROJECT: Andrews St At-Grade/Sub-Grade Demolition (DA	NYSDEC SITE #: E828144	
LOCATION: 300, 304-308, 320 Andrews Street, 25 Evans Street	rk	
ON-SITE AT: 700		
CONTRACTOR(S): GFrederico

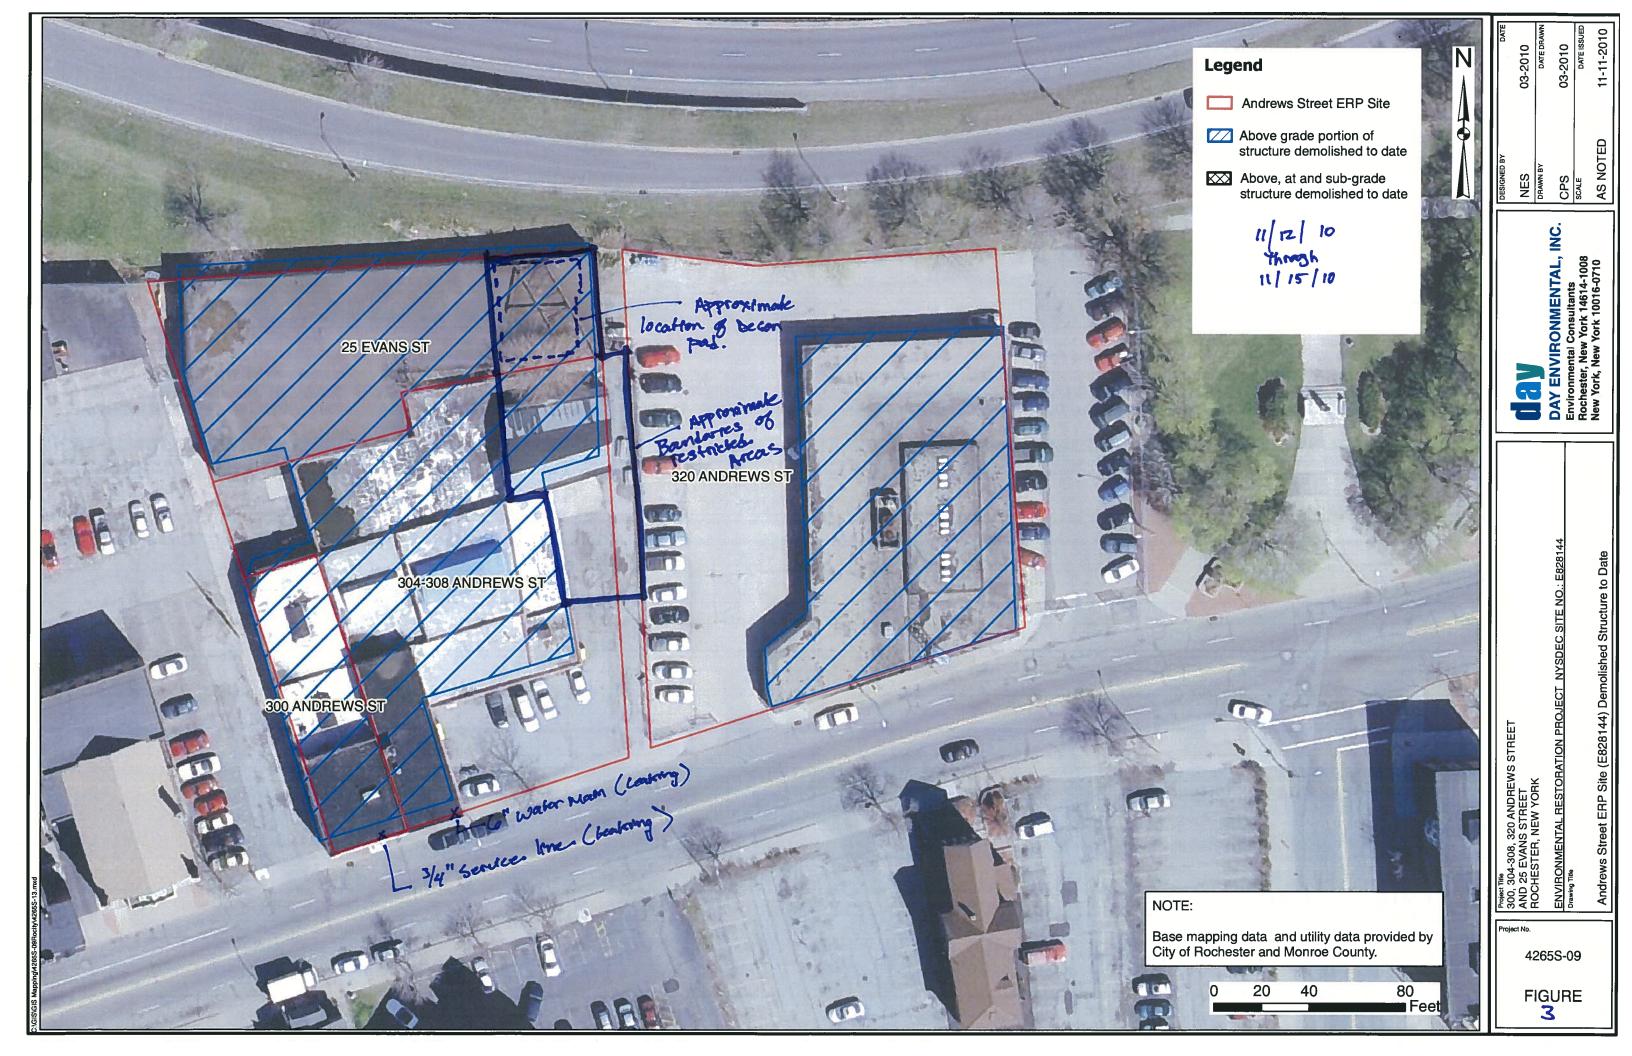
The above grade demolition continued on 11/12/10 and 11/13/10 at the 300, 304-308 and 320 Andrews Street and 25 Evans Street Site. Actives completed included site cleanup measures and the construction of the decon pad. Refer to the attached photos Figure 3.

At-grade and below grade demolition work was not conducted on 11/15/10 due to a leaking 6-inch diameter water main within the southern basement wall of the 304-308 Andrews Street building. In addition, a 3/4-inch service line within the southern basement wall of the 300 Andrews Street building is also leaking but at a much lower rate than the 6-inch water main. The water observed leaking into both 300 and 304-308 Andrews Street parcels is water from the municipal water system located in Andrews Street. Refer to the attached photos and Figure 3 for approximate locations of the 6-inch water main, the 3/4-inch service line and accumulated water within the basement of the 304-308 Andrews Street building. Following a discussion with Sean Keenan (753-7658) with the Monroe County Division of Pure Waters, it was determined that the accumulated water could be pumped from the basement to the combined sewer system without analytical laboratory testing results. Once the water lines have been addressed and are no longer leaking into the basements, the accumulated water will be discharged to the combined sewer system and the at-grade and below grade demolition work will begin at the 300 Andrews Street building. It is currently anticipated that the water main will be decommissioned on 11/16/10 and the at-grade and sub-grade demolition will begin on 11/16/10.

Accessible portions of the restricted area boundaries continue to be established in the field using spray paint. Please refer to the attached photos and Figure 3 for locations of the restricted area boundaries.

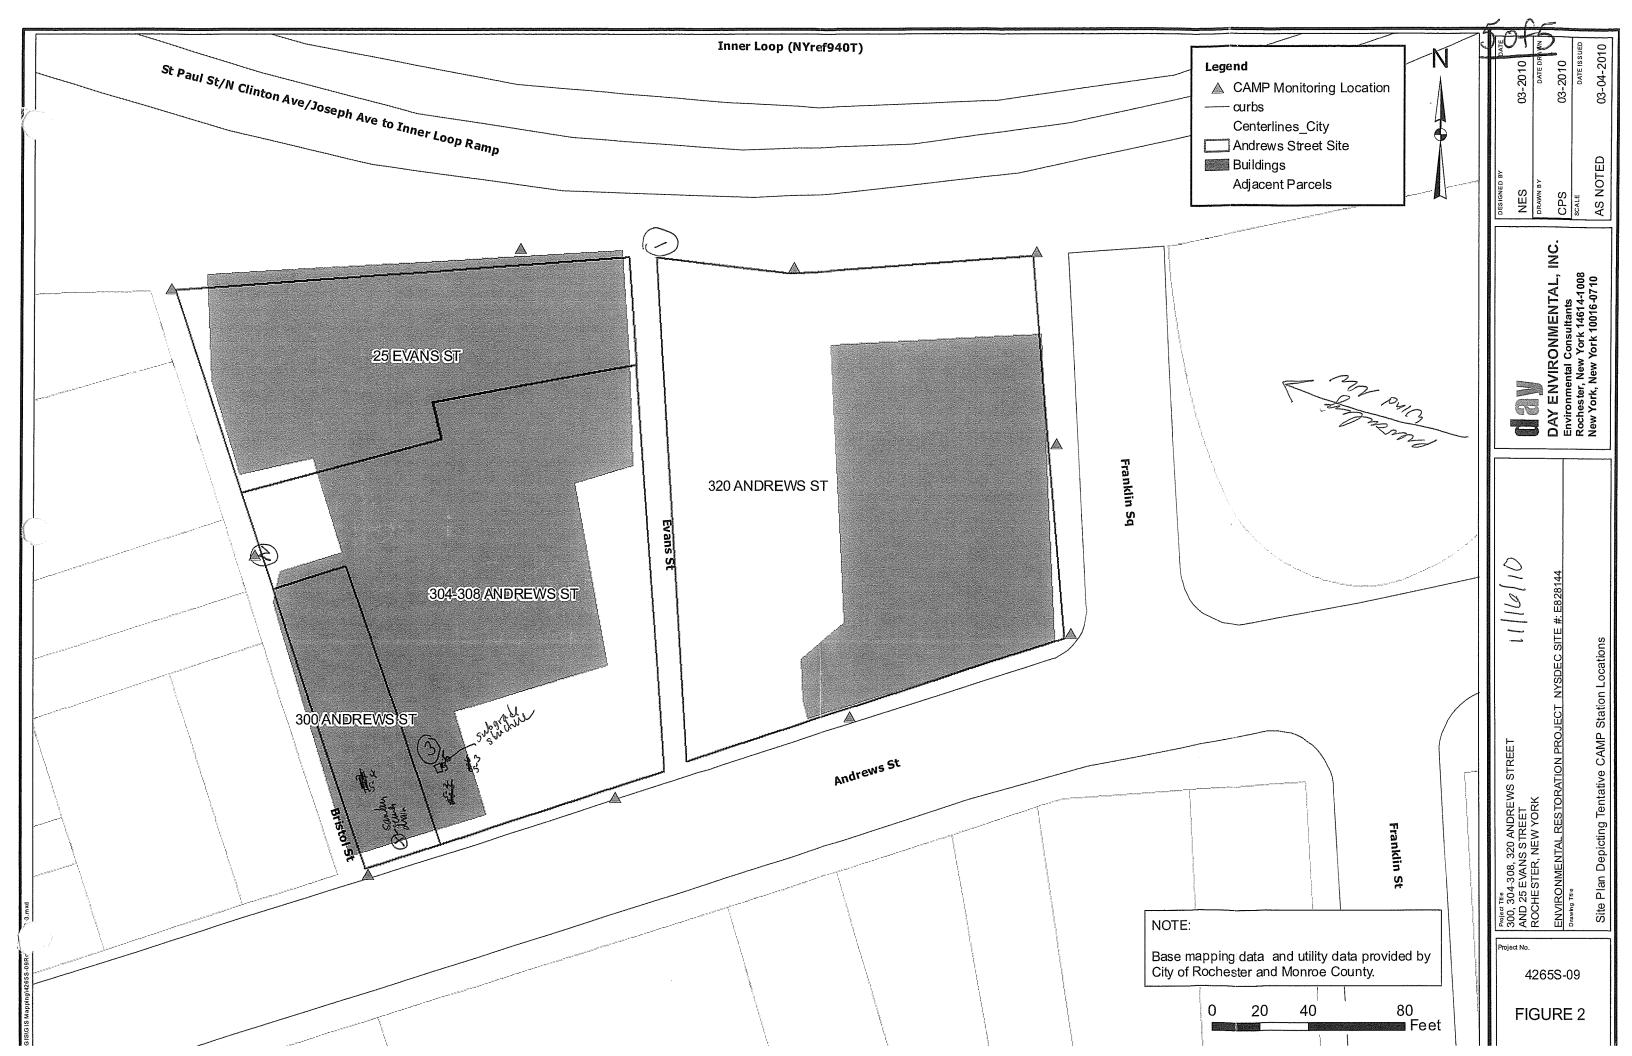
The at-grade and sub-grade demolition began on 11/16/10 at the 300, 304-308, 320 Andrews Street and 25 Evans Street Site. Initially, the water that accumulated in the basement of the 304-308 Andrews Street building from the municipal water system was discharged to the Monroe County Division of Pure Waters Sewer System. Subsequently, portions of the slab and foundation walls from the 300 and 304-308 basements were removed and screened in accordance with the "At-Grade and Sub-Grade Demolition Work Plan, 300, 304-308, 320 Andrews Street and 25 Evans Street, Rochester New York, NYSDEC Site # E828144" prepared by DAY dated October 2010. Underlying overburden soil was also screened in accordance with the Work Plan. Refer to attached photo and Figure 3 depicting the area demolished to date.

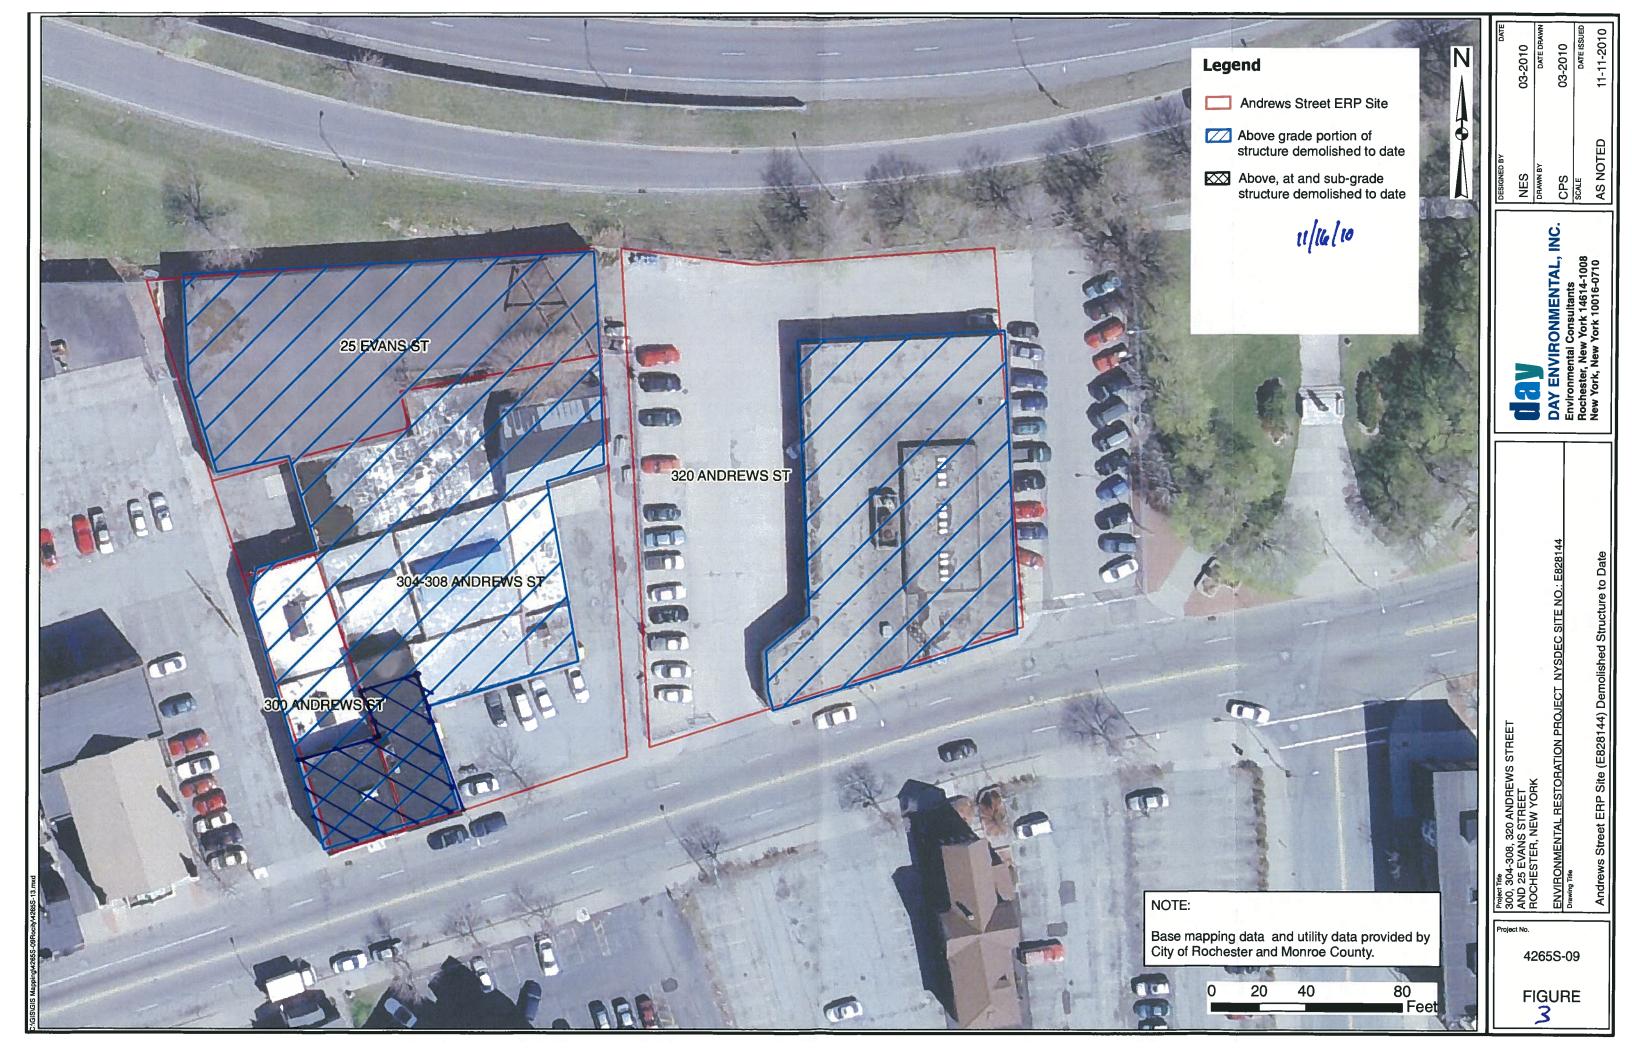
The attached pdf is DAY's daily site report for November 16, 2010. The daily site report includes the CAMP monitoring results, a daily observation report summarizing the demolition activities that were completed and a figure presenting CAMP station designations and sample locations/designations. The collected samples are anticipated to be shipped to Chemtech on 11/18/2010 and DAY or the City will be contacting the NYSDEC in the near future of its input regarding actual samples to be analyzed.

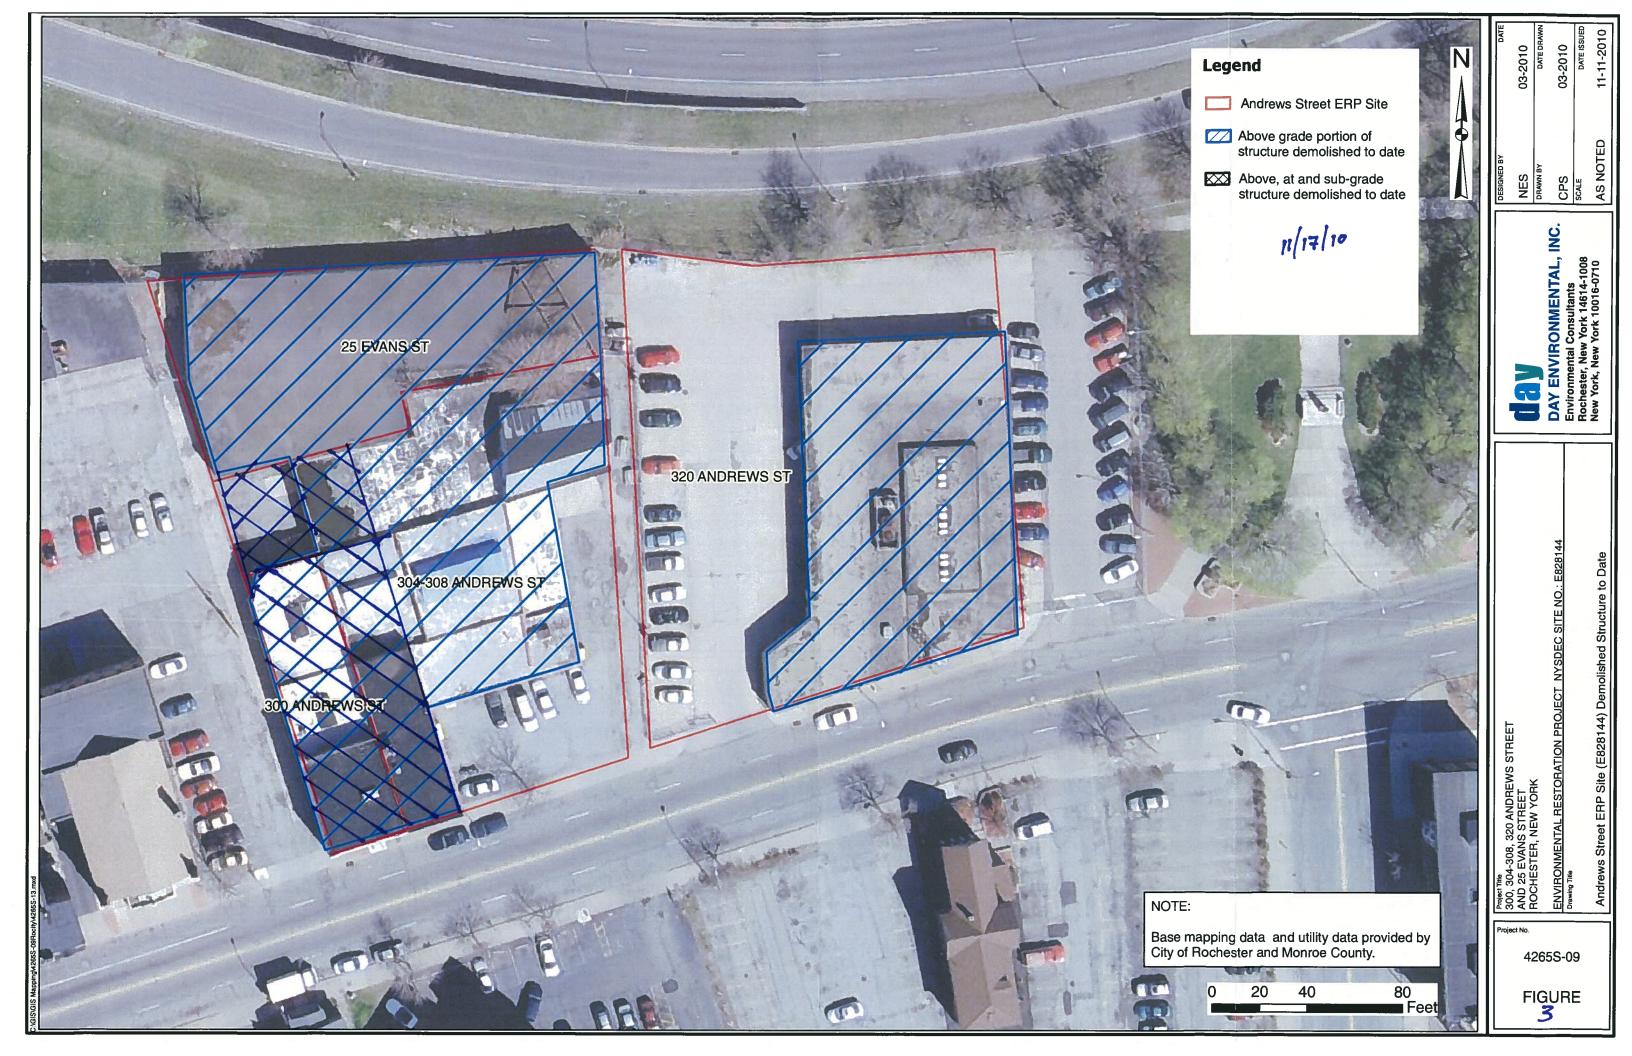
The at-grade and sub-grade demolition continued on 11/17/10, primarily removal of portions of the slab and foundation walls from the 300 and 304-308 basements. Refer to attached photo and Figure 3 and the attached photos depicting the area demolished to date.

At-grade and sub-grade demolition work will not be conducted on 11/19/2010. The contractor will be removing hard debris from the Site. At-grade and sub-grade demolition work is scheduled to resume on 11/29/10; however, this schedule is subject to change and the NYSDEC will be updated as the schedule is finalized.

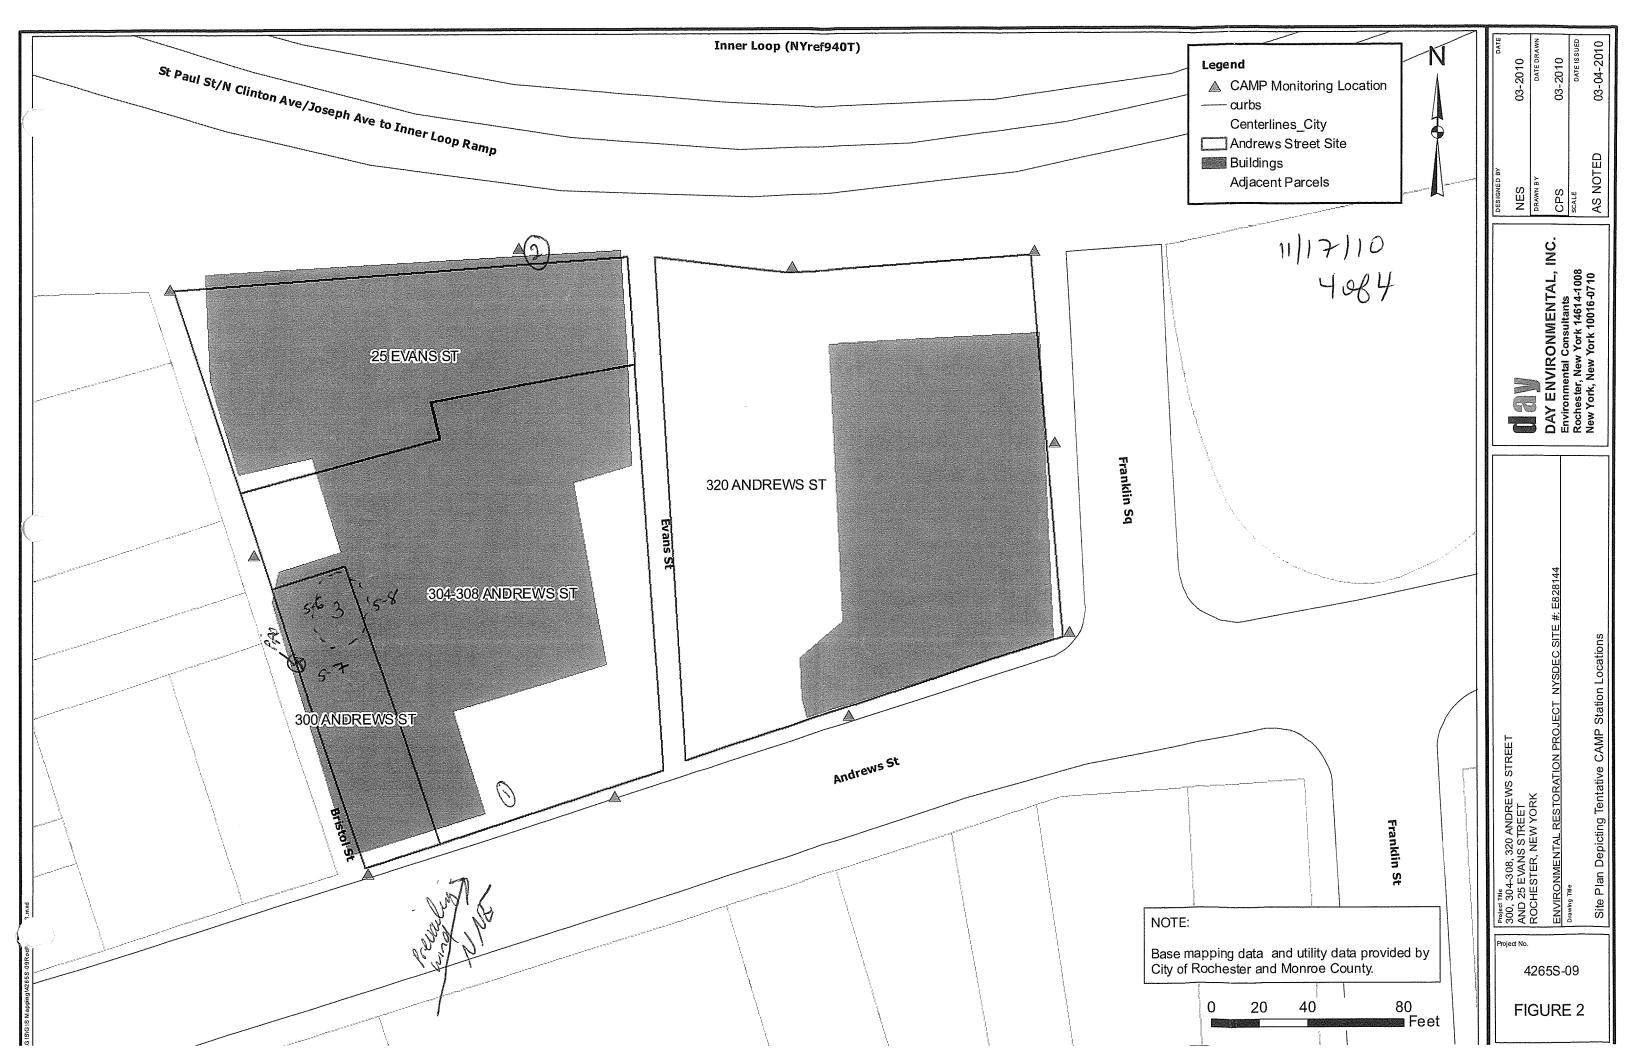
The attached pdf is DAY's daily site report for November 17, 2010. The daily site report includes the CAMP monitoring results, a daily observation report summarizing the demolition activities that were completed and a figure presenting CAMP station designations and sample locations/designations. The collected samples are anticipated to be shipped to Chemtech on 11/18/2010. DAY or the City will be contacting the NYSDEC in the near future for its input regarding actual samples to be analyzed.

The decon pad currently staged on the 25 Evans Street parcel is accumulating rain water. Prior to it's initial use, the accumulated rain water will be pumped to the ground surface.
