**Environmental Restoration  
Record of Decision  
Buffalo Lakeside Commerce Park  
Parcel 4 Site  
City of Buffalo, Erie County, New York  
Site Number E-9-15-193**

## **Buffalo Lakeside Commerce Park-Parcel 4 Environmental Restoration Site City of Buffalo, Erie County, New York Site No. E-9-15-193**

**Buffalo Lakeside Commerce Park  
Parcel 4 Site  
City of Buffalo, Erie County, New York  
Site No. E-9-15-193  
March 2009**

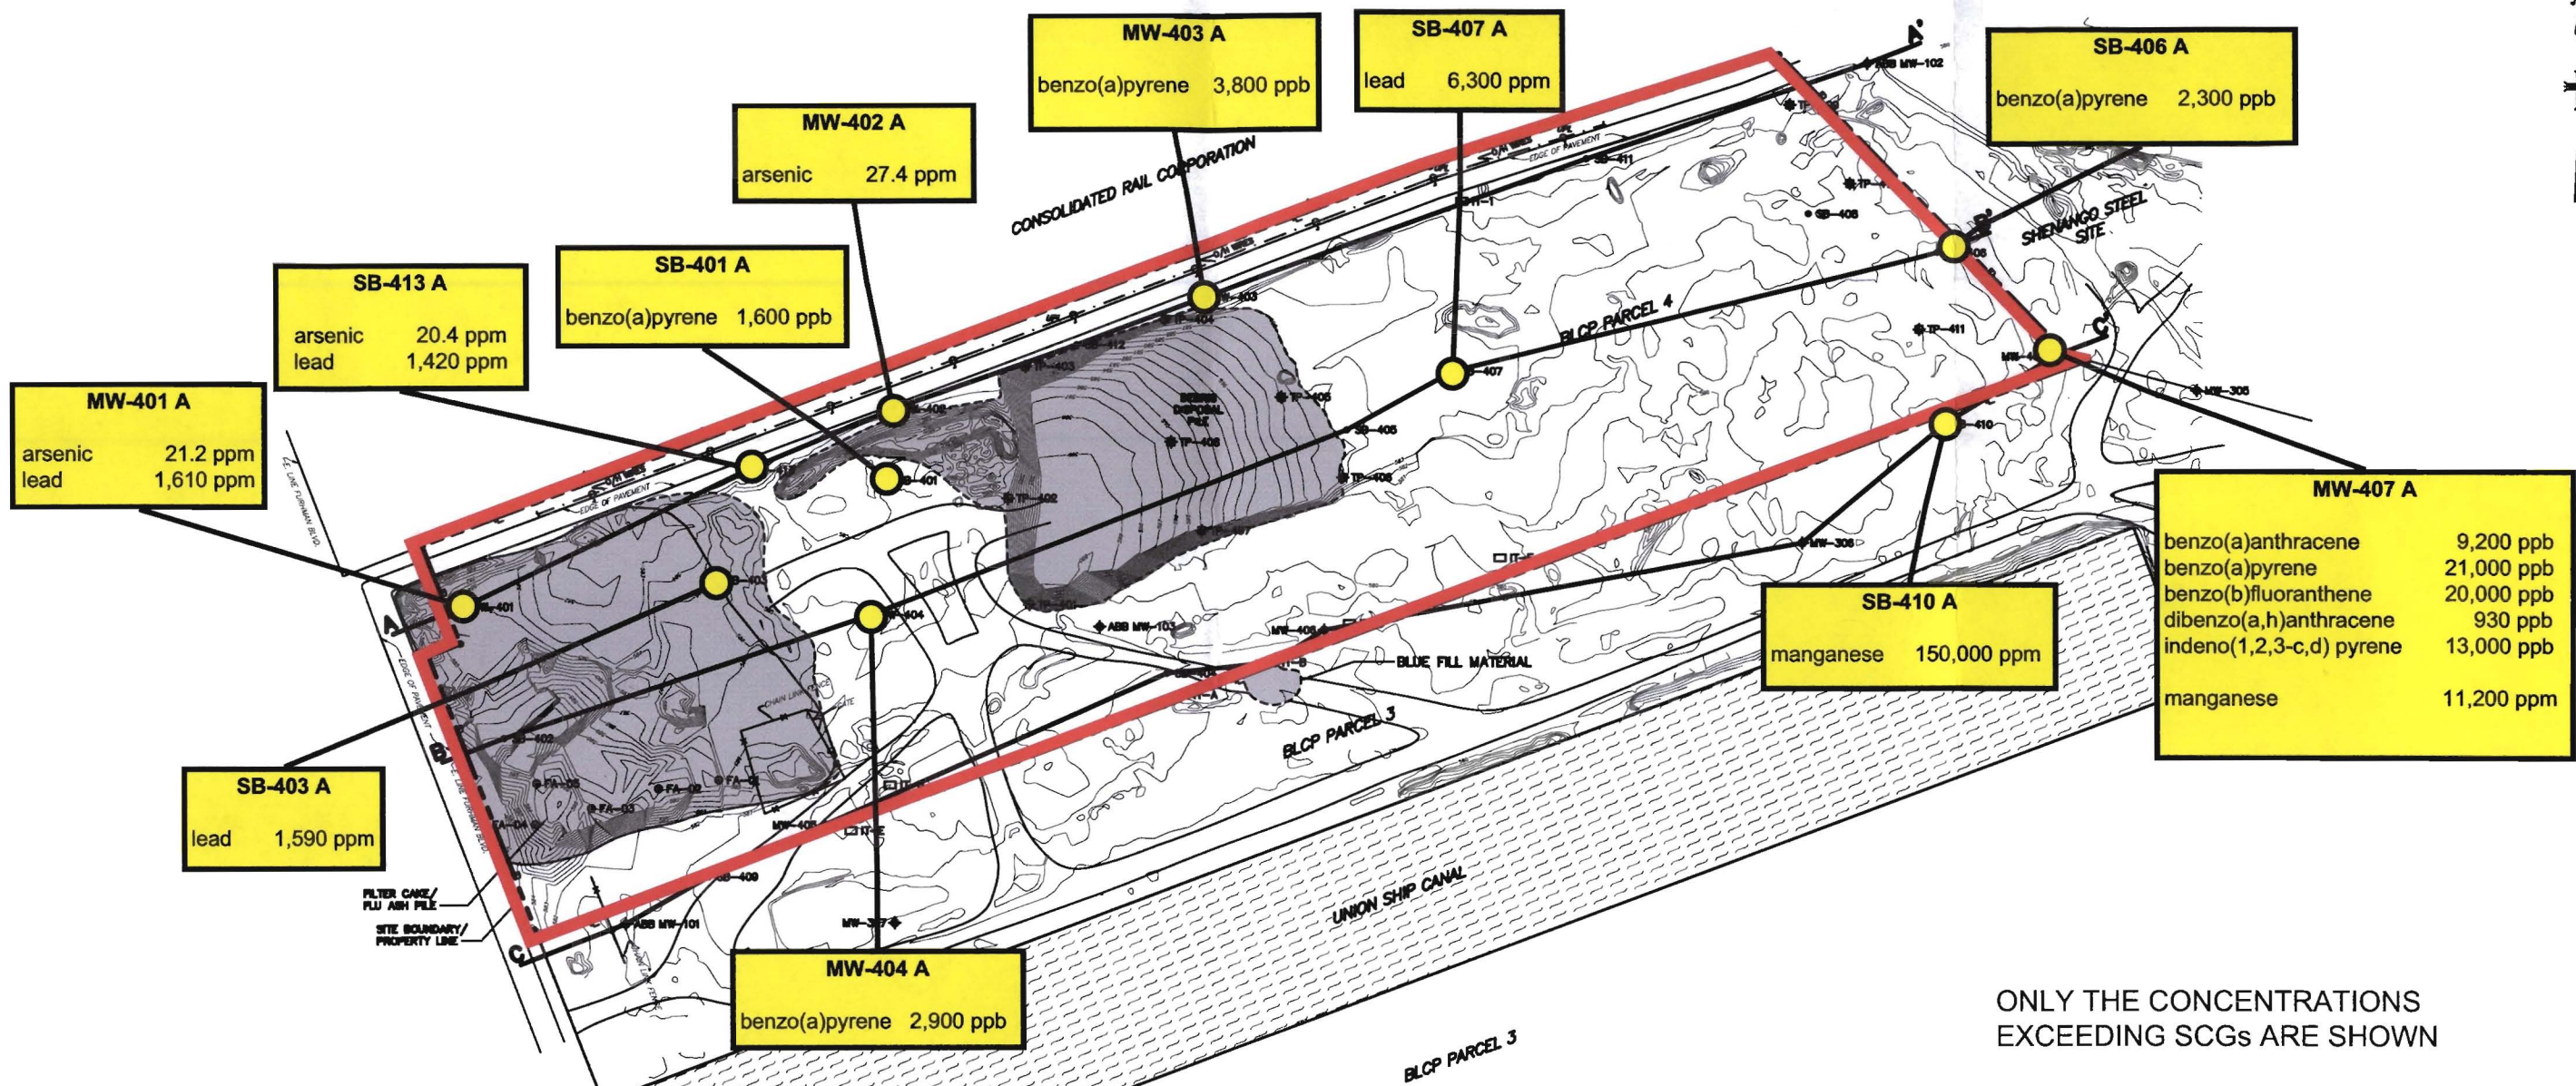
**FIGURE 3  
ANALYTICAL RESULTS  
SURFACE SOIL/FILL**

ONLY THE CONCENTRATIONS EXCEEDING SCGs ARE SHOWN

Seven PAHs were present in surface soil/fill at the Site at concentrations in excess of the 6 NYCRR Subpart 375-6 SCOs for unrestricted use in seven of the twenty surface soil/fill samples collected. Only five of these PAHs were present at levels in excess of the SCOs for restricted commercial use. All five of these PAHs are known carcinogenic PAHs, however, only one of these, benzo(a)pyrene, was present above the typical range found in urban soils. All other PAHs detected were within or below the typical urban background concentrations for PAHs.
