DAILY SITE FIELD ACTIVITY REPORT

PROJECT NO.:	3446.0004Y000	CLIENT:	DATE:	07/11/2024
PROJECT:	360 Kingsland Avenue	Sitex Group LLC	WEATHER:	Temp: 74-89°F, Sunny, RH: 47% Pres: 29.92" Wind: SW @ 12-19 mph
LOCATION:	360 Kingsland Avenue, Brooklyn, NY		TIME:	8:45 – 16:30

Roux D.P.C. (Roux) was onsite to provide environmental monitoring and to oversee the repair of a water main break at the 360 Kingsland property. Roux implemented the Community Air Monitoring Plan (CAMP) during all intrusive activities.

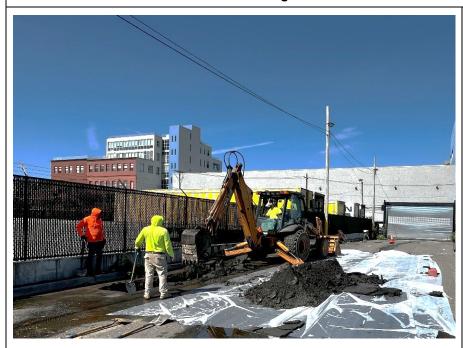
Photo 1: Smiley Waterworks excavating to expose the broken water pipe. Stockpiling excavated soil on poly sheeting.

- Roux set up an upwind and downwind CAMP station.
- Smiley Waterworks excavated around the leaking water line.
- Soil was stained and petroleum odor and sheening were observed. All excavated soil was placed on poly sheeting.
- · Broken pipe was identified and repaired.
- Excavation area was backfilled with 13 CY of clean gravel from Allocco Recycling Ltd.

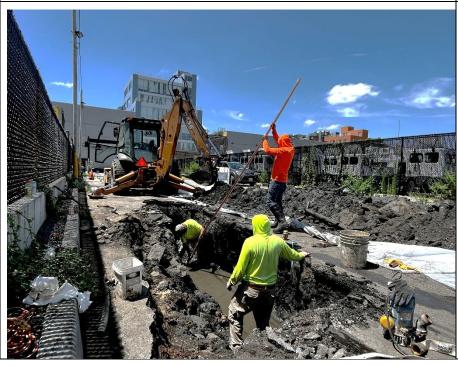
Photo 2: Smiley Waterworks replacing the broken water pipe with a new 2" copper pipe.

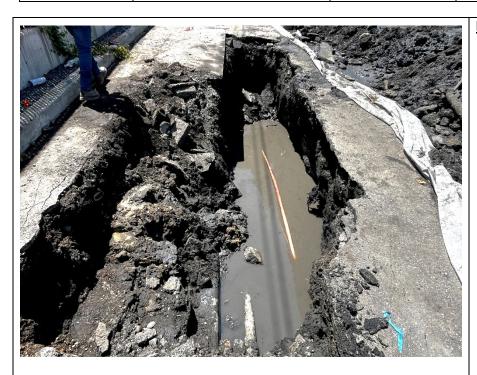
Photo 3: New copper pipe installed.

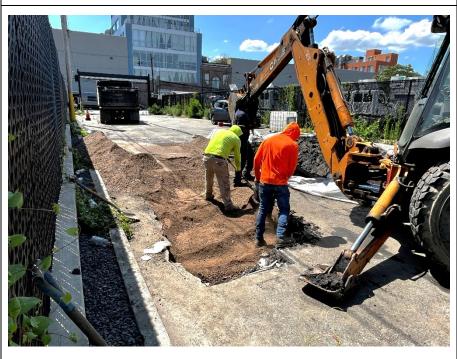
Photo 4: Smiley Waterworks tamping and grading backfill delivered from Allocco Recycling Ltd.
