# **PERIOD REVIEW REPORT**

**FORMER "SAKMANN RESTAURANT CORP." PROPERTY**

**LOCATED AT U.S. ROUTE 9W  
TOWN OF HIGHLANDS  
ORANGE COUNTY, NEW YORK**

**NYSDEC Voluntary Cleanup Site Number: V-00083-3**

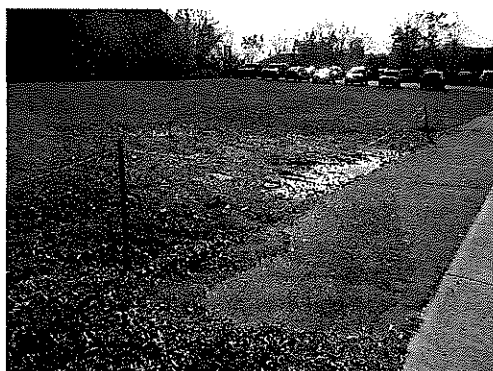
Northwest Area "A"

On November 10, 2017, Michael Tesik, P.E., employed by the NYS Office of Parks, Recreation and Historic Preservation, inspected all areas of the Site where the soil cover had been previously installed. Overall, these areas were found to be intact; however, in a portion of Area "A" in the northwest corner of site, no vegetation cover remains due to the likelihood of vehicles turning around in this area and some of the soils have been slightly disrupted (to a depth of approximately 3 inches) along with a small depression just south of this area (1' wide x 2' long x 1' deep) was observed. These areas should be filled in with topsoil and seeded to establish vegetation growth. Additionally, the southeast Area "B" is thinly covered with vegetation which appears to be subject to some natural erosion and should be reseeded. The southern area of the property, covered by asphalt, is intact.

1. All of the requirements of the SMP including monitoring of the barrier layer have been met during this period of review.
2. All the requirements of the institutional controls (groundwater use restriction, the land use restriction) have been met during this review period.
3. The barrier layer was found to be slightly disrupted. It is recommended that these areas should be filled in with topsoil and reseeded to establish vegetation growth
