# **Hunts Point Food Distribution Center Redevelopment Plan**

## **Investigative Report for the Second Operating Unit of Parcel A, Bronx, NY**

**February 2002  
Revised March 2003**

**Lawler, Matusky & Skelly Engineers LLP**  
One Blue Hill Plaza • Pearl River, New York 10965

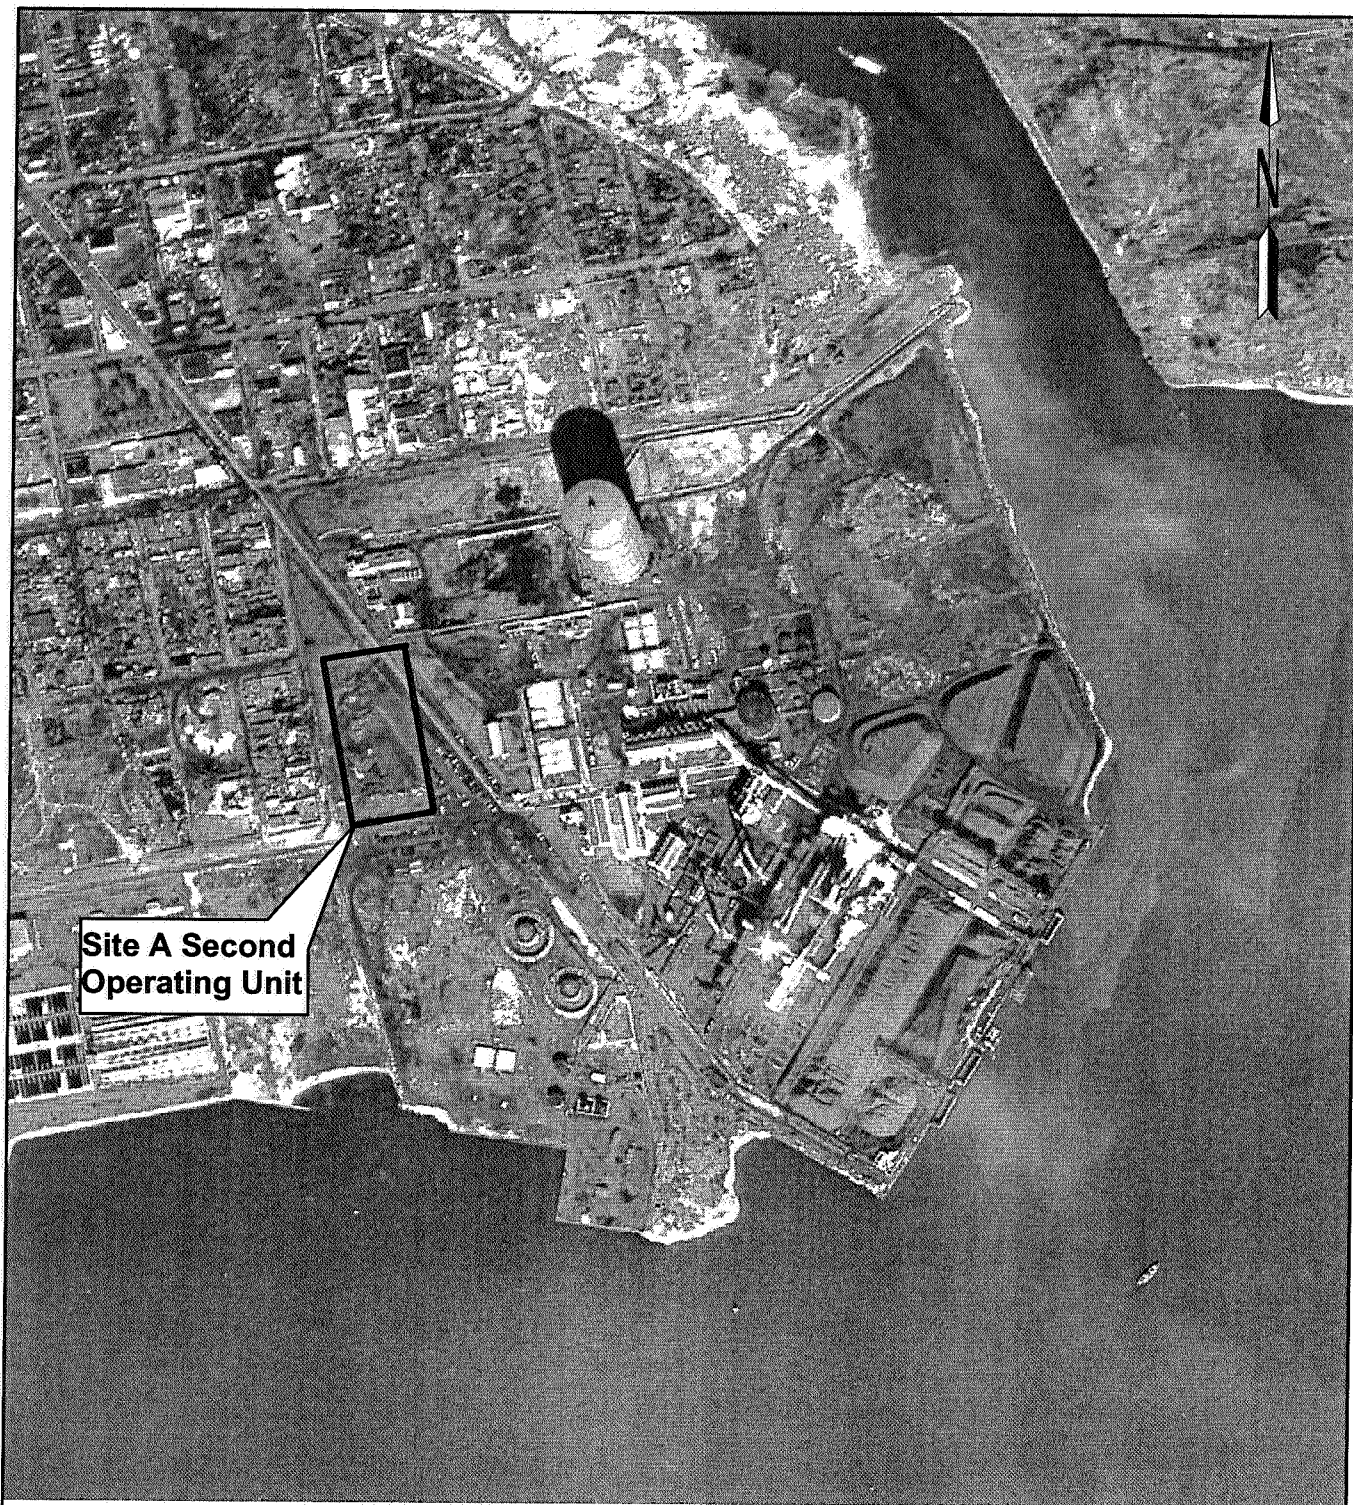
**Aerial  
Photo  
1**

As was noted on the historical aerial photographs (Aerial Photos 1 through 5), and the historic Sanborn maps, the old road bed for Hunt's Point Road ran through the northeast portion of the SOU of Site A

**Hunts Point Site A -  
1954 Aerial Photograph**
