2013 Periodic Review Report

Hunts Point Food Distribution Center
Operable Unit One of Parcel A

Site reconnaissance was conducted on February 27, 2014 by HDR. Photographs were taken during the site visit and are included as Appendix A.

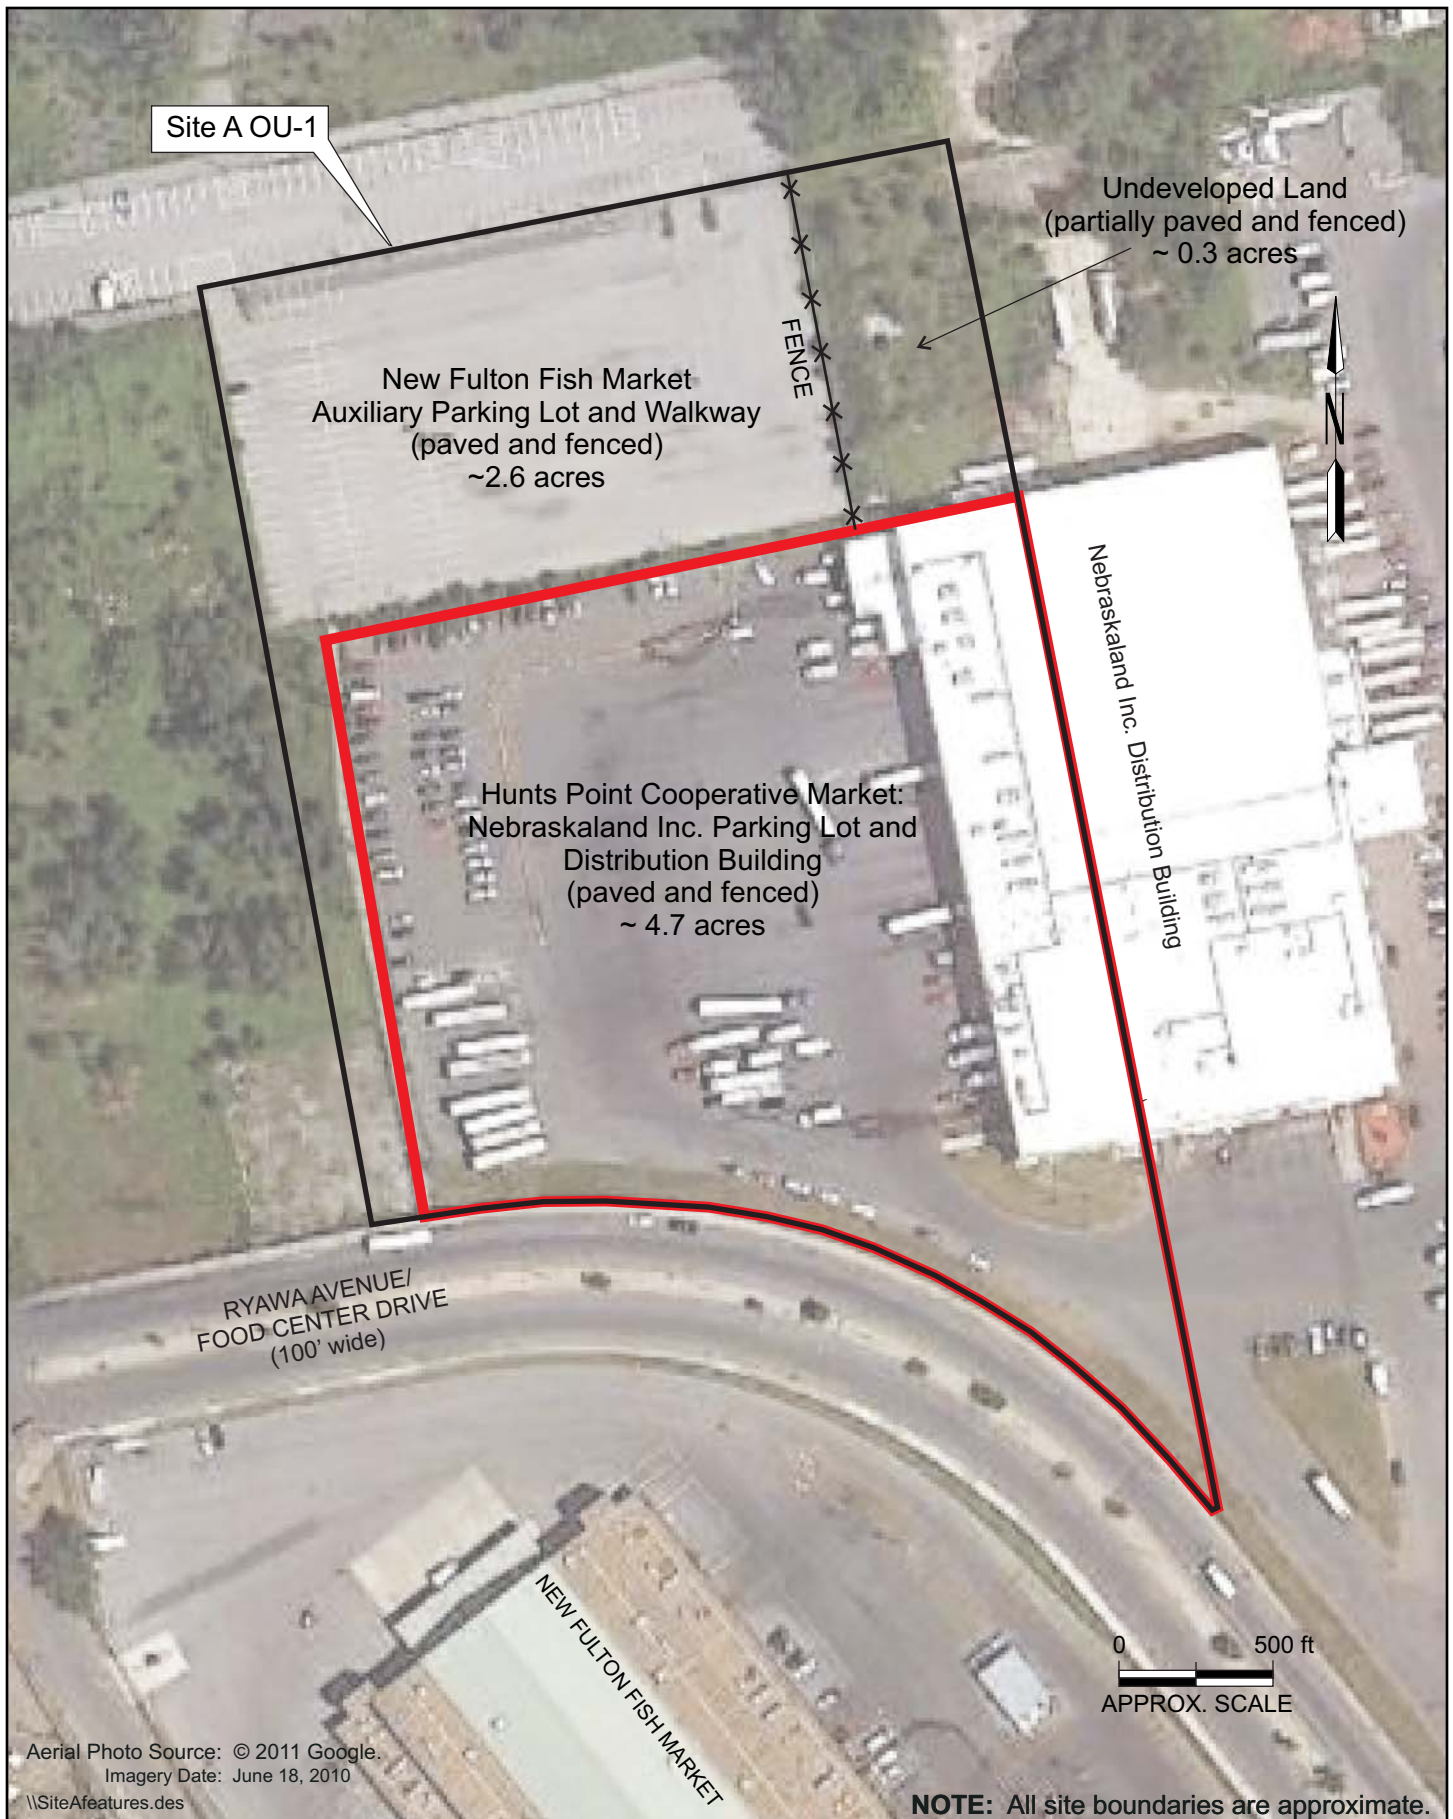
Figure
2

that remains unused and undeveloped (refer to Figure 2). The Fish Market portion of the site includes an employee parking lot measuring approximately 2.6 acres in size. Each area is surrounded with chain link and/or barbed wire fence with a fenced entryway securing Site A OU-1 entirely.

Site A OU-1 Features

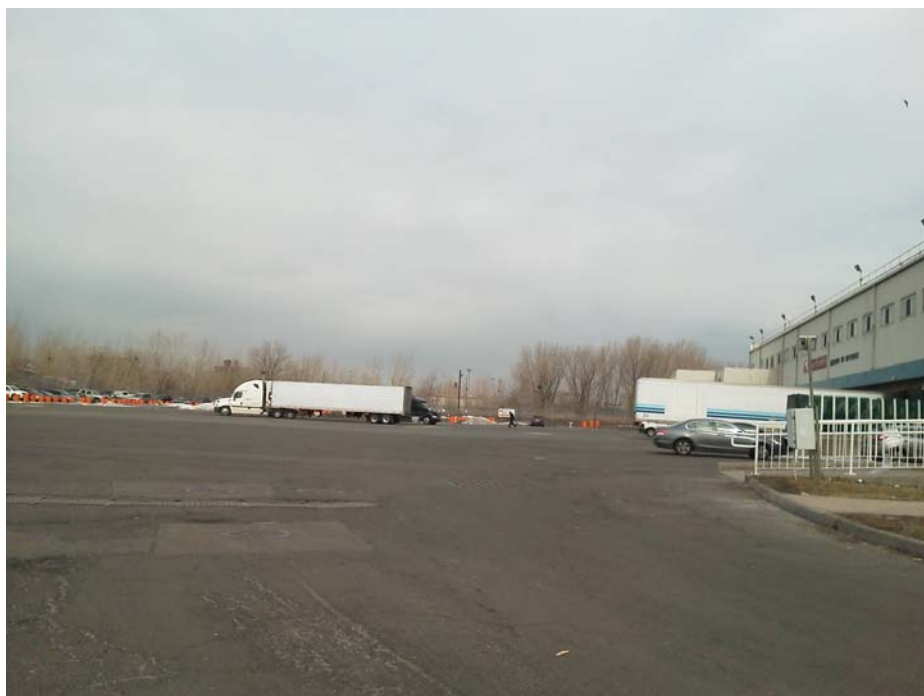
Photograph No. 1 - Hunts Point Cooperative Market southern truck parking portion of Site A OU-1 (looking north)

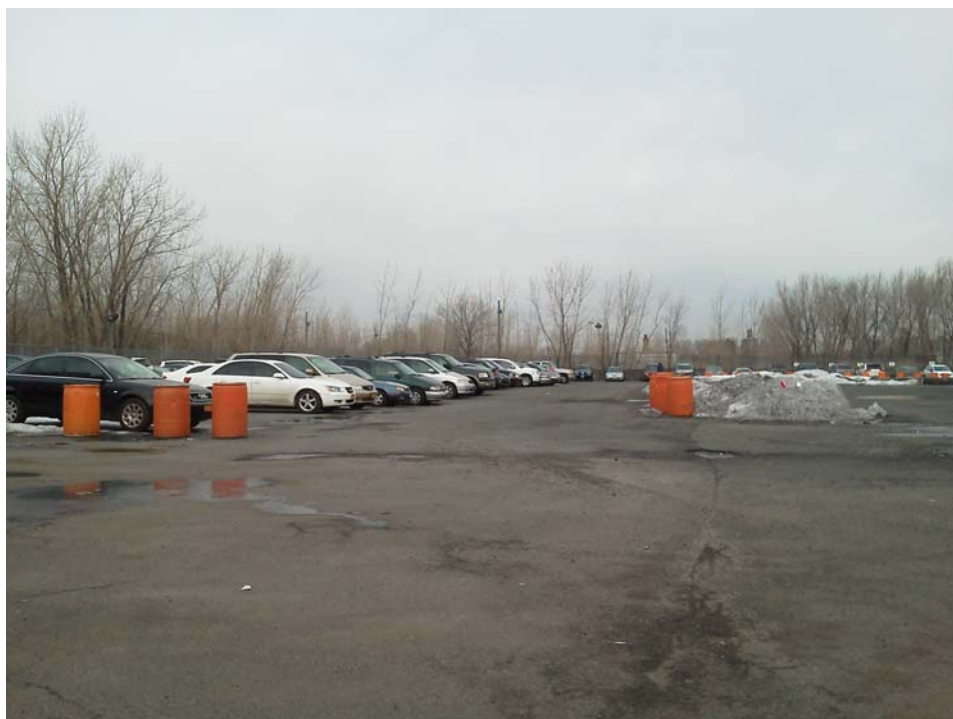
Photograph No. 2 - Hunts Point Cooperative Market employee parking portion of Site A OU-1 (looking north)

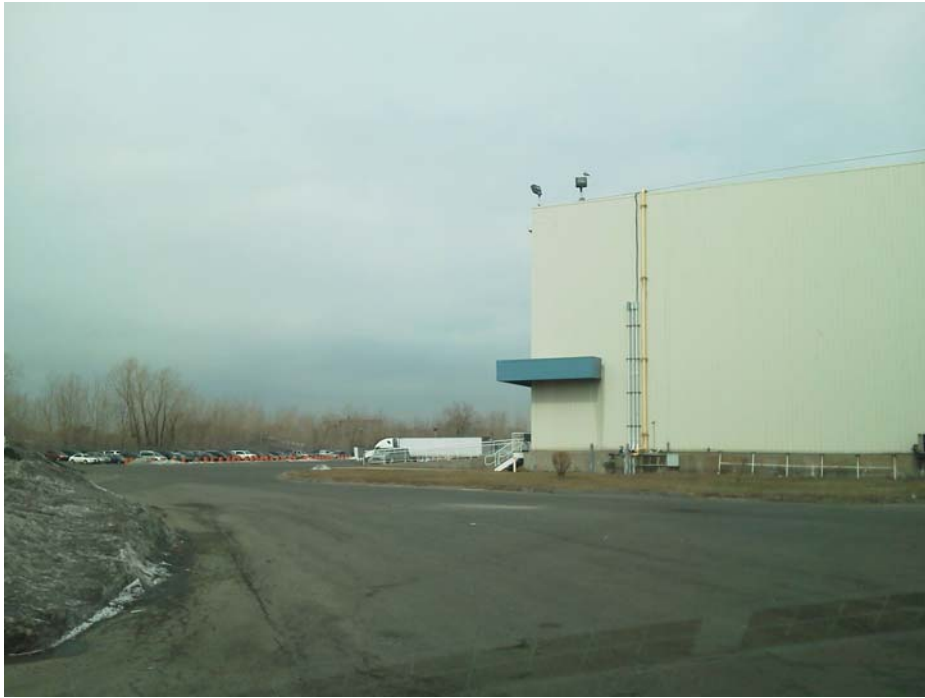
Photograph No. 3 – Hunts Point Cooperative Market vegetated portion of Site A OU-1 (looking North northwest)

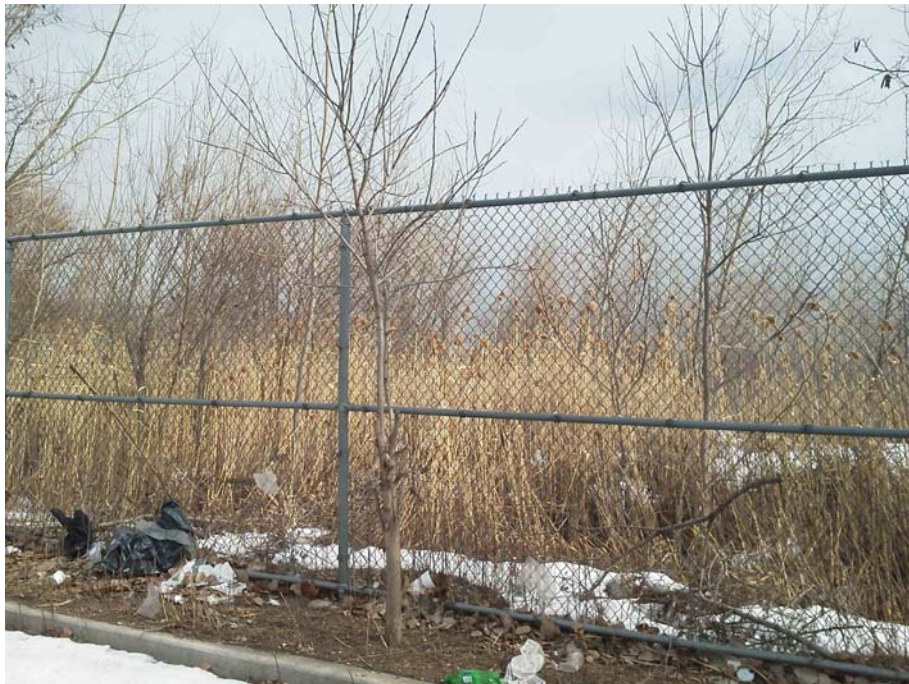
The 0.3 acres in the northeastern corner of the site remains undeveloped. This undeveloped area is vegetated and totally enclosed with fencing. The Site fencing and vegetation prevent contact with the contamination present in the subsurface.

Photograph No.4 - Hunts Point Cooperative Market undeveloped land at northeast end of Site A OU-1 (looking east)

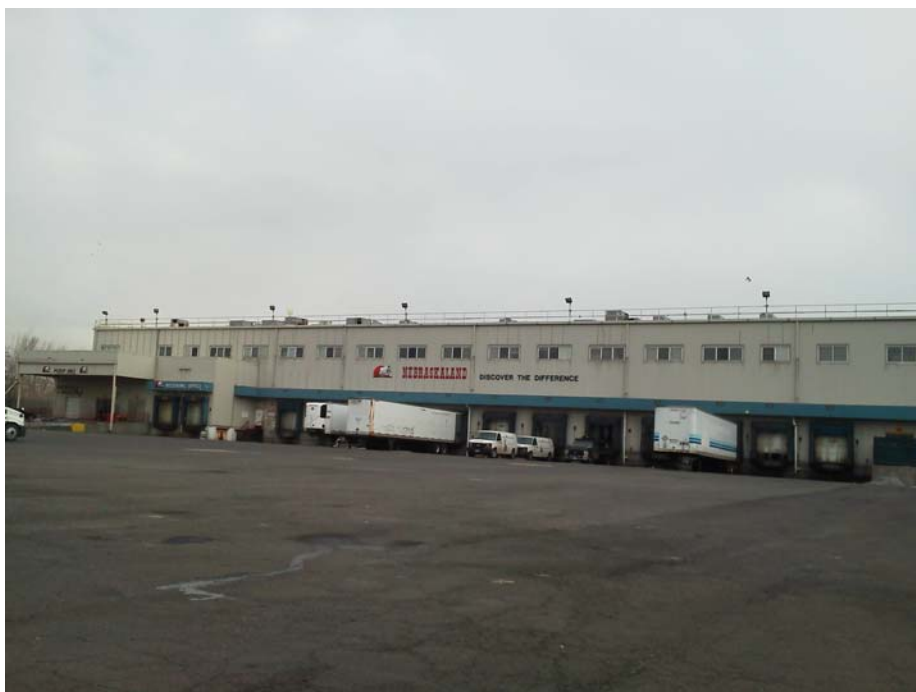
Nebraskaland was observed by HDR under the guidance of Brian Kenny, Operations Manager of the Hunts Point Cooperative Market, Inc. As per Mr. Kenny the Hunts Point Cooperative Market, Inc. has performed no intrusive activities within the bounds of Site A OU-1 within the past year. The eastern portion of the leasehold is currently being used for employee parking and truck staging in association with Nebraskaland distribution activities. Subsurface utilities do exist in this portion of Site A OU-1, however no maintenance or upgrades requiring subsurface intrusion have been performed during this reporting period. An undeveloped, concrete formed building foundation exists on the northern side of the Nebraskaland building; the building slab is being used for truck parking. This concrete foundation has existed for a period of several decades. The Nebraskaland building was later constructed over part of the old concrete foundation. Chain-link cyclone fencing surrounds the Hunts Point Cooperative Market, Inc. portion of Site A OU-1 with access being available through the eastern Hunts Point Cooperative Market gated entrance. Approximately 10 to 20 feet of unpaved and vegetated land exists along the southern perimeter of the site. As per Mr. Kenny, no re-landscaping or excavation of this area has taken place during this reporting period and there has been no addition or removal of fill material or soils. Appendix A illustrates the Hunts Point Cooperative Market, Inc. portion of Site A OU-1.

Photograph No. 5 - Hunts Point Cooperative Market Site A OU-1 Nebraskaland Inc. leasehold (looking east)

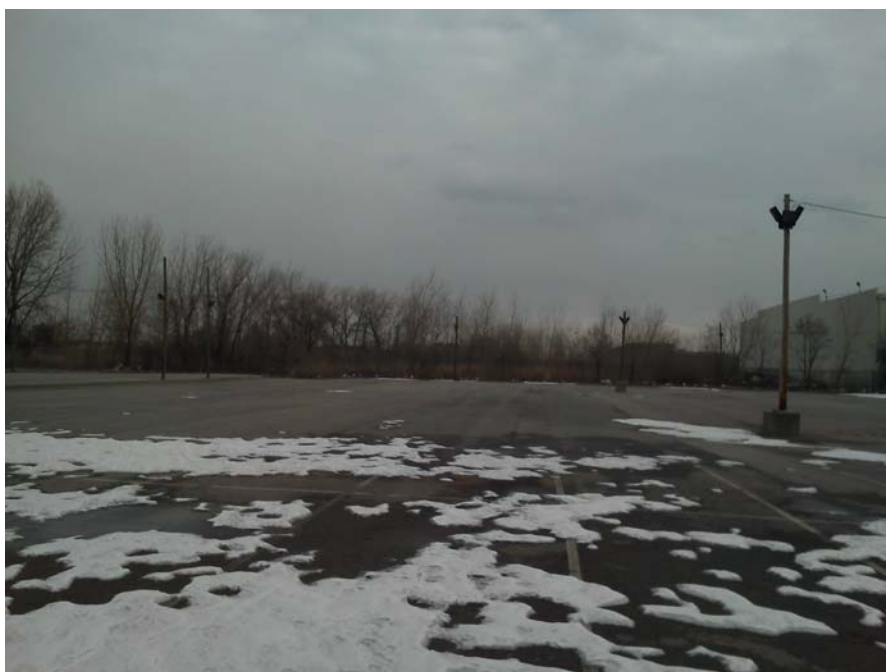
Next, HDR viewed the New Fulton Fish Market supplemental employee parking lot, which constitutes the northwestern portion of Site A OU-1. This portion of Site A OU-1 is completely surrounded by chain-link cyclone fencing and access may only be gained under escort by NYCEDC or Fish Market security personnel. The parking lot was graded and paved during the spring of 2005 during the construction of the New Fulton Fish Market (Site B to the south). During previous construction of the supplemental employee parking lot, no material was exported from Site A OU-1. Imported material was confined to base gravel and asphalt for the parking surface. No vegetated landscaping exists on this portion of Site A OU-1 and the only existing utilities are overhead electric lines servicing the parking lot lighting. It is currently un-occupied.

Photograph No. 6 – New Fulton Fish Market employee parking portion of Site A OU-1 (looking northwest)

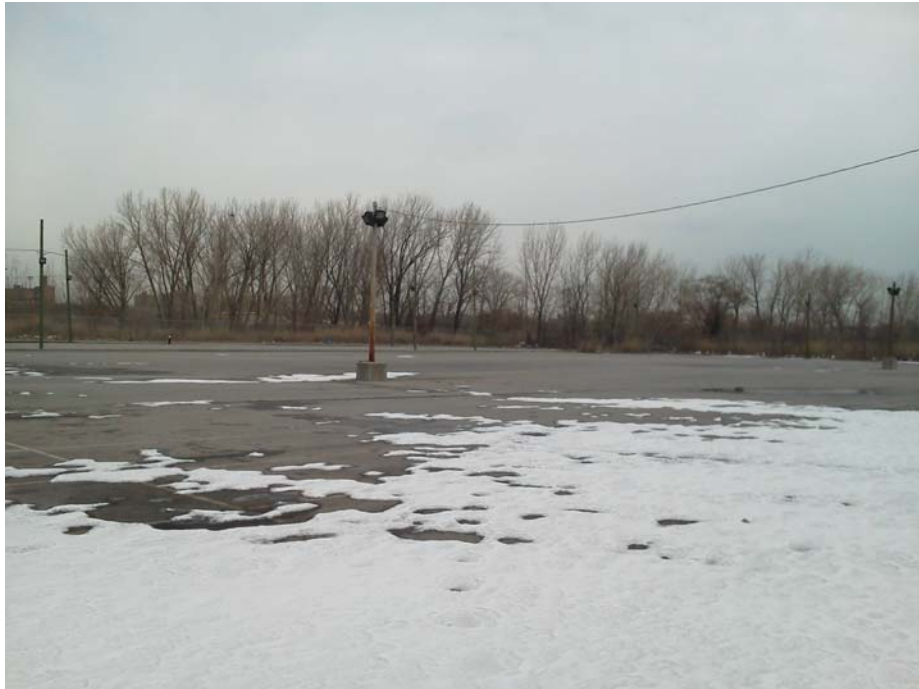
Photograph No. 7 – New Fulton Fish Market employee parking portion of Site A OU-1 (looking southeast)

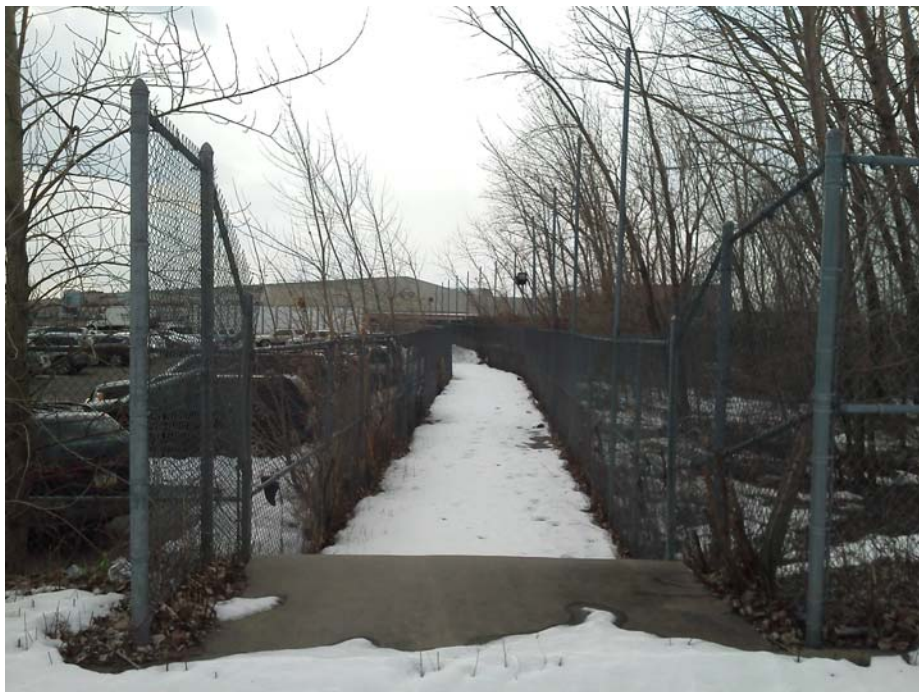
A small walkway was constructed along the western perimeter of Site A OU-1 to offer access to Fish Market employees from Food Center Drive. This walkway is between two chain link fences. Currently this lot is not used for any auxiliary employee parking. When the lot is not being used, the walkway entrance is gated and locked. No asphalt cuts were observed in the pavement of the Fish Market supplemental employee parking lot. Prior to the site reconnaissance, HDR met with George M. Maroulis, the Market Manager of the Fish Market. As per Mr. Maroulis the New Fulton Fish Market has performed no intrusive activities within the bounds of Site A OU-1 within the past year.

Photograph No. 8 – New Fulton Fish Market employee parking walkway on Site A OU-1 (looking south)
