INSPECTION REPORT

Site Number: V-00334-9/915525
Site Name: Grief Bros. Corporation
Location: 2122 Colvin Blvd, Tonawanda
Project Manager: Michael J. Hinton
Project Engineer: Jon Fox ERM
Job Phone: N/A

Date: August 25, 2009

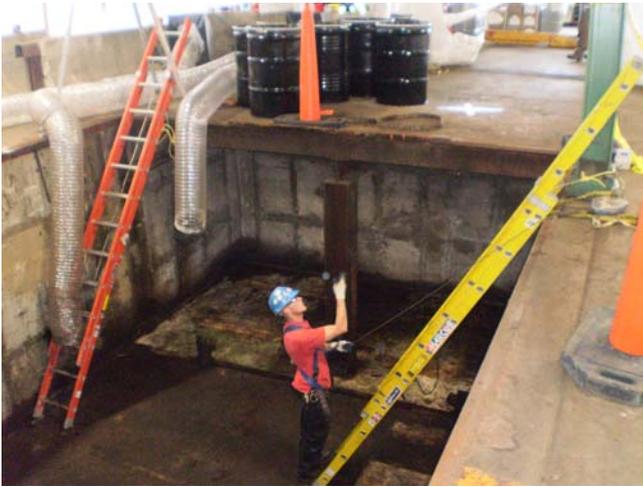
082509-01 Varnish Pit North End.JPG

Nothnagel on site to dore floor and install soil borings/wells in floor of varnish pit.

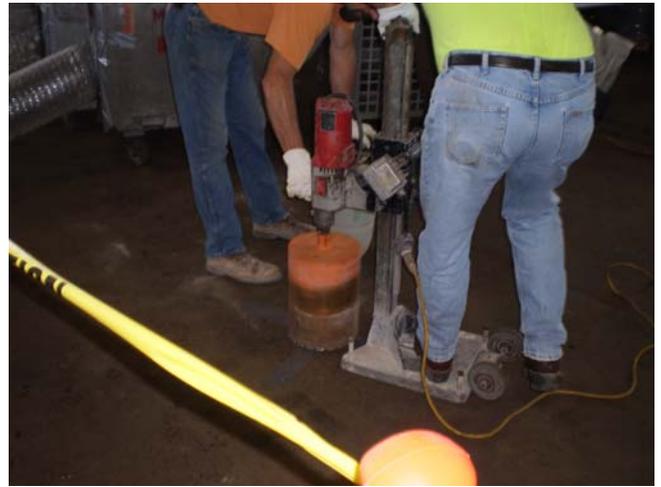
082509-02 Coring Floor.JPG

Coring VP-2 started at 1330 hrs, finished at 1407 hrs

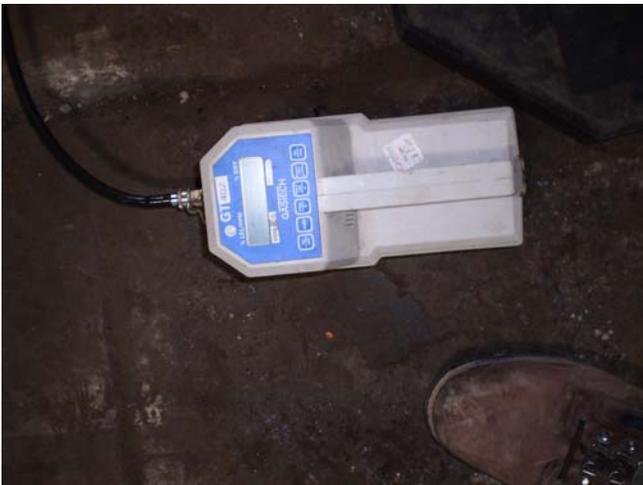
082509-03 Air Monitor.JPG

Air monitoring in place: PID for organic vapors, multi meter for O₂ -20.9%, LEL - 0%, Co - 0 and H₂S - 0
PID at open hole for VP-1 ~400 -1800 ppm. Pit air ~400 ppm. Core from VP-1 bottom stained but no free DNAPL observed. Air on factory floor ~ 0 PID

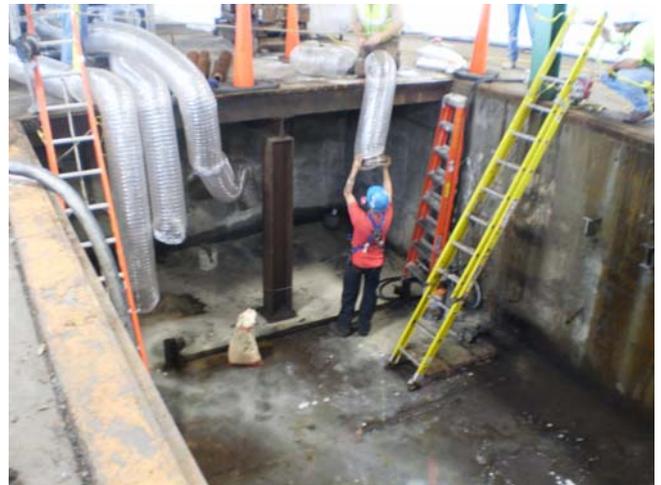
082509-04 Air venting.JPG

Breathing zone air in pit required Level C respiratory protection while additional venting lines re-arranged/installed. After vent re-arranged breathing zone in pit was 0 PID, VP-1 hole was at ~220 PID

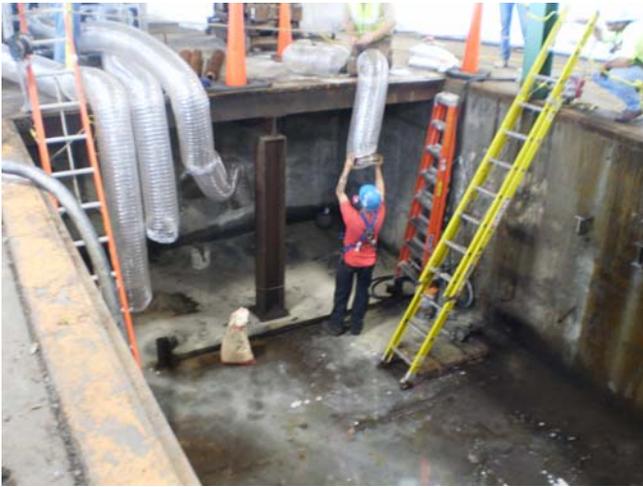
082509-05 VP-1 Drill Rig.JPG

Well at VP-1 hole augered 6' below pit floor with 6.25 hollow stem augers. No split spoons collected. Drill cuttings observed for DNAPL

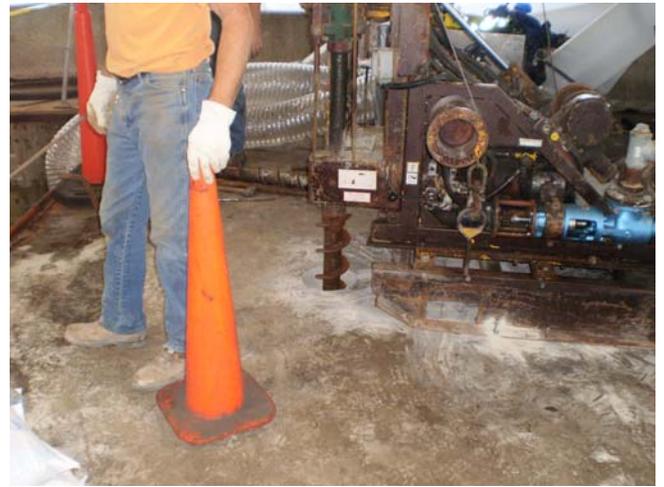
2509-06 VP-1 Drill through floor.JF

Placed 7' slotted 4" screen in hole. Place sand pack around screen. Bottom of VP-1 5'-10" below pit floor.
