Re: Periodic Review Report – Approval with Condition
CE – White Plains MGP
Site #V00438

**Re: Consolidated Edison Company of New York, Inc.
White Plains Former Manufactured Gas Plant Site Periodic Review Report
NYSDEC Site #V00438-3**

PERIODIC REVIEW REPORT
WHITE PLAINS FORMER MGP SITE
White Plains, Westchester, New York
(NYSDEC SITE NO: V00438-3)

SITE WIDE INSPECTION FORM
WHITE PLAINS FORMER MGP SITE

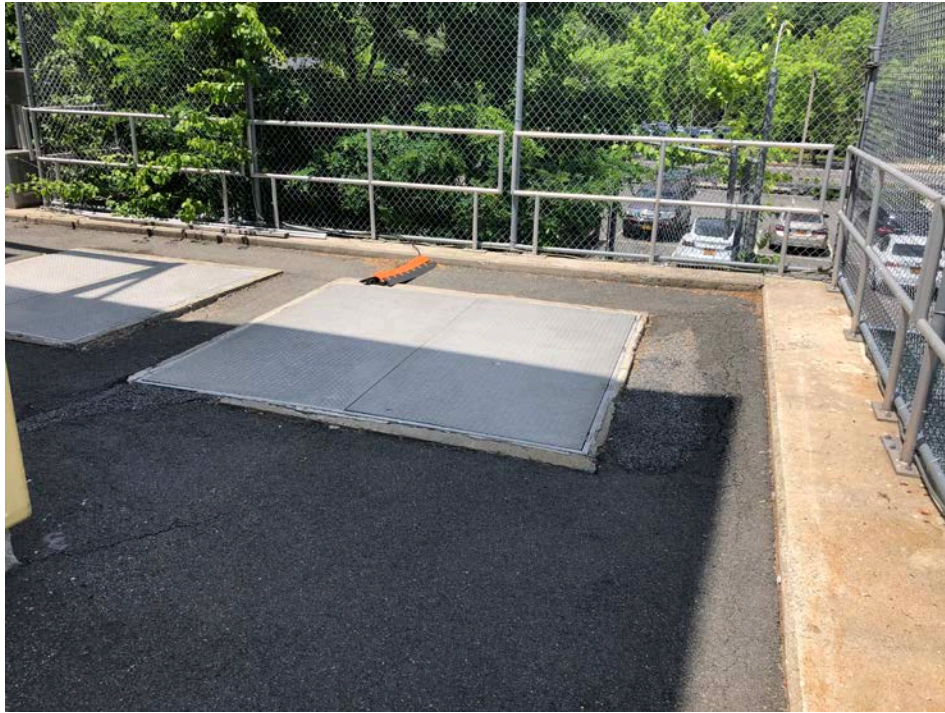
Photo 1: Alley between Transformer Vaults No. 3 and 4 (facing North)

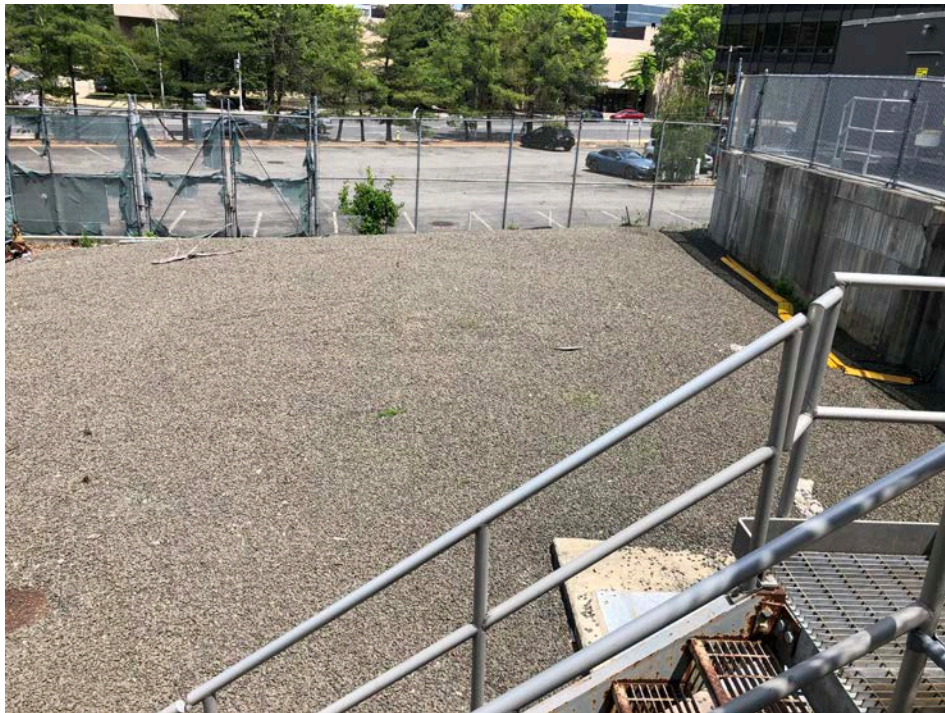
Photo 2: Gravel cover area near Transformer Vault No. 3 (facing East)

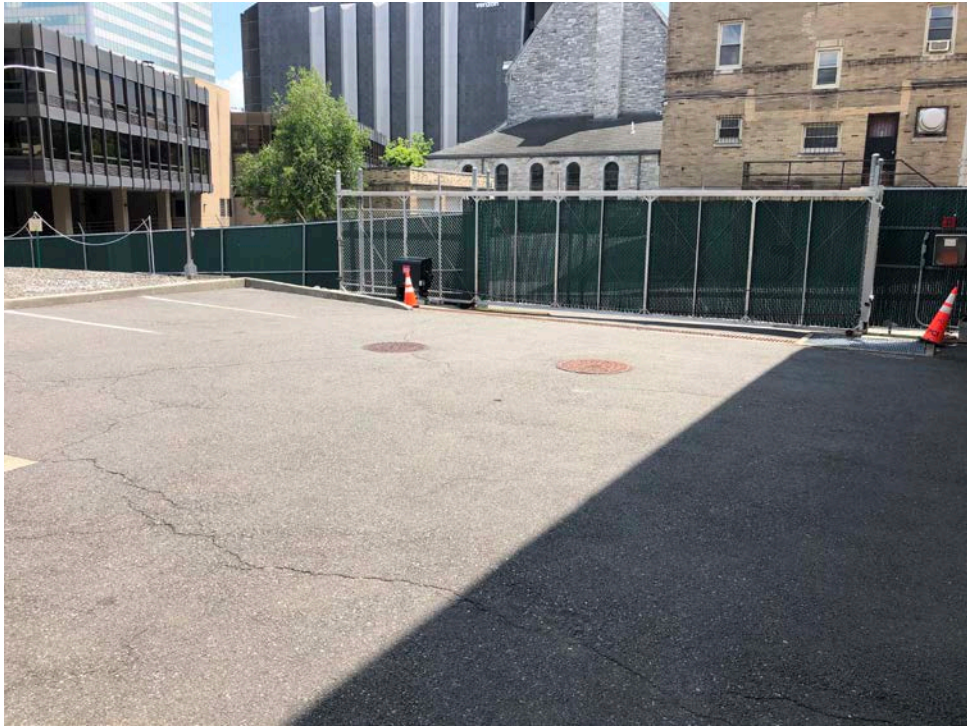
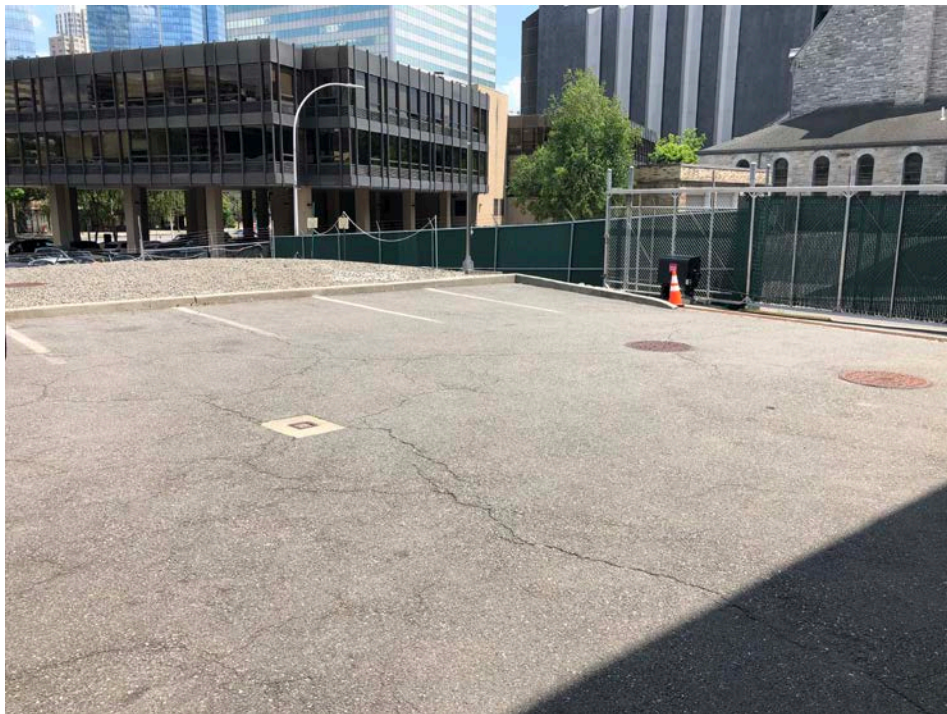
Photo 3: Substation Parking Lot (facing South)

Photo 4: Substation Parking Lot (facing Southeast)

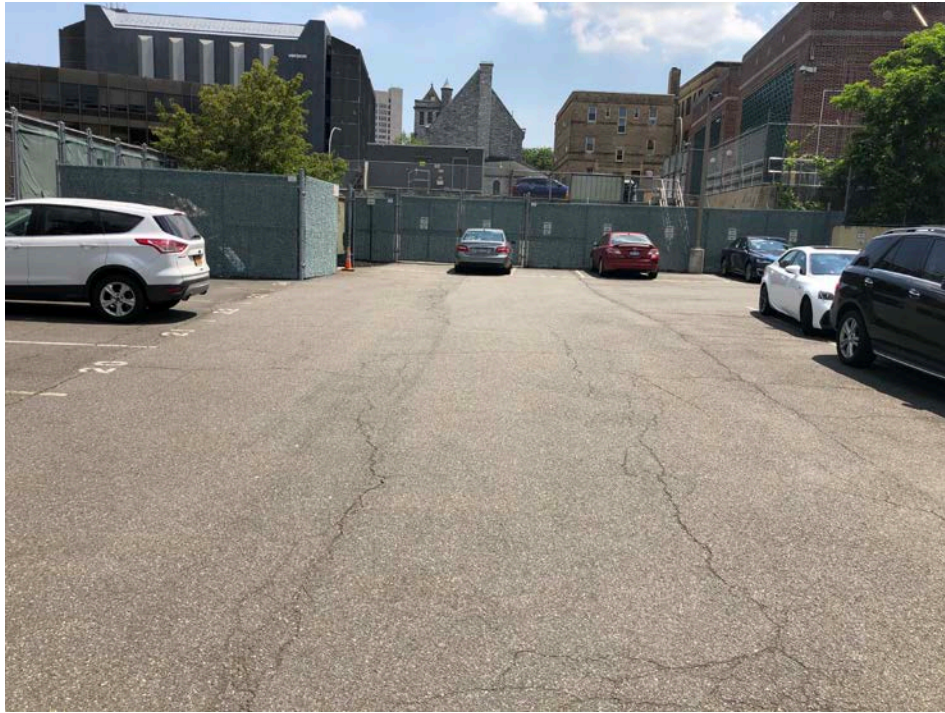
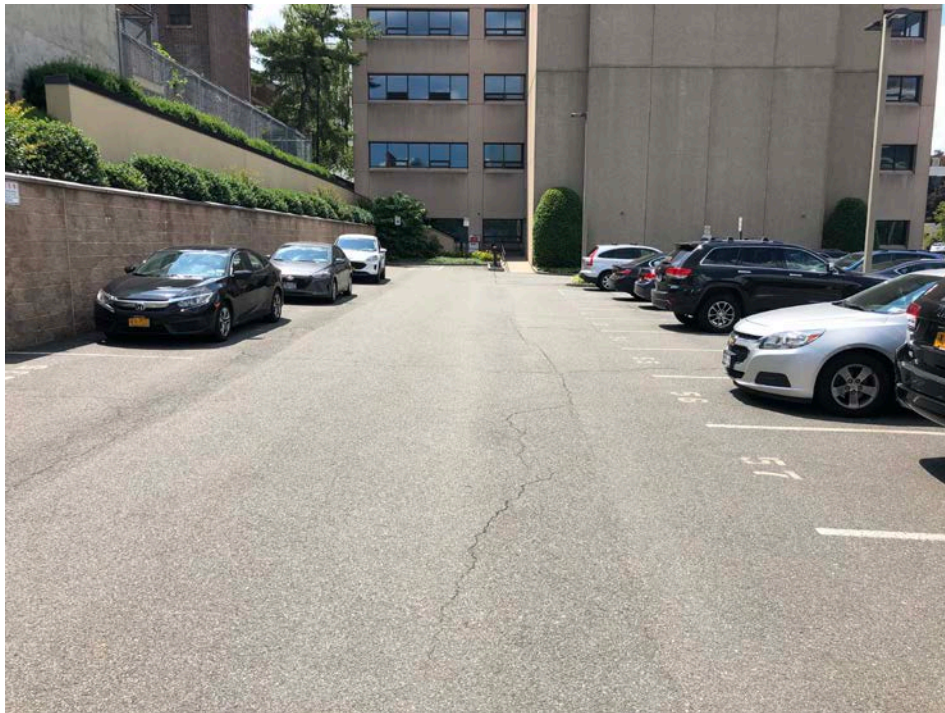
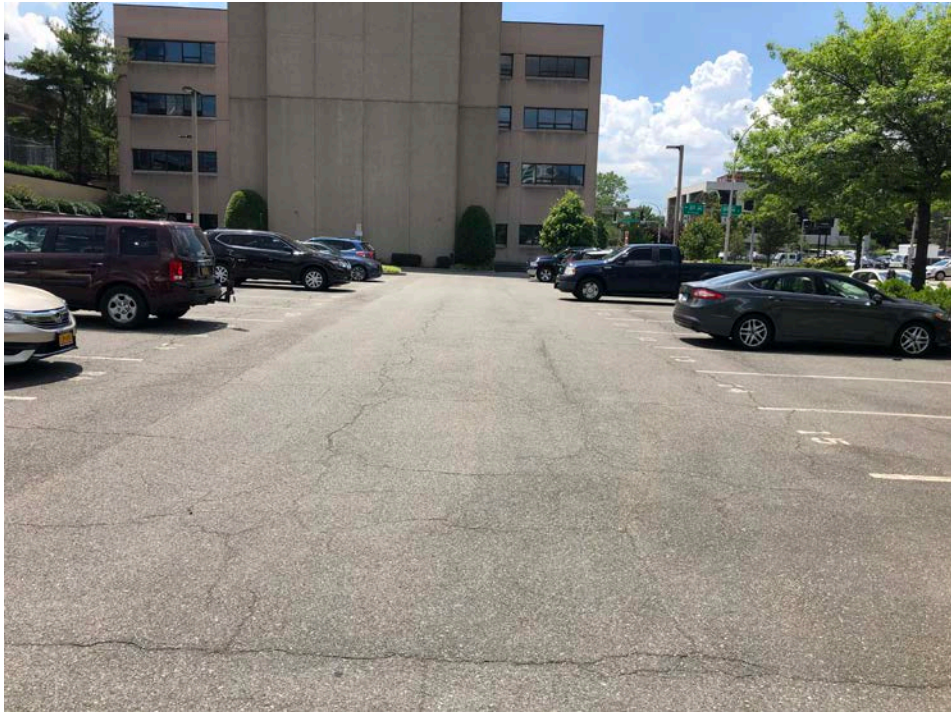
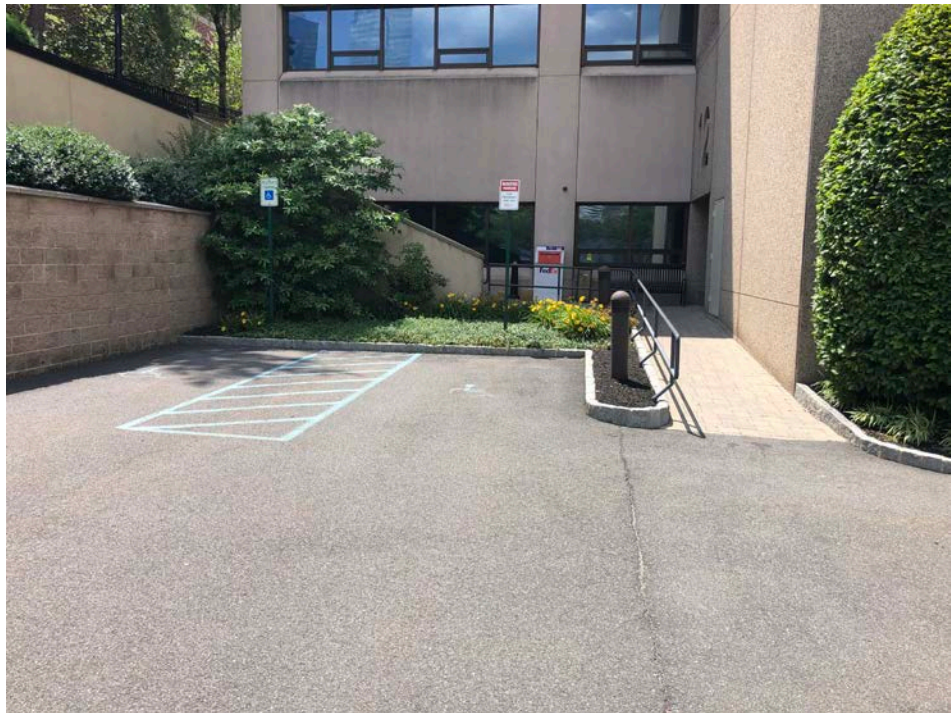
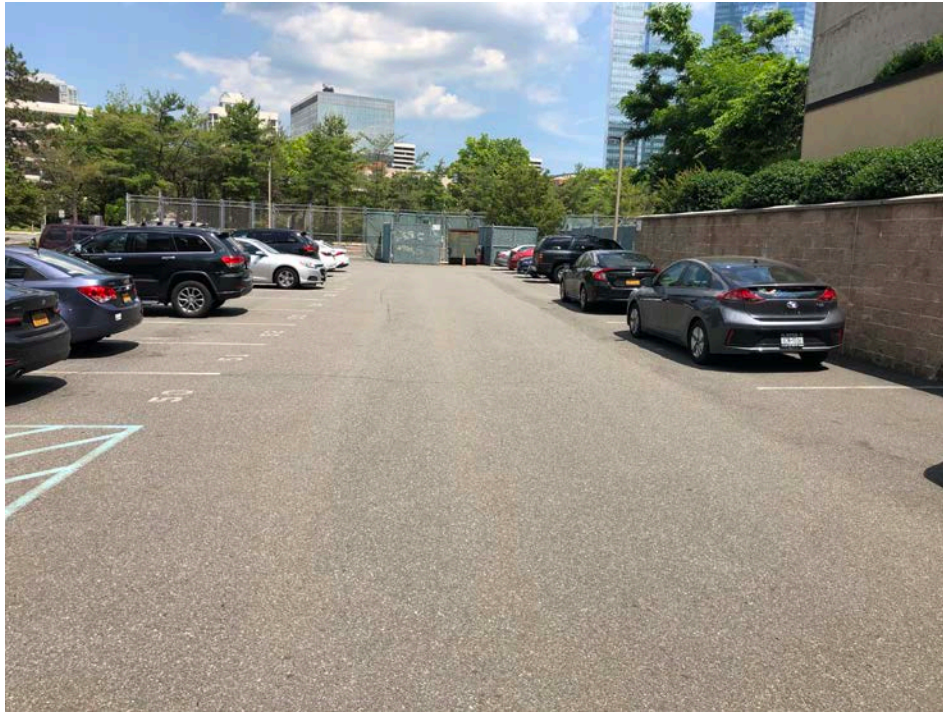
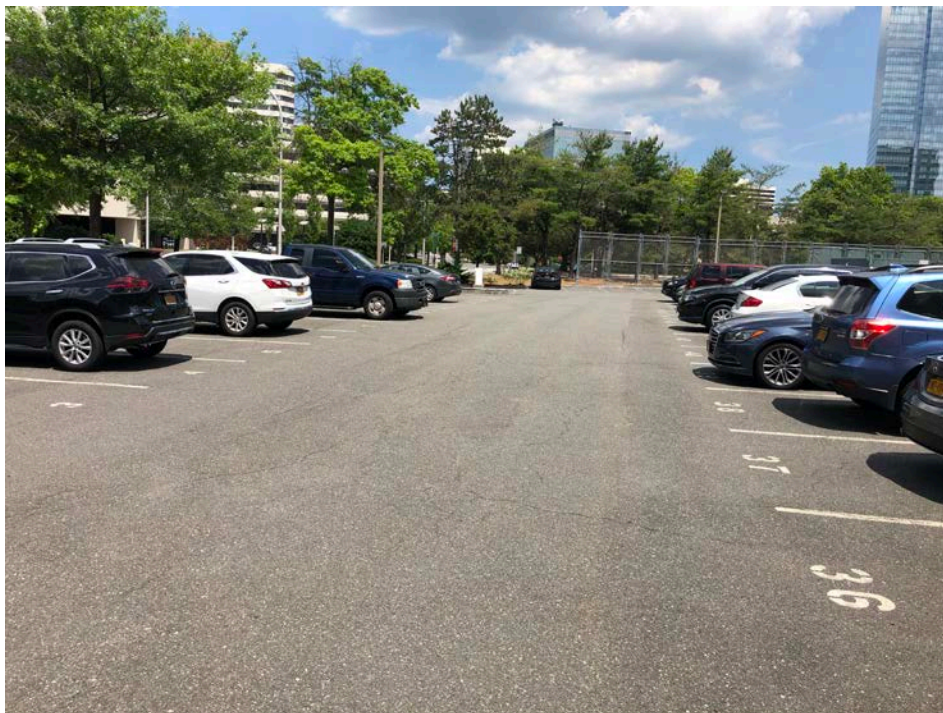
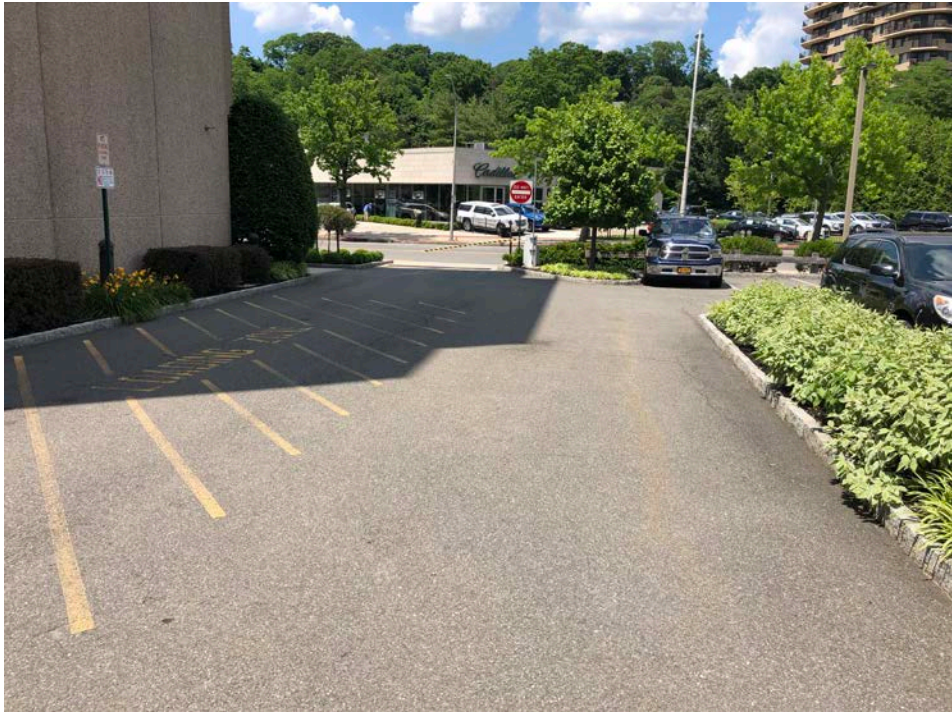
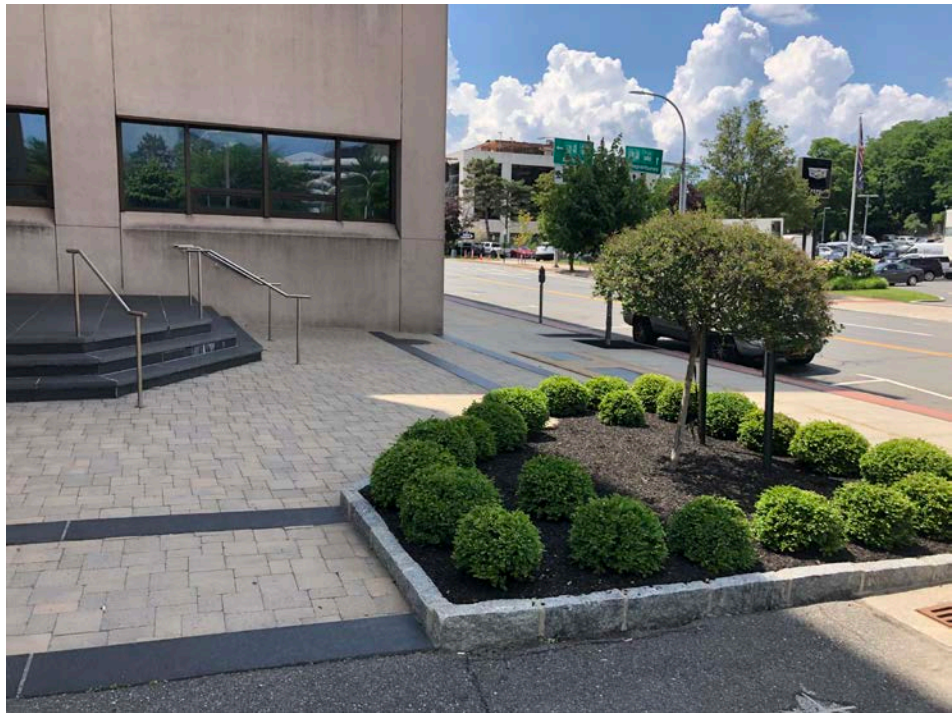
Observed cracks in the asphalt cover of the parking lot composite cover system which appear to be due to the harsh winter conditions of past seasons. Cracks do not appear to have gotten worse since last year's inspection.

Photo 5: Water Street Parking Lot (facing South)

Photo 6: Water Street Parking Lot (facing West)

Photo 7: Water Street Parking Lot (facing West)

Photo 8: Water Street Parking Lot (facing West)

Photo 9: Water Street Parking Lot (facing East)

Photo 10: Water Street Parking Lot (facing East)

Photo 11: Water Street Parking Lot (facing North)

Photo 12: Water Street Parking Lot (facing Northwest)

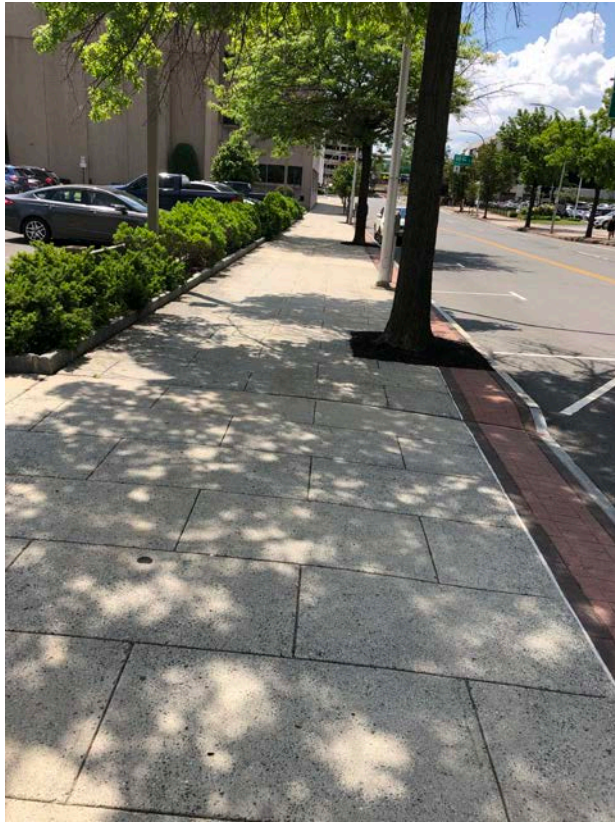
Observed concrete flaking in the sidewalk located along Water Street in the northeast corner of the Site.

Photo 13: Sidewalk Immediately North of Water Street Parking Lot (facing West)

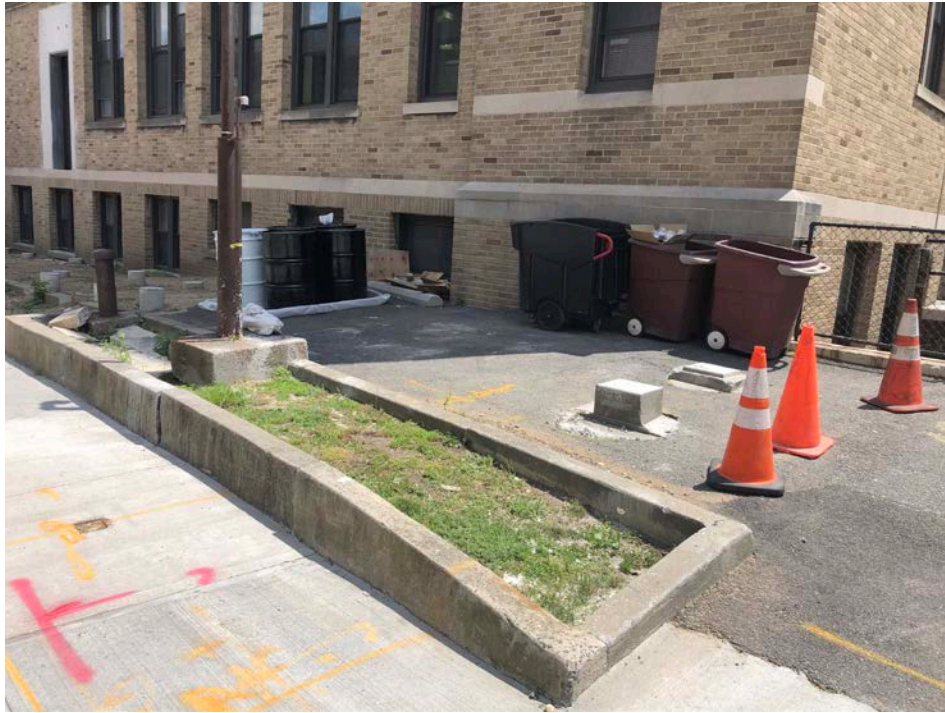
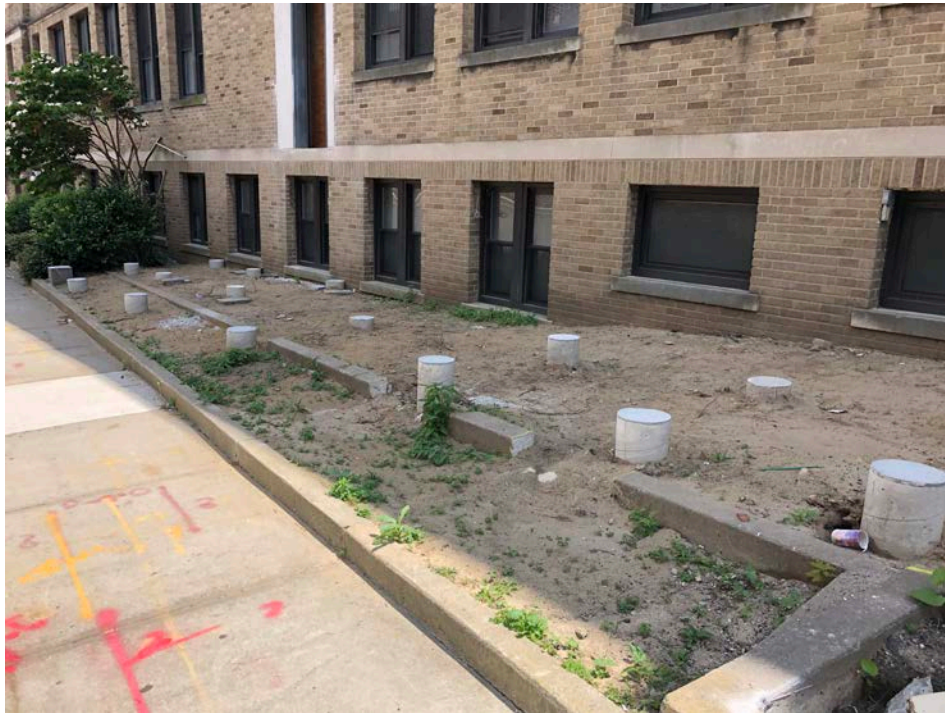
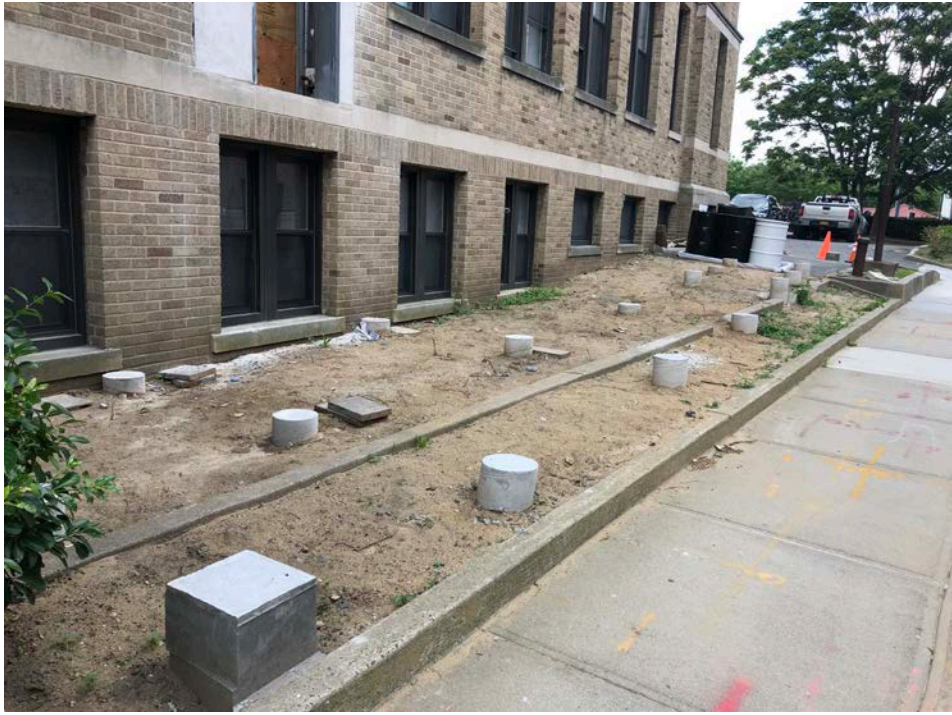
Photo 15: Construction of Handicapped Access Ramp at St. John's

Photo 16: Construction of Handicapped Access Ramp at St. John's

Photo 17: Construction of Handicapped Access Ramp at St. John's
