EXPLANATION OF SIGNIFICANT DIFFERENCE

BATAVIA IRON AND METAL CO., INC. 301 BANK STREET, BATAVIA, NY

City of Batavia / Genesee County / Site No. 819018 / April 2024

Prepared by the New York State Department of Environmental Conservation Division of Environmental Remediation

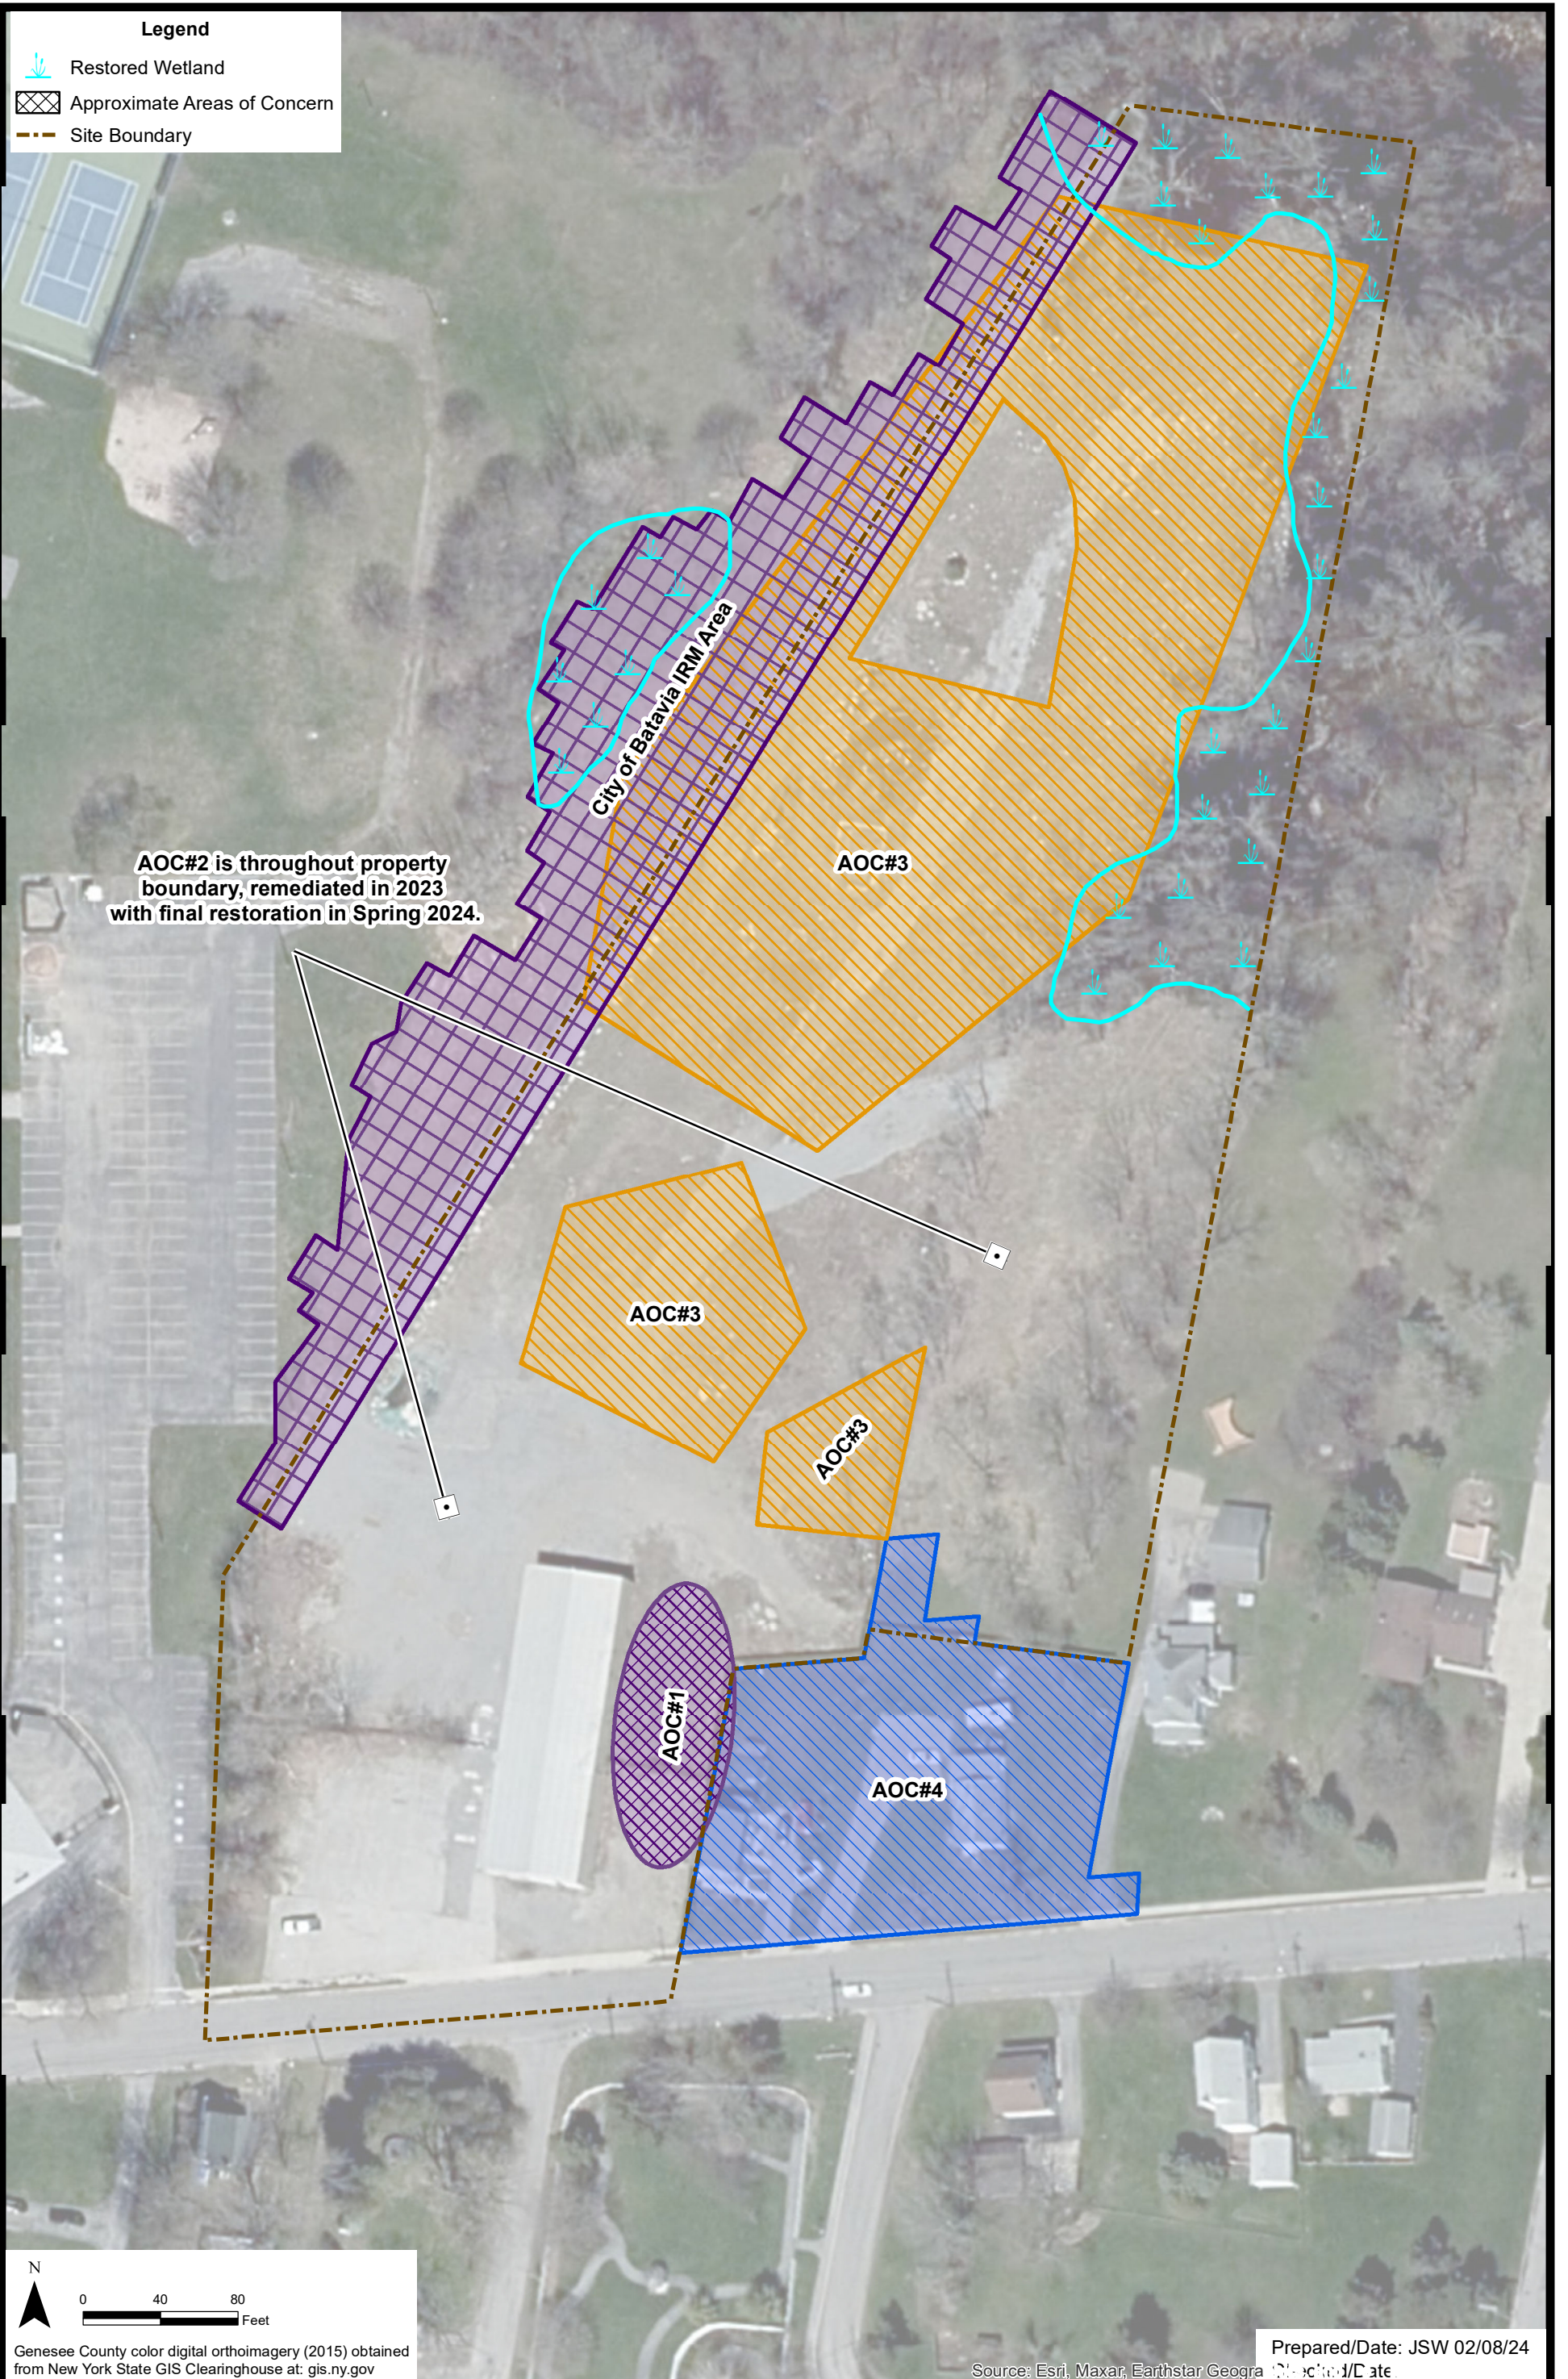
AOC#2 is throughout property boundary, remediated in 2023 with final restoration in Spring 2024.

Areas of Concern

The purpose of this notice is to describe the progress of the remedial actions at the Batavia Iron and Metal Company, Inc Site and to document changes in the overall Site remedy. The Site is part of NYSDEC's Superfund program, and the Record of Decision (ROD) was issued in April 2013. The ROD included a description of the selected remedy for the four areas of concern (AOC) at the Site. Each of the AOCs are shown on Figure 1 and are described as follows:

- AOC #1 – PCB and Pesticide impacted fill located adjacent to (southeast of) the on-site building.
- AOC #2 – PCB and metals impacted soil and fill (surface and sub-surface) throughout the property.
- AOC #3 – Solid waste, otherwise noted as debris piles, present throughout the site.
- AOC #4 – Metals impacted soil at off-site properties located at 303 and 305 Bank Street.

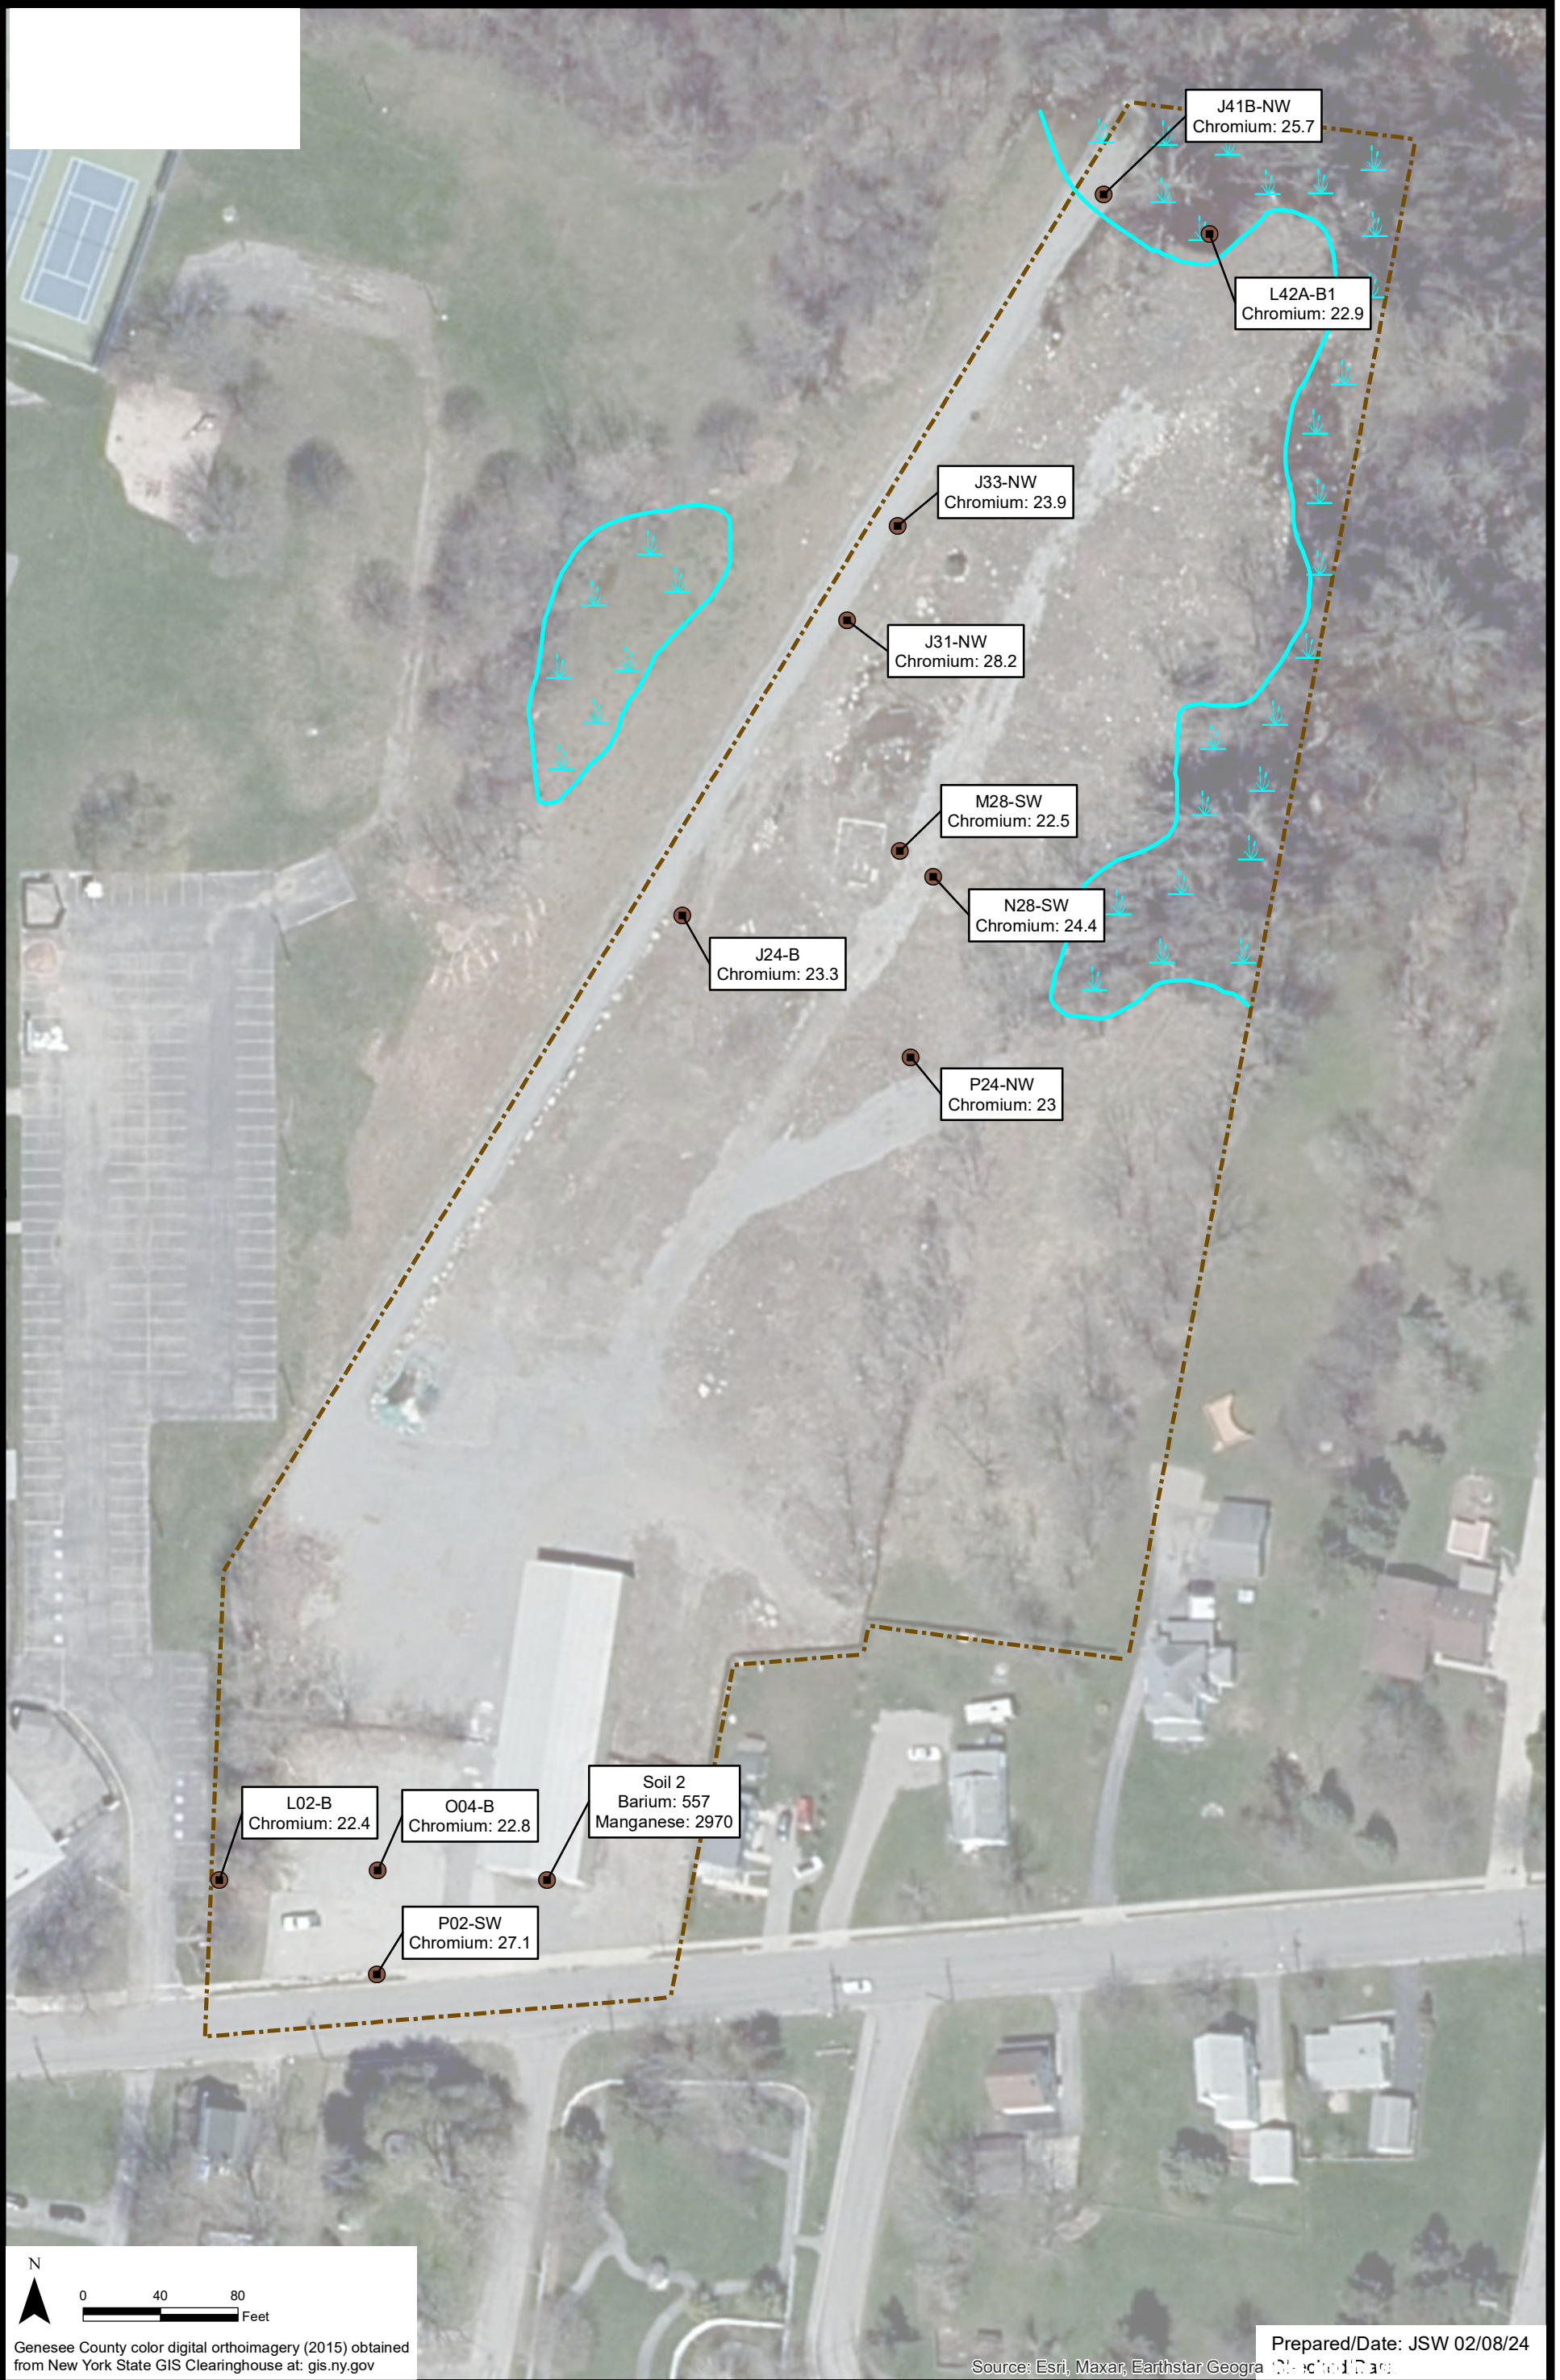
Figure 2

Remaining Soil Exceedances Above RSCOs
Project 3617207507

collected and tested for PCBs and metals. Based on confirmation soil sampling, additional excavations were completed as needed and as feasible to meet the residential RSOs. Locations of remaining soil samples that exceed residential RSOs (limited to exceedances for chromium, barium, and manganese) are shown on Figure 2.

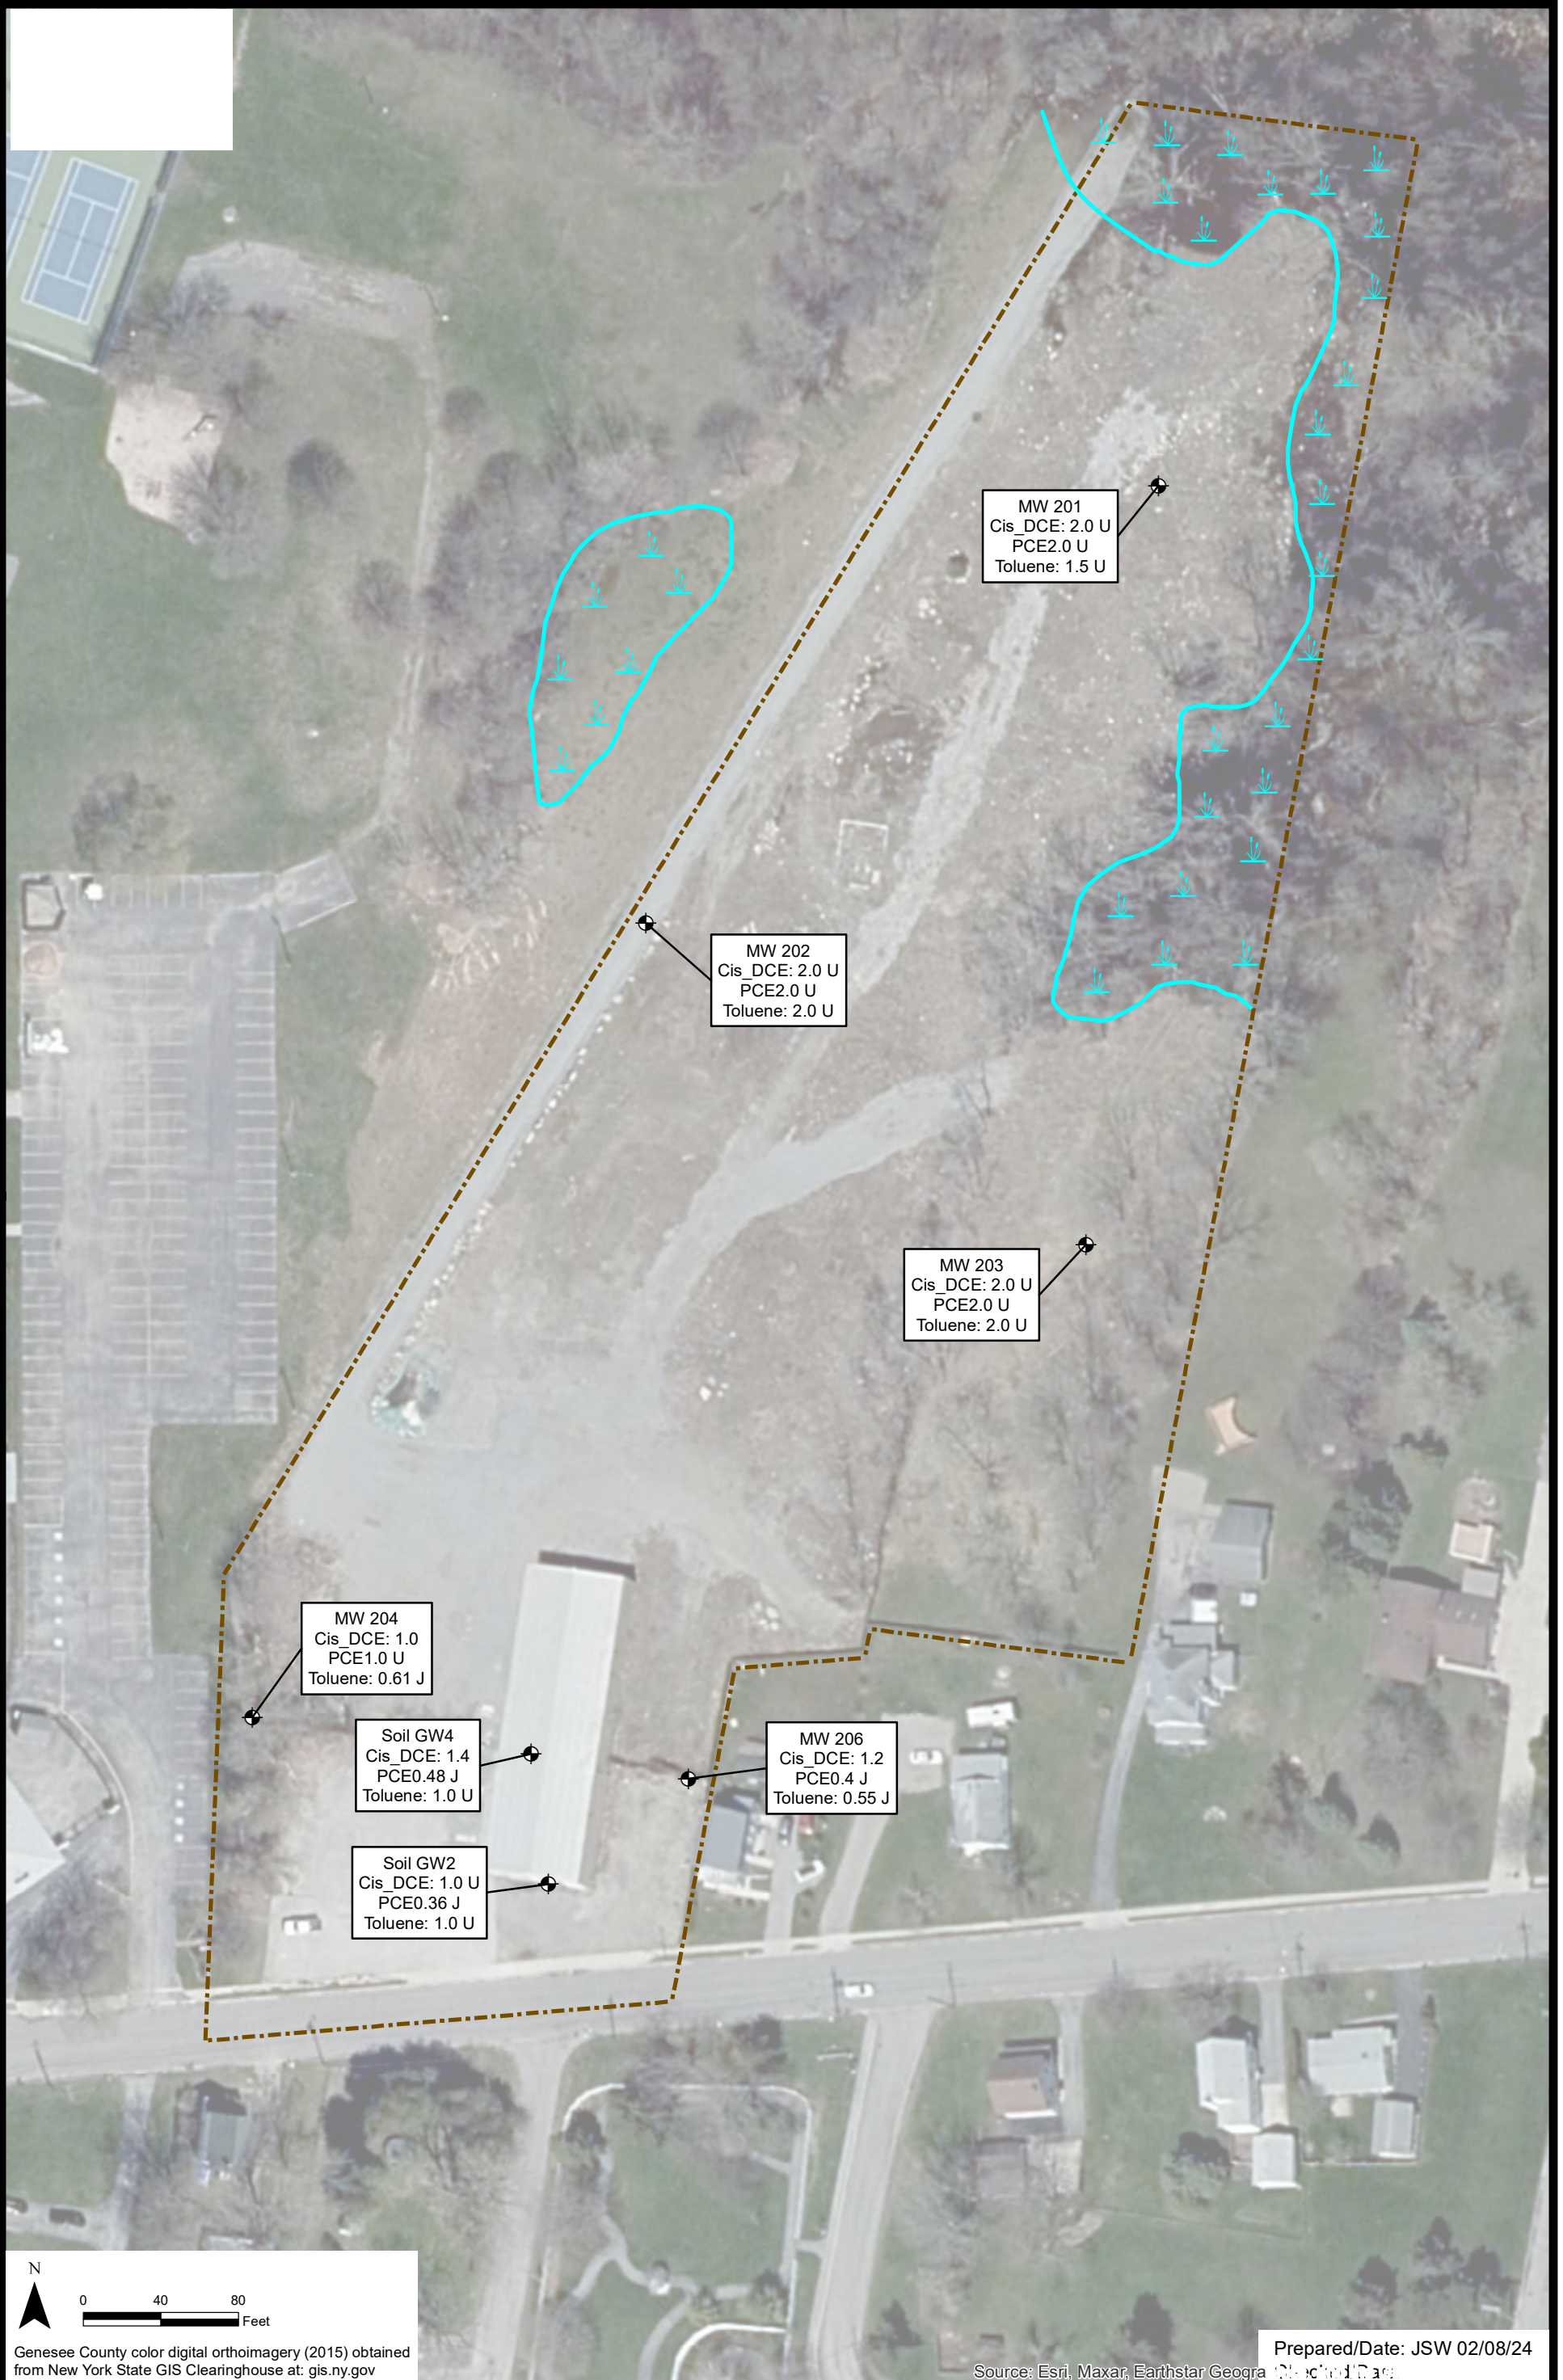
Figure 3

Groundwater Sampling Locations
