FACT SHEET Brownfield Cleanup Program

Site Name: Pierce Arrow Business Center
DEC Site #: C915312
Address: 155-157 Chandler Street
Buffalo, NY 14207

Interim Remedial Measure Proposed

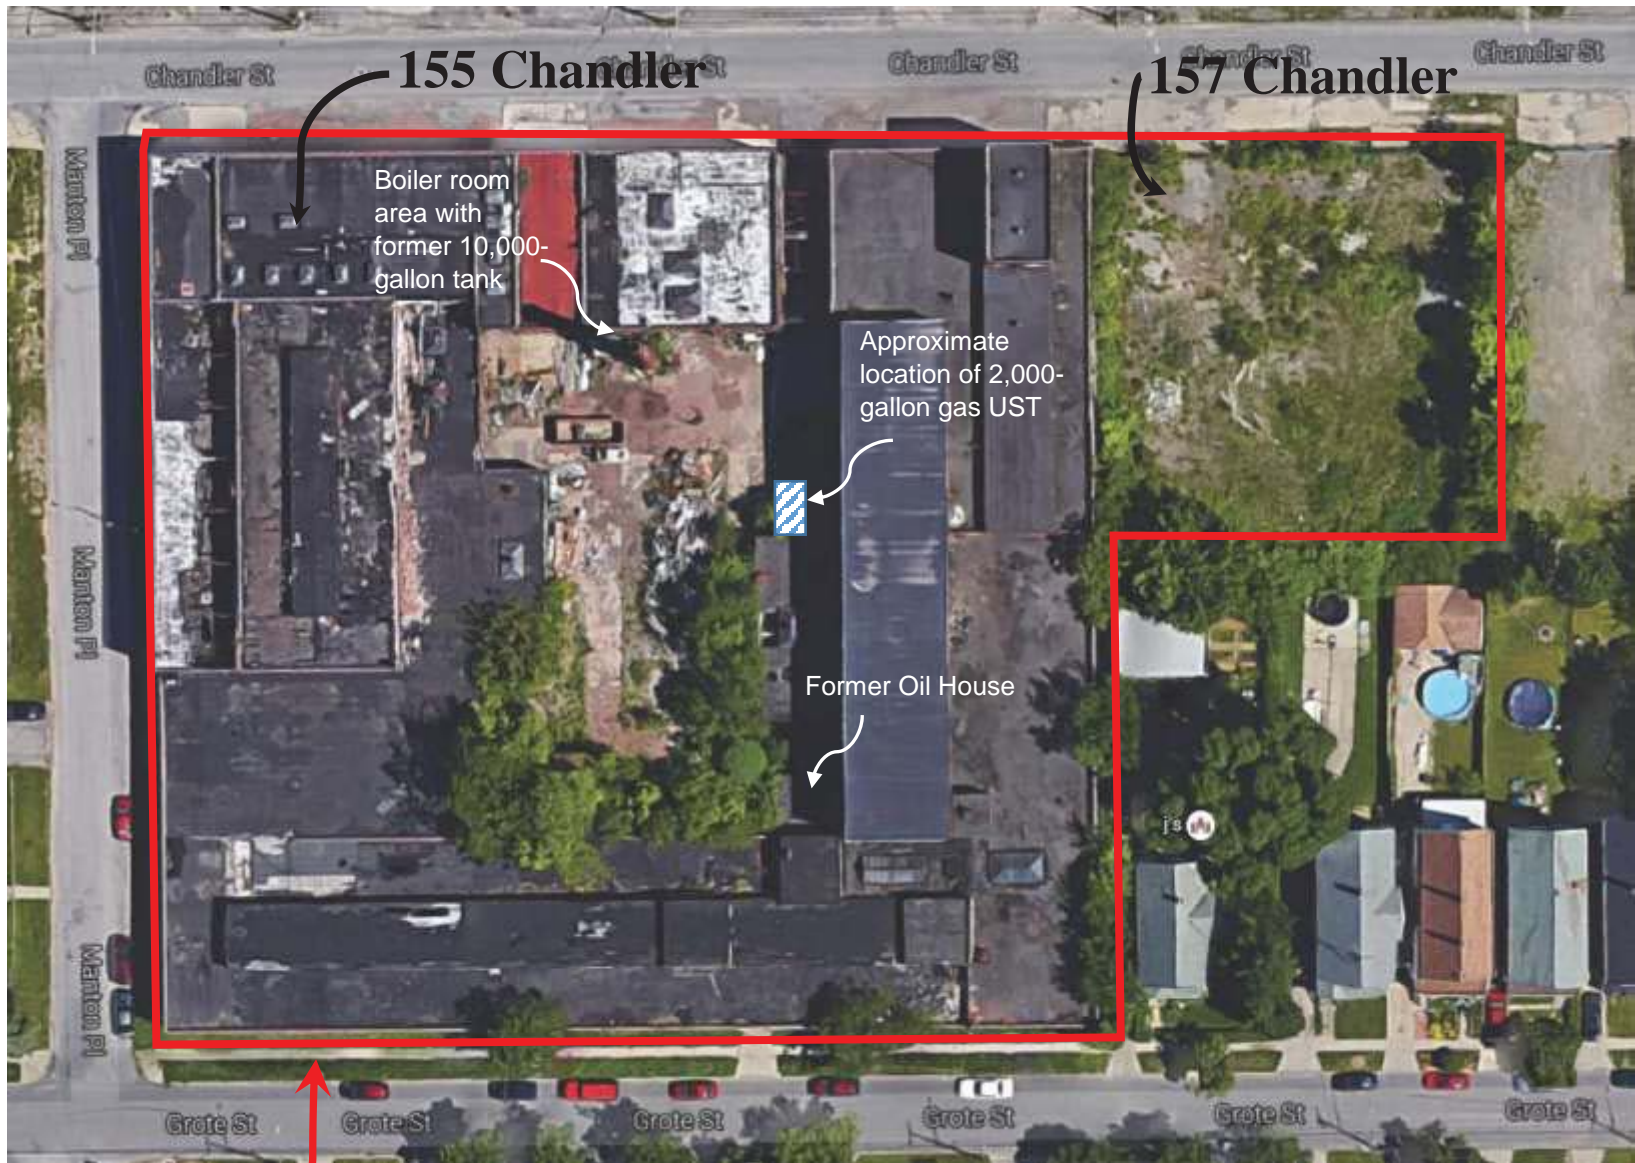
**155 Chandler**

**157 Chandler**

Boiler room area with former 10,000-gallon tank

Approximate location of 2,000-gallon gas UST

Former Oil House

**BCP Boundary Limits**

<b>HAZARD EVALUATIONS, INC.</b>		
<i>Phase I/II Audits – Site Investigations – Facility Inspections</i>		
<b>SITE LIMITS</b>		
155 and 157 CHANDLER STREET BUFFALO, NEW YORK		
<b>R &amp; M LEASING LLC</b>		
BUFFALO, NEW YORK		
DRAWN BY: LSH	SCALE: NOT TO SCALE	PROJECT: e1601
CHECKED BY: EB	DATE: 10/16	FIGURE

Location – This 2.37 acres site consists of two contiguous parcels (155-157 Chandler Street) in the City of Buffalo. The site is bound to the north by Chandler Street, to the west by Manton Place, and to the south by Grote Street. The property is located within a mixed industrial, commercial, and residential area.

Site Features – The 155 Chandler parcel is improved with one 65,000 square foot building which surrounds a large 22,000 square foot brick and gravel courtyard. The 157 Chandler parcel is a vacant gravel lot.
