Subject: Annual LUC Inspection Report, Sites 1, 2, and 3 — NWIRP Bethpage

Date: February 2016

This memorandum documents the inventory of 123 groundwater monitoring wells for NWIRP Bethpage shown in Figure 1. The purpose of the well inventory was to locate, photograph, evaluate the physical condition of, and measure the groundwater level and depth of each well to assure that data collected from these wells is representative of subsurface conditions, and to evaluate the physical condition of each well.

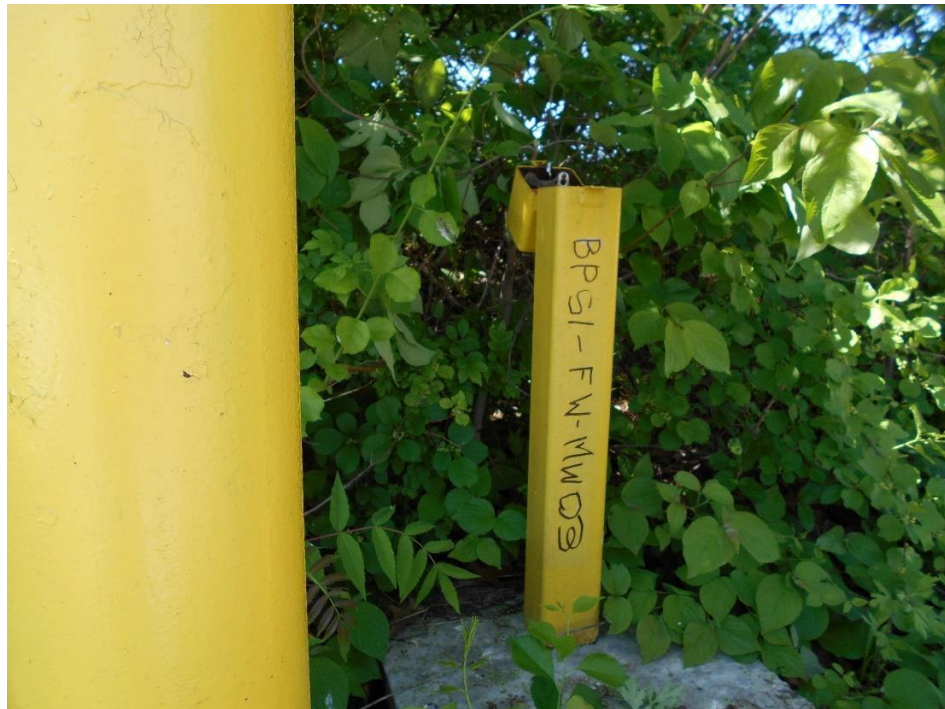
Photo 4: Site 1- BPS1-FW-MW03

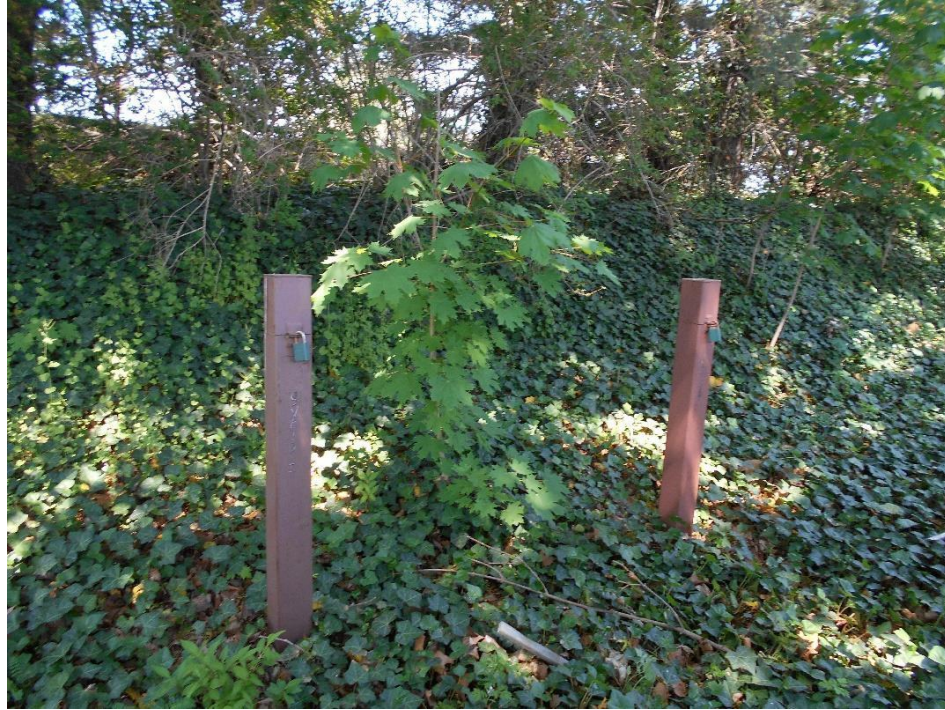
*Photo 9:* Site 1- SVE 1011 + SVE 101D

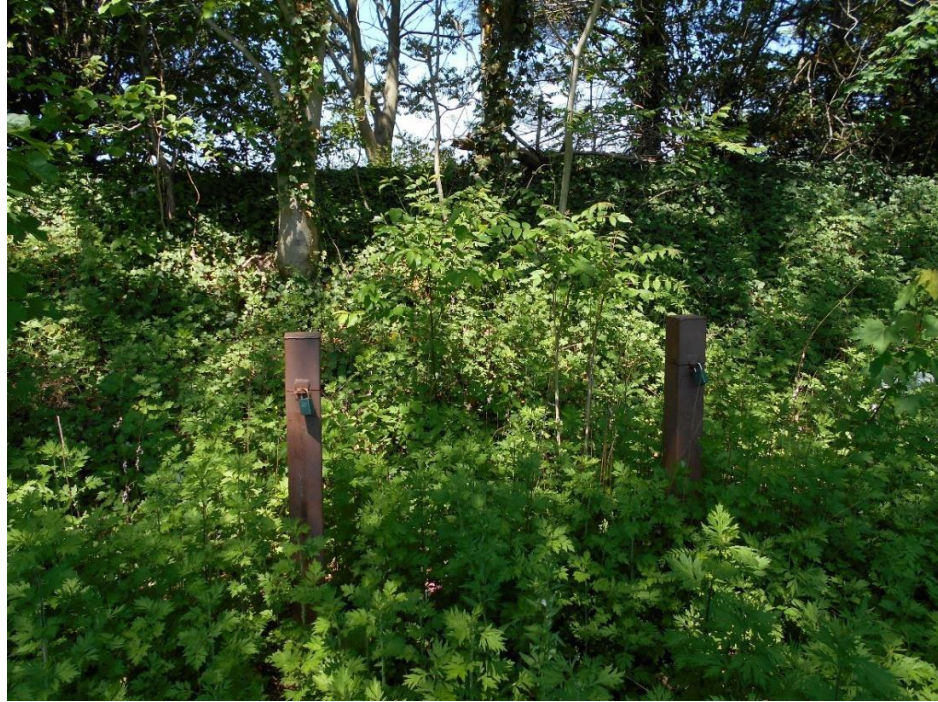
*Photo 15:* Site 1- SVE 104I and SVE 104D

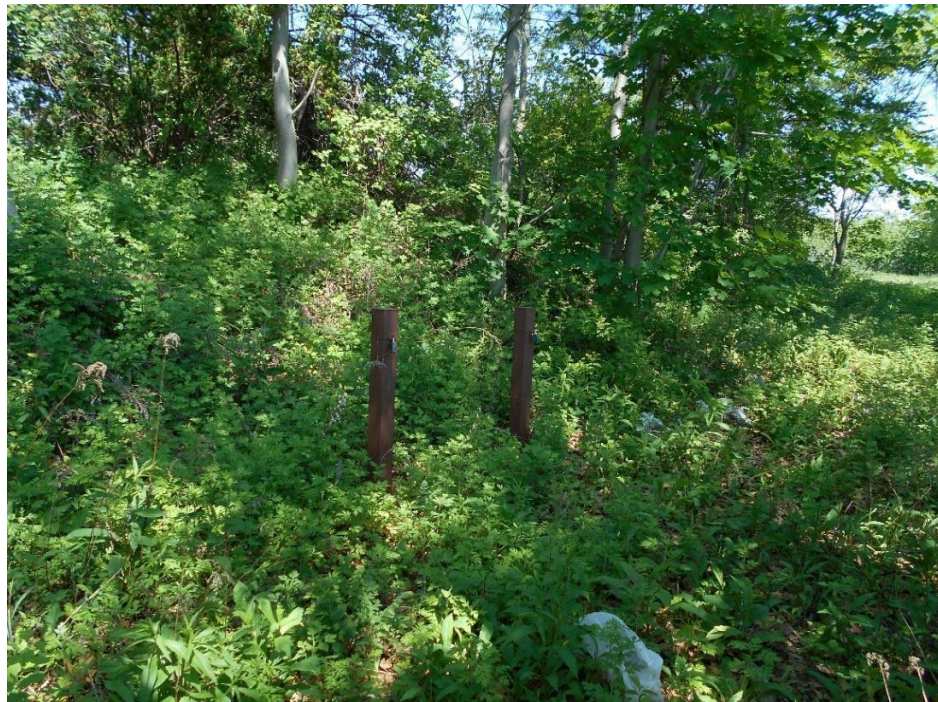
*Photo 16:* Site 1- SVE 105I and SVE 105D

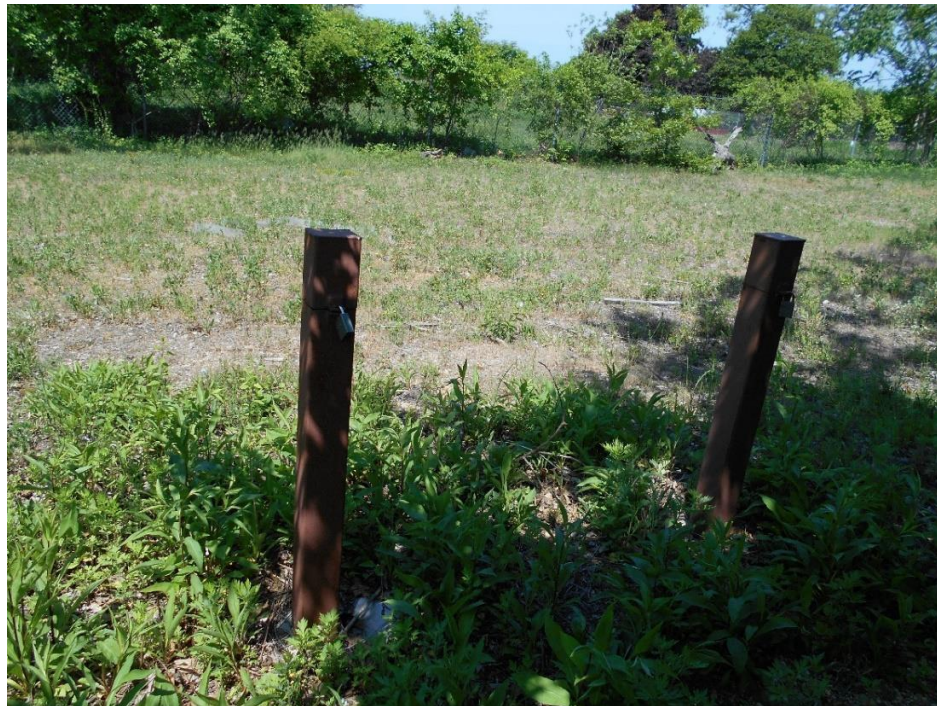
*Photo 18* Site 1- SVE 106I and SVE 106D

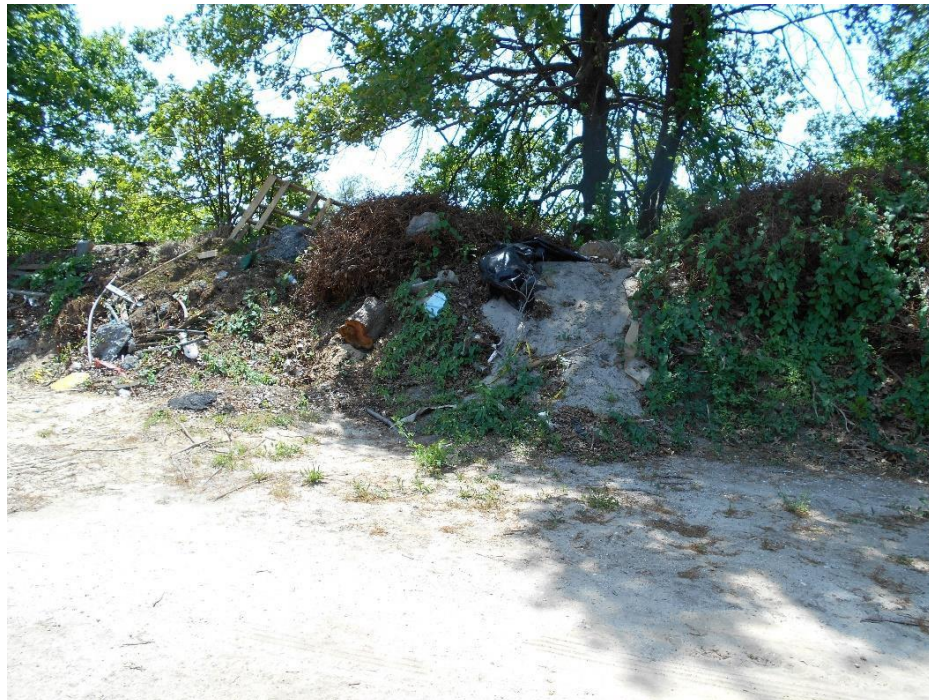
*Photo 24* Site 2- Debris across from 308

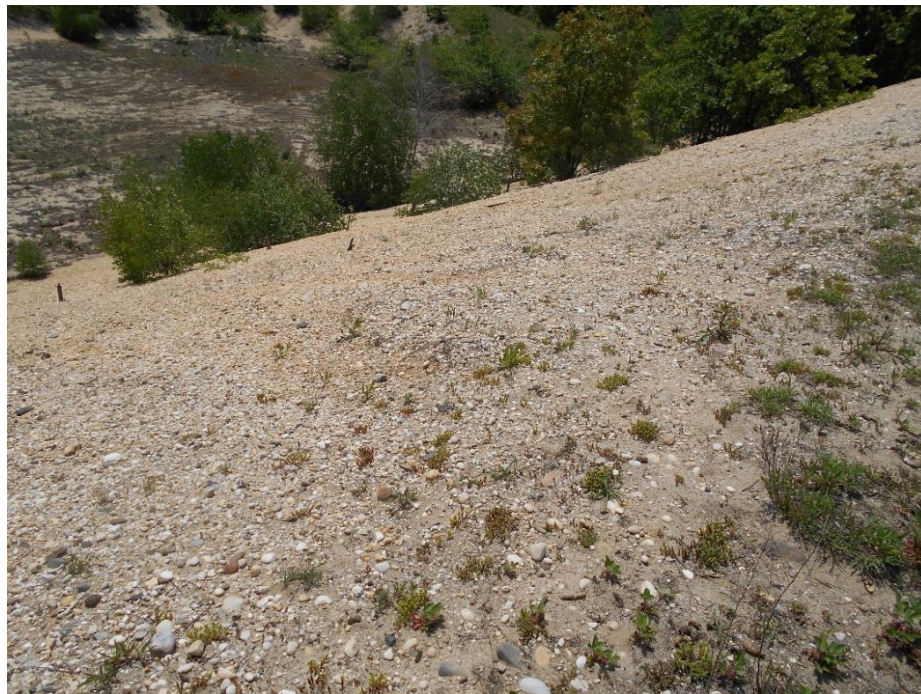
*Photo 28:* Site 2- Southeast basin, north wall

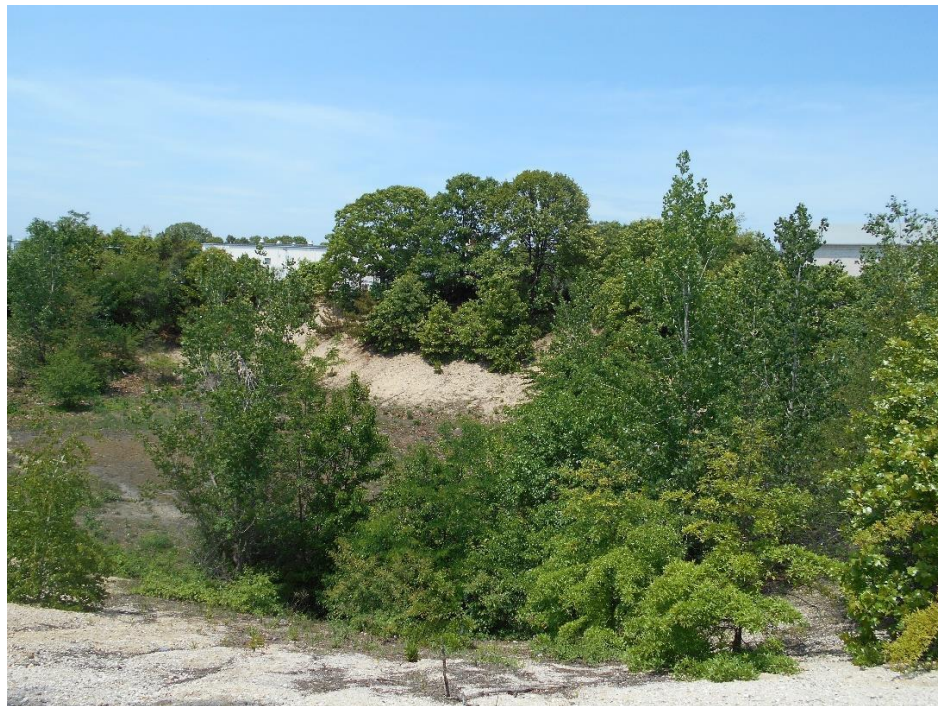
*Photo 36:* Site 2- Southwest basin

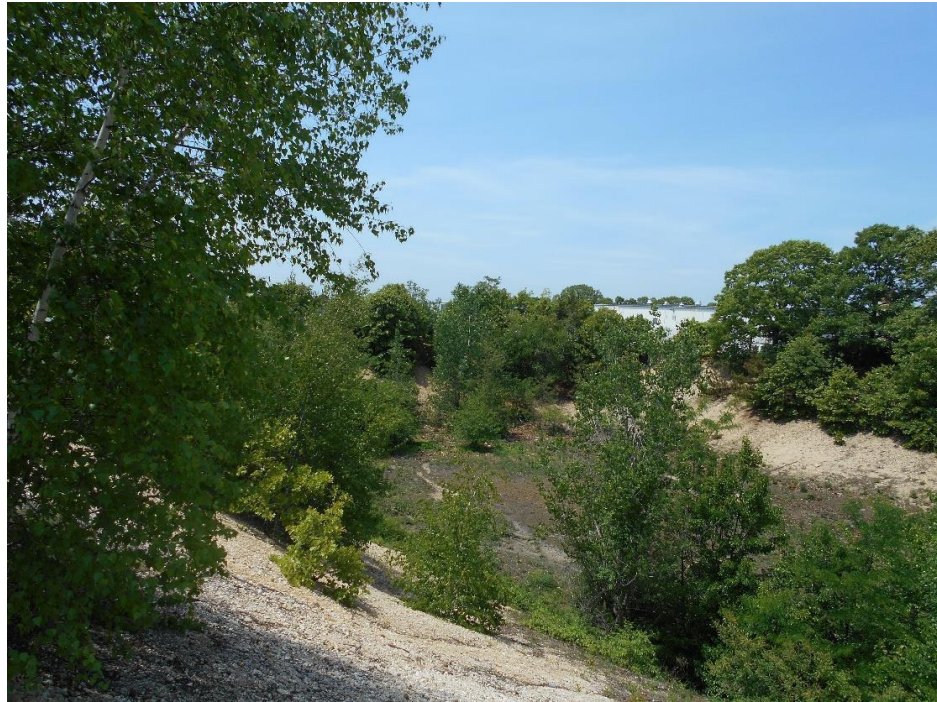
*Photo 37:* Site 2- Southwest basin

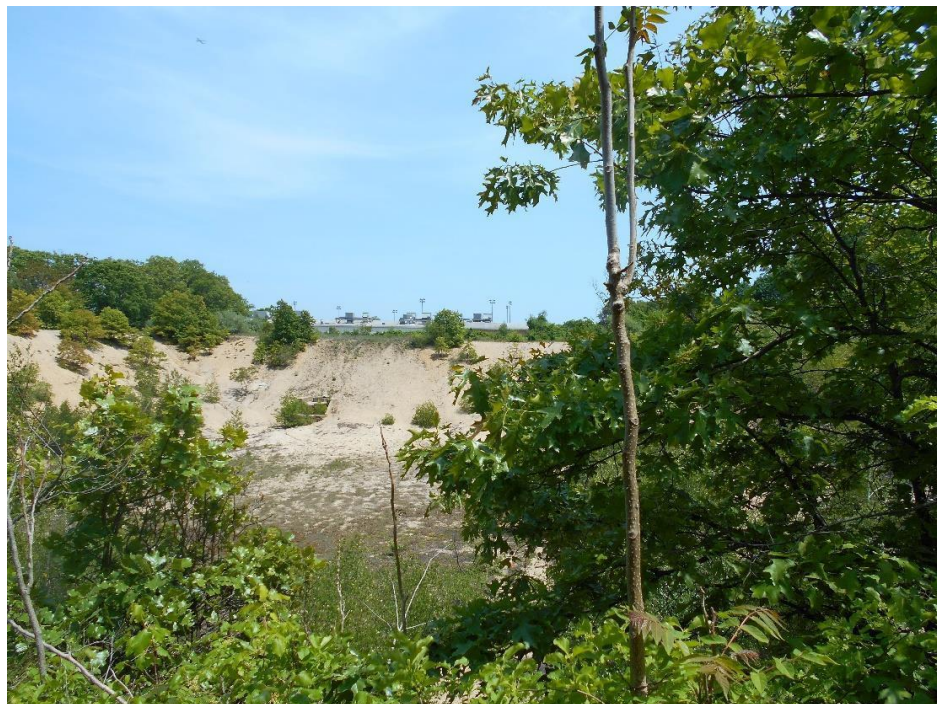
*Photo 38:* Site 2- Southeast basin from east

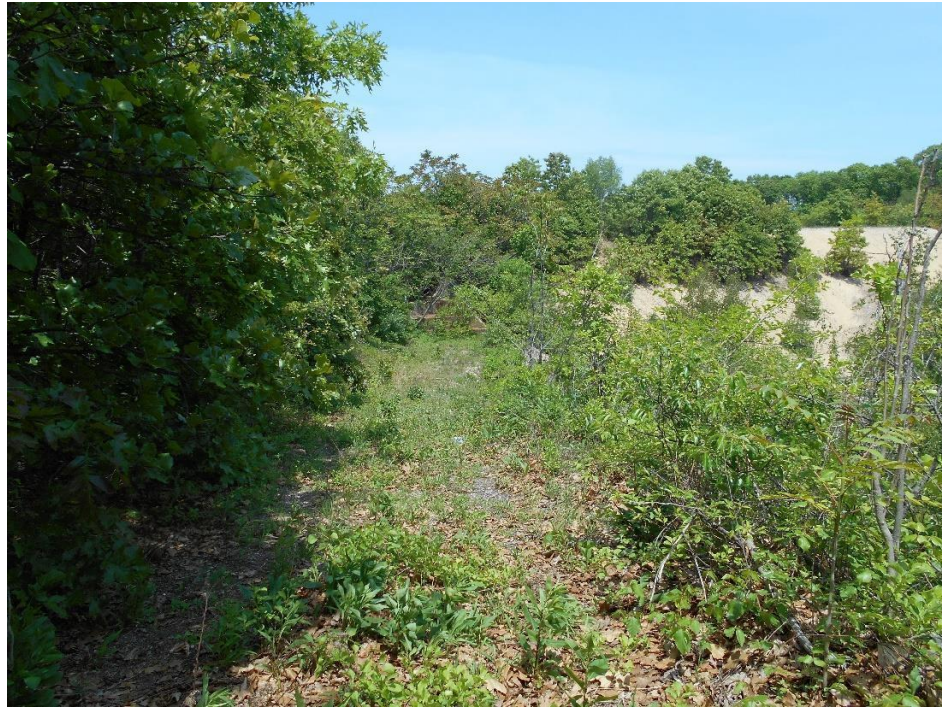
*Photo 39:* Site 2- Southeast basin facing north

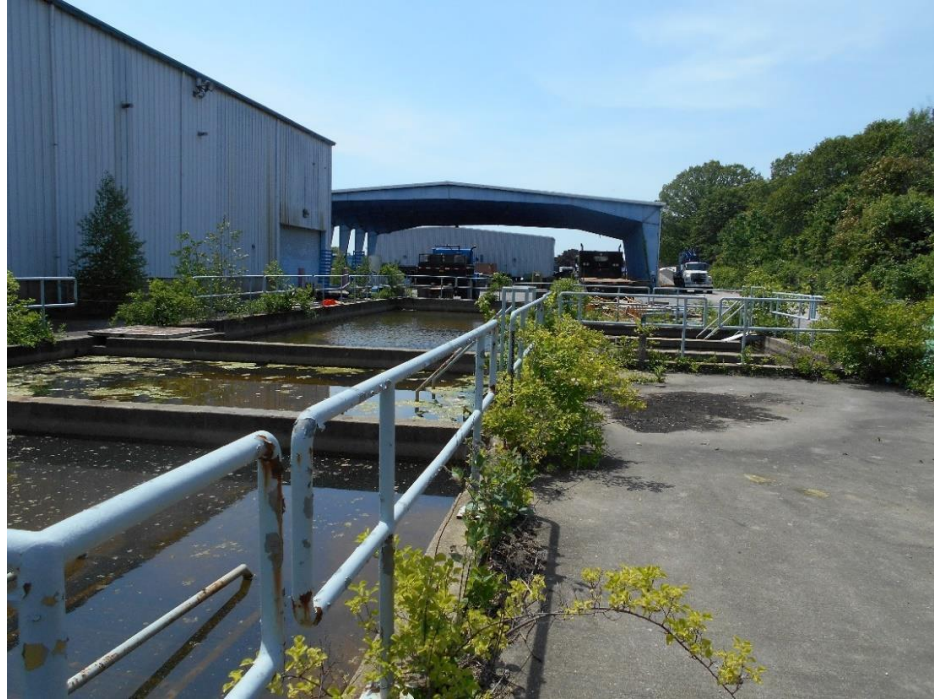
*Photo 41:* Site 3- Basins outside county building

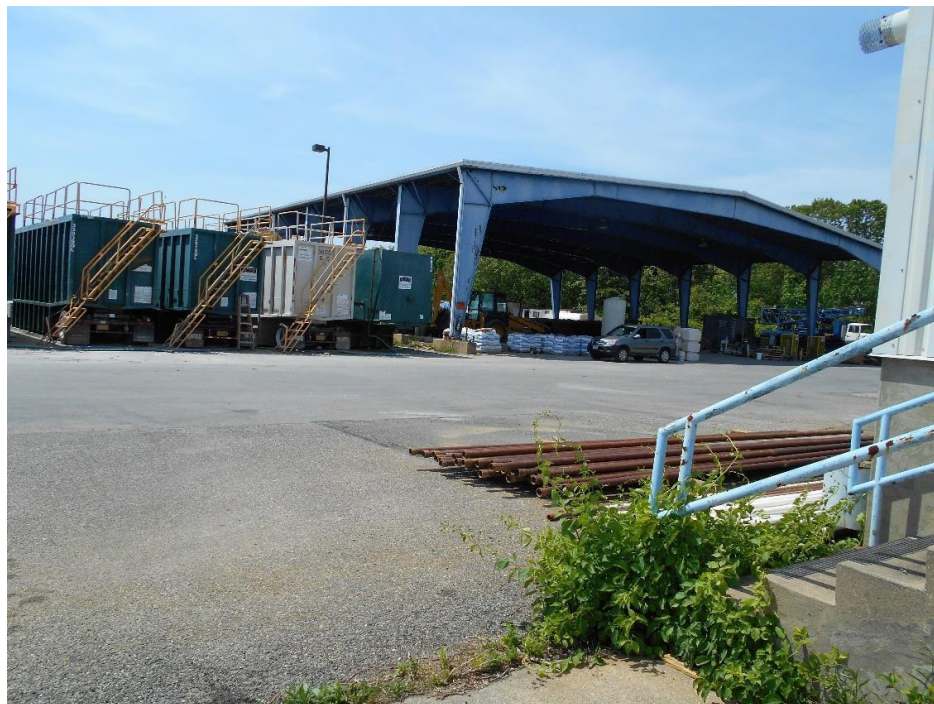
Photo 44: Site 3- Staging area

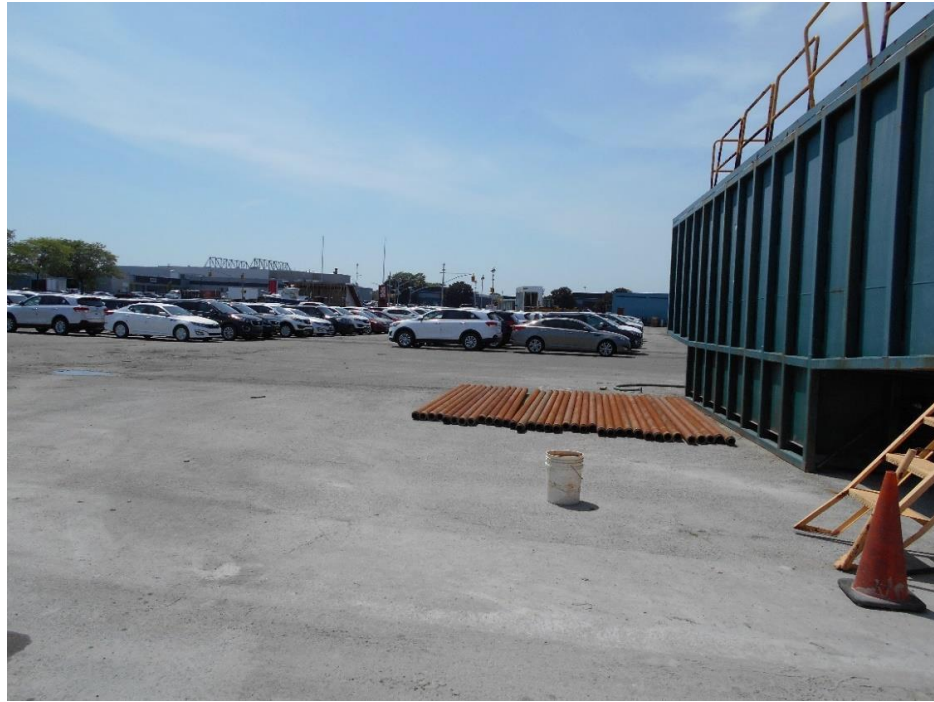
*Photo 45:* Site 3- Kias

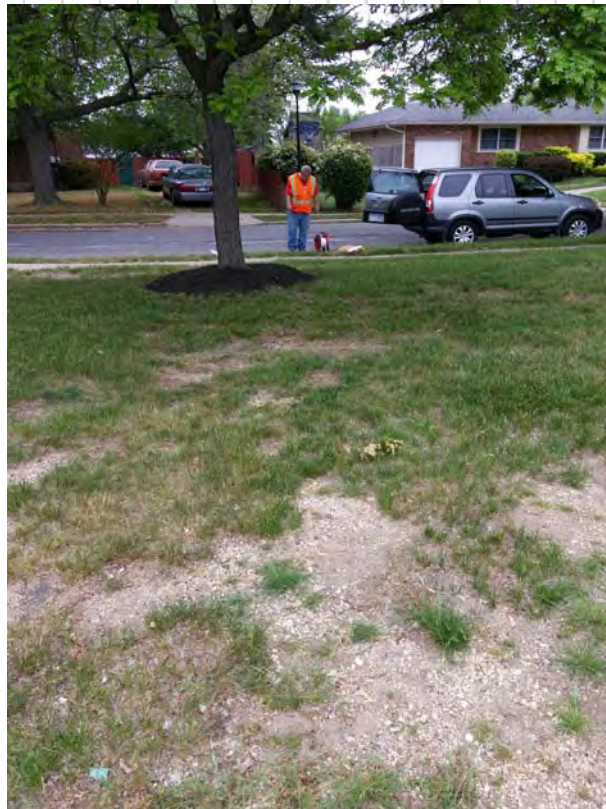
<b>Needs Bolts:</b>	No
<b>Needs Lock:</b>	Yes
<b>Date/Time Measured:</b>	5/28/2015 2:15:38 PM
<b>Depth of Water:</b>	34.36
<b>Depth of Boring:</b>	760
<b>Notes:</b>	052815 needs locking J plug but has bladder pump setup
Note: N/A - not applicable

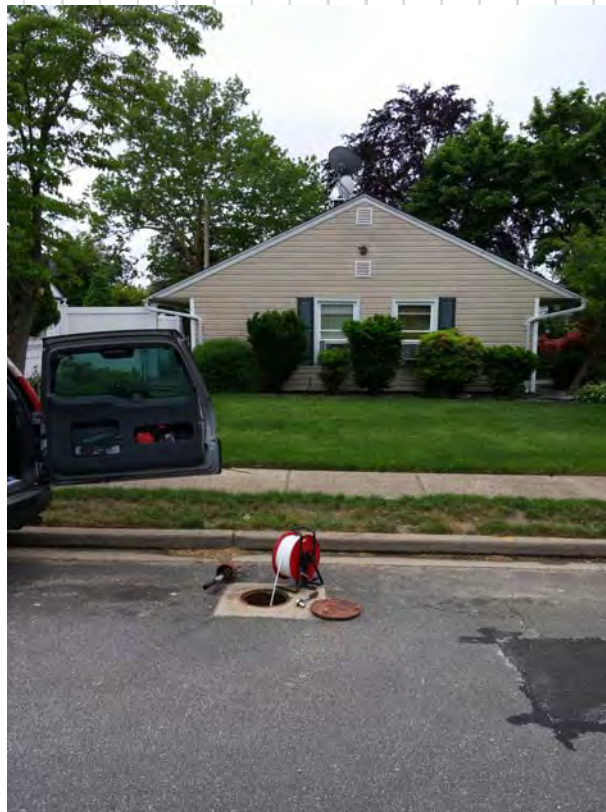
<b>Needs Bolts:</b>	Yes
<b>Needs Lock:</b>	Yes
<b>Date/Time Measured:</b>	5/28/2015 4:30:26 PM
<b>Depth of Water:</b>	34.78
<b>Depth of Boring:</b>	743
<b>Notes:</b>	052815 needs J plug with lock and the transducer to be hung from that J plug, two bolts stripped out, grout has expanded and some needs to be removed
Note: N/A - not applicable

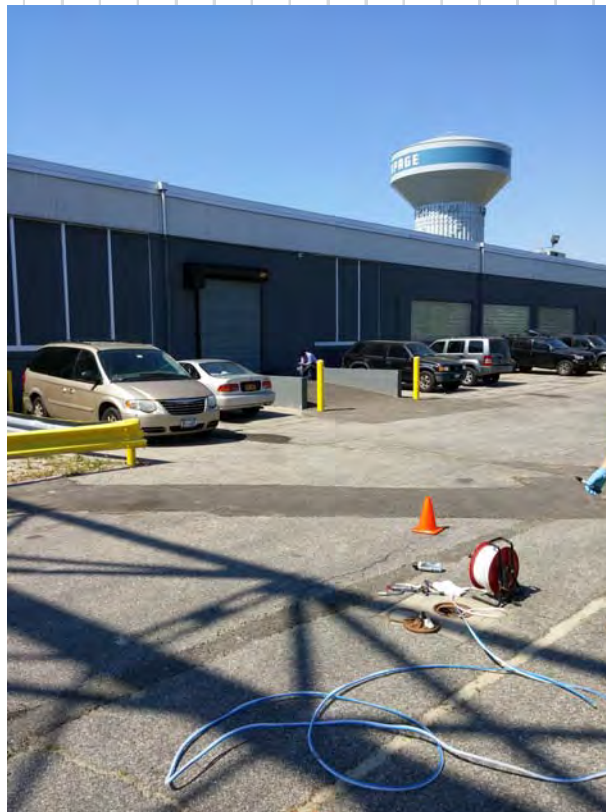
<b>Needs Bolts:</b>	Yes
<b>Needs Lock:</b>	No
<b>Date/Time Measured:</b>	5/28/2015 10:12:00 AM
<b>Depth of Water:</b>	47.25
<b>Depth of Boring:</b>	61.95
<b>Notes:</b>	Site 4; 10:12, 2 bolt ears broken

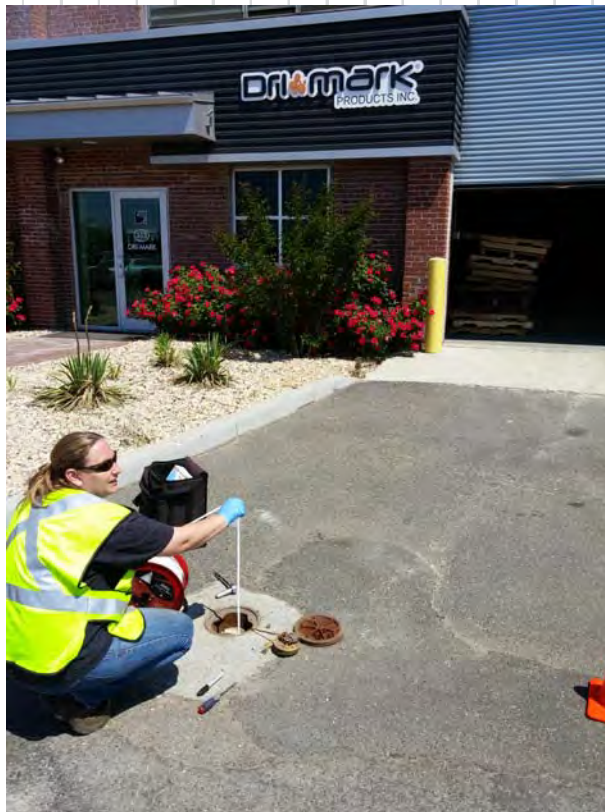
<b>Field Inventory Results</b>	
<b>Needs Bolts:</b>	Yes
<b>Needs Lock:</b>	No
<b>Date/Time Measured:</b>	5/26/2015 2:13:26 PM
<b>Depth of Water:</b>	50.9
<b>Depth of Boring:</b>	64.6
<b>Notes:</b>	Site 4; 11:18; 1 bolt needs to be rethreaded
Note: N/A - not applicable

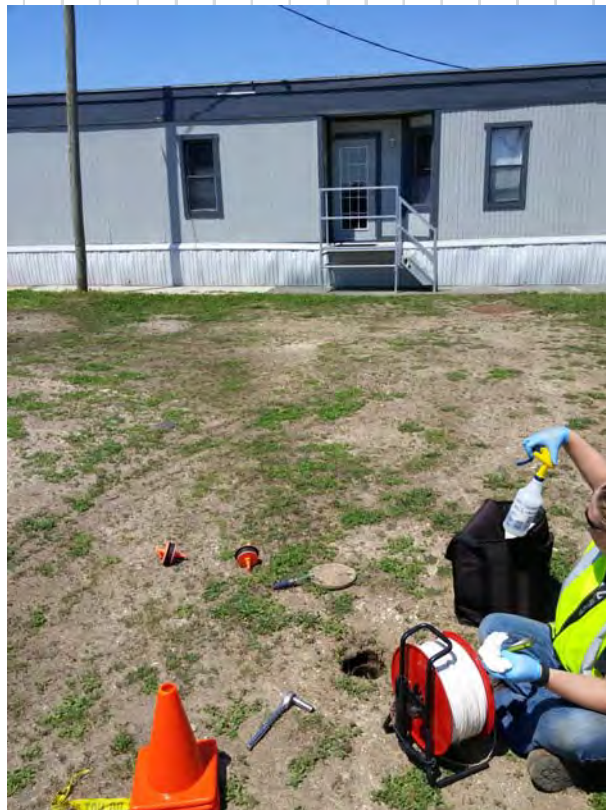
<b>Needs Bolts:</b>	Yes
<b>Needs Lock:</b>	Yes
<b>Date/Time Measured:</b>	5/26/2015 4:03:16 PM
<b>Depth of Water:</b>	51.95
<b>Depth of Boring:</b>	67.02
<b>Notes:</b>	Site 4; 11:32; OLM blebs at 51.95', tape coated with OLM bottom 6", needs j-plug, bolts, and lock; riser pipe will need to be cut down to accommodate a j-plug
Note: N/A - not applicable

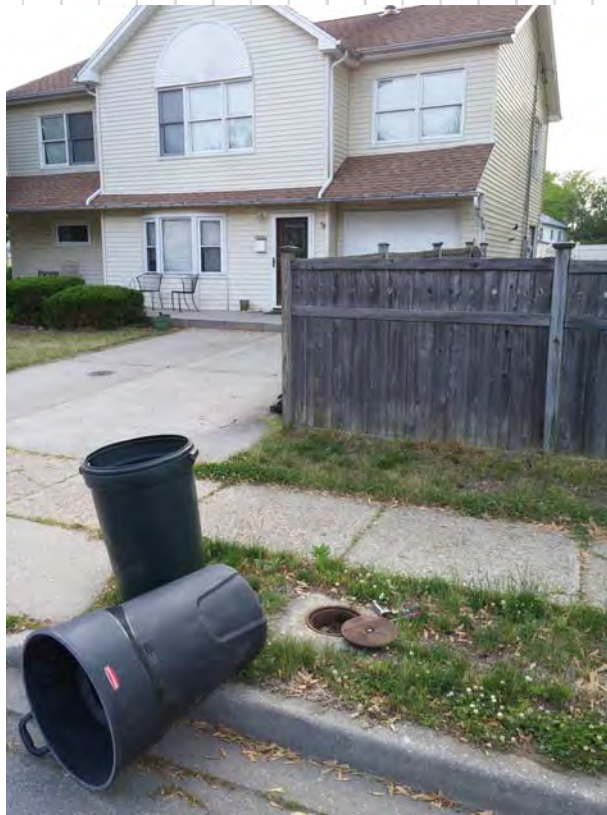
<b>Field Inventory Results</b>	
<b>Needs Bolts:</b>	No
<b>Needs Lock:</b>	No
<b>Date/Time Measured:</b>	5/28/2015 4:53:00 PM
<b>Depth of Water:</b>	39.51
<b>Depth of Boring:</b>	112
<b>Notes:</b>	052815 some sand needs to be removed from wellbox
Note: N/A - not applicable

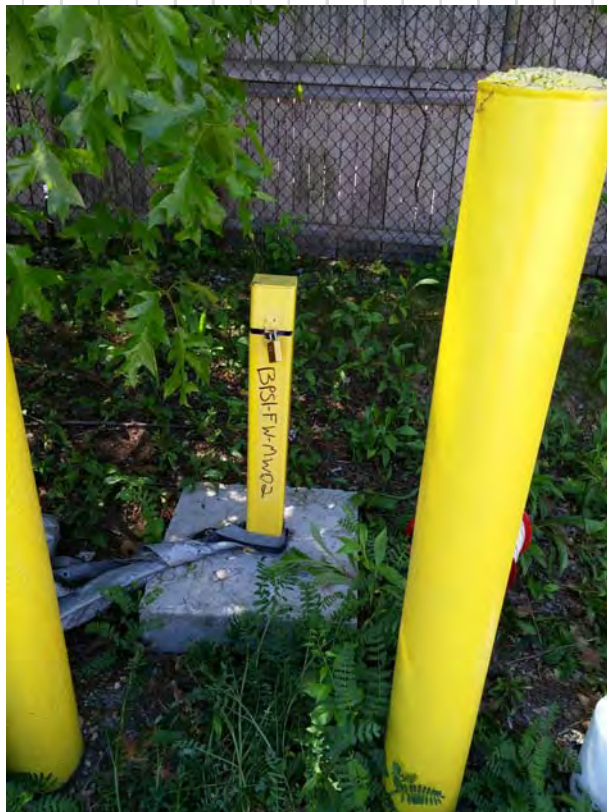
<b>Field Inventory Results</b>	
<b>Needs Bolts:</b>	No
<b>Needs Lock:</b>	No
<b>Date/Time Measured:</b>	5/26/2015 7:12:00 AM
<b>Depth of Water:</b>	55.47
<b>Depth of Boring:</b>	64
<b>Notes:</b>	052615 j-plug needs repair
Note: N/A - not applicable
