SMP Photolog – Vault Sampling

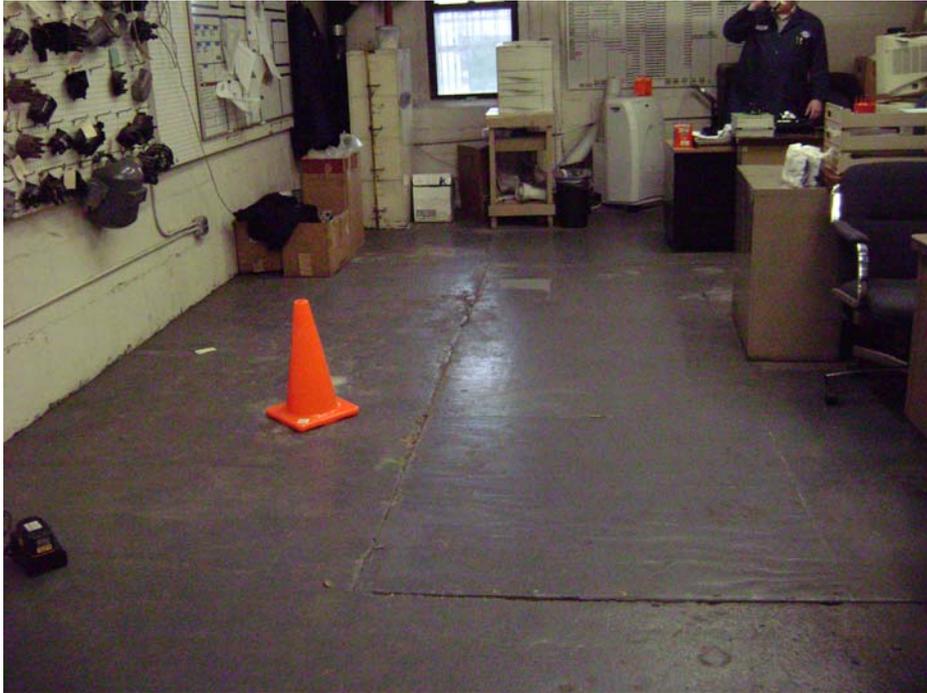
Photo #1: Vault #1 located to the right of MW15 (orange cone) facing south.

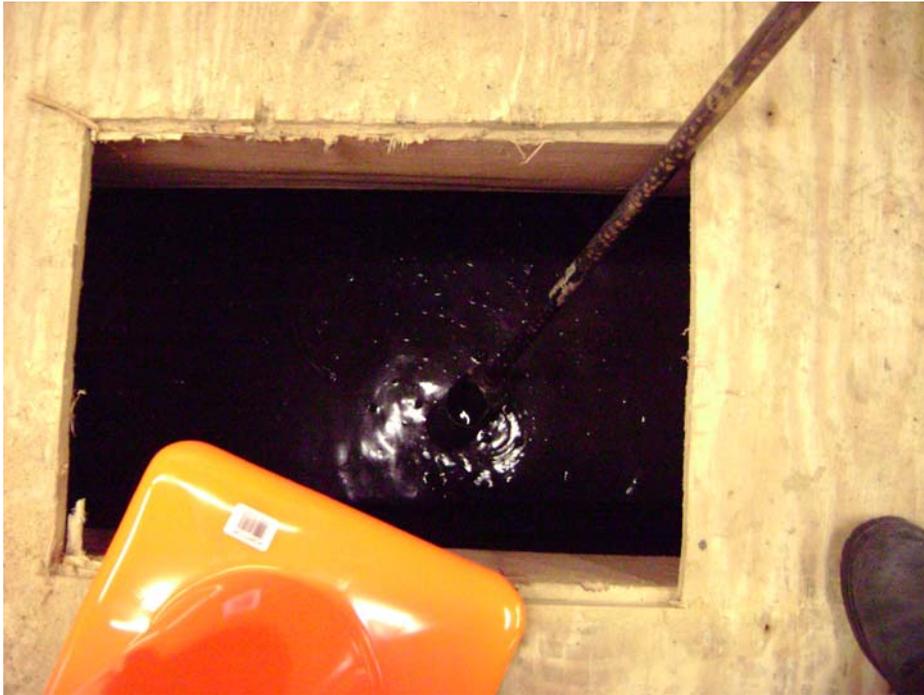
Photo #3: An approximate 2 by 2 foot square was cut in the center of the planks. An estimated six inches of water in Vault #1.

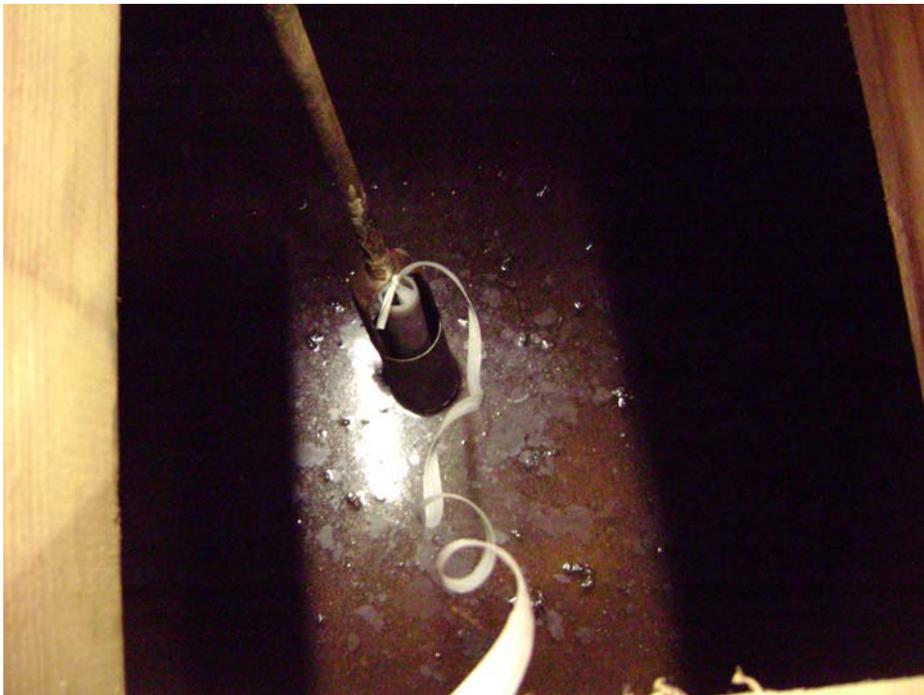
Photo #4: Collecting water sample from bottom of Vault with bailer and hand auger for assistance. Sheen visible on water.

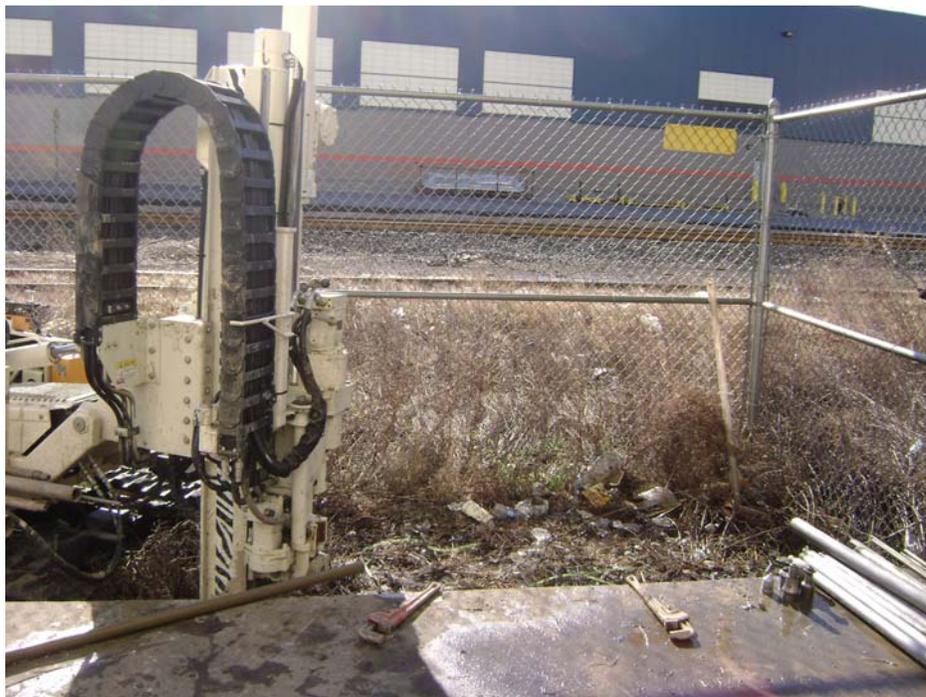
Photo #16: Installing MW14.

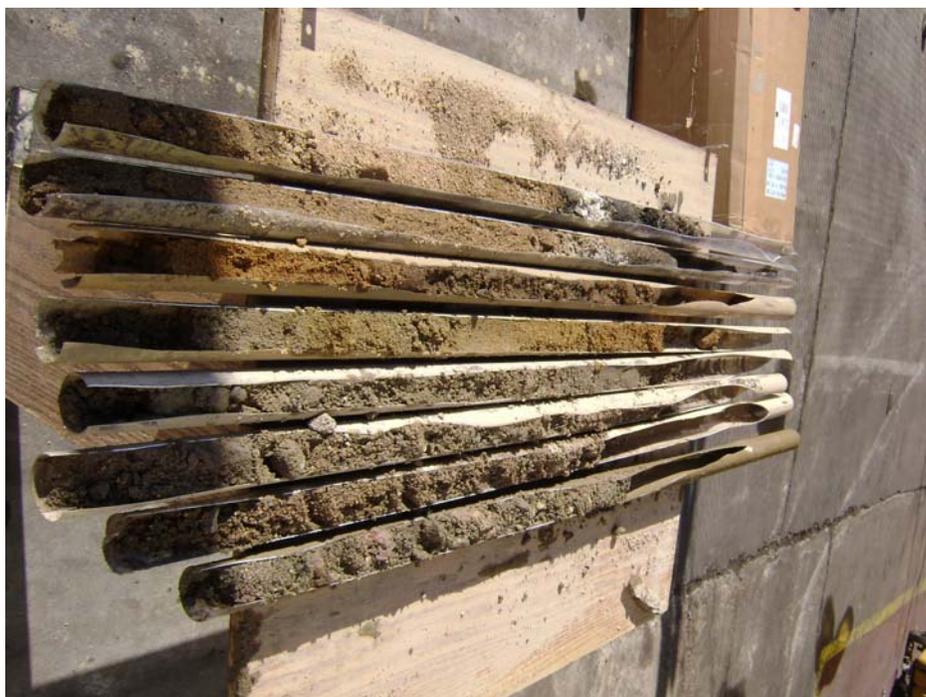
Photo #17: MW14 Soil Borings.

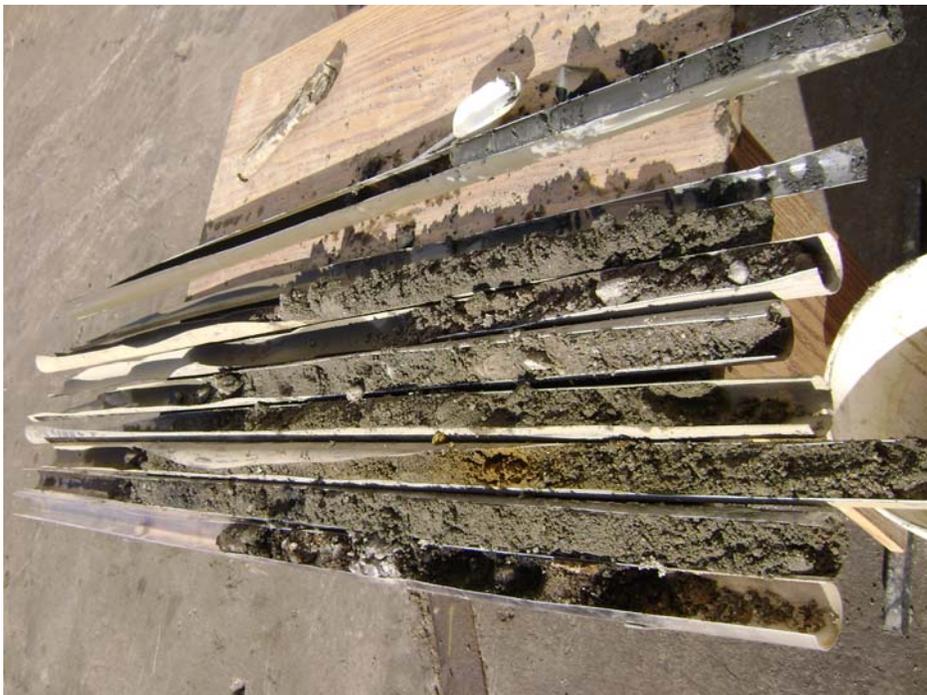
Photo #19: SG01 Soil Borings.

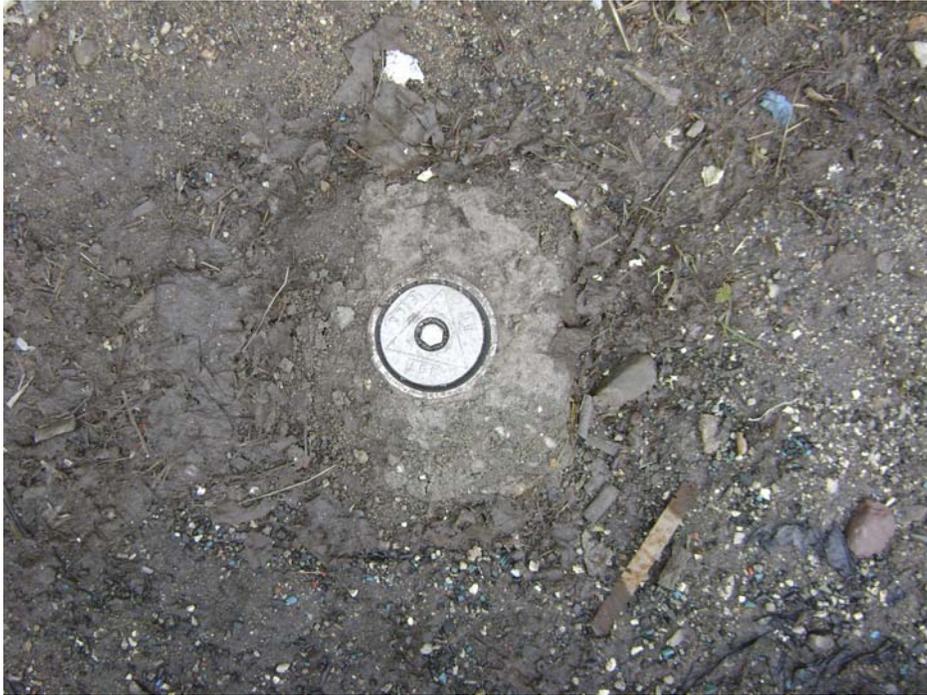
Photo #20: SG01 Soil Vapor Port.

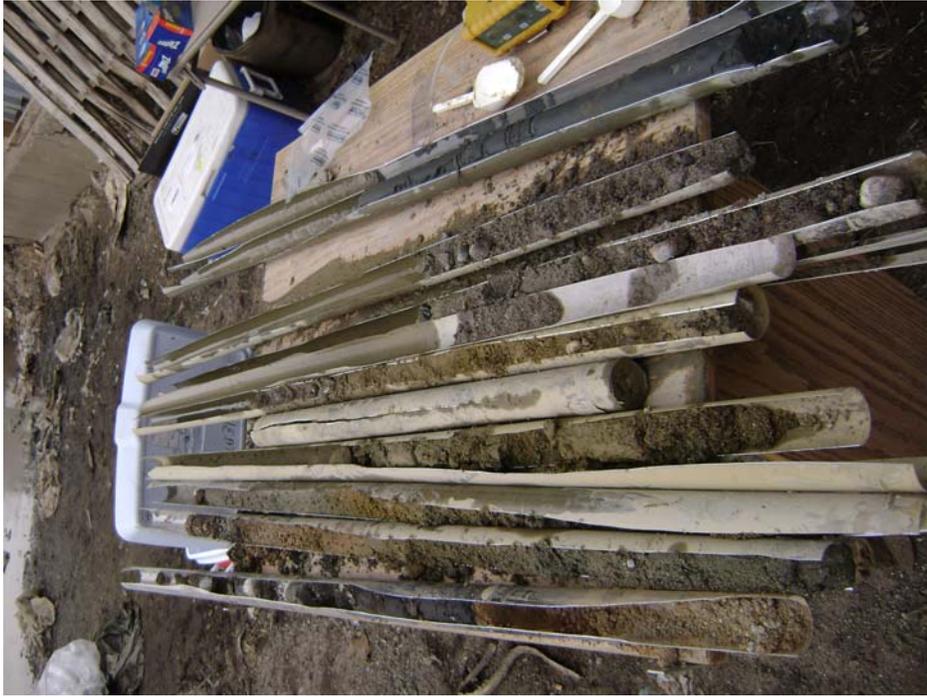
Photo #22: SG02 Soil Borings.

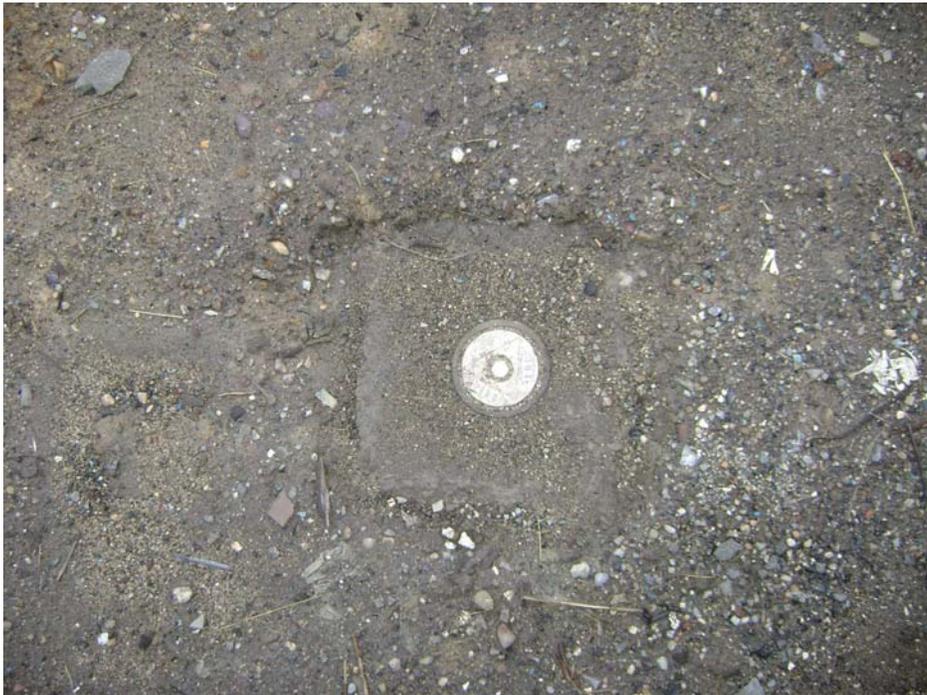
Photo #23: SG02 Soil Vapor Port.

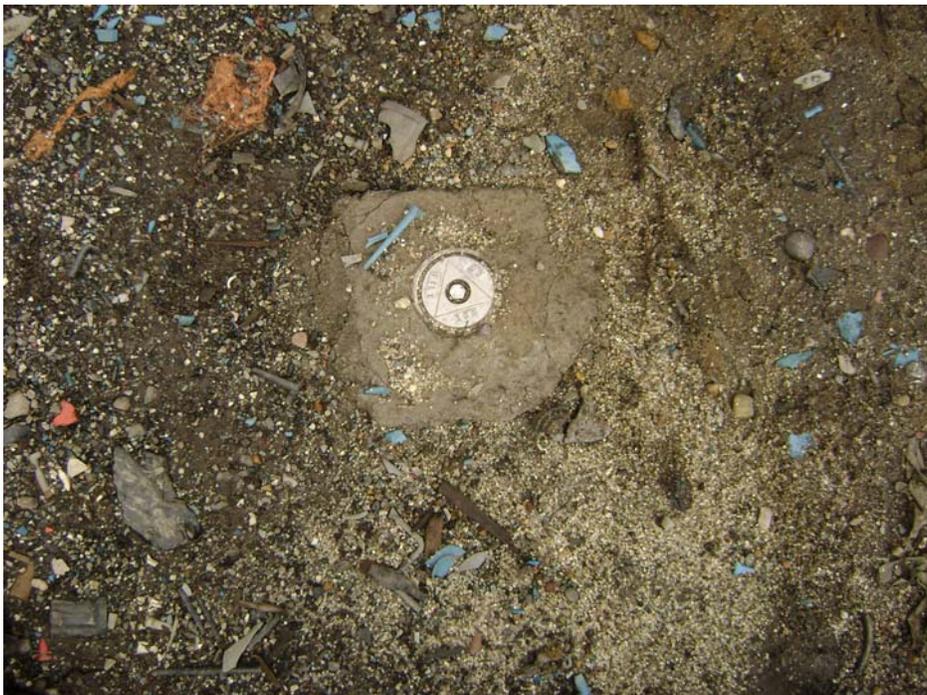
Photo #25: SG03 Soil Vapor Port.

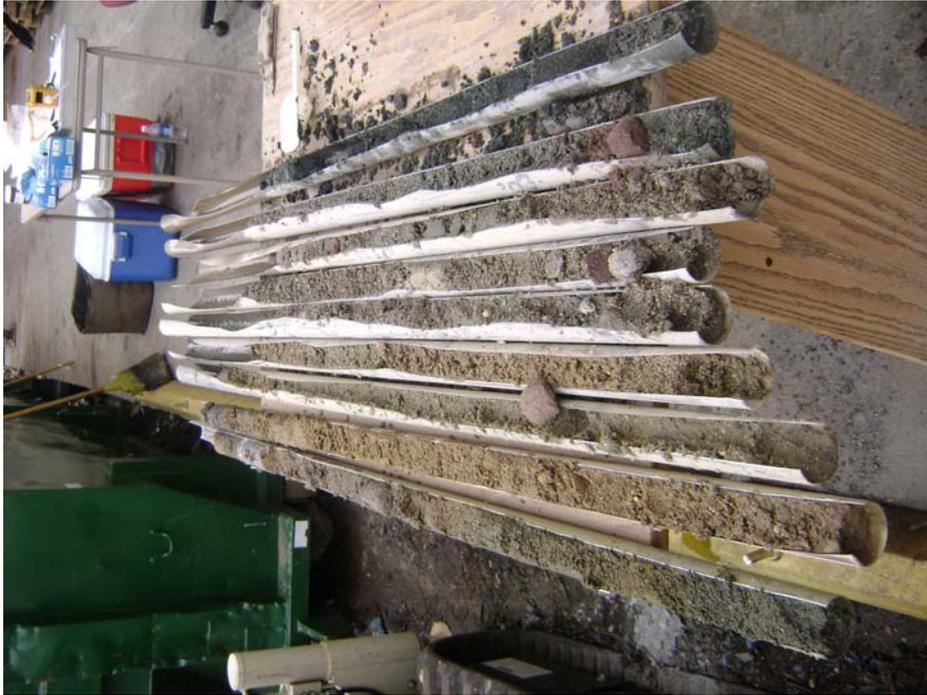
Photo #26: SG03 Soil Borings.

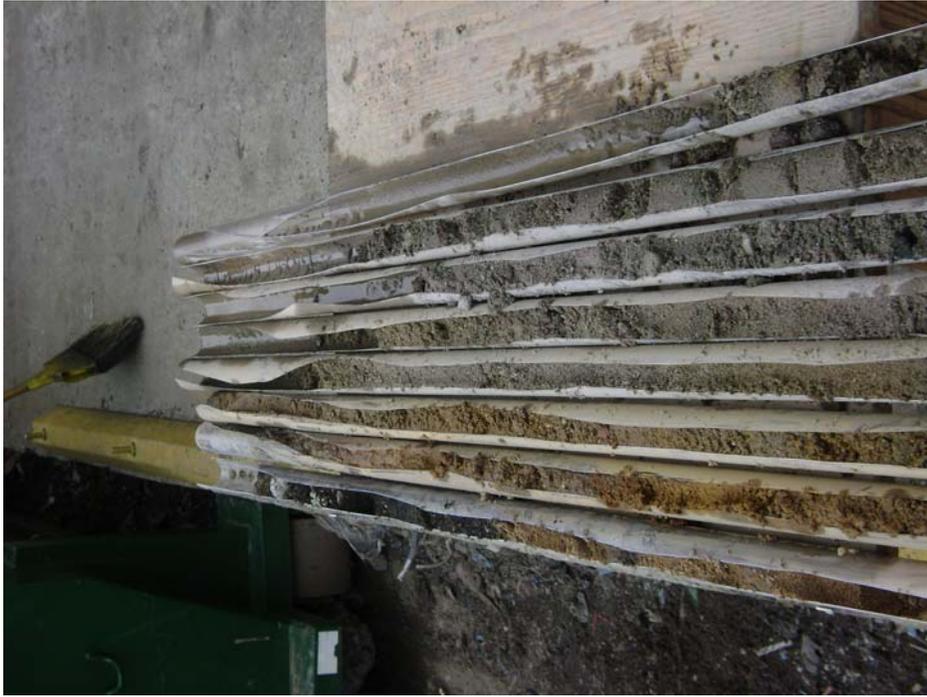
Photo #28: SG04 Soil Borings.

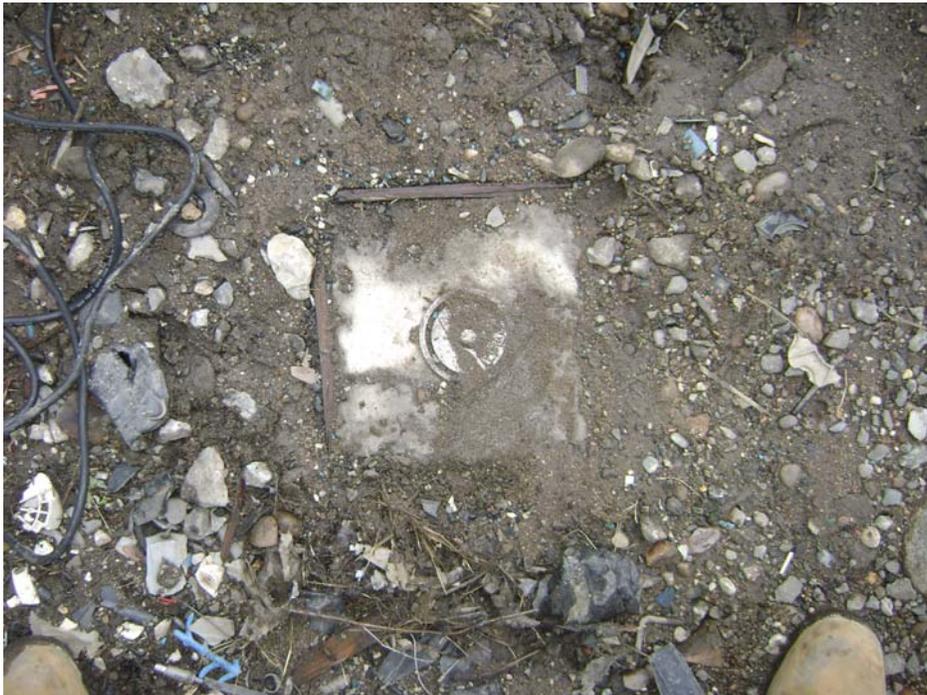
Photo #29: SG04 Soil Vapor Port.

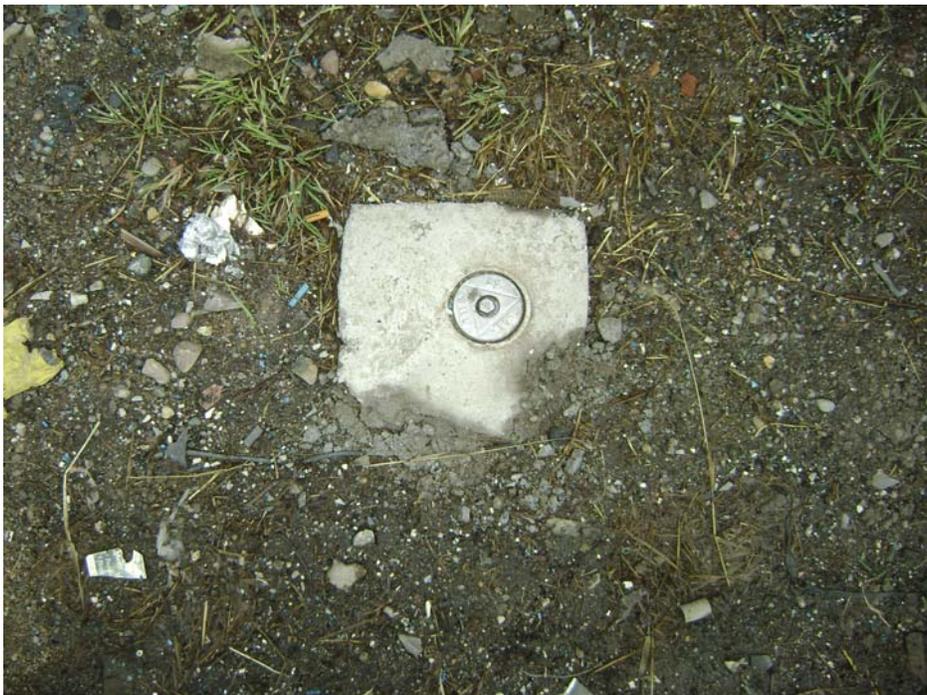
Photo #31: SG05 Soil Vapor Port.

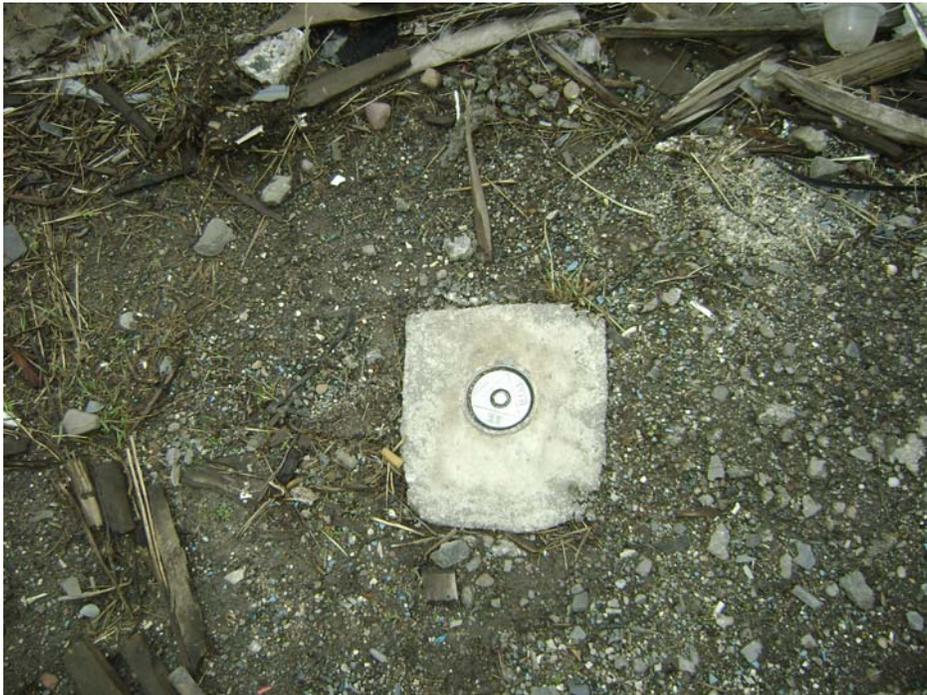
Photo #33: SG06 Soil Vapor Port.

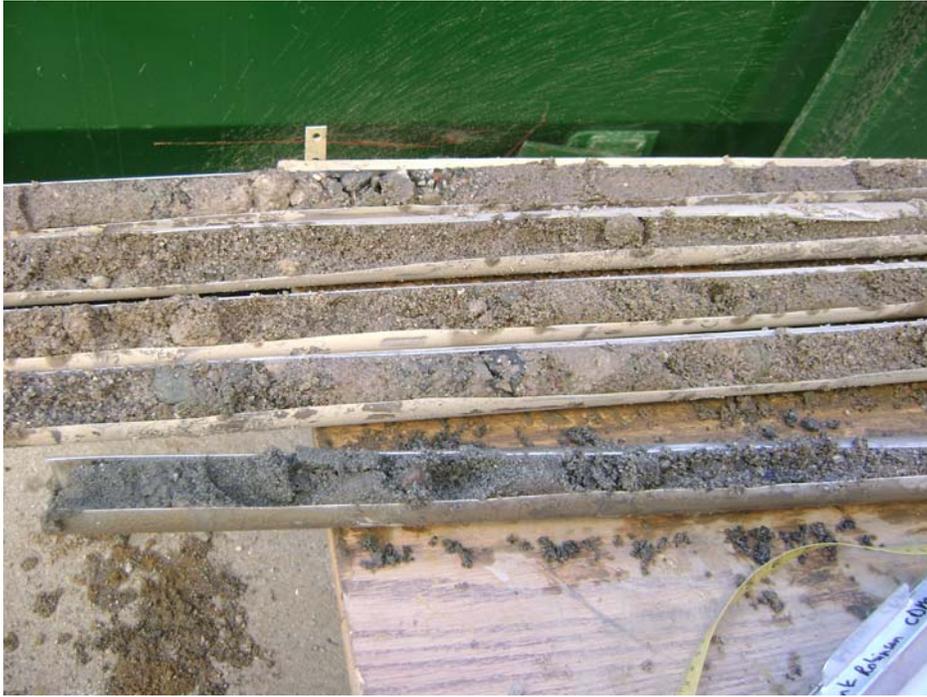
Photo #34: SG06 Soil Borings.

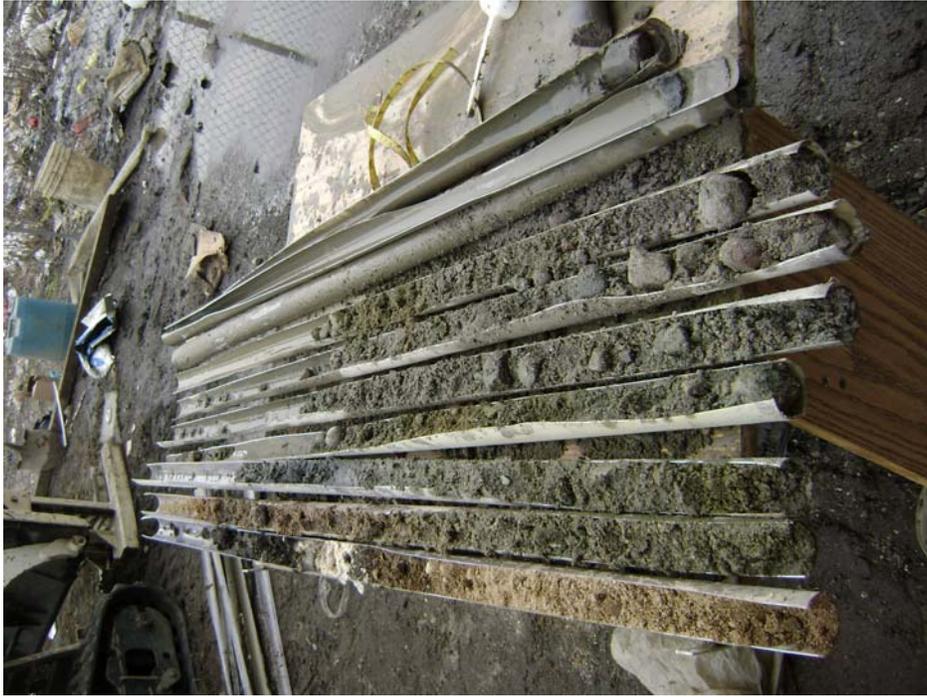
Photo #36: SG07 Soil Borings.

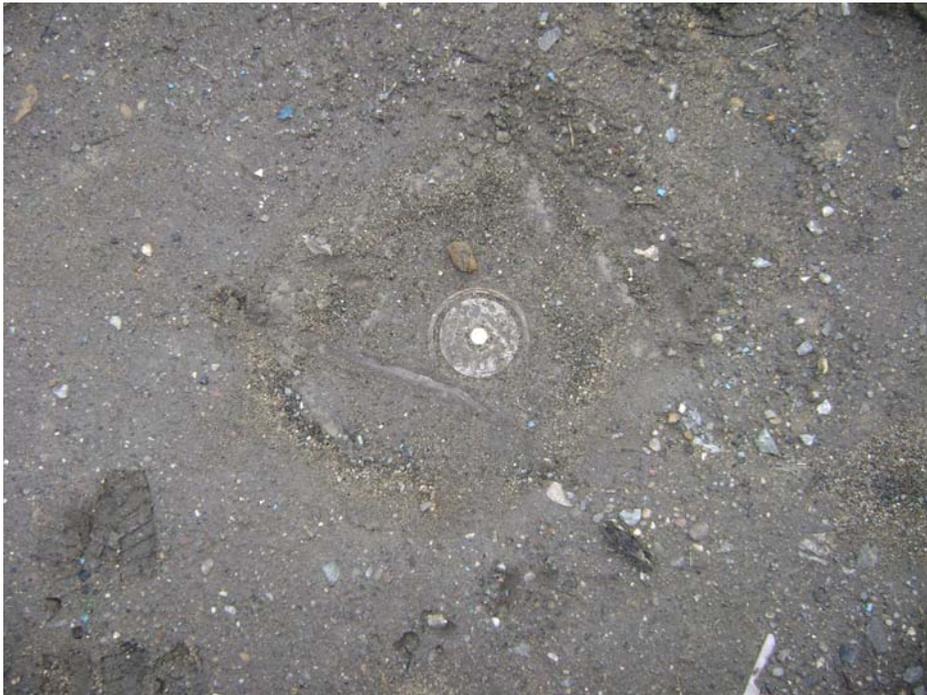
Photo #39: SG08 Vapor Port.

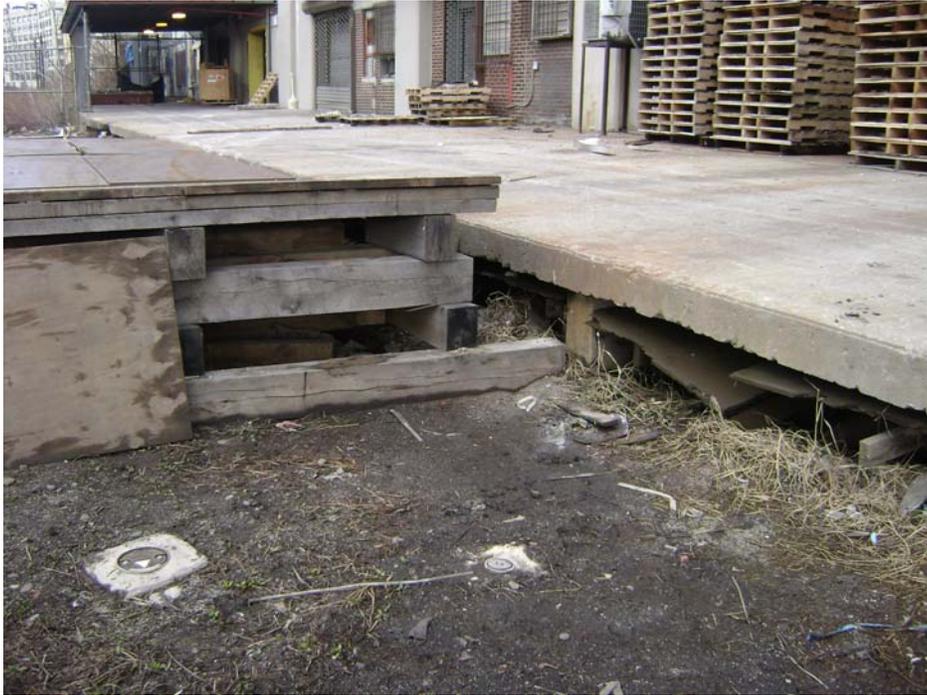
Photo #40: SG09 Location and MW16 (to the left).

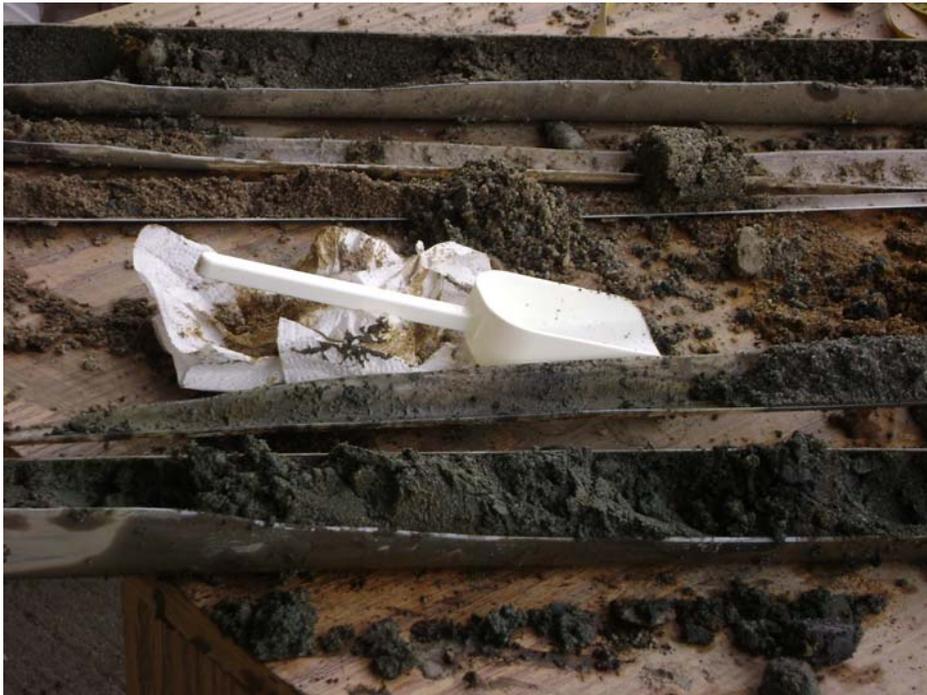
Photo #41: SG09 Soil Borings.

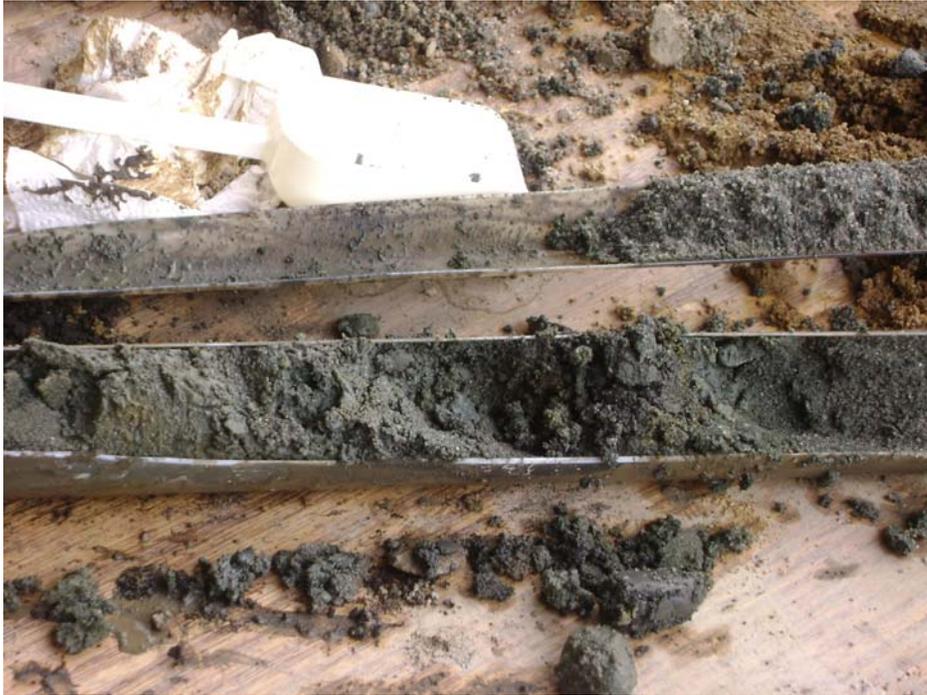
Photo #42:SG09 Soil Borings.

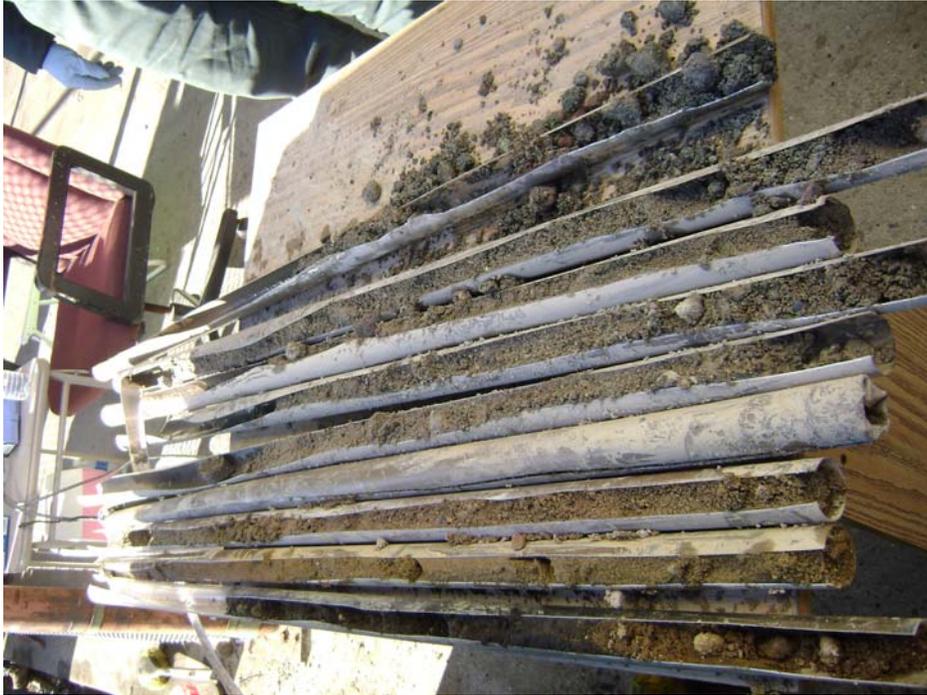
Photo #44: SG10 Soil Borings.

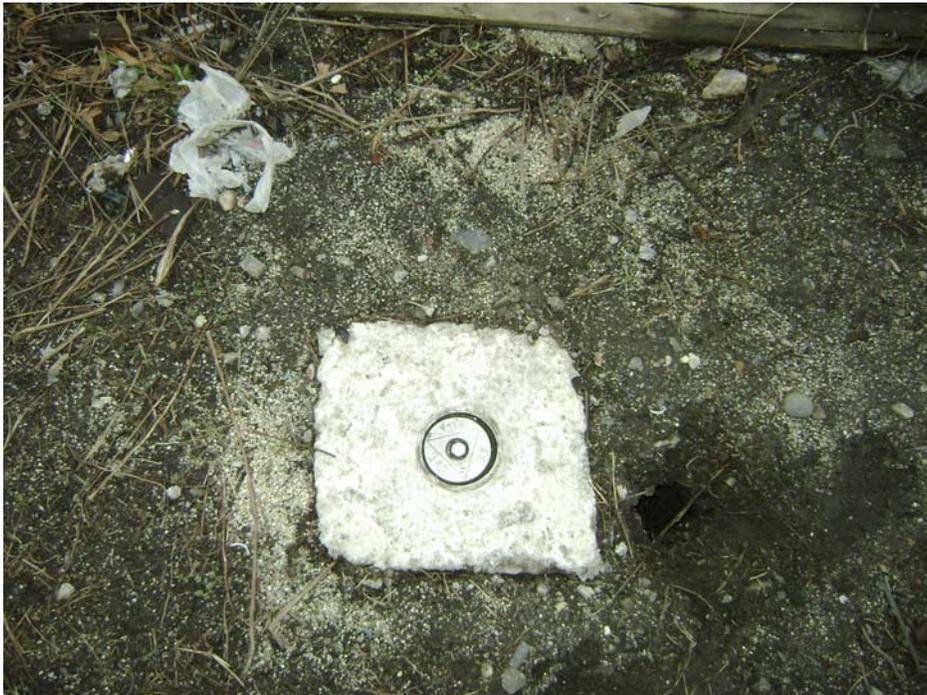
Photo #45: SG10 Soil Vapor Port.

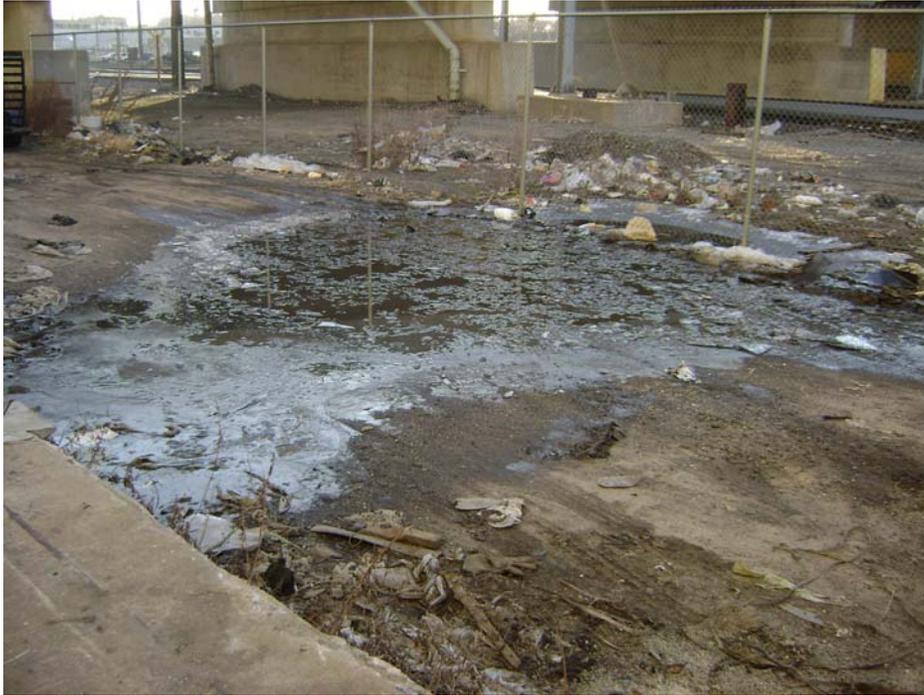
Photo #48: Large puddle in alleyway which was present through all sampling events.

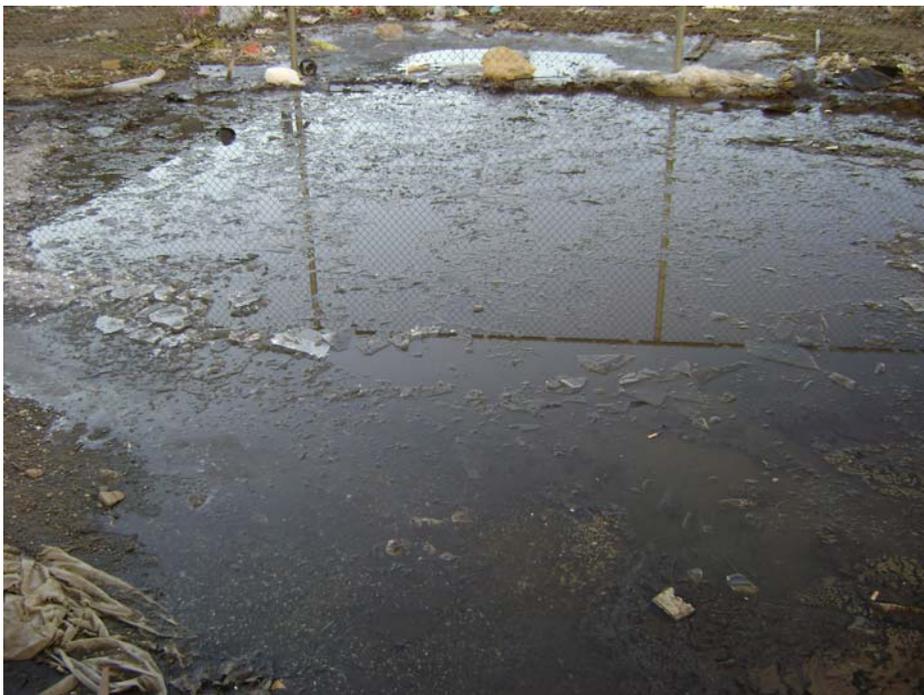
Photo #49: SG01, SG02, SG07, and SG08 were moved to the east since the location of the puddle covered initial SG01 and SG02 locations.

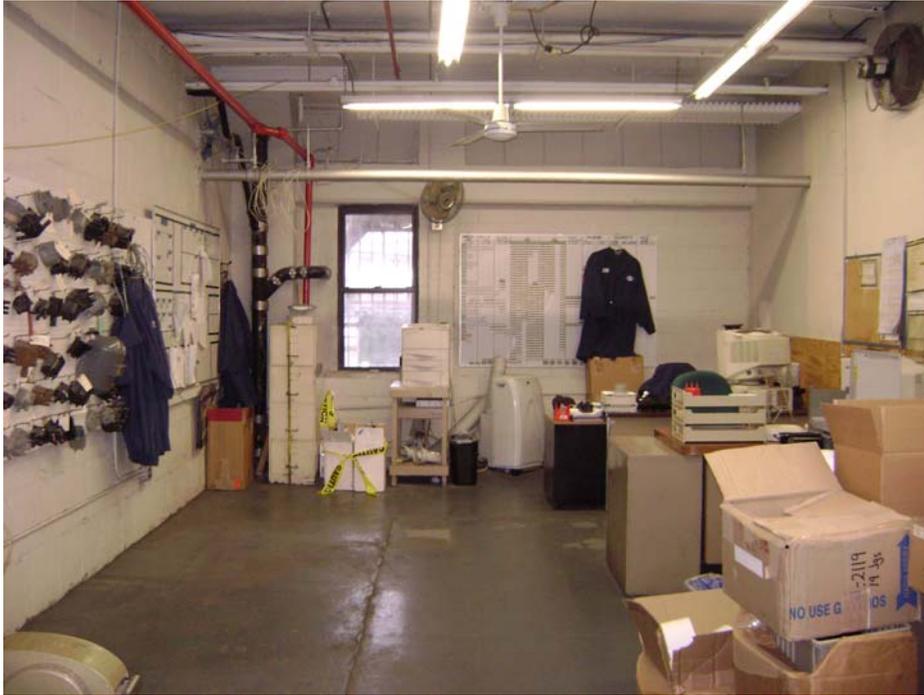
Photo #52: SB01 and Indoor Air (IA01) Location.

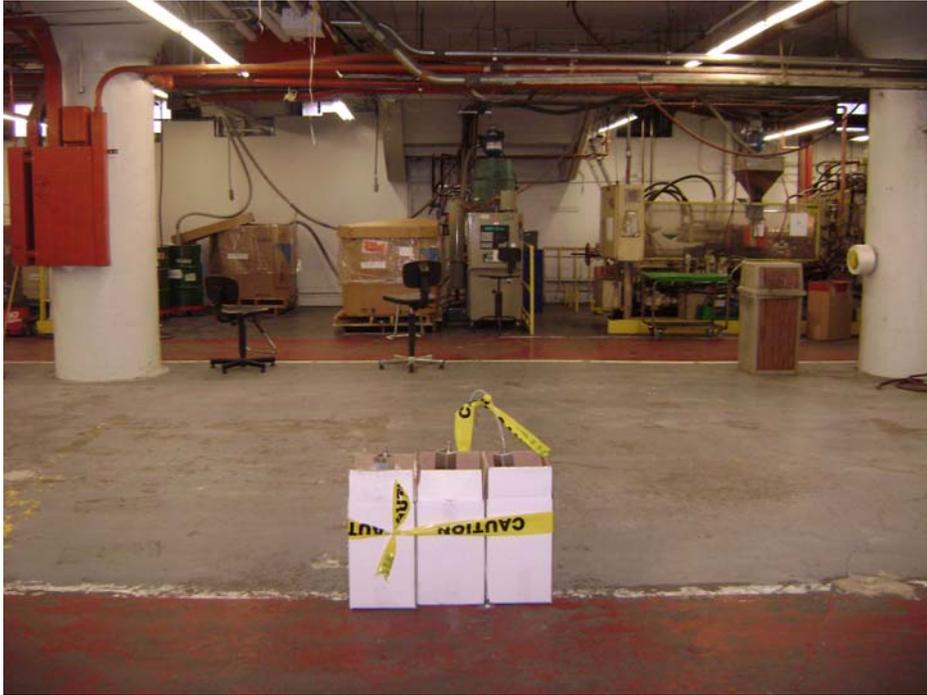
Photo #54: SB02 and Indoor Air (IA03 & IA33) Location.

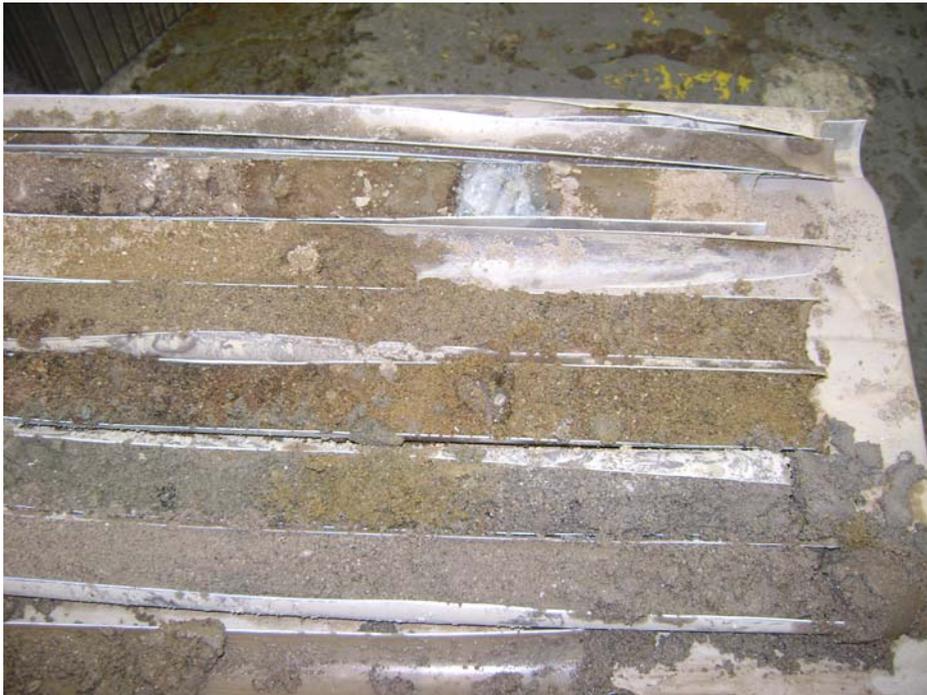
Photo #55: SB02 Soil Borings.

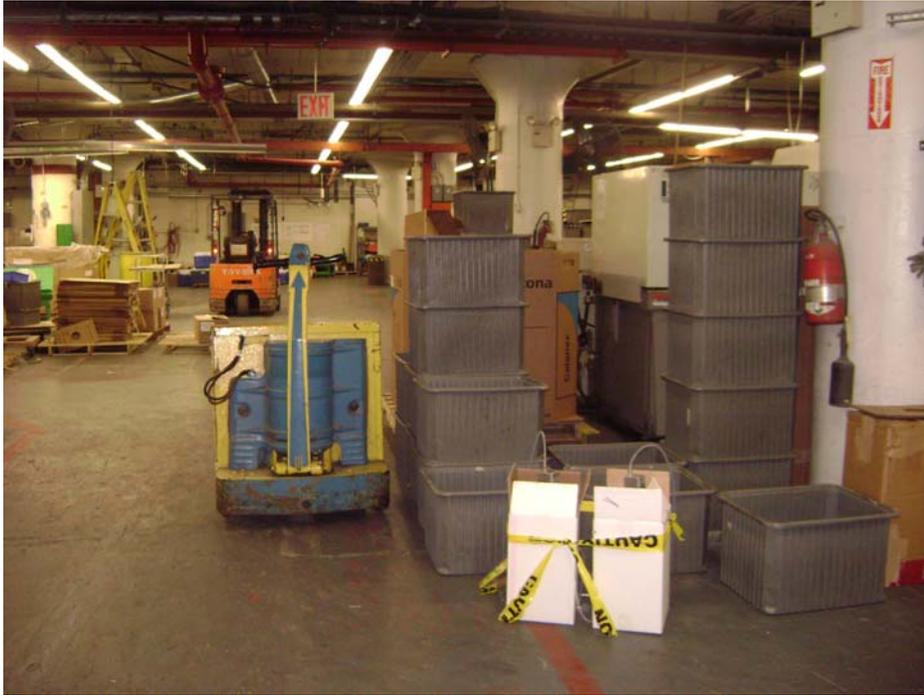
Photo #56: SB03 Location.

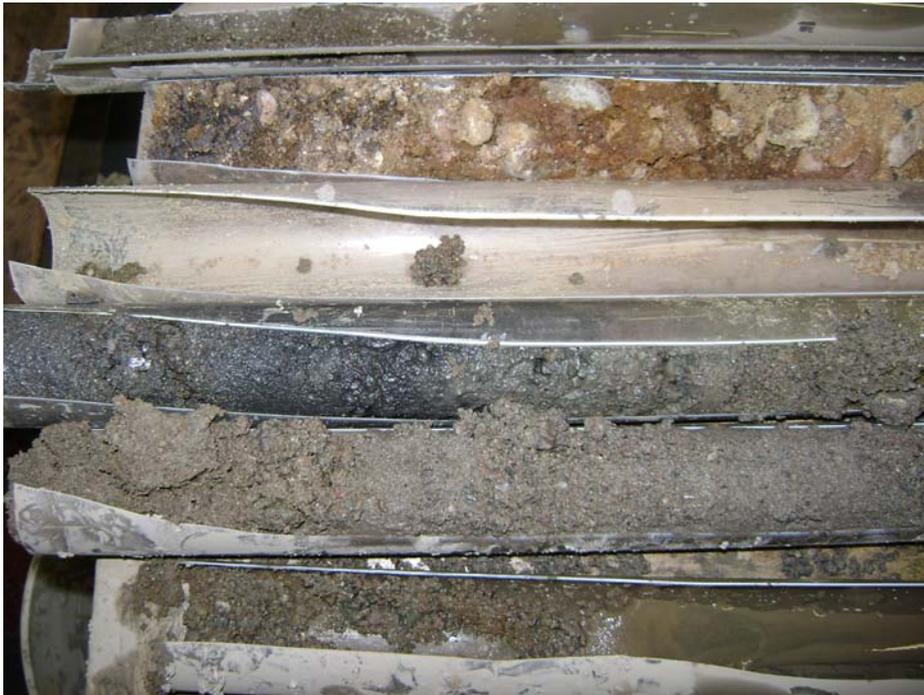
Photo #57: SB03 Soil Borings.

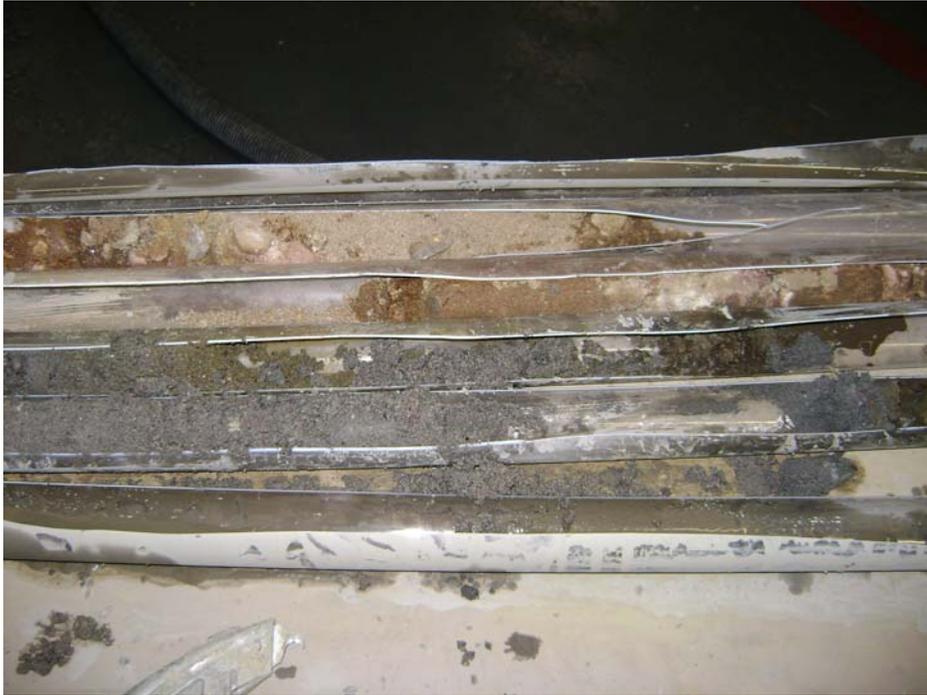
Photo #58: SB03 Soil Borings

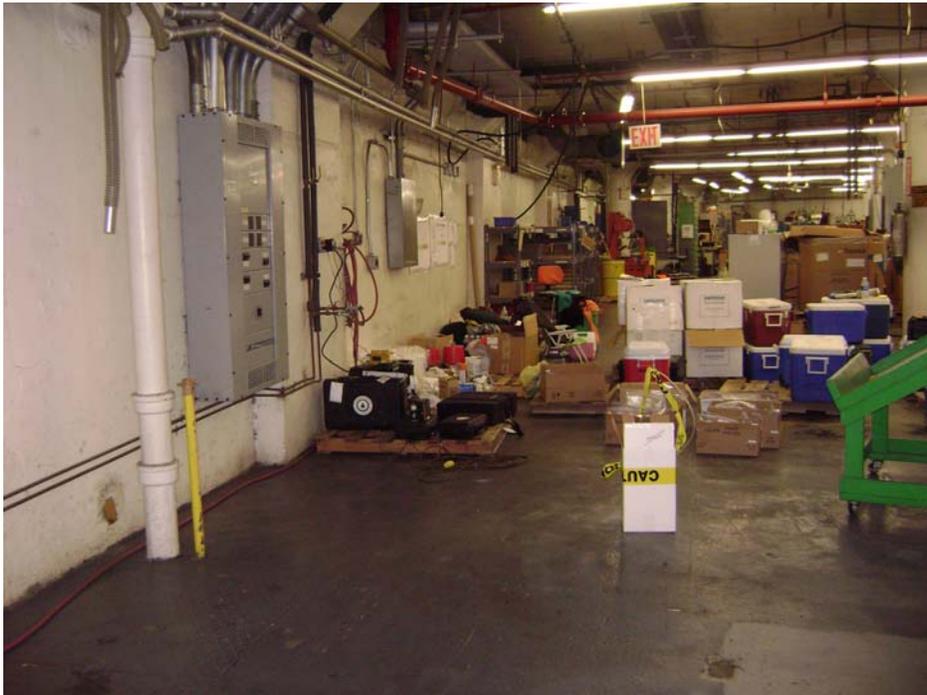
Photo #59: SB04 Location.

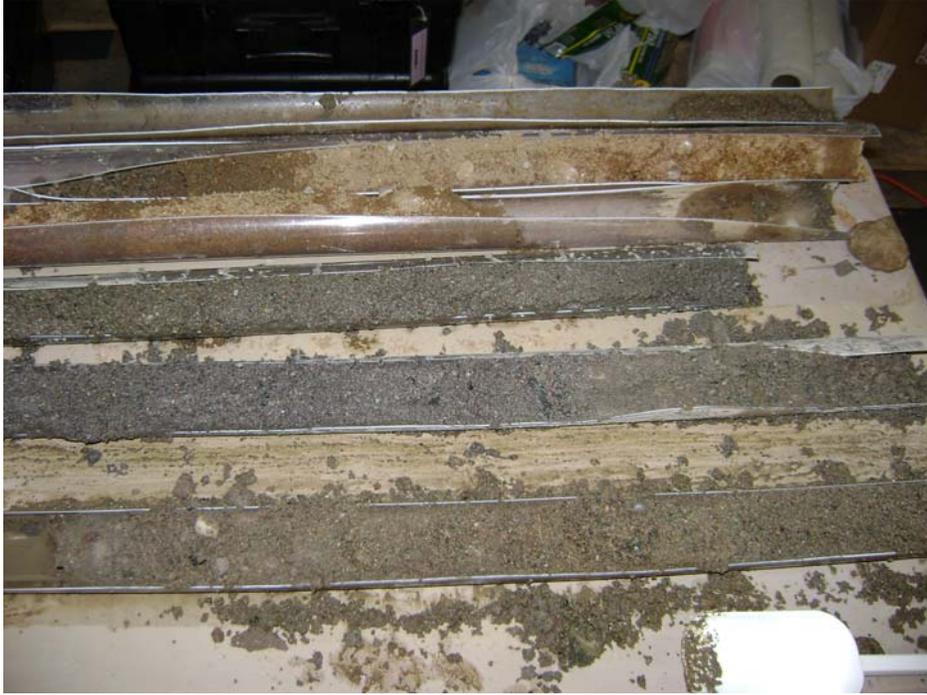
Photo #60: SB04 Soil Borings.

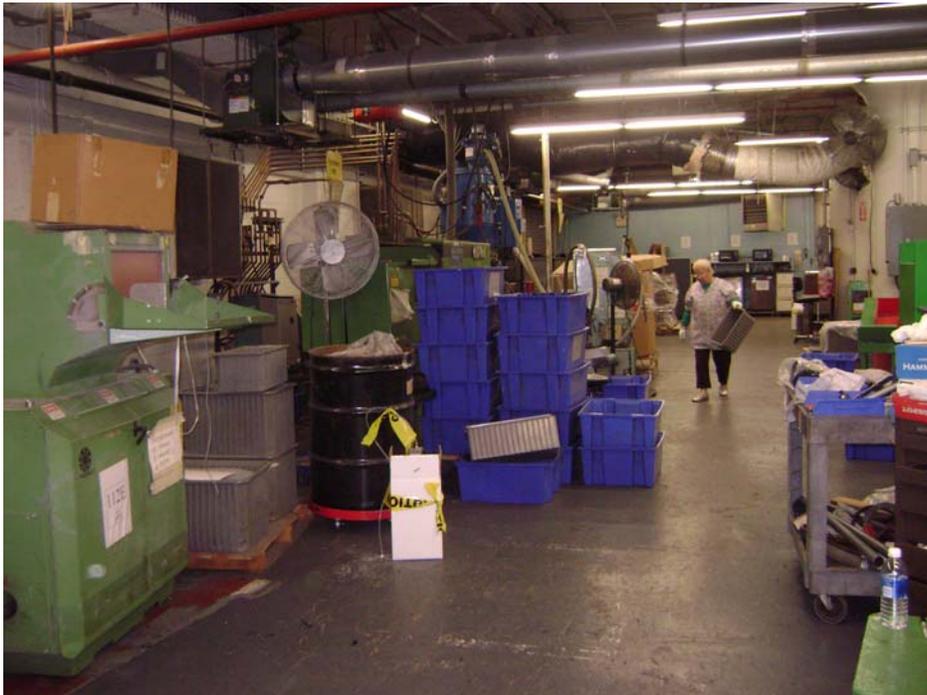
Photo #61: SB05 Location.

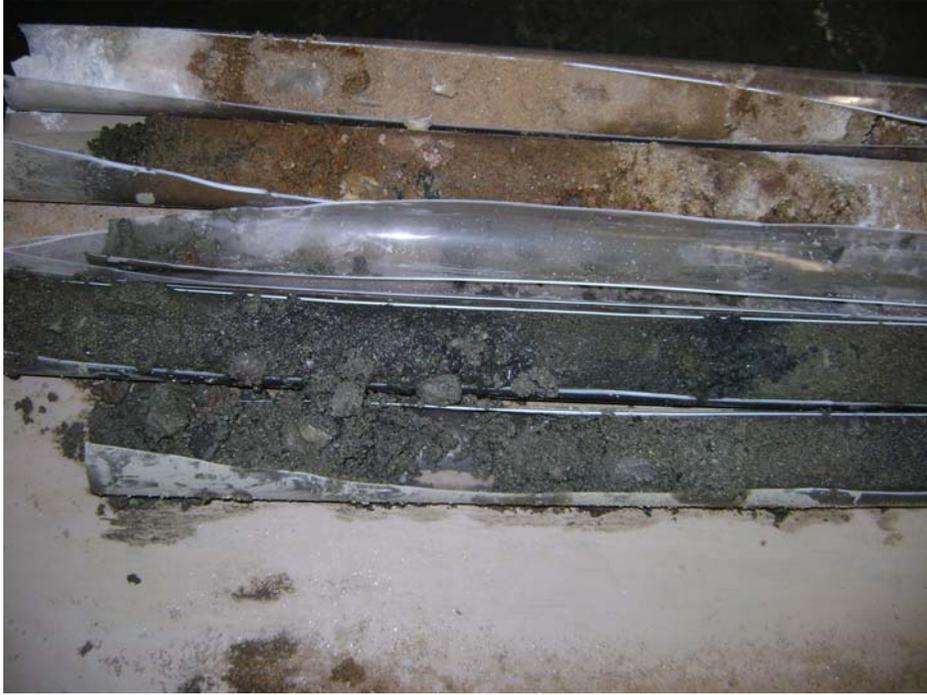
Photo #62: SB05 Soil Borings.
