SMP Photolog – Vault Sampling

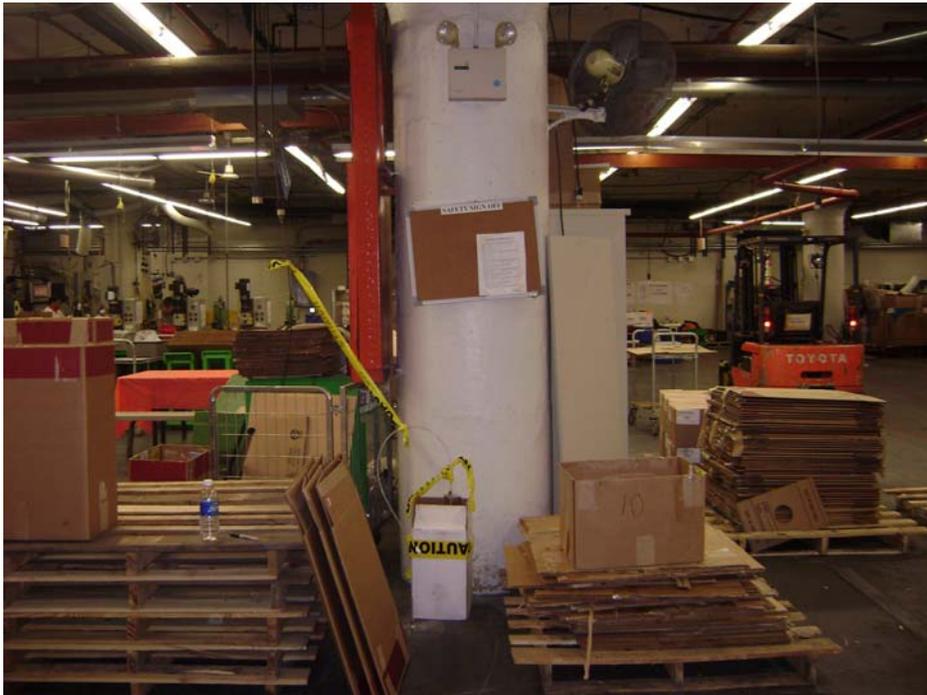
Photo #63: SB06 Location.

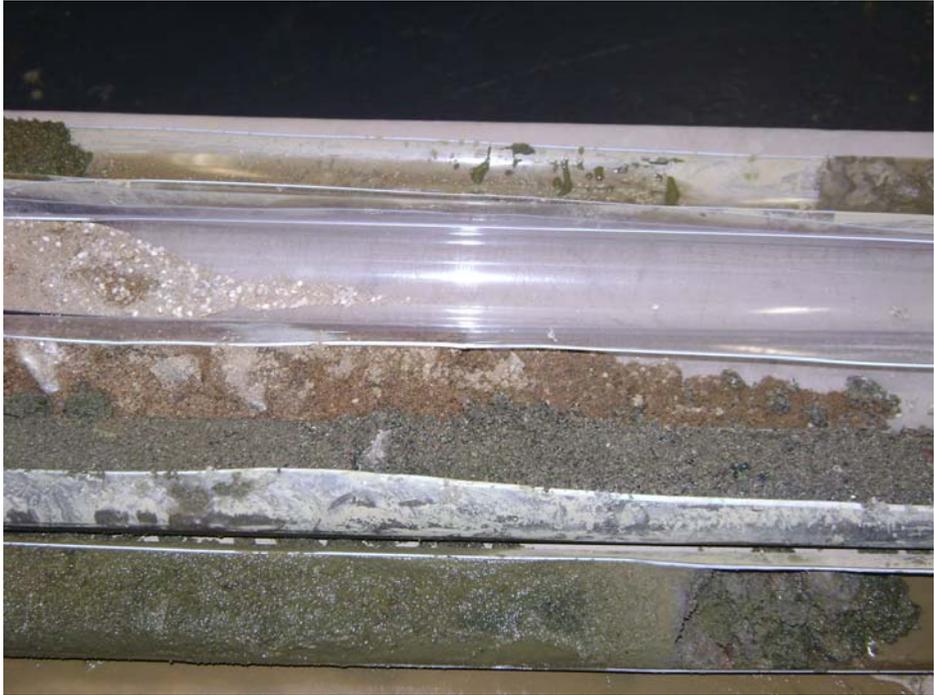
Photo #64: SB06 Soil Borings.

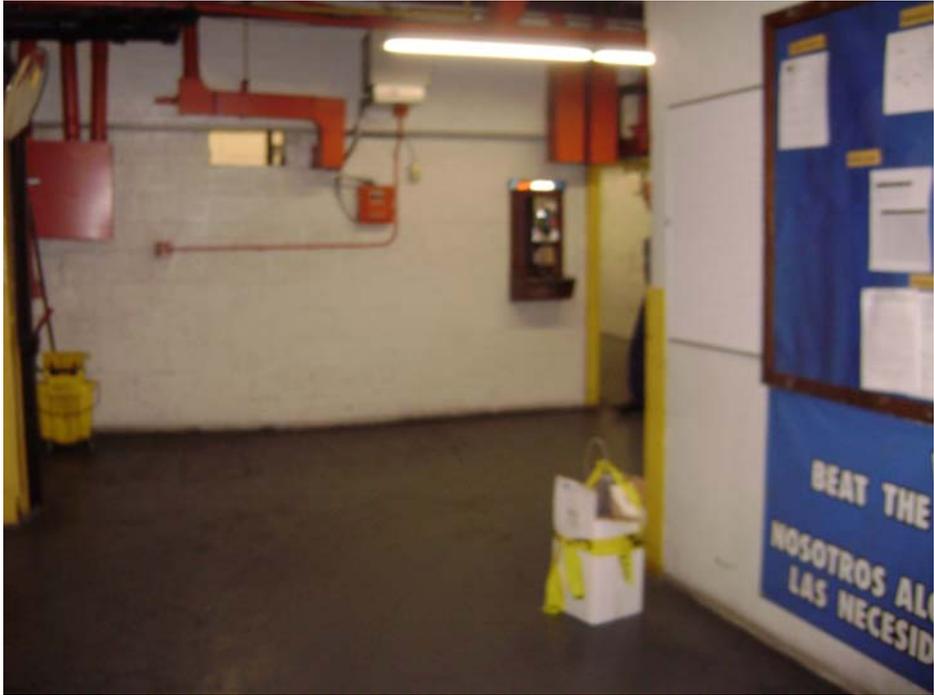
Photo #65: SB07 Subslab Location.

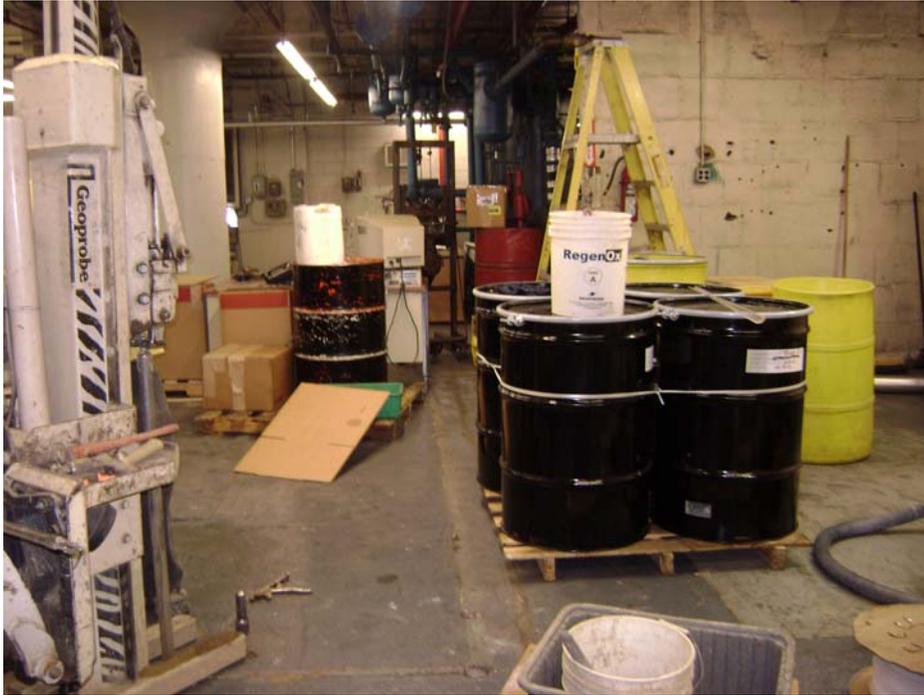
Photo #66: Drums in the vicinity of SB07 Soil Boring Location.

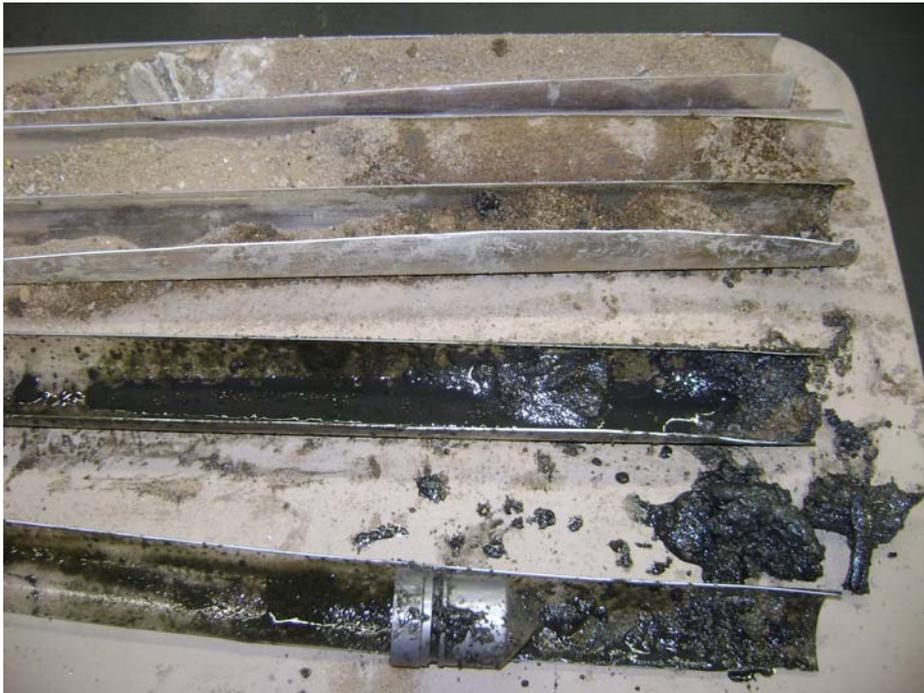
Photo #67: SB07 Soil Borings.

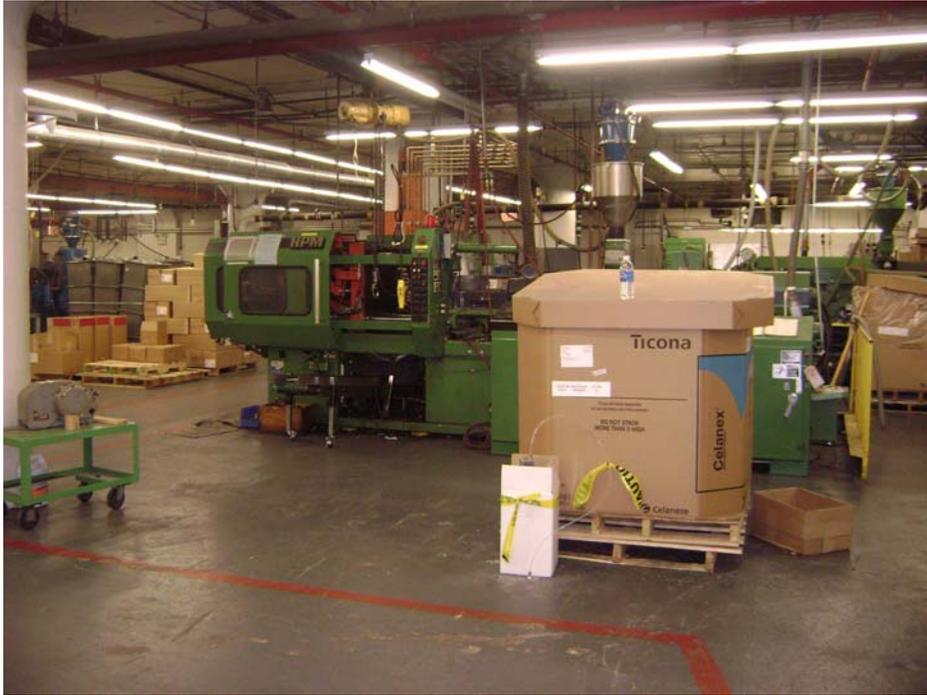
Photo #68: SB08 Location.

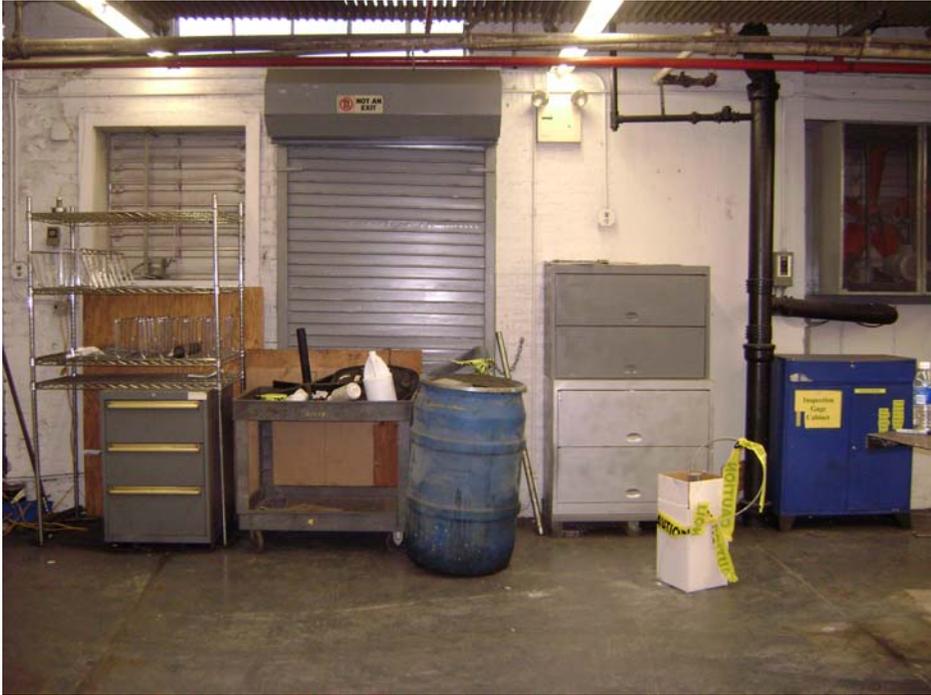
Photo #70: SB09 Location.

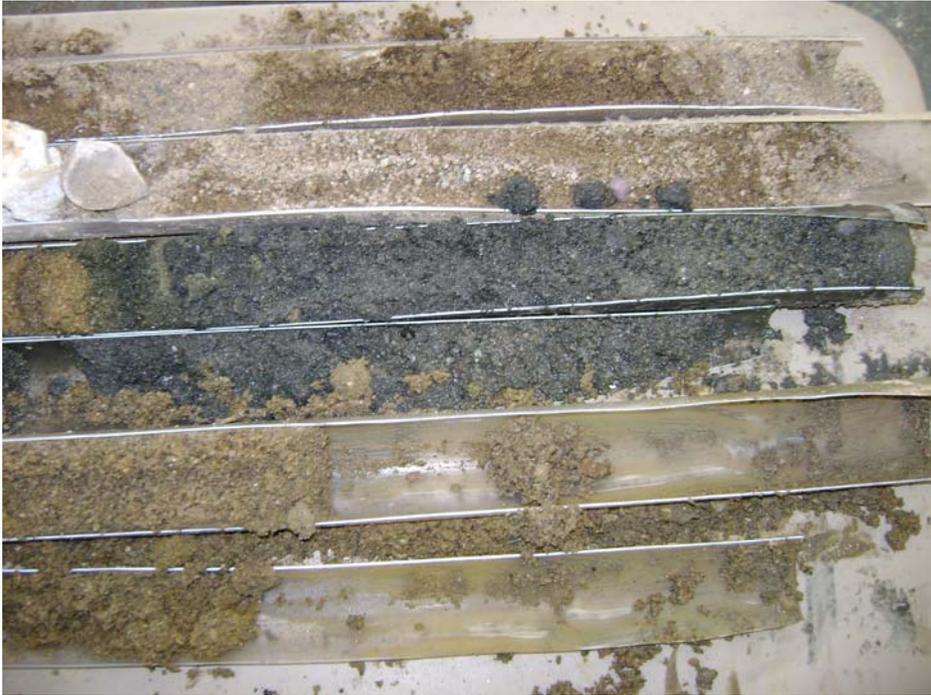
Photo #71: SB09 Soil Borings.

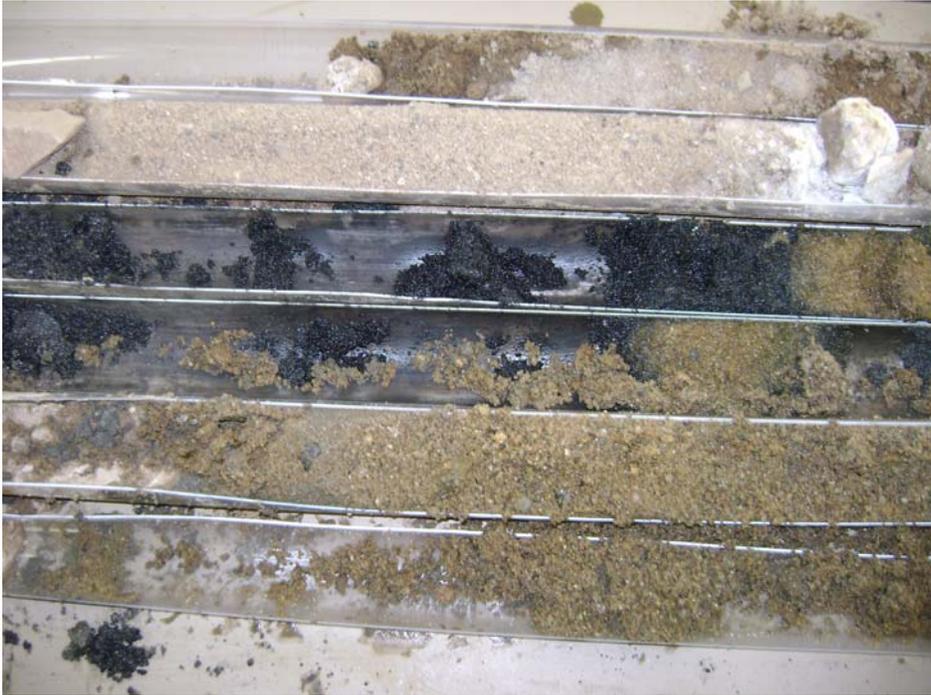
Photo #72: SB09 Soil Borings.

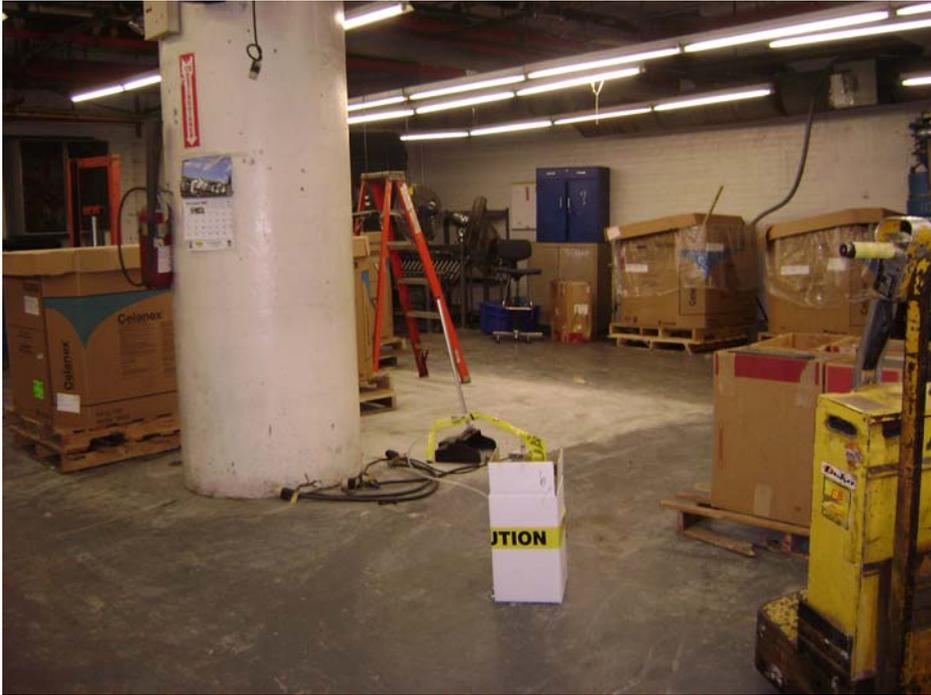
Photo #73: SB10 Location.

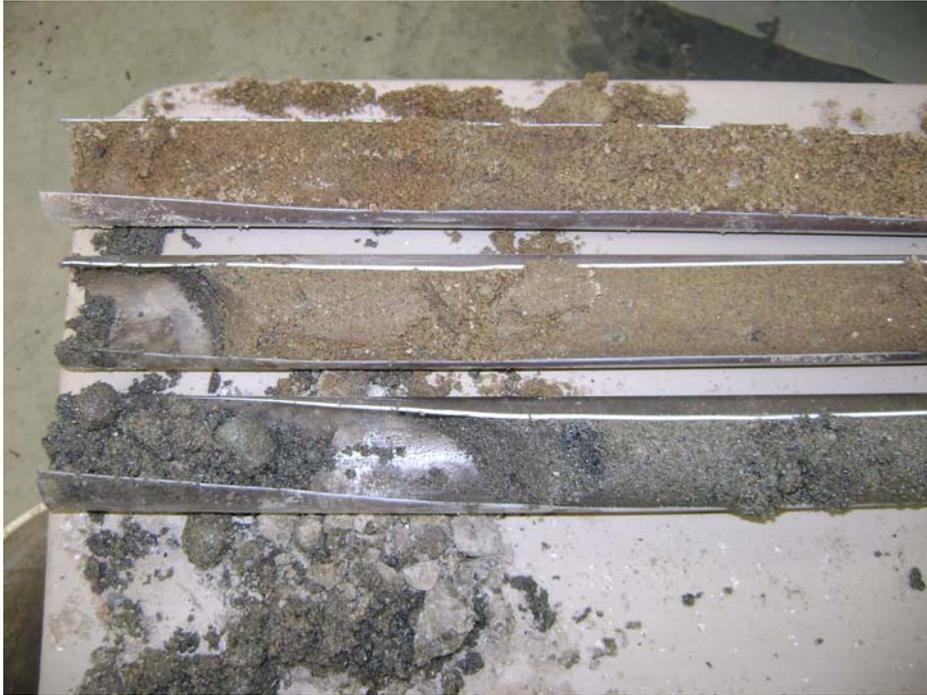
Photo #74: SB10 Soil Borings.

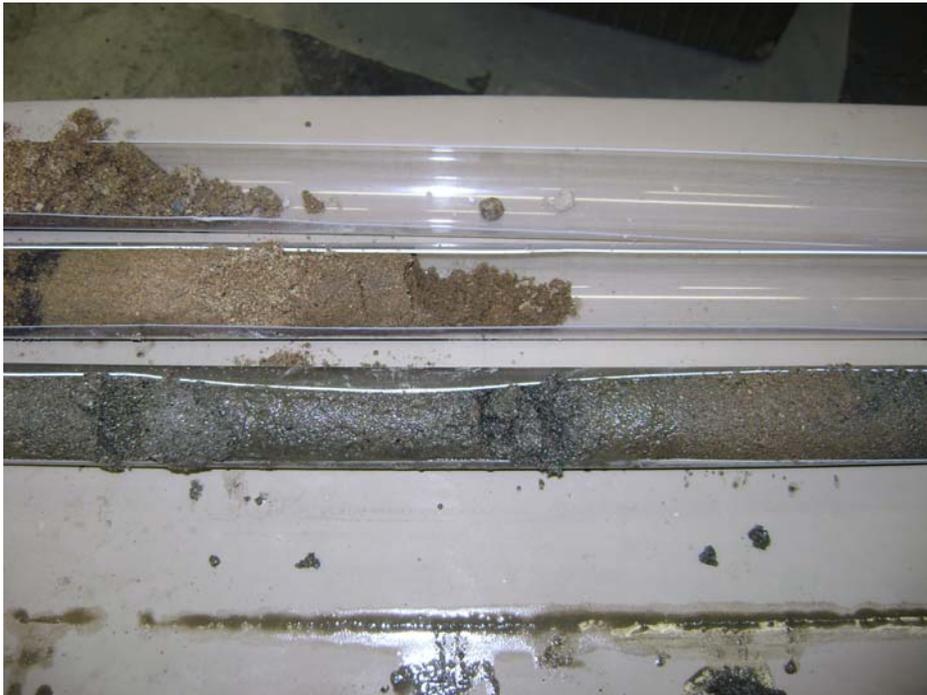
Photo #75: SB10 Soil Borings.

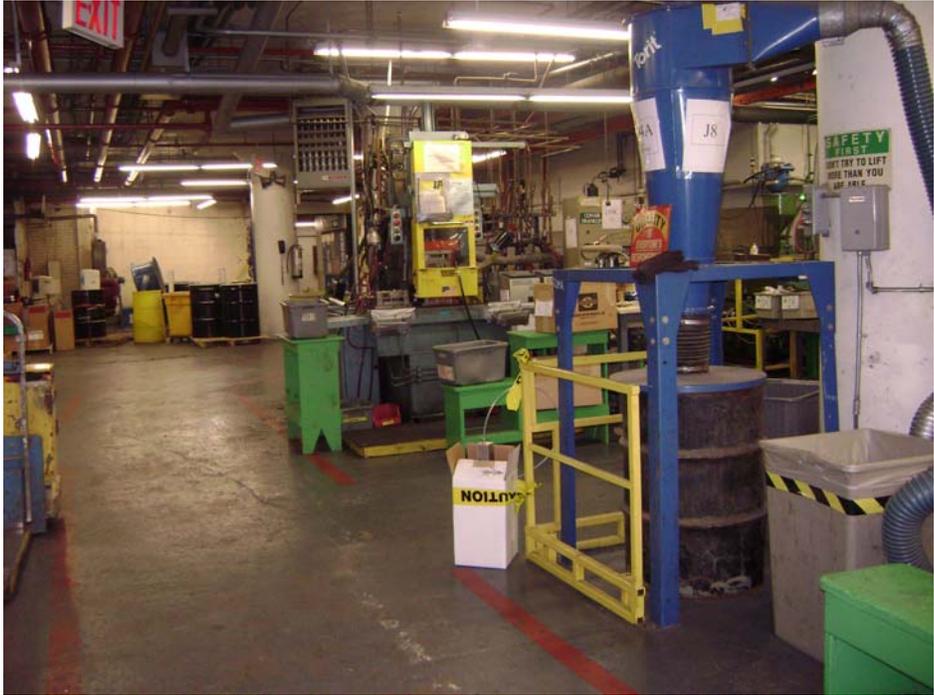
Photo #76: SB11 Location.

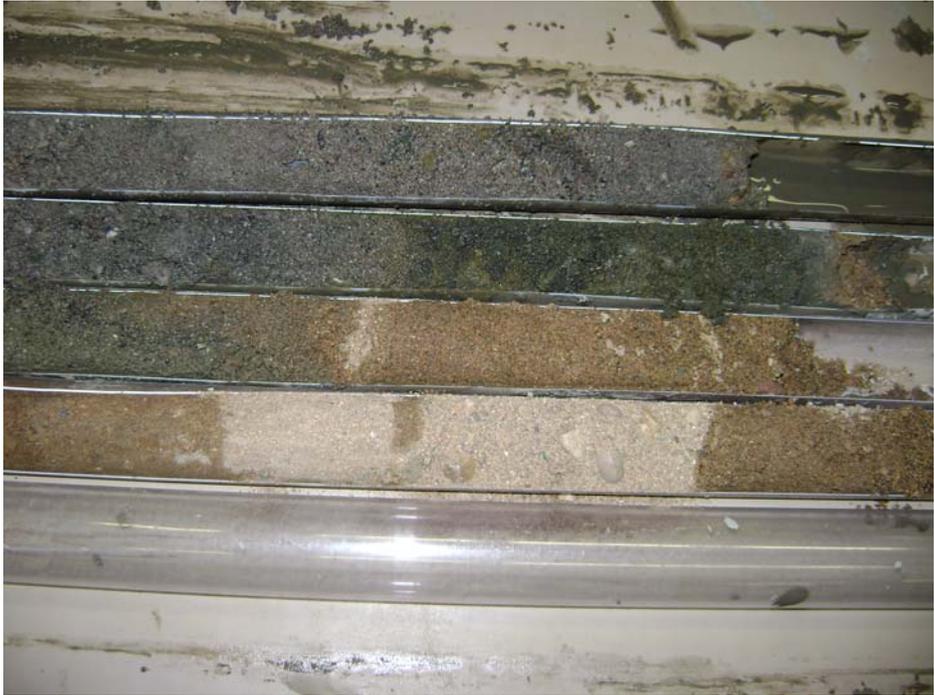
Photo #77: SB11 Soil Borings.

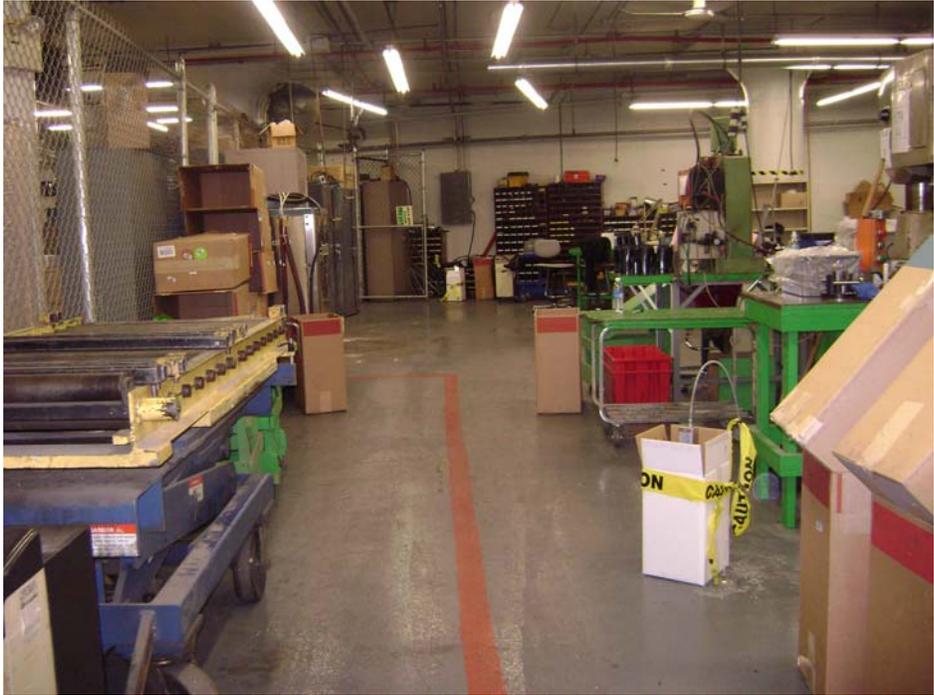
Photo #78: SB12 Locations.

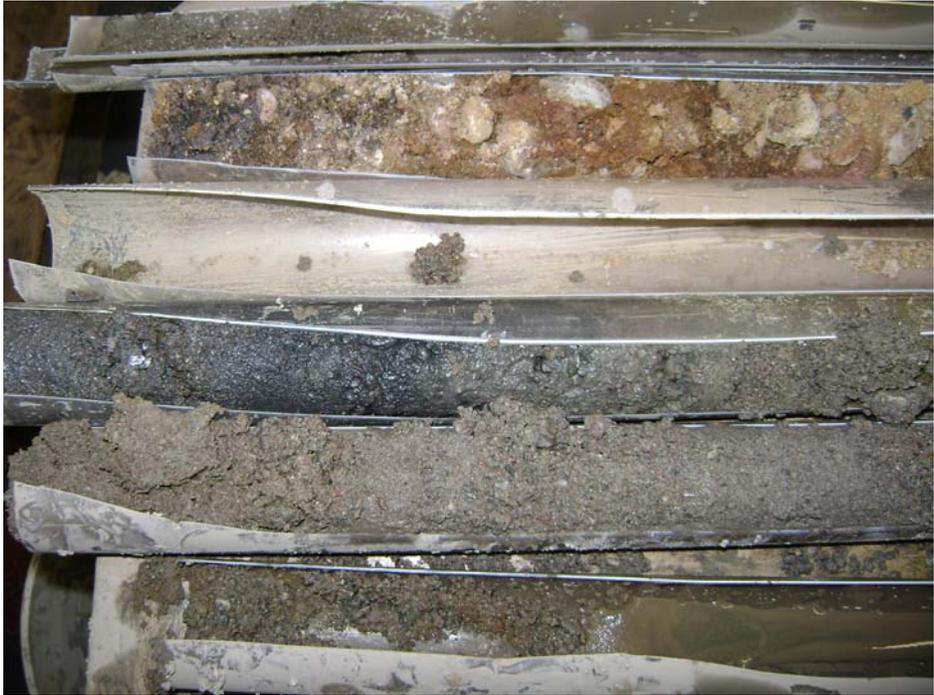
Photo #79: SB12 Soil Borings.

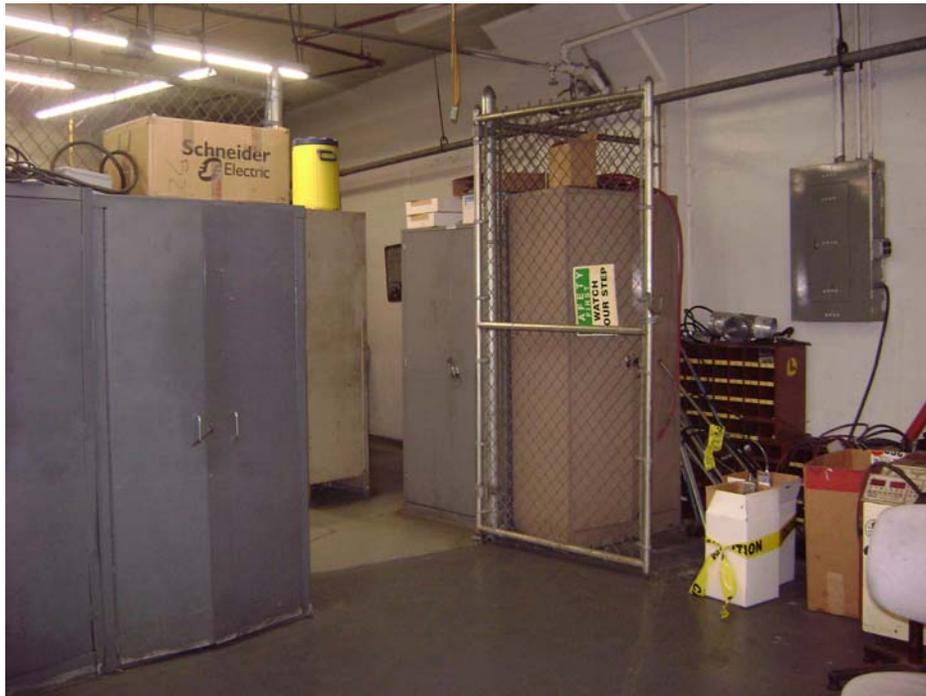
Photo #80: SB13 and Indoor Air (IA01) Location.

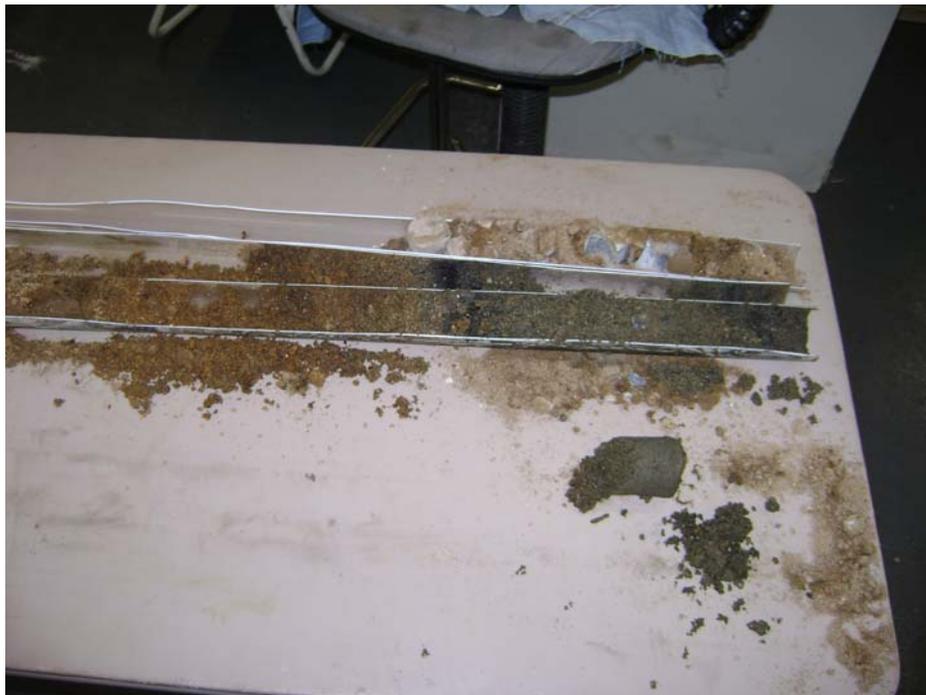
Photo #81: SB13 Soil Borings.

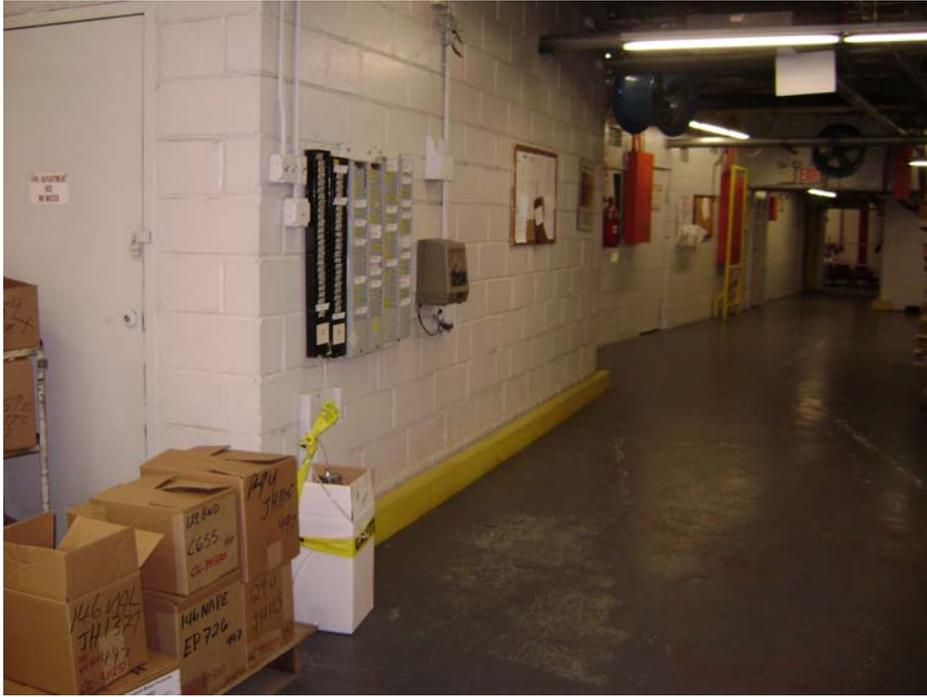
Photo #82: SB14 Location.

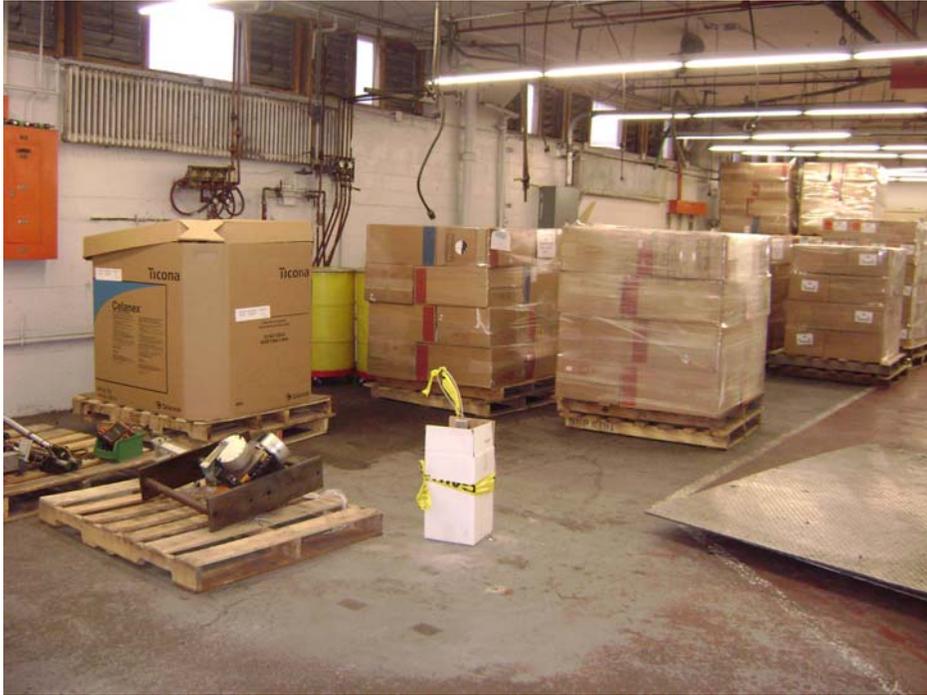
Photo #82: SB15 Location.

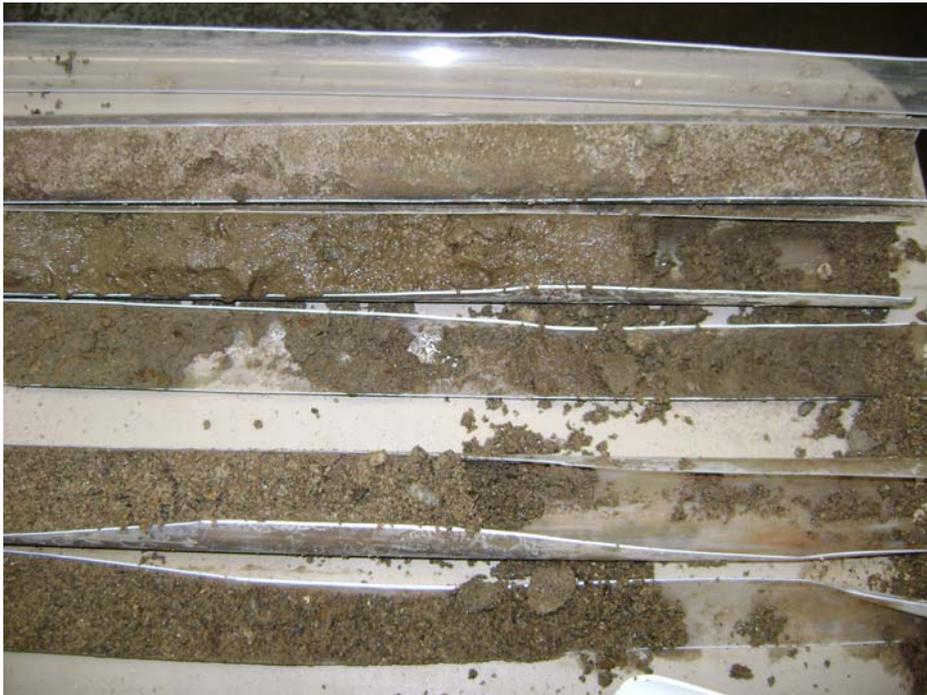
Photo #83: SB15 Soil Borings.

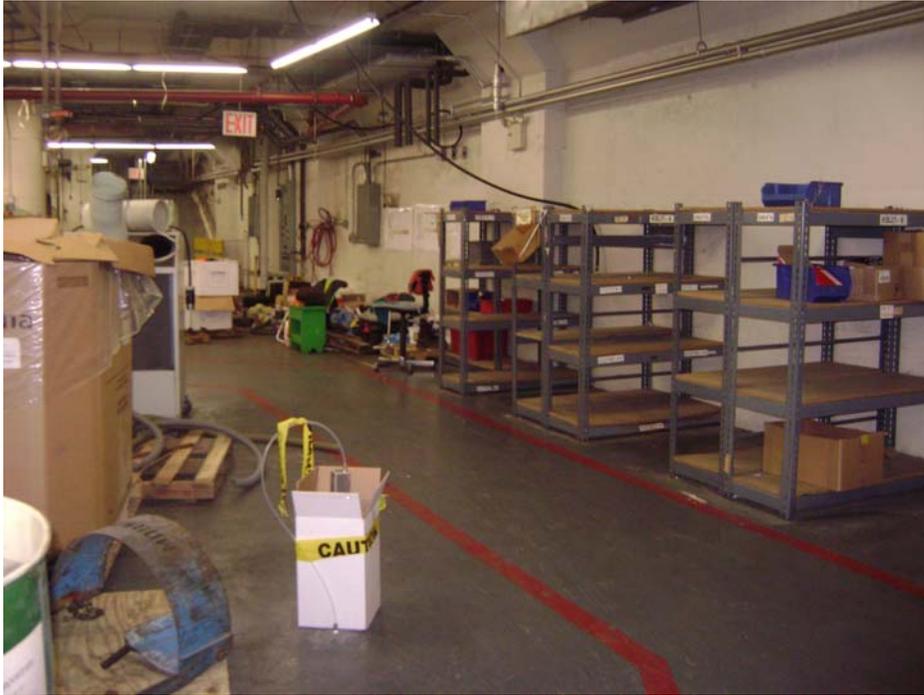
Photo #84: SB16 Location.

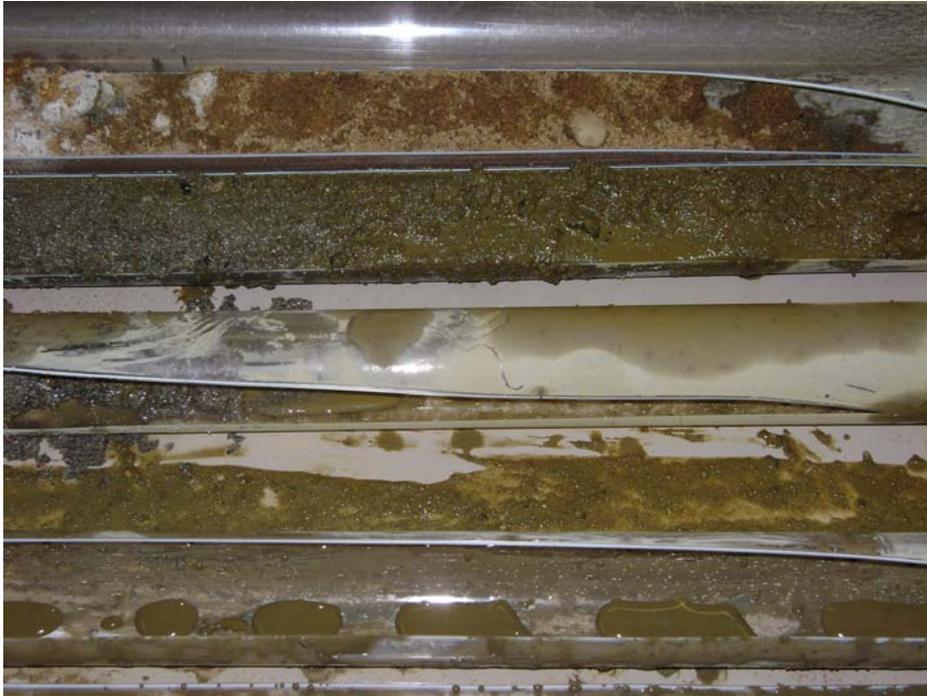
Photo #86: SB16 Soil Borings

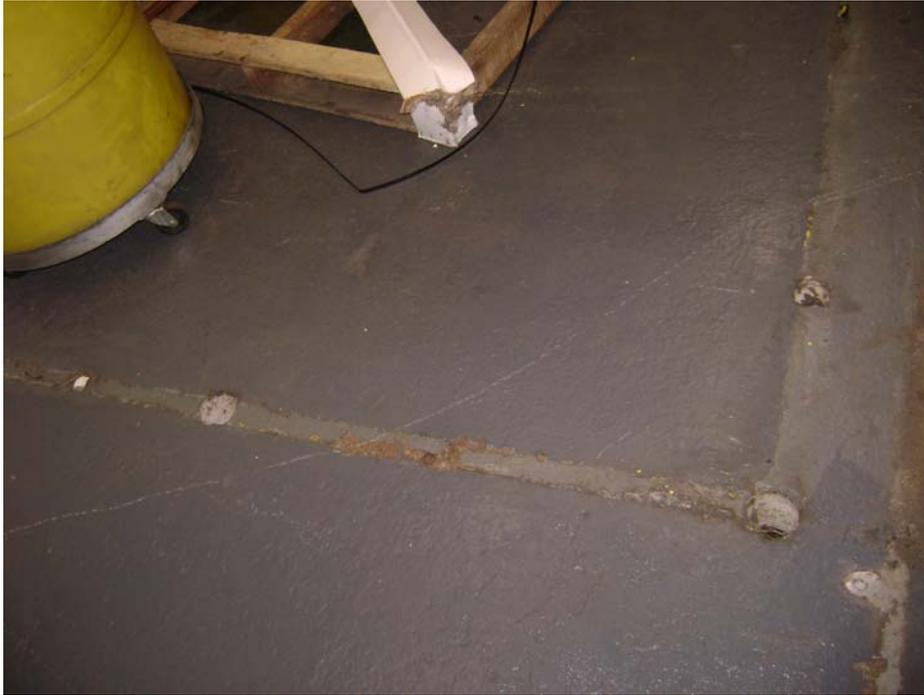
Photo #87: Holes in subslab where heavy equipment were previously bolted in. The openings penetrate through the subslab.

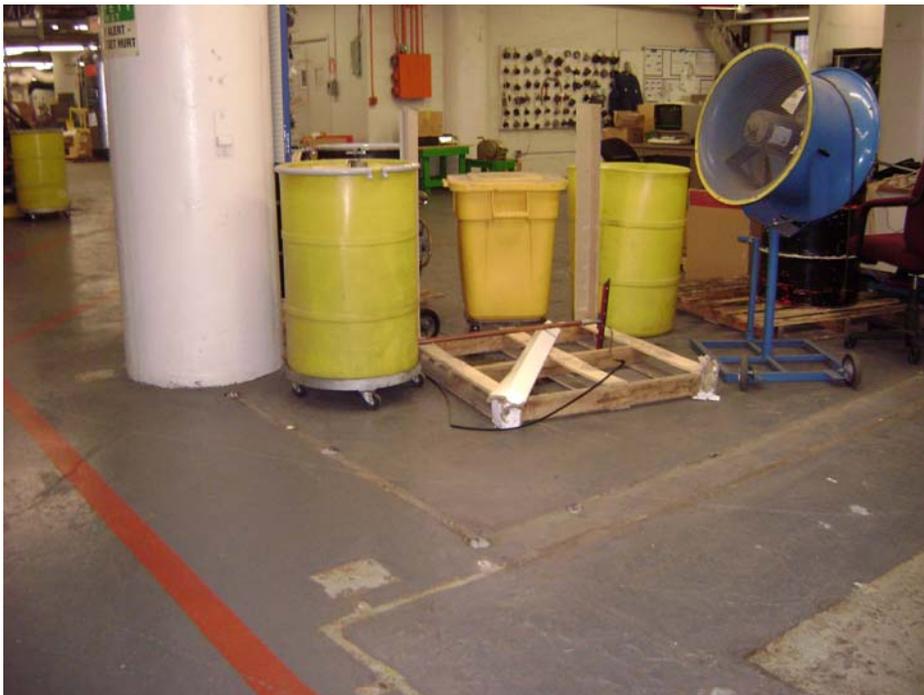
Photo #88: Holes in subslab.

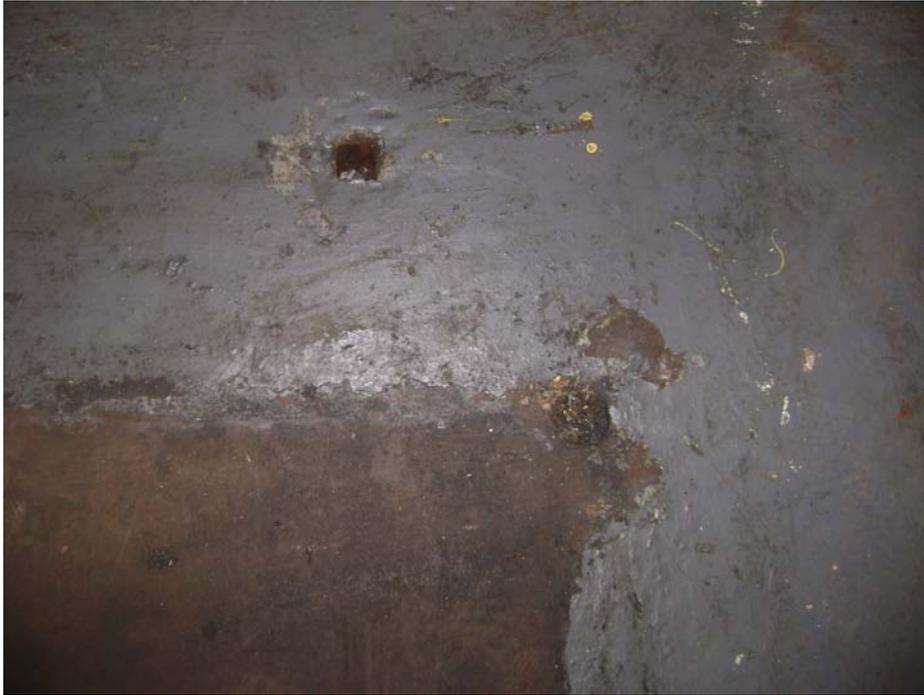
Photo #89: Holes in subslab.

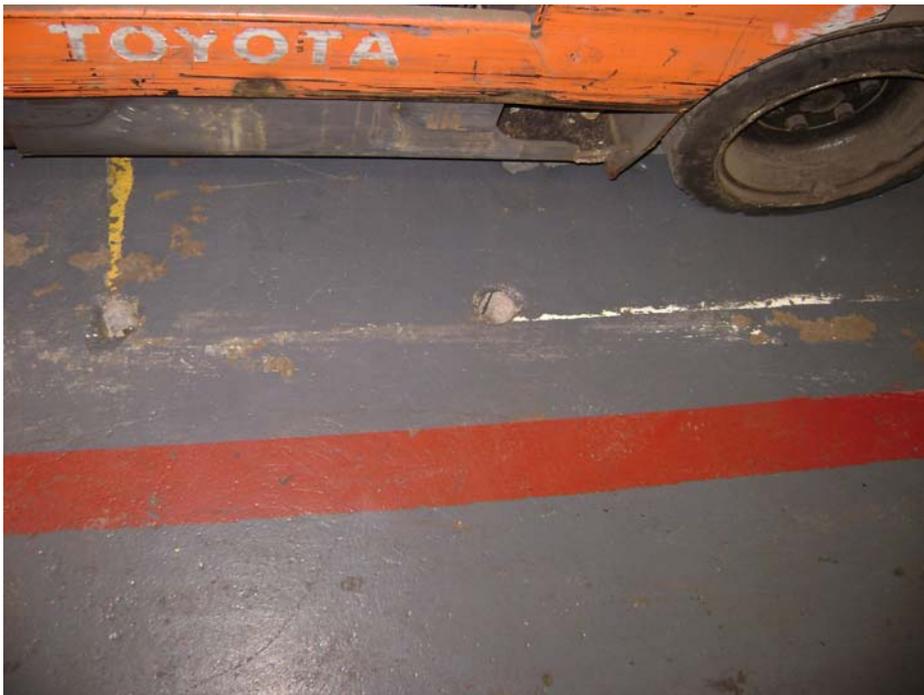
Photo #90: Holes in subslab.
