GLOBALFOUNDRIES B322 Renovation Project Closure Certification for SWMUs in Building 322, Hopewell Junction, NY Permit Module II of IBM's 6NYCRR Part 373 Hazardous Waste Management Permit

This Certification Letter has been prepared by Arcadis of New York, Inc. (Arcadis) to document the closure of solid waste management units (SWMUs) as part of the partial demolition project for Building 322 at the GLOBALFOUNDRIES US2 LLC Fab 10 Facility, Hopewell Junction, New York. The SWMU closure work was performed pursuant to the *Plan for Closure of SWMUs in Building 322, Hopewell Junction, NY* prepared by Arcadis (April 20, 2018) and approved by New York State Department of Environmental Conservation (NYSDEC) on May 9, 2018.

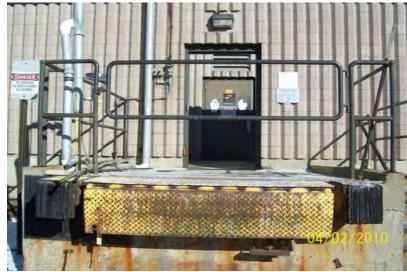
Area of Tank 208 located at B/322 W.

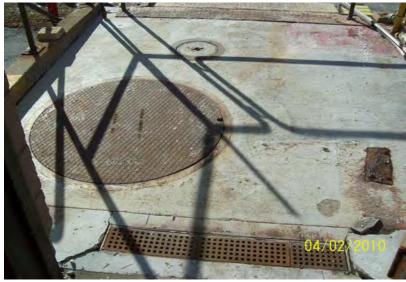
Manhole to access Tank 208 and clean out port to pump out Tank 208.

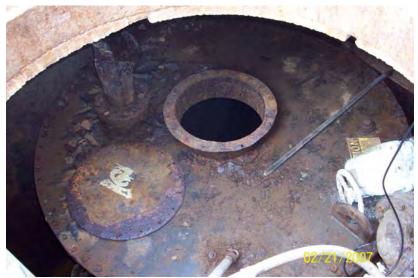
Top of Tank 208

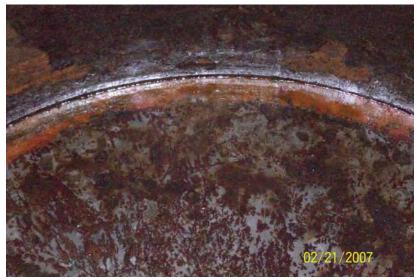
Interior of Tank 208 after the tank was decontaminated.

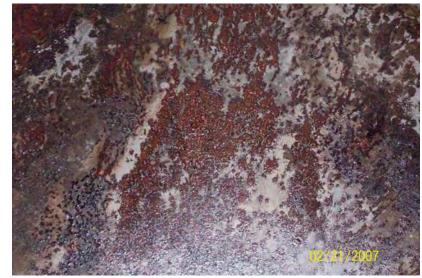
Interior of Tank 208 after the tank was decontaminated.

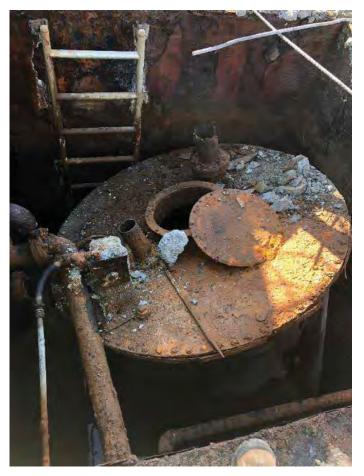
Pumping Water Out Of Solvent Tank

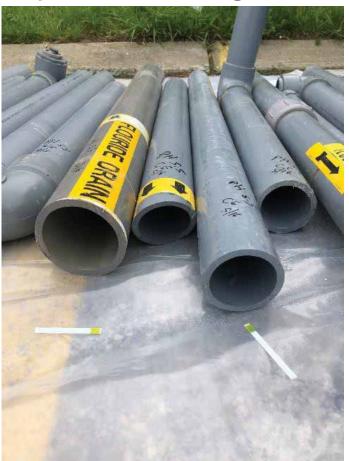
Fluoride Pipe Sampled And Inspected After Being Cleaned

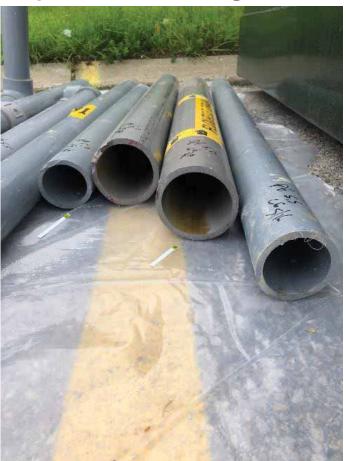
Fluoride Pipe Sampled And Inspected After Being Cleaned

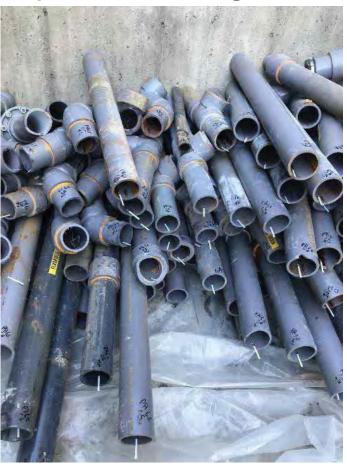
Fluoride Pipe Loaded Out In Dumpster After Sampled And Inspected

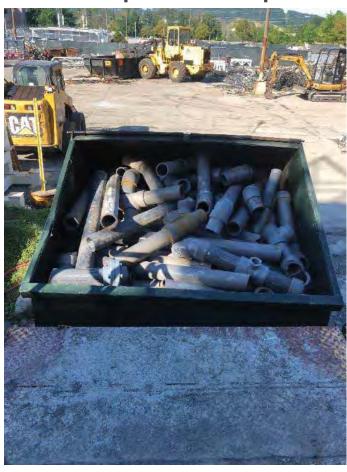
Fluoride Pipe That Has Been Removed From B322 Waiting To Be Cleaned

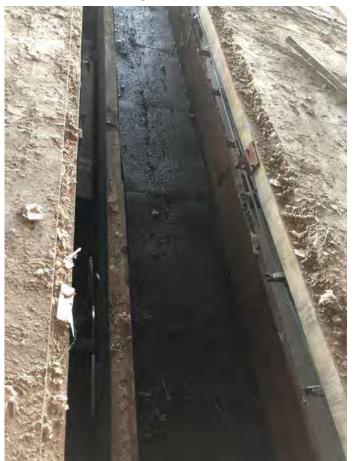
Cleaned Trench After Fluoride Pipe Was Removed

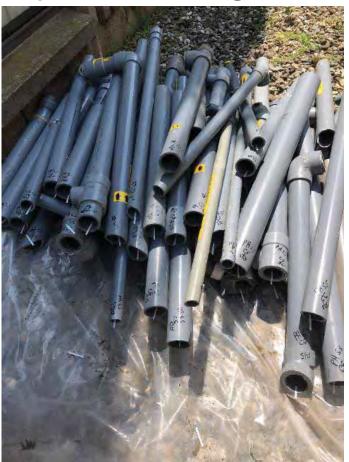
Industrial Waste Pipe Sampled And Inspected After Being Cleaned

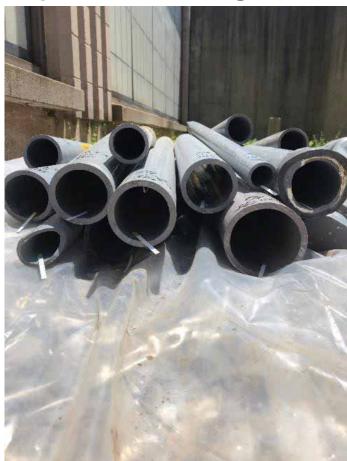
Industrial Waste Pipe Sampled And Inspected After Being Cleaned

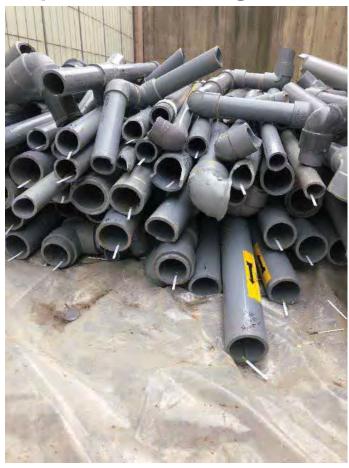
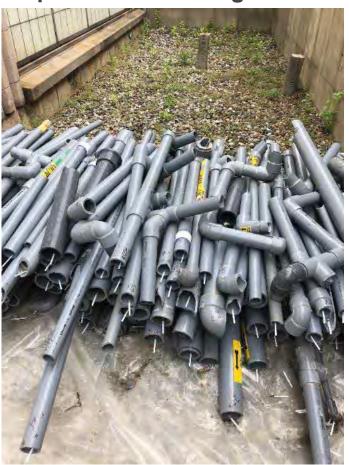
Industrial Waste Pipe Sampled And Inspected After Being Cleaned

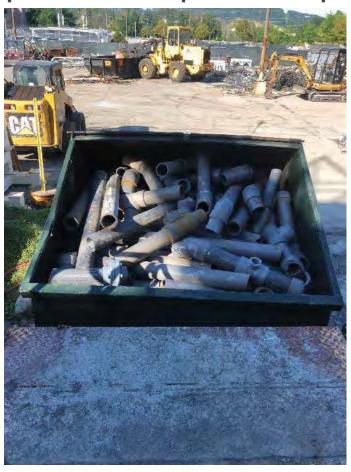
Industrial Waste Pipe Going Out Of Building Capped

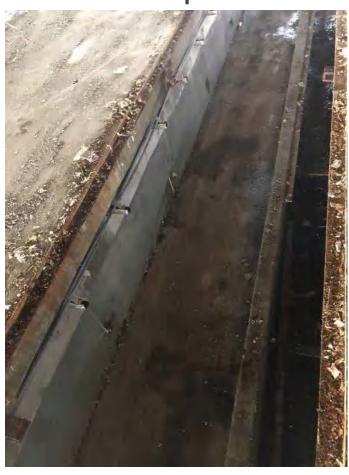
Cleaned Trench After Industrial Waste Pipe Was Removed

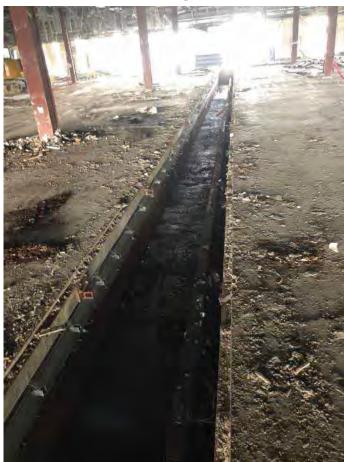
Cleaned Trench After
Industrial Waste Pipe Was Removed

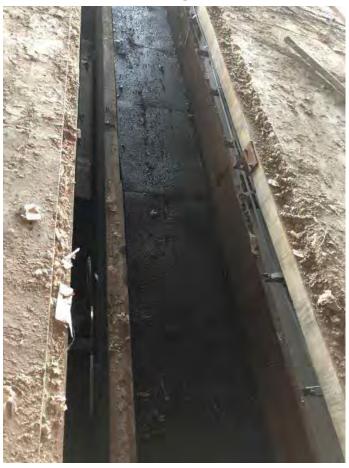
Cleaned Trench After Industrial Waste Pipe Was Removed

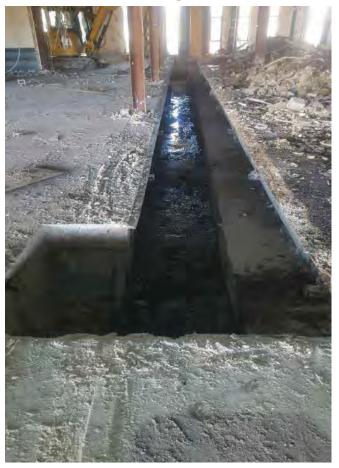
Solvent Pipe Pre-Removal

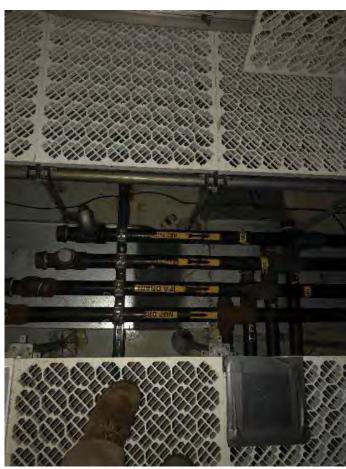
Solvent Pipe Pre-Removal

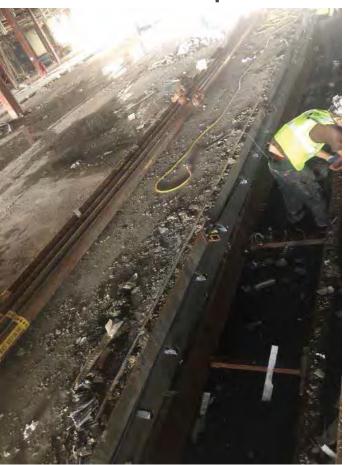
Removal Of Solvent Pipe

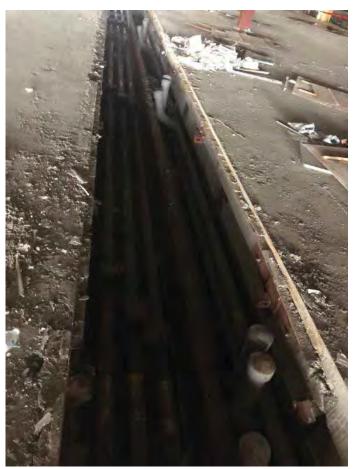
Solvent Pipe Removed

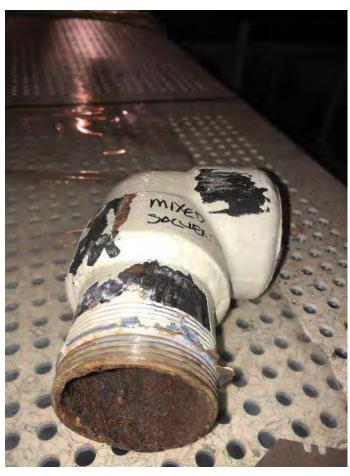
Roll-off Container For Hazardous Waste Solvent Pipe
