# PERIODIC REVIEW REPORT JUNE 2017 – JUNE 2022

**TUXEDO WASTE DISPOSAL SITE  
TUXEDO, NEW YORK 10987**

**NYSDEC Site No. 336035**

**Work Assignment No. D009812-25**

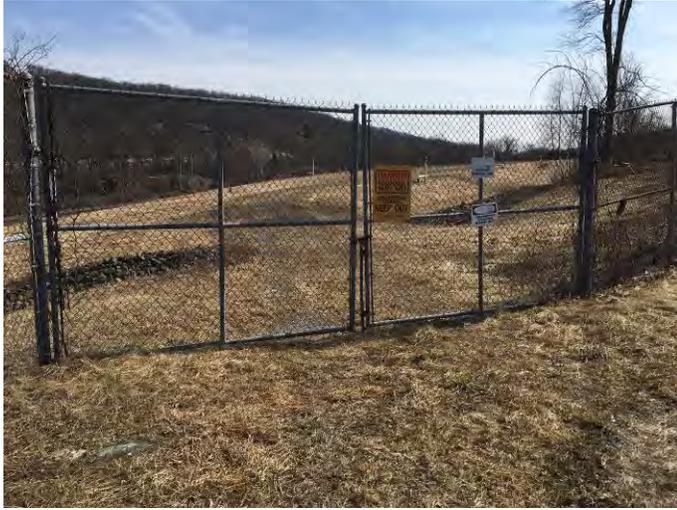
**Photo 1:** Looking southwest. View of the project and entry gate.

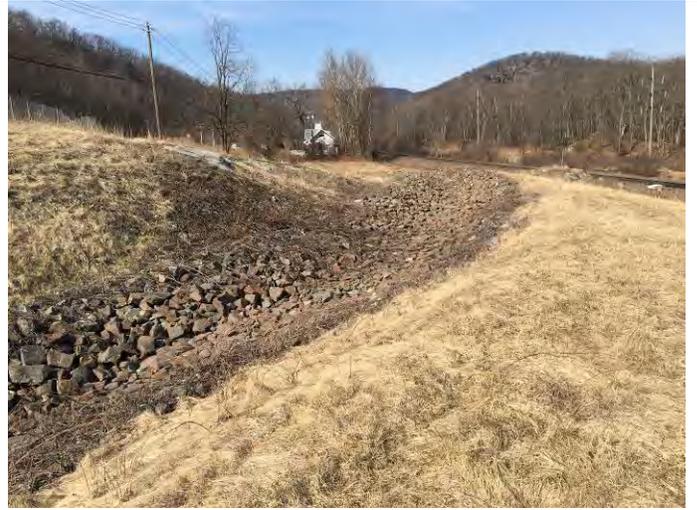
**Photo 2:** Looking north. View of drainage swale north of the entry gate.

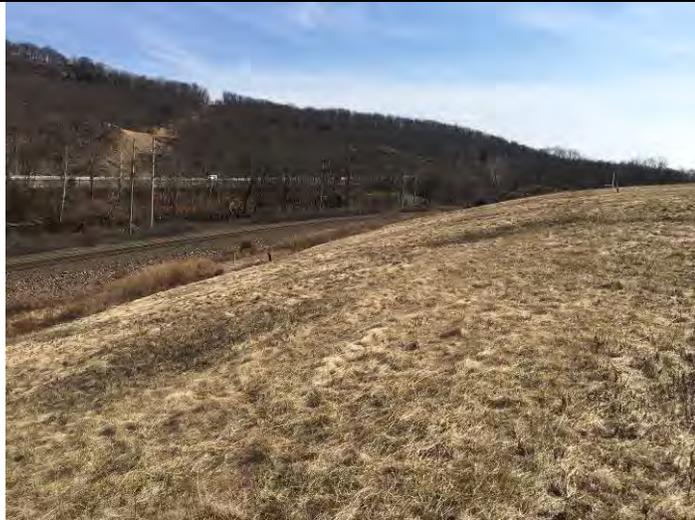
**Photo 3:** Looking southeast. View of the southeast slope of the landfill cap.

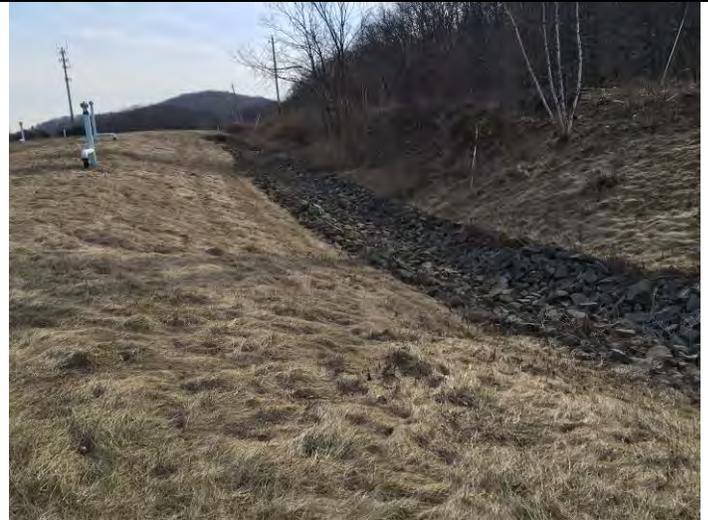
**Photo 4:** Looking south. View of drainage swale on the western side of the site.

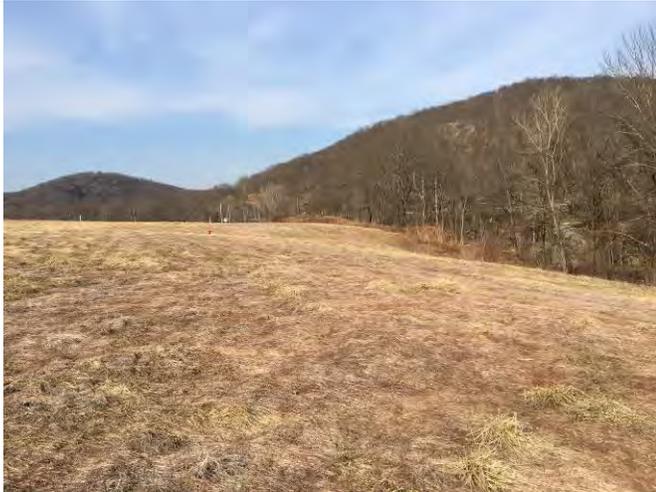
**Photo 5:** Looking northeast. View of landfill cap.

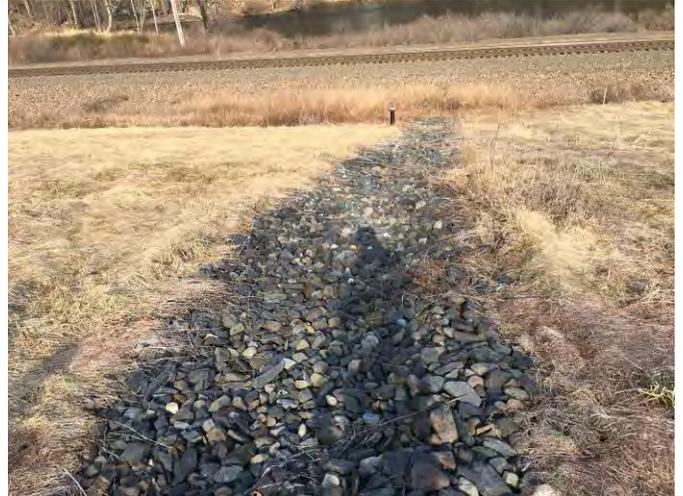
**Photo 6:** Looking east. View of drainage swale on eastern slope of landfill.

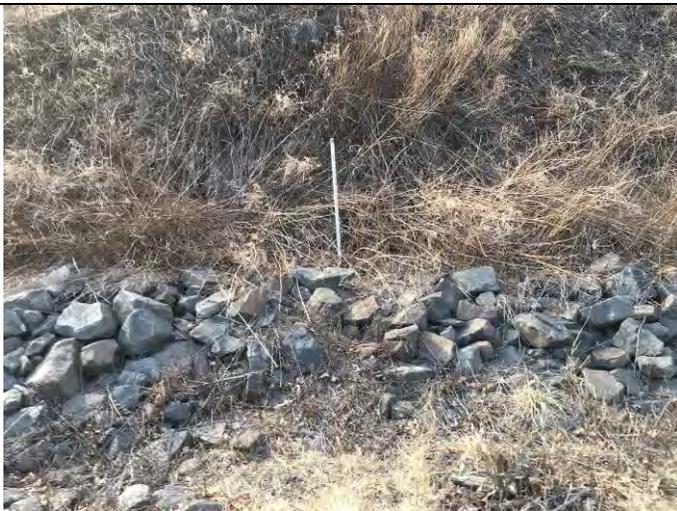
**Photo 7:** Looking west. View of perimeter monitoring point (PMP).

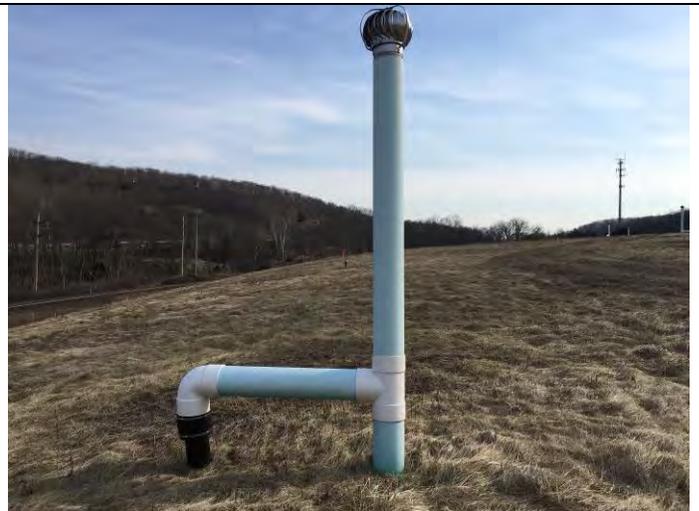
**Photo 8:** Looking southeast. View of gas vent station-1 (GVS-1).

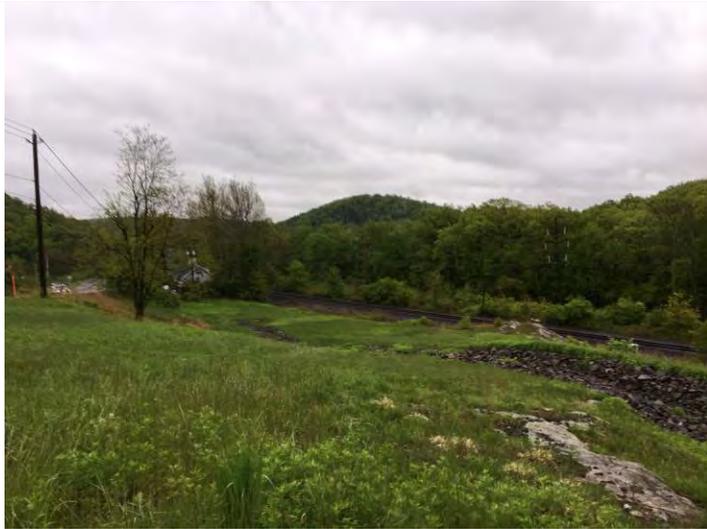
**Photo 1:** Looking north. View of the north end of the Site and a drainage swale.

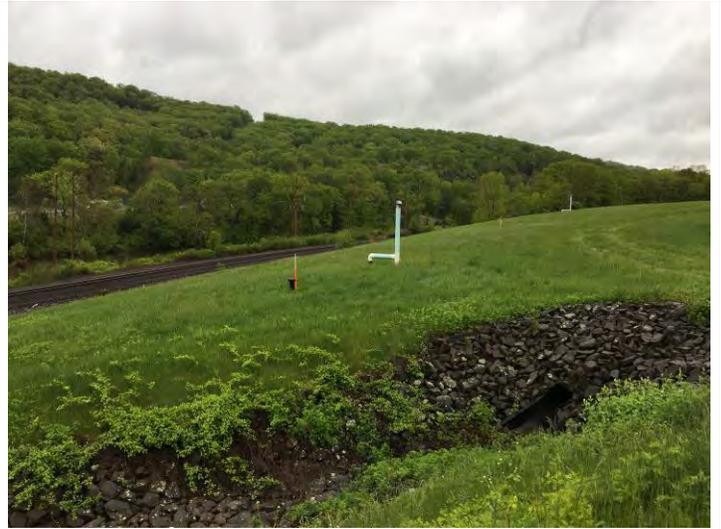
**Photo 2:** Looking southwest. View of the southeast slope of the landfill cap.

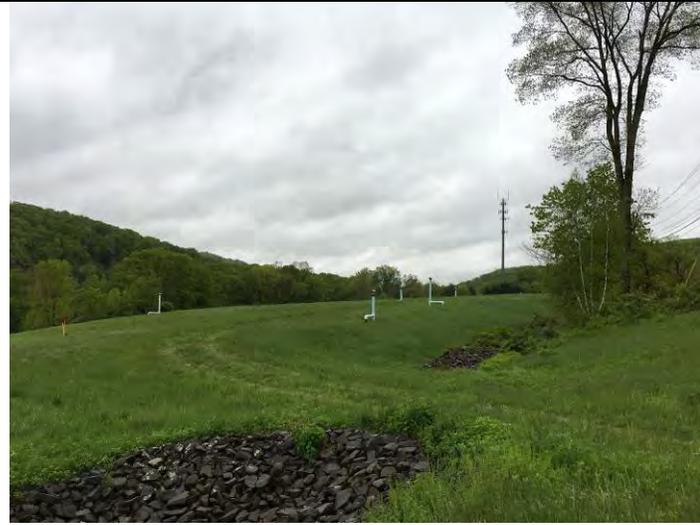
**Photo 3:** Looking south. View of the landfill cap and gas monitoring vents.

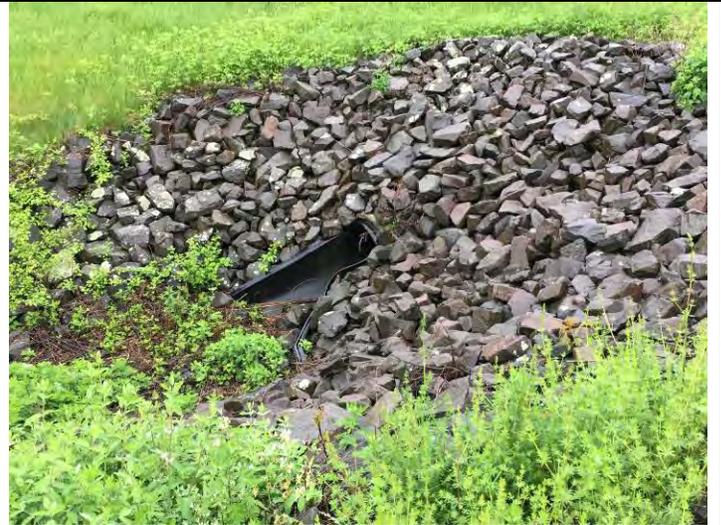
**Photo 4:** Looking south. View of drainage area on northern side of landfill.

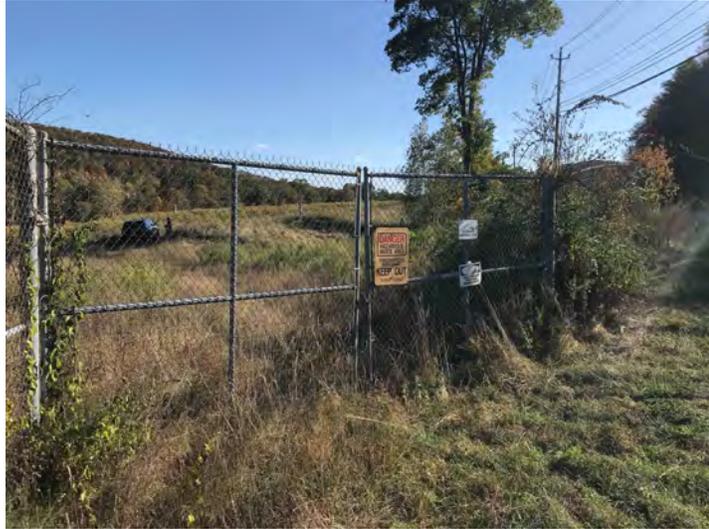
**Photo 1:** Looking southeast. View of the northern gated entrance to the Site.

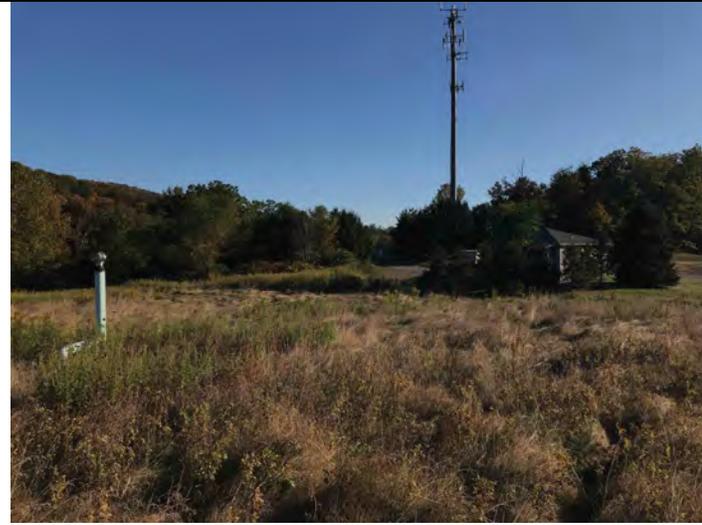
**Photo 3:** Looking southeast. View of the landfill cap and gas monitoring vent.

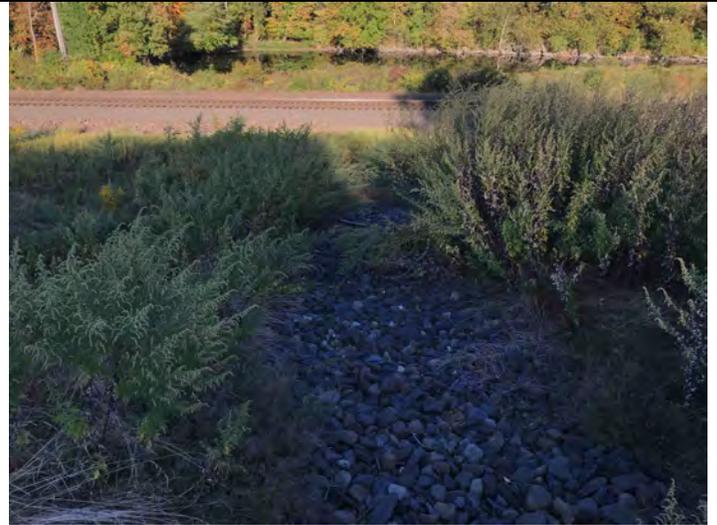
**Photo 4:** Looking east. View of drainage area on northern side of landfill.

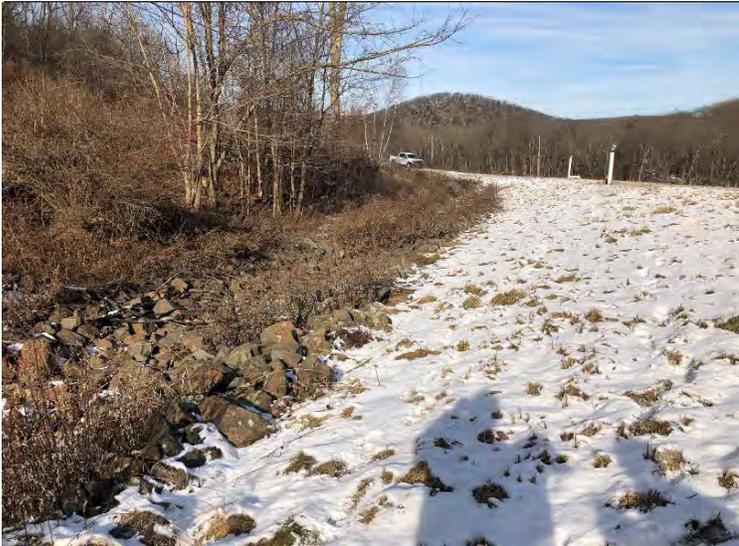
**Photo 1:** Looking north. View towards the gated entrance of the Site.

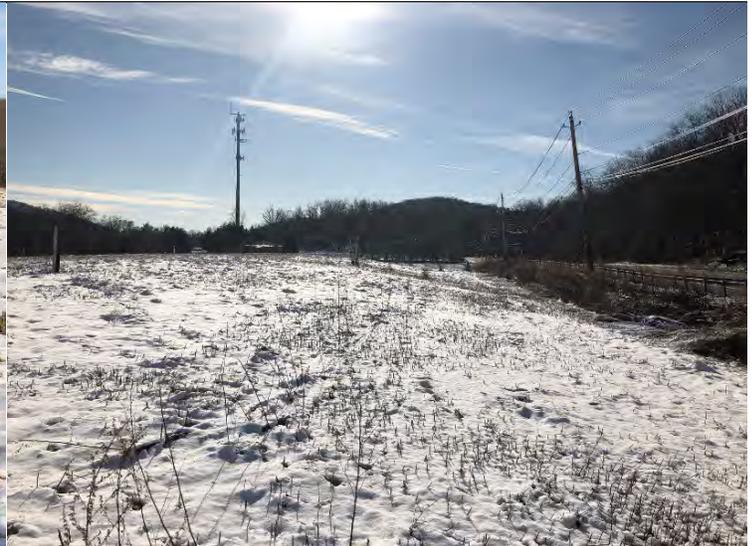
**Photo 2:** Looking south. View of monitoring wells and vent stations.

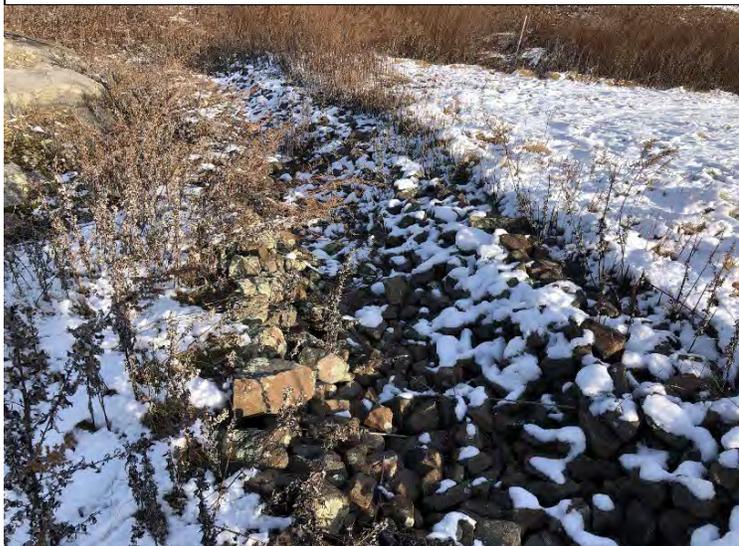
**Photo 3:** Looking east. View of drainage area on northern side of landfill.

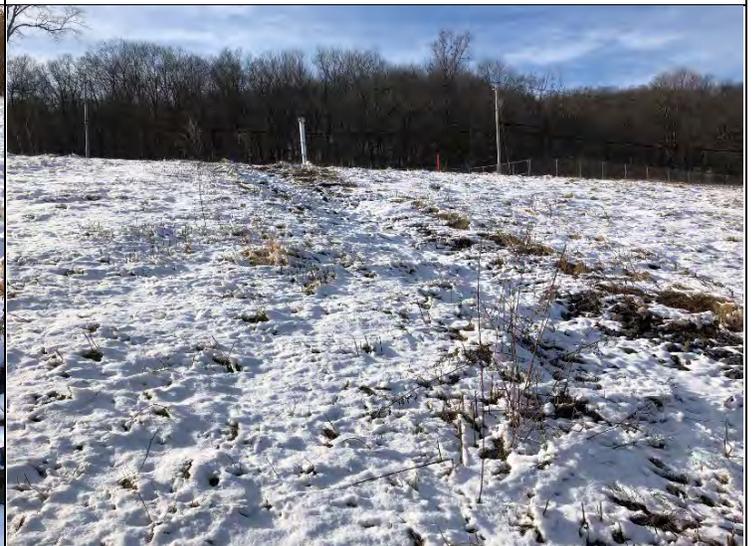
**Photo 4:** Looking west. View of landfill cap and western side of the landfill.

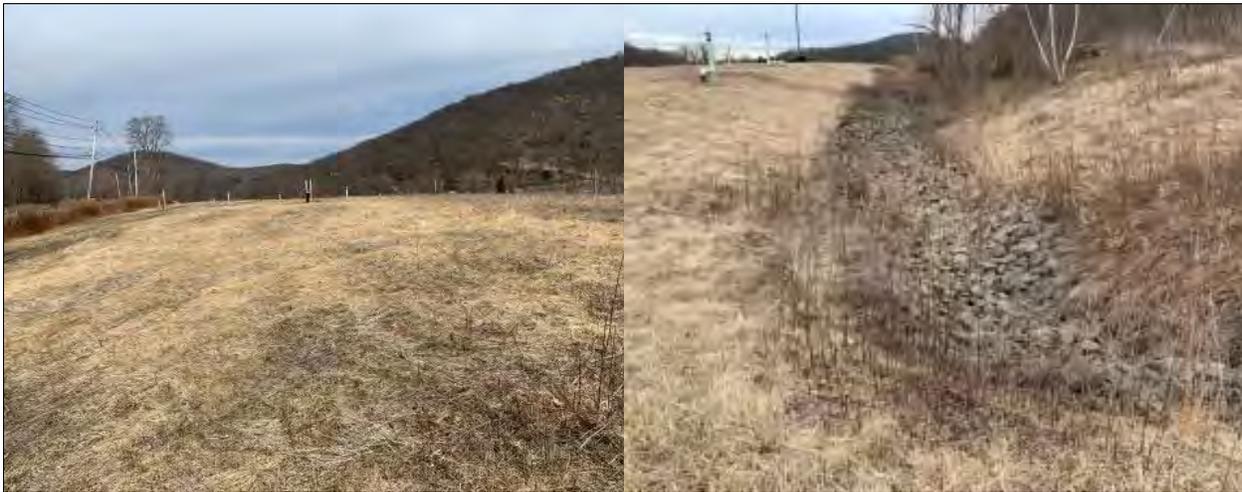
**Photo 1:** Looking north. View the northern end of the landfill cap.

**Photo 2:** Looking south. View of drainage swale south of the entry gate.

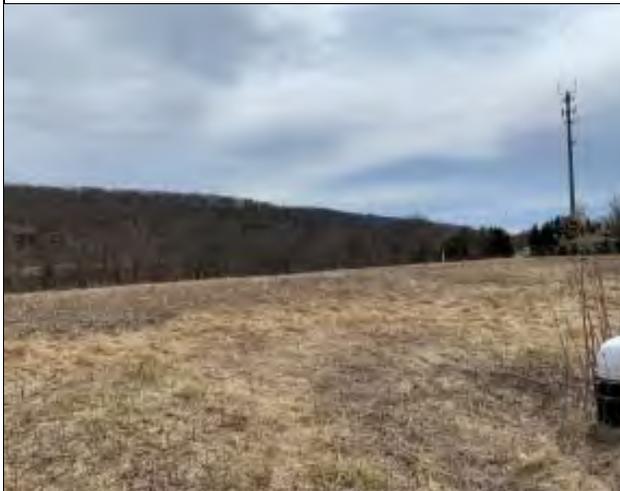
**Photo 3:** Looking southeast. View of the southeast slope of the landfill cap.

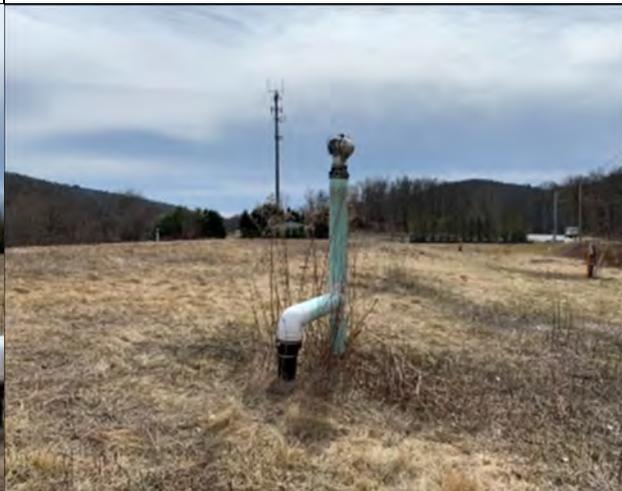
**Photo 4:** Looking south. View of south portion of landfill cap.

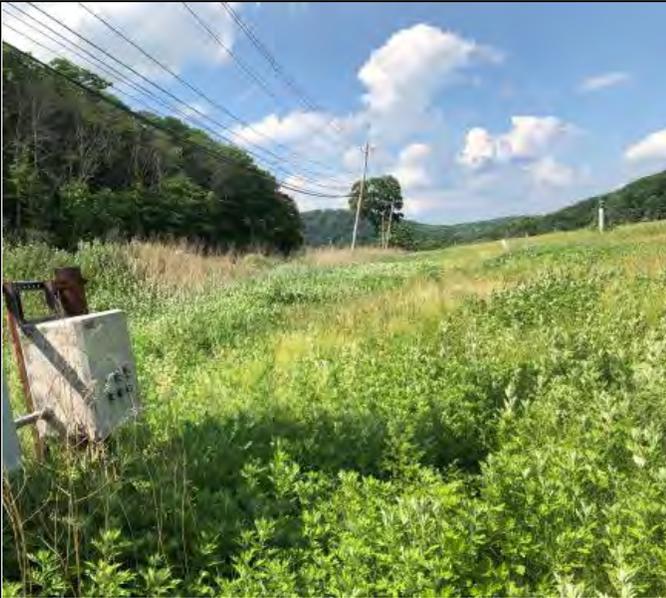
**Photo 1:** Looking north. View the southern end of the landfill cap.

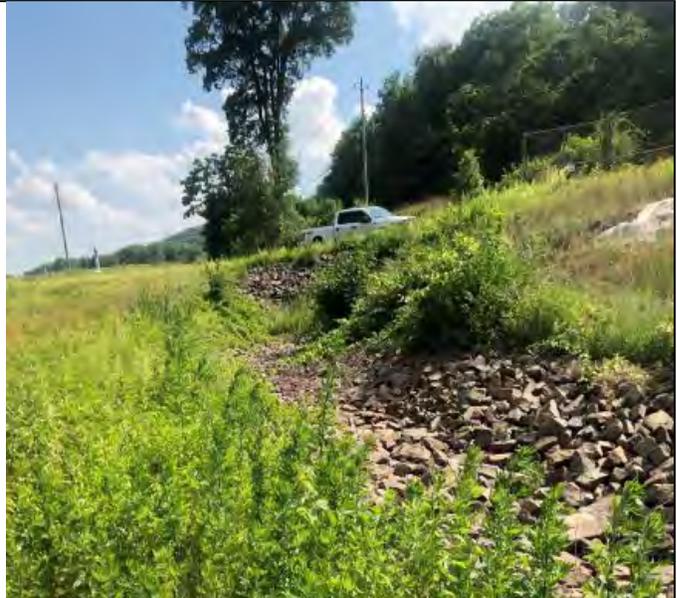
**Photo 2:** Looking south. View of drainage swale south of the entry gate.

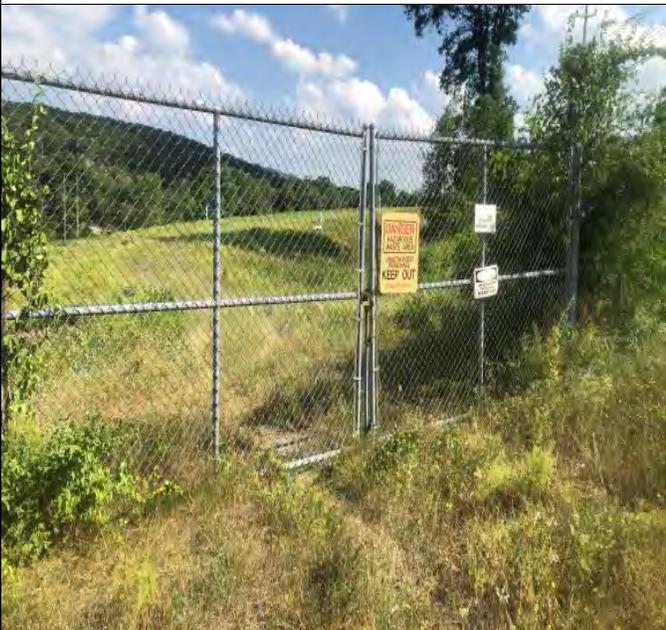
**Photo 3:** Looking southeast at the entrance gate.

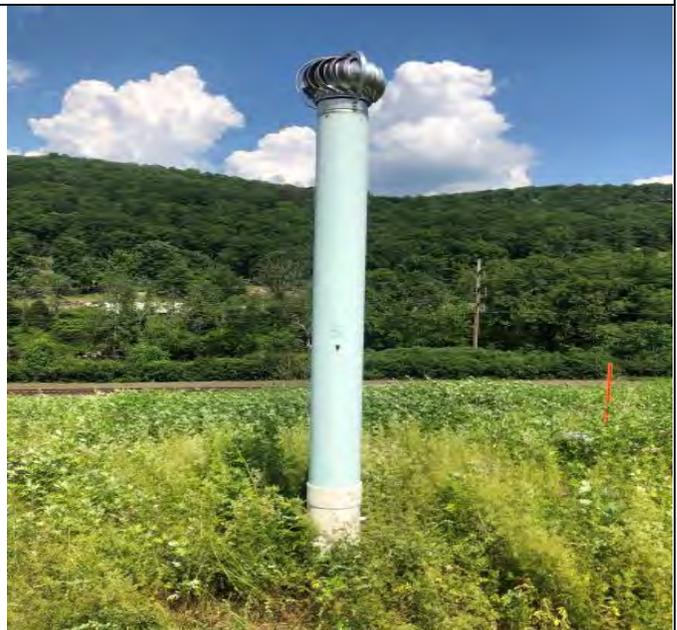
**Photo 4:** Looking south. View of south portion of landfill cap.

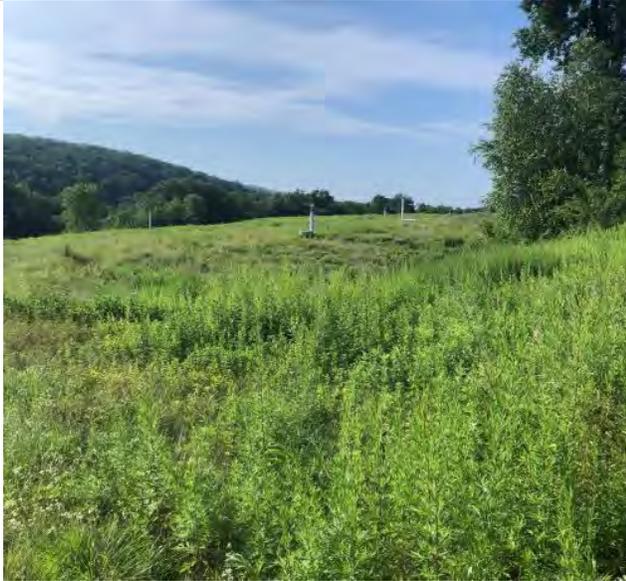
**Photo 1:** Looking northeast. View the northern end of the landfill cap.

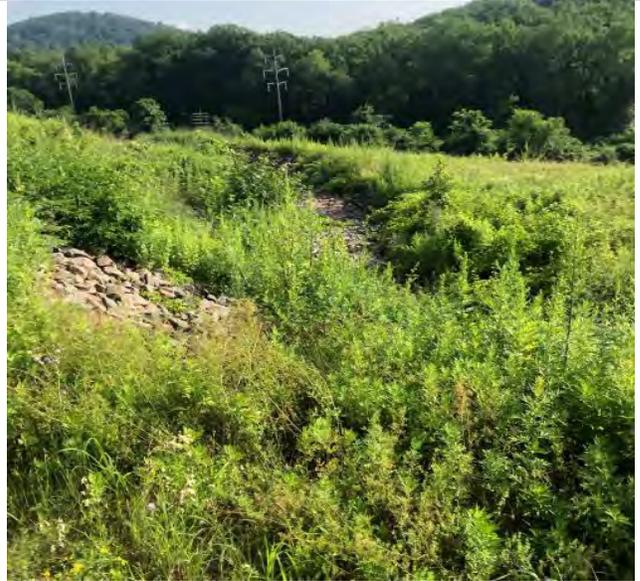
**Photo 2:** Looking northeast. View of drainage swale north of the entry gate.

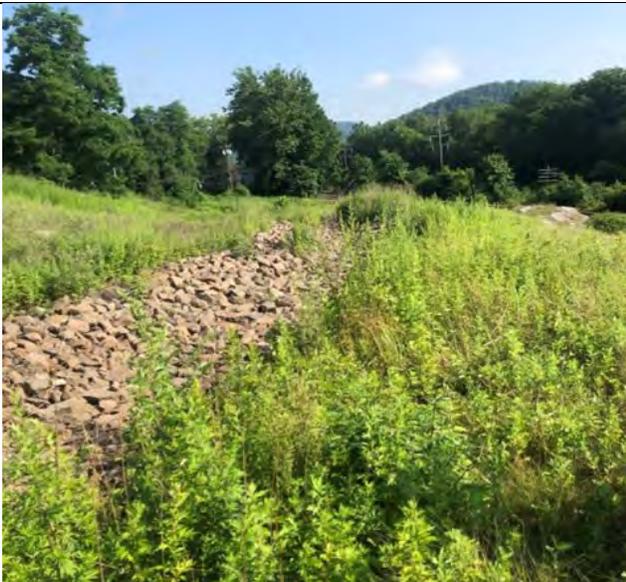
**Photo 3:** View looking north. Looking at the drainage swale at the north most portion of the Site.

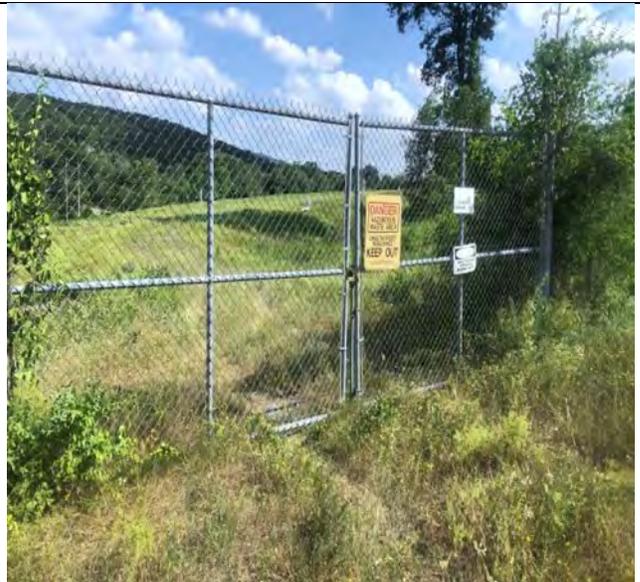
**Photo 4:** Looking southeast at the entrance gate.

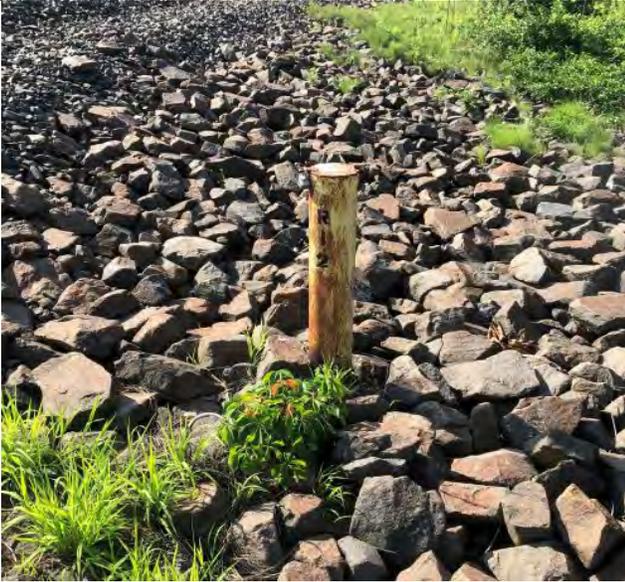
**Photo 5:** Looking south. View the monitoring well RI-2.

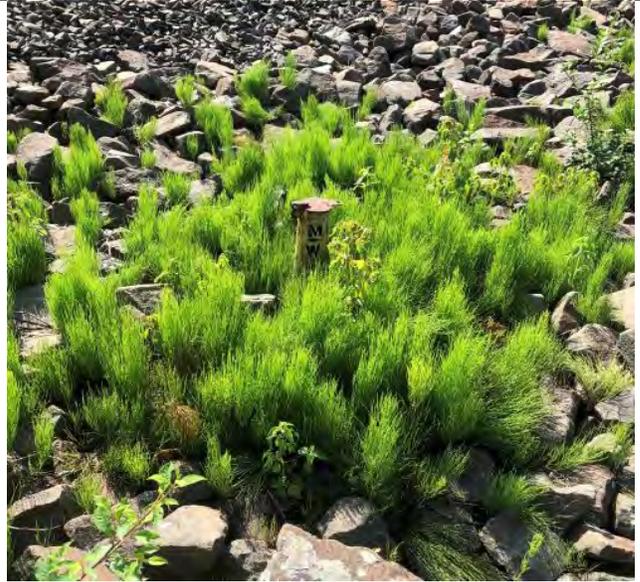
**Photo 6:** Looking west. View of monitoring well MW-5.

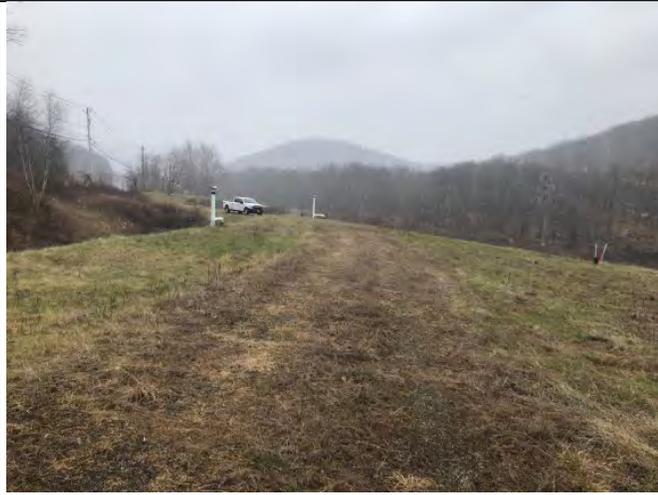
**Photo 1:** Looking northeast. View the northern end of the landfill cap.

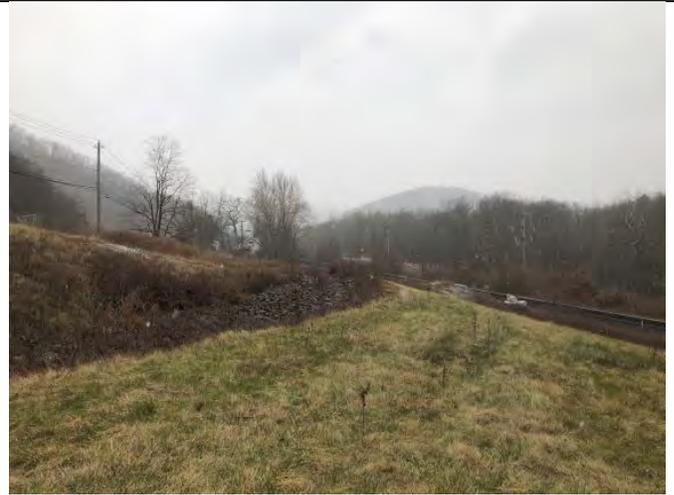
**Photo 2:** Looking north. View of drainage swale north of the entry gate.

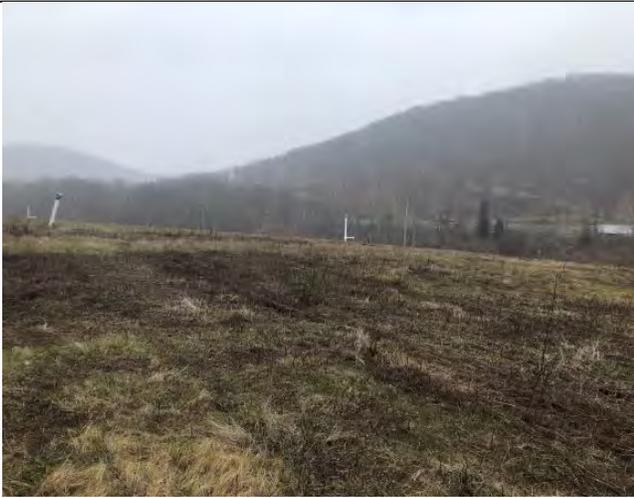
**Photo 5:** Looking northeast. Overview of landfill cap.

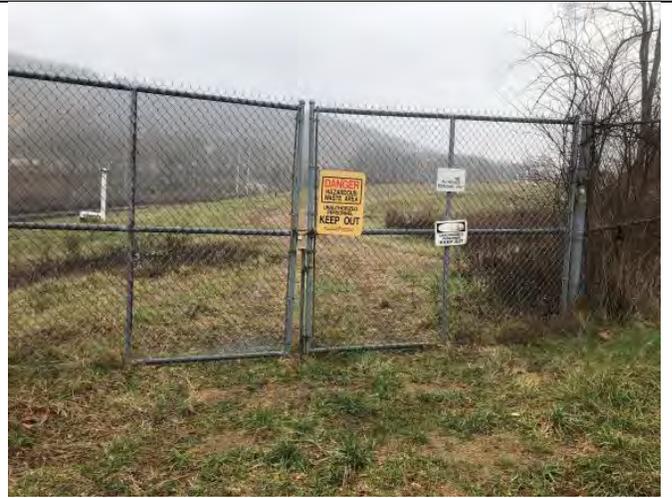
**Photo 6:** Looking southeast at the locked entrance gate.

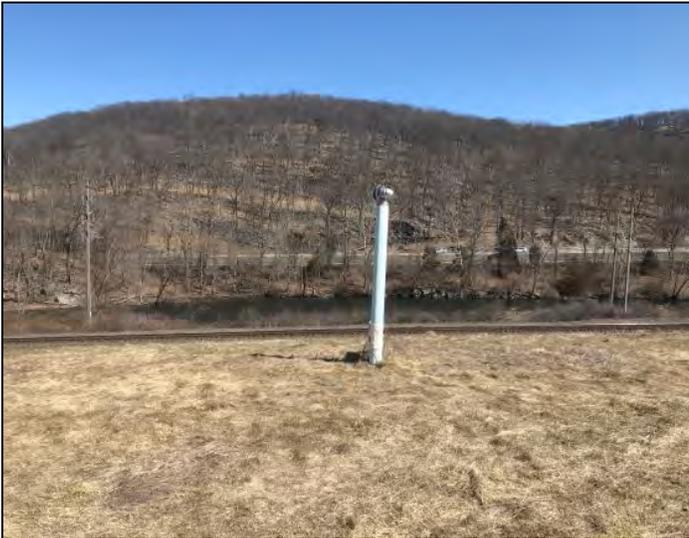
**Photo 1:** Looking east at GVS-1.

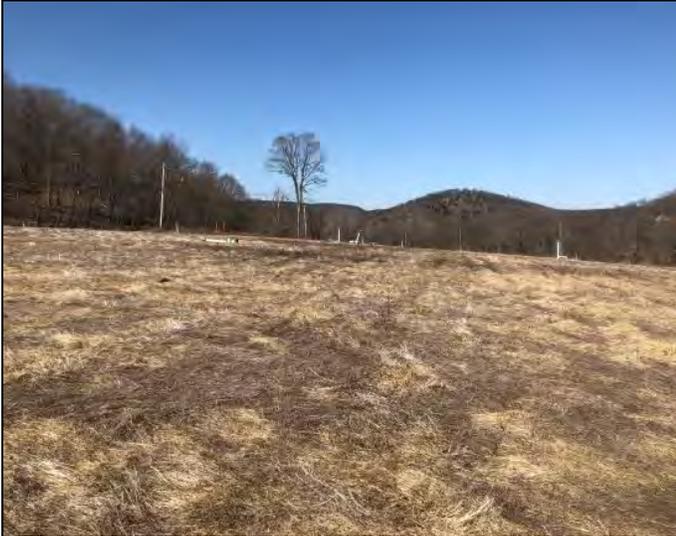
**Photo 5:** Looking north at an overview of the landfill cap.

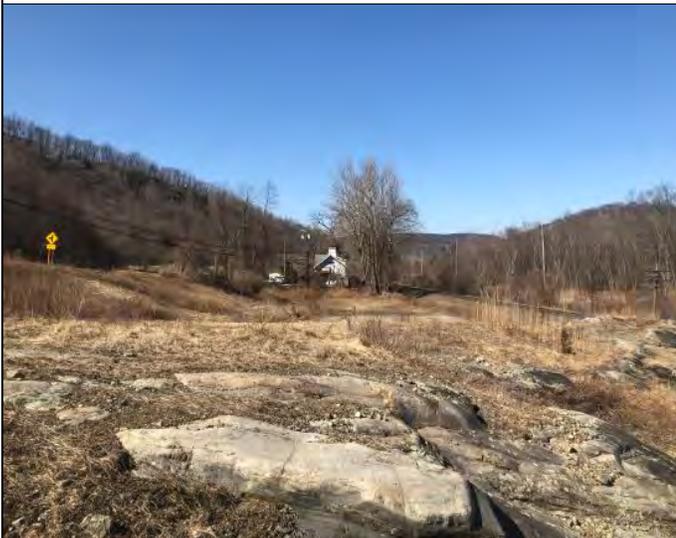
**Photo 7:** Looking north at an overview of the northern portion of the site.

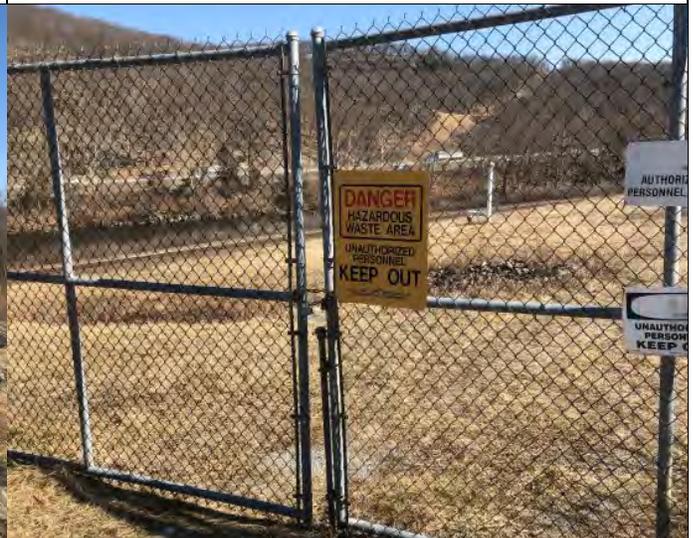
**Photo 8:** View of the locked entrance gate upon demobilizing from the site.

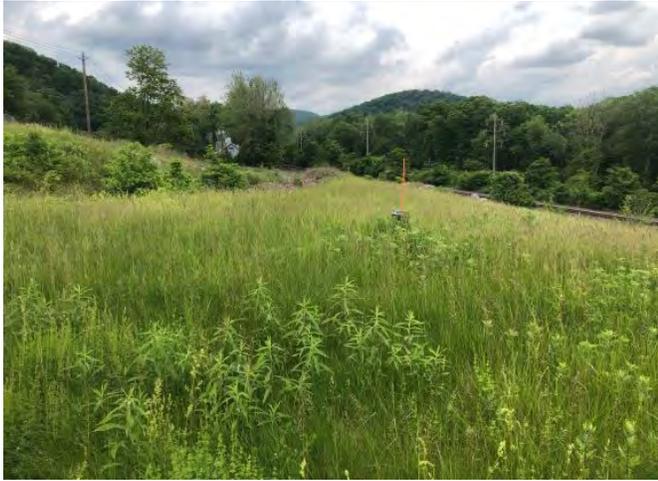
**Photo 1:** View looking north at an overview of the northern portion of the landfill cap.

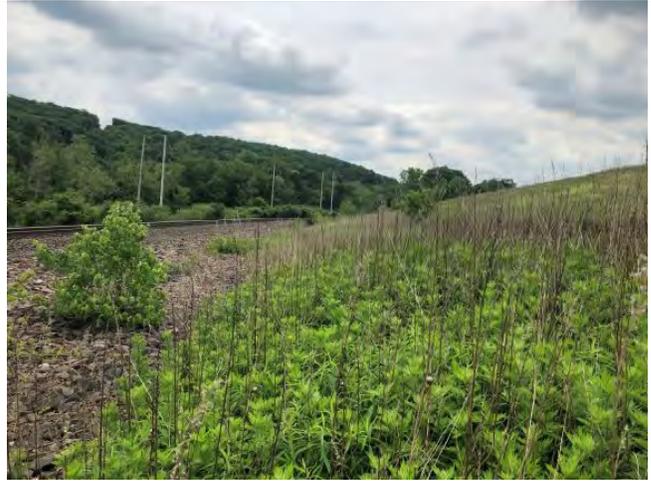
The team performed a site walk, inspection, and a landfill gas monitoring event. The landfill cap inspection involved walking the perimeter of the landfill and the top of the landfill. The landfill cap appeared intact and in good condition. It was dry and the soil stable, with no visible erosion, cracks, settlement, or seeps. No animal burrows were noted throughout the cap. The drainage swales and channels did not contain water and are in good condition. The swales and channels are stable with no visible areas of active erosion. As noted in the last quarter inspection by the team, the dead vegetation in the drainage channels, as well as this season's new vegetation, is currently tall and dense. This may impede the flow of water if not addressed, especially in the event of a high intensity storm.

**Photo 2:** Looking south. View of the high vegetation (both alive and dead) located in all of the drainage swales.

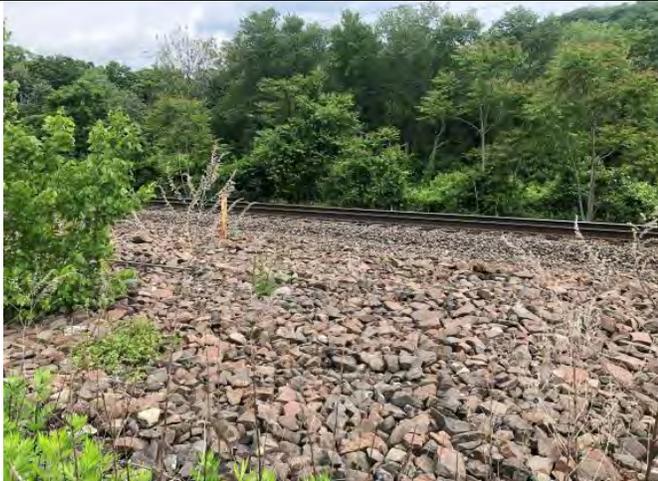
**Photo 3:** View looking east. Overview of the area of monitoring well RI-4.

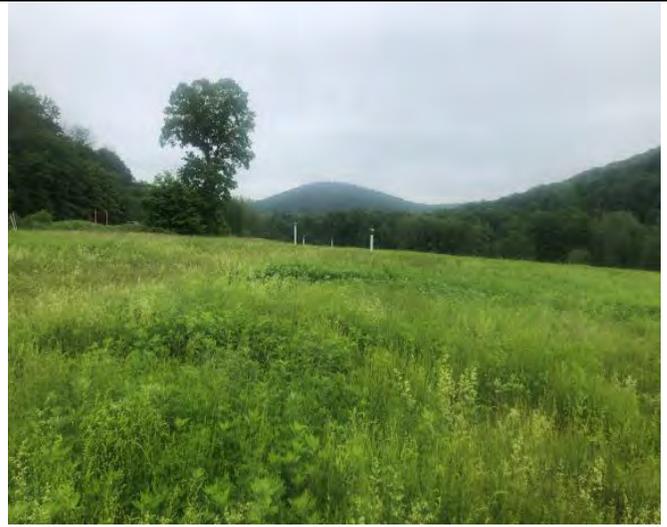
**Photo 6:** View looking north at an overview of the landfill cap.

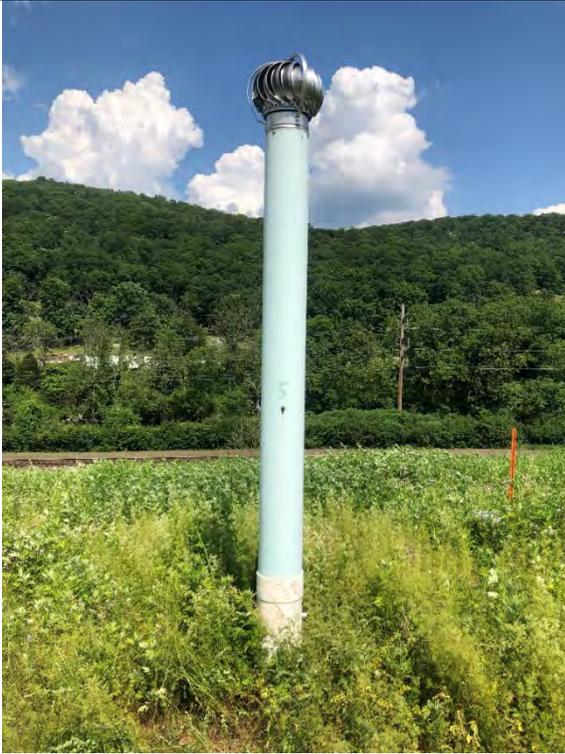
**Photo 1:** Looking east at GVS-5.

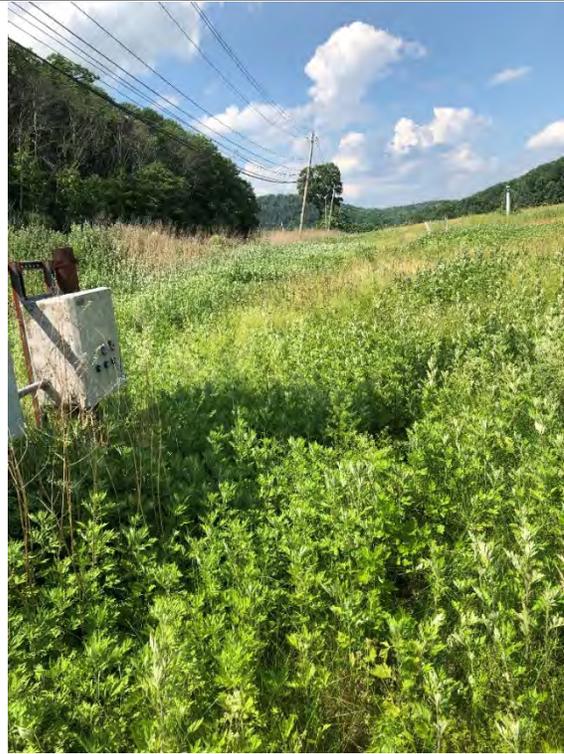
**Photo 2:** Looking South along the perimeter of the site.

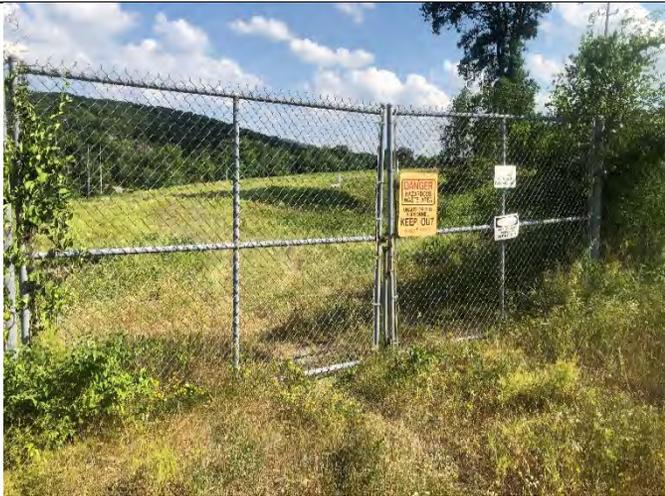
**Photo 3:** View of the locked entrance gate upon leaving the site.

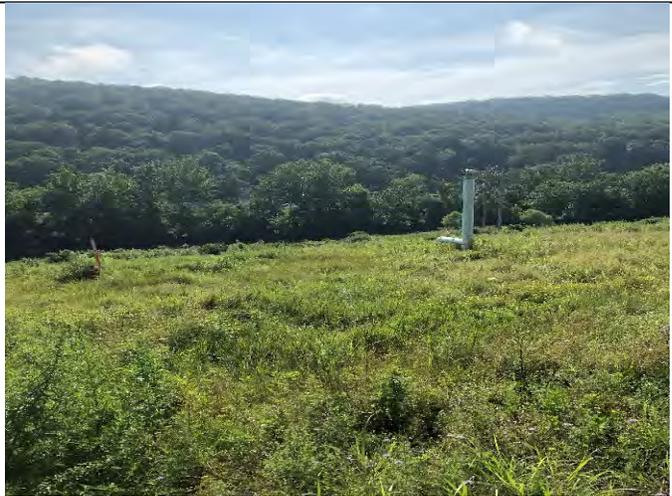
**Photo 4:** View looking West showing an overview of the site conditions.

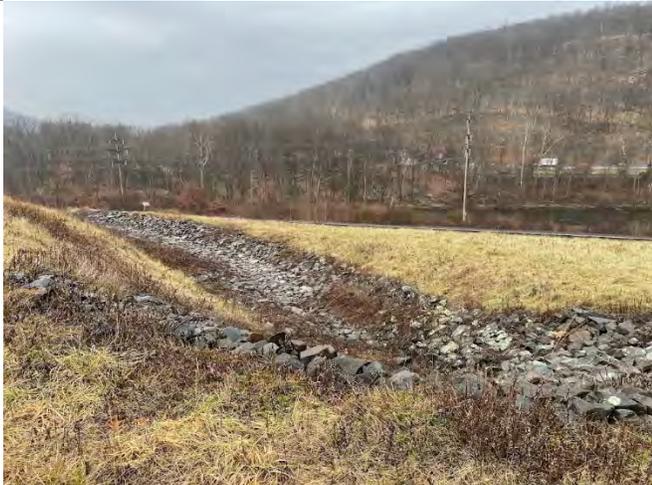
**Photo 1:** Looking northeast at drainage swale in northern portion of the Site.

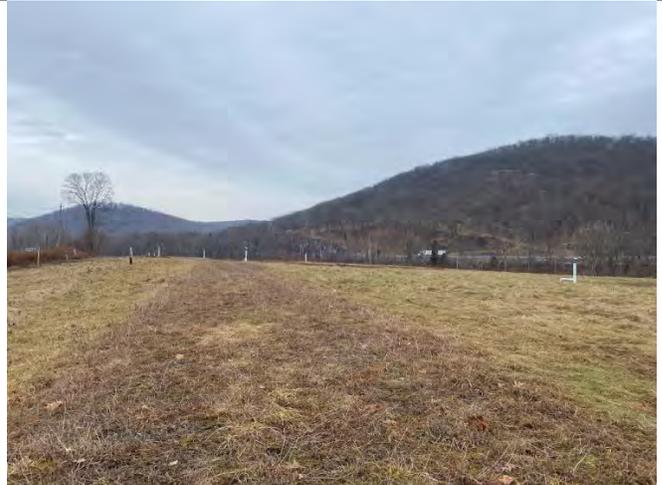
**Photo 2:** Overview of Site looking north, taken from the access road.

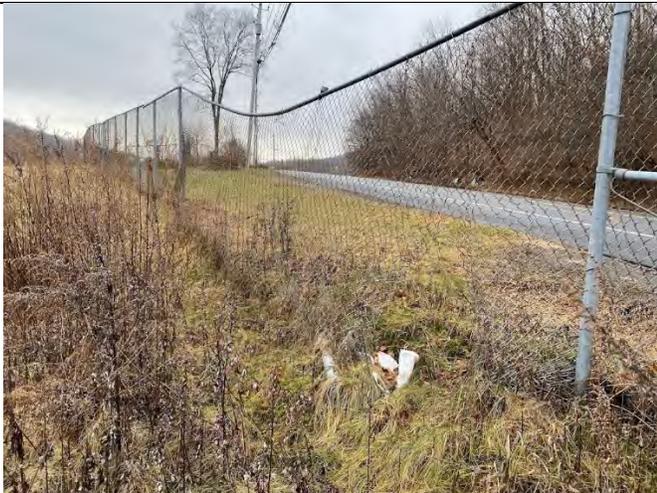
**Photo 3:** View of hole in the northern end of fence

TRC conducted a site walk, inspection, as well as a landfill gas monitoring event. The landfill inspection included walking the perimeter of the landfill, areas of the landfill slope and the top of the landfill. The landfill cap was dry and the soil stable, with no visible erosion, cracks, settlement, or seeps. The landfill cap appeared intact and in good condition. The swales, channels and basin are stable with no noticeable areas of active erosion. Vegetation is low throughout the site, with most vegetation being dead due to the seasonal conditions. The drainage swales and basins contain some denser areas of dead vegetation, which may impede the flow of water in the event of a high rain volume or a severe storm event.. A hole was noted in the northern end of the fence. TRC recommends that regular maintenance be performed to remove the dead vegetation and that the fence be repaired.

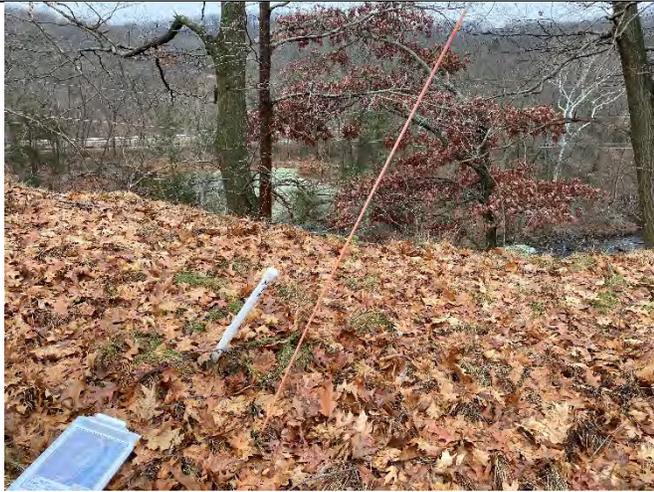
**Photo 5:** View of lopsided PMP-8, looking east.

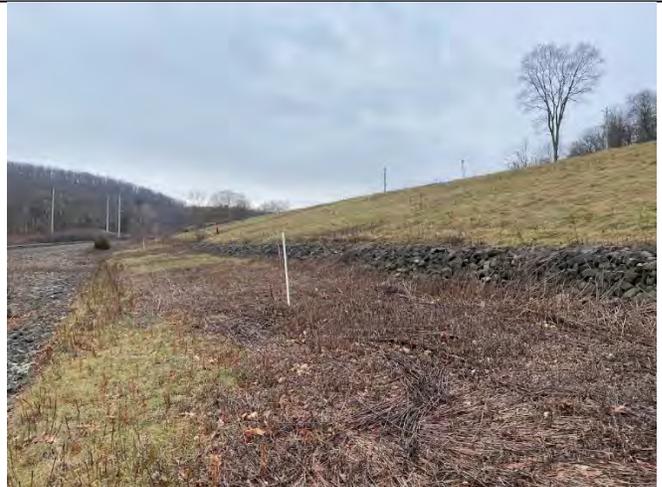
**Photo 6:** View of eastern side of landfill, looking south.

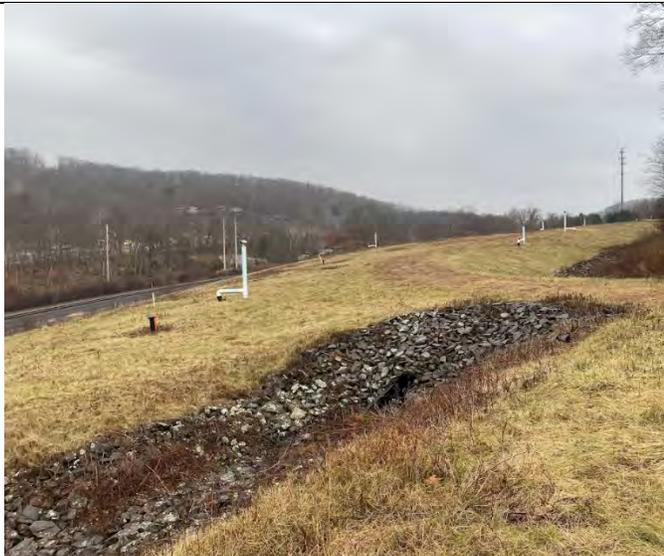
**Photo 7:** Overview of Site taken from northern portion, looking south.

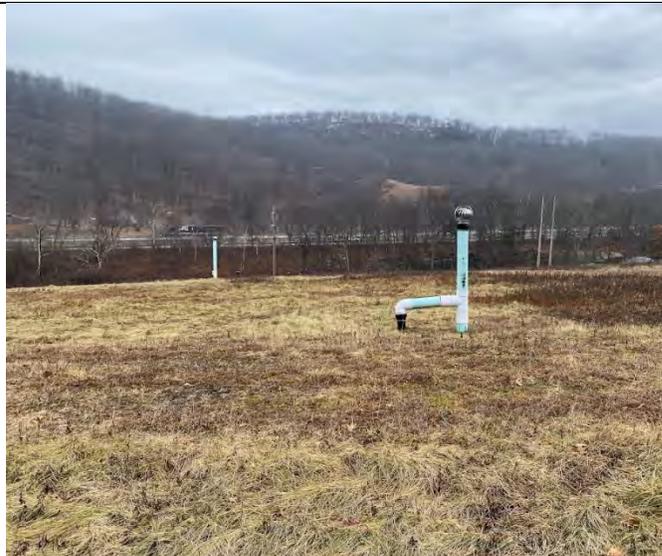
**Photo 8:** View of GVS-4 looking east.

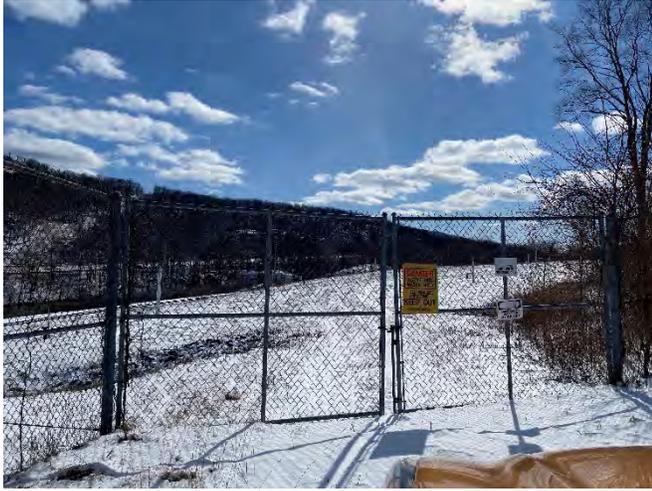
**Photo 1:** View of entrance gate to the Site, looking south.

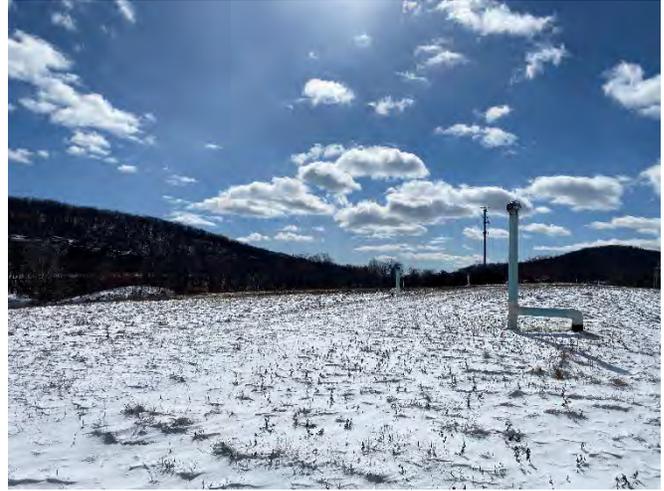
**Photo 2:** Overview of Site looking south, taken from the access road.

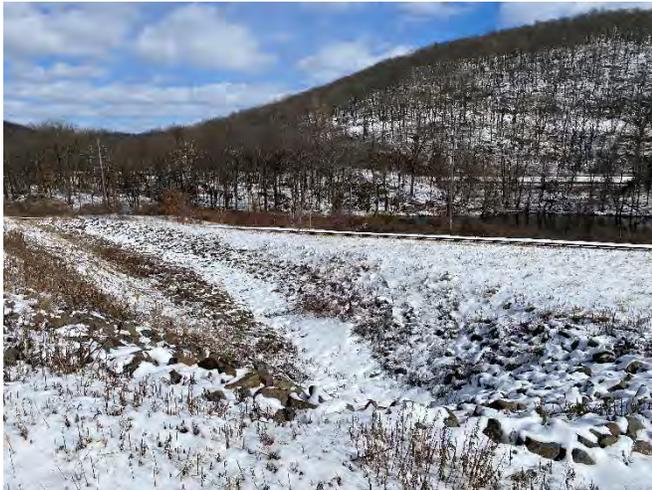
**Photo 3:** View of drainage swale in the northern portion of Site, looking north.

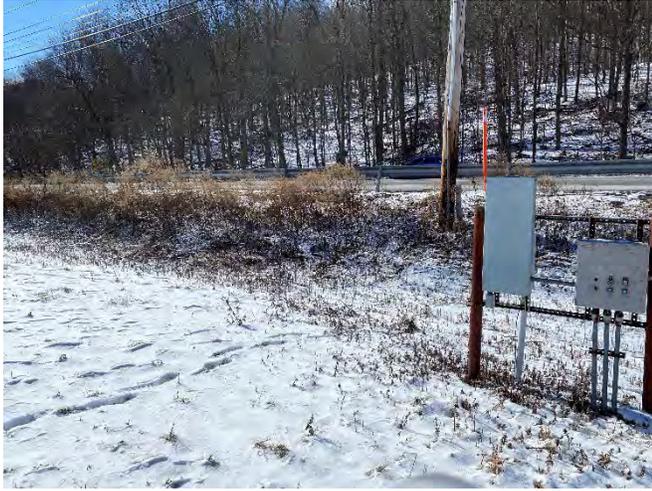
**Photo 5:** View of general area of PMP-3, looking west.
