# PERIODIC REVIEW REPORT JUNE 2017 – JUNE 2022

**TUXEDO WASTE DISPOSAL SITE  
TUXEDO, NEW YORK 10987**

**NYSDEC Site No. 336035**

**Work Assignment No. D009812-25**

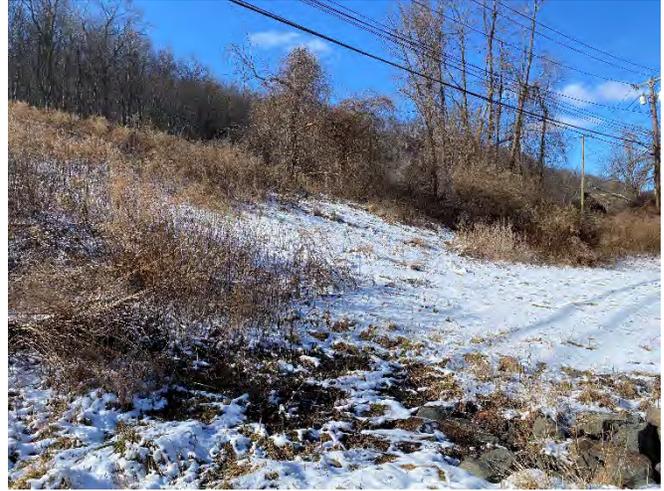
**Photo 6:** View of general area of PMP-1, looking north.

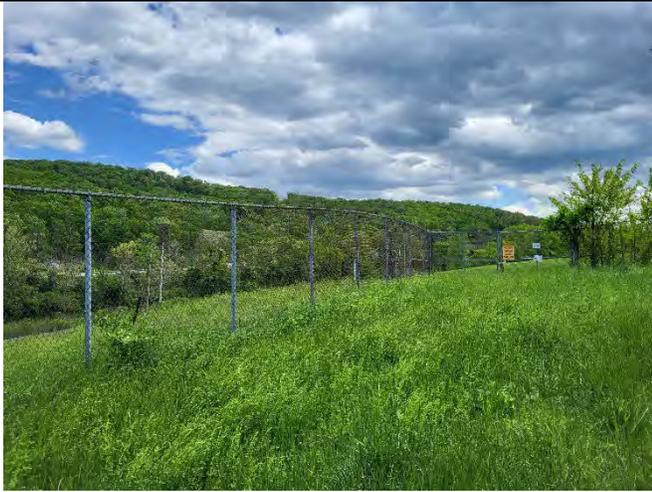
**Photo 1:** View of entrance gate to the Site, looking south.

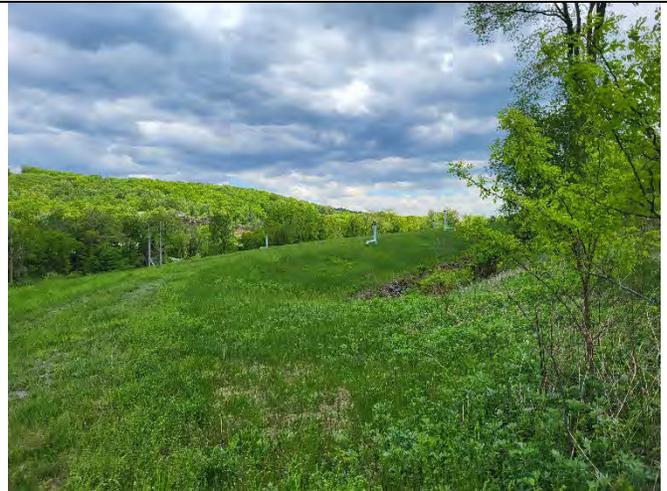
**Photo 4:** Overview of Site from entrance gate, looking south.

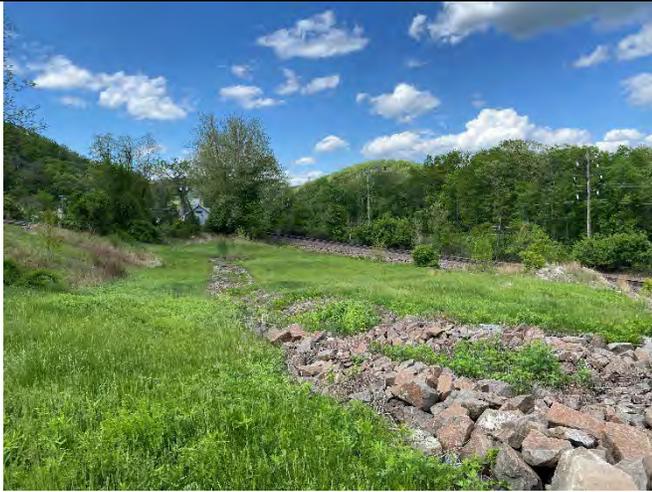
**Photo 5:** View of drainage swale in northern portion of Site, looking north.

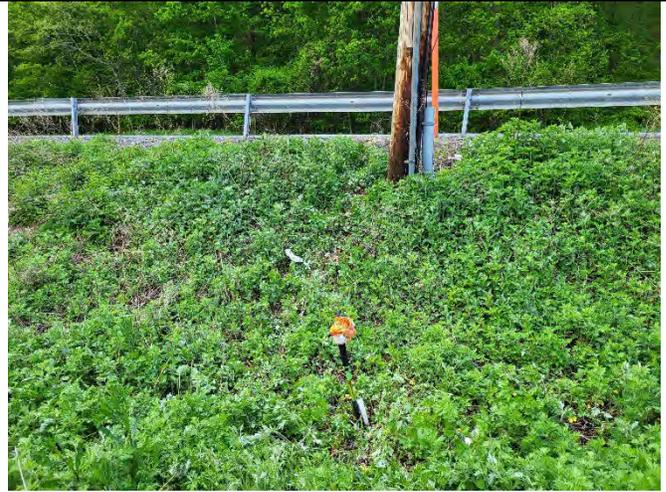
**Photo 6:** View of PMP-3, looking west.

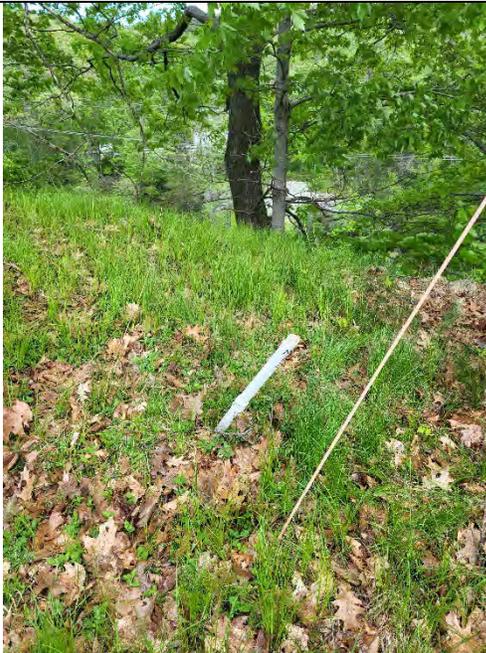
**Photo 7:** View of PMP-8, looking east.

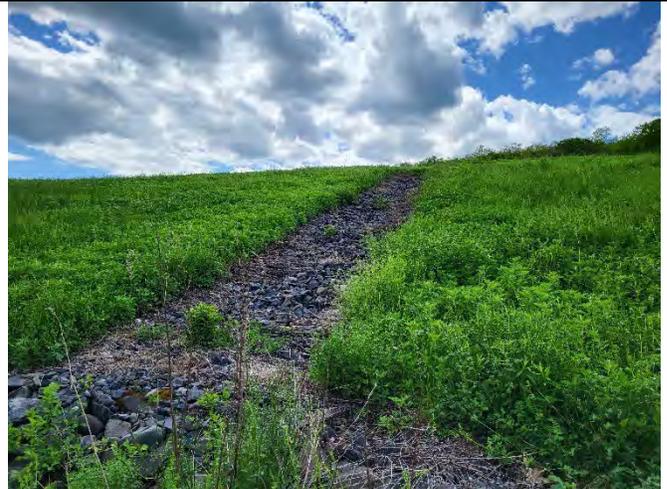
**Photo 10:** View of drainage swale on east side of landfill cap, looking west.

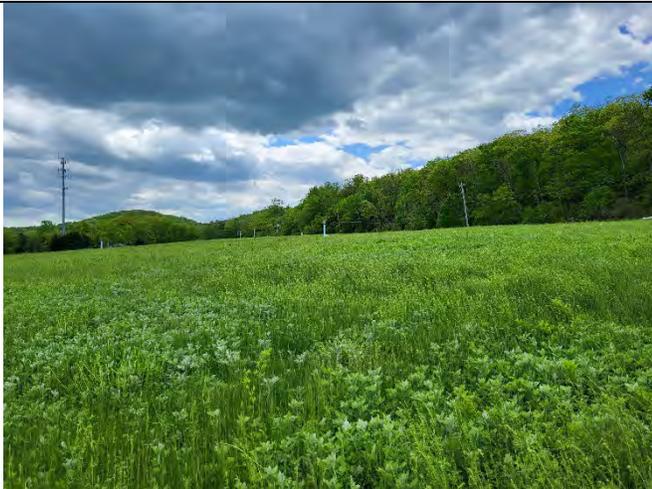
**Photo 11:** View of landfill cap taken from central portion, looking southwest.

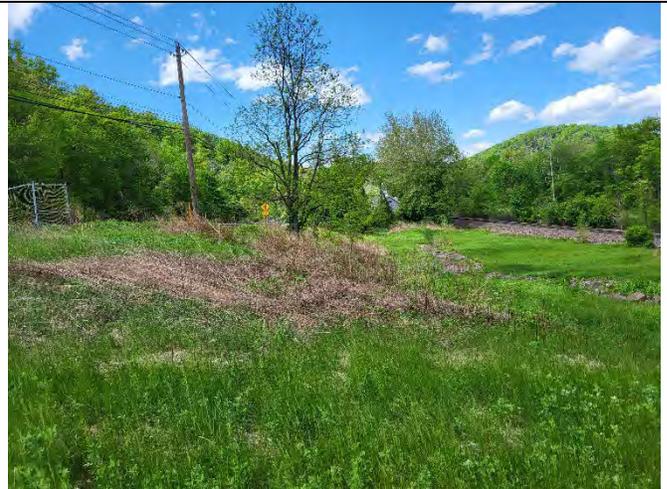
**Photo 12:** View of general area of PMP-1, looking north.
