| FACILITY: <b>Former Bendix Landfill)</b> | NYSDEC SITE NO. 401005 |

### LANDFILL INSPECTION CHECKLIST

# Honeywell (Bendix) Inactive Closed Landfill. Follow-up Inspection 10/28/14 and 10/30/14

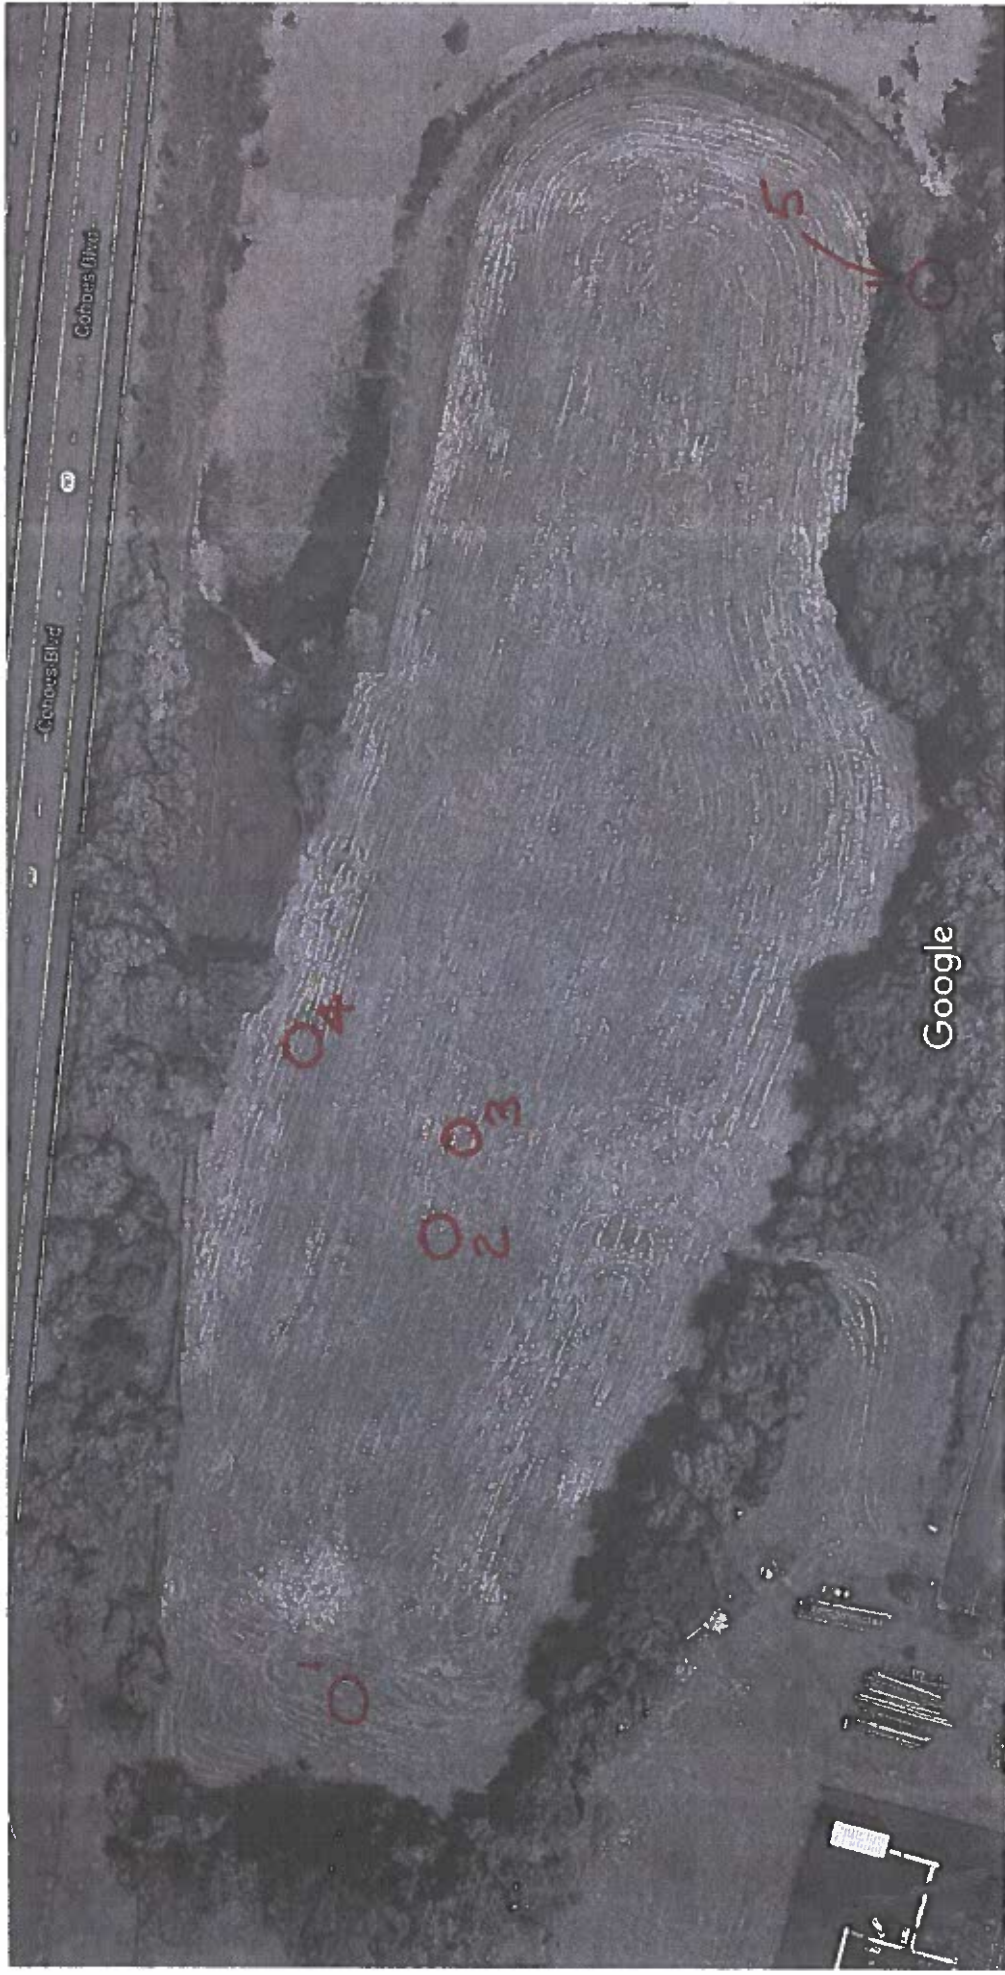
1-4: WOOD CHUCK HOLES

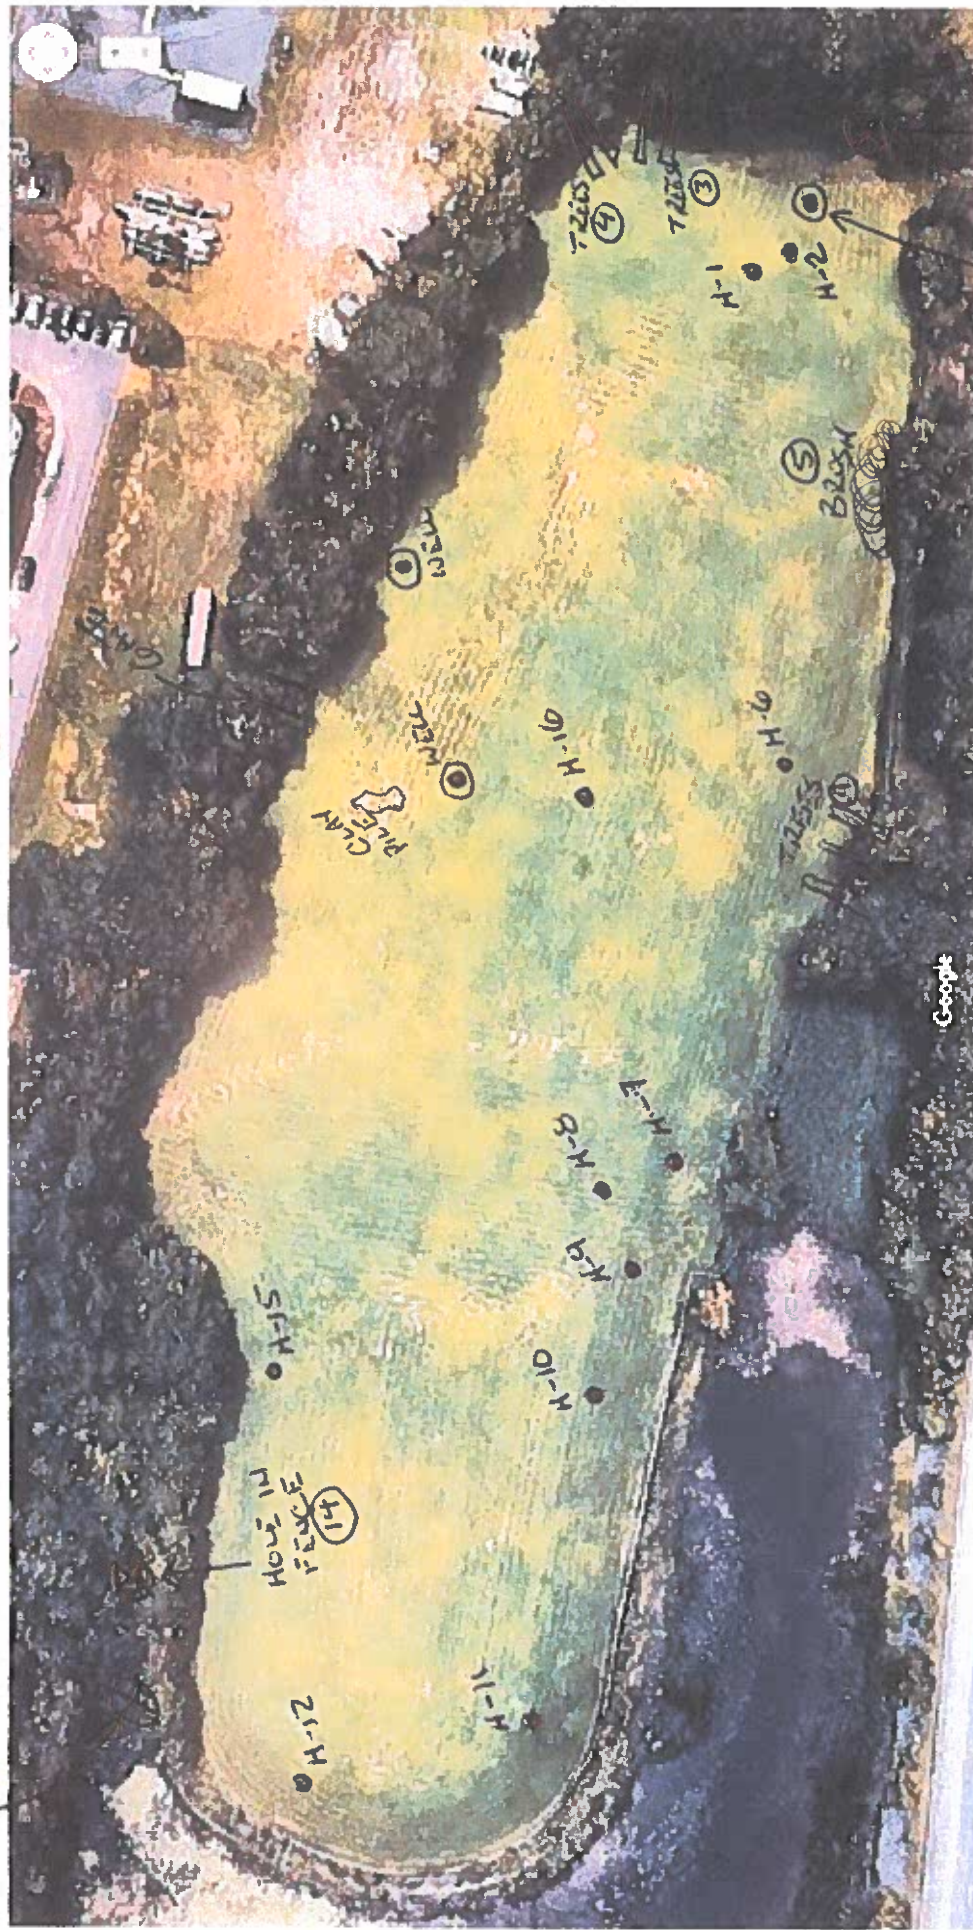
# GREEN ISLAND HONEYWELL LANDFILL MAP

| Item No. | Item Description | Condition | | | Maintenance Required? | | | Comments |
|---|---|---|---|---|---|---|---|---|
| <p>① FENCE LINE COULD USE A GOOD "TRIM JOB" ON THE EAST AND SOUTH ENDS</p> <p>7/12: TREE &amp; BRUSH COMPANY CONTACTED</p> <p>ASBESTOS " "</p> | | | | | | | | |

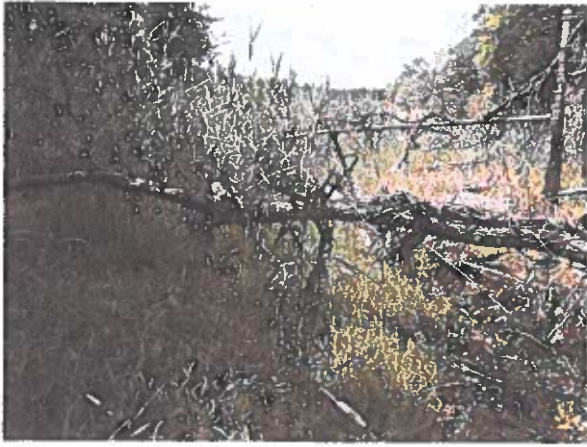
14 (Hole In Fence)

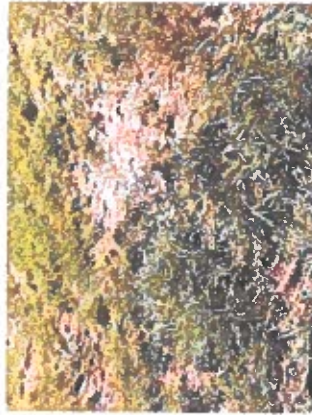
Standing Water #5a

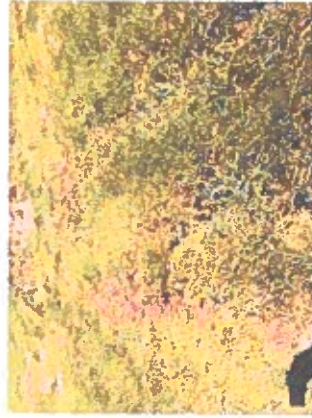
Standing Water #5b

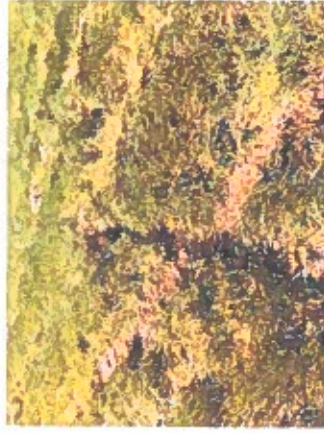
Standing Water #5c

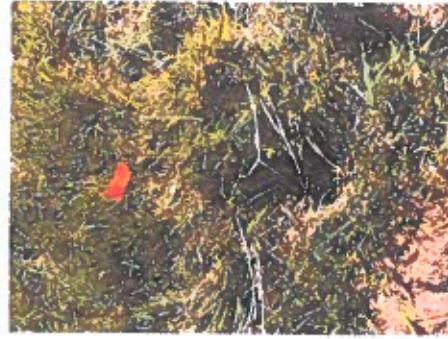
Chuck Hole #14

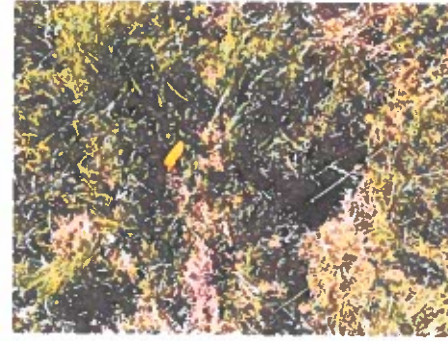
Chuck Hole #15

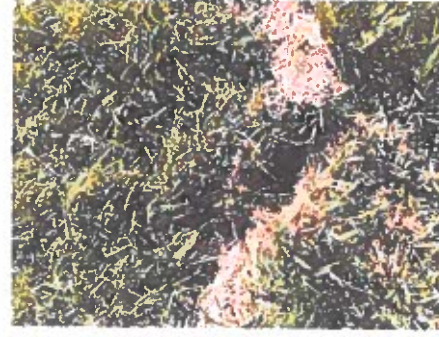
Chuck Hole #16

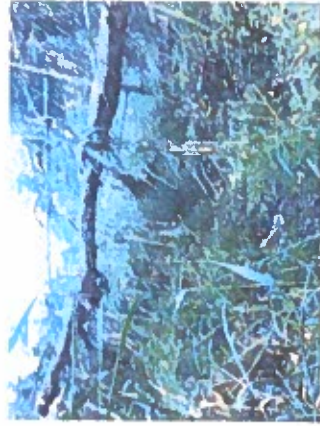
North Fence #1d

| Item No. | Item Description | Condition | | | Maintenance Required? | | | Comments |
|---|---|---|---|---|---|---|---|---|
| 4 | Is Site perimeter fence secure/in good condition? | | X | | | | X | (2) HOLES AND (1) DOWN SECTION |

| Item No. | Item Description | Condition | | | Maintenance Required? | | | Comments |
|---|---|---|---|---|---|---|---|---|
| <p>SEE ATTACHED PICTURES...</p> <p>① FENCE PEOPLE CONTACTED 10-5-18</p> <p>② HOLE REPAIR CONTACTED 10-8-18</p> | | | | | | | | |

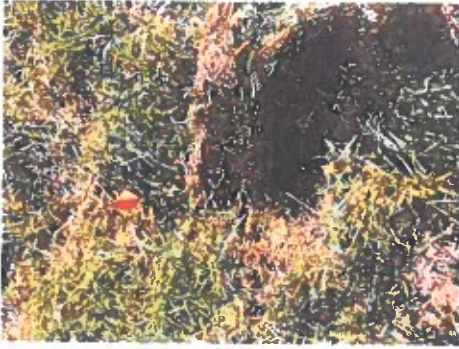
Chuck Hole #10

| Item No. | Item Description | Condition | | | Maintenance Required? | | | Comments |
|---|---|---|---|---|---|---|---|---|
| 15 | Is there evidence of damage due to burrowing animals? | X | | | | | X | 15 WOODCHUCK HOLES |
