**Construction Completion Report
Admiral Cleaners (401075)
Interim Remedial Measure No. 1 (IRM No.1)
Watervliet, New York**

January 2021
Version: FINAL
EA Project No. 16025.04

Christopher Schroer, Project Manager
EA Science and Technology

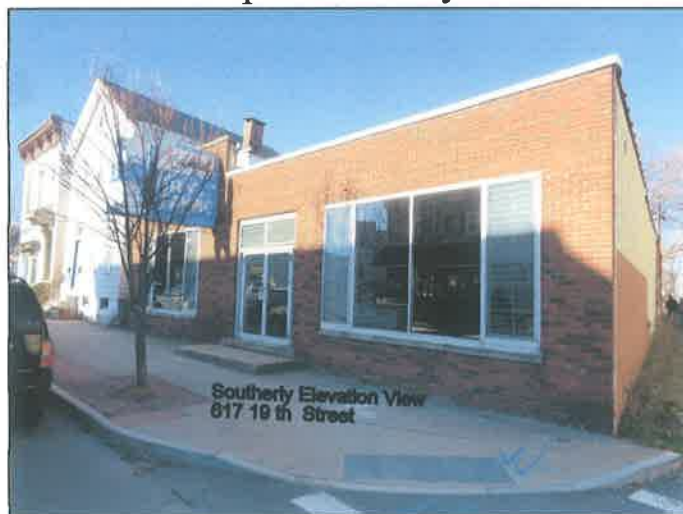
Photograph 1 shows the front Southerly elevation view of the building as seen from 19th Street. The building consists of the original structure which includes the entrance door and large window section as seen in Photograph 1. A later addition was constructed on the West side of the original building so as to provide for additional clear span open space. The addition can be seen in Photograph 1 to the left of the sign.

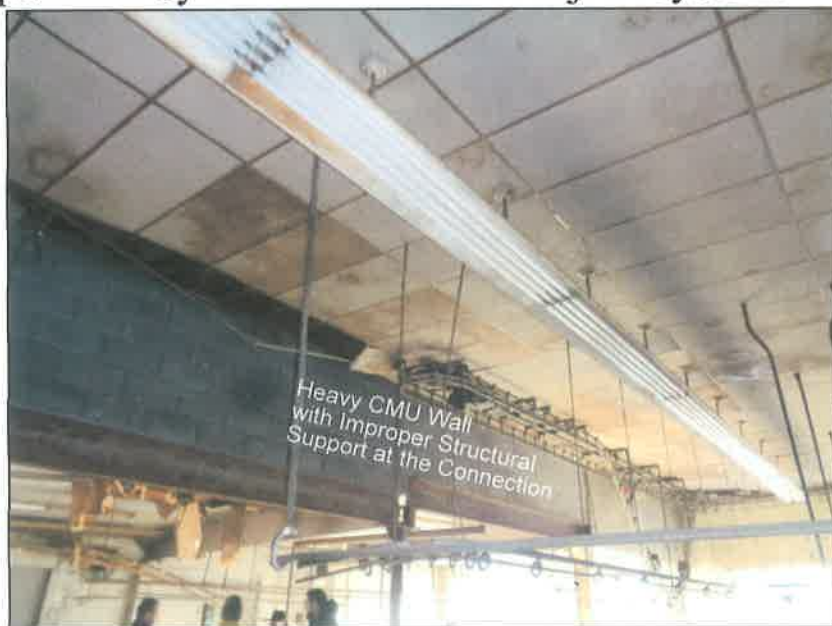
In order to obtain clear span openings between the original building and the addition, large wide flange steel beams were inserted to support the upper masonry wall sections of the original structure as shown in Photographs 11 and 12. These are heavy loads imposed on the beam sections, columns and connections. In addition to the weight of the upper concrete block bearing wall, roof framing members from the Westerly addition are supported by this steel beam and column assembly. During the course of our evaluation, we noted that some of the beam and column connections were improperly made and are highly structurally deficient. Eccentric loads have been placed on columns and improper beam shims have been installed as depicted in Photograph 12. These structural deficiencies that we have encountered are a concern because if a localized collapse of roof framing members occurred, this will induce lateral loads and a thrusting action against this masonry wall assembly which is shown in Photograph 11 and will result in a roll-over effect in the beams which are shown in Photograph 12 thus destabilizing the column support assembly. This collapse mechanism is a high hazard condition.

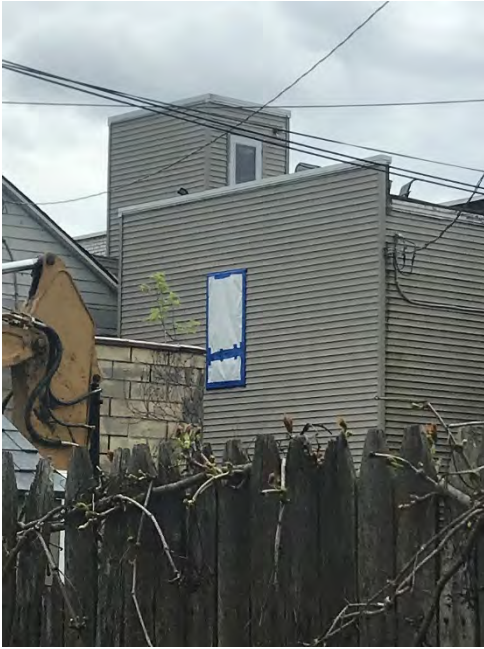
Window cover on Mr. Gagliardi's east facing window of residence.

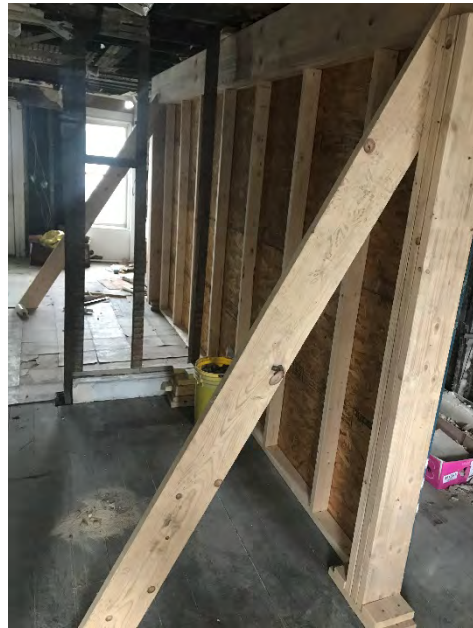
Shoring on second floor of 621 19th St.

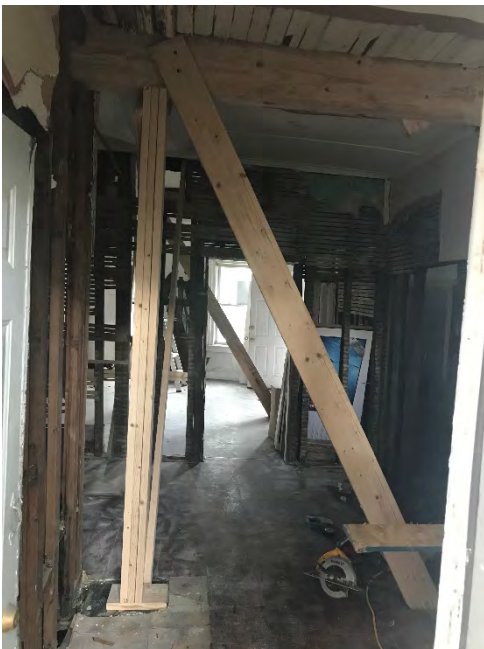
Shoring on first floor of 621 19th St.

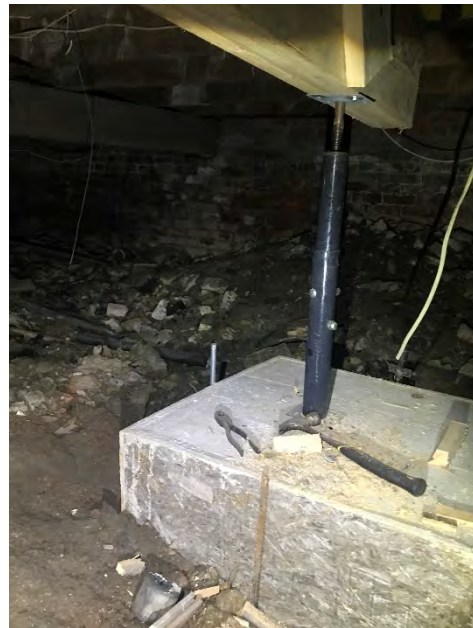
Floor supports in the basement of 621 19th St.

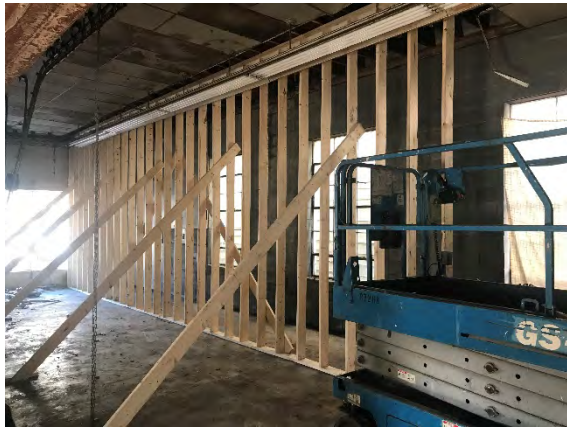
Completed support wall inside building (completed 5/4/20)

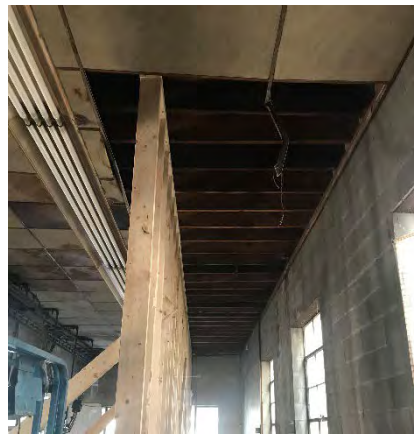
Portion of the ceiling removed for support wall construction (completed 5/4/20)

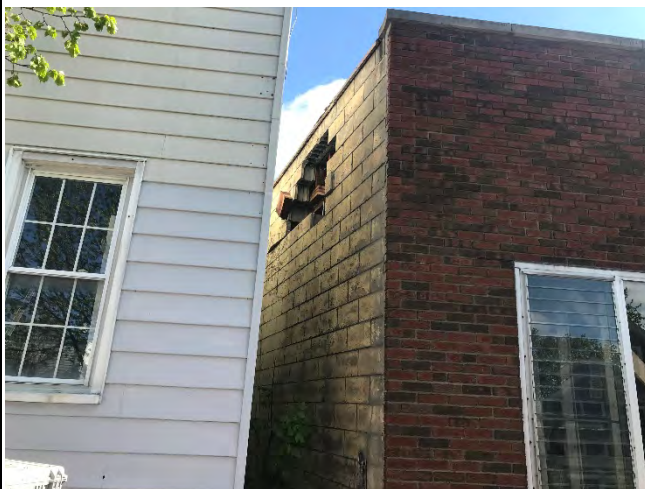
Hand demo started on the south west corner from the inside.

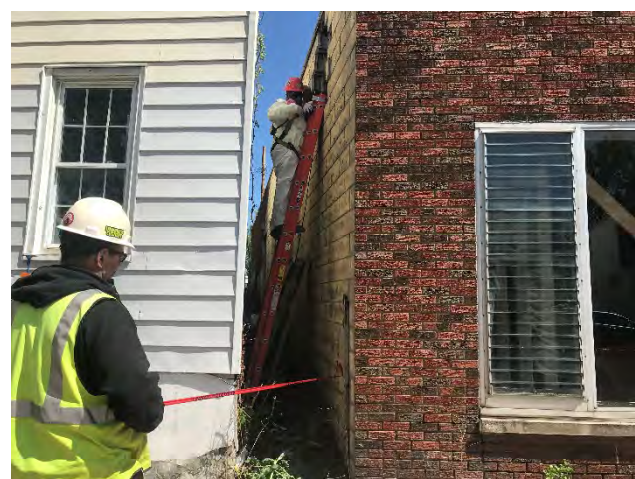
Hand demo now being performed from the outside due to complications inside.

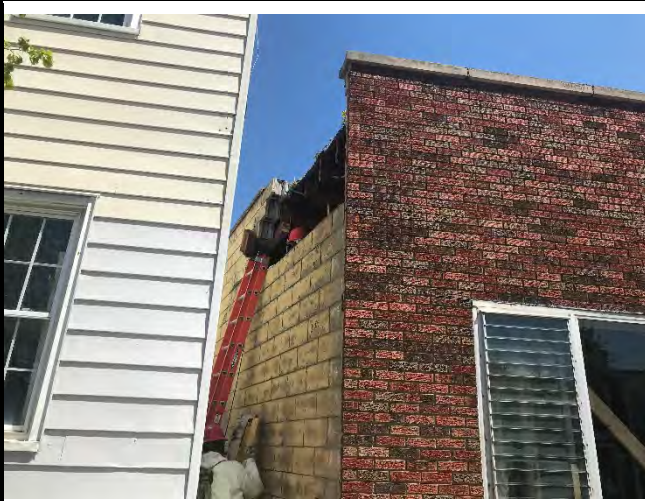
Portions of the roof removed during hand demo of west wall

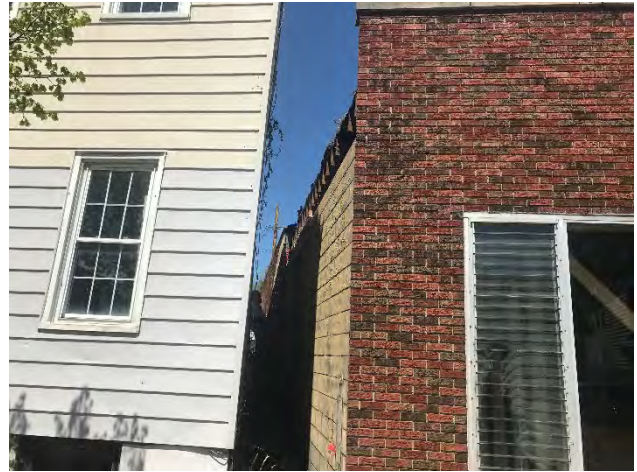
Top six rows of block removed up to the end of the support wall

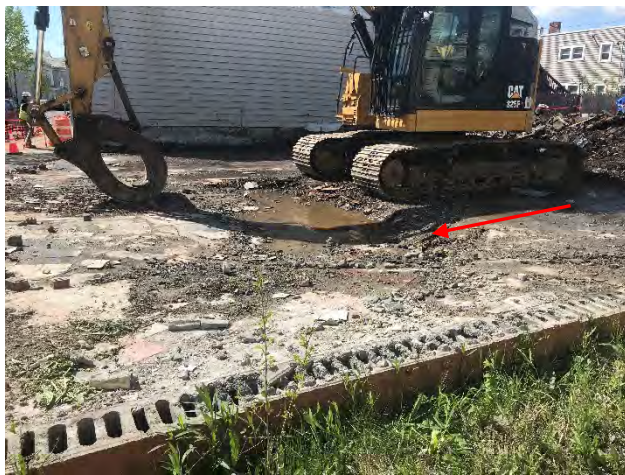
3-6" depression in southeast portion of the slab

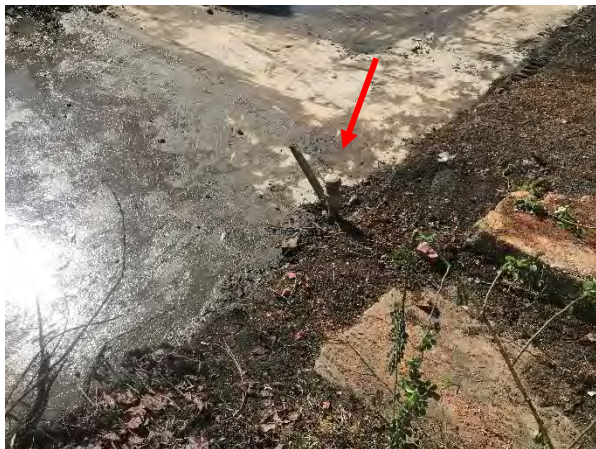
Vent pipe along west end of foundation believed to belong to Mr. Gagliardi

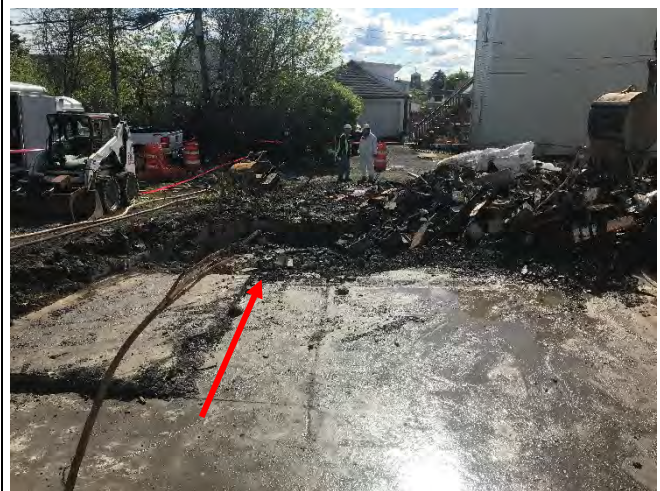
Recessed floor along north wall filled with debris (former boiler room)

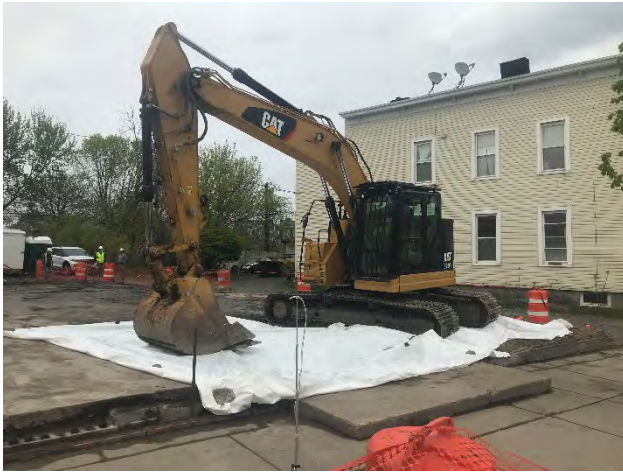
Exposed soil from slab removal covered with 2 layers of 6 mil poly

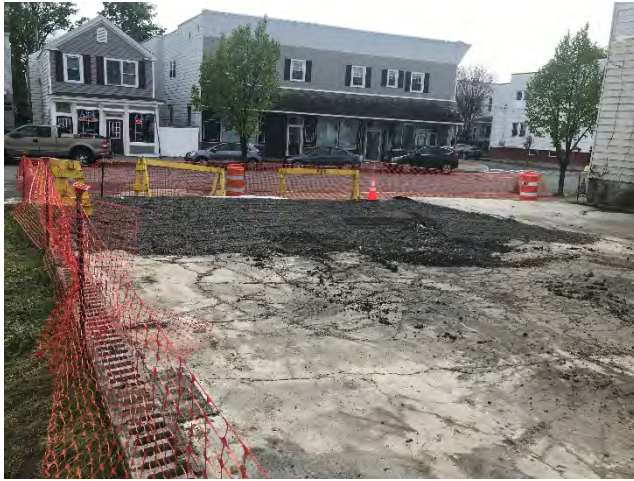
Southeast corner of the slab and former stoop area filled with crusher run looking south

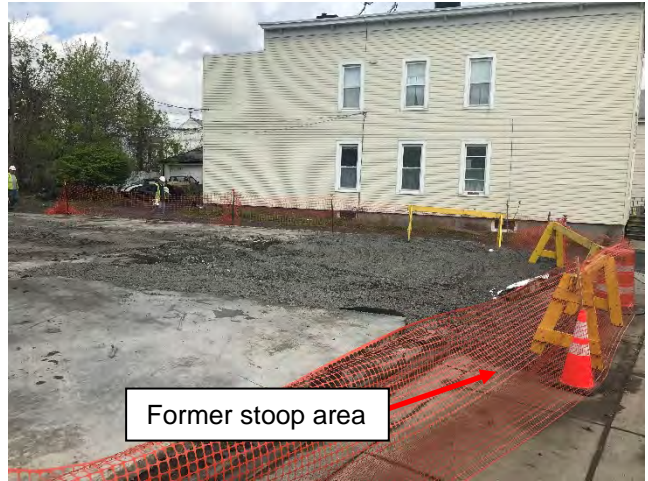
Southeast corner of the slab and former stoop area filled with crusher run looking east

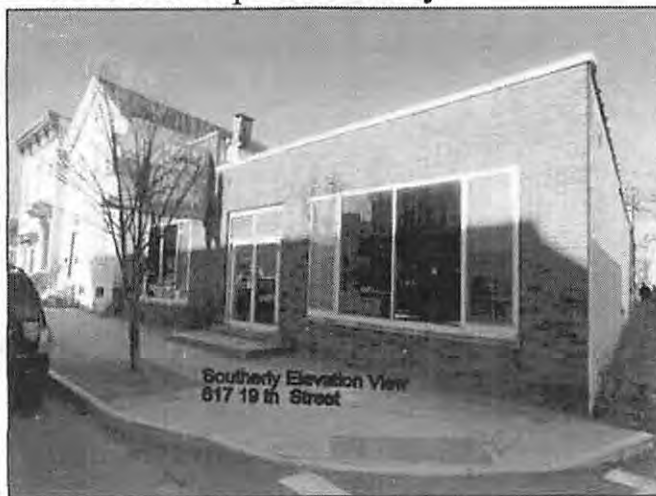
Photograph 1 shows the front Southerly elevation view of the building as seen from 19th Street. The building consists of the original structure which includes the entrance door and large window section as seen in Photograph 1. A later addition was constructed on the West side of the original building so as to provide for additional clear span open space. The addition can be seen in Photograph 1 to the left of the sign.

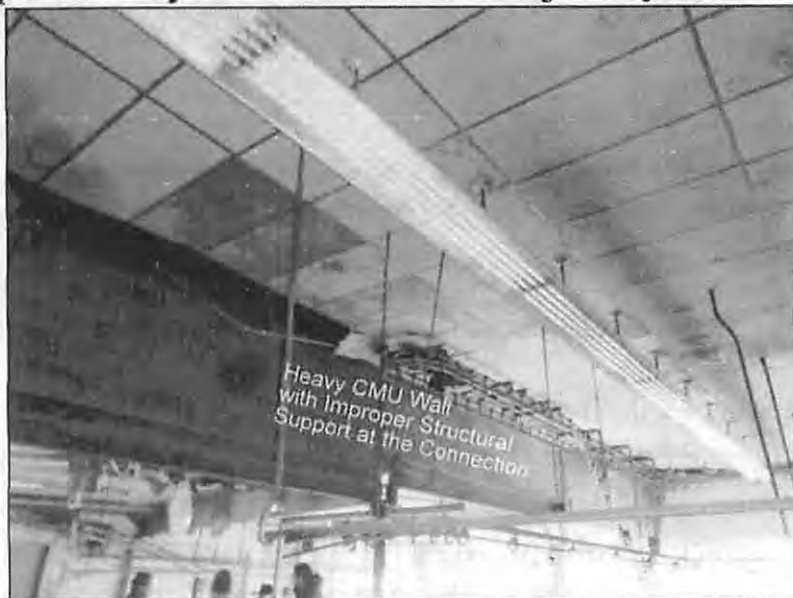
In order to obtain clear span openings between the original building and the addition, large wide flange steel beams were inserted to support the upper masonry wall sections of the original structure as shown in Photographs 11 and 12. These are heavy loads imposed on the beam sections, columns and connections. In addition to the weight of the upper concrete block bearing wall, roof framing members from the Westerly addition are supported by this steel beam and column assembly. During the course of our evaluation, we noted that some of the beam and column connections were improperly made and are highly structurally deficient. Eccentric loads have been placed on columns and improper beam shims have been installed as depicted in Photograph 12. These structural deficiencies that we have encountered are a concern because if a localized collapse of roof framing members occurred, this will induce lateral loads and a thrusting action against this masonry wall assembly which is shown in Photograph 11 and will result in a roll-over effect in the beams which are shown in Photograph 12 thus destabilizing the column support assembly. This collapse mechanism is a high hazard condition.
