NEW YORK STATE DEPARTMENT OF ENVIRONMENTAL CONSERVATION  
DIVISION OF HAZARDOUS WASTE REMEDIATION  
INSPECTOR'S DAILY REPORT

| Site Name: <u>SCHUY SENECA ST. PSA</u> | Sheet <u>1</u> of <u>    </u> | AM | PM |

Figure 2-1  
Site Layout Plan

Schenectady (Seneca St.) Site

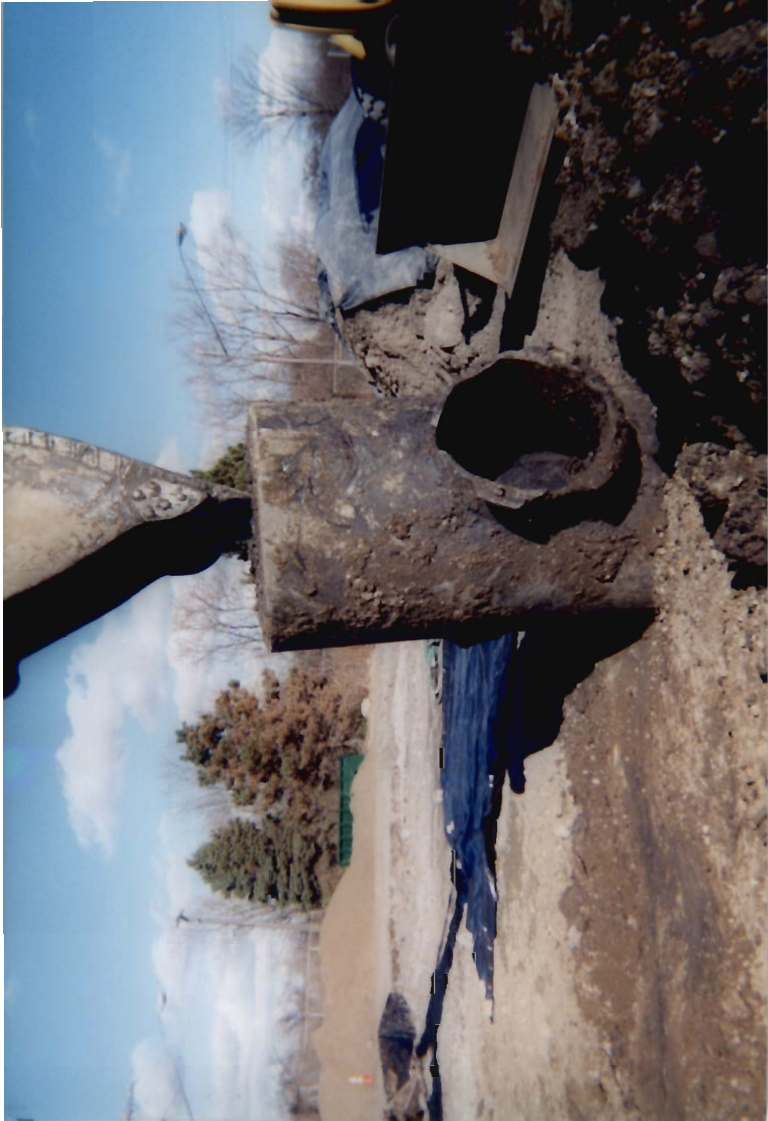
11/20

DRIP PT AFTER REMOVAL FROM EXCAVATION.

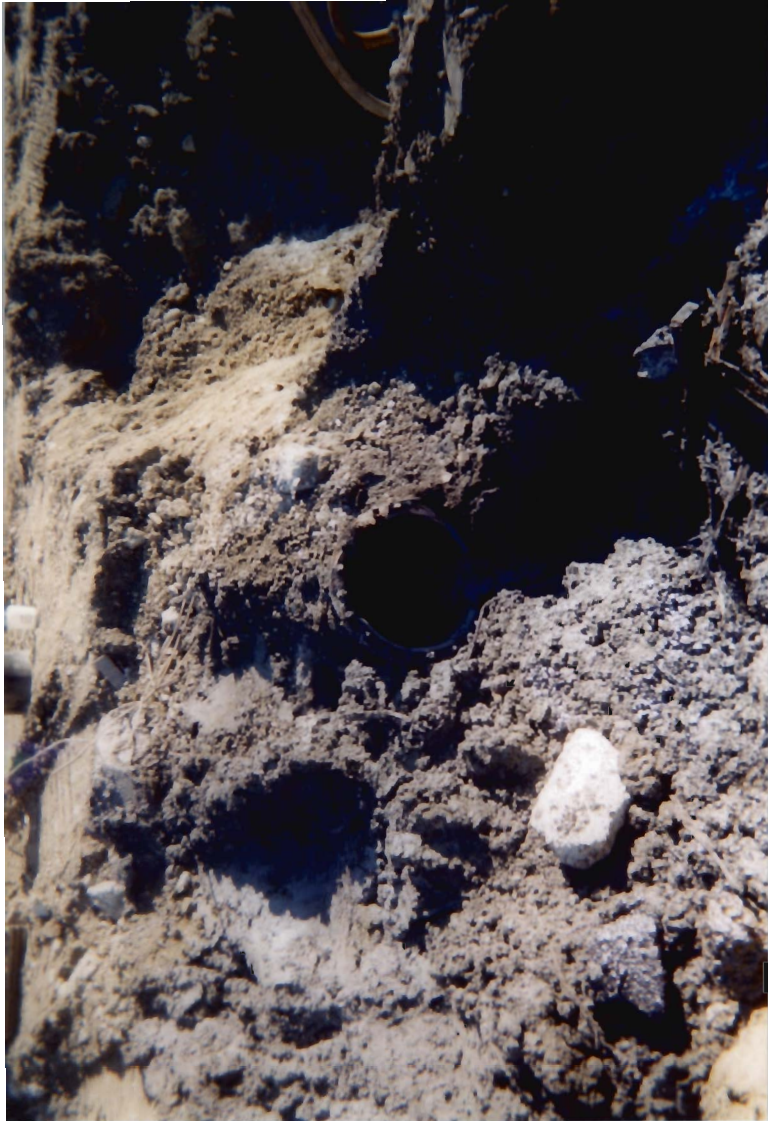
11/20

PAKING CMT, 36" PIPE HANDING FROM DEEP POT INTO HOLE.

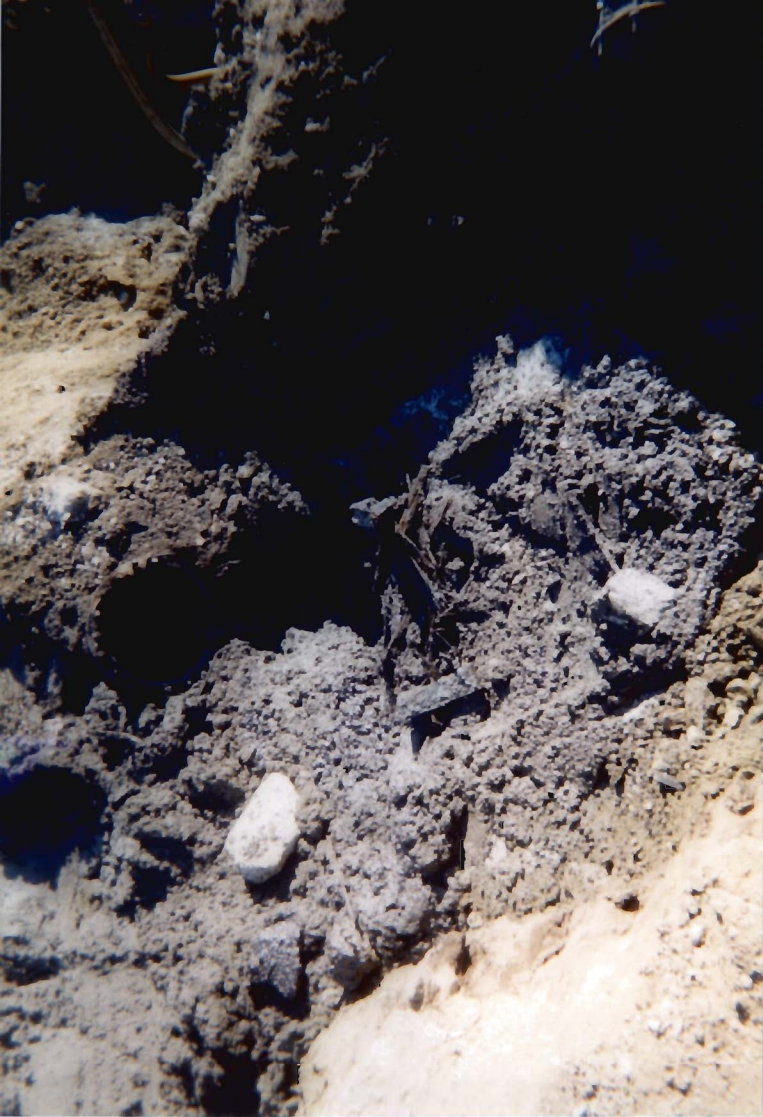
11/12

THE SATURATED SOIL SURROUNDING THE POT PLANT.

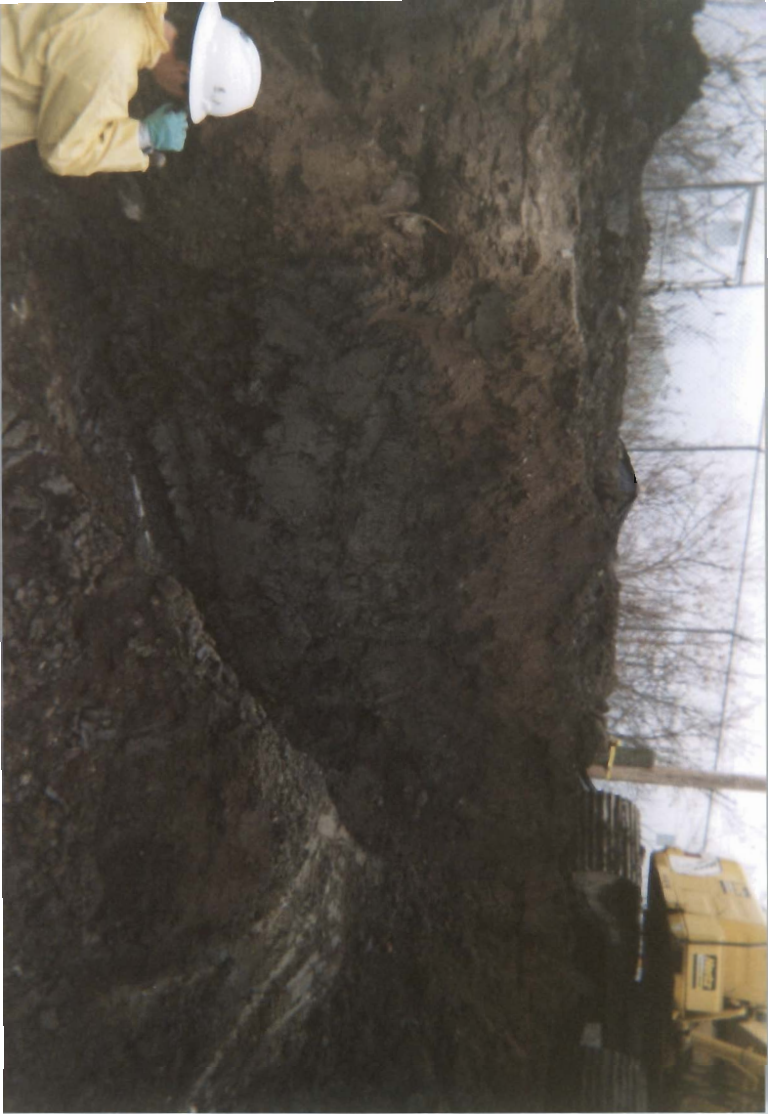
11/26/01

FACING NORTHWEST, WEST WALL OF EXCAVATION FOR 2.5" PIPE  
ON WEST SIDE OF HOLE.

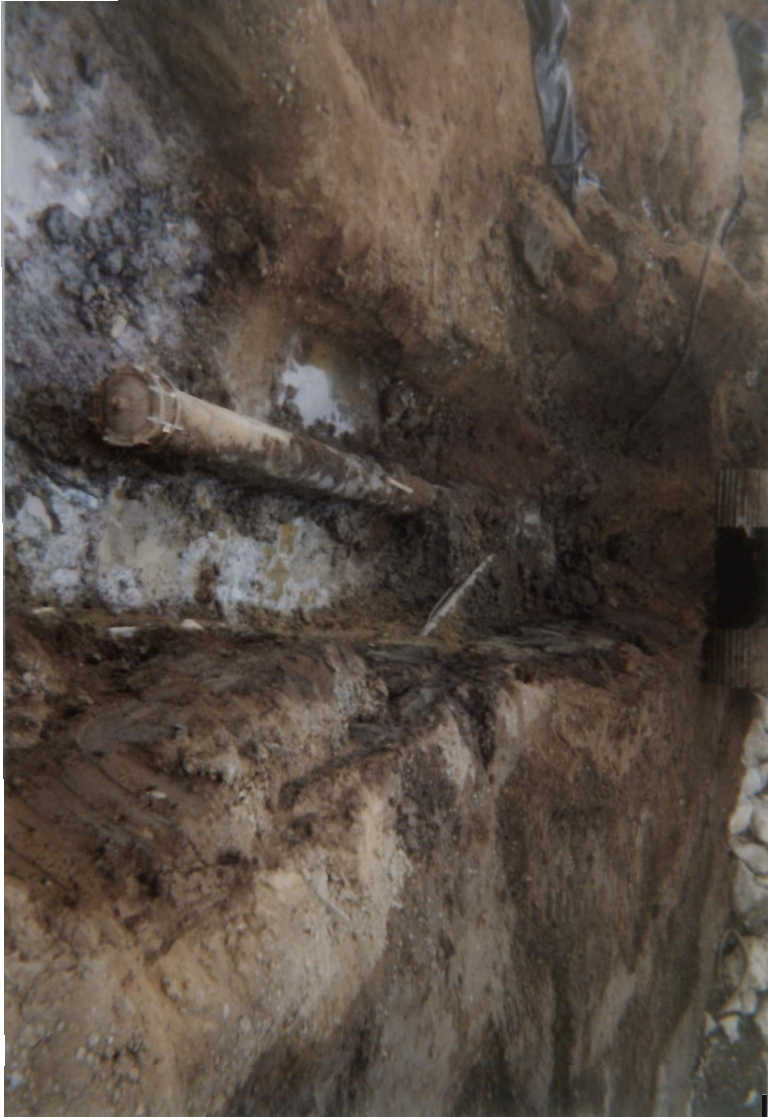
11/26

FACING SOUTH, EXCAVATION ABOVE 12" PAPER.

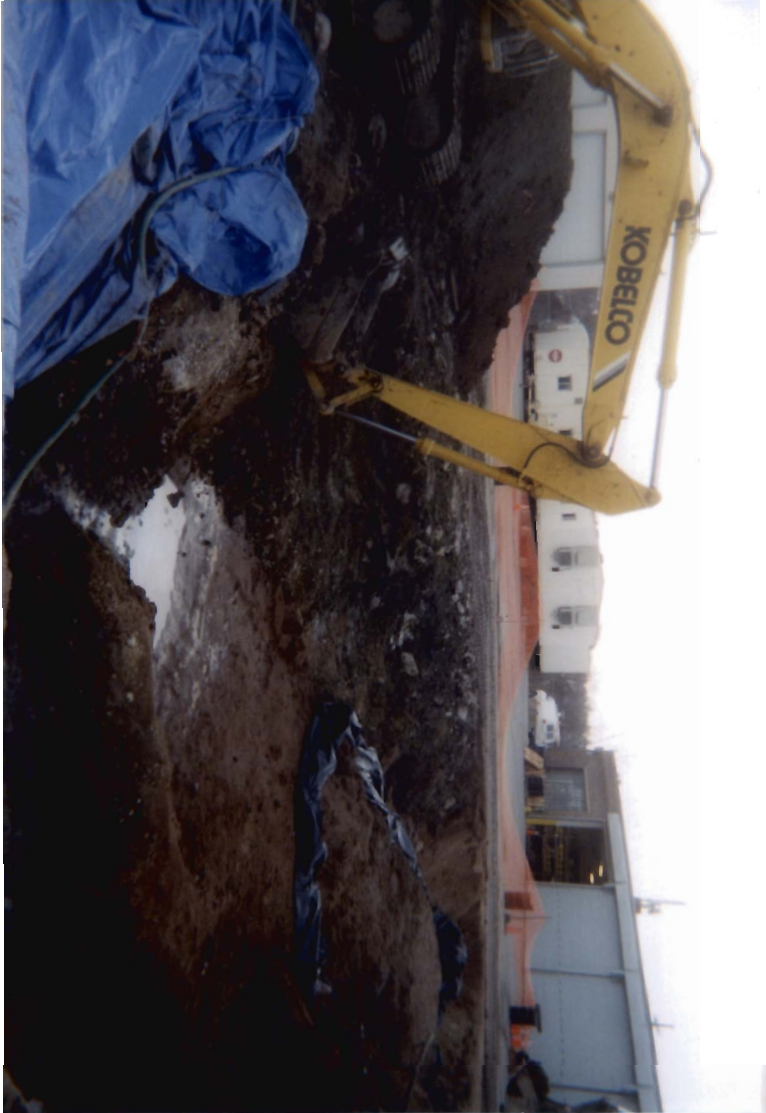
11/26

FACING SOUTHEAST, EXCAVATION WITHIN KENNELM.

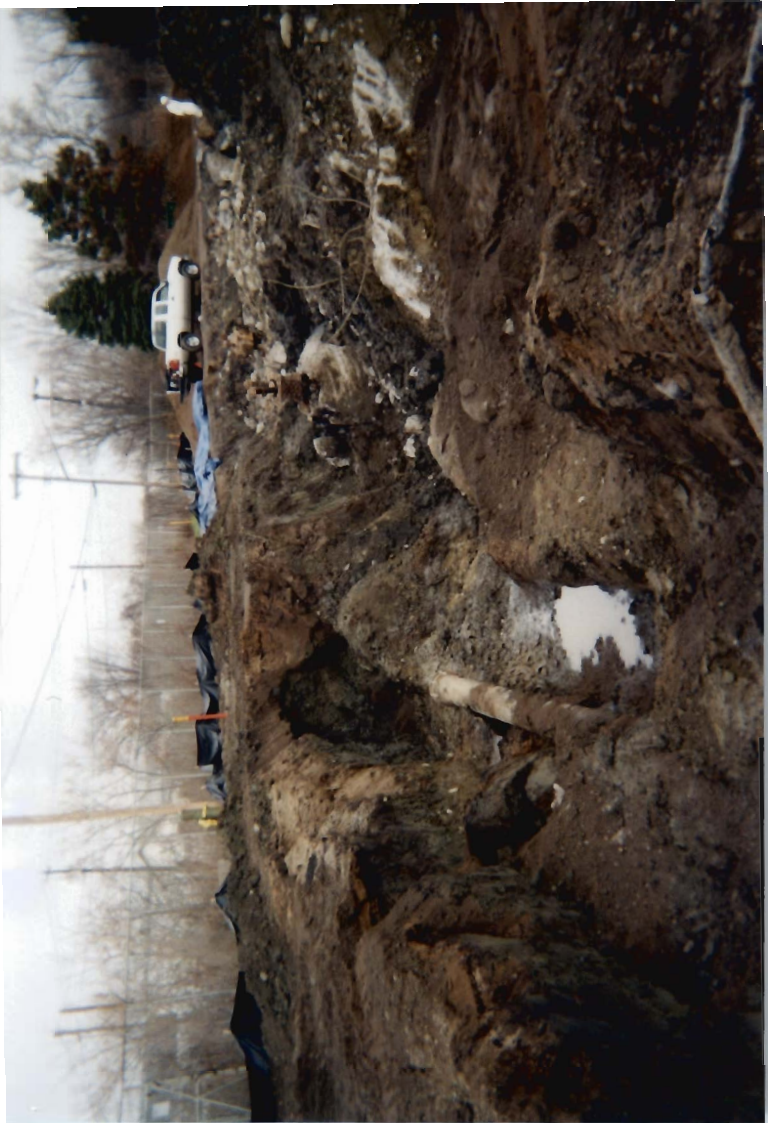
11/27/01

FLYING NORTH, EXHIBITION AIRCRAFT 12" PIPE AND DRIP PIT AREA.

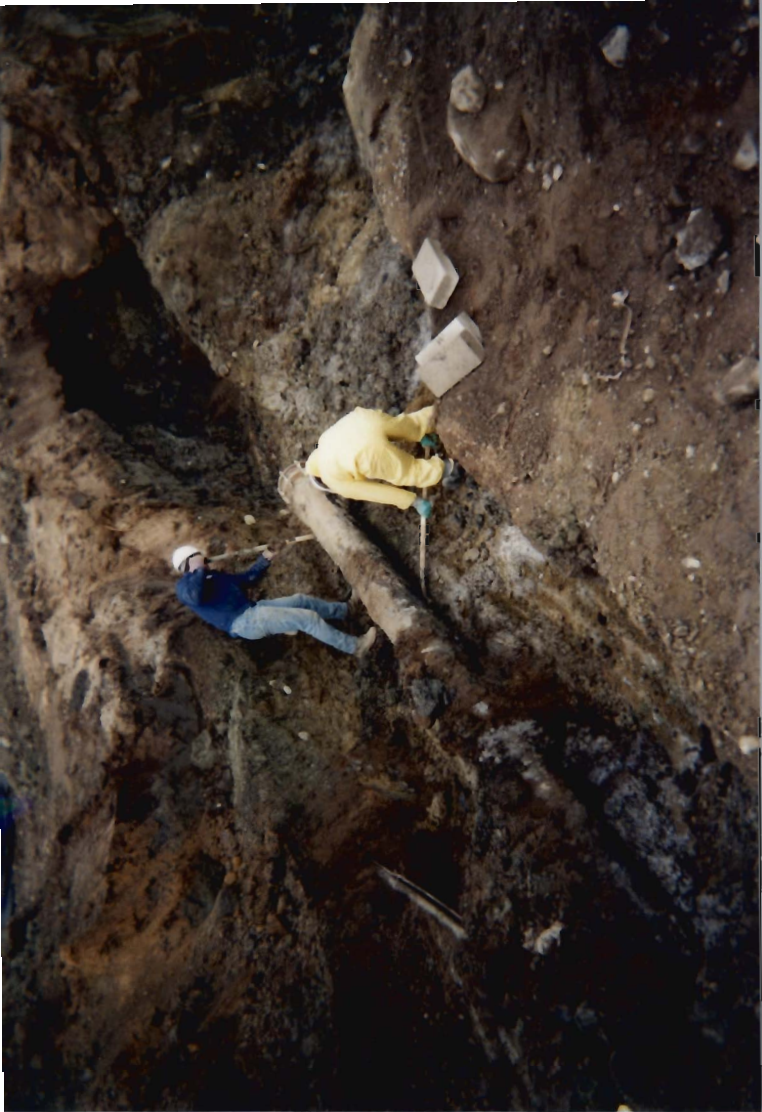
11/27/01

REMOVING IMPACTED MATERIAL FROM AROUND 12" DIA.

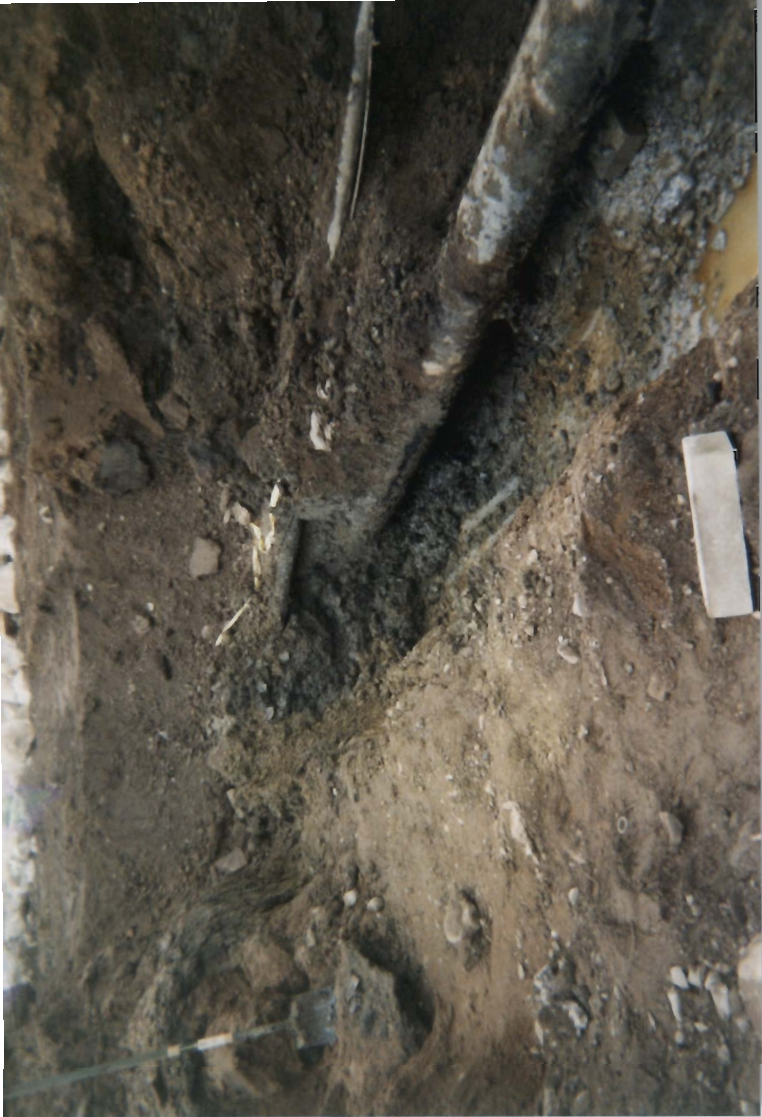
11/27/01

FACING SOUTH, END OF EXPLANATION FROM UNDER 12" PIPE AT  
ELECTRICIAN CABLES CROSSING. THIS CAN BE SEEN LIFTING IN  
FROM SOUTH CORN.

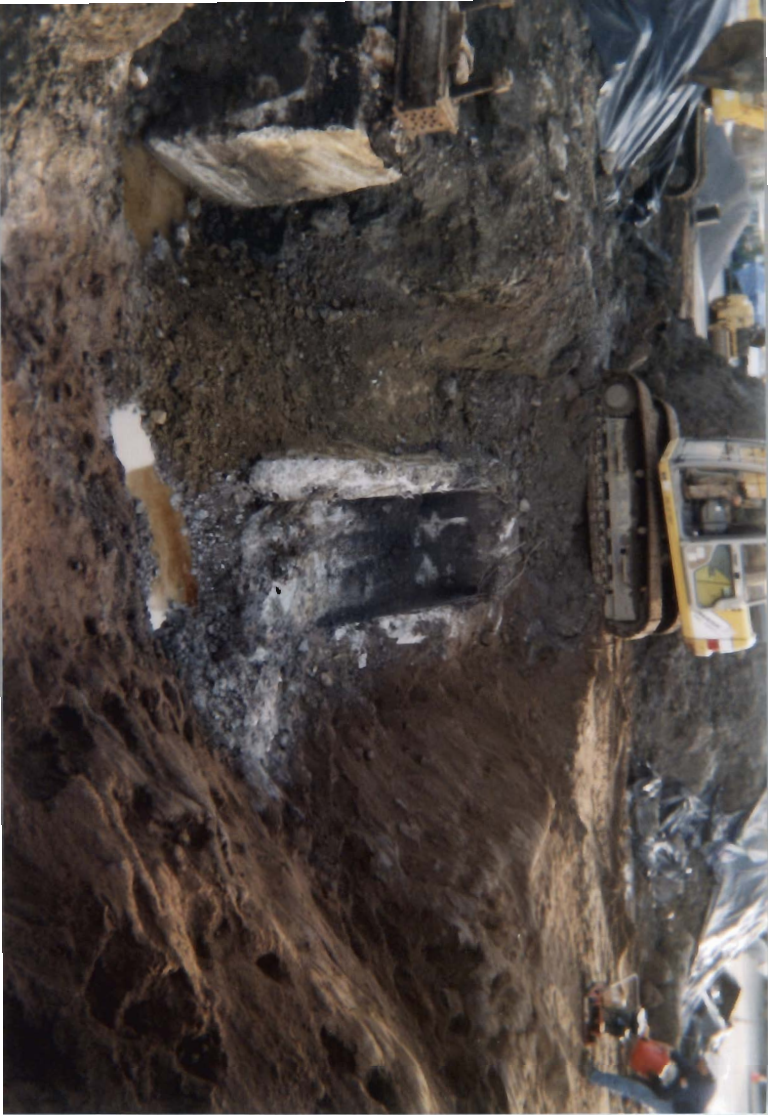
11/28/01

FRANC LBSI, CONCRETE PIPE VAULT.

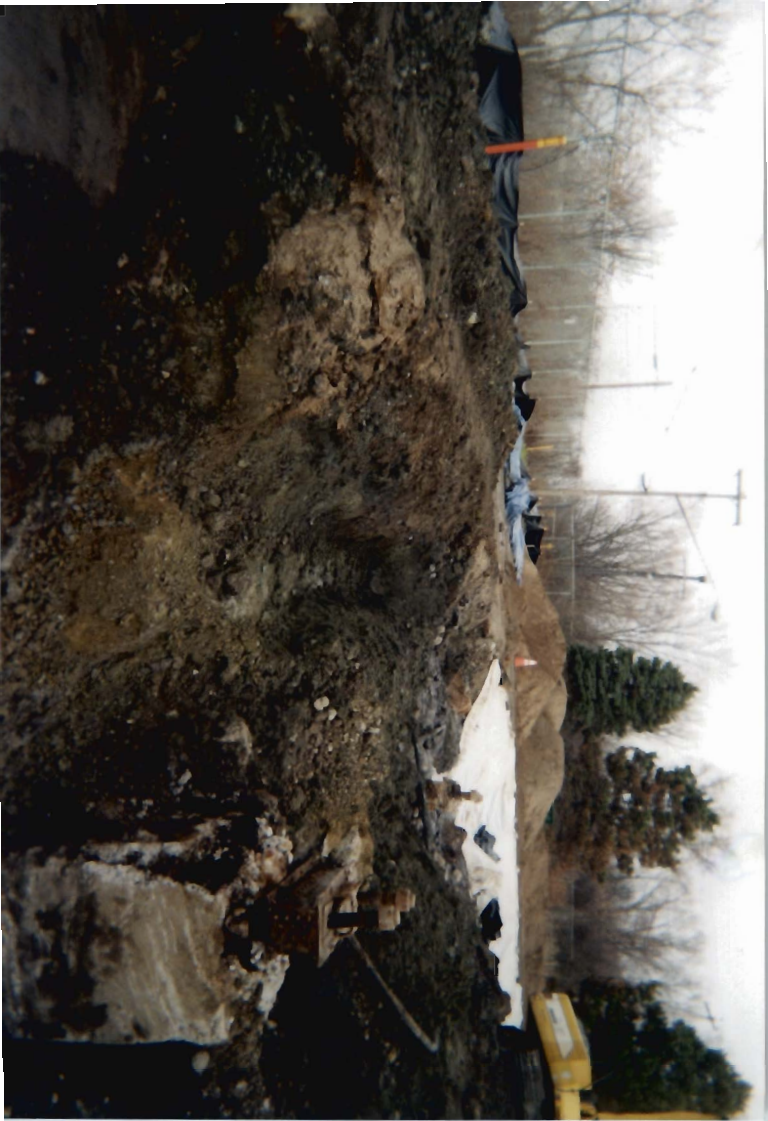
11/28/01

FACING NORTHWEST, EXCAVATION OF 2.5" GA PIPE.

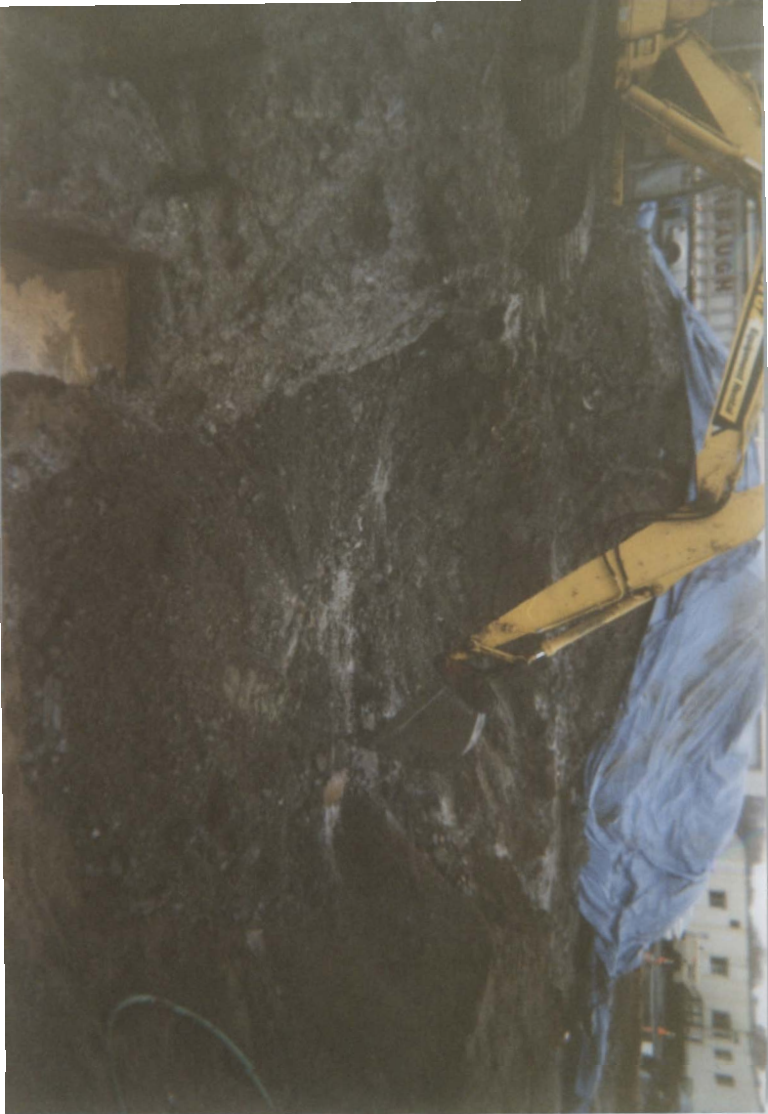
11/28/01

FACING EAST, EXCAVATION OF CONCRETE VAULT.

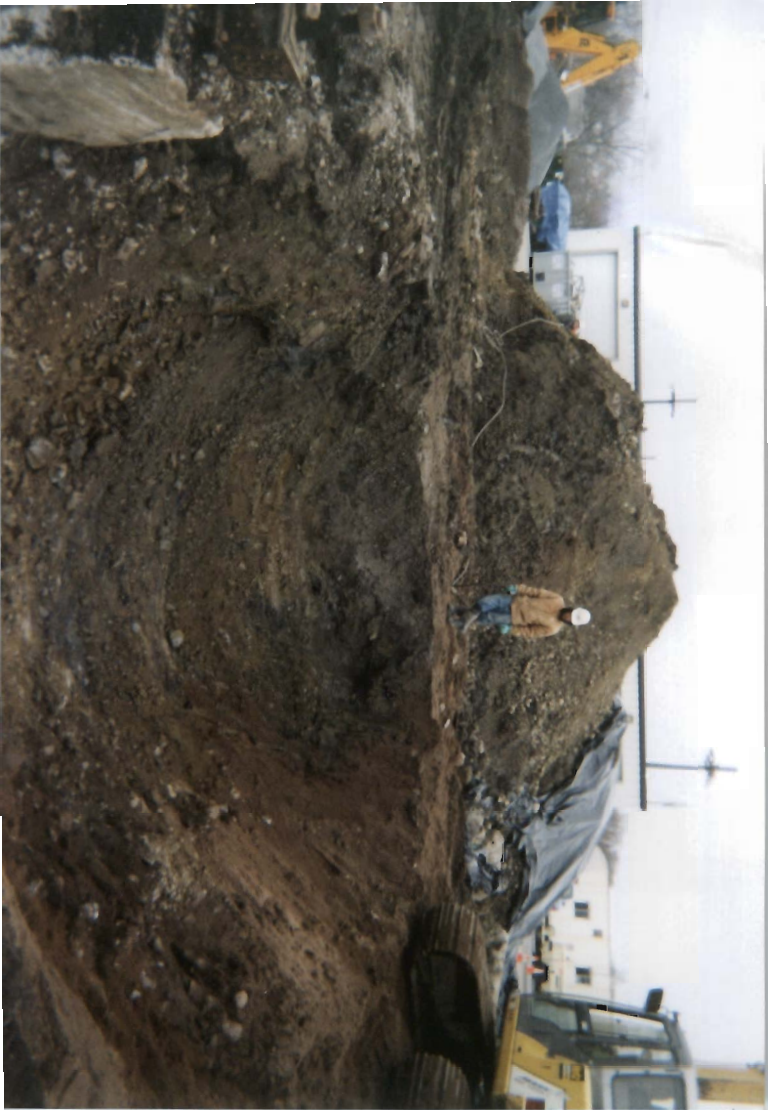
11/29/01

FACING EAST, ON THE EXPLANATION INSIDE: RENOWNED BRAND FOR NEWTON
