**FINAL
TECHNICAL MEMORANDUM
2017 LONG TERM MONITORING OF
LANDFILL AREAS OF CONCERN
FORMER GRIFFISS AIR FORCE BASE
ROME, NEW YORK**

PREPARED BY: Bhate Environmental Associates, Inc.

DATE: June 14, 2018

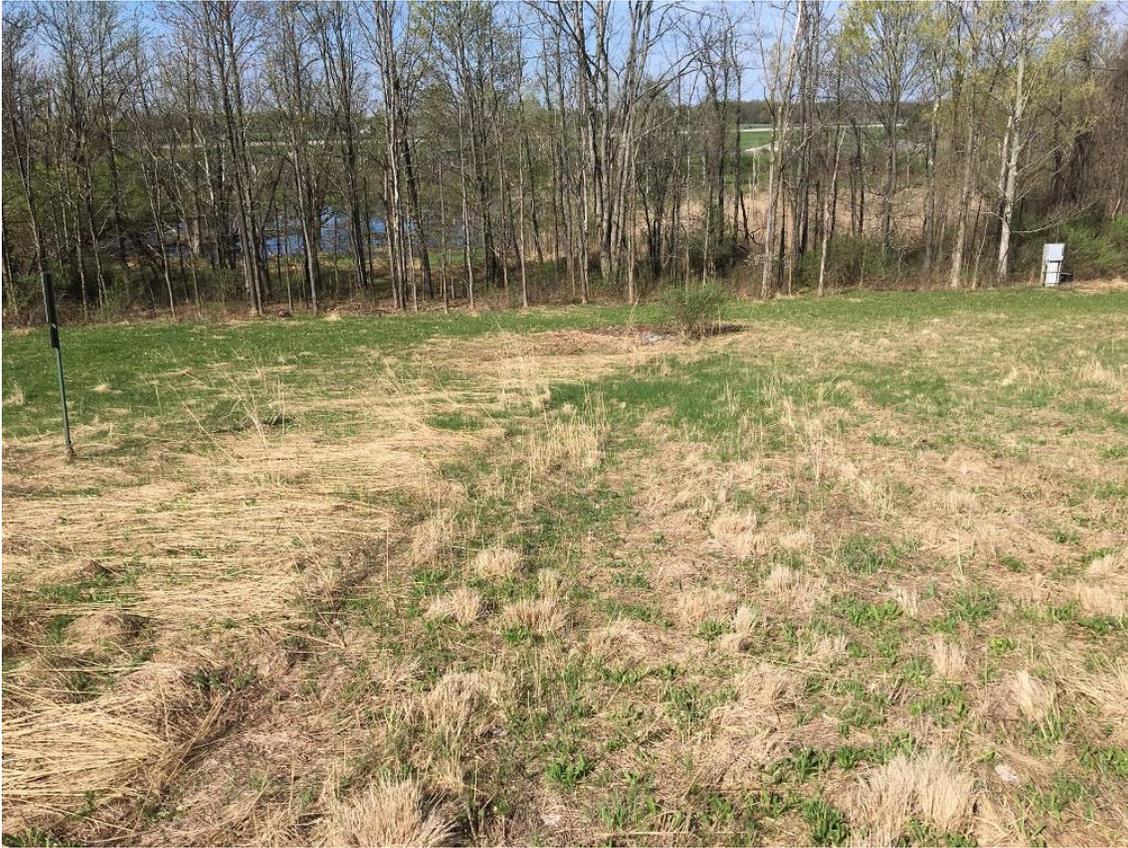
April 2017 Photo 3: LF001 (Landfill 1 AOC) – Facing southwest at the southwest corner of LF001. Photograph taken near LF1GMP-1

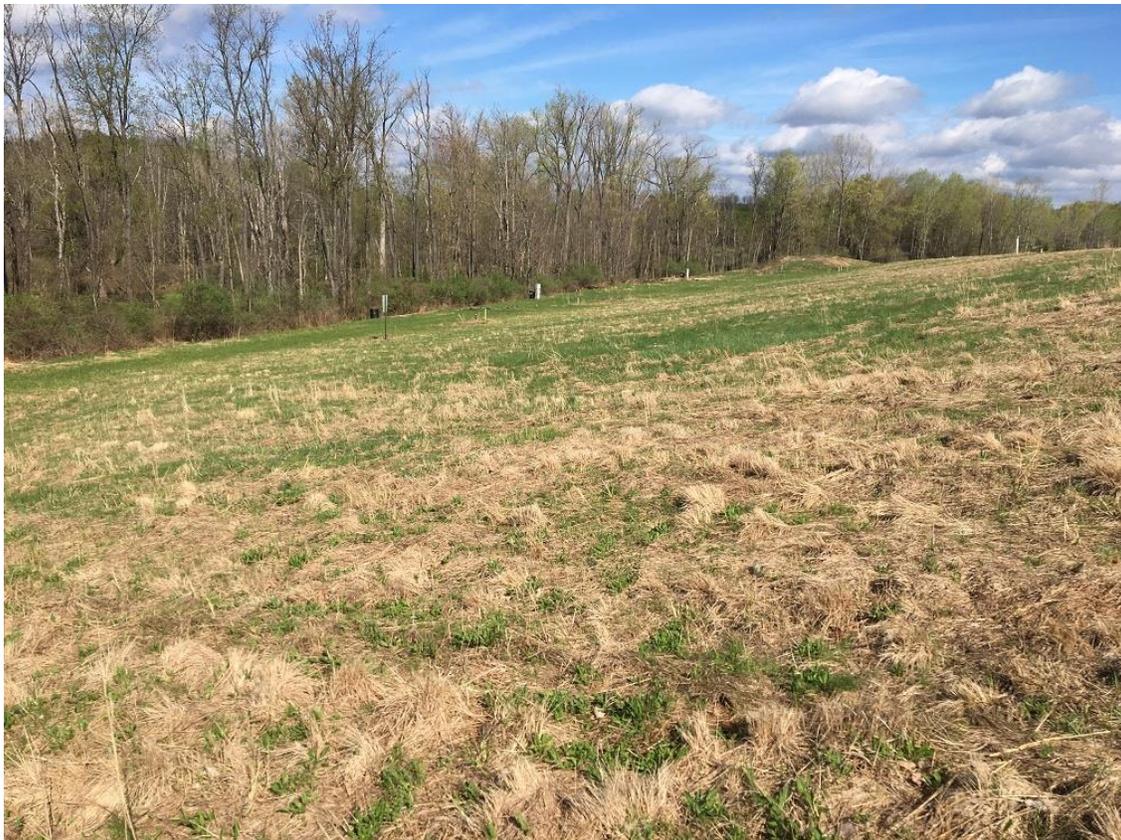
April 2017 Photo 4: LF001 (Landfill 1 AOC) – Facing northwest along western boundary of LF001. Photograph taken near Vent 4

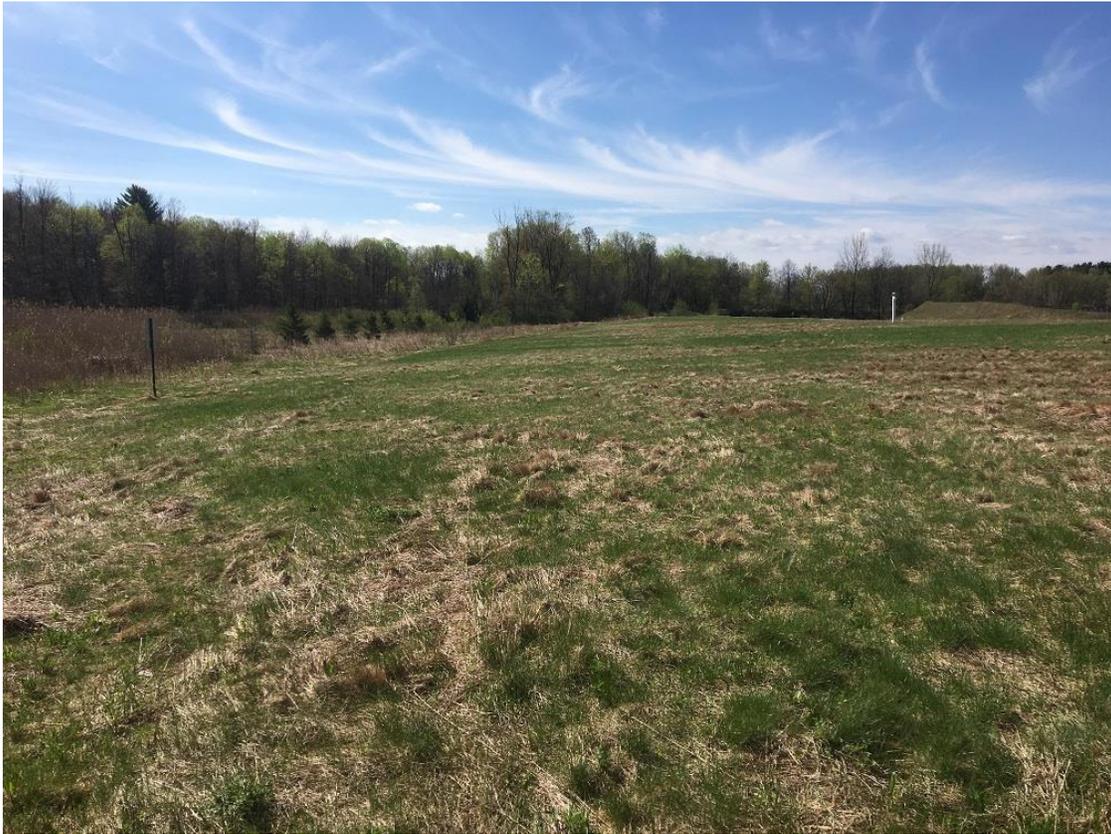
April 2017 Photo 9: LF001 (Landfill 1 AOC) – Facing south along eastern boundary of LF001. Photograph taken near Vent-22.

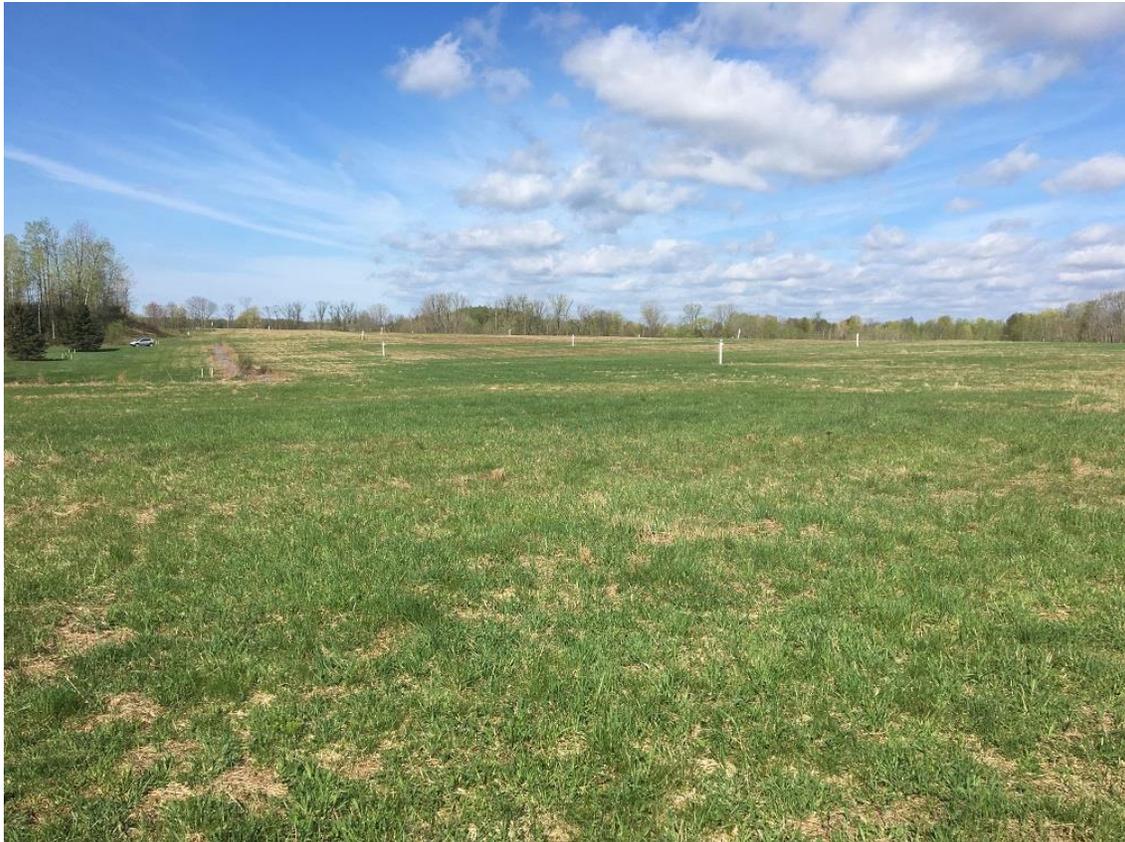
April 2017 Photo 10: LF001 (Landfill 1 AOC) – Facing west along southern boundary of LF001. Photograph taken from southeast corner near Vent-20

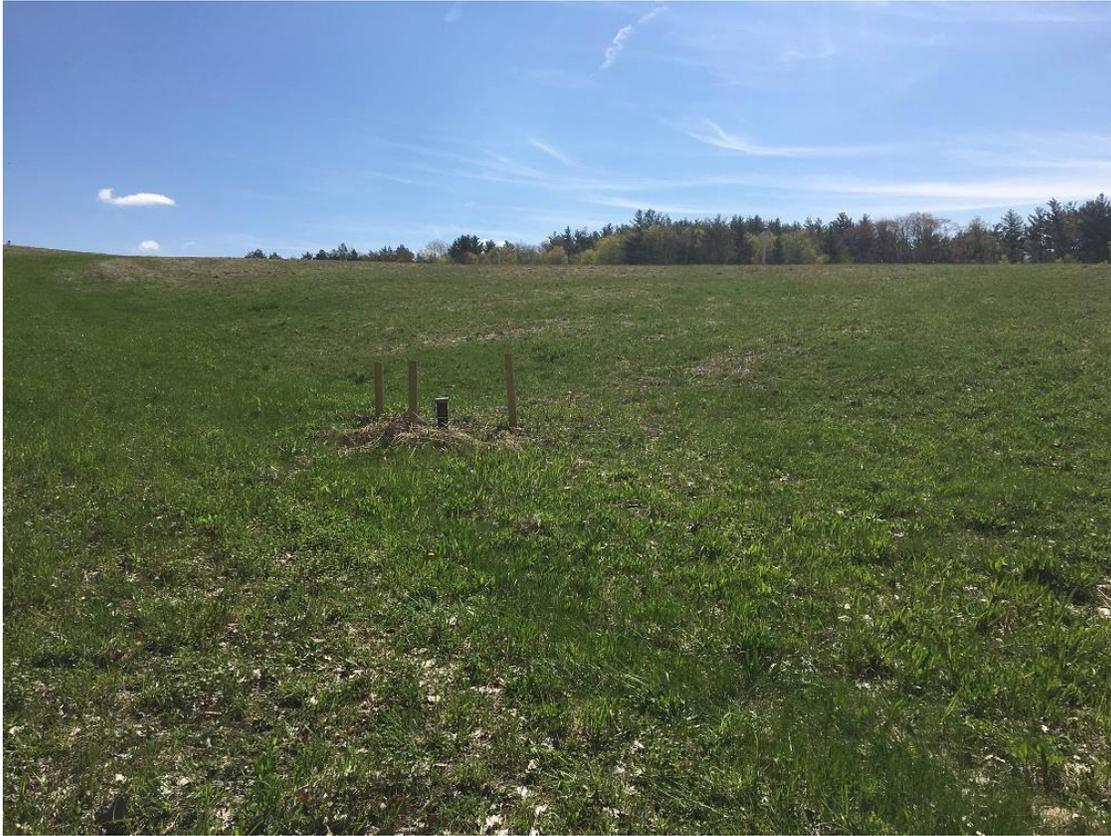
April 2017 Photo 1: LF002 (Landfill 2/3 AOC) – Facing northeast along the western boundary of LF002 at VENT-03.

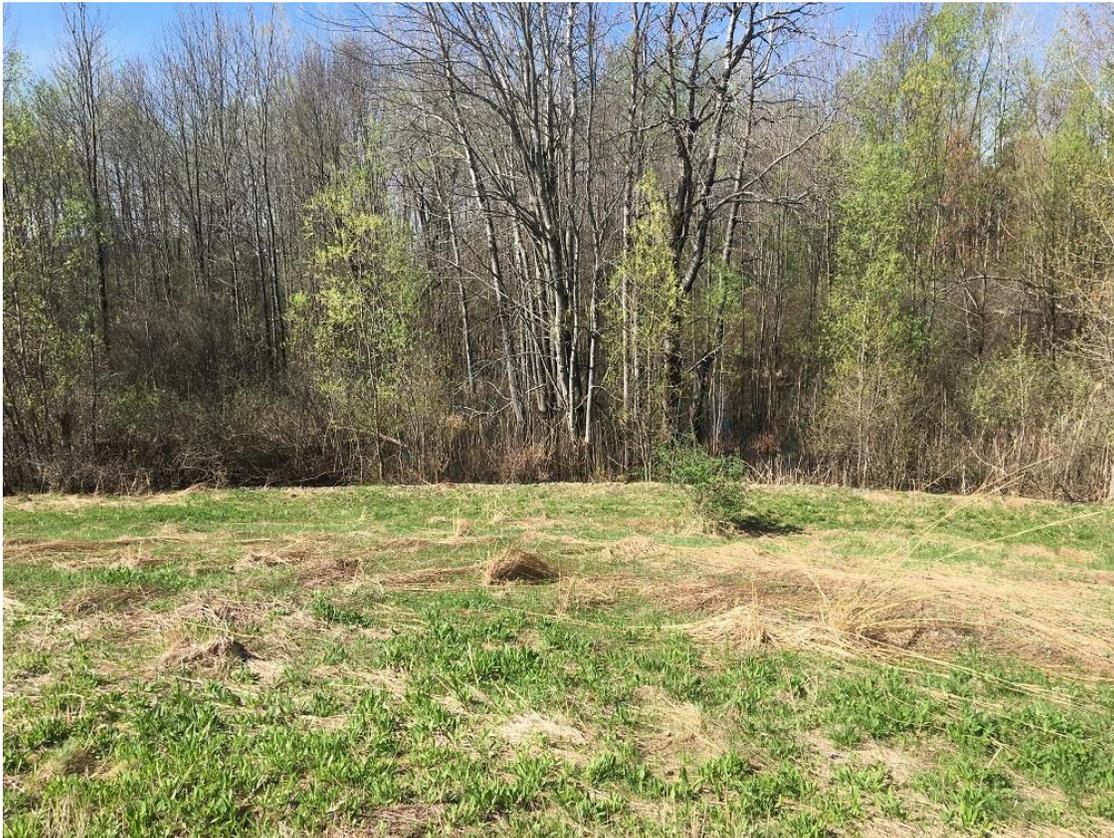
April 2017 Photo 2: LF002 (Landfill 2/3 AOC) – Facing south at southern boundary of LF002. Photograph taken near Vent-09

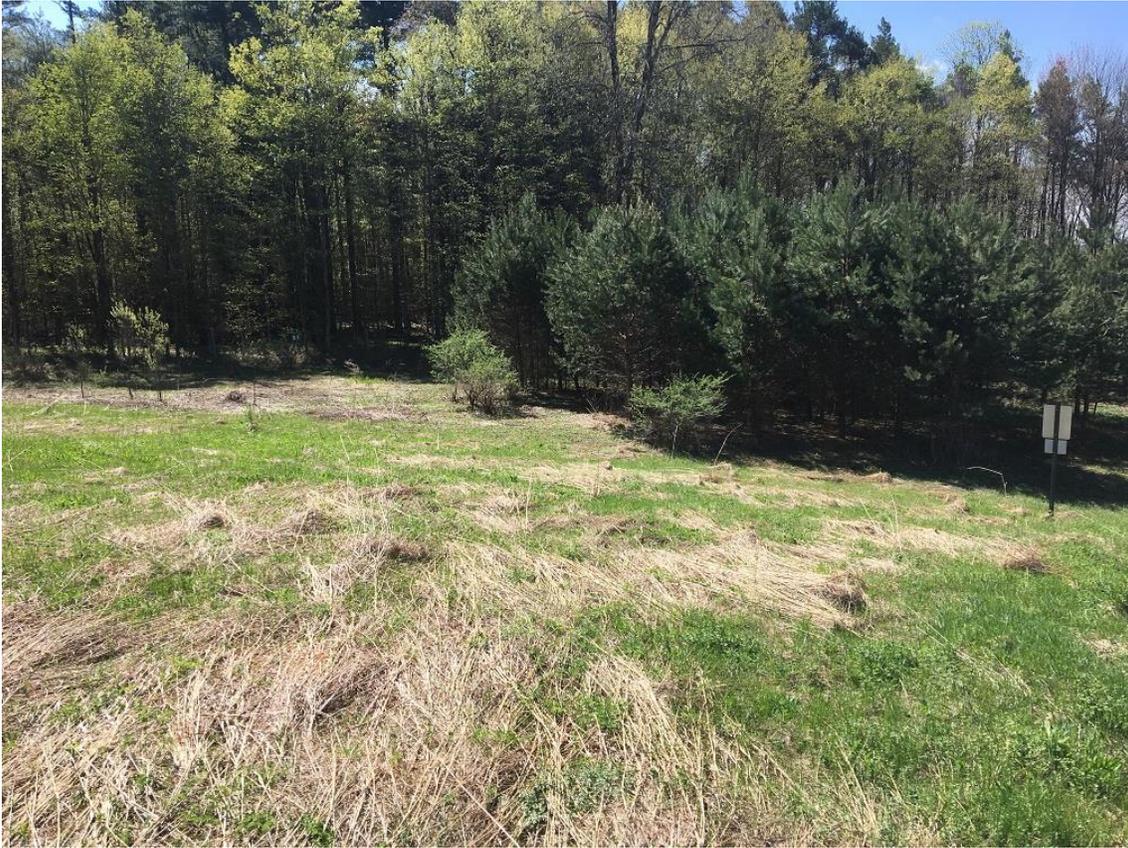
April 2017 Photo 3: LF002 (Landfill 2/3 AOC) – Facing south at the southwest corner of LF002. Photograph taken near Vent-08

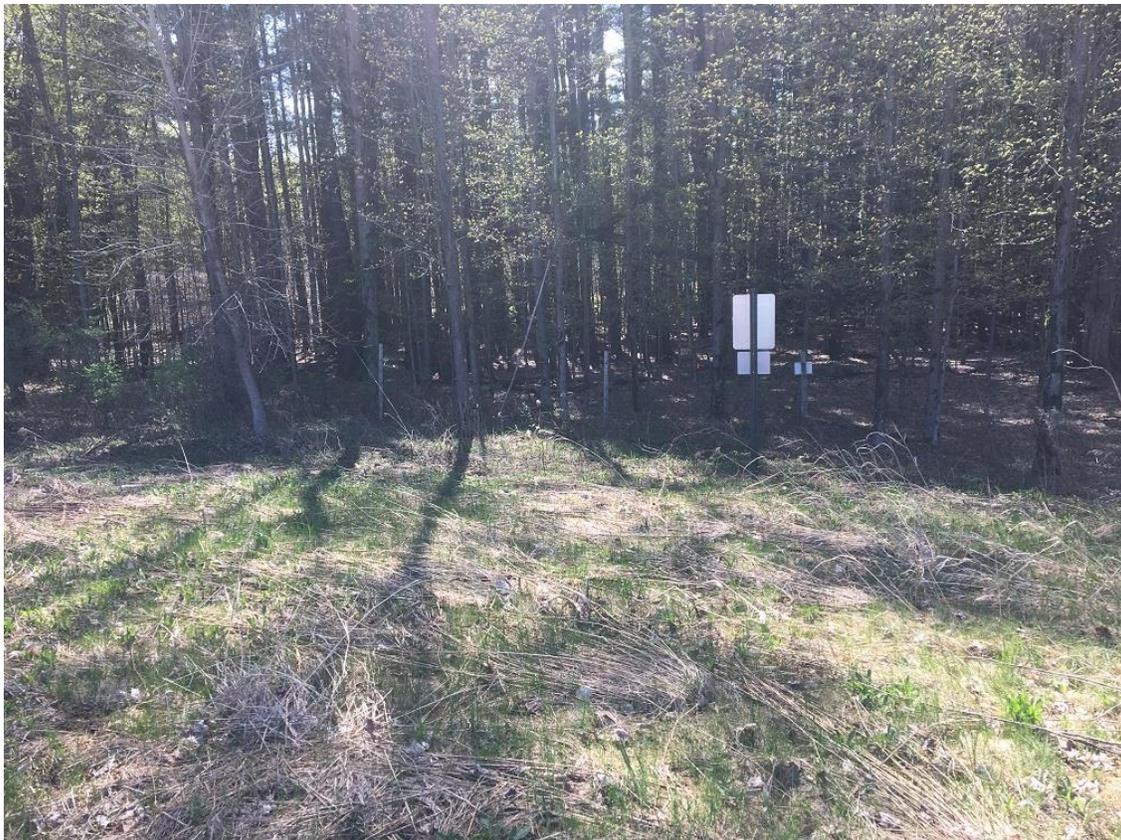
April 2017 Photo 4: LF002 (Landfill 2/3 AOC) – Facing east along eastern boundary of LF002. Photograph taken near GMP-06

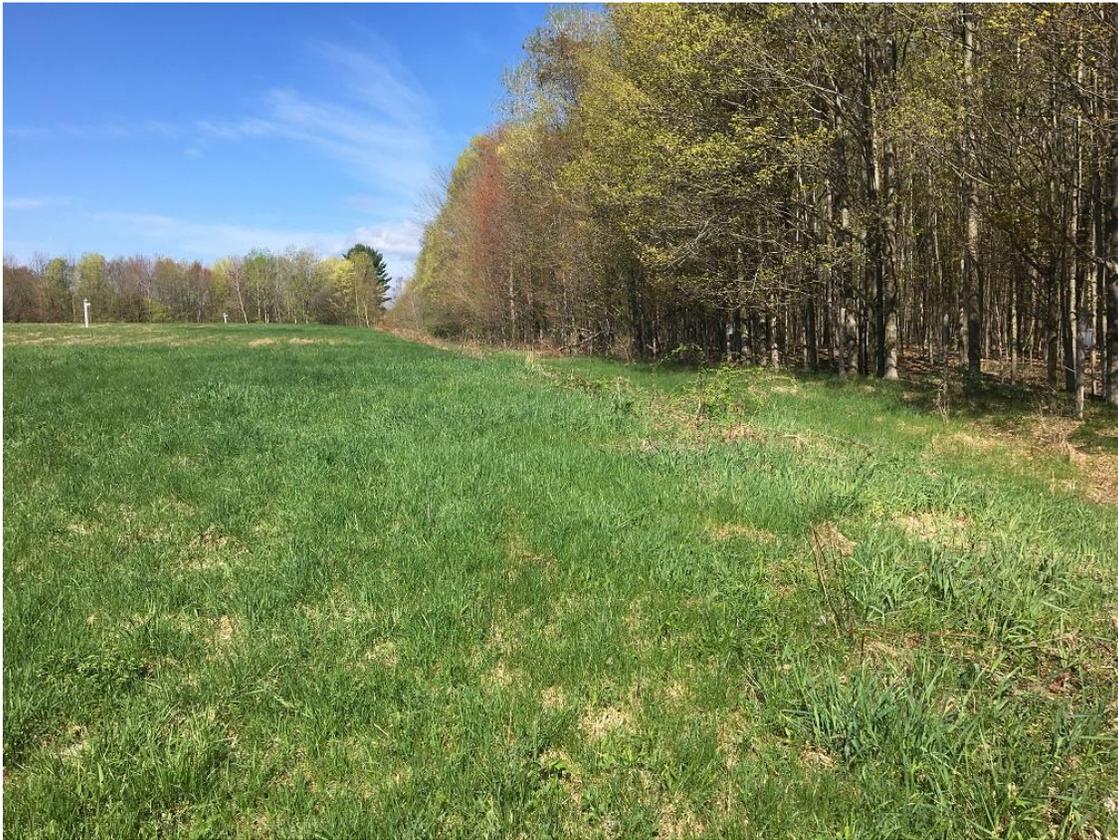
April 2017 Photo 5: LF002 (Landfill 2/3 AOC) – Facing west along northern boundary of LF002. Photograph taken near GMP-04

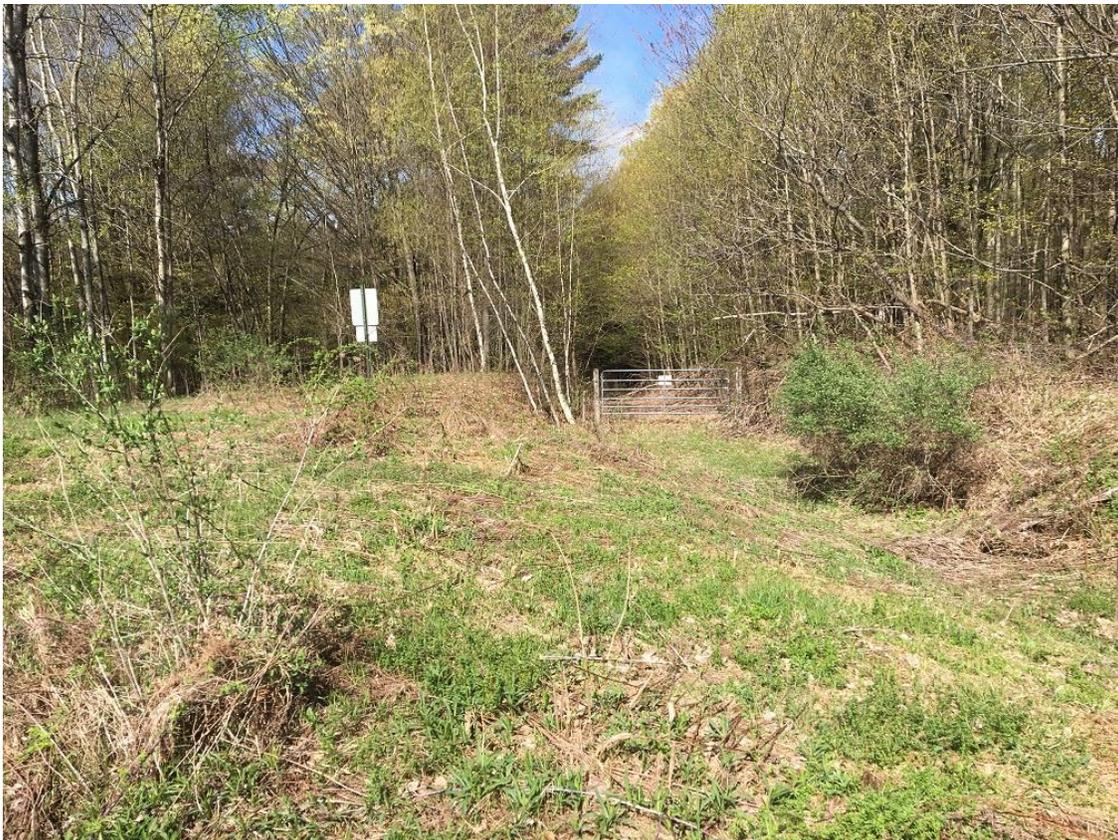
April 2017 Photo 6: LF002 (Landfill 2/3 AOC) – Facing northwest at northwest corner of LF002. Photograph taken near Vent-01

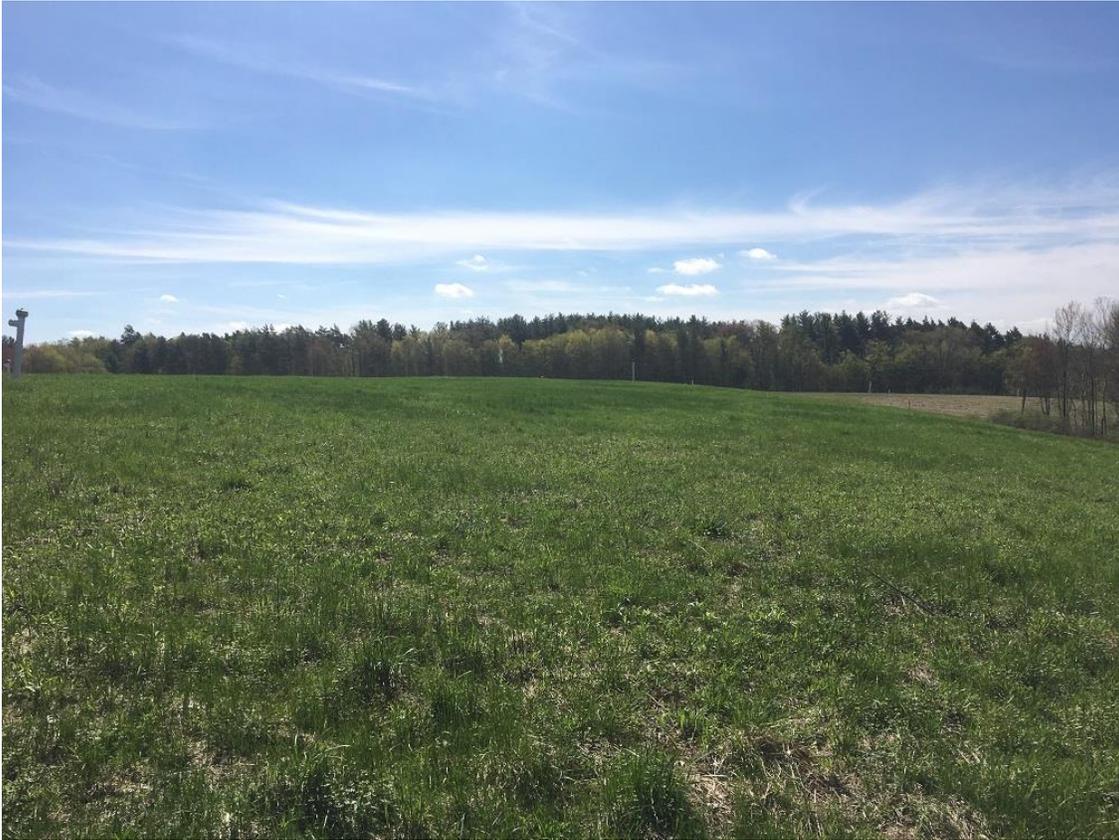
April 2017 Photo 7: LF002 (Landfill 2/3 AOC) – Facing southeast at center of LF002. Photograph taken near Vent-01 in northwest corner of LF002.

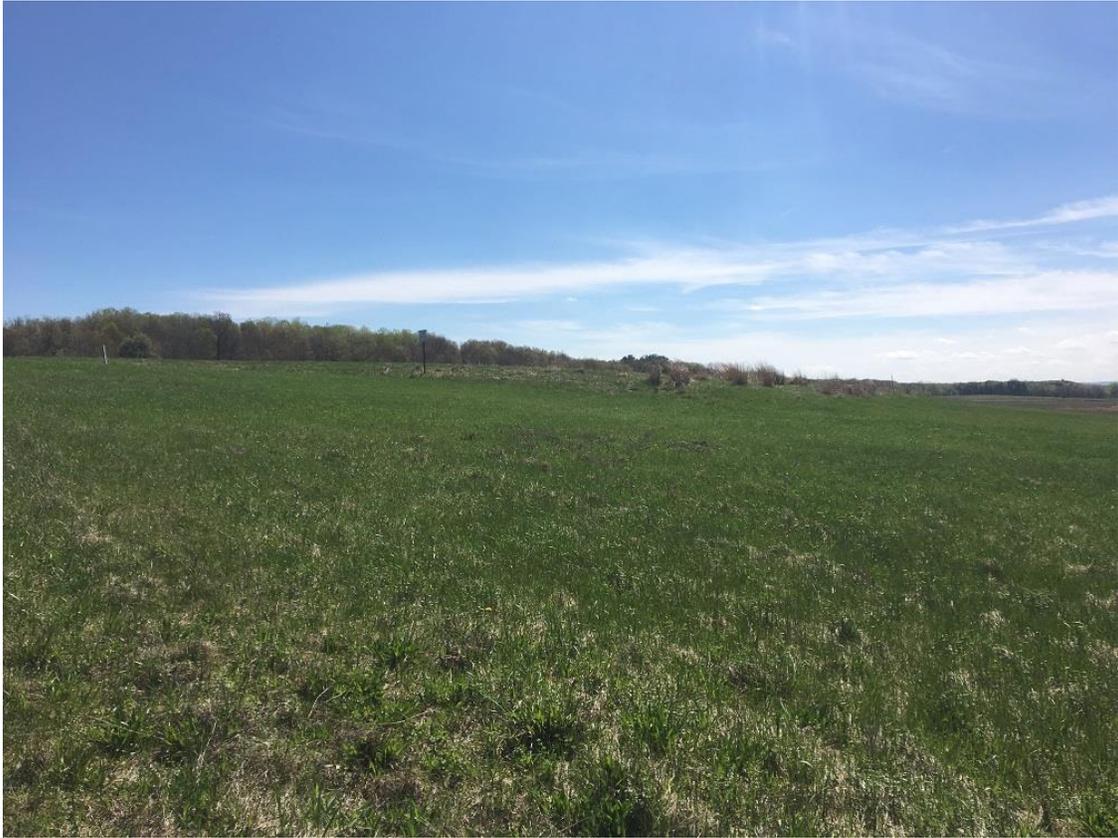
April 2017 Photo 1: LF003 (Landfill 7 AOC) – Facing east from the southwest corner of western block

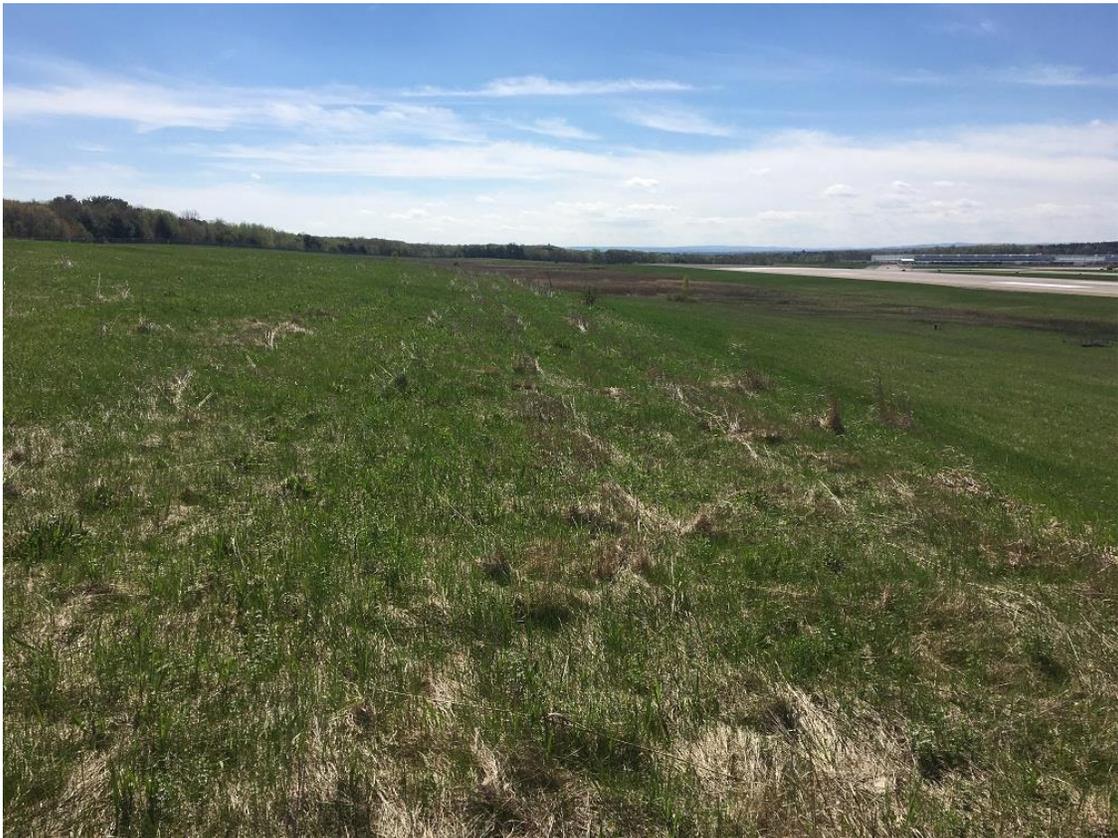
April 2017 Photo 2: LF003 (Landfill 7 AOC) – Facing southwest along southern boundary of western block

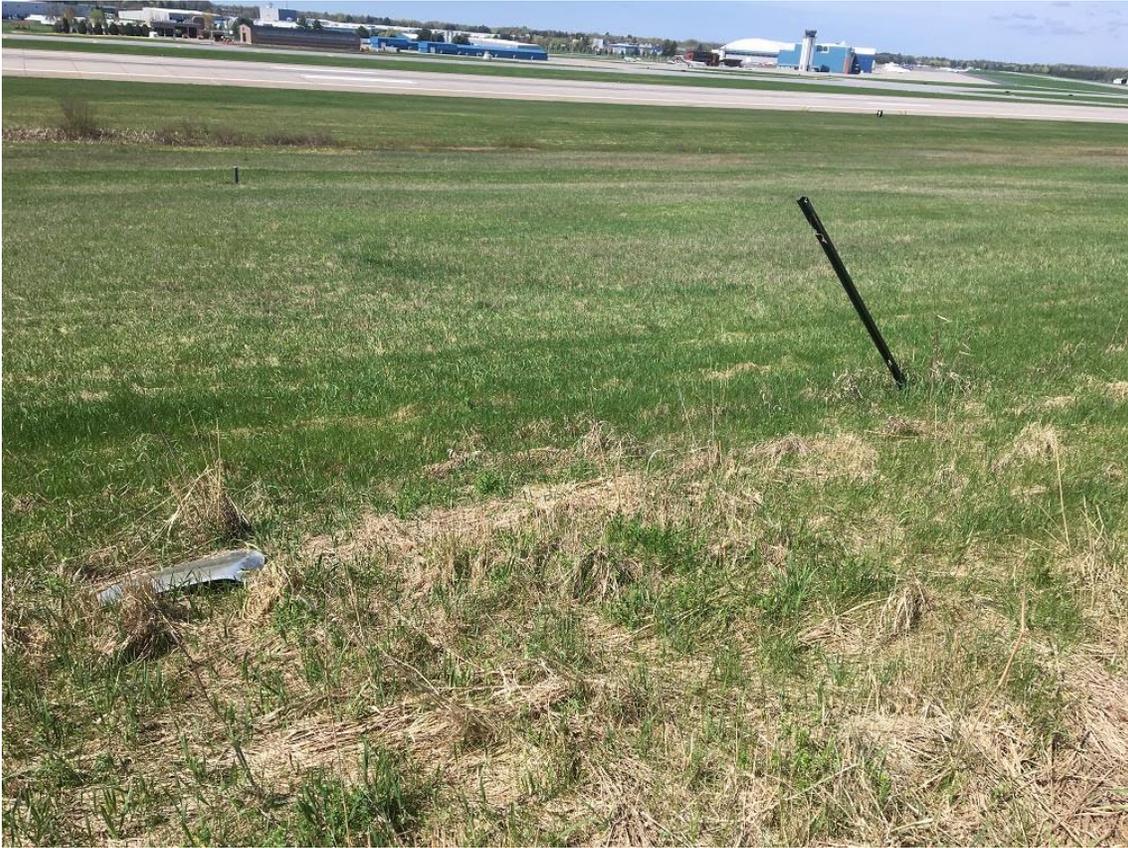
April 2017 Photo 3: LF003 (Landfill 7 AOC) – Facing south from southern boundary of western block

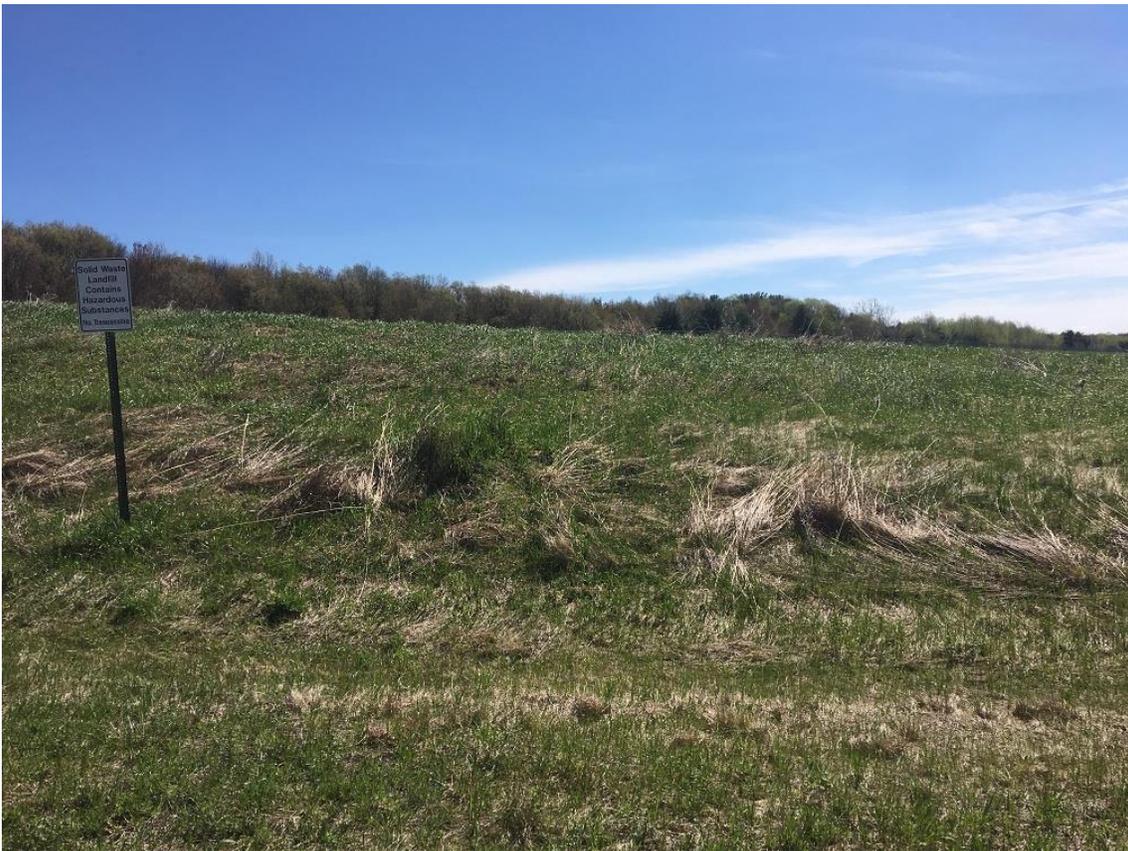
April 2017 Photo 4: LF003 (Landfill 7 AOC) – Facing east towards eastern block. Photograph taken from the southeast corner of western block

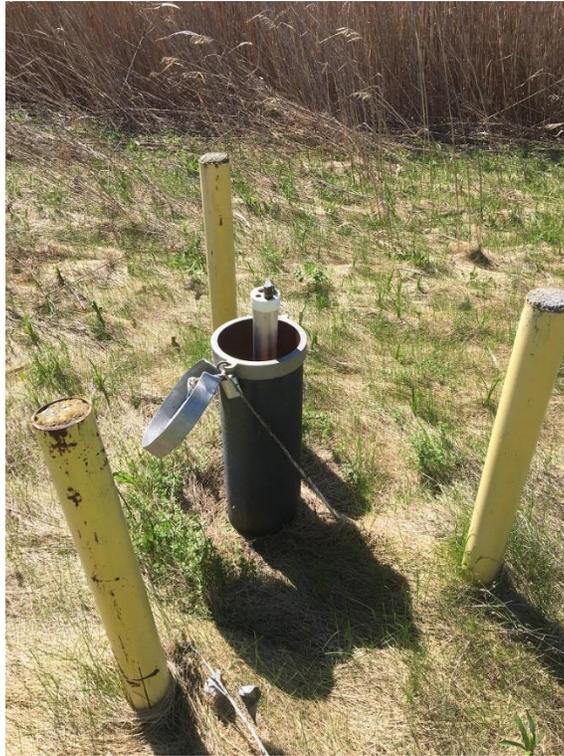
April 2017 Photo 5: LF003 (Landfill 7 AOC) – Submersible pump stuck in monitoring well LF7MW-30 at southwest corner of eastern block

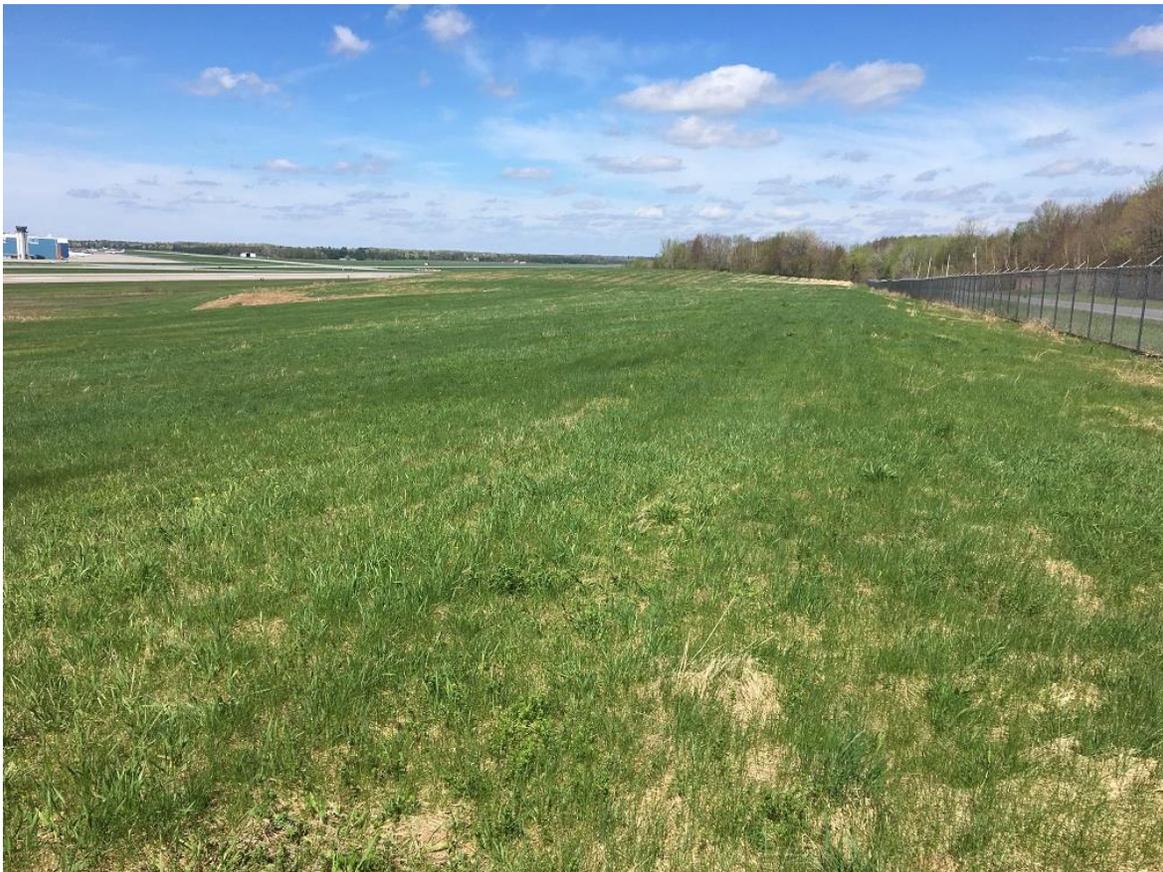
April 2017 Photo 6: LF003 (Landfill 7 AOC) – Facing northwest along northern boundary of eastern block.

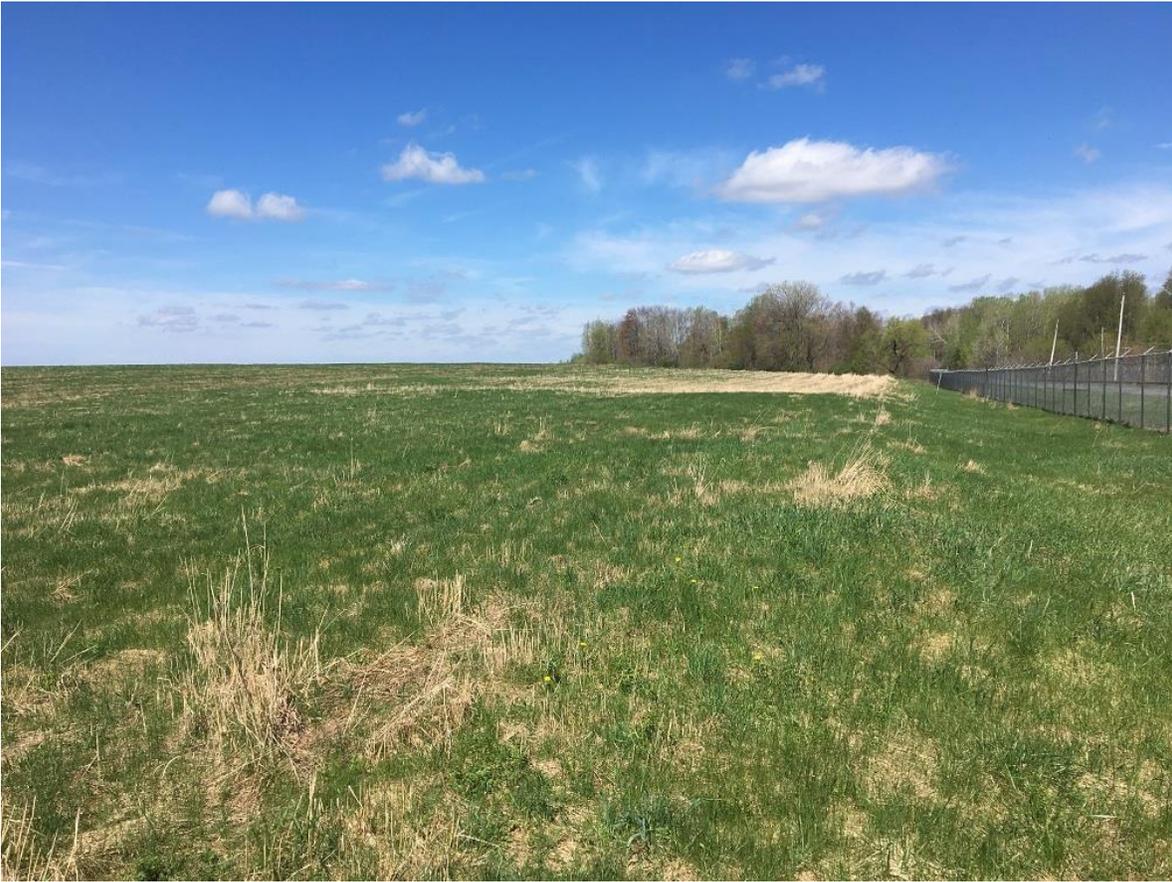
April 2017 Photo 7: LF003 (Landfill 7 AOC) – Facing northwest along northern boundary of western block.

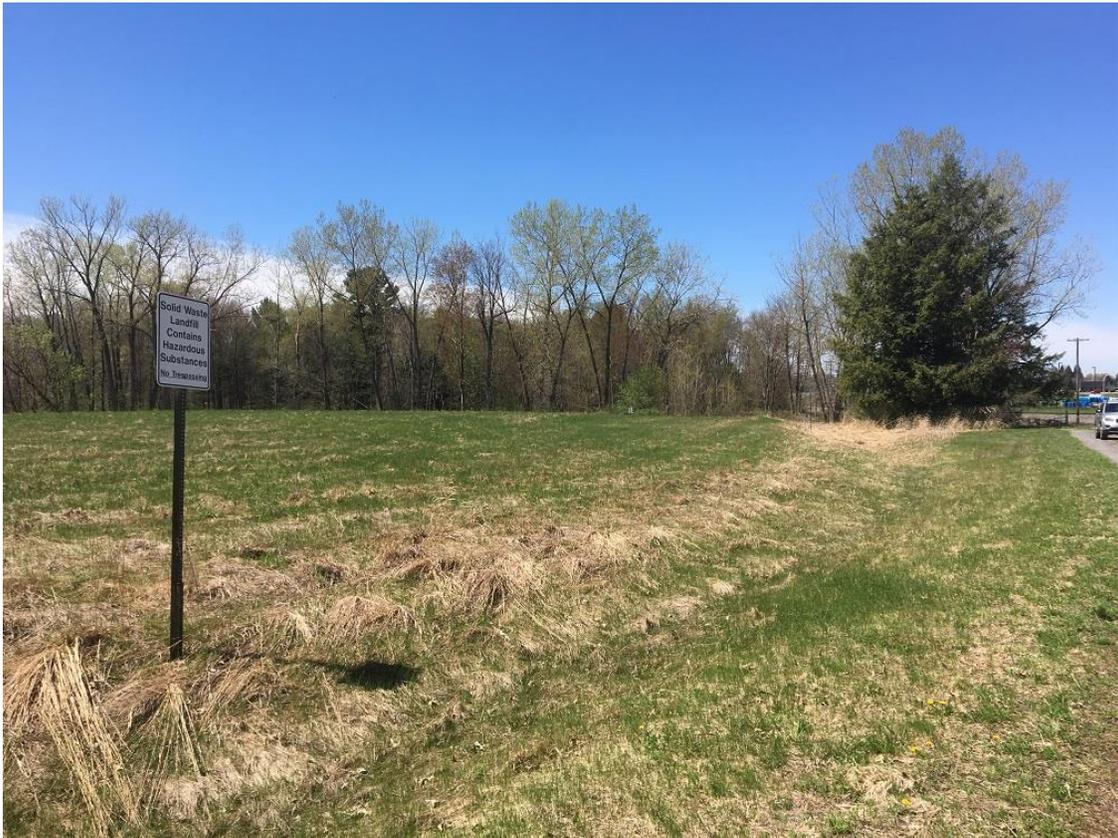
April 2017 Photo 1: LF007 (Landfill 5 AOC) – Facing west along northern boundary of LF007

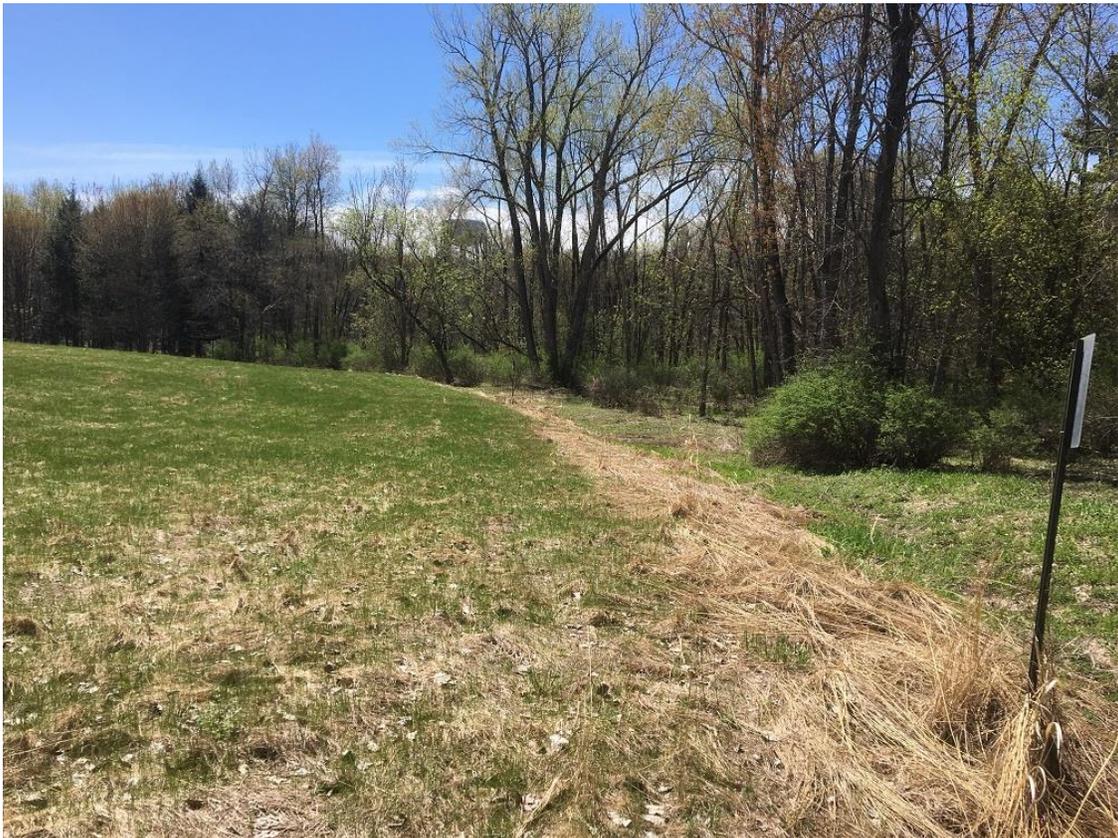
April 2017 Photo 2: LF007 (Landfill 5 AOC) – Facing southwest along western boundary of LF007. Photograph taken from northwest corner of LF007

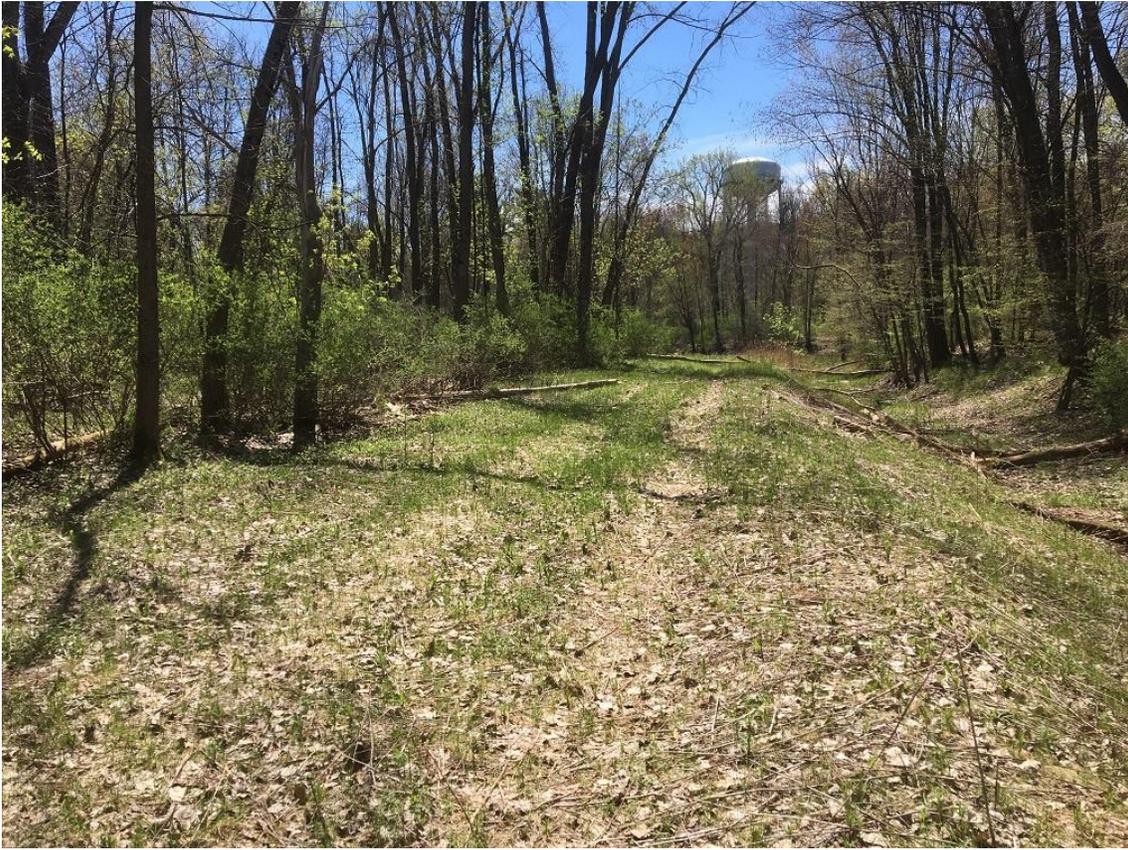
April 2017 Photo 3: LF007 (Landfill 5 AOC) – Facing south along ditch west of LF007

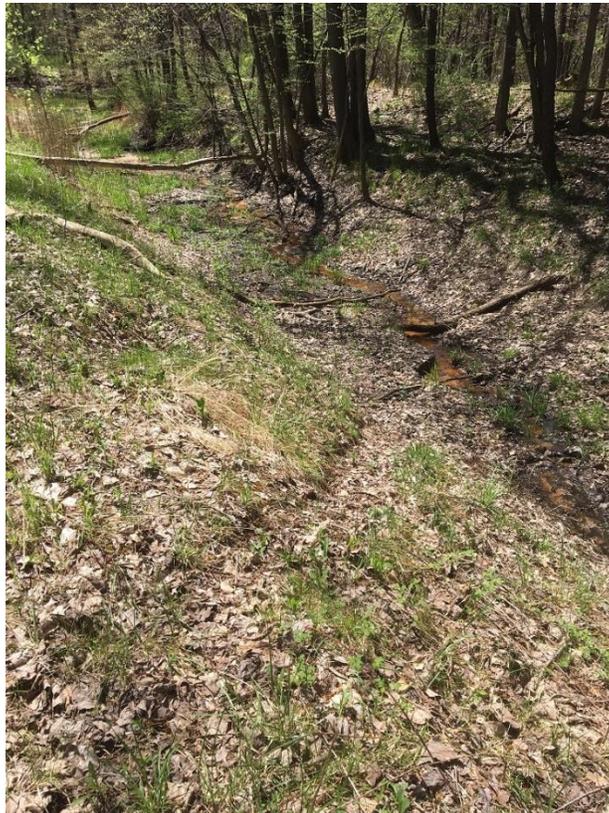
Leachate Breakouts – Leachate observed in stream to west

April 2017 Photo 4: LF007 (Landfill 5 AOC) – Facing south along ditch west of LF007 at potential landfill leachate.

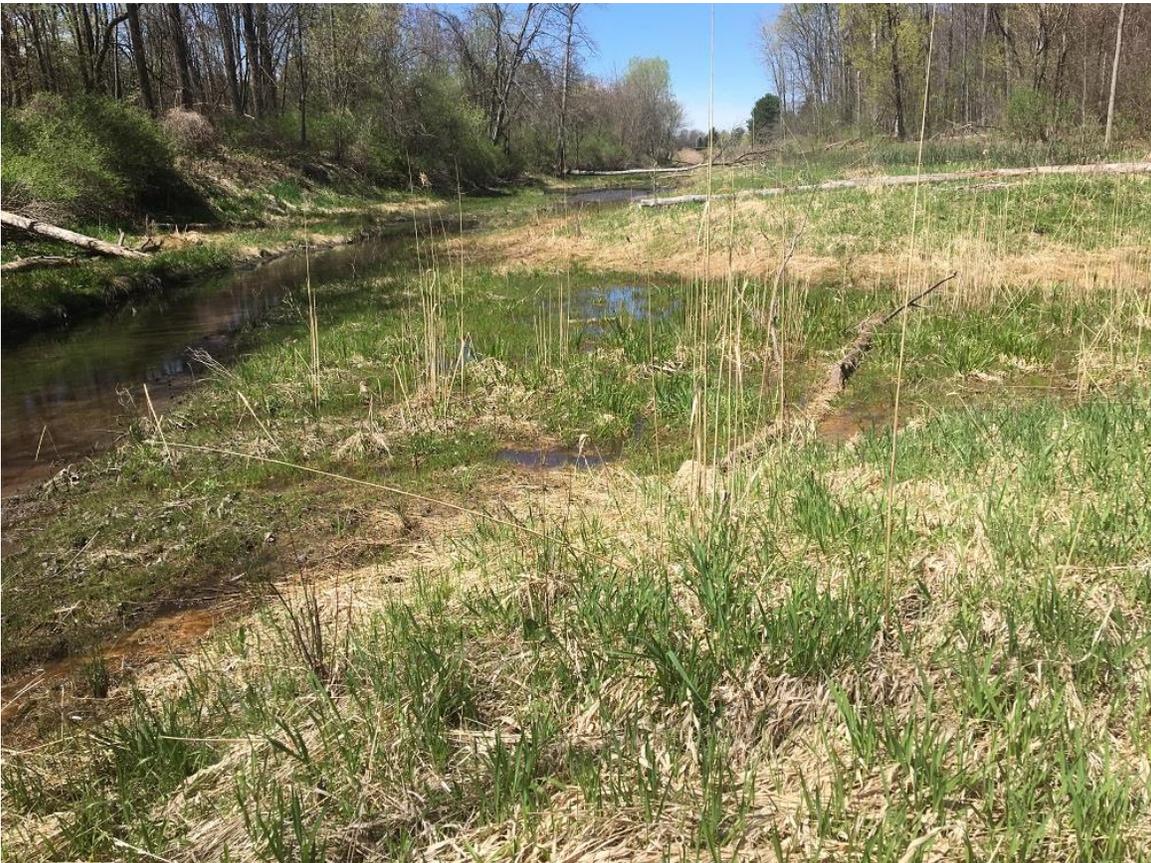
April 2017 Photo 6: LF007 (Landfill 5 AOC) – Facing west at confluence of three mile creek and the ditch southwest of LF007

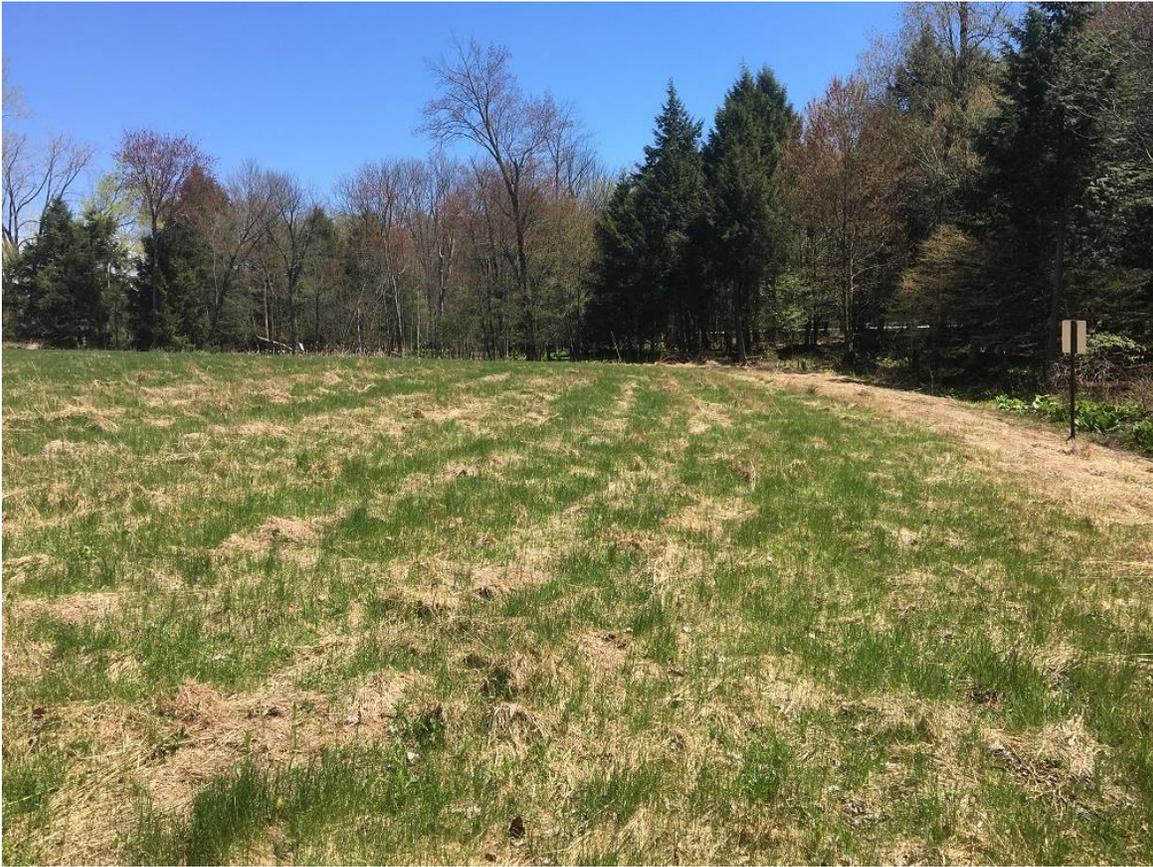
April 2017 Photo 7: LF007 (Landfill 5 AOC) – Facing east along southern boundary of LF007
