**FINAL
TECHNICAL MEMORANDUM
2017 LONG TERM MONITORING OF
LANDFILL AREAS OF CONCERN
FORMER GRIFFISS AIR FORCE BASE
ROME, NEW YORK**

PREPARED BY: Bhate Environmental Associates, Inc.

DATE: June 14, 2018

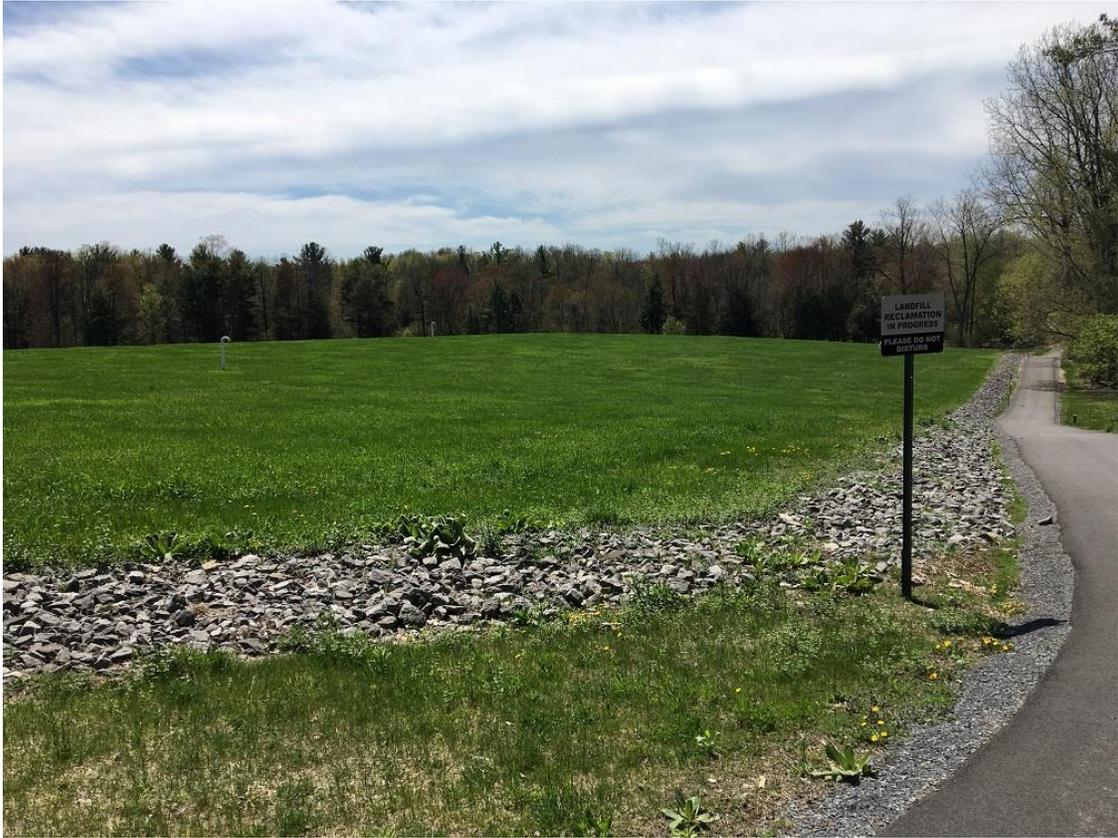
April 2017 Photo 1: LF009 (Landfill 6 AOC) – Facing southwest along walking path on the western boundary of LF009.

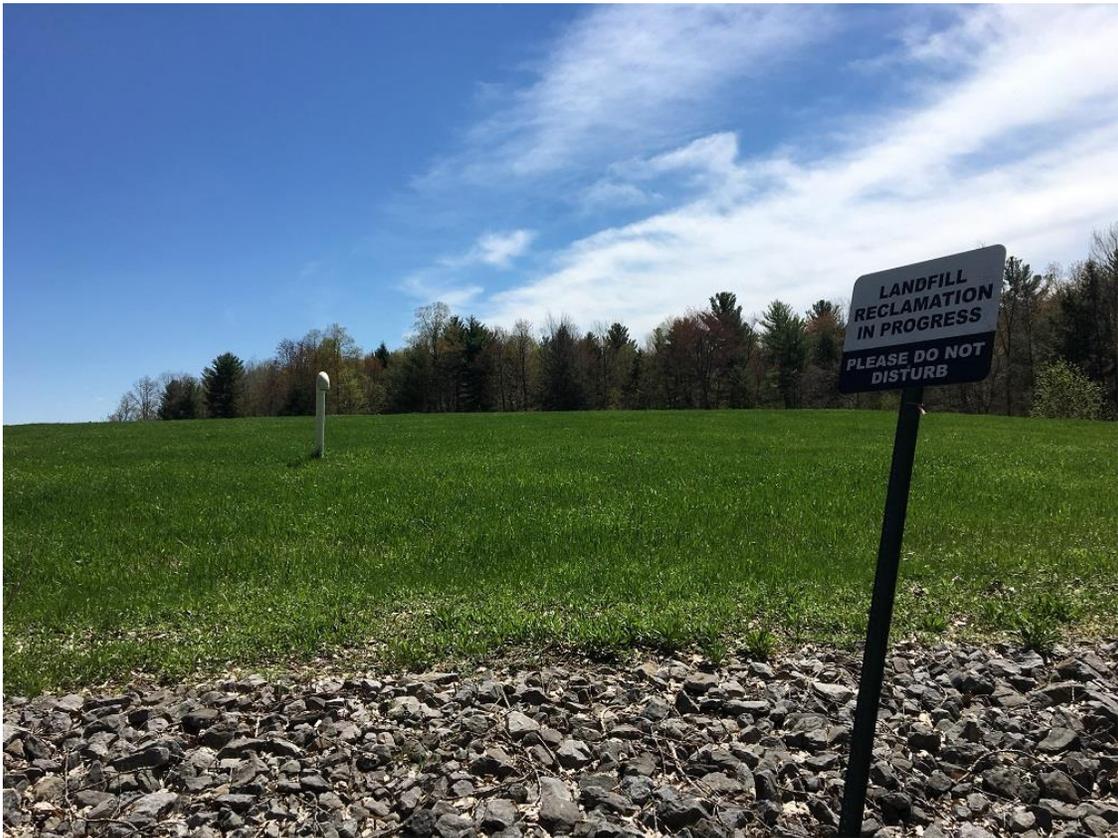
April 2017 Photo 2: LF009 (Landfill 6 AOC) – Facing southeast from western boundary of LF009 towards Vent-03.

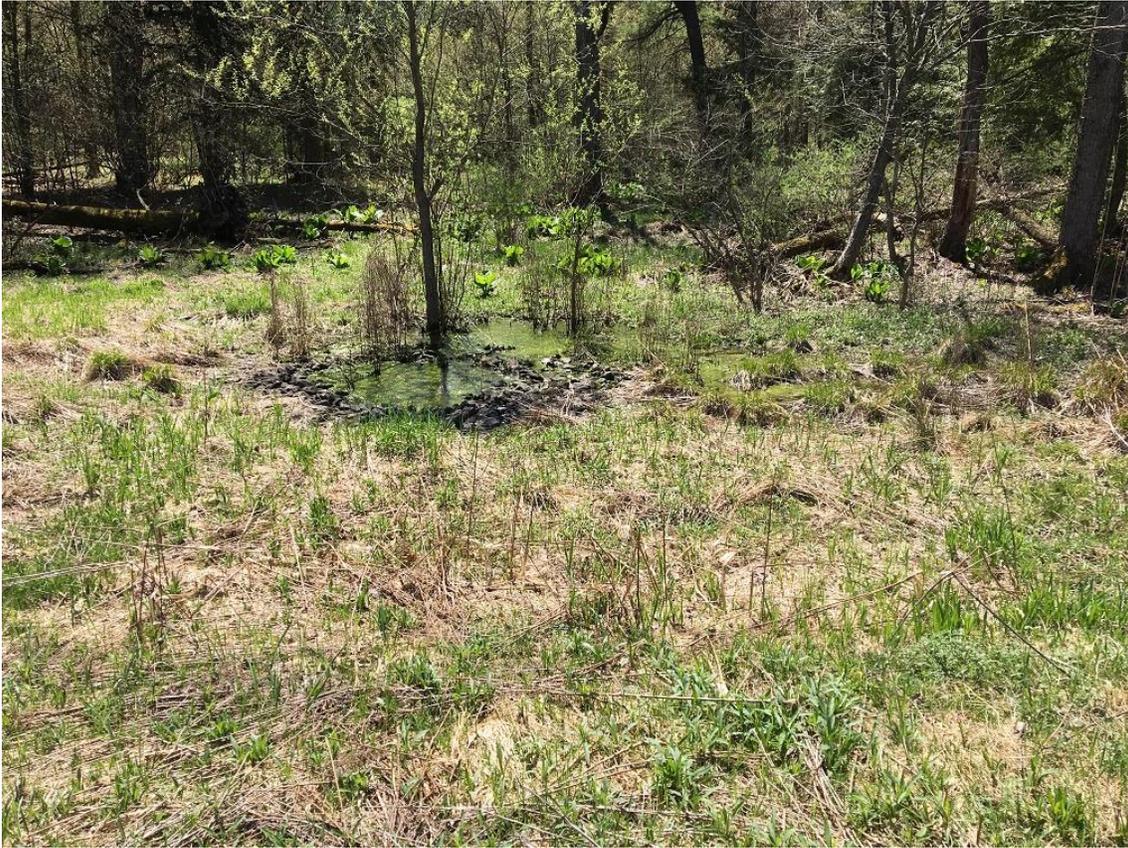
April 2017 Photo 3: LF009 (Landfill 6 AOC) – Facing southwest at the southern boundary of the landfill downslope of VENT-05.

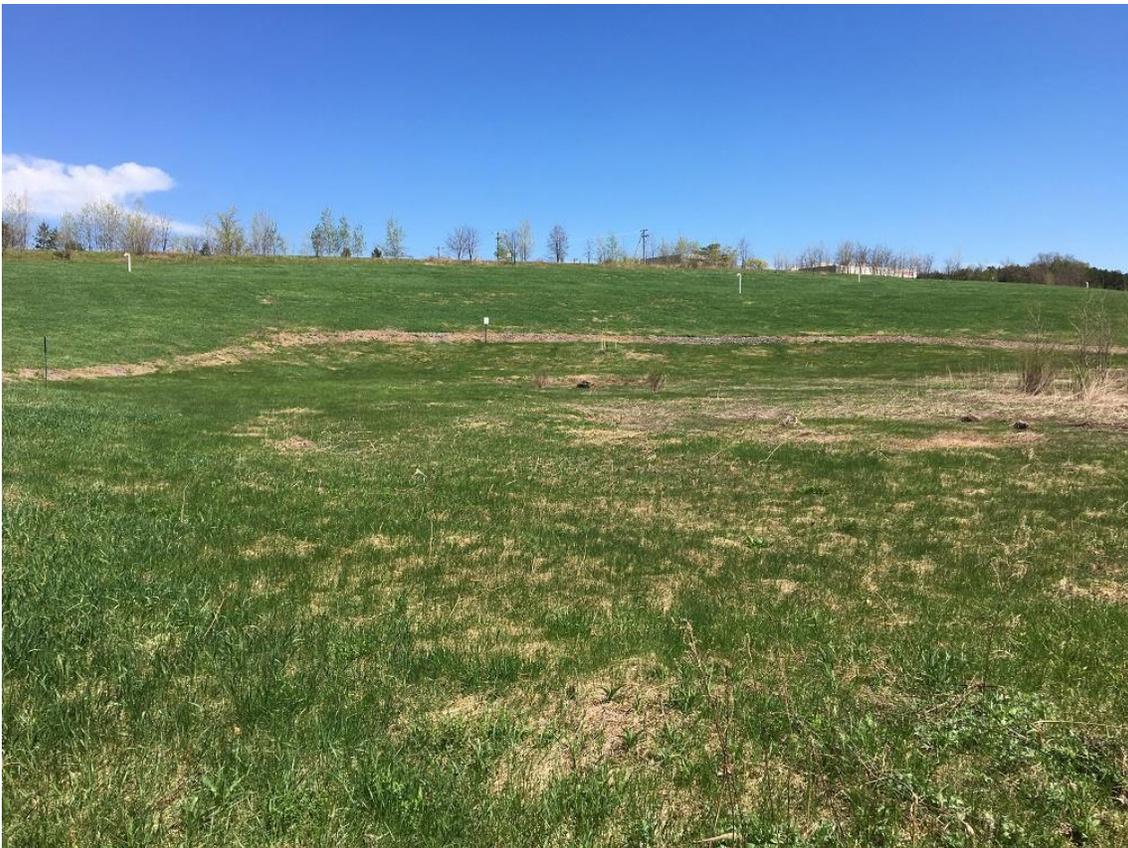
April 2017 Photo 4: LF009 (Landfill 6 AOC) – Facing northeast towards GMP-12. Photograph taken near GMP-13.

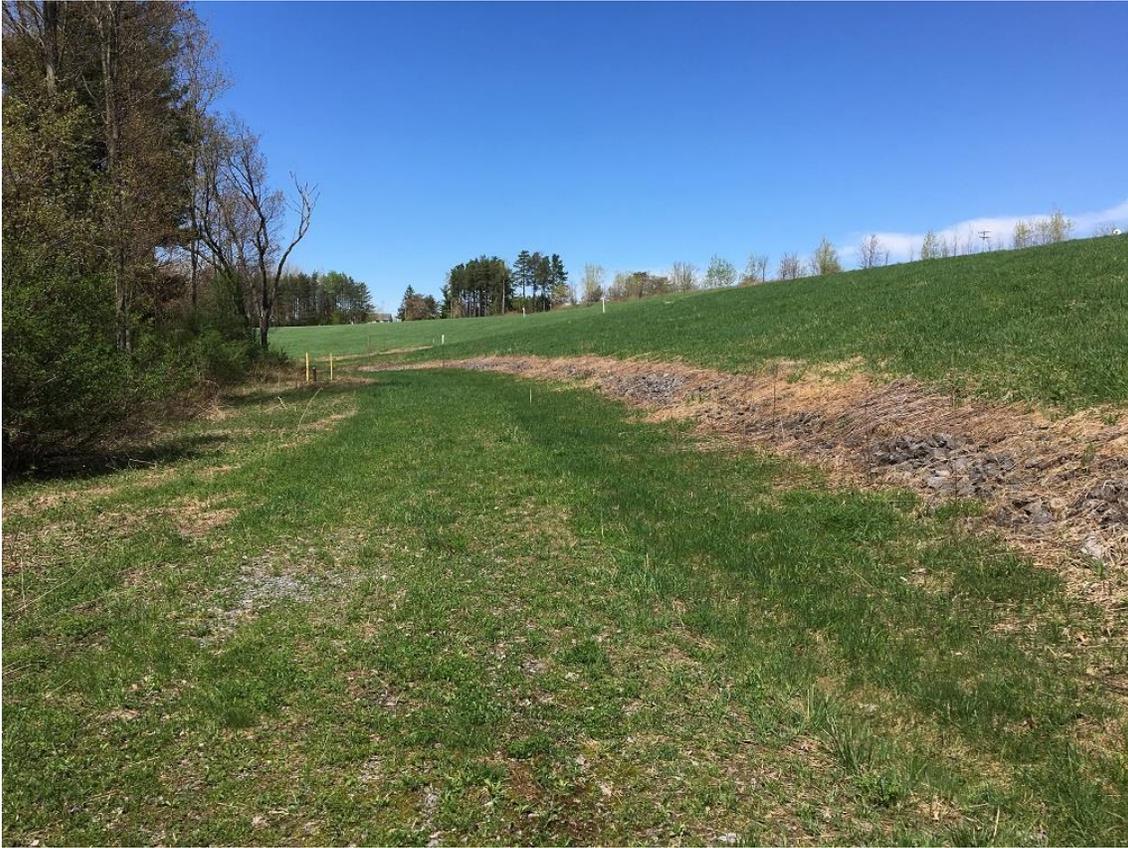
April 2017 Photo 5: LF009 (Landfill 6 AOC) – Facing north-northwest along southern boundary of LF009. Photograph taken near GMP-11.

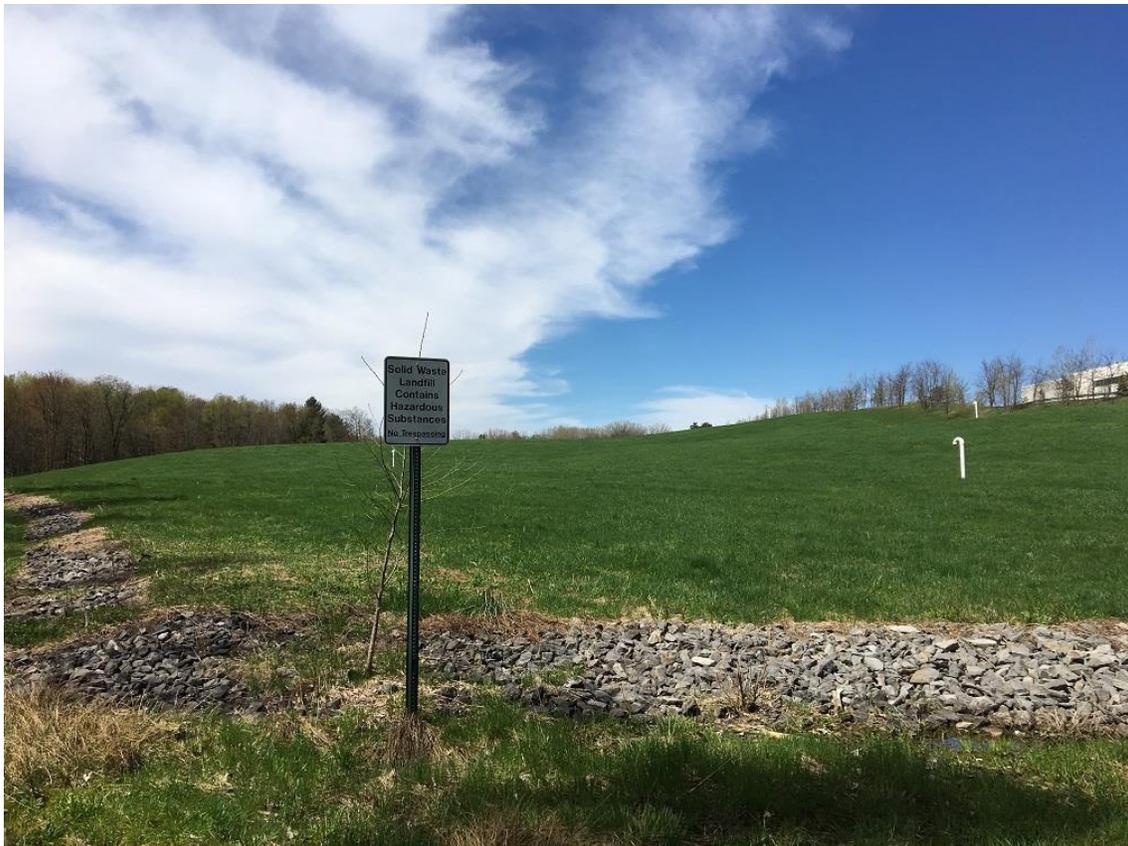
April 2017 Photo 6: LF009 (Landfill 6 AOC) – Facing northwest from south east corner of LF009 near GMP-08.

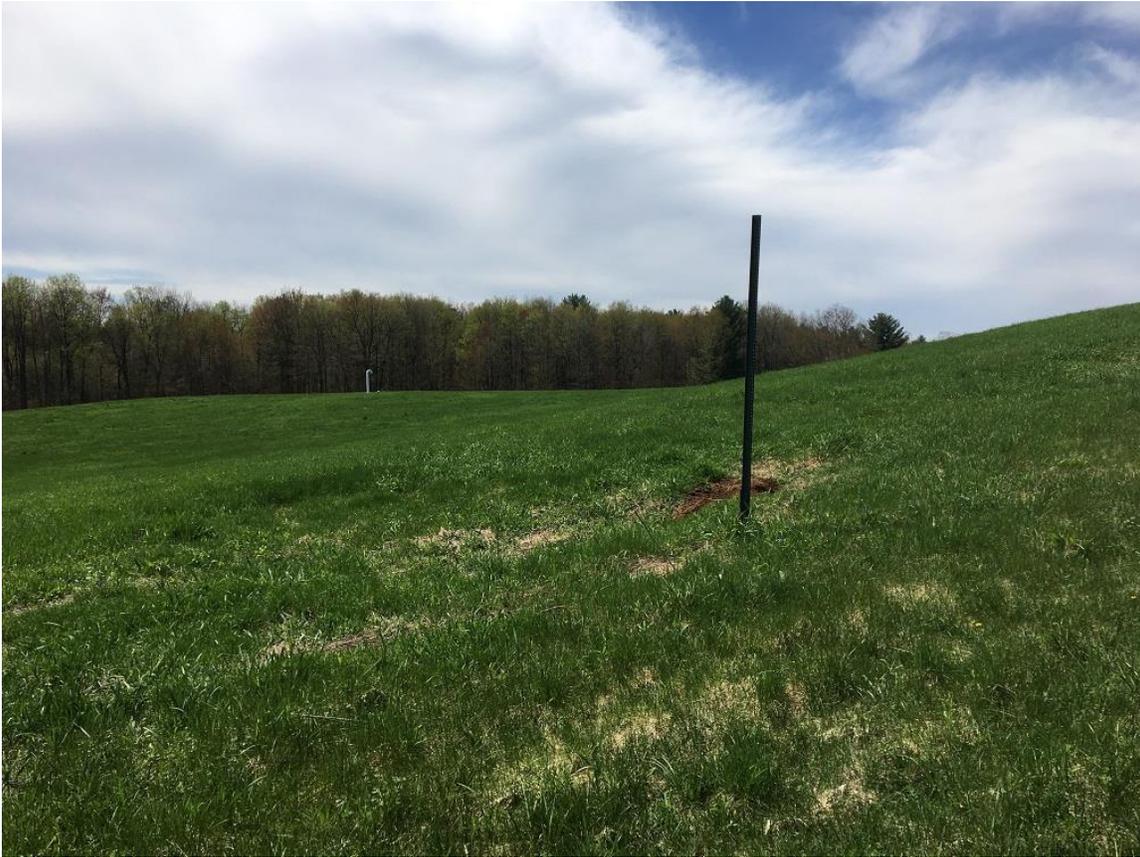
April 2017 Photo 7: LF009 (Landfill 6 AOC) – Facing south from northern boundary of LF009 near VENT-11.

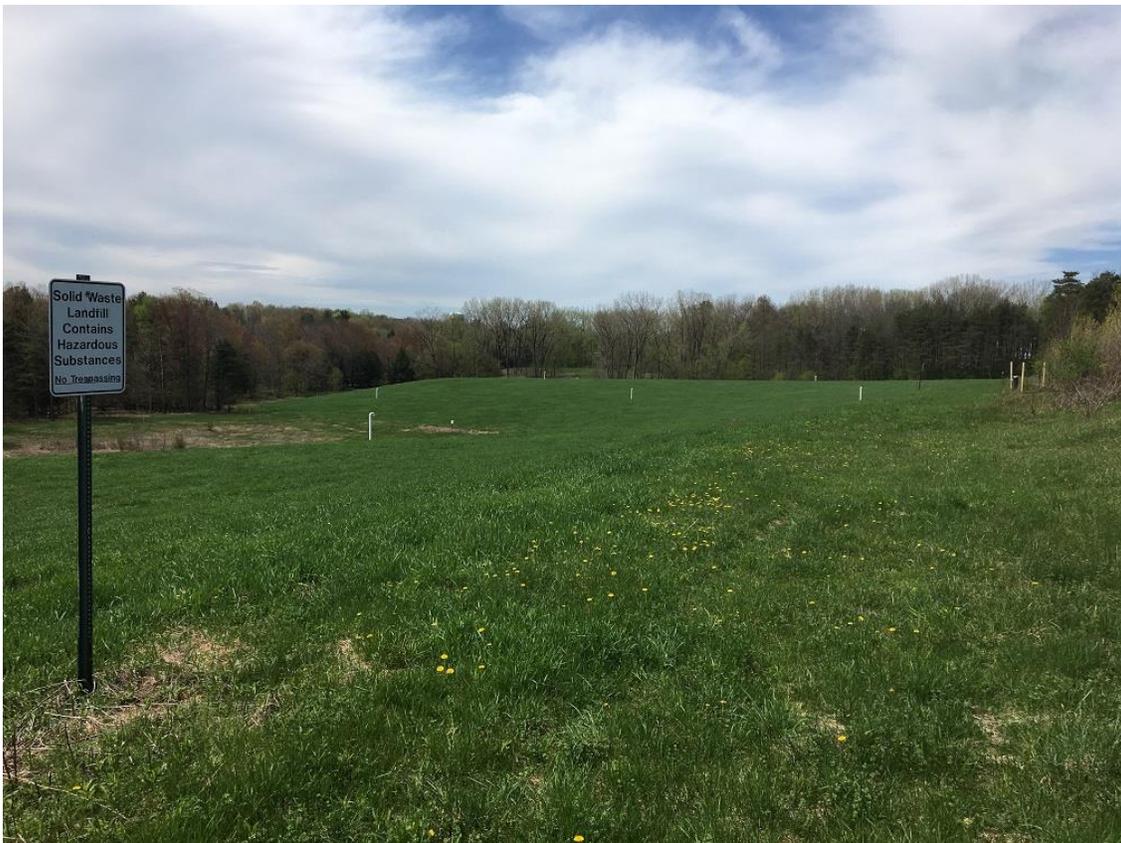
April 2017 Photo 8: LF009 (Landfill 6 AOC) – Facing west from northern boundary of LF009 near VENT-07.

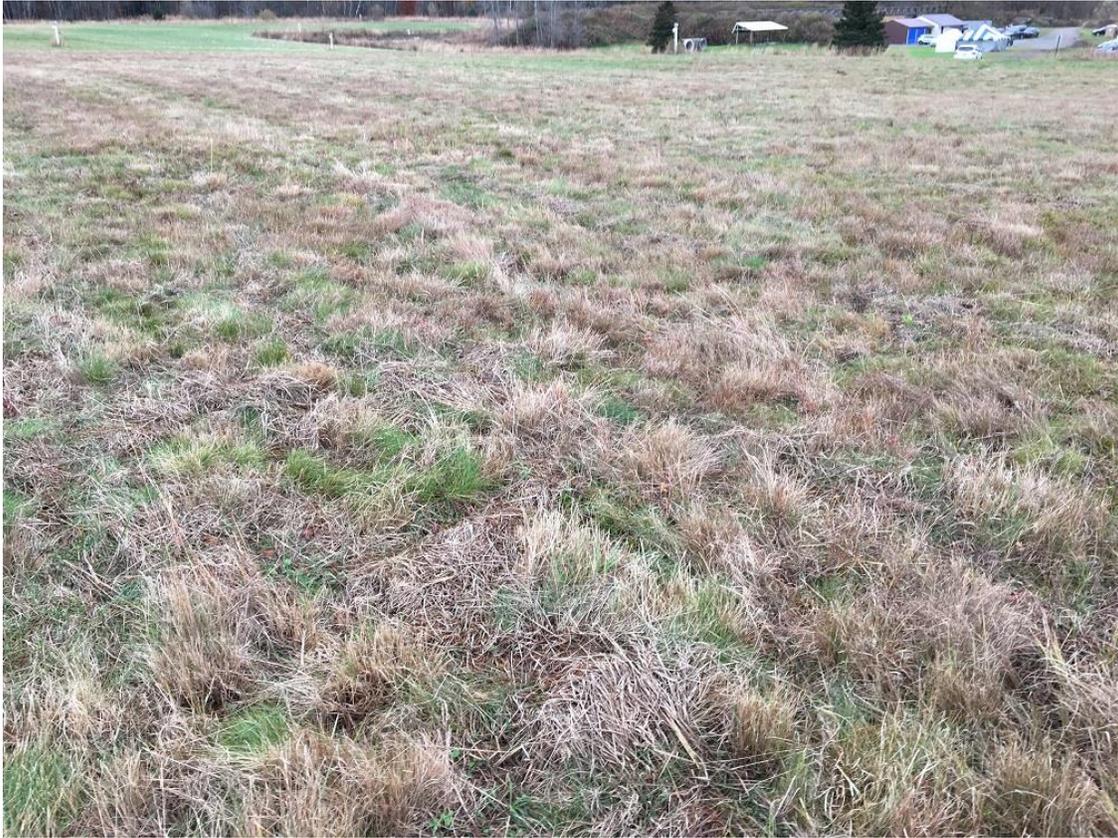
November 2017 Photo 1: LF001 (Landfill 1 AOC) – Facing southeast from Vent-9

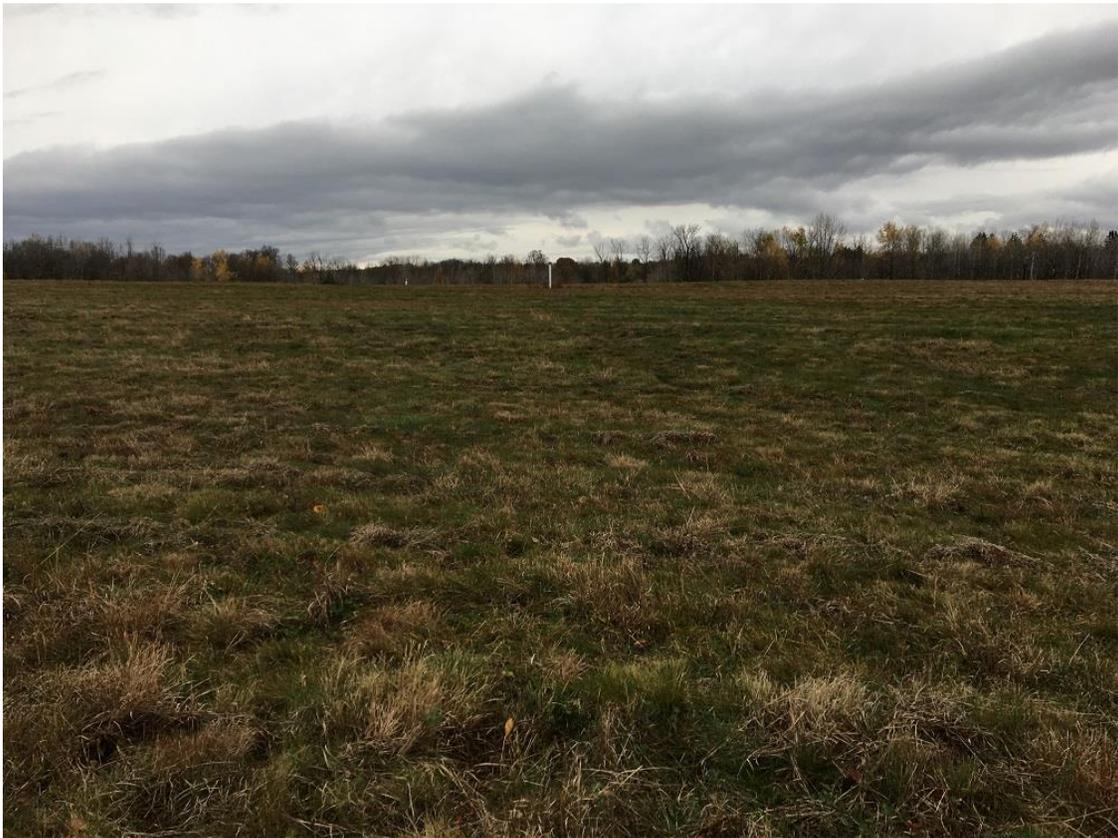
November 2017 Photo 2: LF001 (Landfill 1 AOC) – Facing southeast standing between Vent-10 and Vent-13

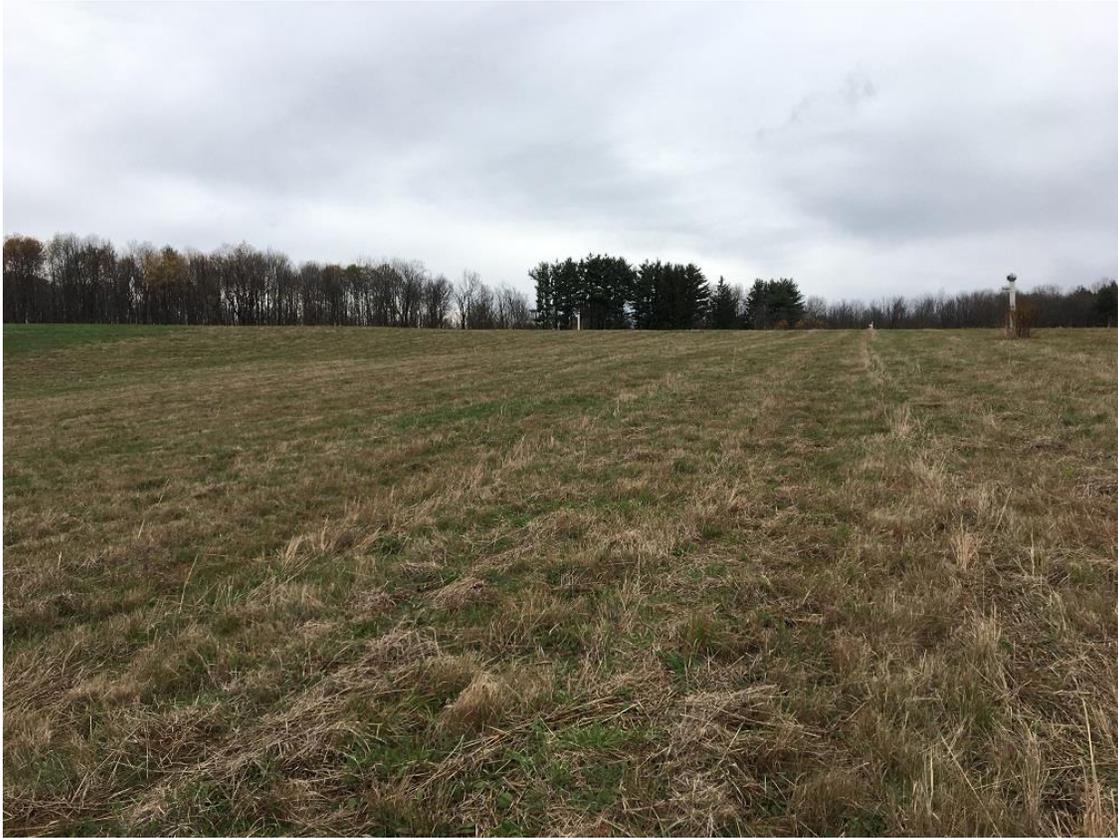
November 2017 Photo 1: LF002 (Landfill 2/3 AOC) – Facing northeast from VENT-10

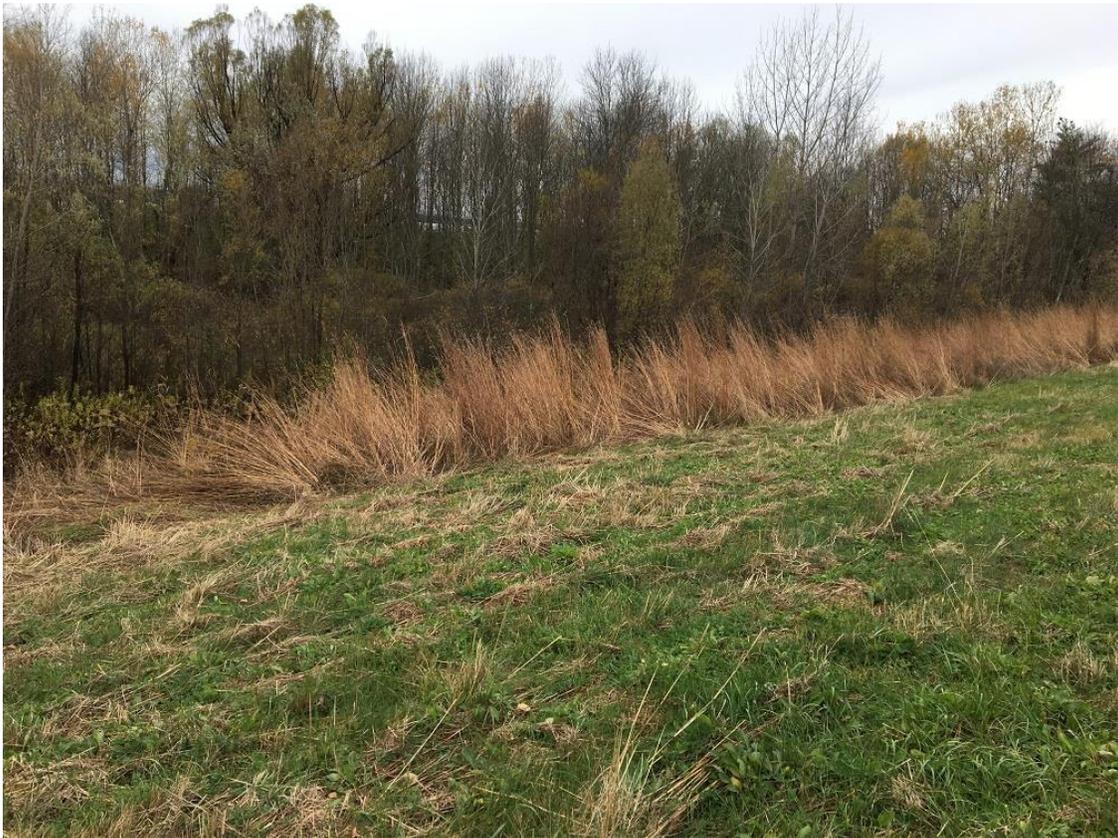
November 2017 Photo 2: LF002 (Landfill 2/3 AOC) – Facing southwest from VENT-09

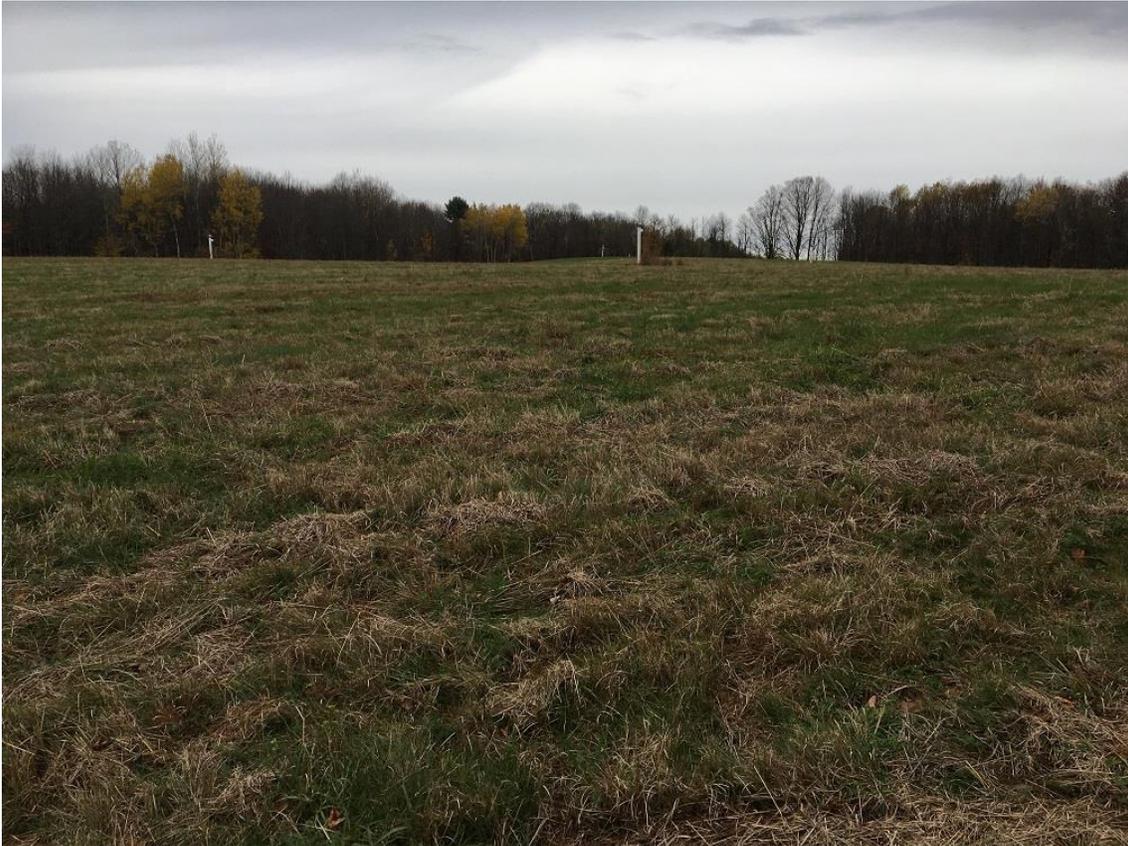
November 2017 Photo 3: LF002 (Landfill 2/3 AOC) – Facing north towards VENT-06

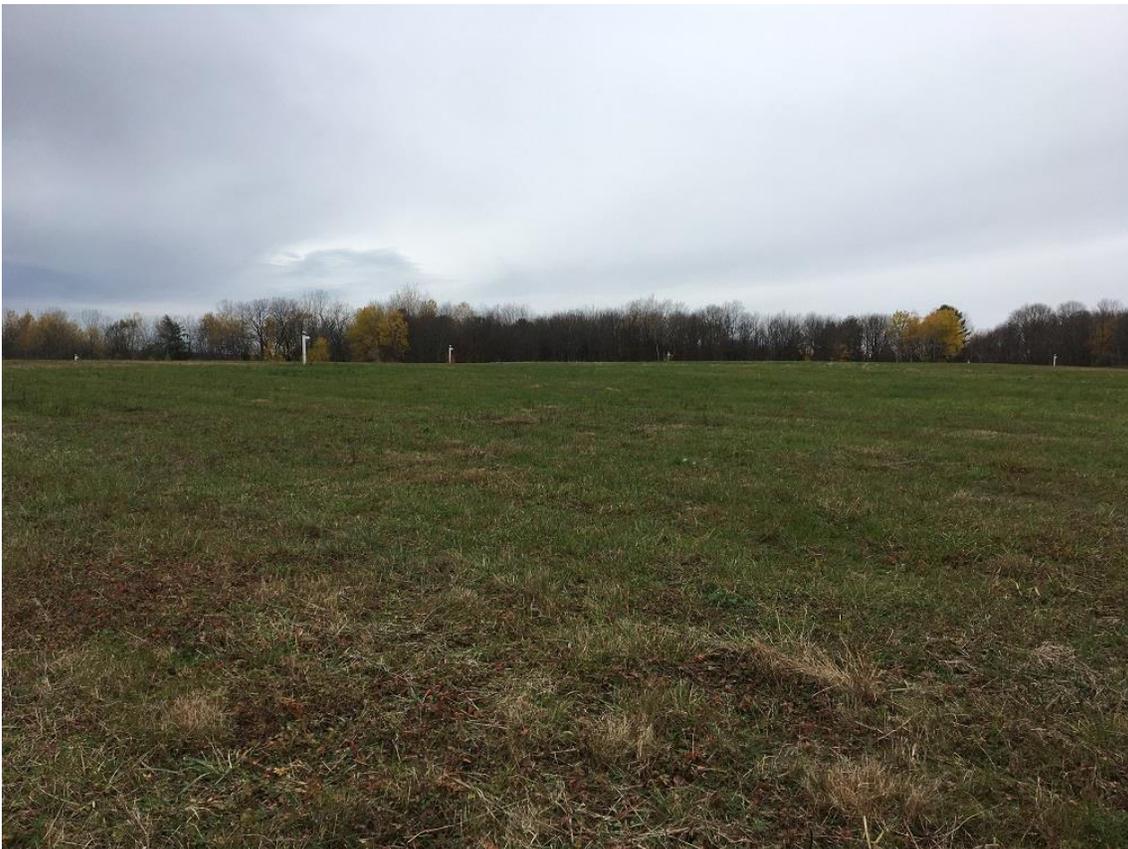
November 2017 Photo 4: LF002 (Landfill 2/3 AOC) – Facing east towards VENT-05

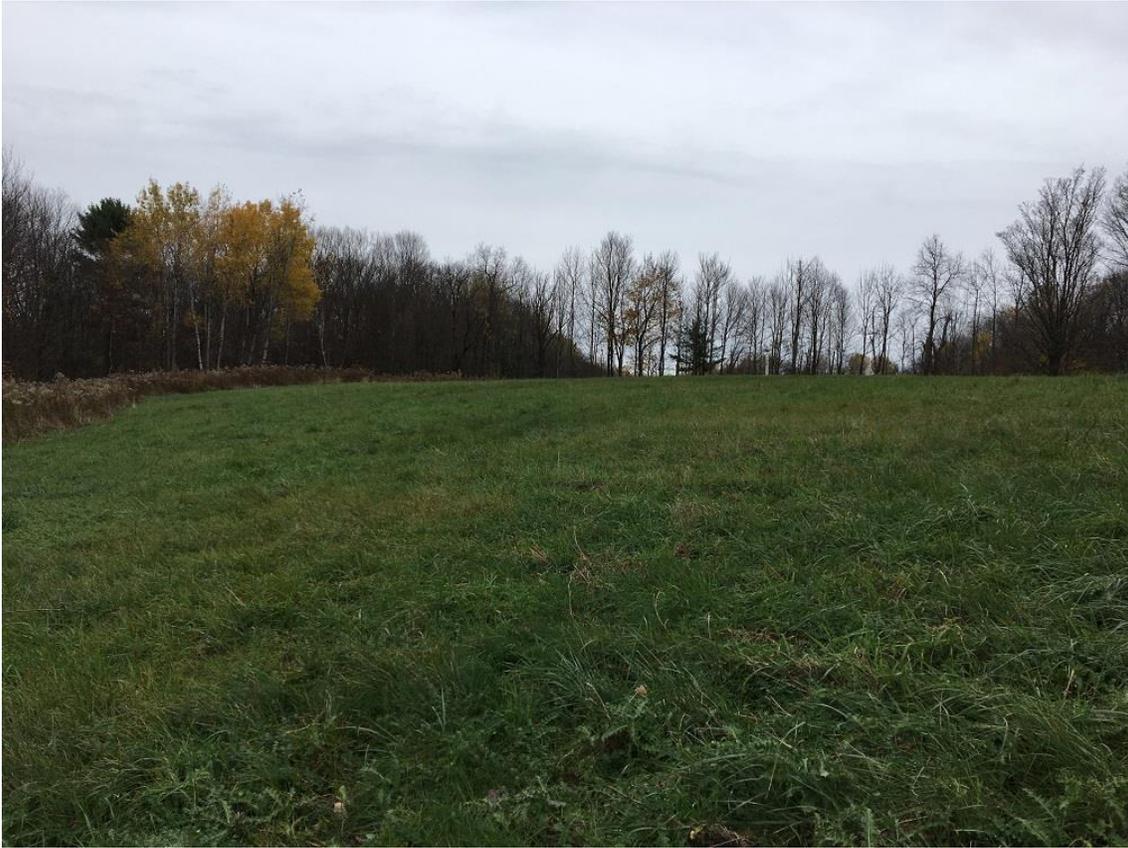
November 2017 Photo 5: LF002 (Landfill 2/3 AOC) – Facing north towards VENT-13

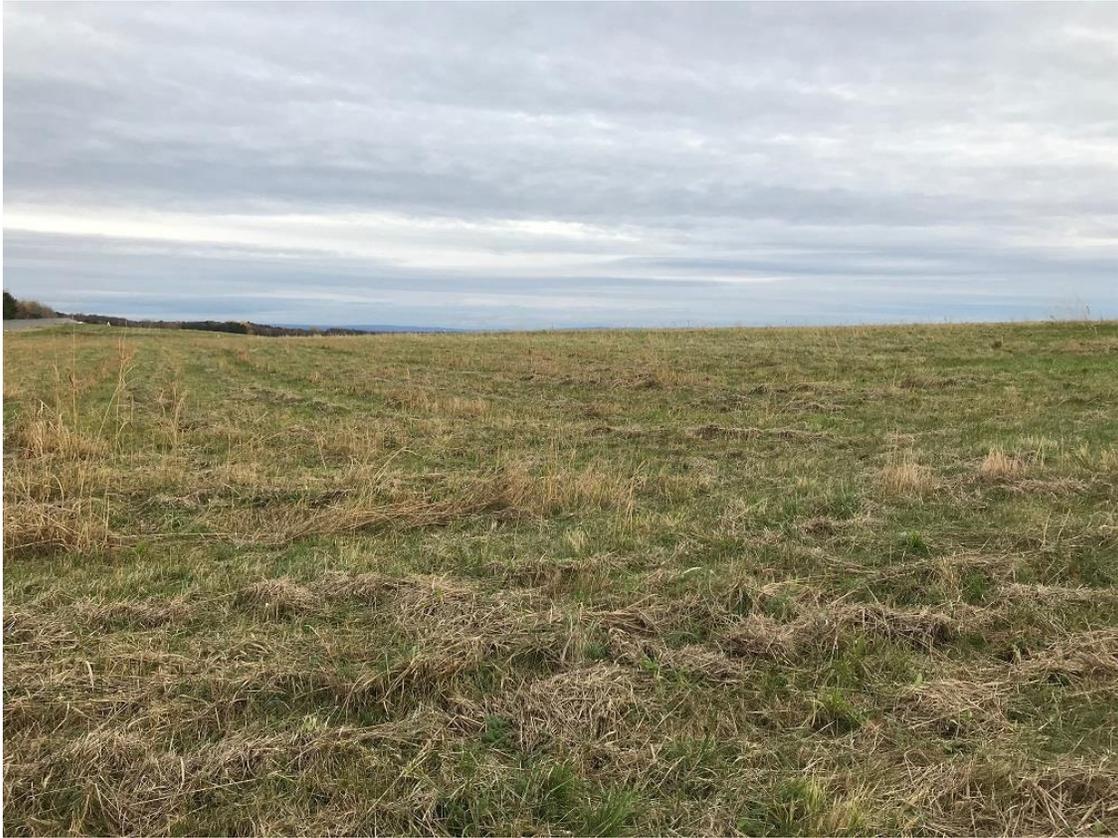
November 2017 Photo 1: LF003 (Landfill 7 AOC) – Facing southeast from the northwest corner of western block

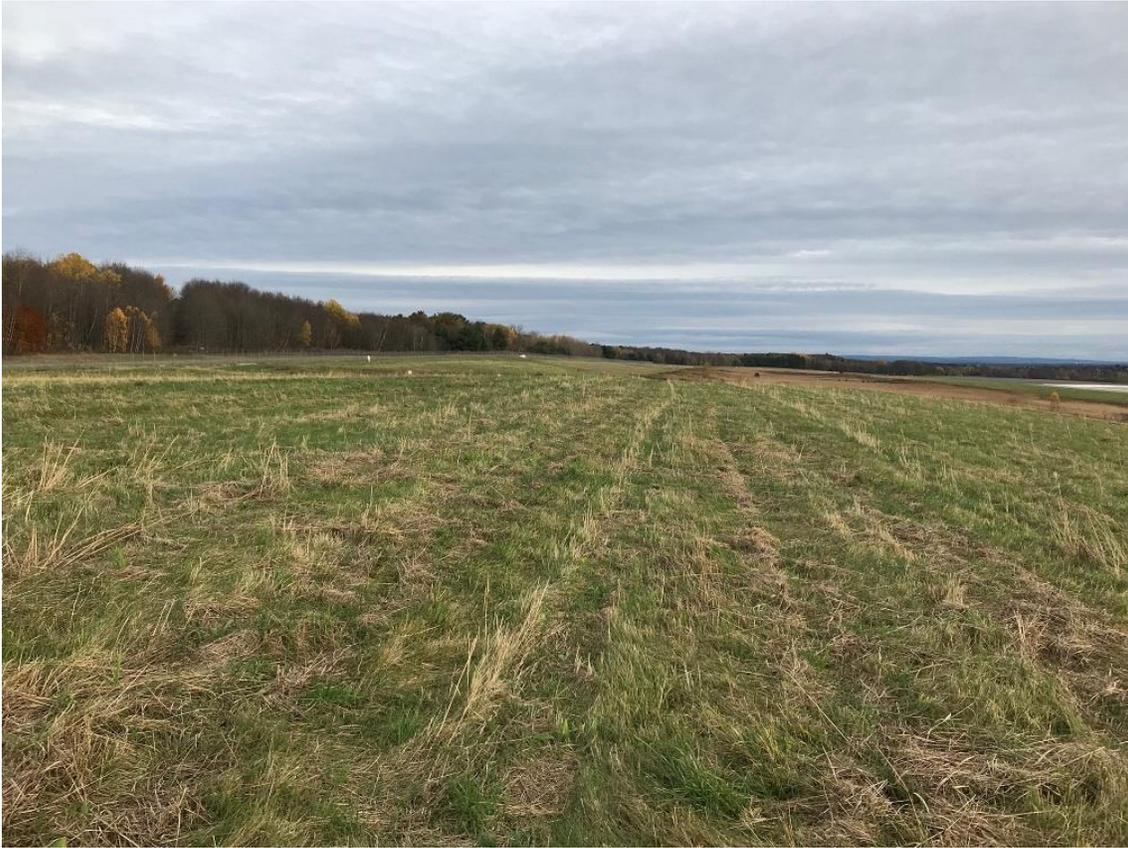
November 2017 Photo 3: LF003 (Landfill 7 AOC) – Facing southeast from center of western block

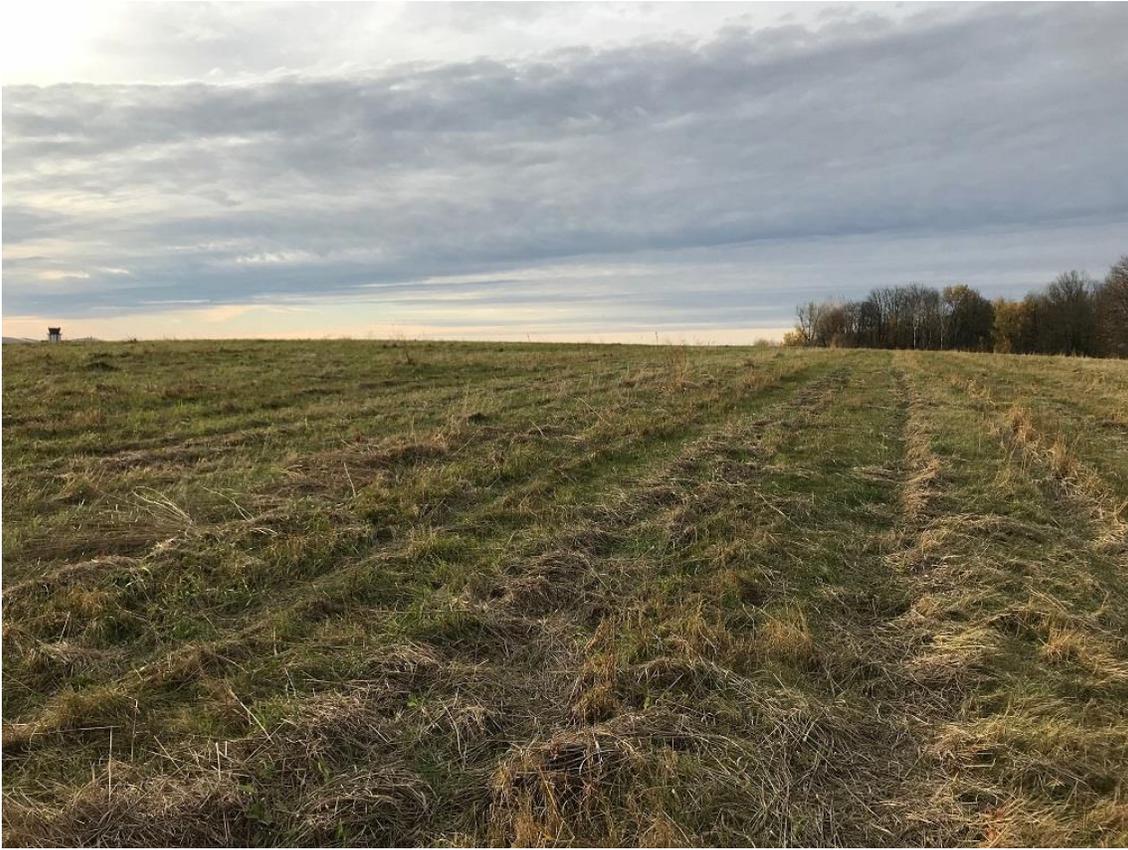
November 2017 Photo 5: LF003 (Landfill 7 AOC) – Facing northwest towards the center of LF003 western block

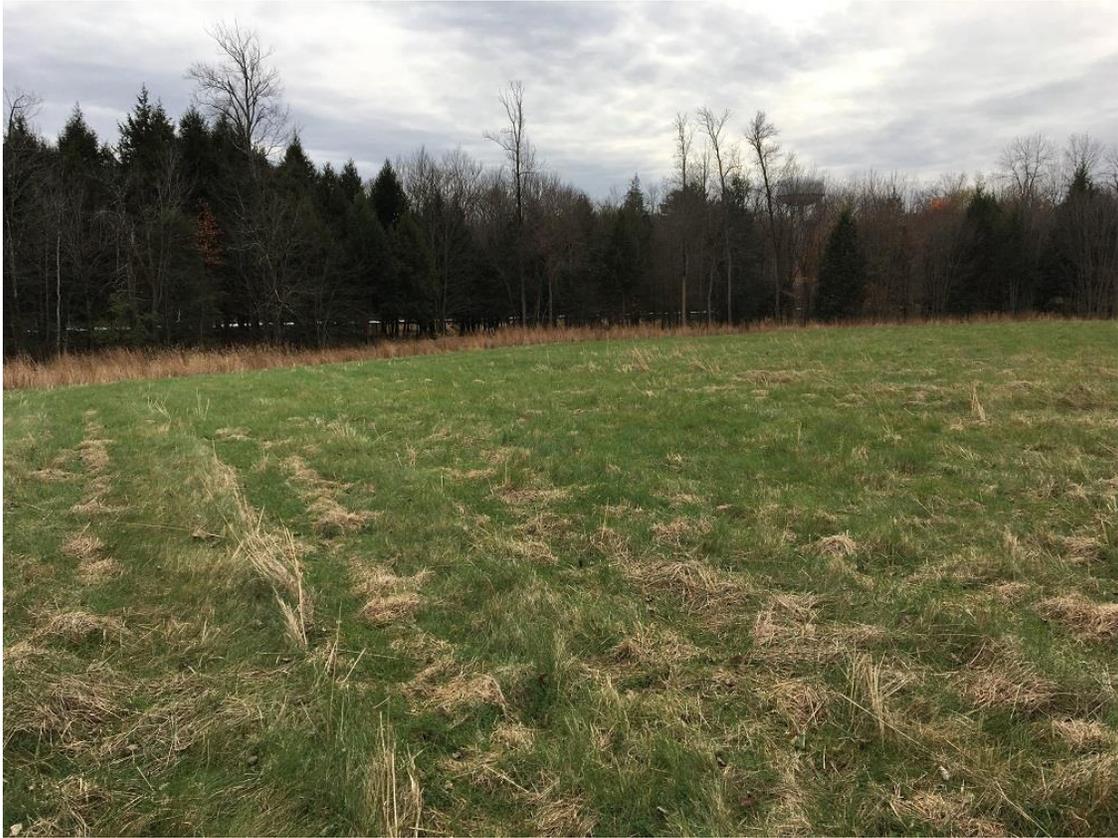
November 2017 Photo 1: LF007 (Landfill 5 AOC) – Facing southwest at southern edge of LF007

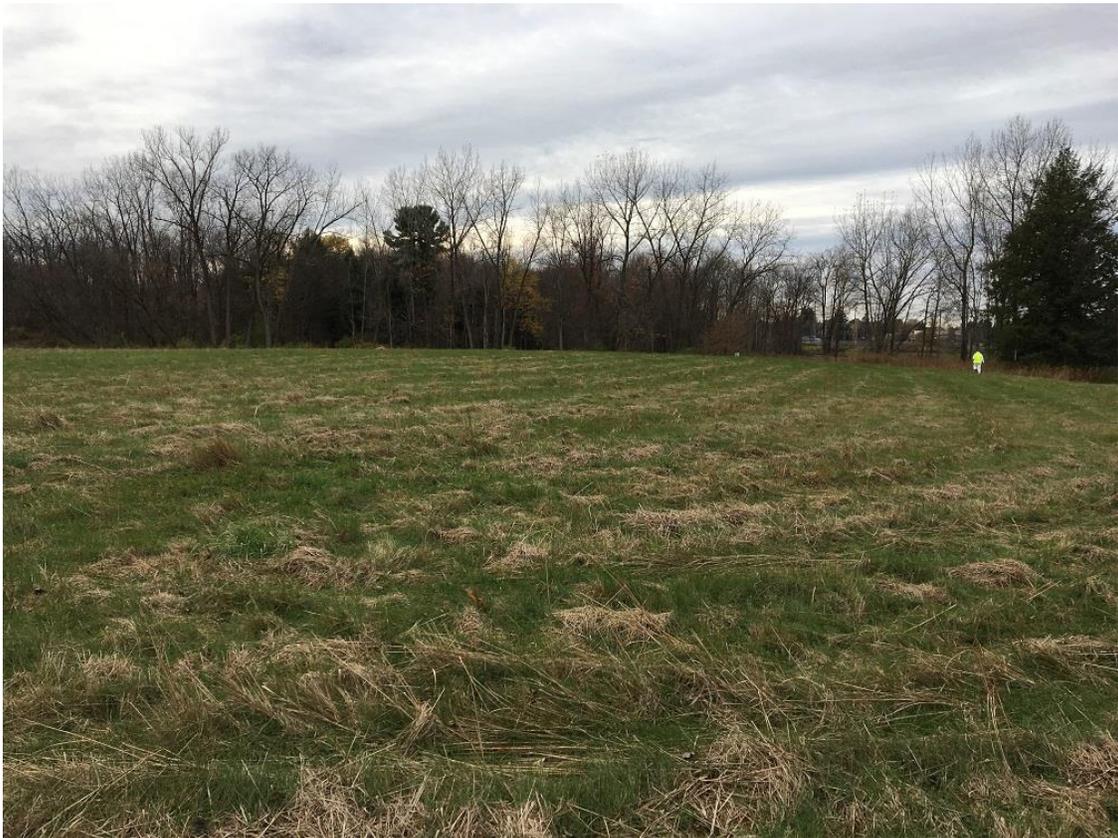
November 2017 Photo 2: LF007 (Landfill 5 AOC) – Facing west towards northwest corner of LF007

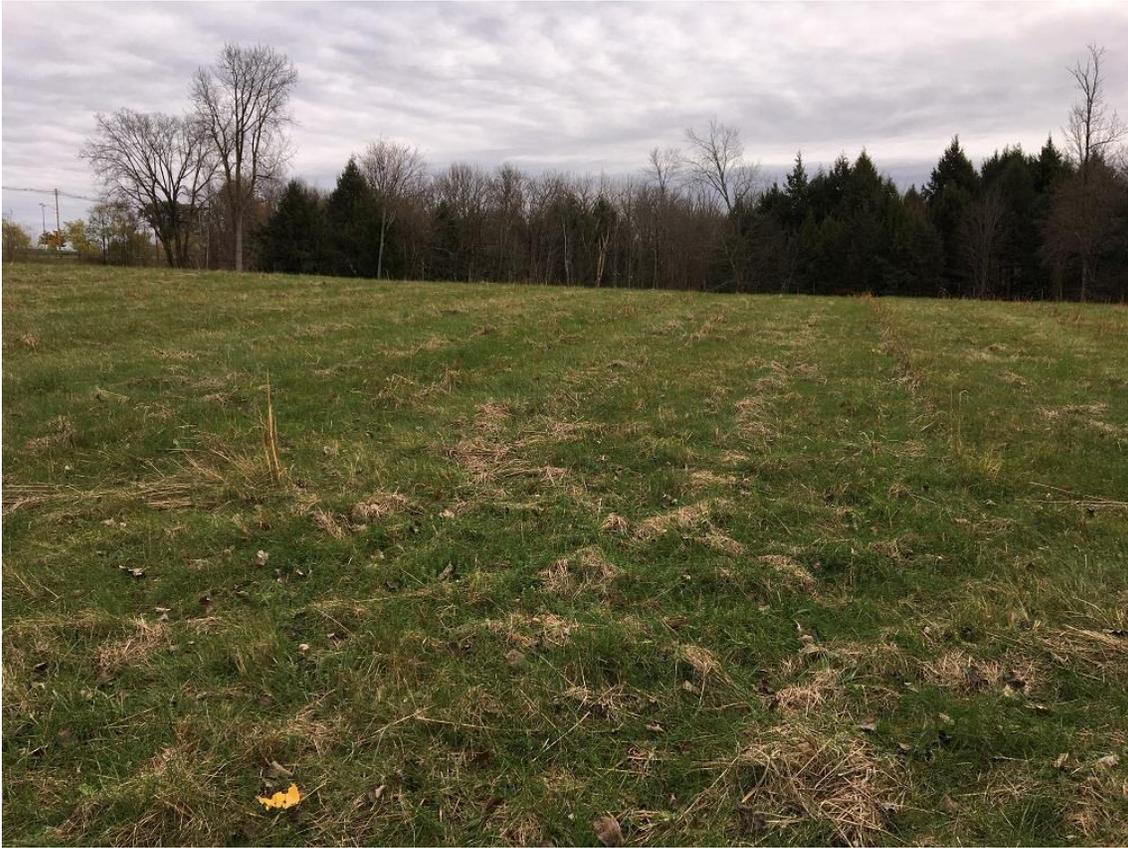
November 2017 Photo 3: LF007 (Landfill 5 AOC) – Facing east towards the center of LF007

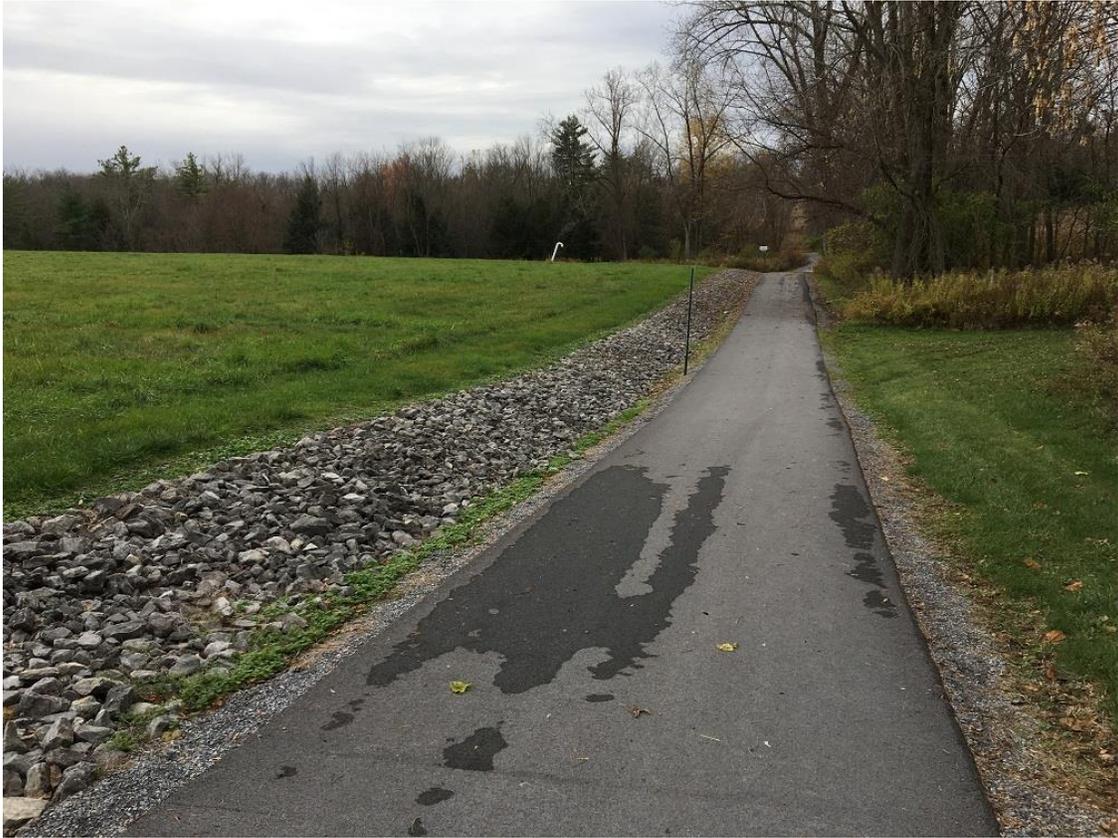
November 2017 Photo 1: LF009 (Landfill 6 AOC) – Facing southwest along walking path on the western boundary of LF009

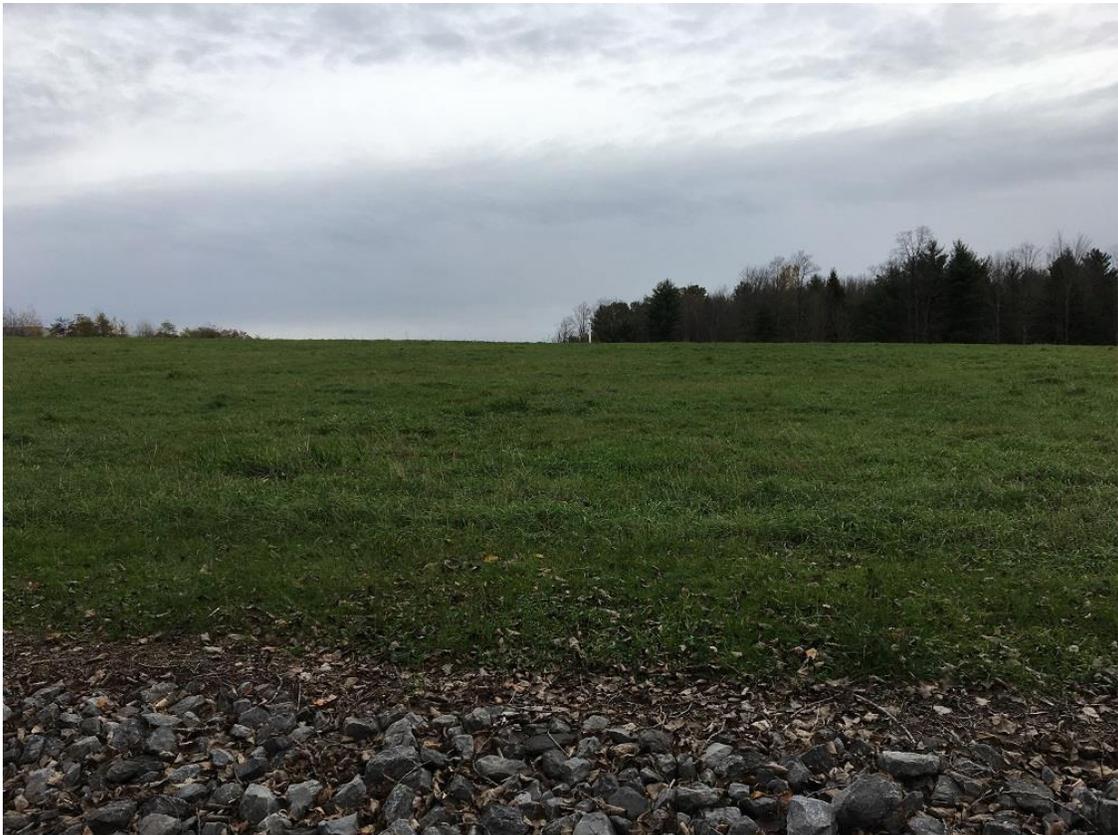
November 2017 Photo 2: LF009 (Landfill 6 AOC) – Facing southeast from western boundary of LF009 near GMP-01
