**FINAL
TECHNICAL MEMORANDUM
2017 LONG TERM MONITORING OF
LANDFILL AREAS OF CONCERN
FORMER GRIFFISS AIR FORCE BASE
ROME, NEW YORK**

PREPARED BY: Bhate Environmental Associates, Inc.

DATE: June 14, 2018

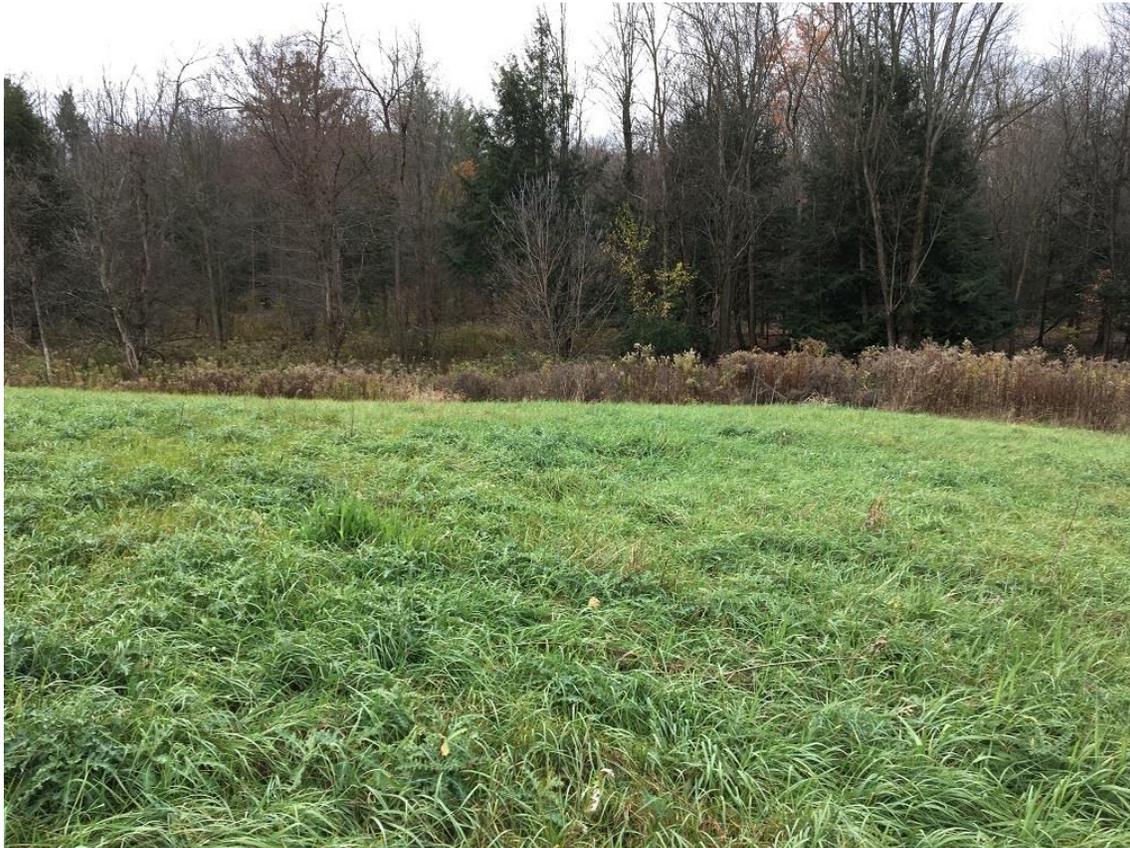
November 2017 Photo 3: LF009 (Landfill 6 AOC) – Facing southwest at the southern boundary of the landfill downslope of VENT-03

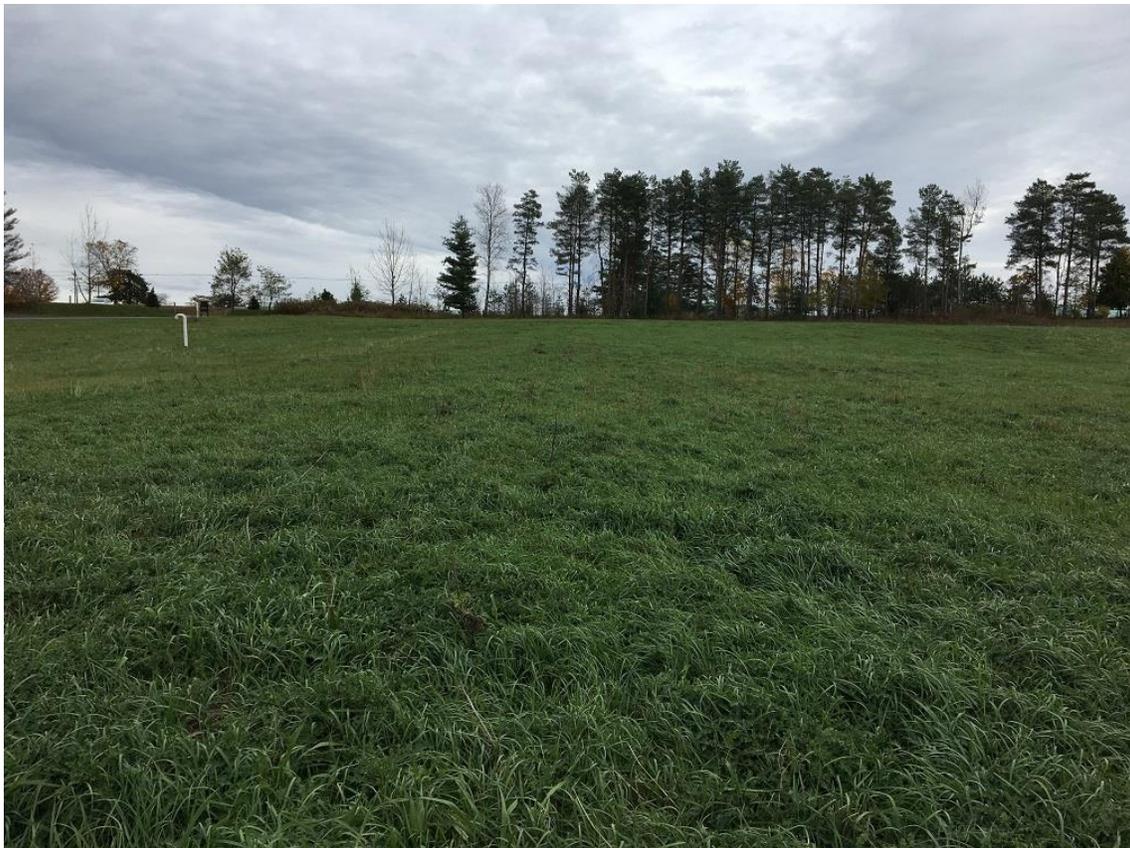
November 2017 Photo 4: LF009 (Landfill 6 AOC) – Facing northeast towards VENT-02

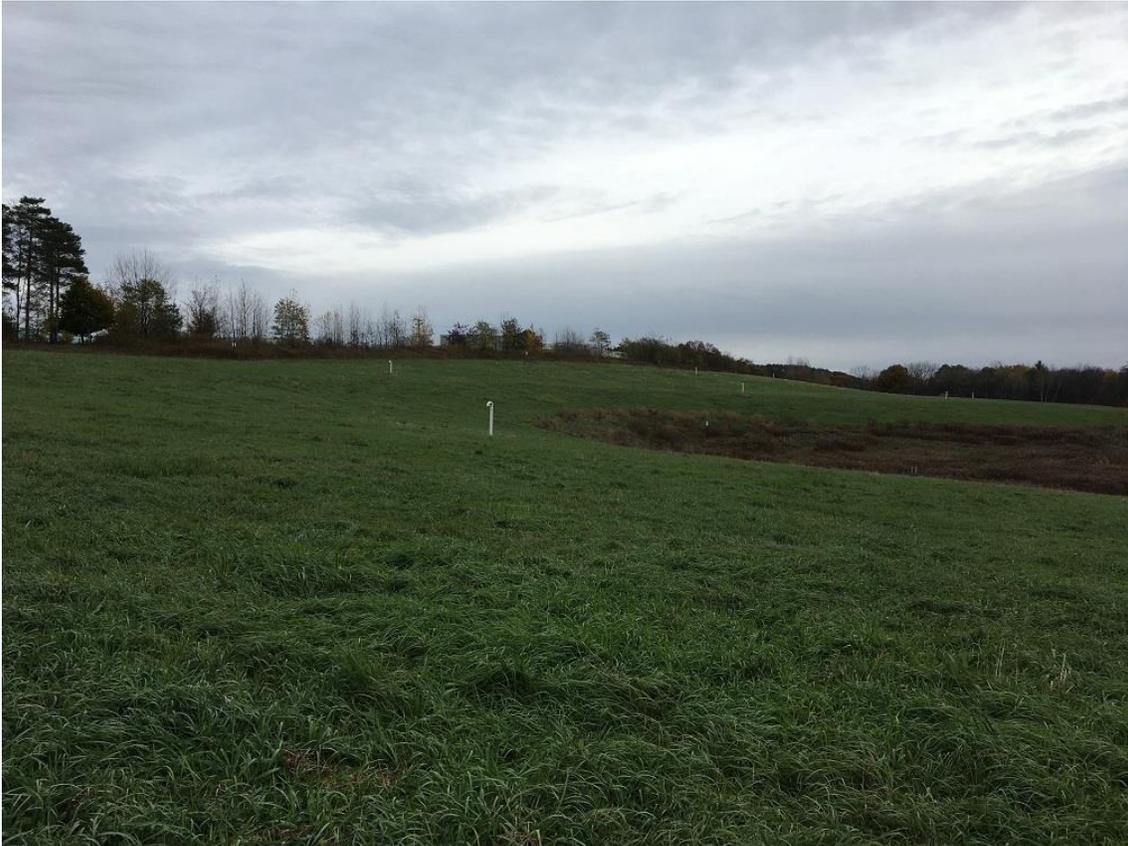
November 2017 Photo 5: LF009 (Landfill 6 AOC) – Facing southeast towards VENT-06

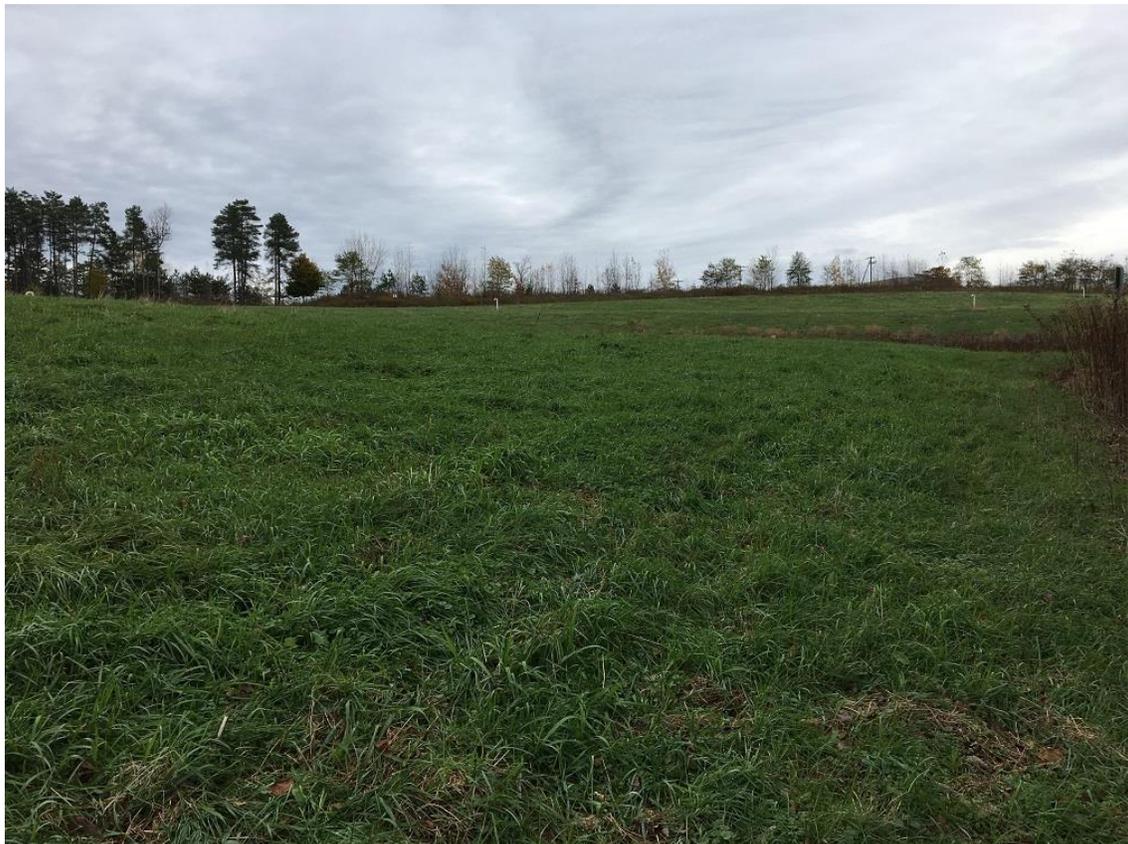
November 2017 Photo 6: LF009 (Landfill 6 AOC) – Facing east from southern boundary of LF009 near GMP-13.
