April 11, 2013

Re: Building Demolition Evaluation
Former Haz-O-Waste (Northeast Environmental Services) Site
NYSDEC Site No. 727003
Work Assignment (WA) No. D007620-9
TRC Project No. 198432.0000.0000

PHOTOGRAPHIC RECORD

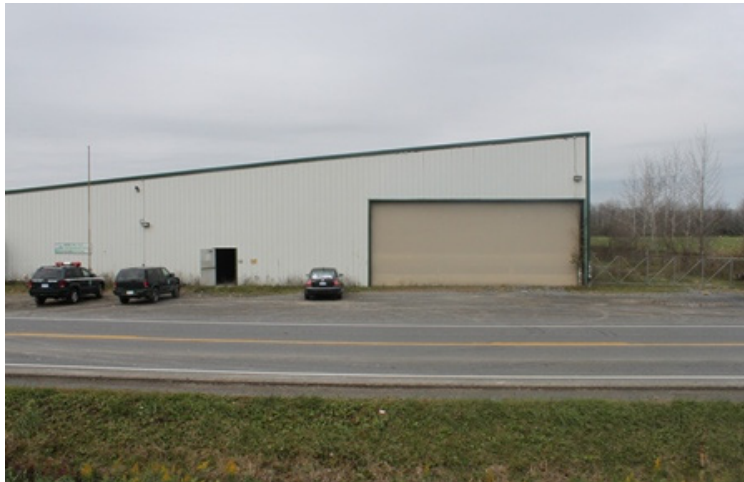
Photo 01 Haz-O-Waste Building; main entrance, parking and overhead service door, looking north.

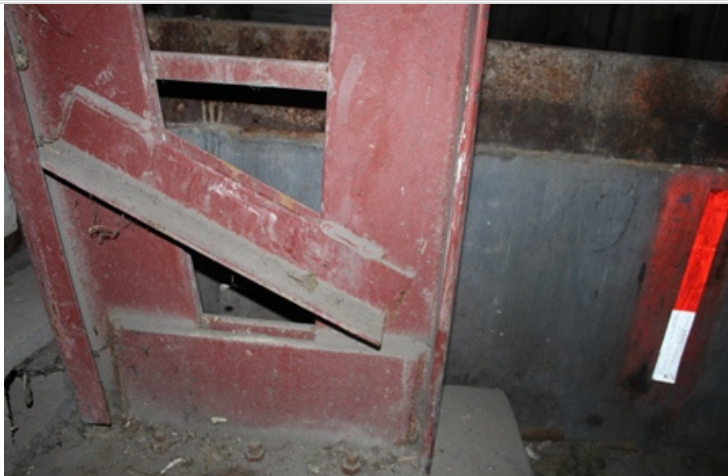
Photo 03 Close up view of column. Structural elements of exterior building shell.

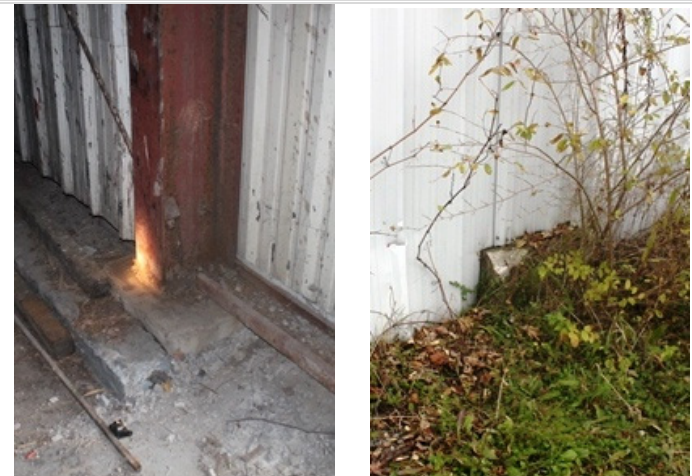
Photo 04 Concrete block that serves as column support on east side of building.
Left: Photo shows inside metal building wall.
Right: Shows concrete block protruding outside of metal building wall.

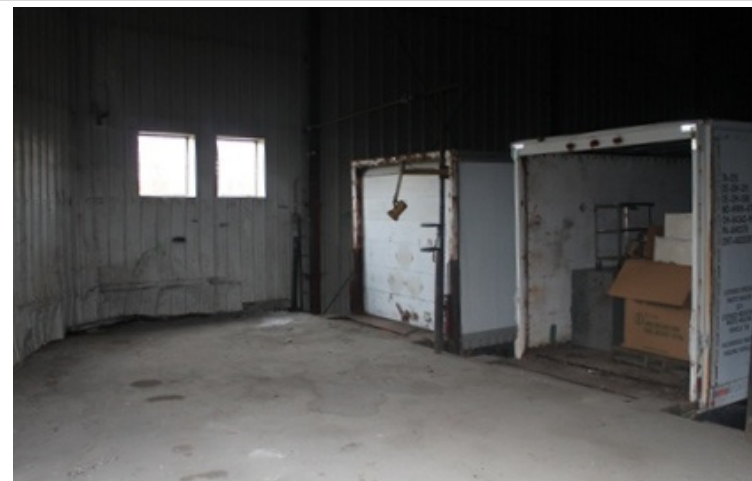
Photo 06 Loading Dock raised approximately four (4) feet above Truck Unloading Pad. Files within trailers.

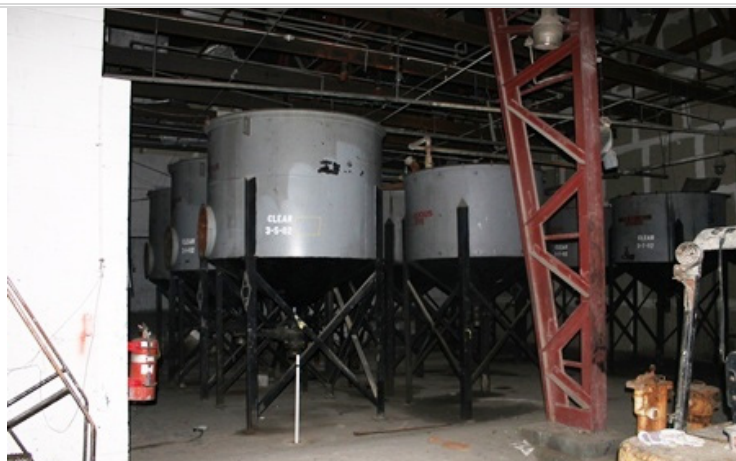
Photo 07 Former hazardous waste storage tanks (previously emptied and cleaned) in Tank Room.

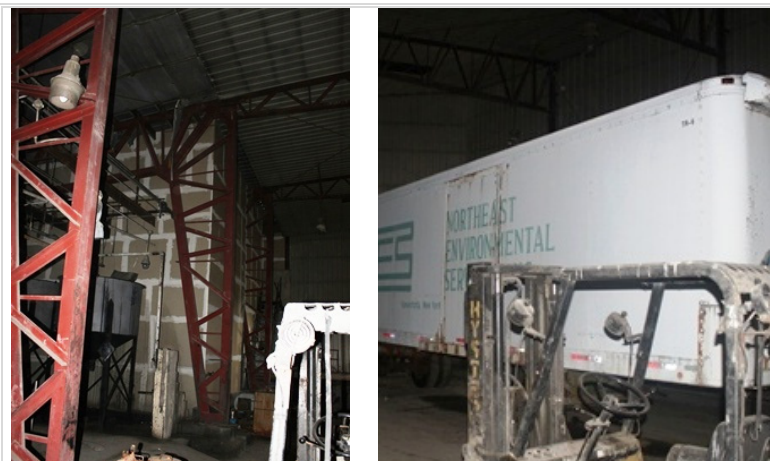
Photo 08 Left: columns and overhead truss construction in unloading area. Right: Existing forklift and trailer.

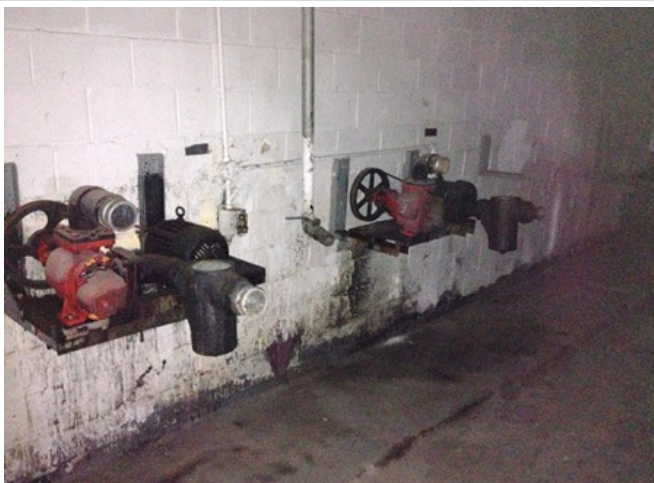
Photo 09 Transfer pumps mounted to wall in Tank Room.

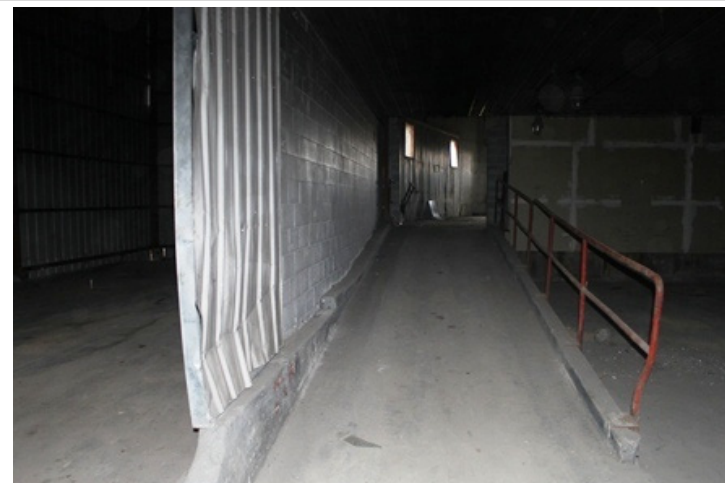
Photo 10 Ramp to Loading Dock.

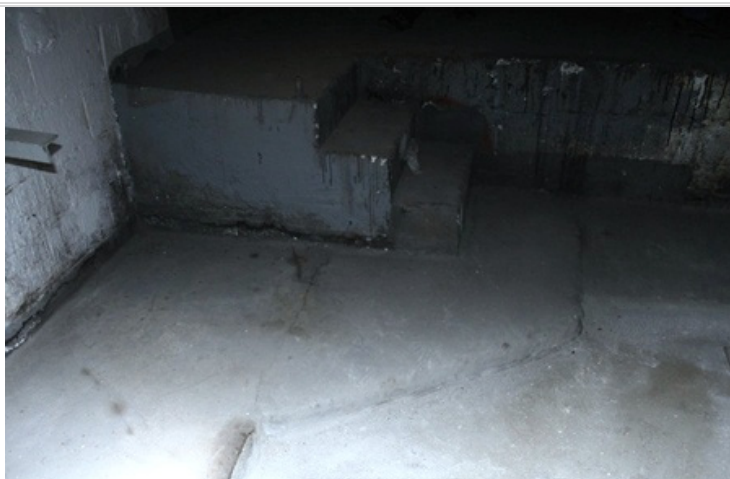
Photo 11 Concrete block steps up to Halogenated Staging Area.

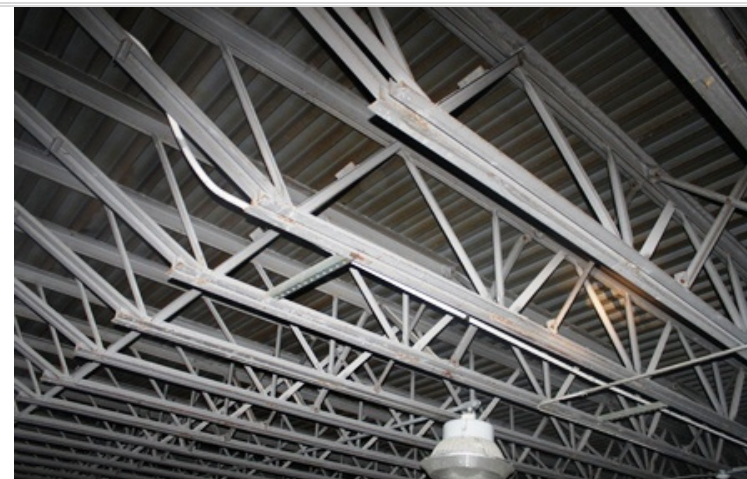
Photo 12 Overhead construction of Halogenated Staging Area.

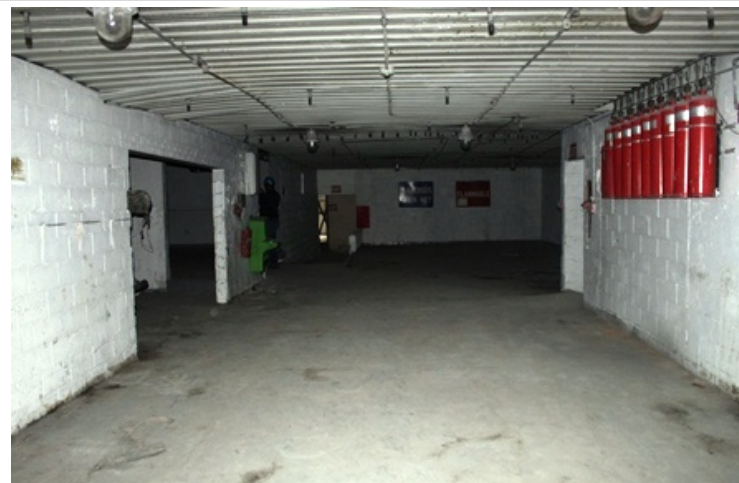
Photo 14 Halogenated Staging Area, looking south toward entrance door of building.

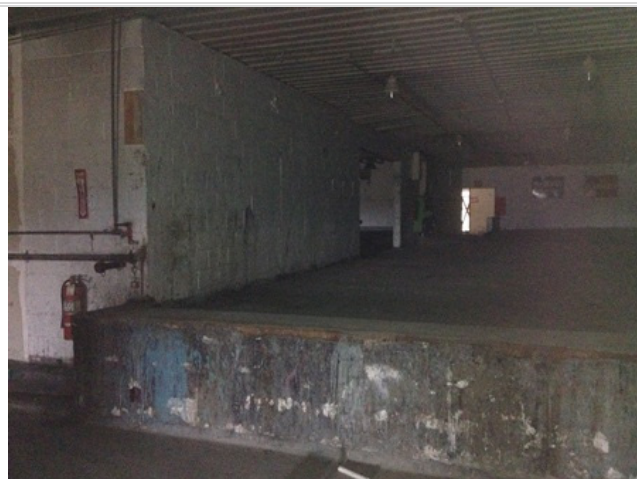
Photo 15 Concrete drop-off from Halogenated Staging Area.

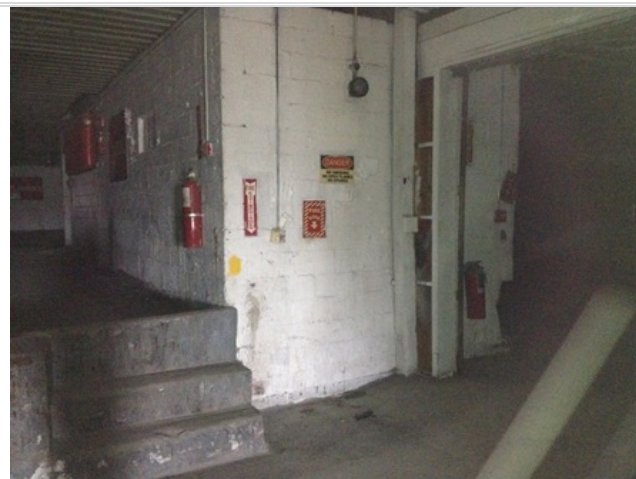
Photo 16 Steep concrete stairs from Halogenated Staging Area to Bases and Non-Acute Solids/Sludges Staging Area.

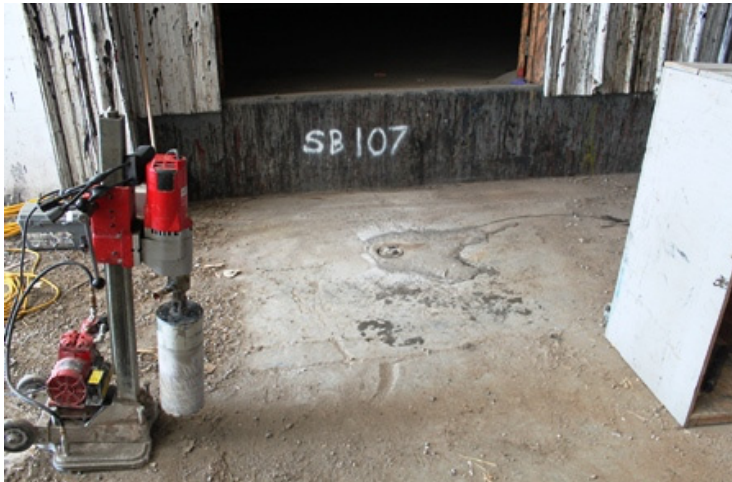
- Slab elevations and thicknesses are variable throughout the building and the groundwater surface is within a few feet of the bottom of the floor slabs throughout most of the building. In addition, as stated above, the Department has indicated that there are areas of the building where a hydrostatic condition has been observed, at least seasonally, where groundwater wells up under pressure when the floor slab is penetrated. Furthermore, based on review of historical building drawings, it is not likely that there is an existing continuous gravel/aggregate layer below the various floor slabs. An effective vapor extraction system is required to capture vapor phase VOCs generated during ISTR, and the combination of these conditions would complicate design of the vapor extraction system. As a result of the existing sub-slab conditions, pilot testing within the footprint of the building prior to vapor extraction system design would likely be required, if the building is not removed. Demolition and removal of the building floor slabs would mitigate the sub-slab complications associated with design of the vapor extraction system component of the ISTR system.

Photo 17 Step up into Lab Pack Staging and Consolidation Area No. 1 from unloading area (approximately 30" in height). Concrete core on the left shows the floor slab thickness in the unloading area.

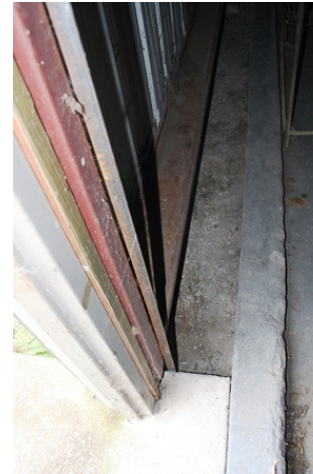
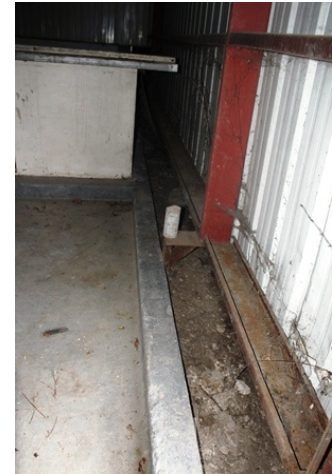
Photo 18 Concrete flooring and curb/berm.

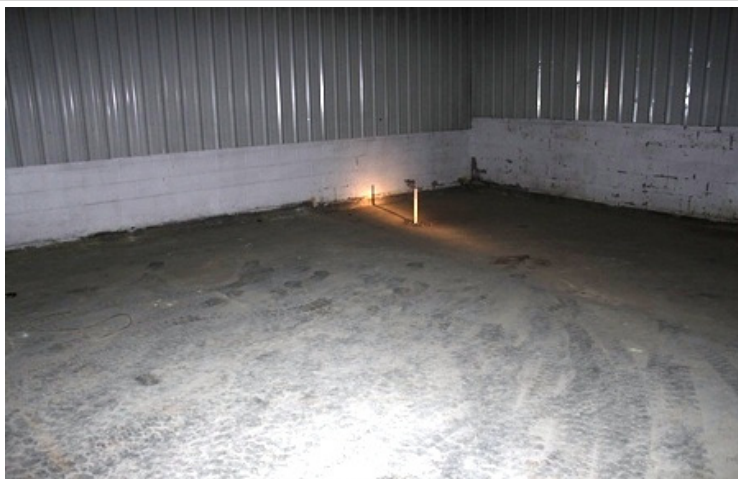
Photo 21 Stick-up monitoring well, northwest corner of building.

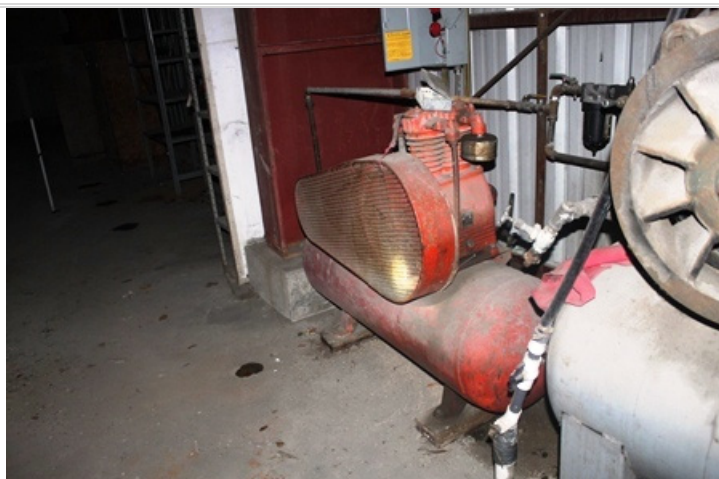
Photo 23 Compressor.

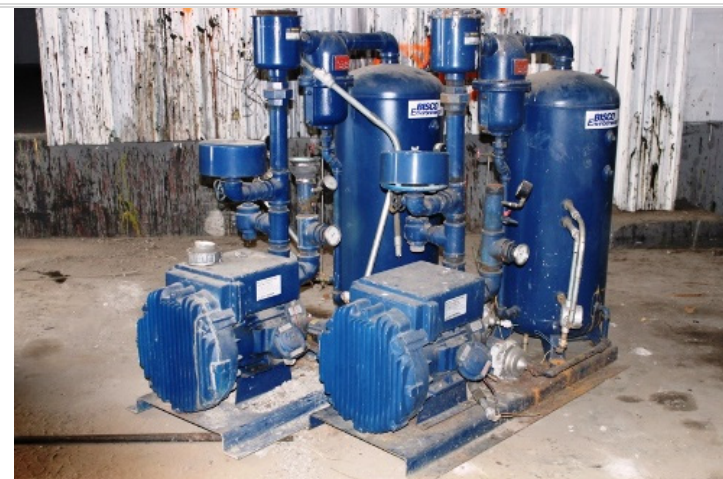
Photo 24 Skid mounted soil-vapor extraction (SVE) systems. Each SVE system includes a Rotron Model EN858BD72WL blower and Solberg Model No. CSL-851-250HC vacuum filter.

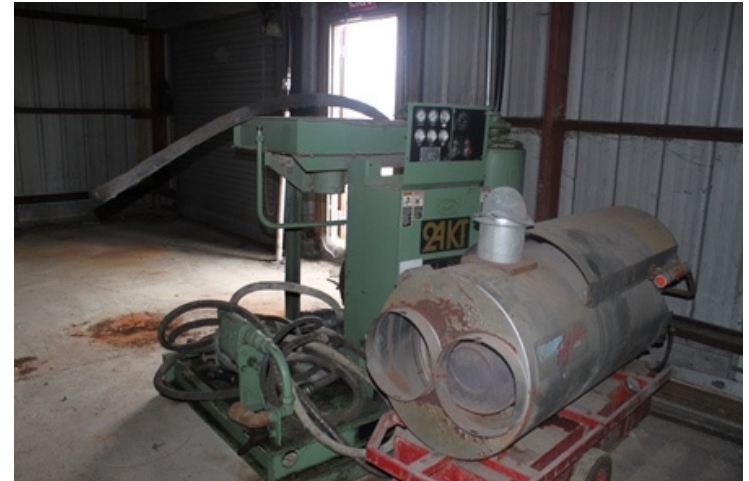
Photo 26 Frost-Fighter forced-air heating system portable heater.

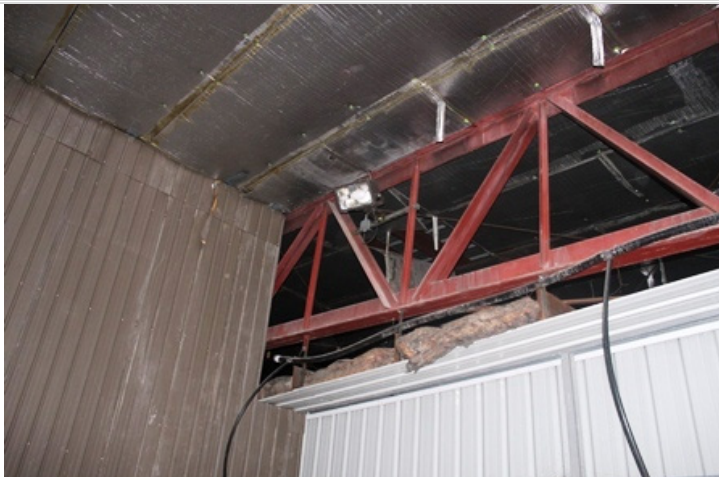
Photo 27 Overhead steel truss supporting new metal building structure.

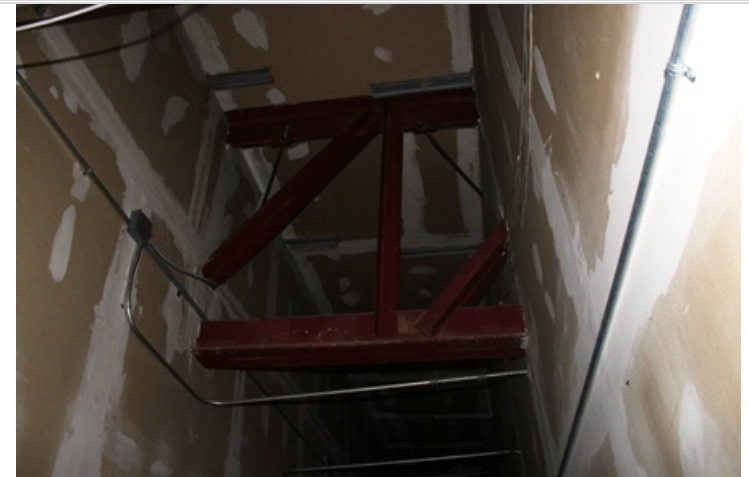
Photo 28 Overhead steel truss near electrical room and boiler room.

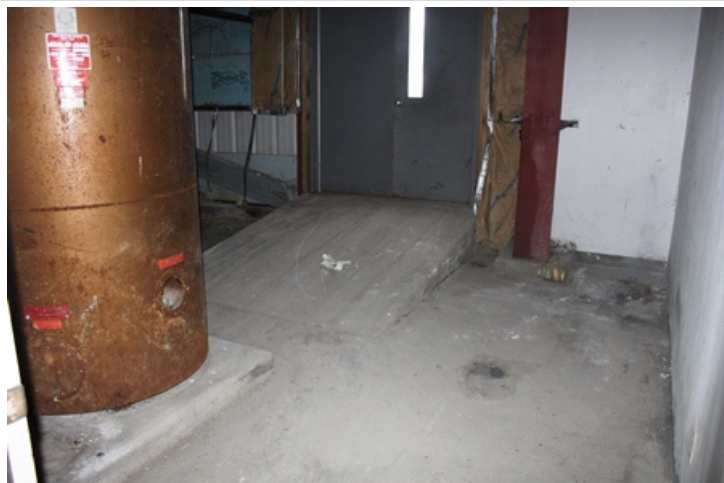
Photo 29 Boiler Room doorway opens to western side of building. The entrance/exit slopes down into room. Boiler on concrete pad.

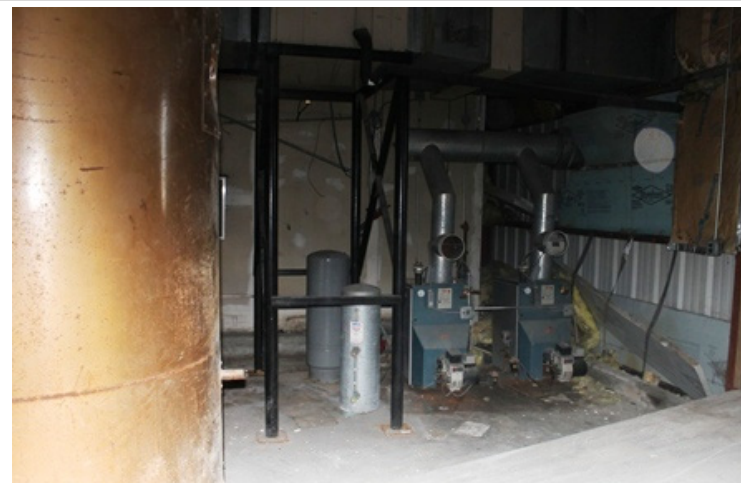
Photo 30 Boiler Room concrete slab elevation lower than entrance. Fuel oil-fired building heating system. The fuel oil tank was previously removed.

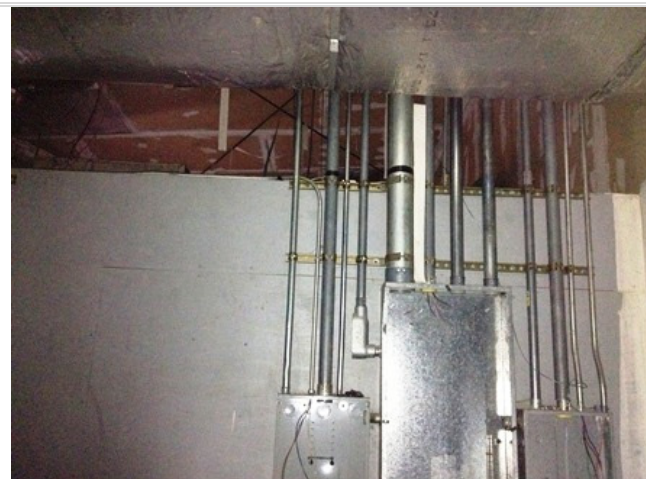
- As indicated previously, the building electrical conduits have been gutted and the building is without lighting. Demolition of the building would eliminate the need to provide temporary lighting throughout the building for remedy implementation, and the potential hazards associated with interior temporary lighting. Interior lighting would consume resources and energy which is contrary to the objectives of DER-31.

Photo 36 Utility Room. Electrical panels on wall and raceways out of the room.

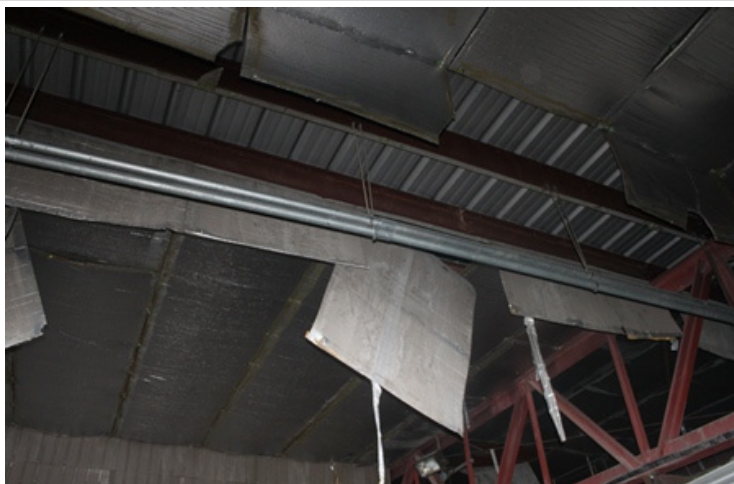
Photo 37 Overhead ceiling insulation in southwest area of building.

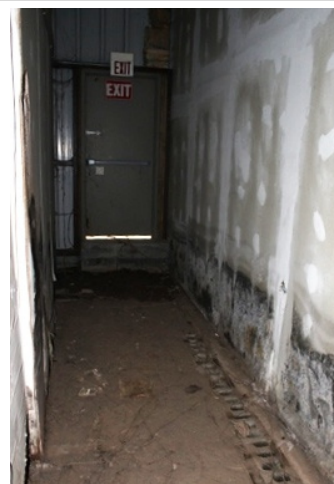
- Visual inspection shows significant evidence of water damage in the southwestern portions of the building, possibly due to the proximity of the Erie Canal and discharge from the drainage ditch that runs parallel to the canal. The water damage indicates the building is susceptible to flooding. Flooding in and around the building during implementation of the remedy could cool the subsurface and reduce the effectiveness/efficiency of ISTR. Demolition of the building and Site stormwater drainage modifications could mitigate the potential for flooding during ISTR.

Photo 38 Left: Overhead construction near Laboratory and Office Supplies Room. Right: Exit to southwest side of building (apparent mold at the base of drywall).

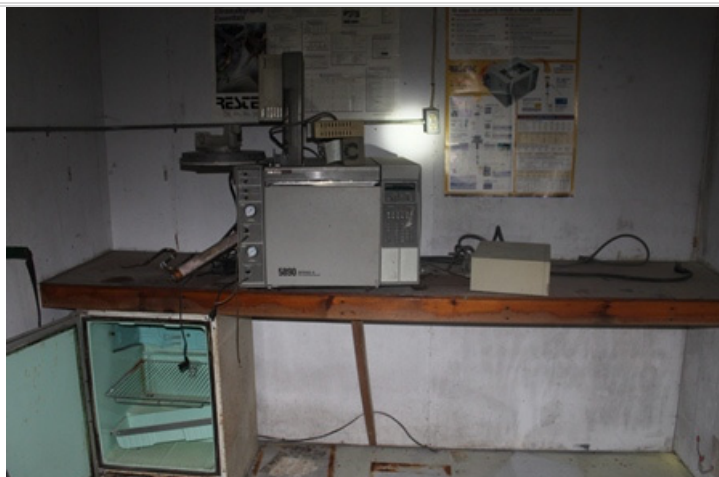
Photo 39 Laboratory, with Hewlett Packard HP 5890 Series H Gas Chromatograph.

- Equipment and materials that are not hazardous or cannot be used as part of the Site remedy can be considered for asset recovery or reclamation. For example, laboratory equipment remaining at the Site could be offered for sale. Pre-fabricated metal building manufacturers can be contacted to determine if there is a potential for reuse of parts of the building. Equipment such as tanks, compressors, mechanical equipment, and forklifts as well as the onsite remediation equipment such as blowers and moisture separators may also be salvageable. Rebar from concrete can be removed and stockpiled separately and sold as scrap. Remaining building materials which are not hazardous and have an intrinsic value, such as structural steel, can also be reclaimed as scrap.

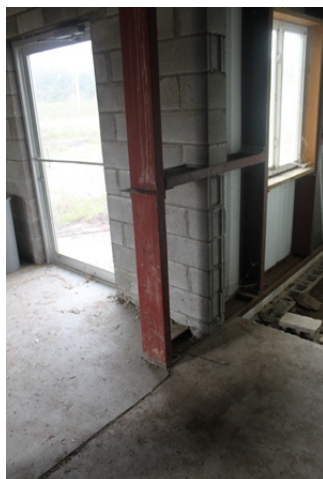
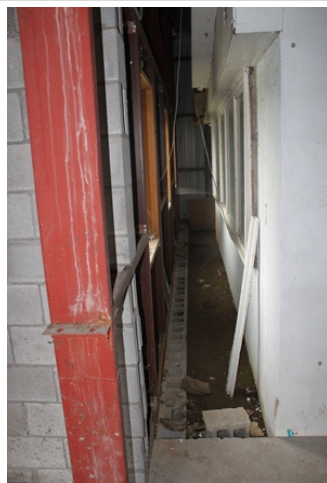
Photo 45 Left: Building column near main entrance to building.
Right: Exposed soil within building envelope.

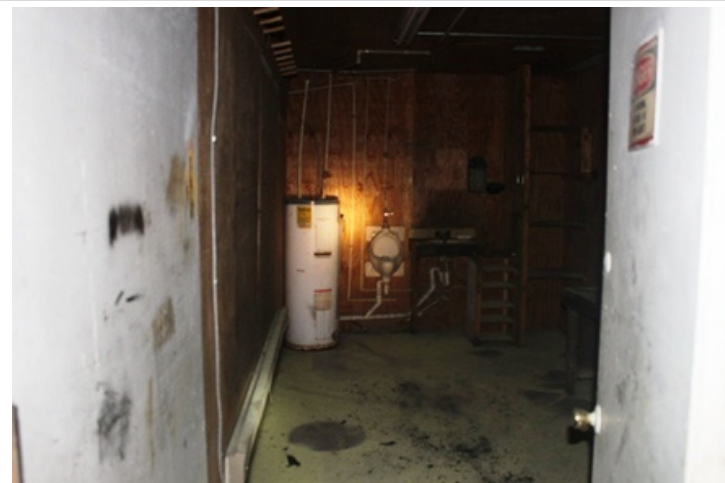
Photo 46 Hot water heater between Men and Women's Locker rooms.

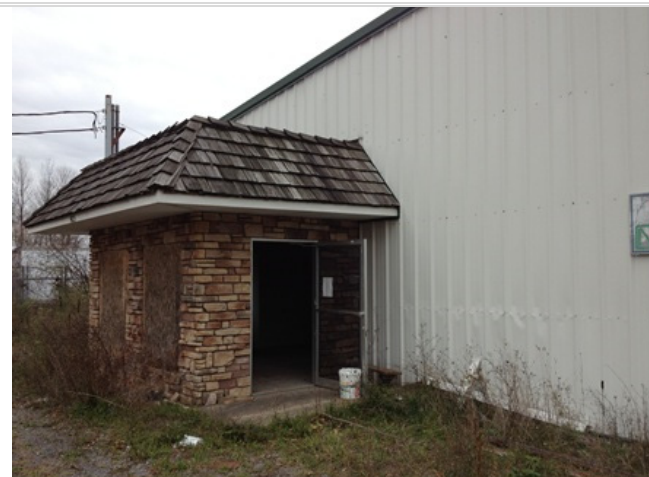
Photo 48 Building entrance and Reception Area. Windows are boarded.

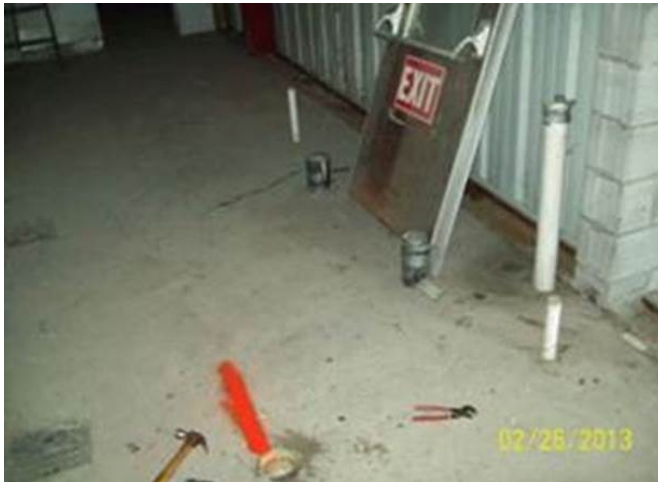
connecting plumbing fixtures to the sanitary holding tanks. There are additional buried piping/structures adjacent to and west of the building including the sanitary holding tanks, stormwater piping/structures, and electrical conduits between the industrial building and two remediation system enclosures north of the building. Buried piping, pipe bedding material and conduit can serve as preferential pathways and cause uneven subsurface heating during ISTR. Buried plastic piping, such as the existing stormwater piping on the western side of the building, could be damaged by ISTR due to the typical subsurface temperatures within the treatment zone, potentially causing flooding and cooling of the treatment area. Additionally, if electrical resistive heating (ERH) technology is used, buried metal piping/structures could cause short circuiting of electrical current supplied to the subsurface. Demolition and removal of underground utilities and structures will alleviate design and implementation complications.

Photo 49 Four aboveground pipes co-located with a sanitary cleanout within the main entrance vestibule area of the building.

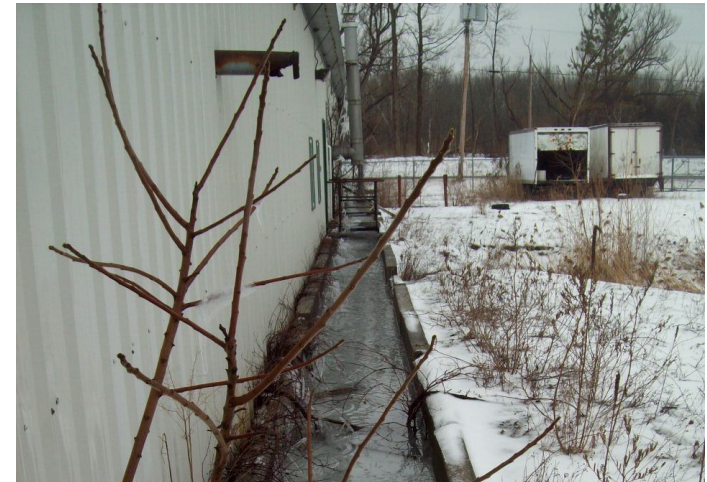
Photo 50 Stormwater collection trench located along the west side of the building looking south.

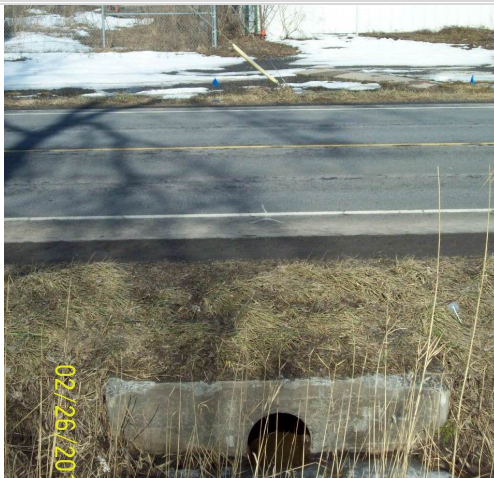
Photo 51 Culvert that conveys stormwater from the drainage ditch along Canal Road to the Site looking north.

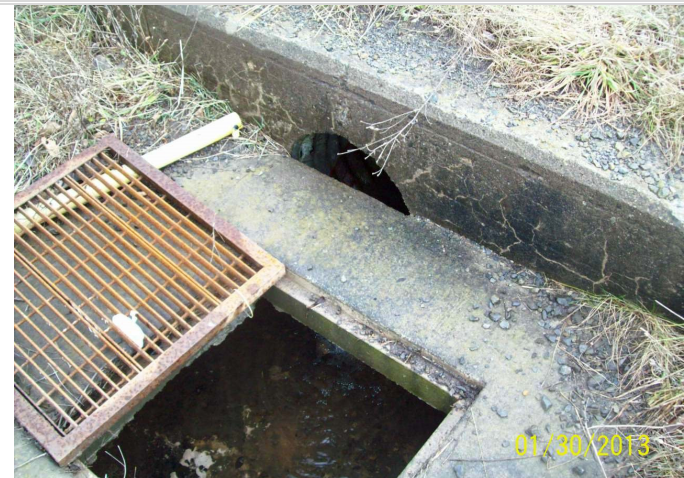
Photo 52 Catch basin.

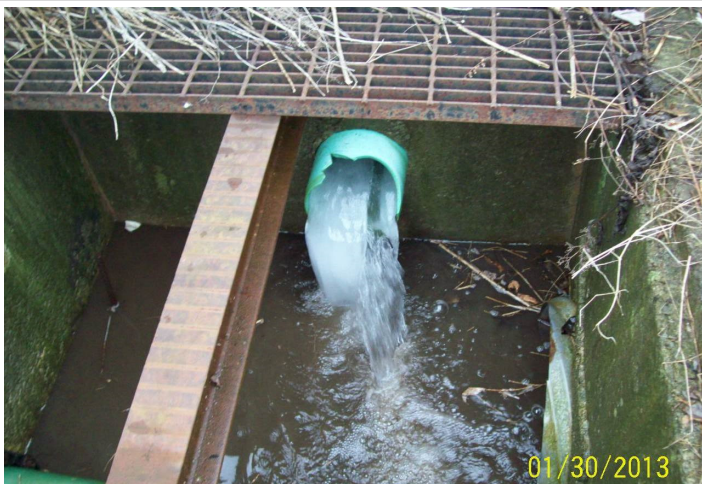
Photo 53 Catch basin next to the stormwater collection trench. This catch basin receives discharge from the stormwater collection trench and the catch basin to the south.

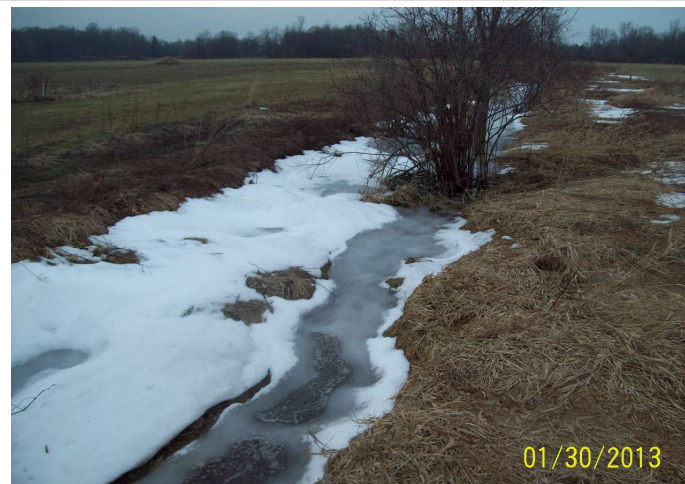
Photo 54 Stormwater transferred north to the Site farmland.

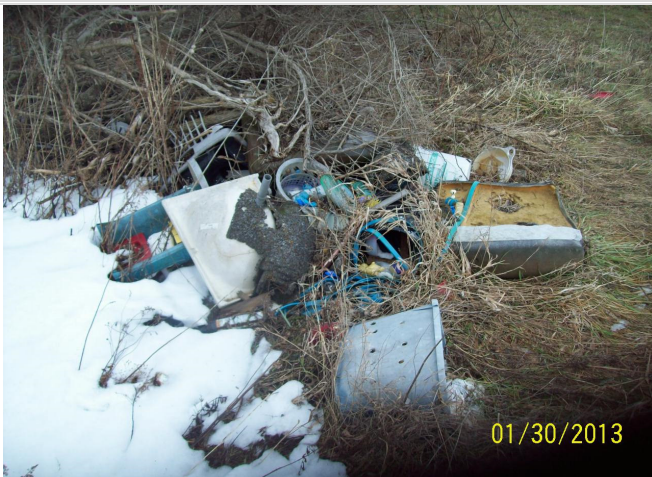
Photo 55 Farmland near remediation area.

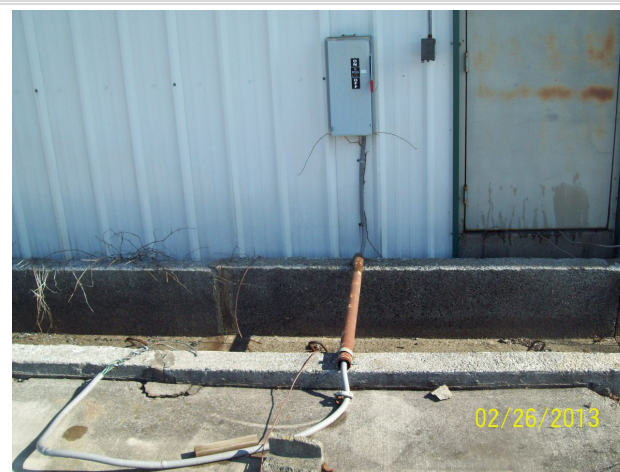
Photo 56 Existing out-of-service electrical box and conduit on the west side of the building.

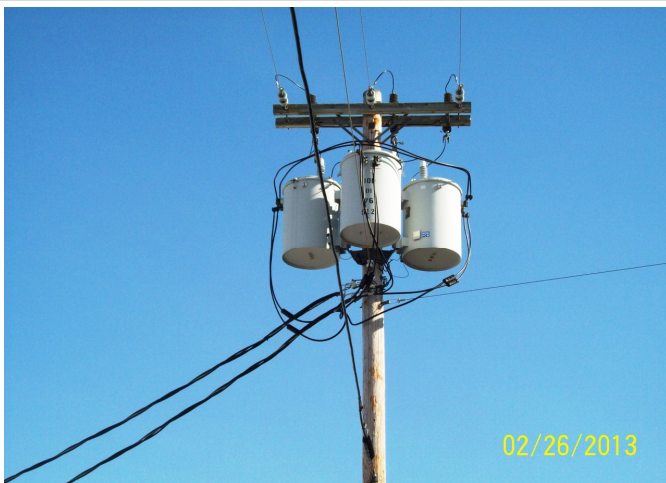
Photo 57 Overhead service lines and transformers connecting to a typical wooden utility pole on the north side of Canal Road.

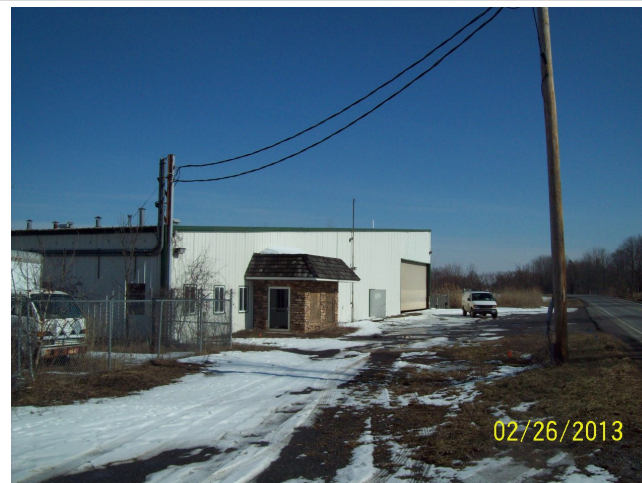
Photo 58 Overhead service line on the north side of Canal Road. Metal utility pole attached to the southwest corner of the building.

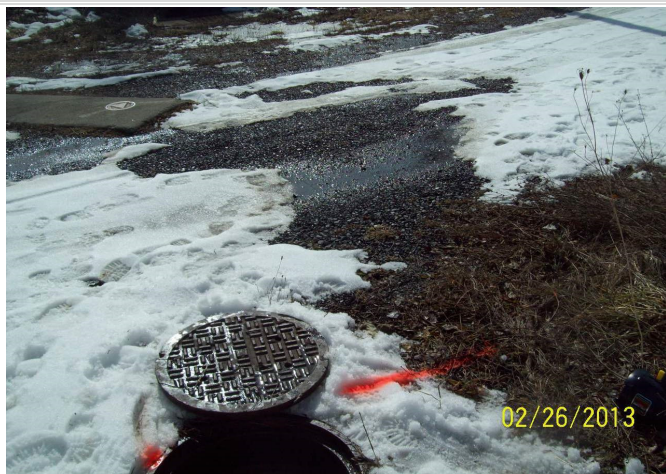
Photo 59 Unlabeled 24" diameter manhole near the vestibule on the south side of the Building.
