**Sub-Slab Depressurization Systems  
Buildings TR-20 (partial) and Stormwater  
Treatment Plant  
Interim Corrective Measure  
ONONDAGA, NEW YORK**

**Construction Completion Report**

**NYSDEC Site Number: 734043**

**NOVEMBER 11, 2025**

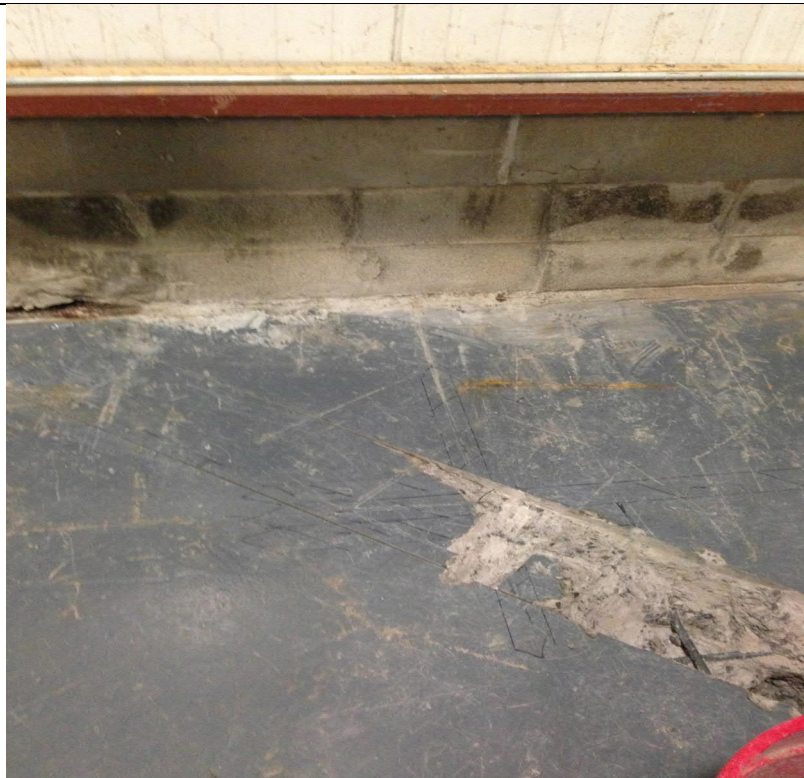
GPR markings of thought to be rebar, turned out to be insulated copper wire.

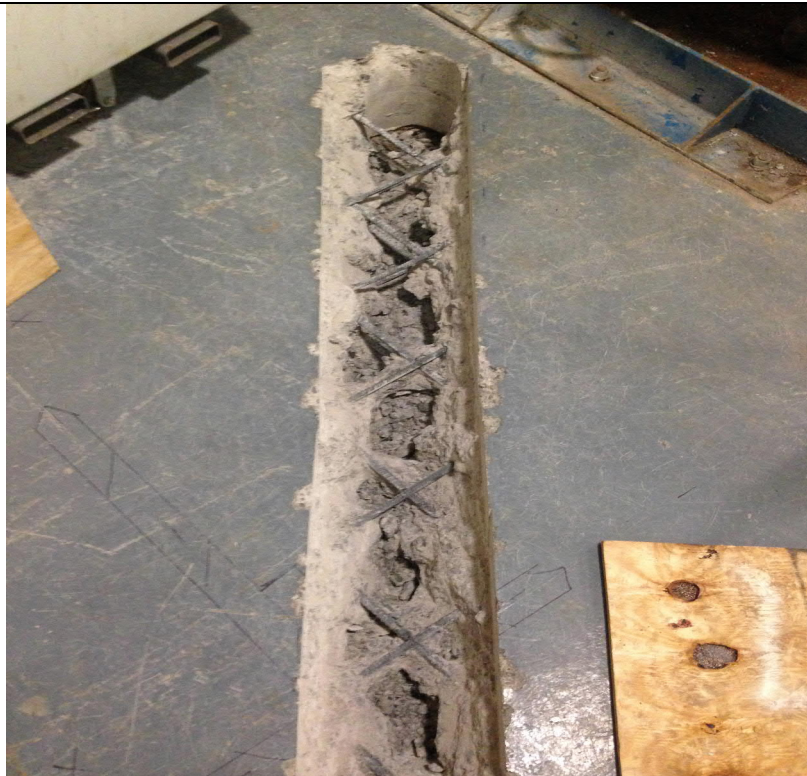
EP-7 trench excavation.

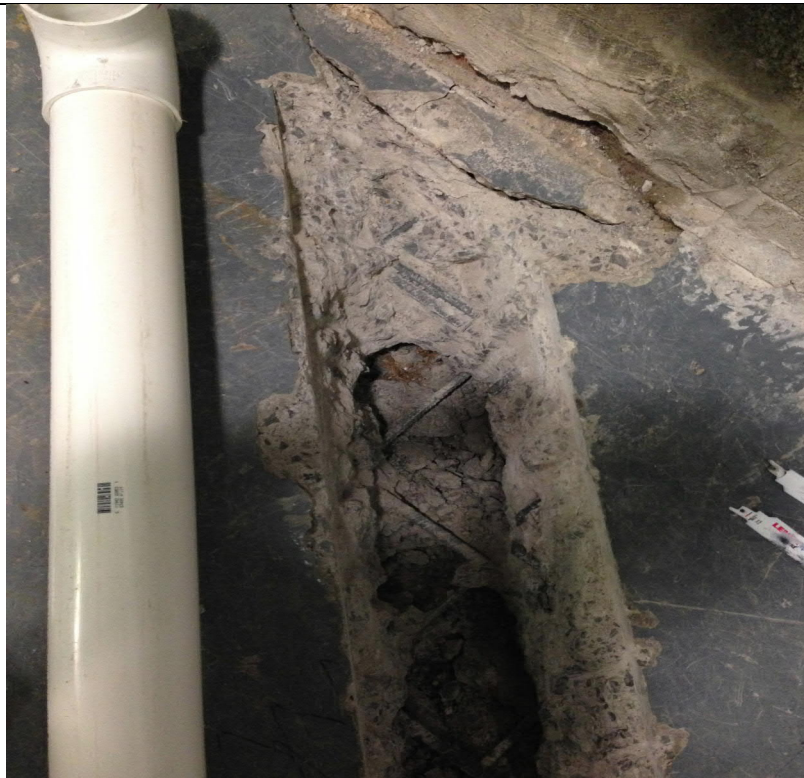
EP-7 trench at south  
wall, column M53  
~3.5' to the east.

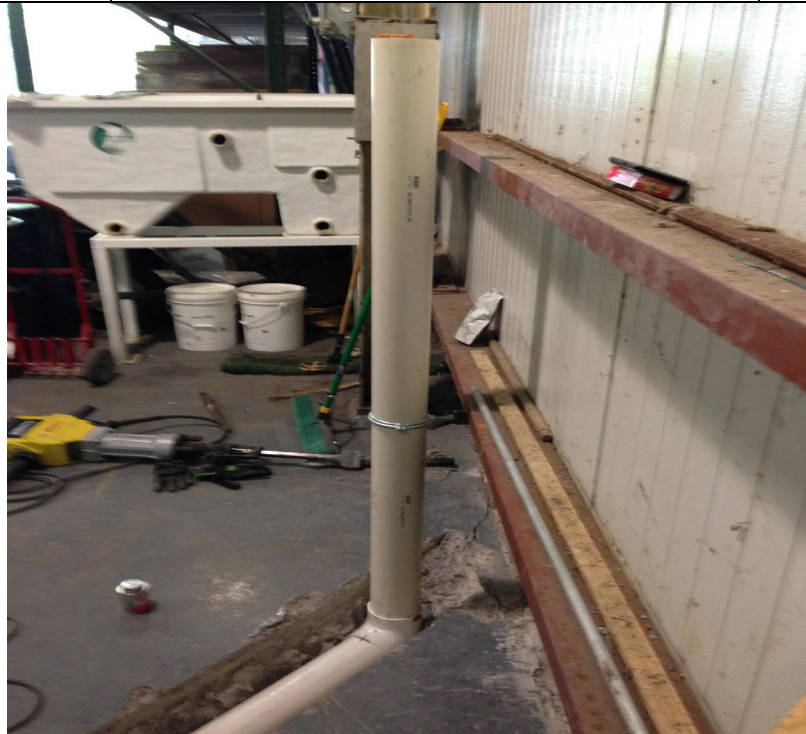
EP-7 trench piping to southern wall of SWTP. Mid-pipe distance to horizontal red beam face is 5.5 inches.

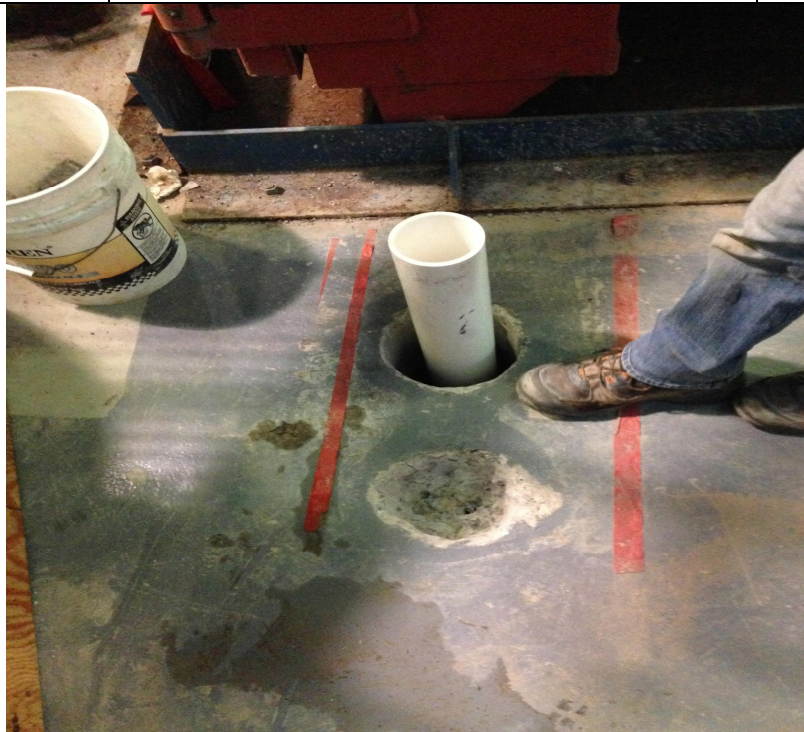
EP-4 with PVC piping.

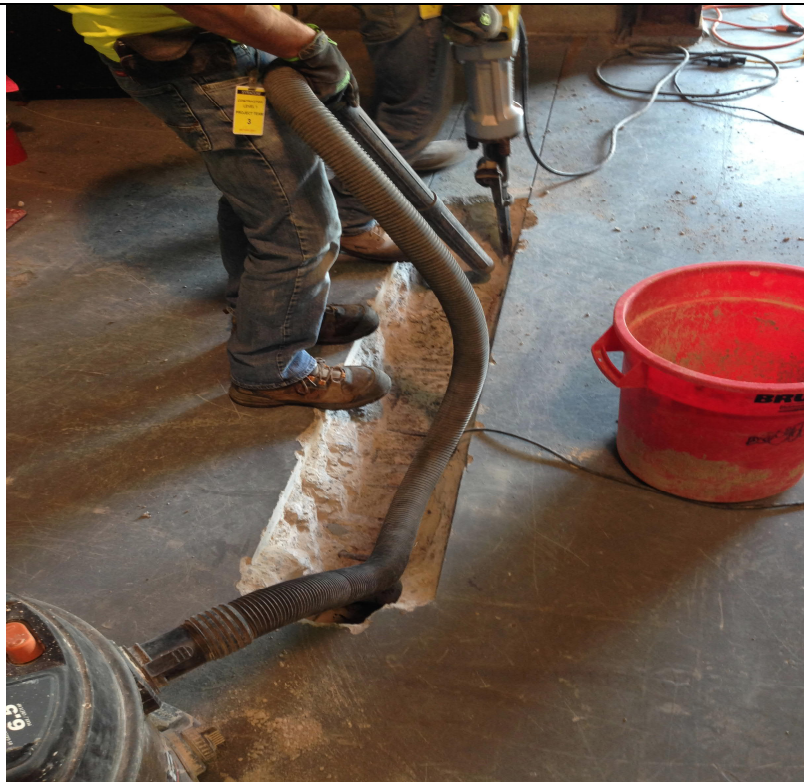
Excavating EP-5 trench to east wall near column N53.

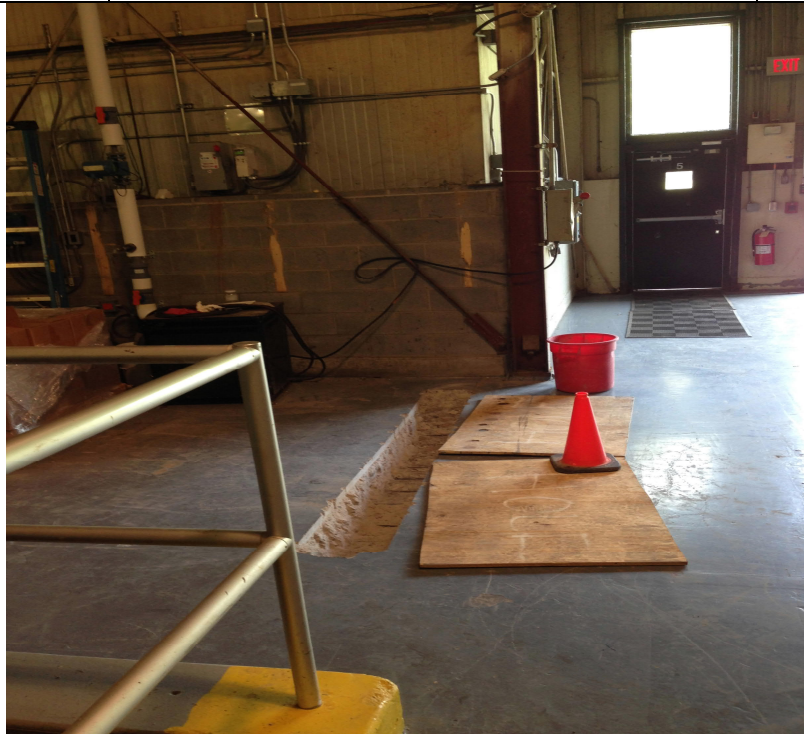
8' of 10' of EP-5 trench excavated to first layer of rebar at depth of 7 inches.

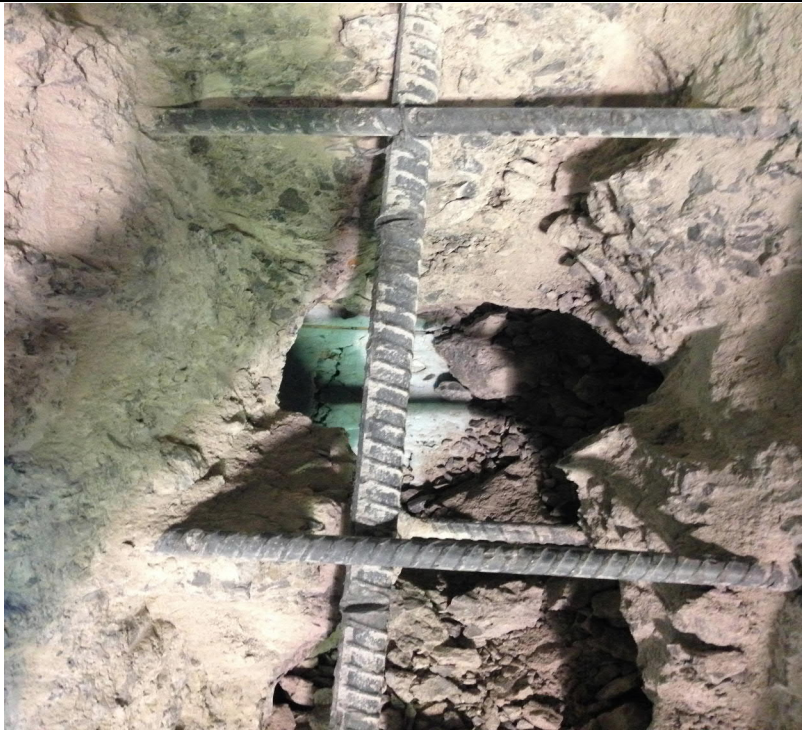
Green Styrofoam 17" beneath top of slab in EP-5 trench (~2' west of column N53).

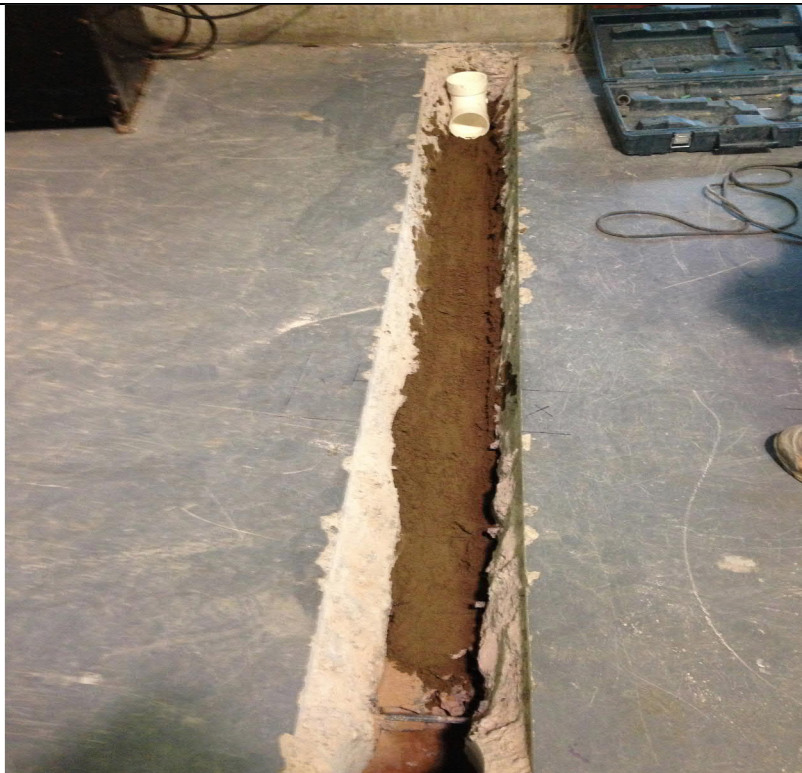
EP-5 trench excavated with sand added to base.

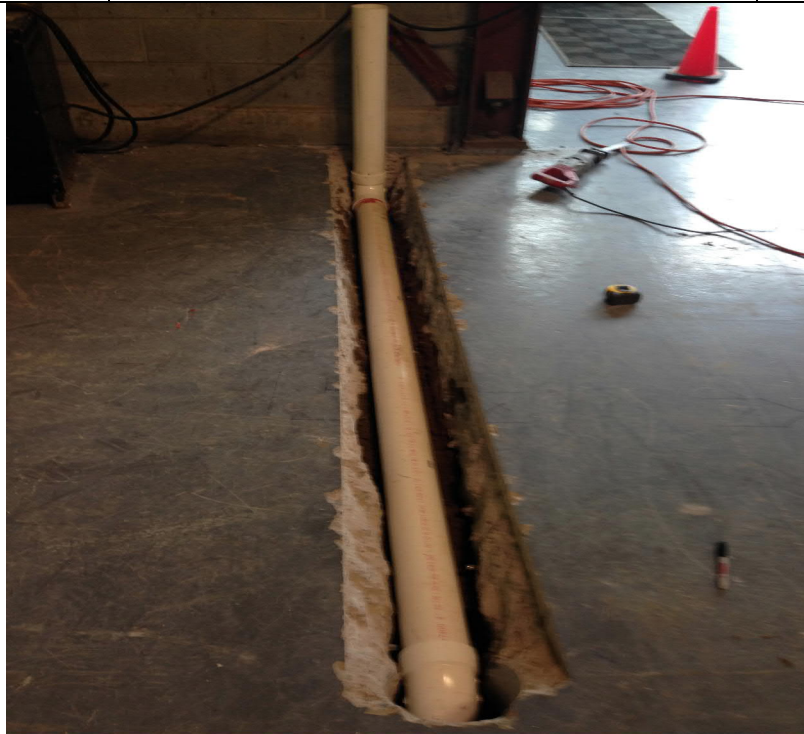
PVC pipe fitted and glued into place in EP-5 trench.

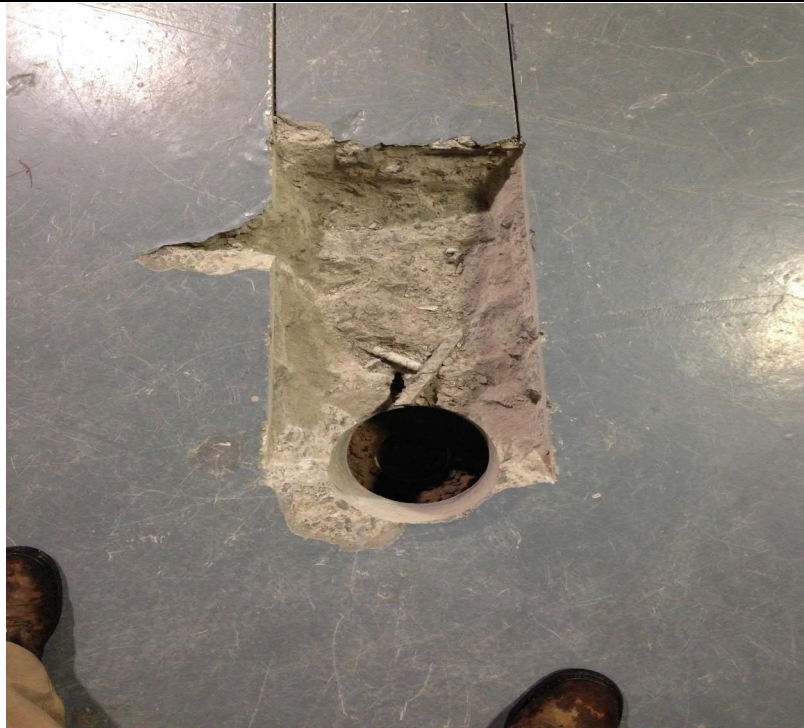
EP-2 previous coring unearthed.

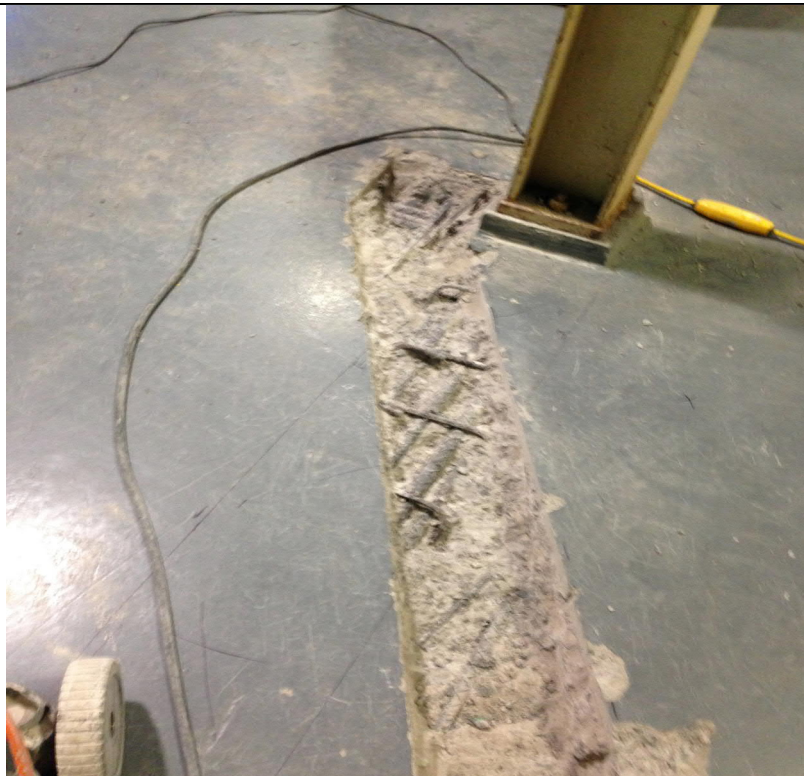
EP-2 grade beams exposed (running from column to column on all sides of column O50)

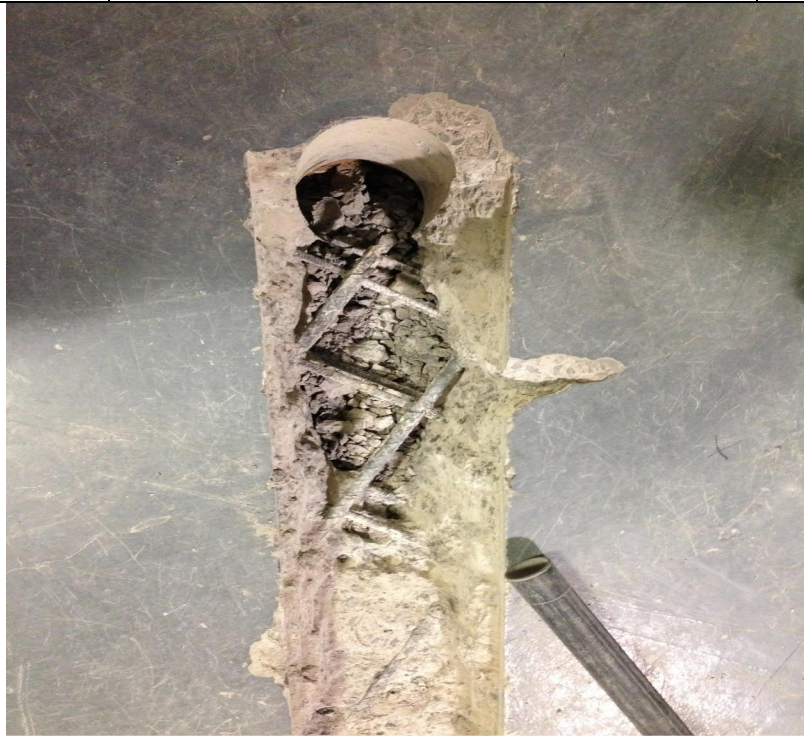
EP-2 screen coring and nearby rebar.

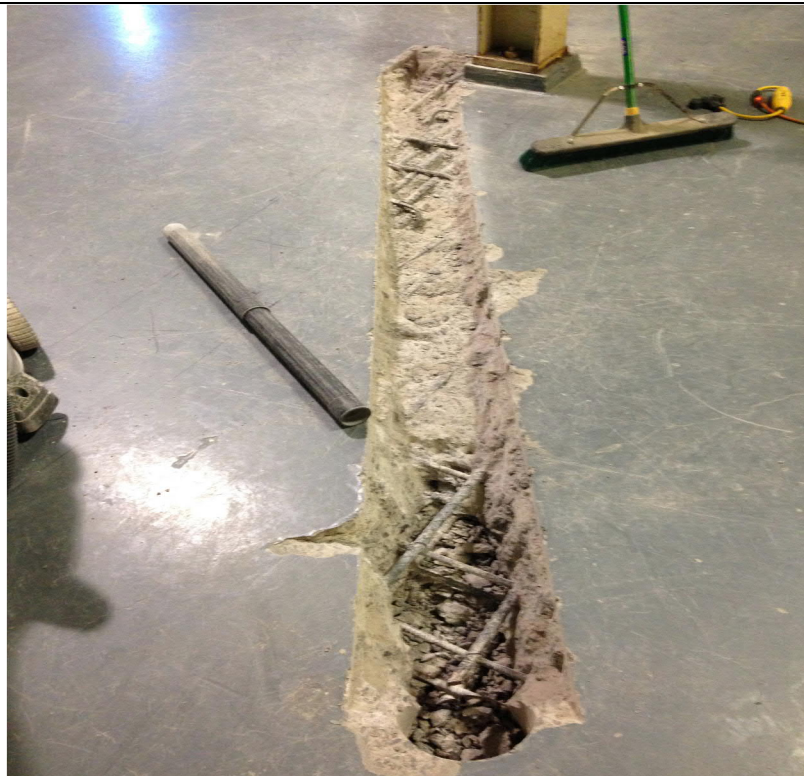
EP-2 trench to north side of column Q50.

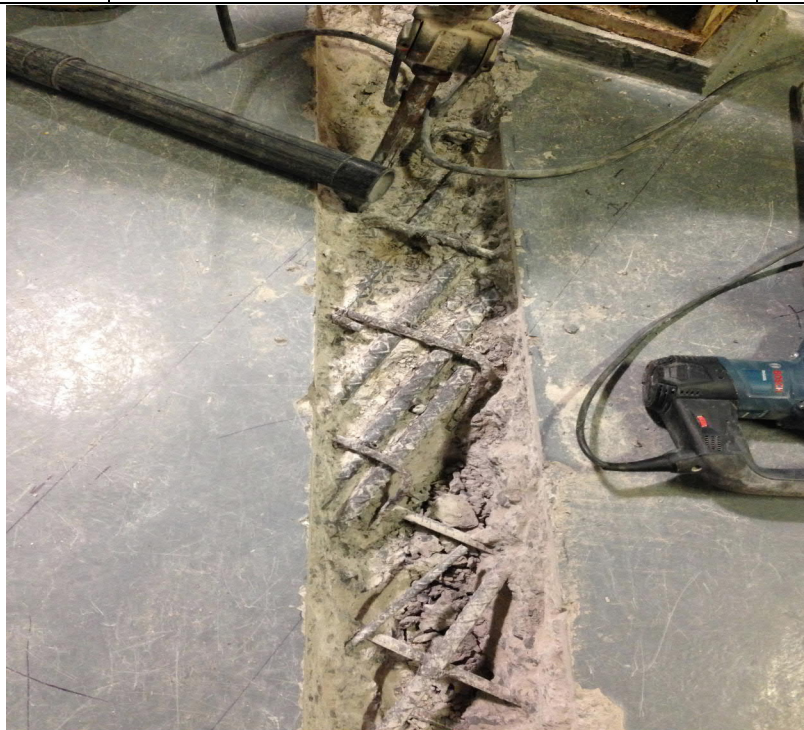
Close up of EP-2 trench crossing E-W running grade beam.

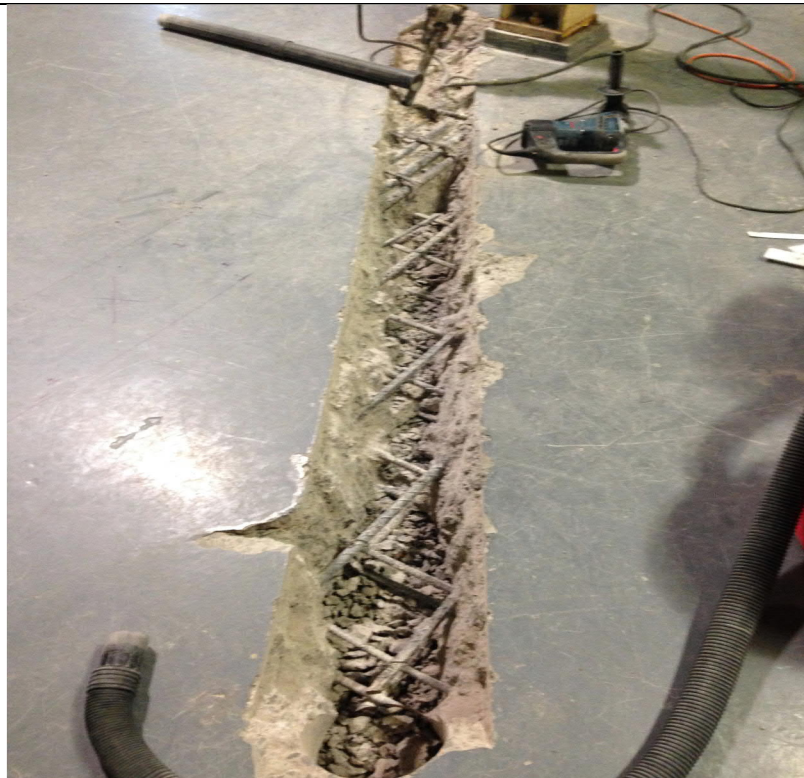
EP-2 trench excavation progress.

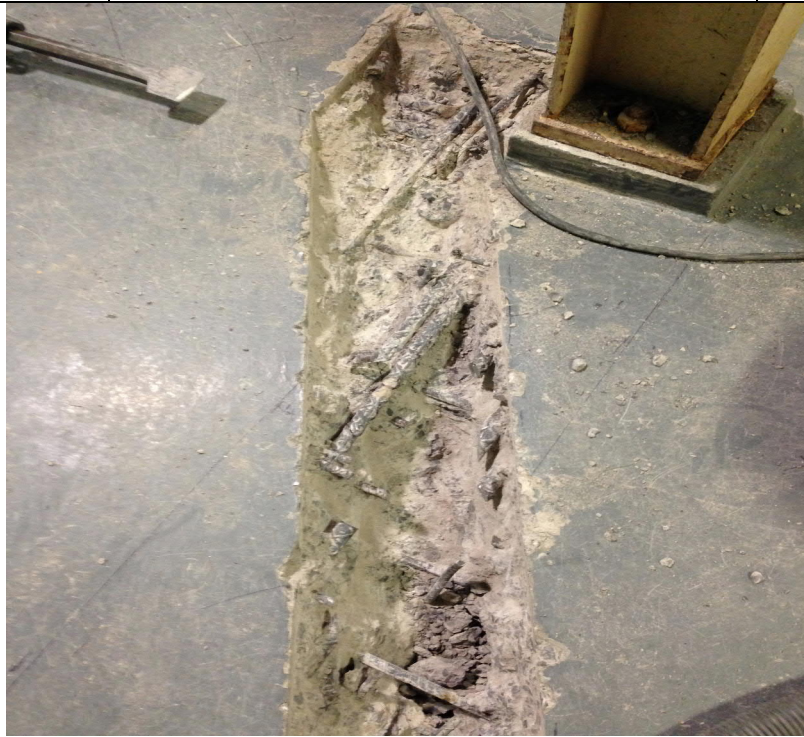
Progress of cutting through E-W running grade beam.

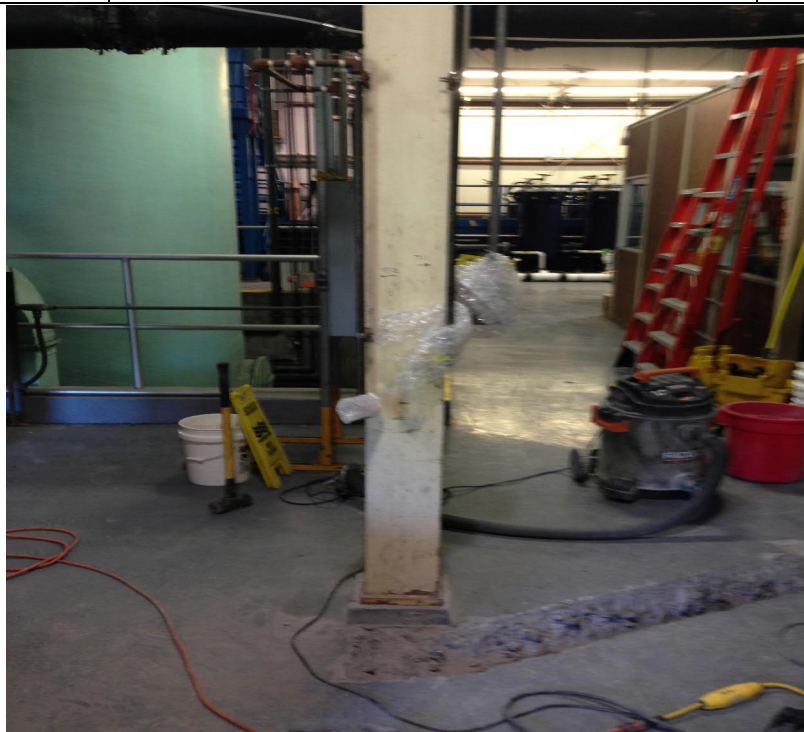
EP-2 trench at column O50.

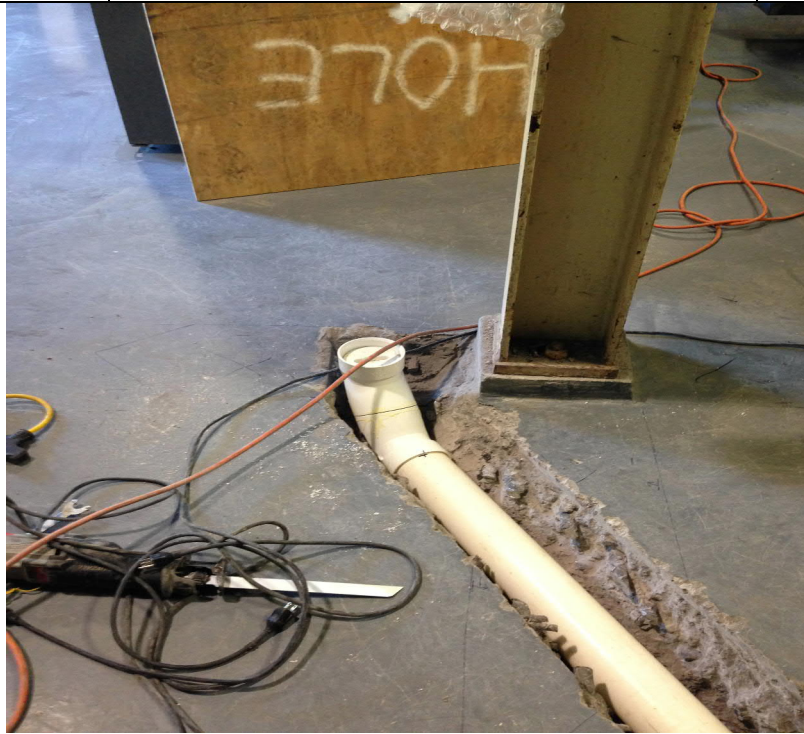
PVC pipe in EP-2 trench near column O50 (2-45 degree angle PVC angles used)

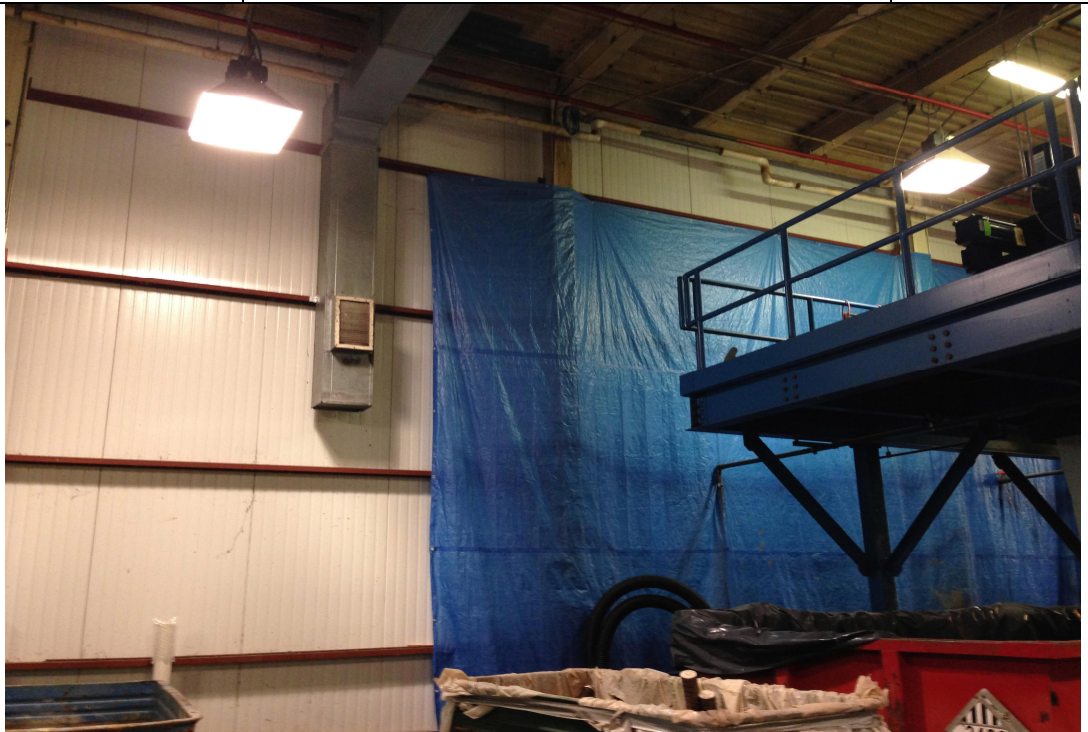
EP-7 piping to come underneath and to the right of grey venting. Red beam (near inlet/outlet of grey venting) to be followed horizontally.

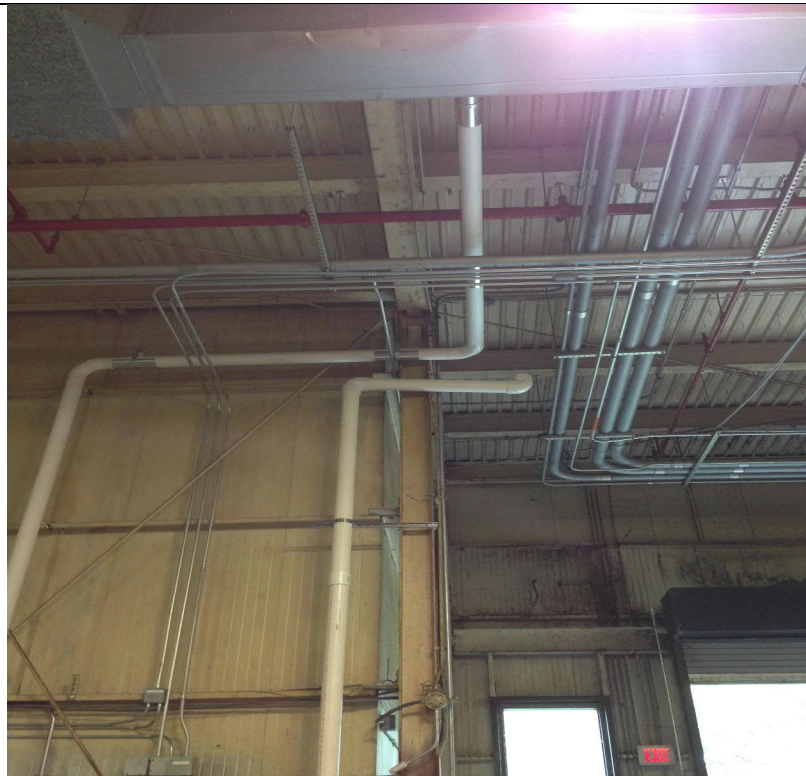
Vertical piping from EP-5 (SSDS piping to parallel existing white conduit)

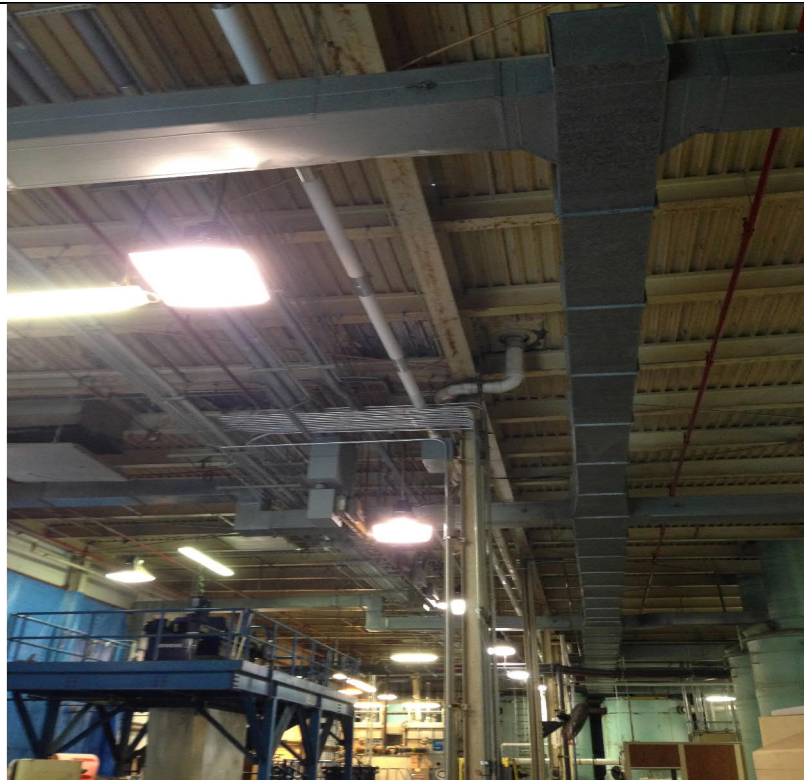
**Photo No.**  
**4**

Ceiling shot of "N" column line. SSDS piping of EP-5 will run parallel to white conduit.

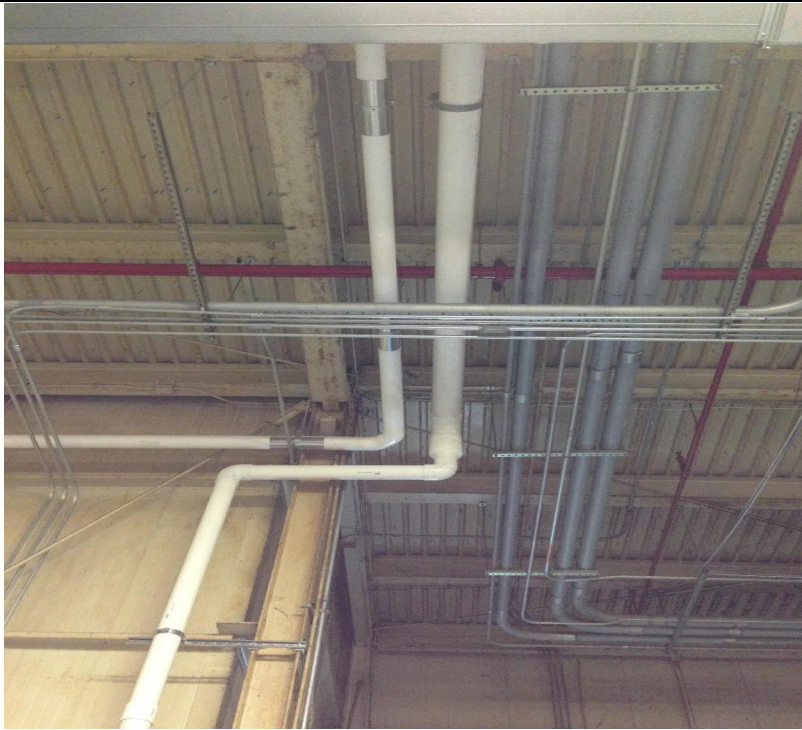
**Photo No.**  
**1**

EP-5 vertical 4" piping transitioning into 6" piping at column N53.

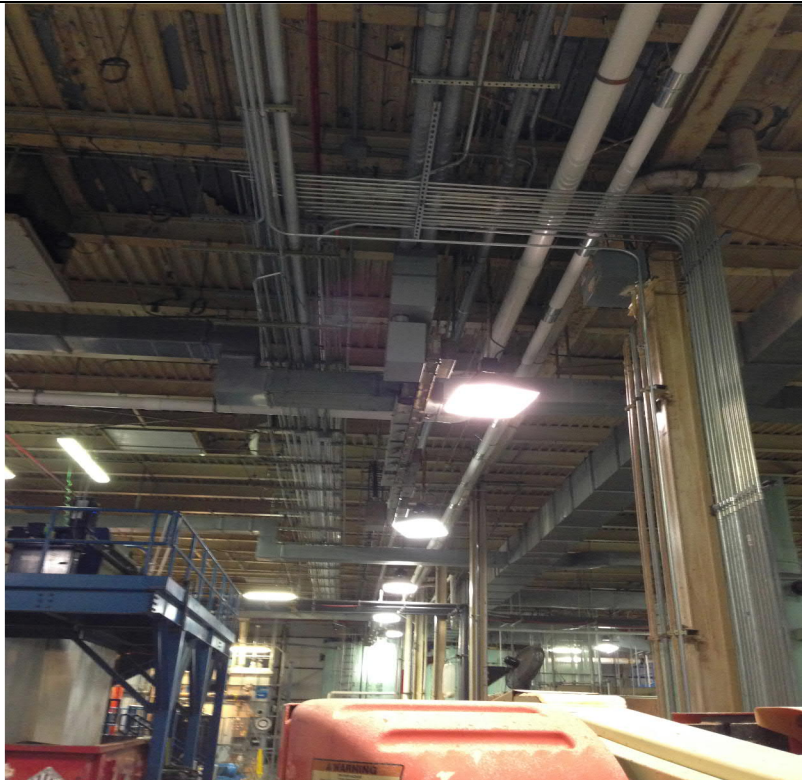
**Photo No.**  
**2**

EP-5 overhead 6" PVC piping near column N52.

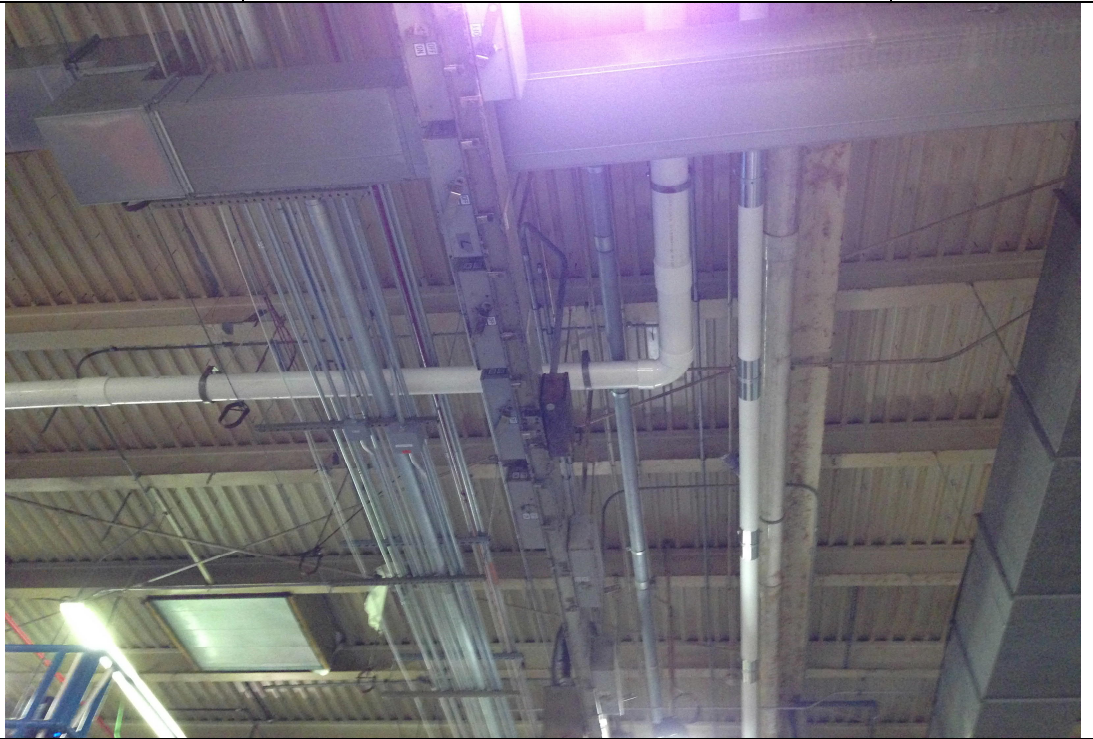
**Photo No.**  
**3**

EP-5 overhead 6" piping running along column "N" line elbowing south to "M" column line.

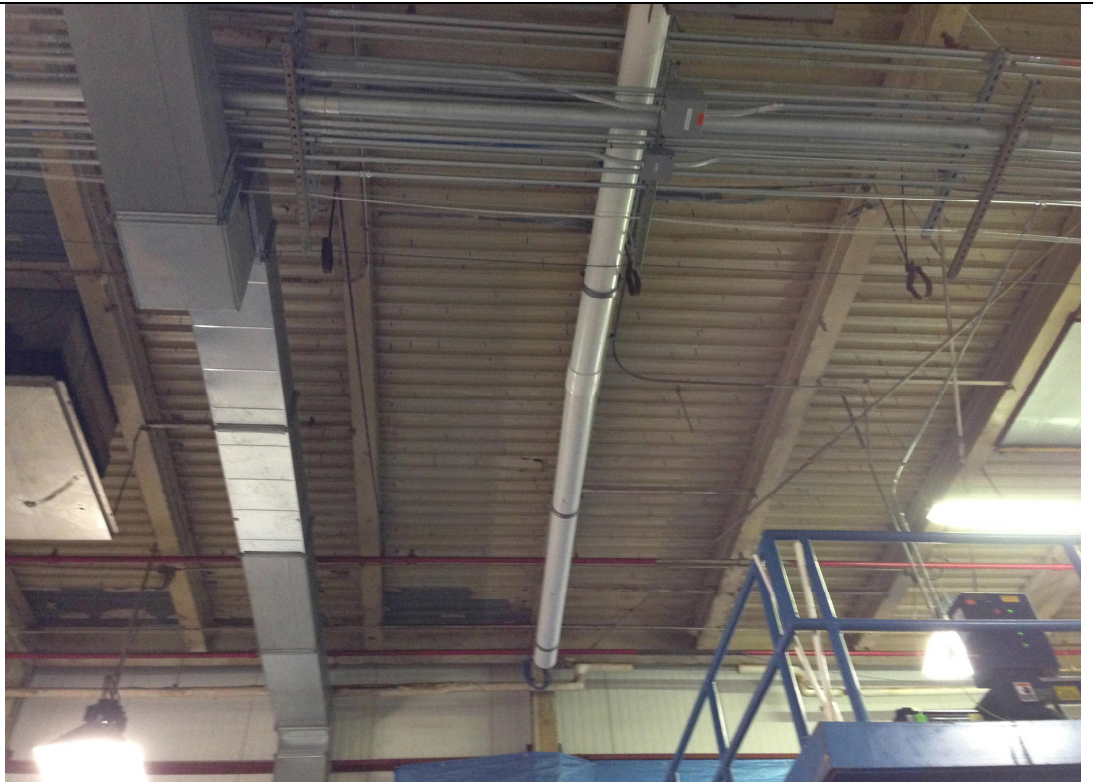
**Photo No.**  
**4**

EP-5 overhead 6" piping from N column line (not glued/set into place)

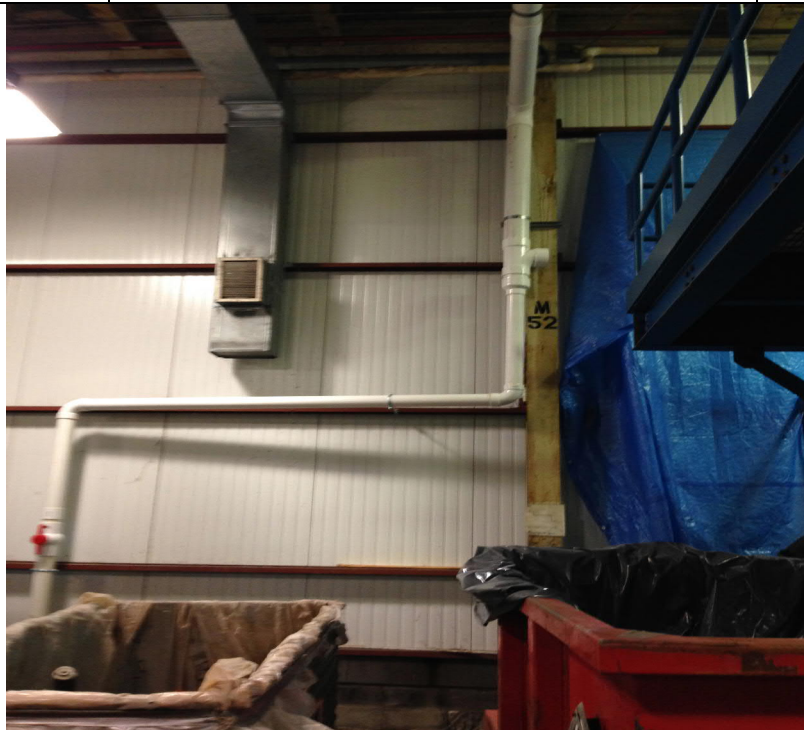
**Photo No.**  
**1**

EP-7 piping joining  
EP-5 piping at column  
M52. Ball valve mid-  
point placed 65" from  
top of slab.

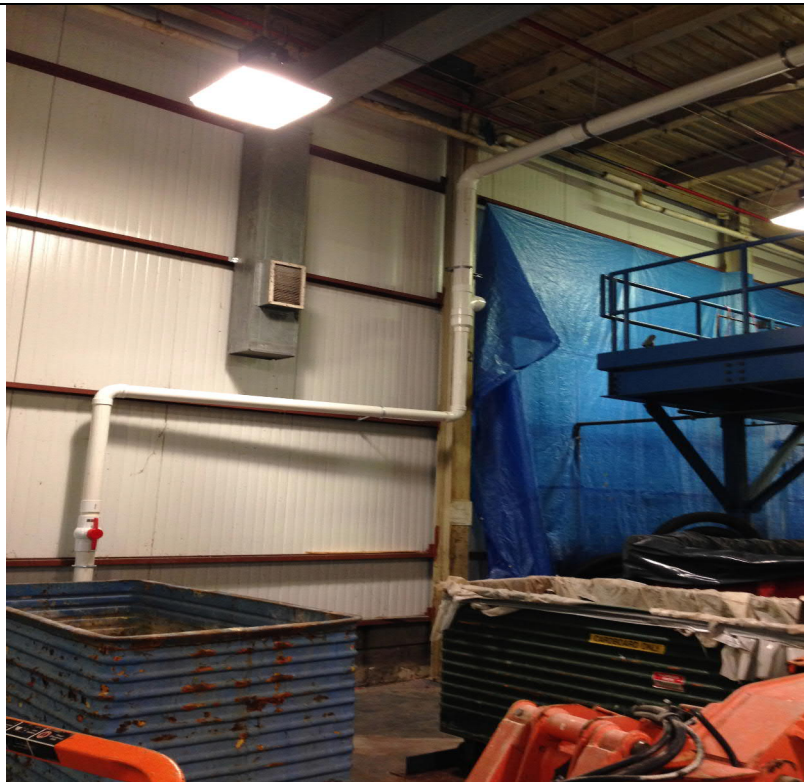
**Photo No.**  
**2**

EP-7 piping joining  
EP-5 piping at column  
M52.

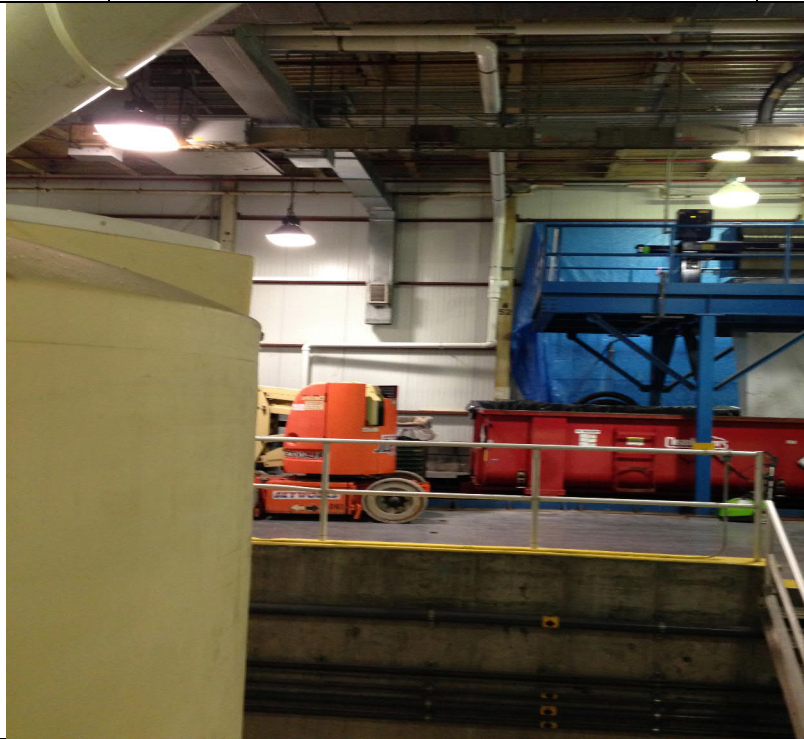
**Photo No.**  
**3**

EP-5 and EP-7 overhead piping.

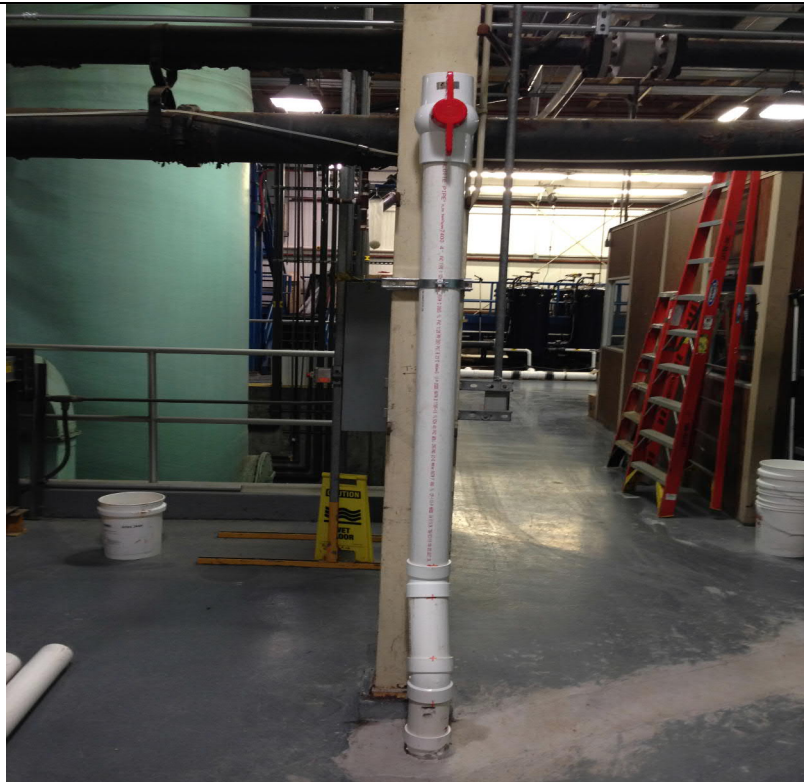
**Photo No.**  
**4**

EP-2 piping along column O50. Ball valve mid-point placed 66" above top angle. Valve mid-point 92" above top of slab.

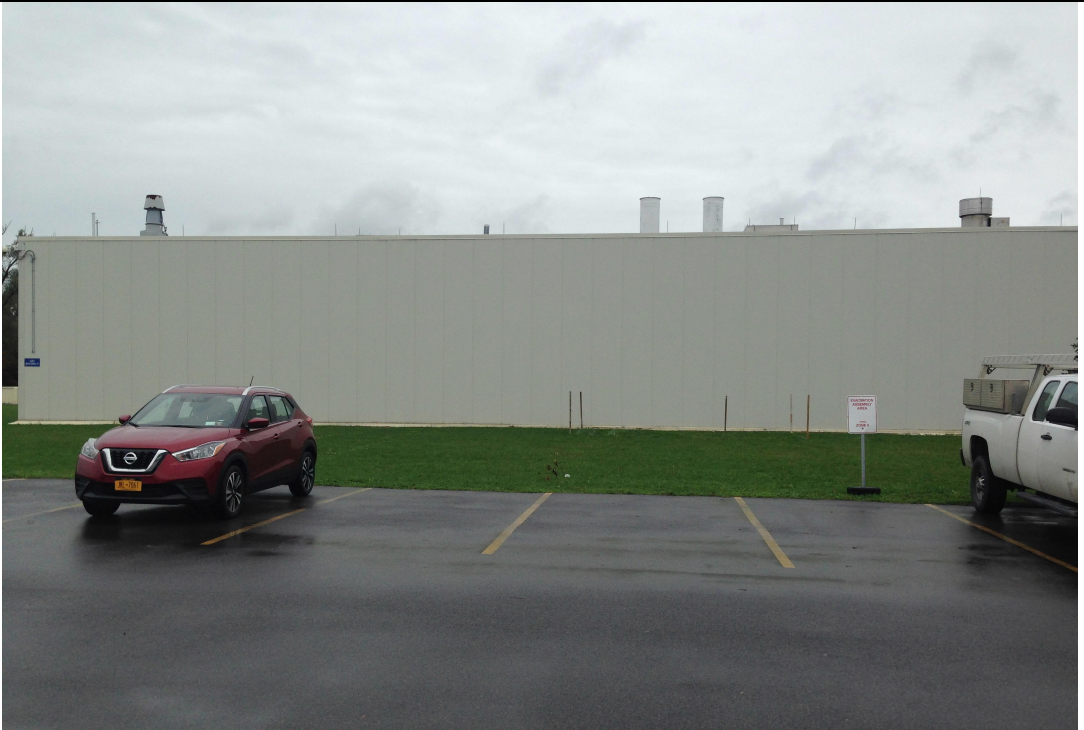
**Photo No.**  
**1**

Stake out for the footprint of the shed concrete pad. Stakes are spaced 11'X23'. Actual pad will be 10'X22'.

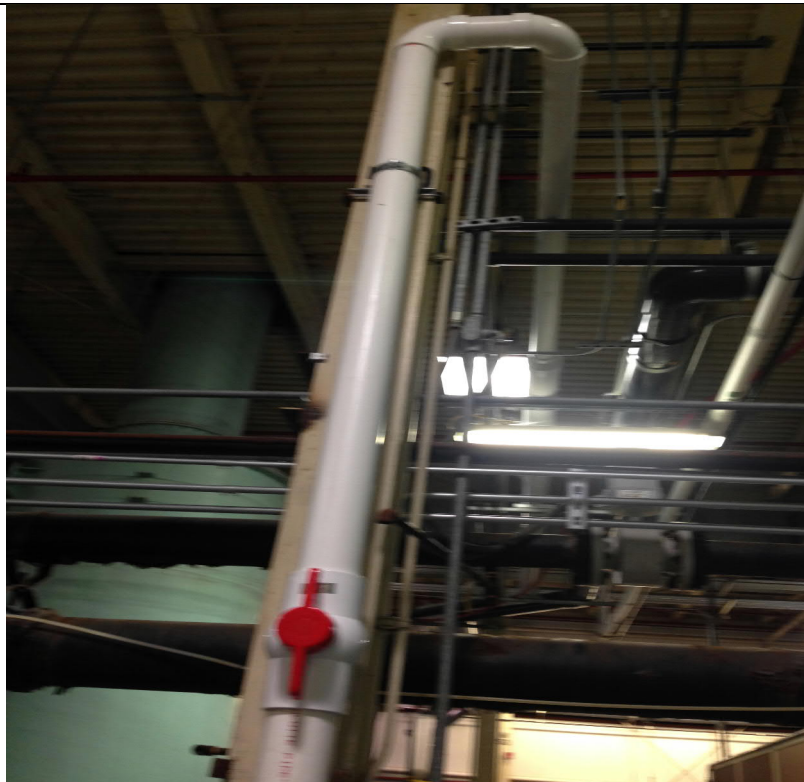
**Photo No.**  
**2**

EP-2 piping on column Q50 extending to existing bridge work.

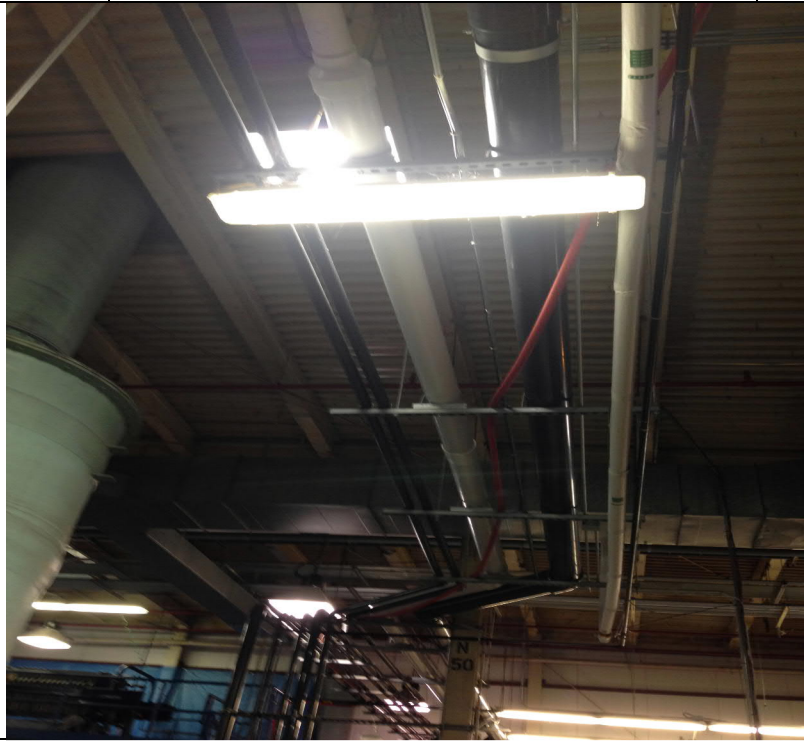
**Photo No.**  
**3**

EP-2 piping on existing bridgework.

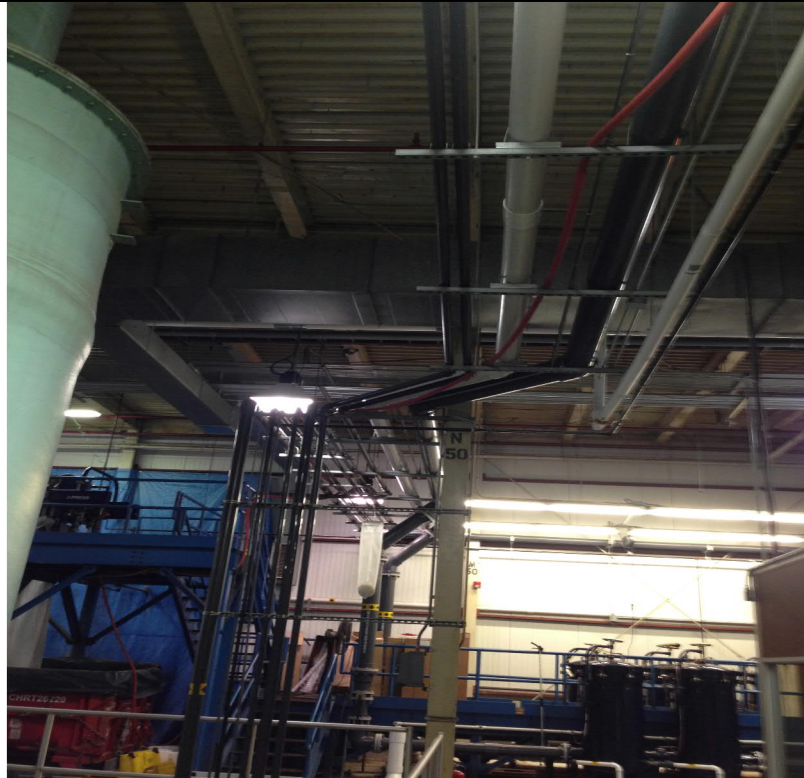
**Photo No.**  
**4**

EP-2 piping on existing bridgework extending to southern wall (slightly east of column M50).

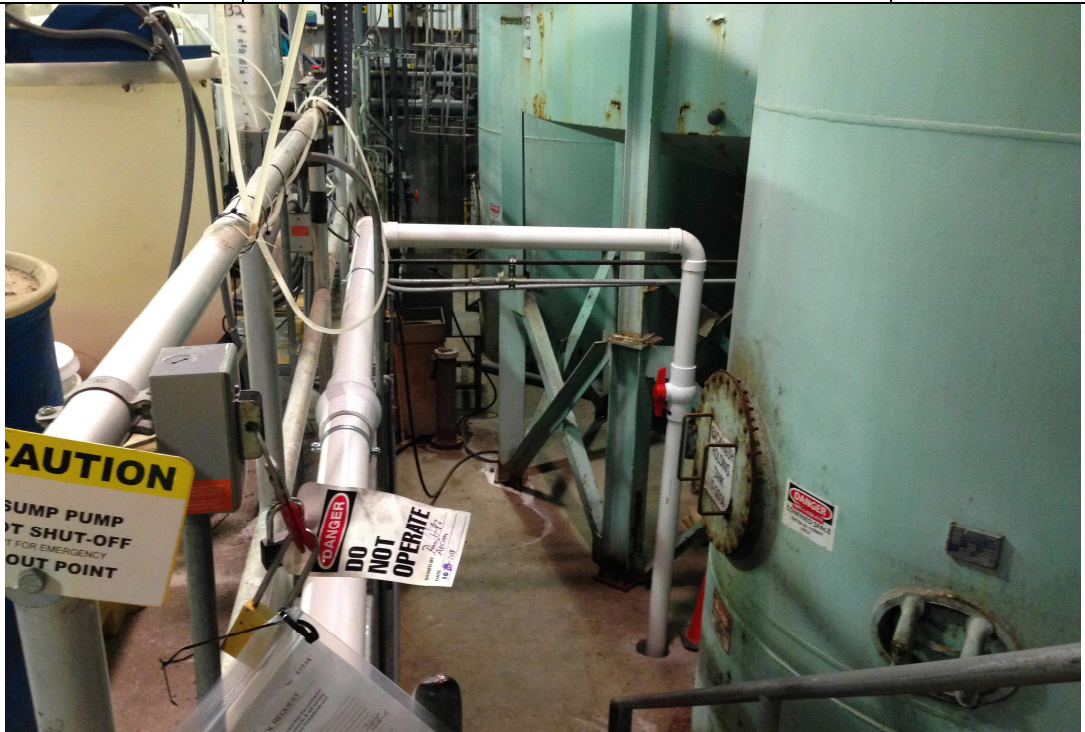
**Photo No.**  
**1**

EP-6 piping joining  
EP-1 piping.
