**Sub-Slab Depressurization Systems  
Buildings TR-20 (partial) and Stormwater  
Treatment Plant  
Interim Corrective Measure  
ONONDAGA, NEW YORK**

**Construction Completion Report**

**NYSDEC Site Number: 734043**

**NOVEMBER 11, 2025**

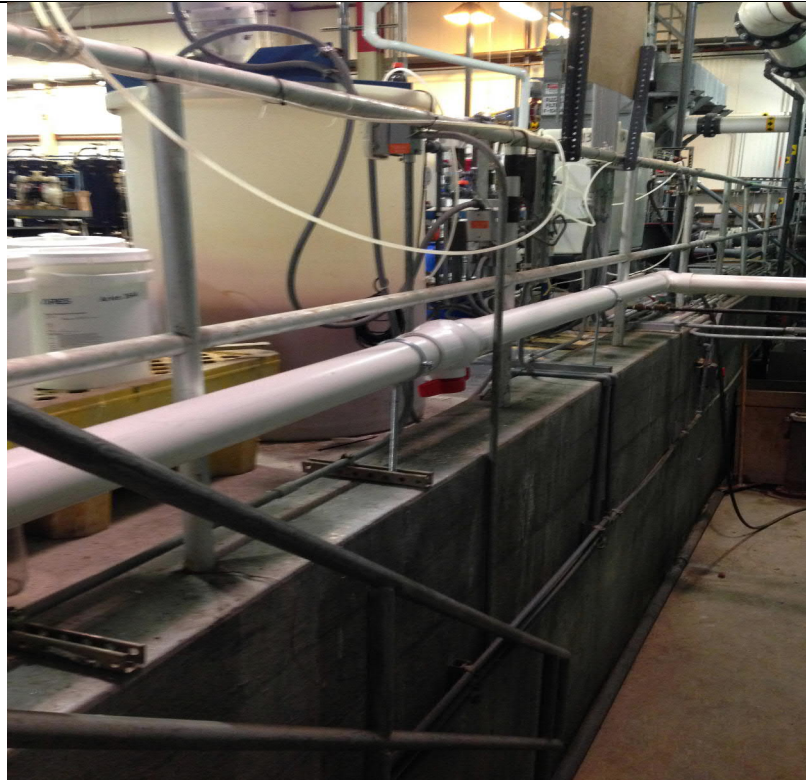
**Photo No.**  
**2**

EP-1 valve location  
(underside of piping).  
Bracing system of  
band and thread-rod  
anchored into existing  
bracket.

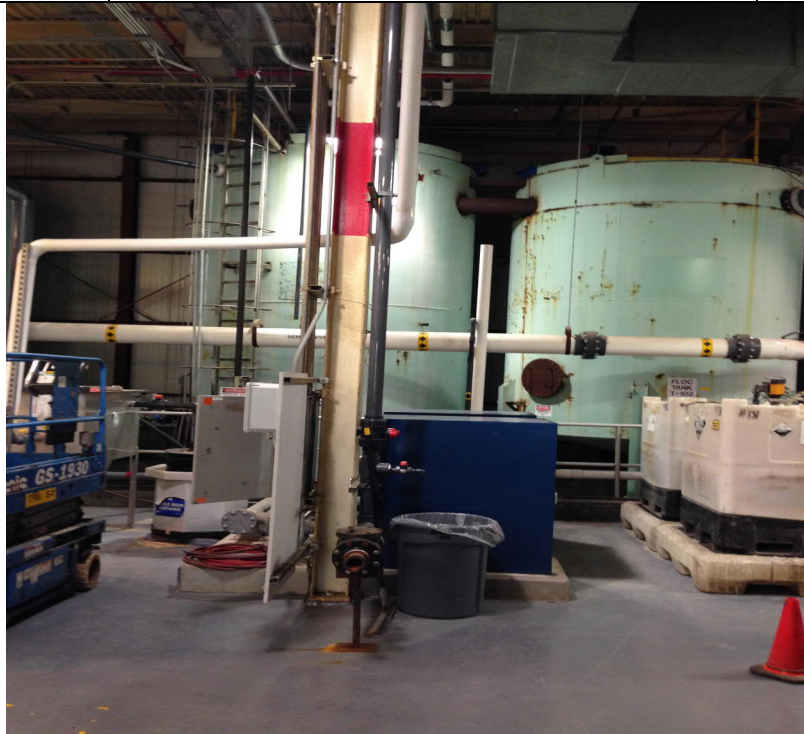
**Photo No.**  
**3**

EP-1 and EP-6 vertical piping extending to ceiling (pictured in space between the 2 green tanks)

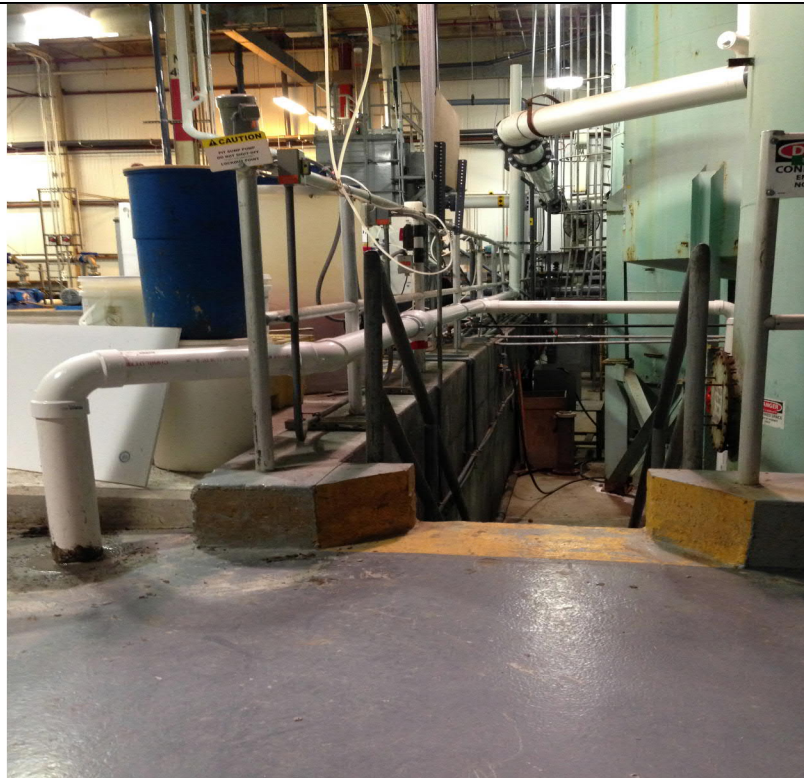
**Photo No.**  
**4**

EP-1 and EP-6 piping along eastern pit rim of western pit.

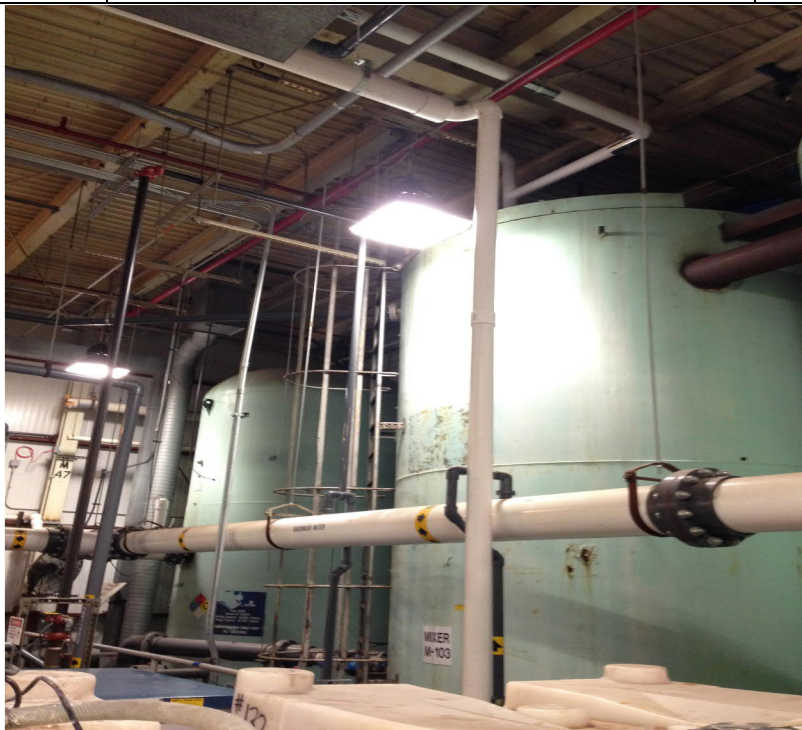
**Photo No.**  
**1**

EP-1/EP-6 4" vertical piping transitioning to 6" horizontal piping about 2' north of "N" column line.

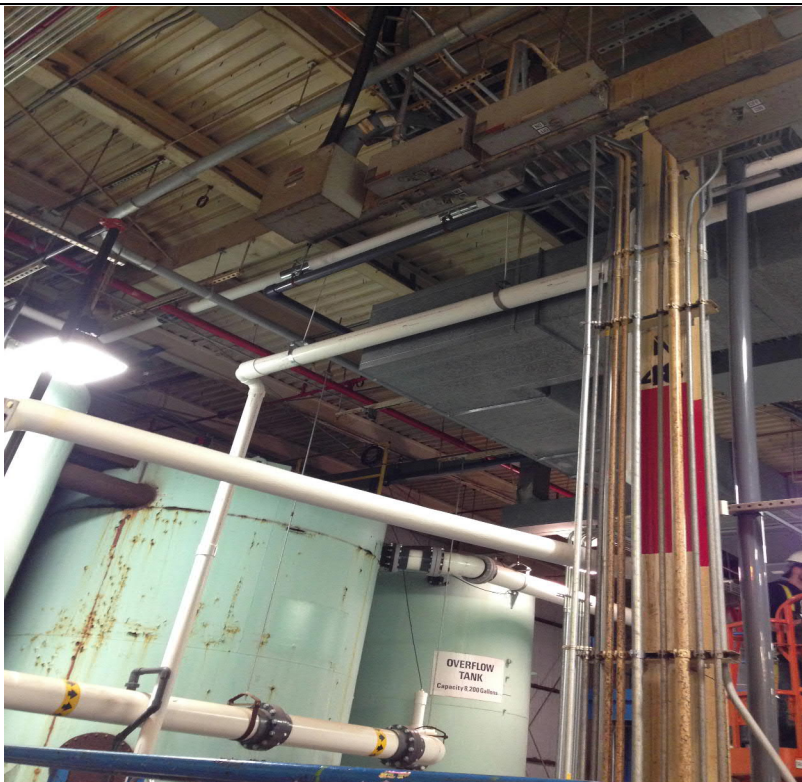
**Photo No.**  
**2**

EP-1/EP-6 vertical and horizontal piping along column "N" line.

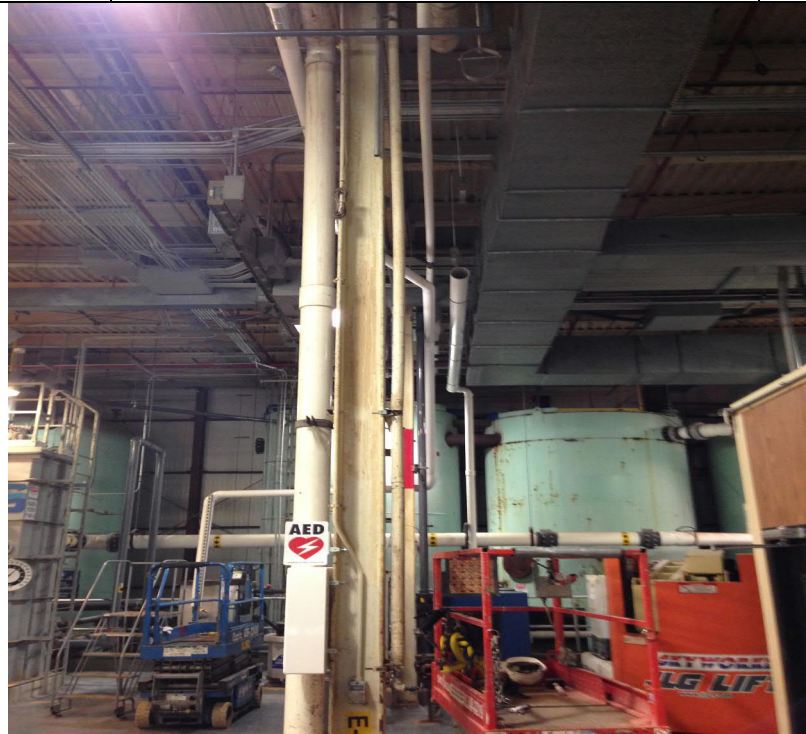
**Photo No.**  
**3**

EP-1/EP-6 vertical and horizontal piping along column "N" line.

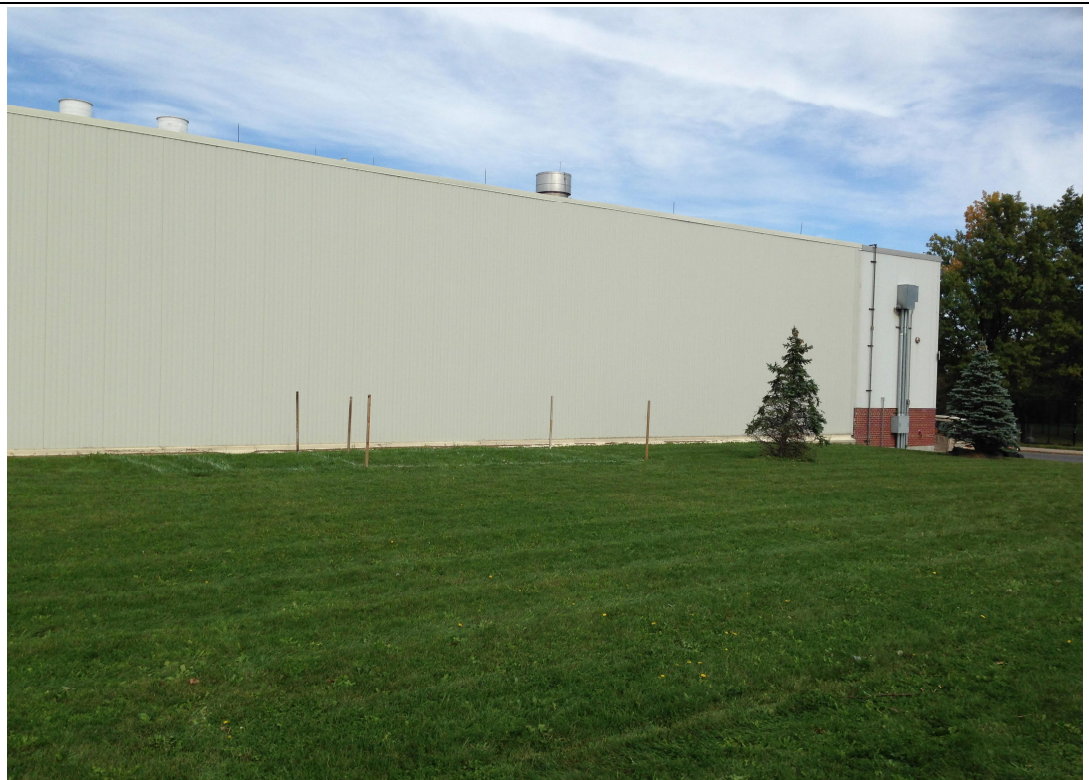
**Photo No.**  
**4**

New location of staked shed pad footprint (moved 10' to the East).

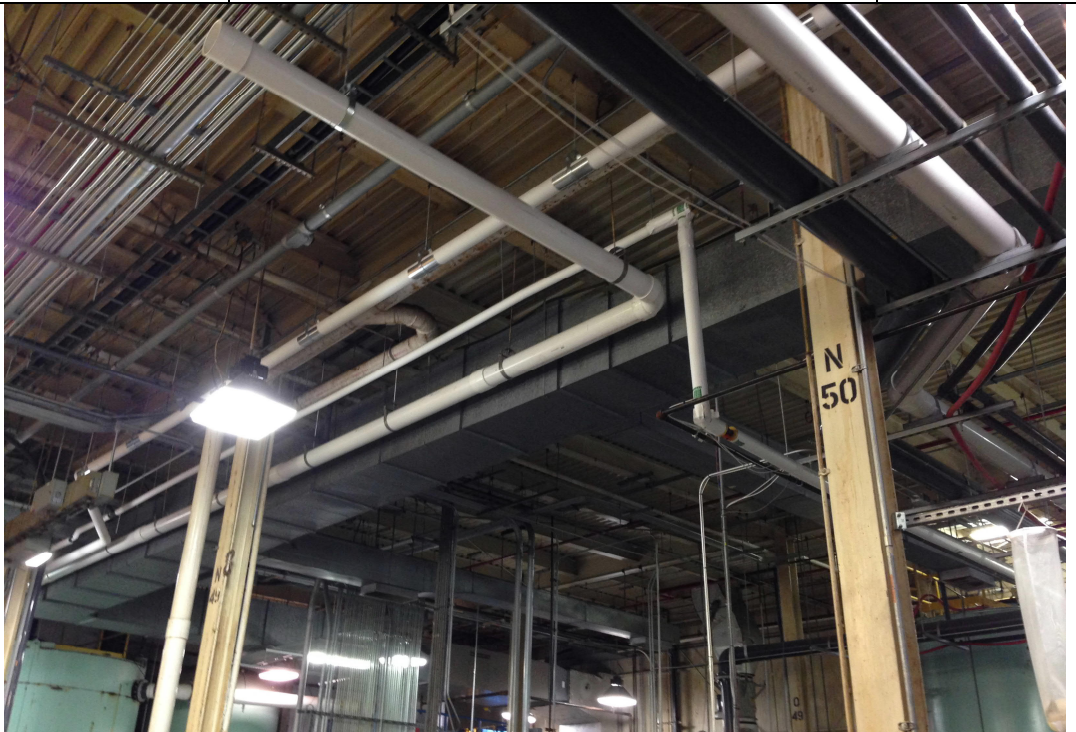
**Photo No.**  
**1**

EP-1/EP-6 6" overhead PVC piping along "N" column line and elbow to south.

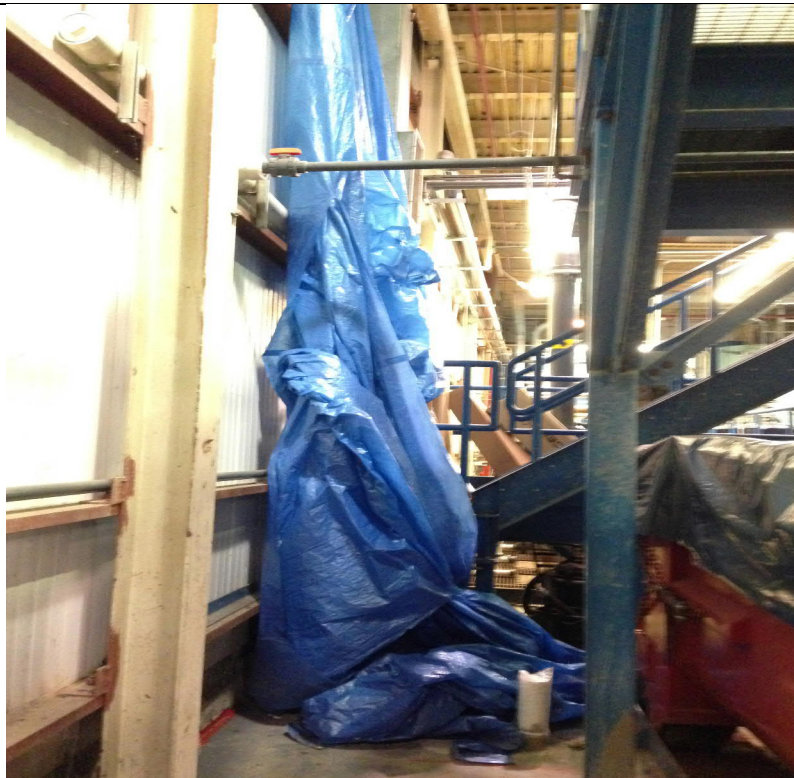
**Photo No.**  
**2**

EP-4 location (lower right). Showing tight area behind blue structure (filter press). Numerous pipes and conduits restricting aerial lift usage.

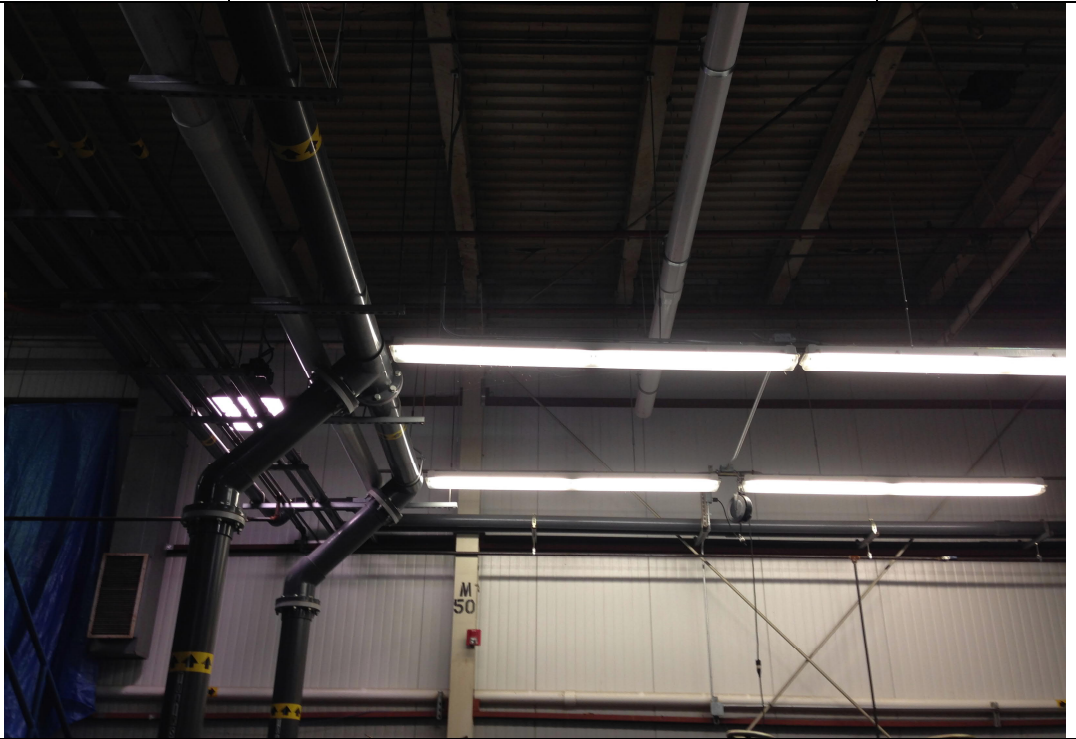
**Photo No.**  
**3**

EP-1/EP-6 horizontal line extending to southern wall ("M" column line).

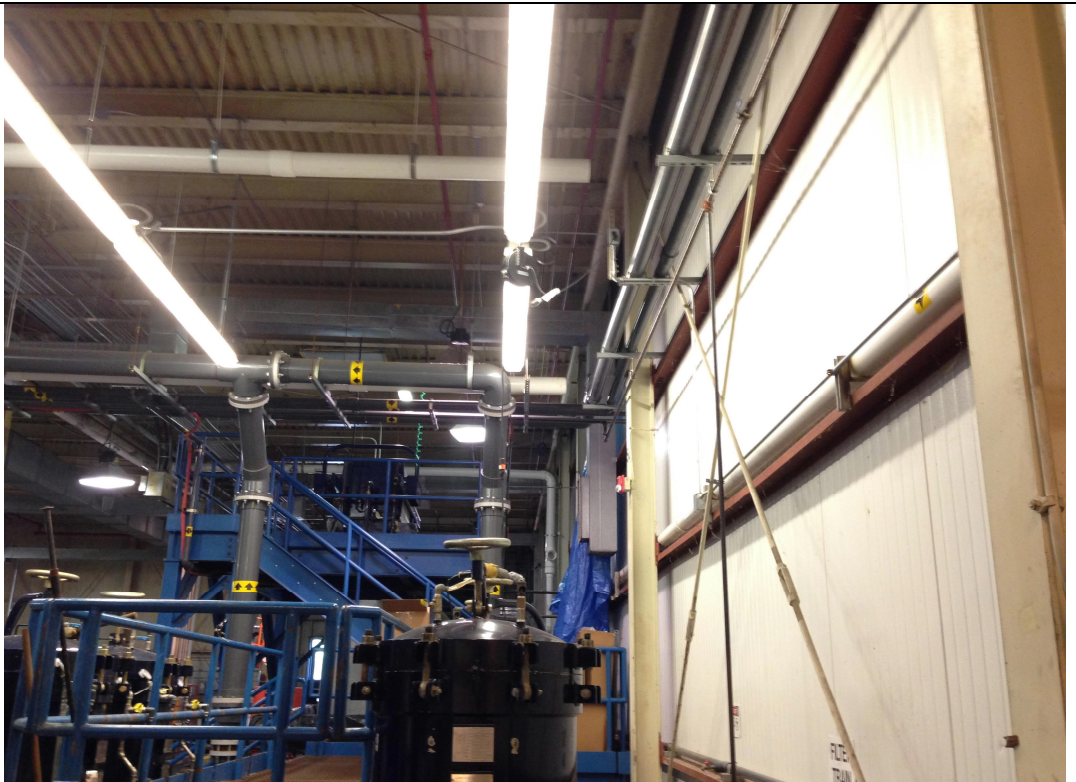
**Photo No.**  
**4**

EP-1/EP-6 line in foreground. Showing vast network of existing piping and bracing to east of EP-1/EP-6 line.

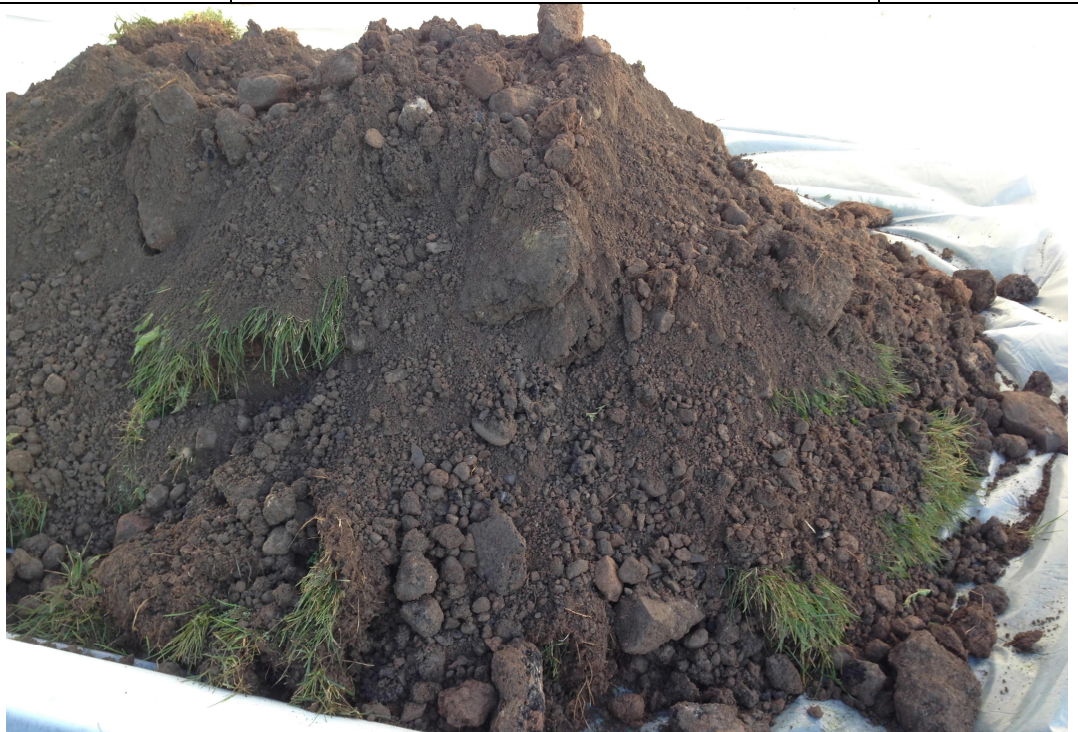
**Photo No.**  
**1**

Closeup of excavated soils from SWTP concrete pad.

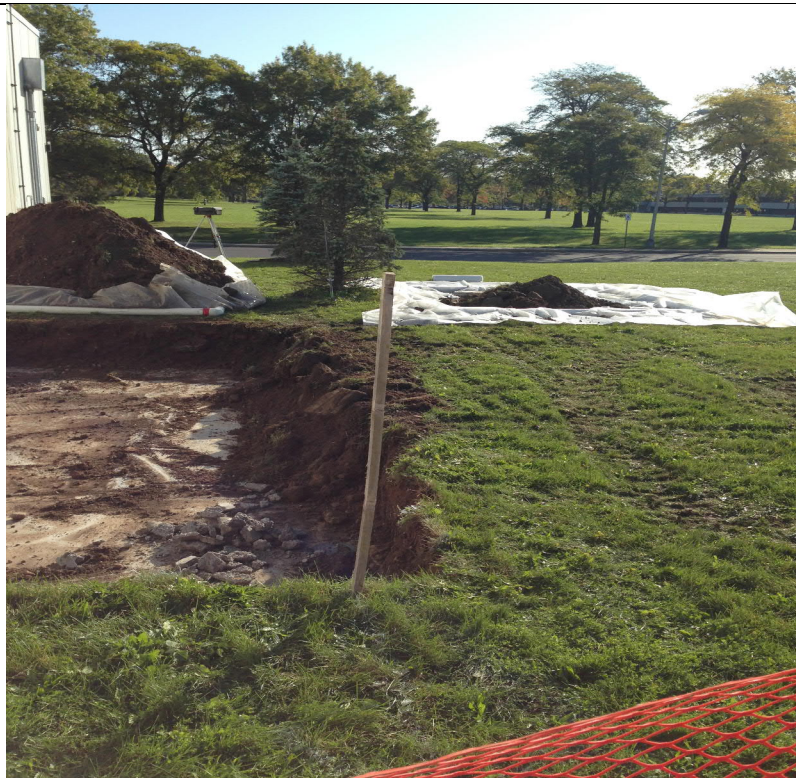
**Photo No.**  
**2**

Excavated soil piles and excavated concrete pad area.

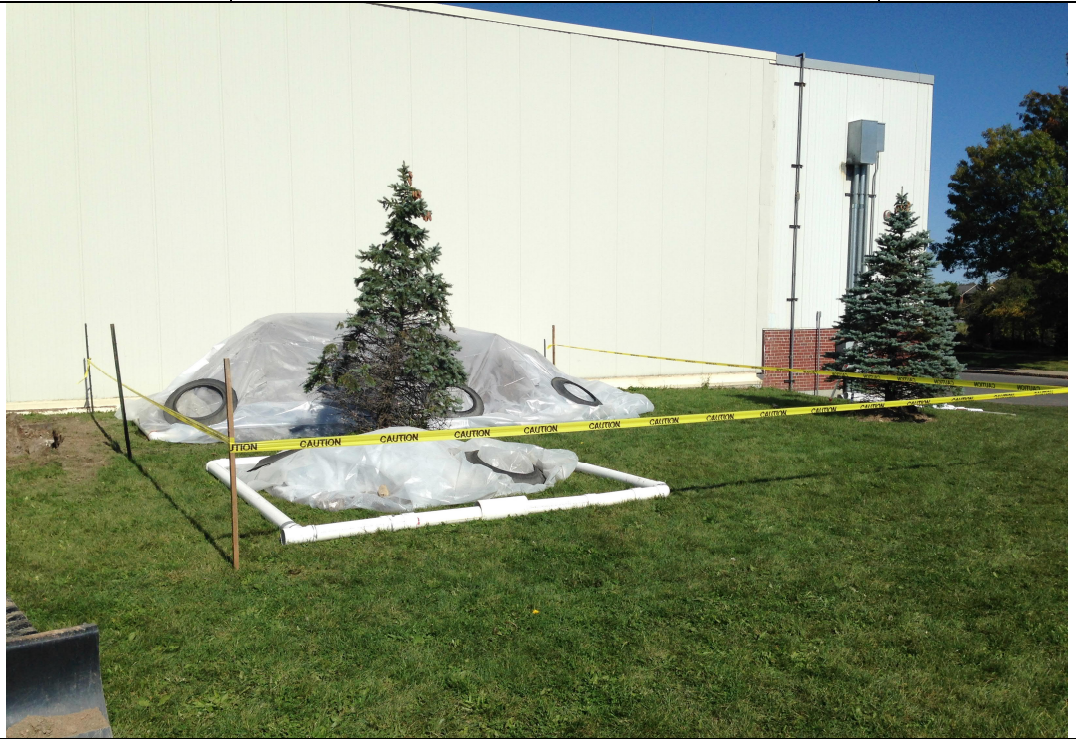
**Photo No.**  
**3**

Covered excavated soil piles.

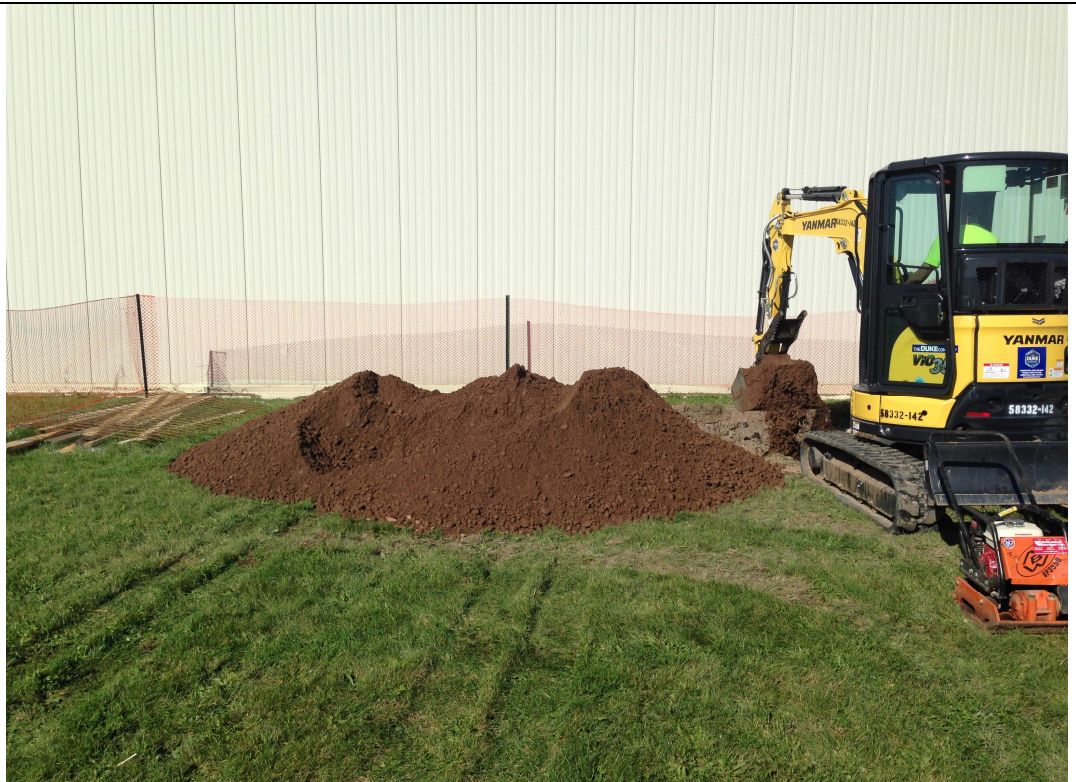
**Photo No.**  
**4**

Stone sub-base being added to excavated concrete pad area.

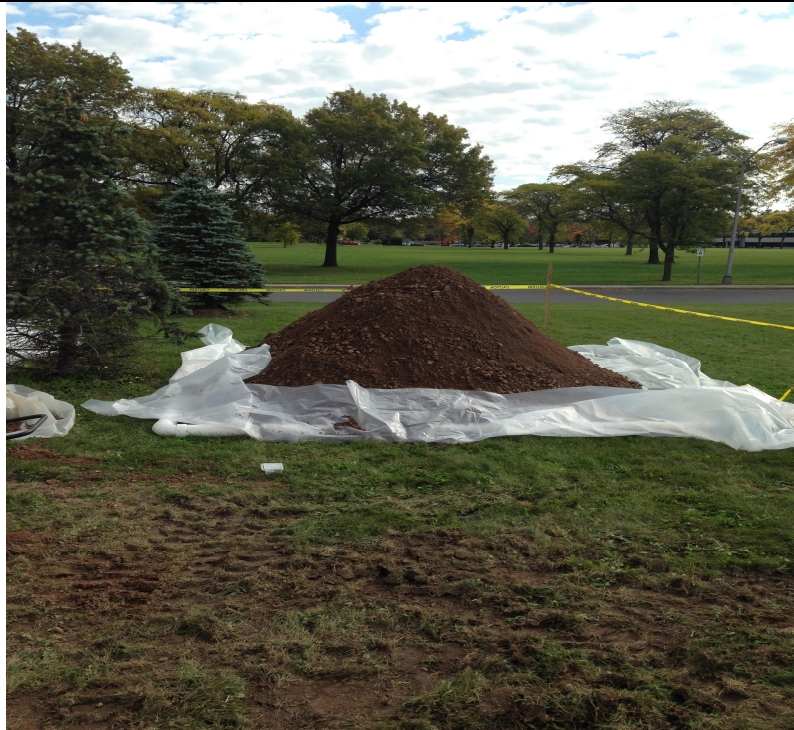
**Photo No.**  
**1**

Excess trucked in stone added to excavated soil pile.

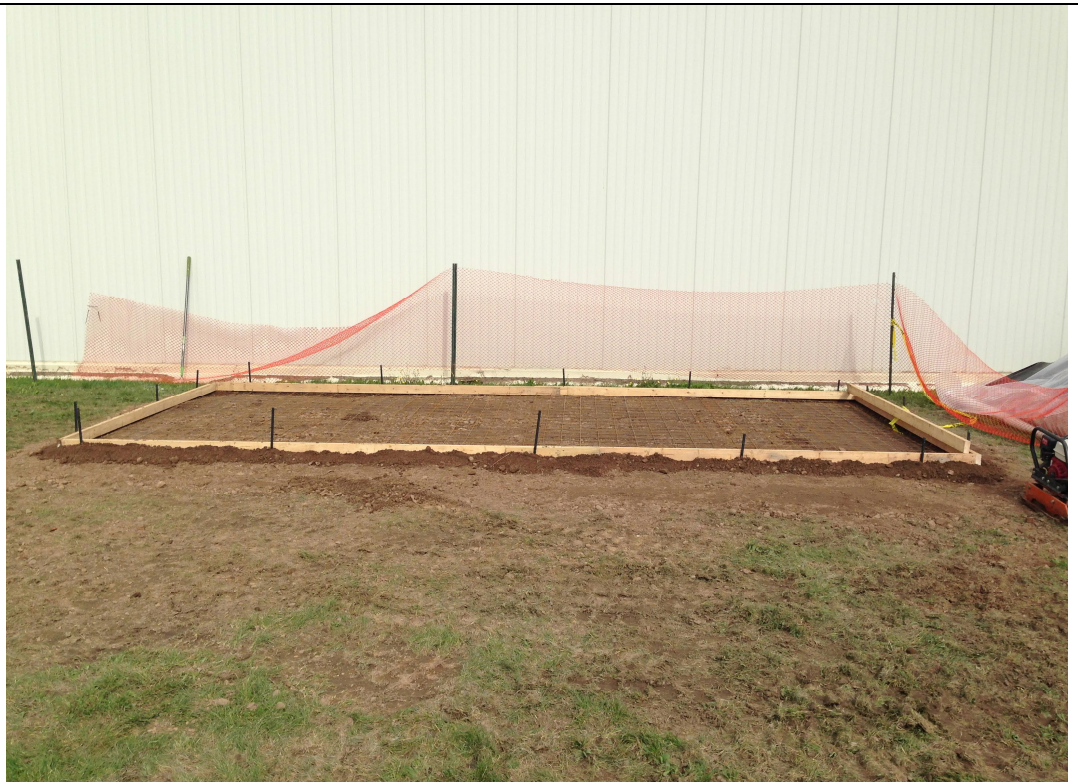
**Photo No.**  
**2**

Concrete pad area prior to concrete pouring.

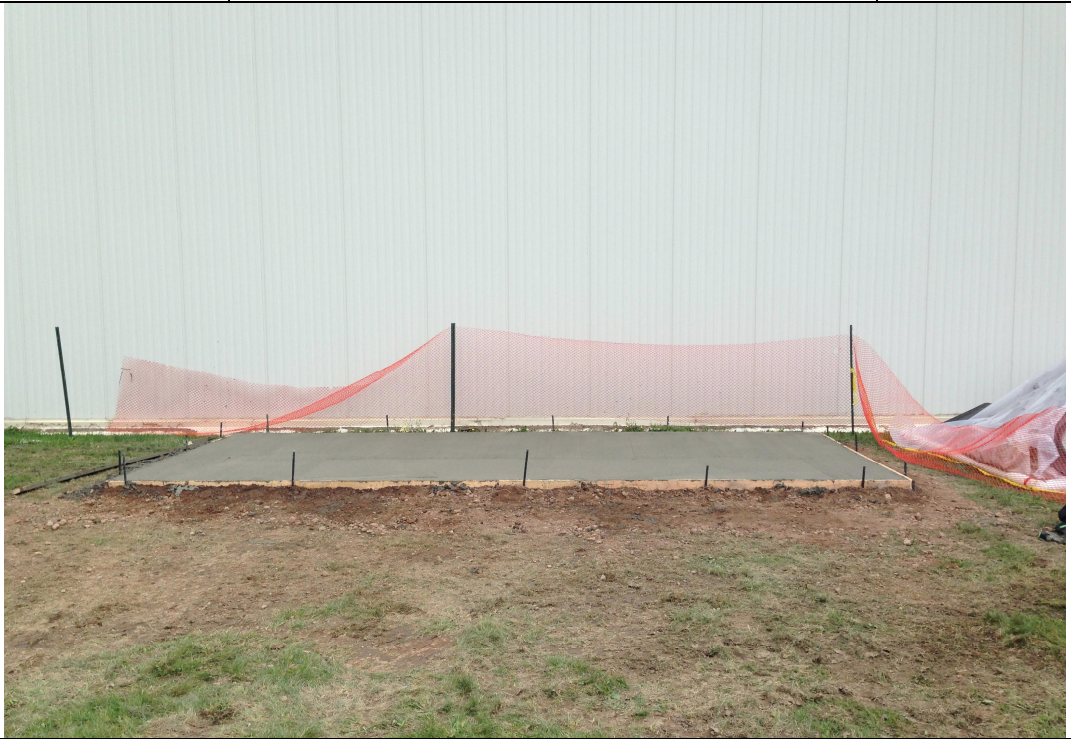
Finished concrete pad area.

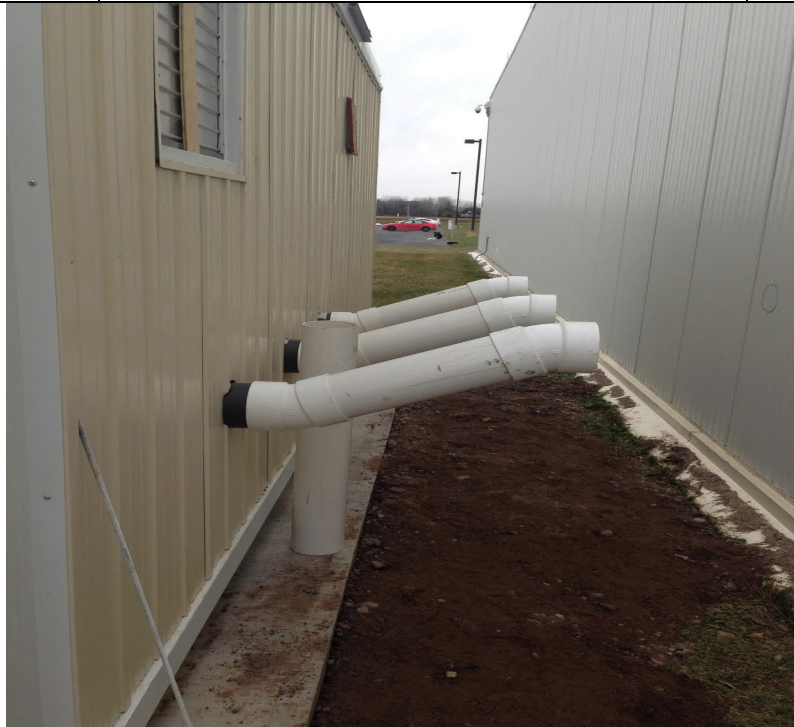
Piping extending from system shed intakes.  
2 – 22.5 degree elbows used per intake.

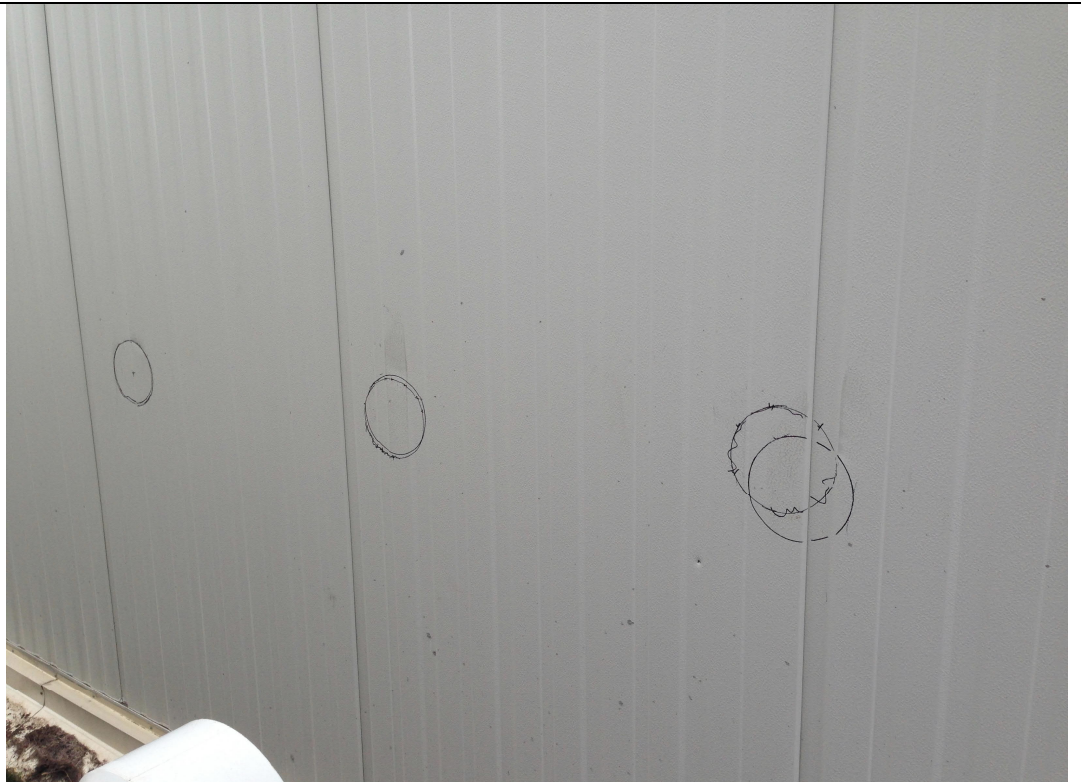
**Photo No.**  
**4**

Markings indicating wall penetrations on south wall of SWTP building.

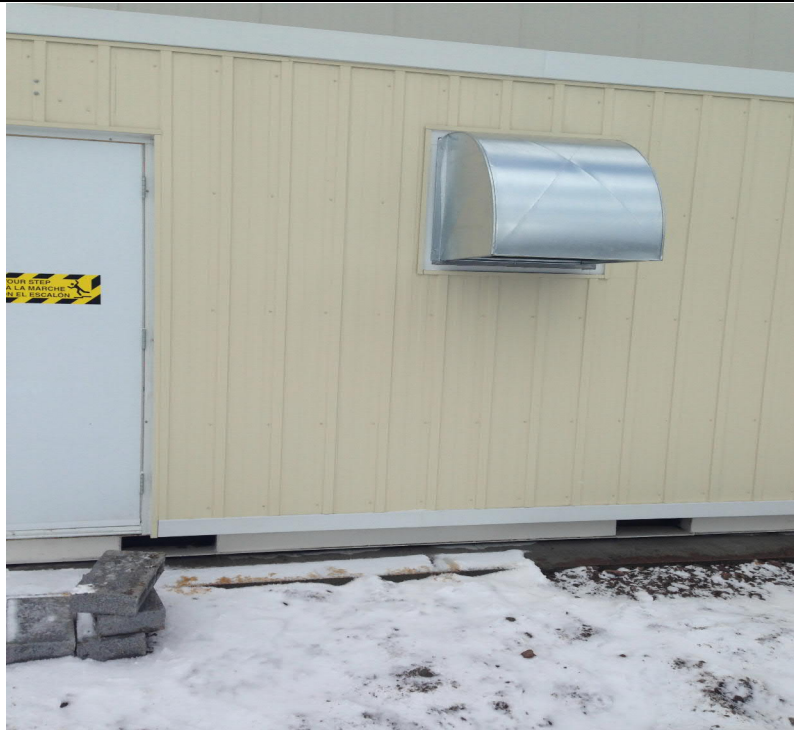
Installed hood over louver.

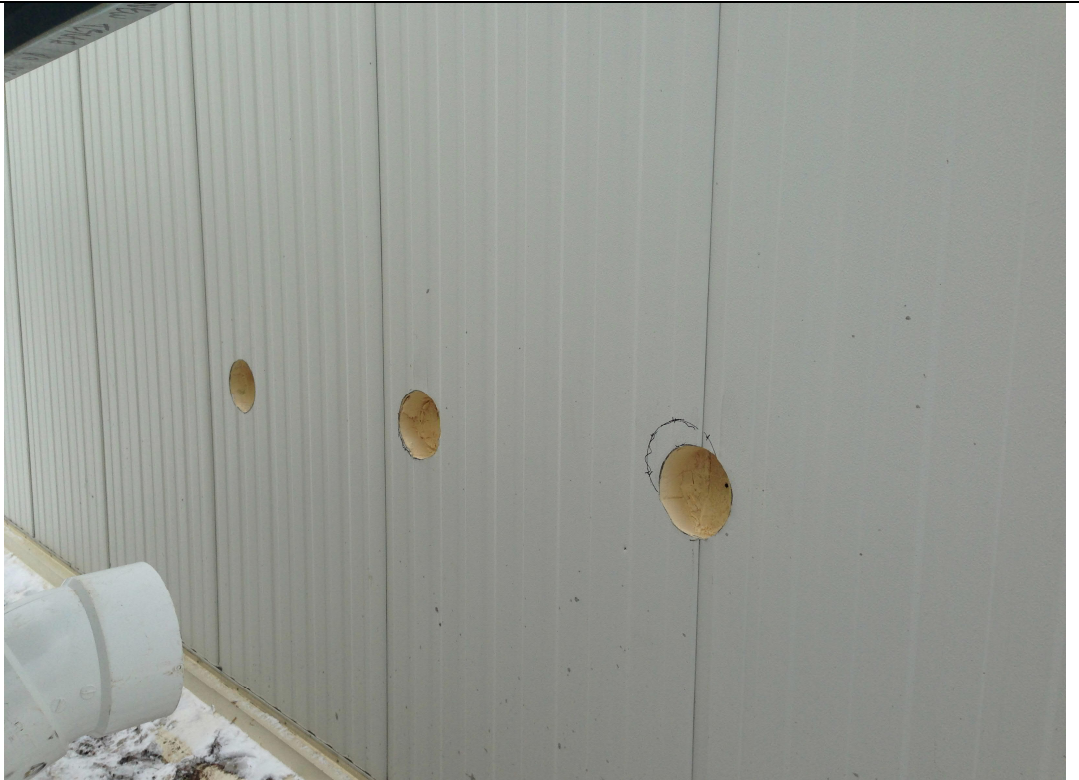
**Photo No.**  
**2**

Partial south wall penetrations of SWTP.

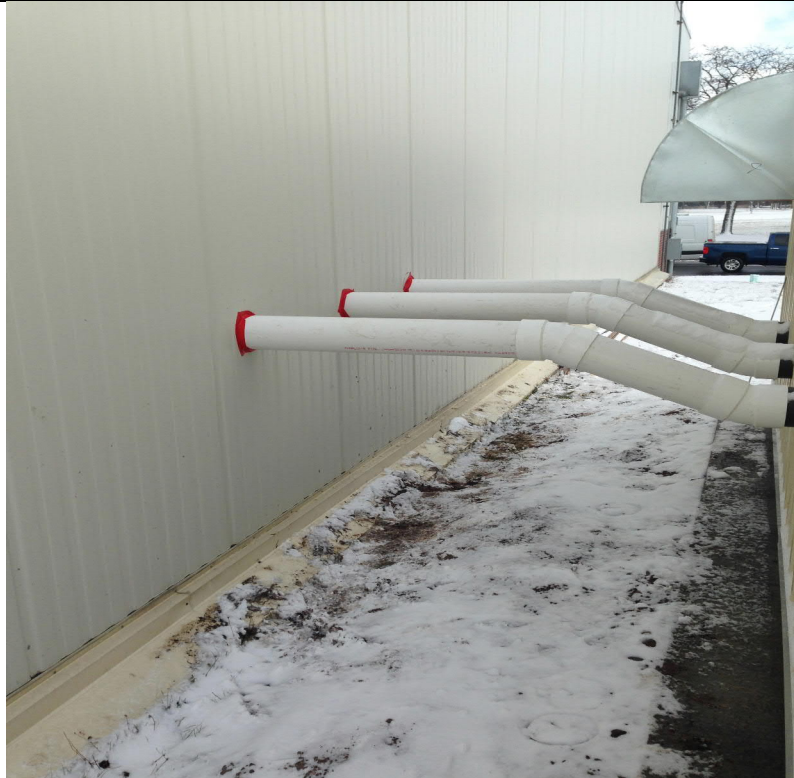
System intake piping from shed to SWTP building. Temporarily sealed with red tape.

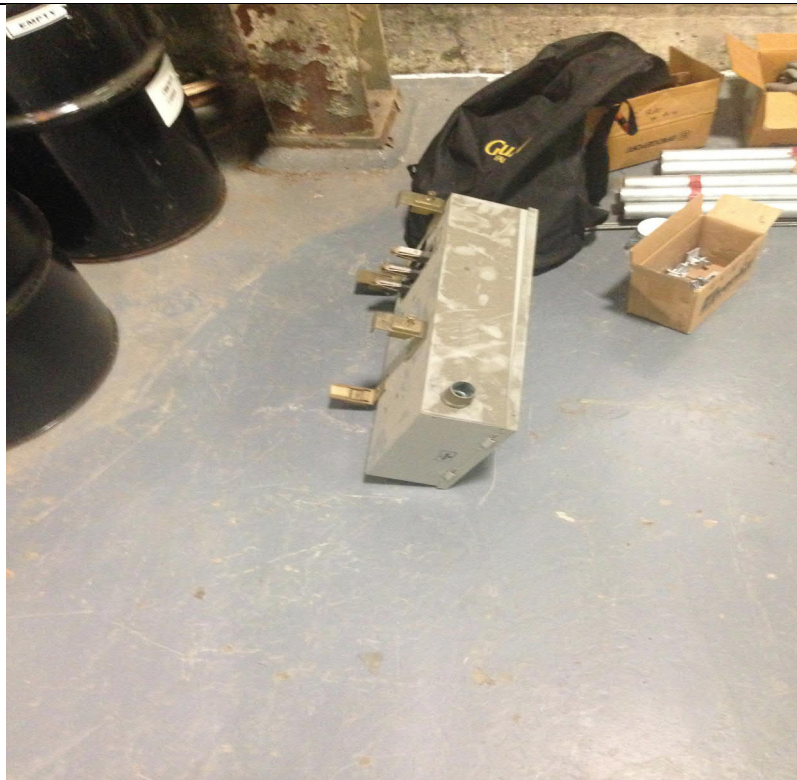
Electrical staging area. Box to be installed on busbar.

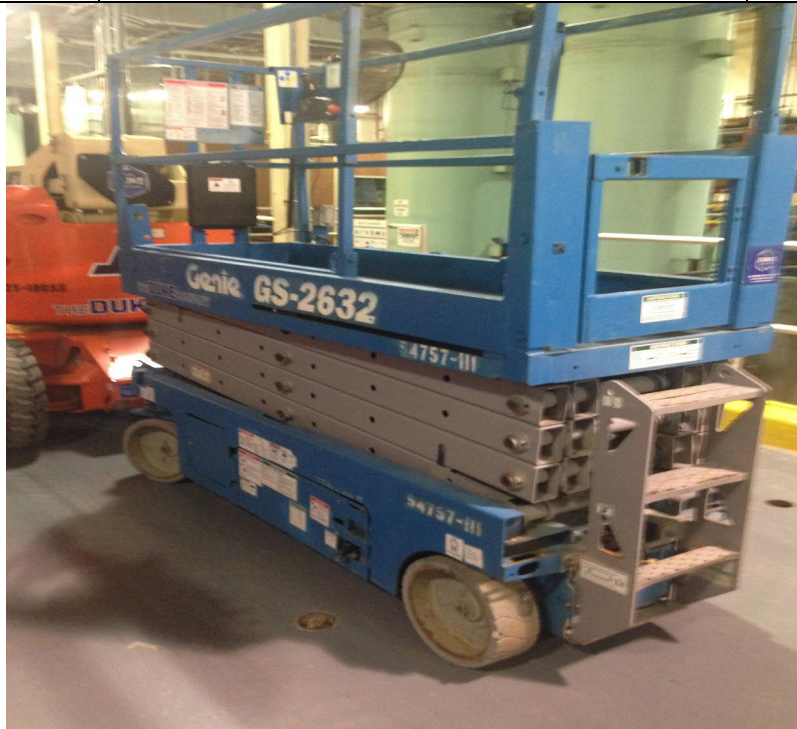
Scissor lift

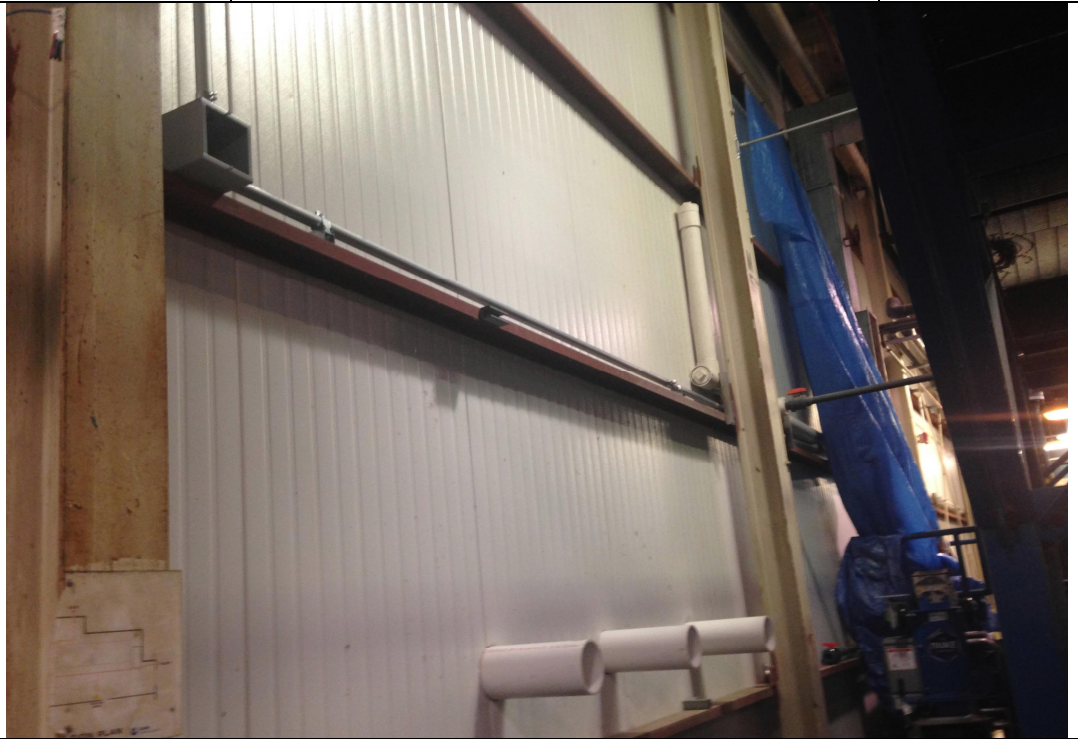
**Photo No.**  
**4**

Electrical conduit running up towards ceiling just west of column M52 on south wall.

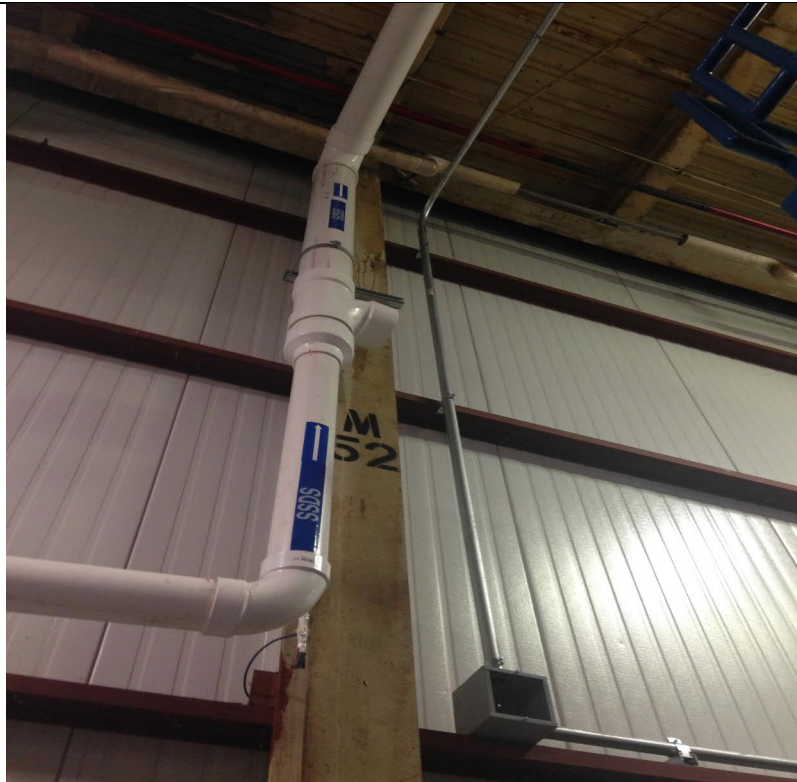
**Photo No.**  
**1**

Swapped out aerial manlift. Smaller basket and smaller base.

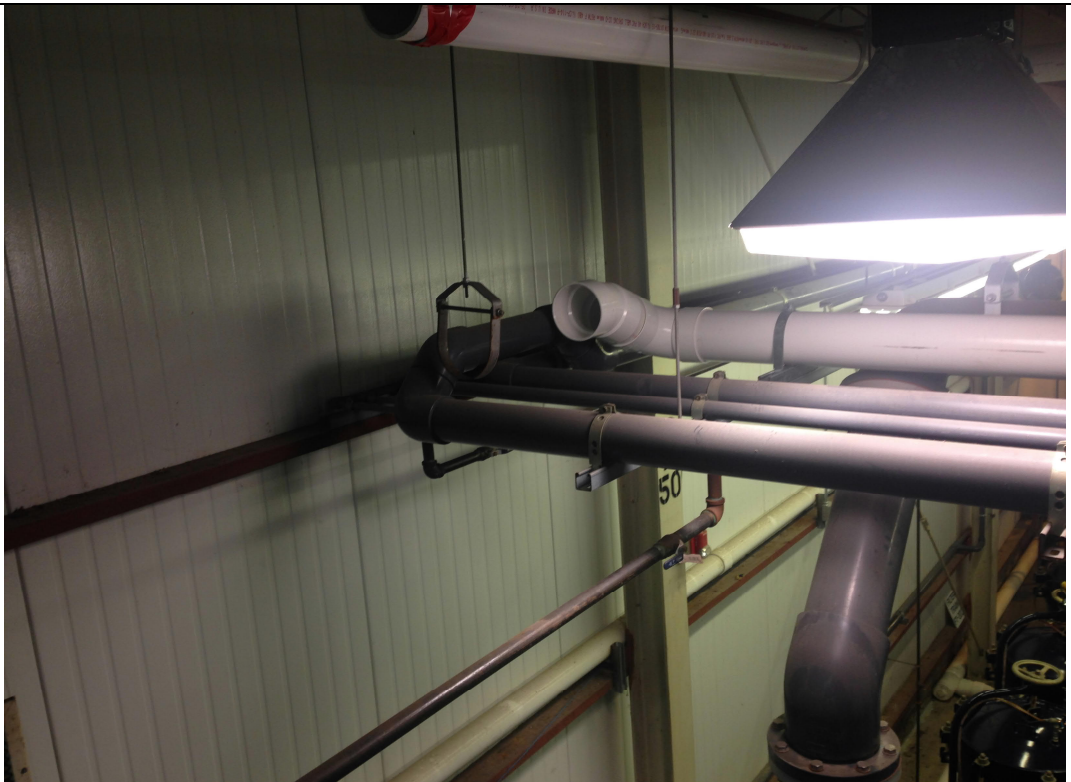
**Photo No.**  
**3**

Angled piping of EP-2 line

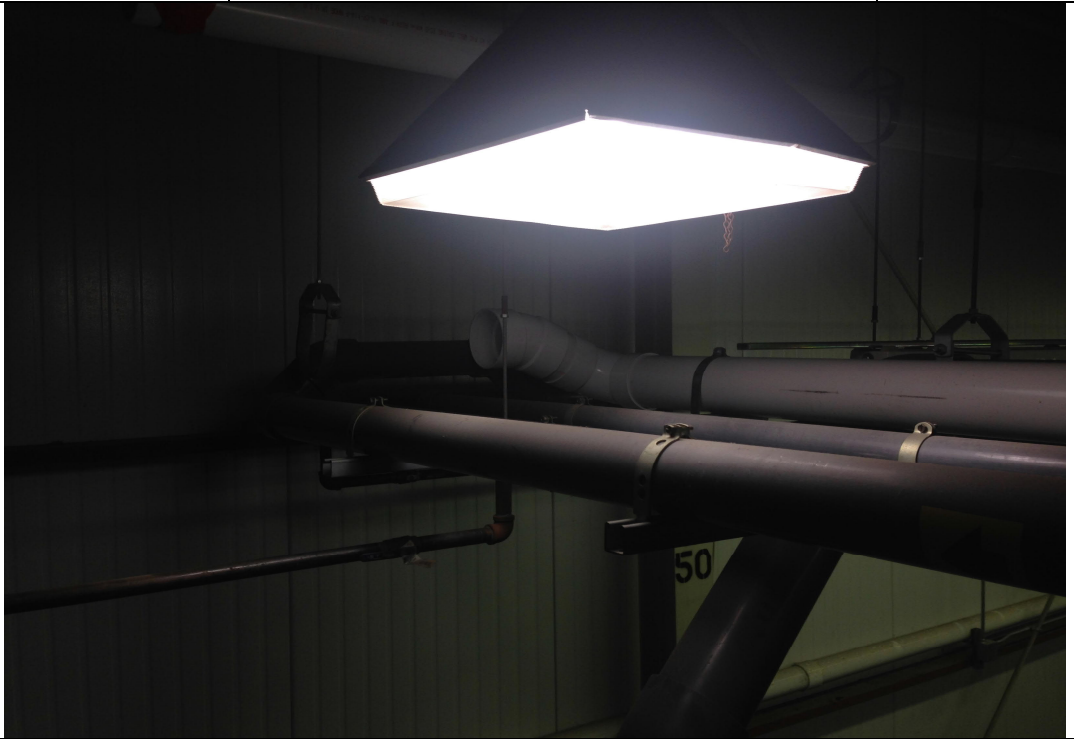
**Photo No.**  
**1**

Interior 8" exhaust piping between column M51 and M52.

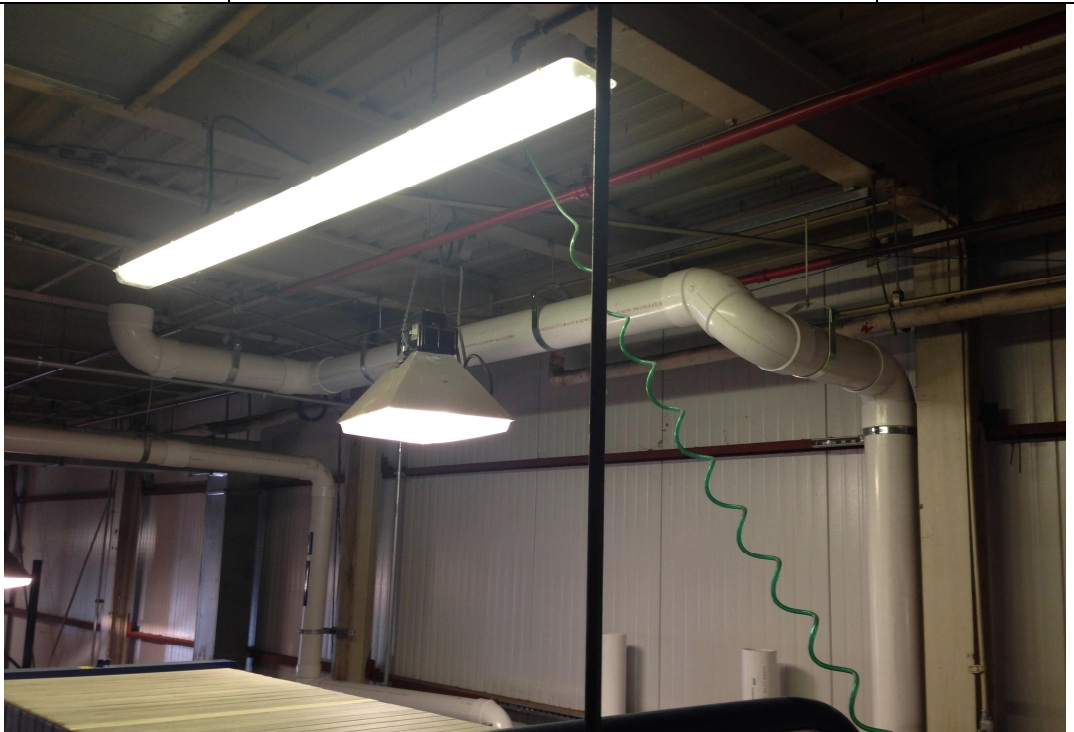
**Photo No.**  
**2**

Exhaust piping pictured on right.  
Building exhaust fan pictured on left.

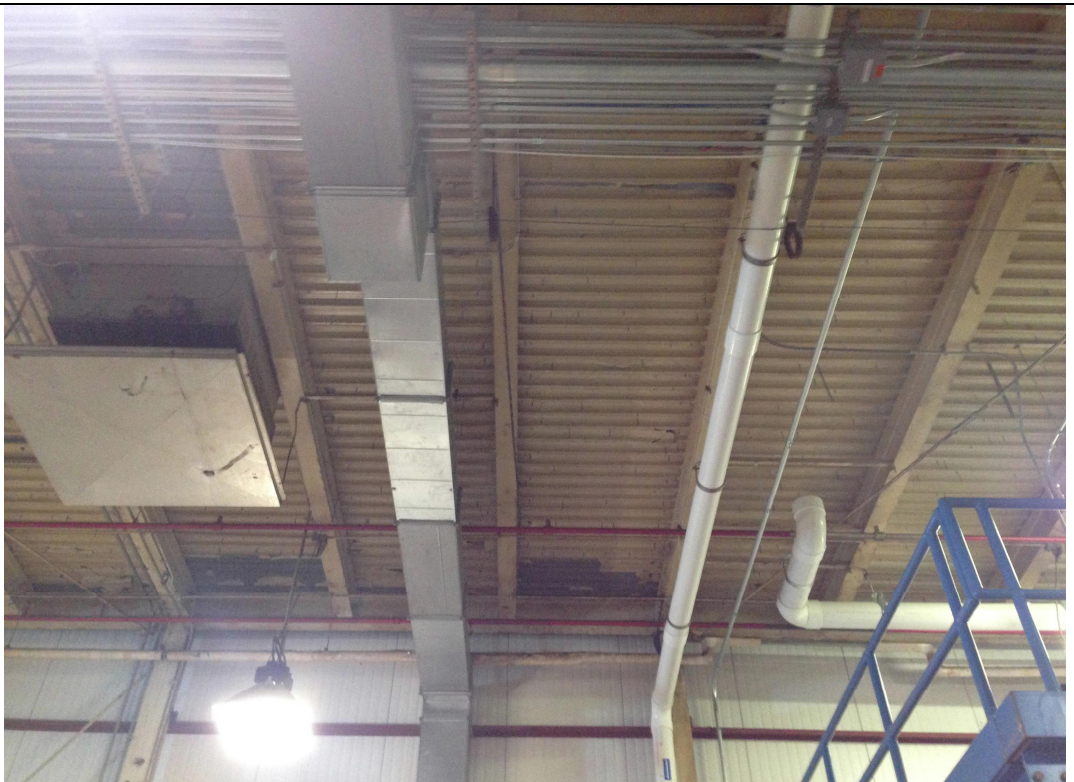
**Photo No.**  
**3**

Fully connected piping of EP-1/EP-6 line (top and right piping) and EP-4/EP-2 line (lower and left piping).
