**Sub-Slab Depressurization Systems  
Buildings TR-20 (partial) and Stormwater  
Treatment Plant  
Interim Corrective Measure  
ONONDAGA, NEW YORK**

**Construction Completion Report**

**NYSDEC Site Number: 734043**

**NOVEMBER 11, 2025**

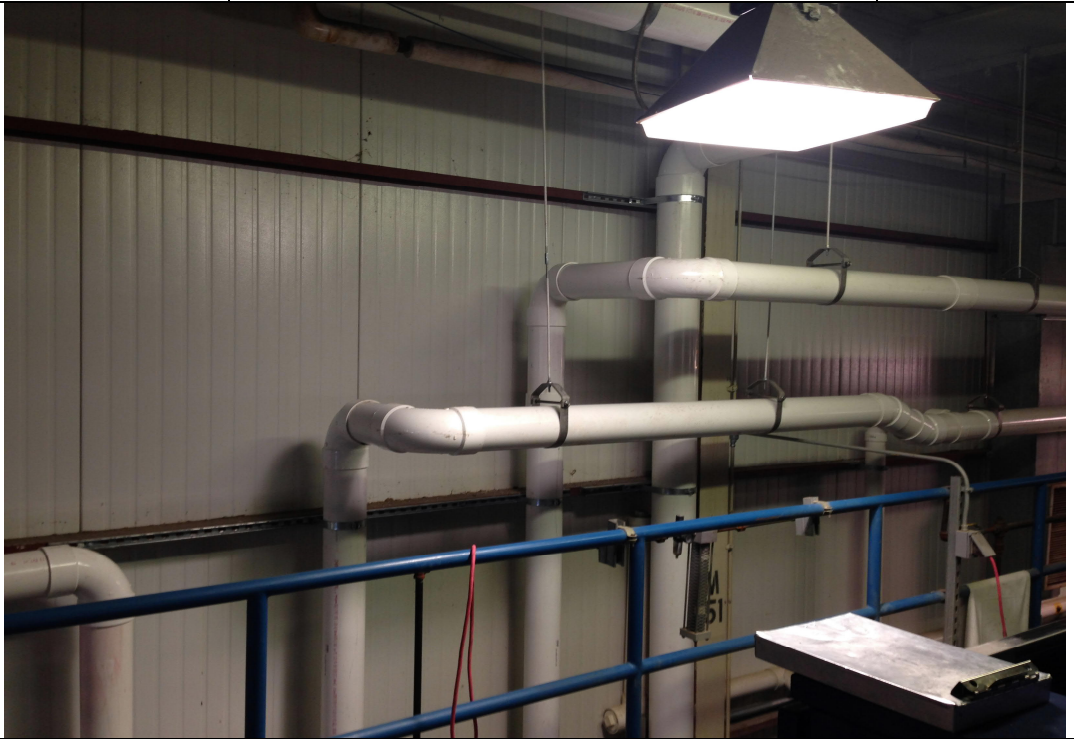
**Photo No.**  
**4**

Ground shot of all piping on south wall of SWTP.

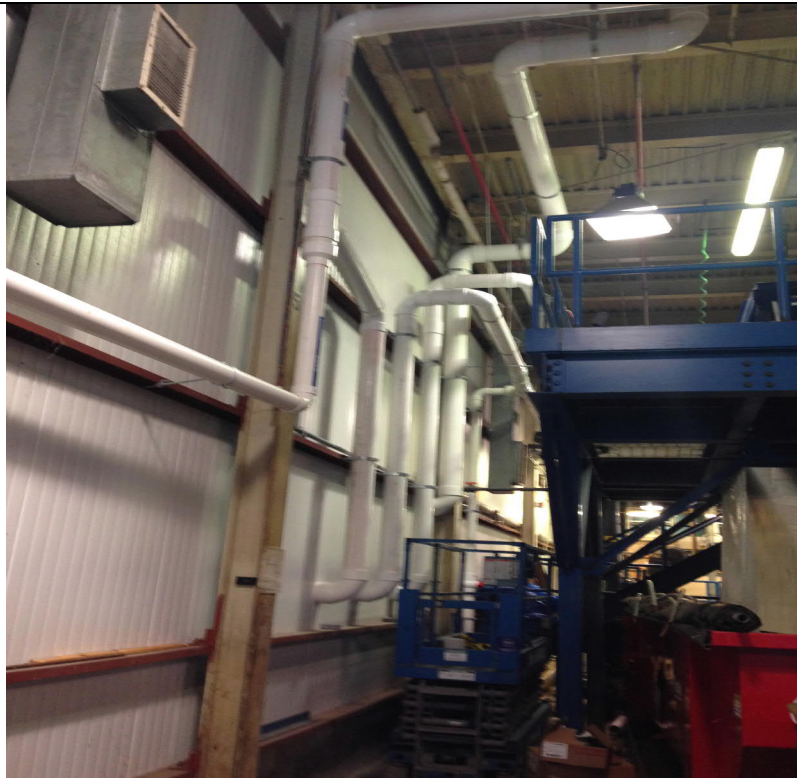
**Photo No.**  
**1**

8" exhaust piping running along column M51.

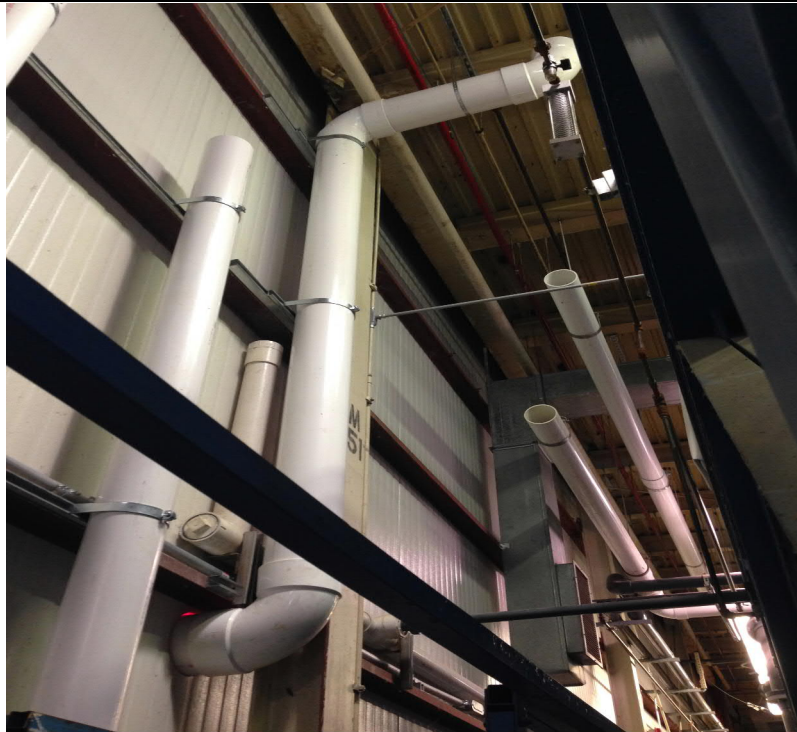
**Photo No.**  
**2**

Fully connected EP-5/EP-7 line and south wall.

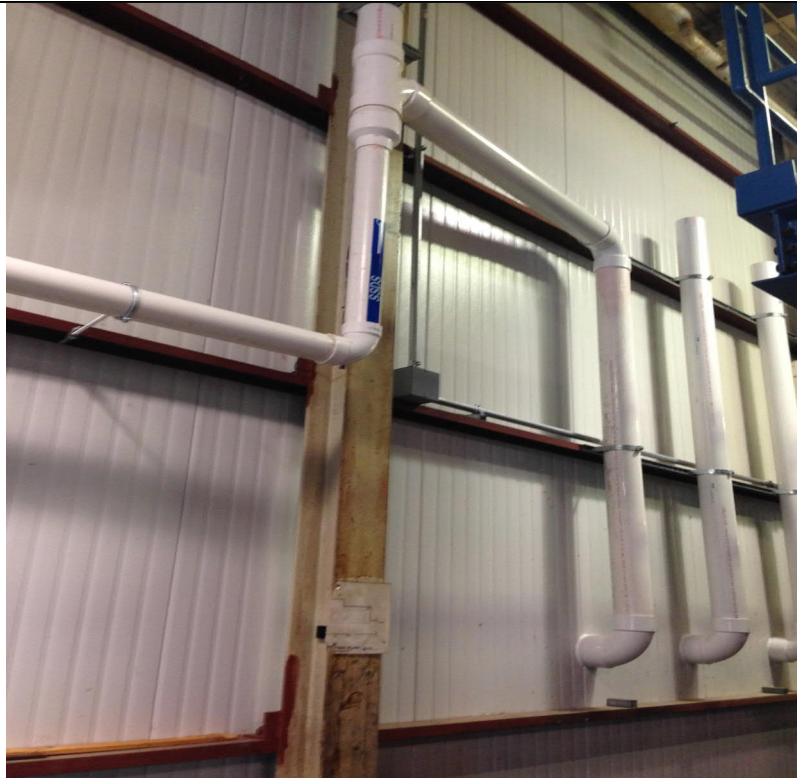
**Photo No.**  
**3**

EP-4 piping with 4" PVC from screen to south wall.

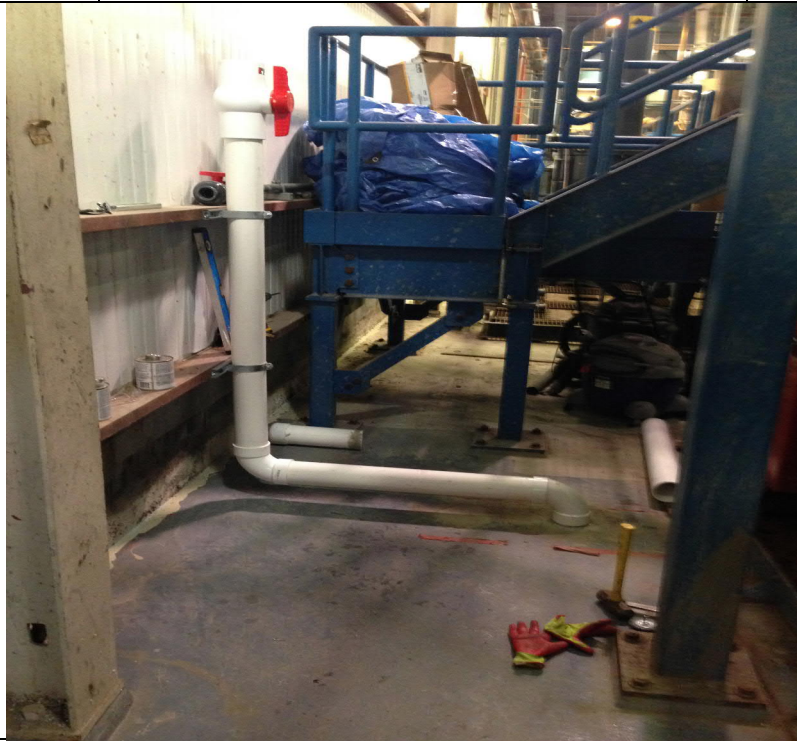
**Photo No.**  
**4**

EP-4 vertical connection to EP-2 pipeline.

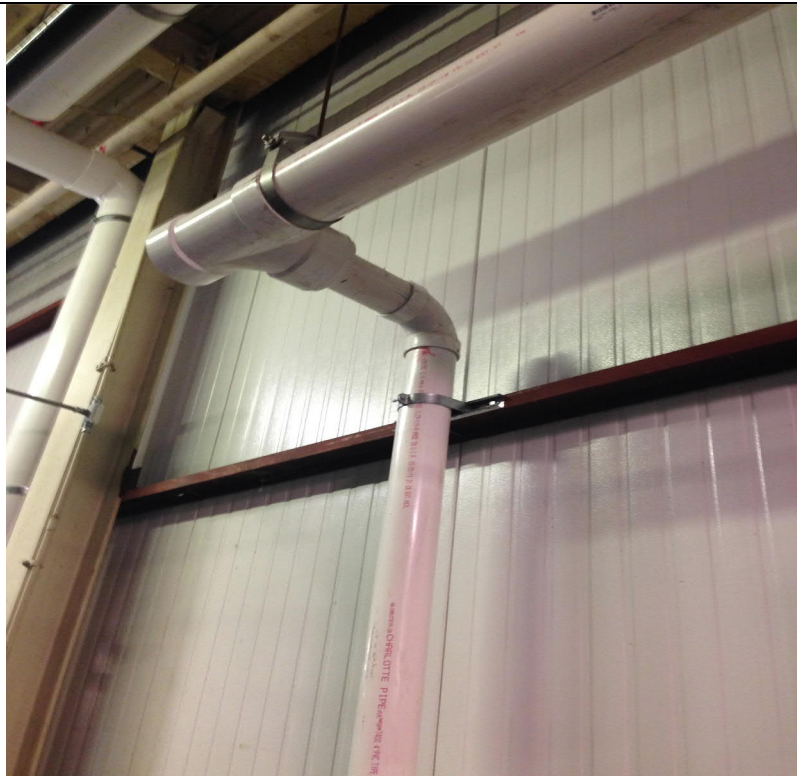
**Photo No.**  
**1**

Overhead piping of  
EP-1/EP-6 line (top)  
and EP-2 line (bottom)

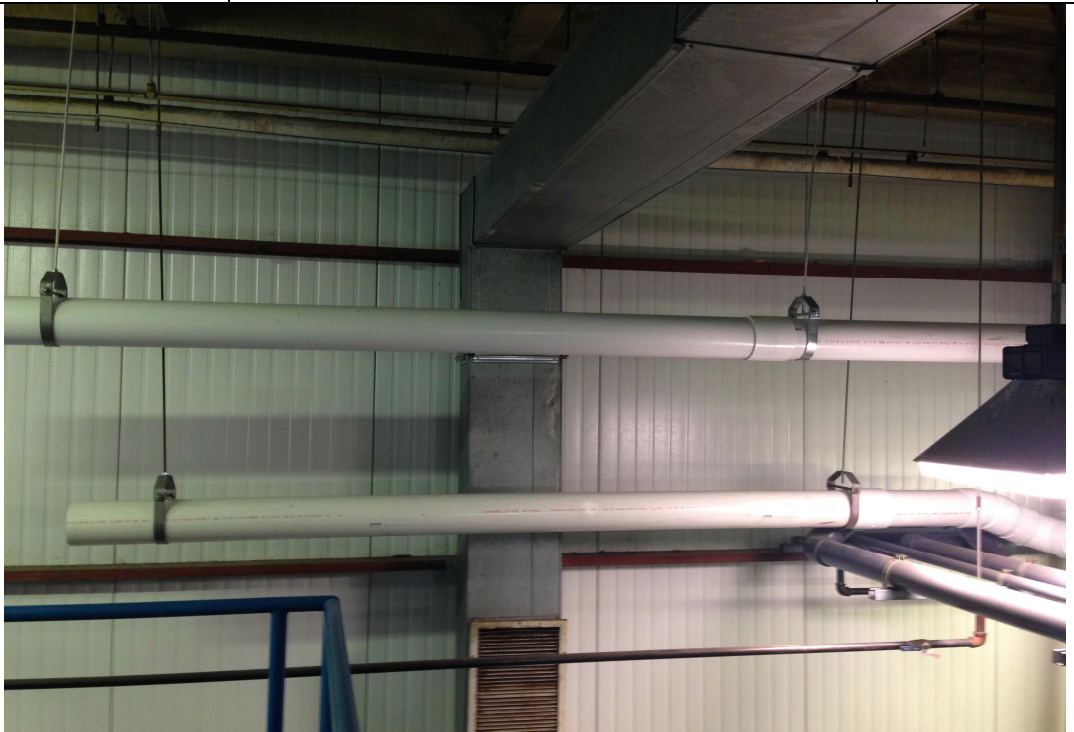
**Photo No.**  
**2**

Exhaust 8" piping from  
shed through south  
wall of SWTP building.

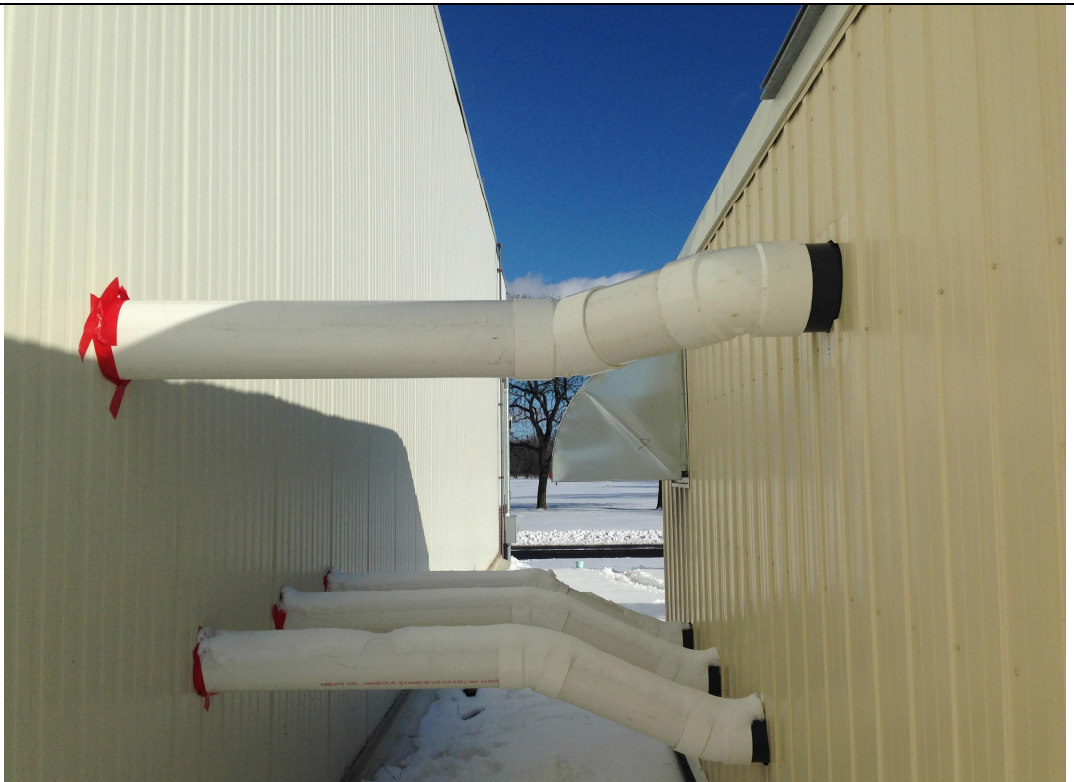
**Photo No.**  
**1**

Insulation on intake piping. Jackets on all piping.

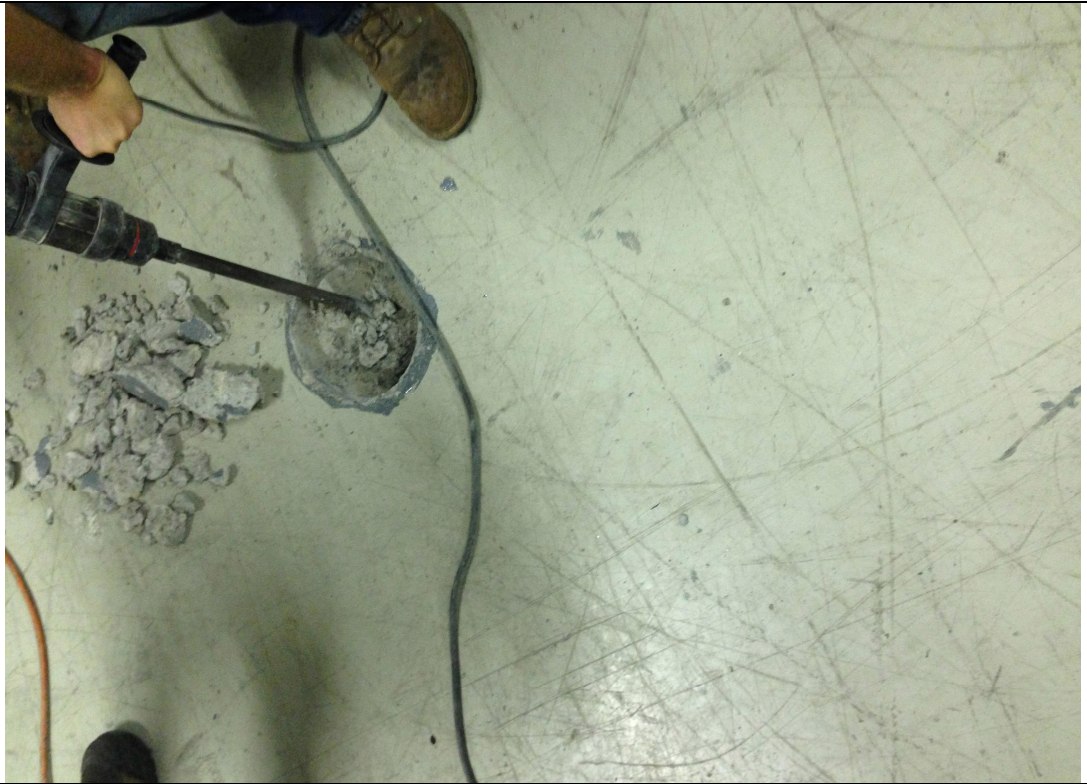
Column U6 view with fire alarm to be moved to west side of column girder.

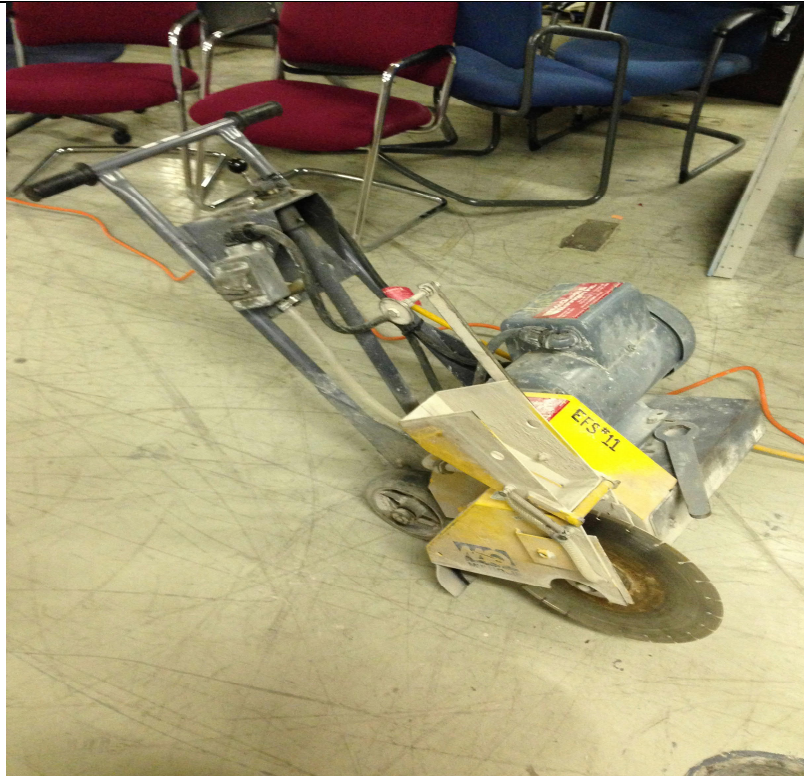
Saw cutting of concrete slab from EP-2 to column U3.

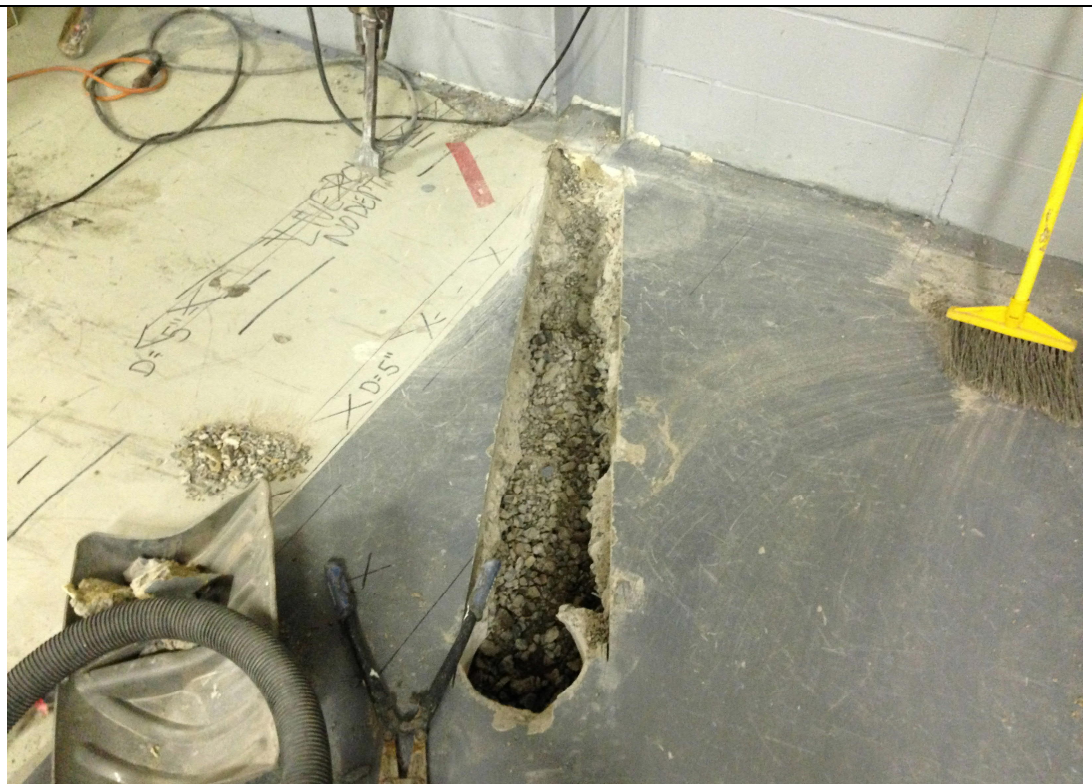
Completed jackhammering of trench EP-4 to U6

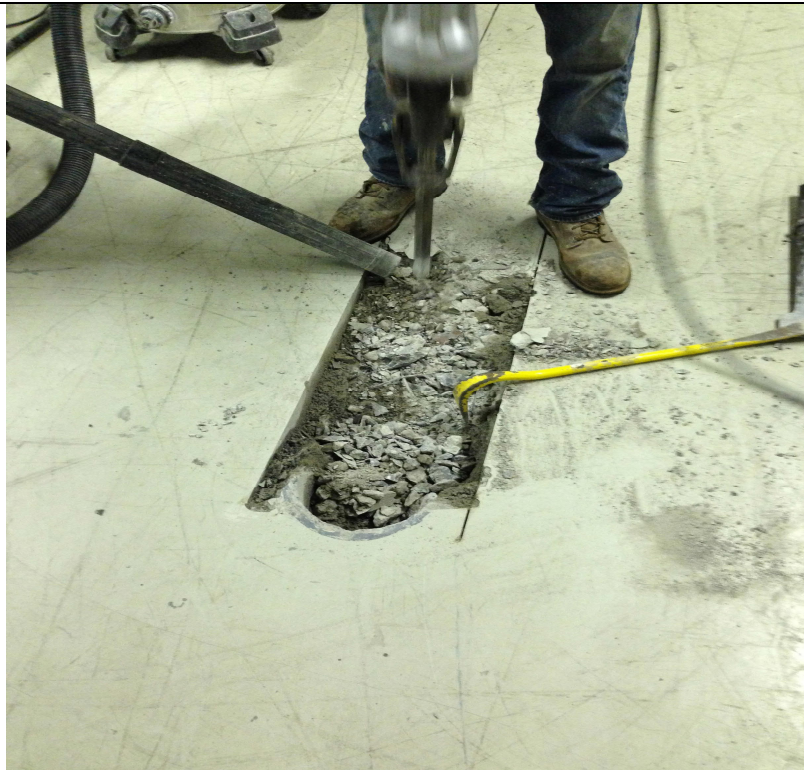
Working on piping in EP-2 to column U3 trench.

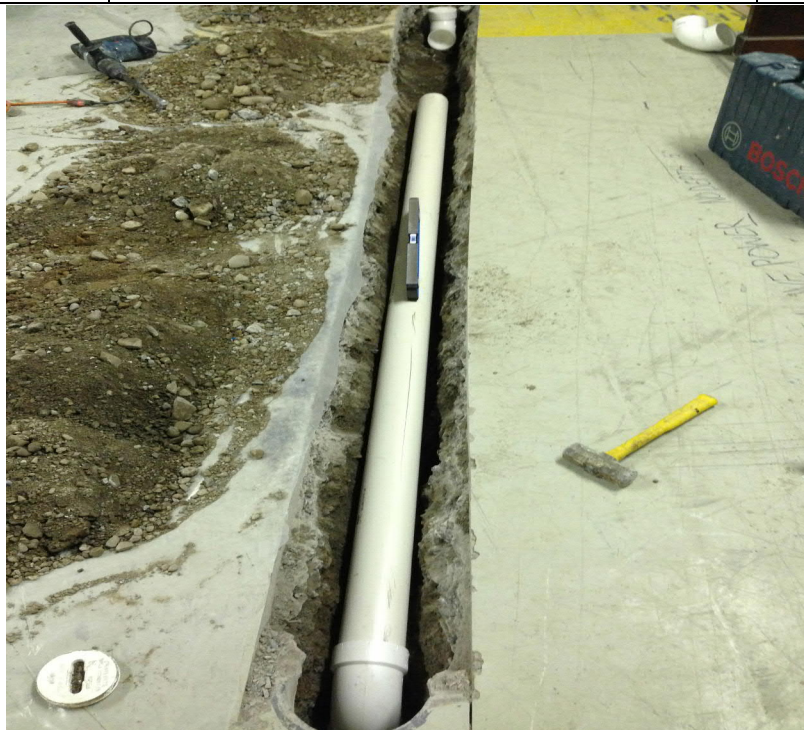
**Photo No.**  
**2**

Piping installed with backfill on EP-2 to column U3 trench.

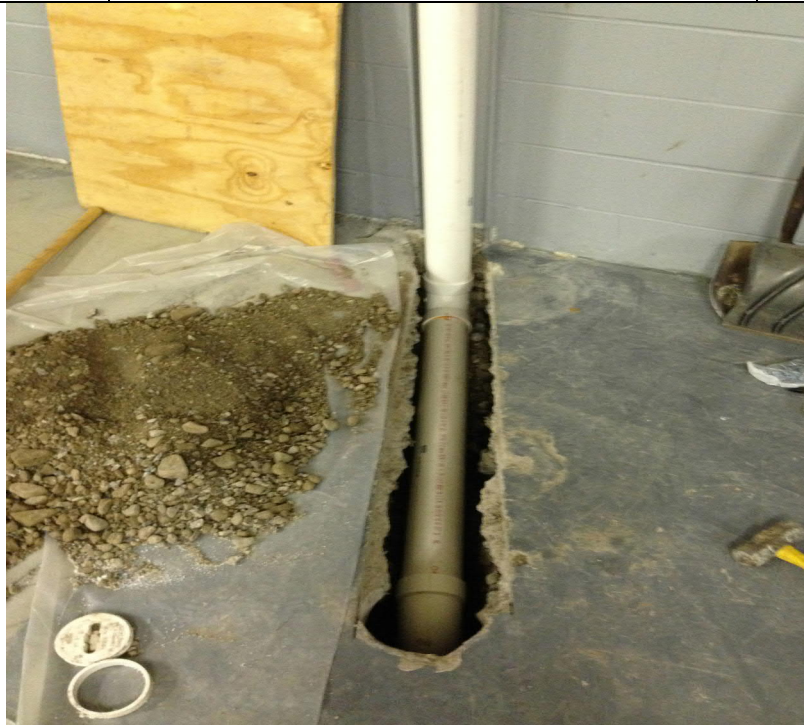
Completed piping of EP-4 to column U6 trench.

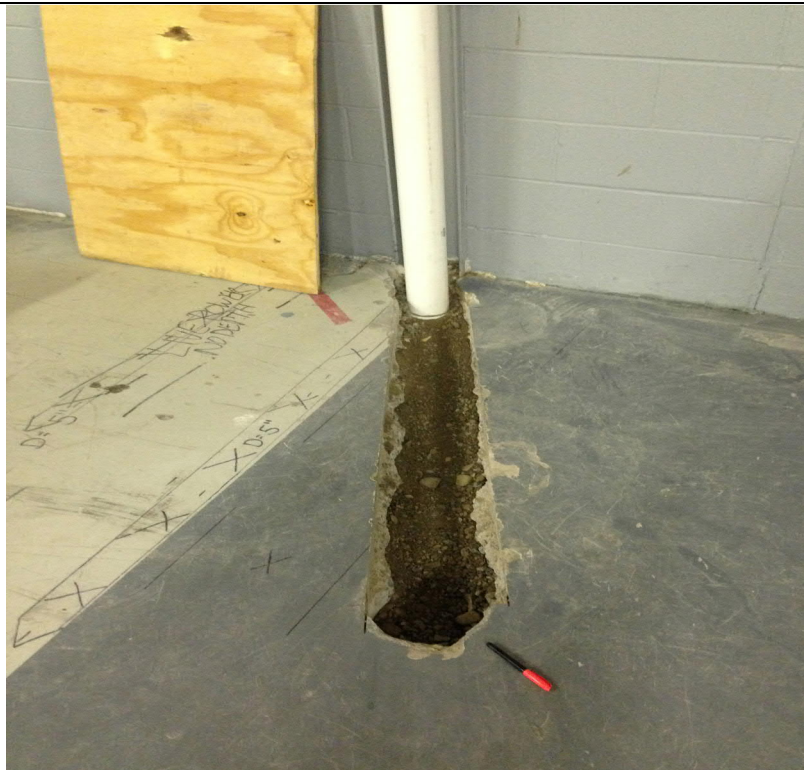
**Photo No.**  
**4**

Piping installed with backfill on EP-4 to column U6 trench.

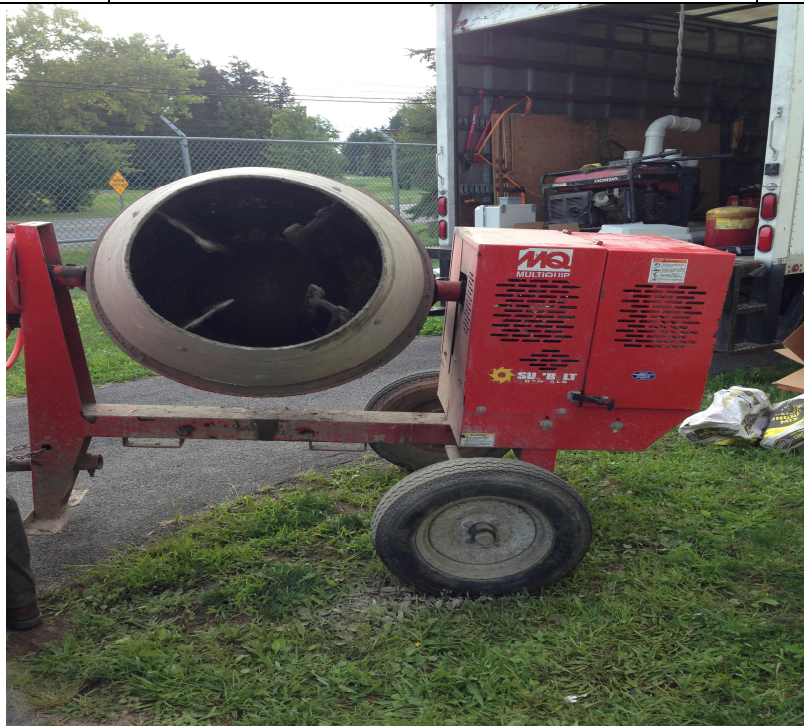
**Photo No.**  
**1**

Tow behind gas powered cement mixer.

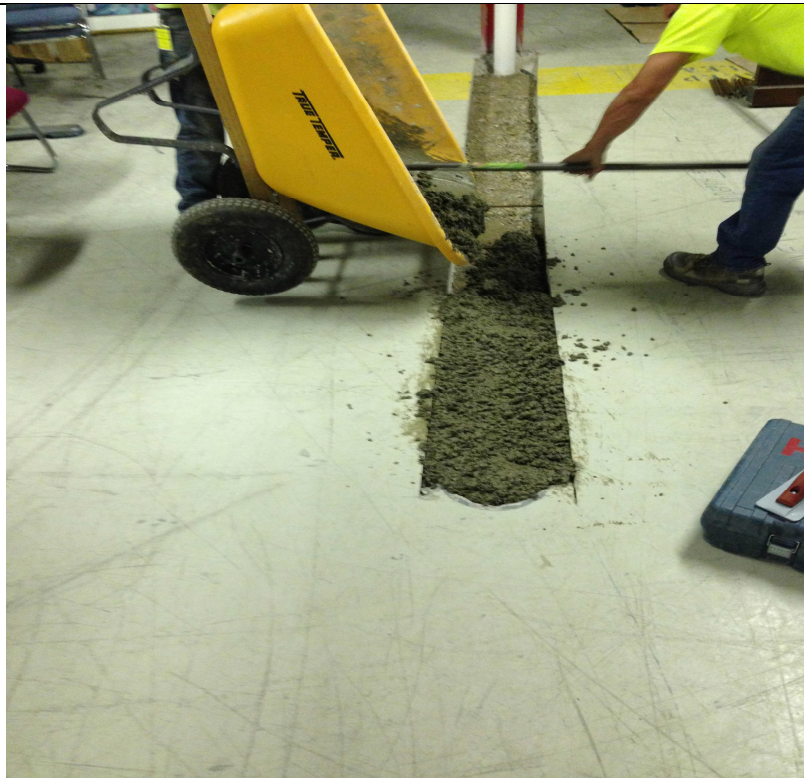
**Photo No.**  
**2**

Pouring concrete into EP-2 trench.

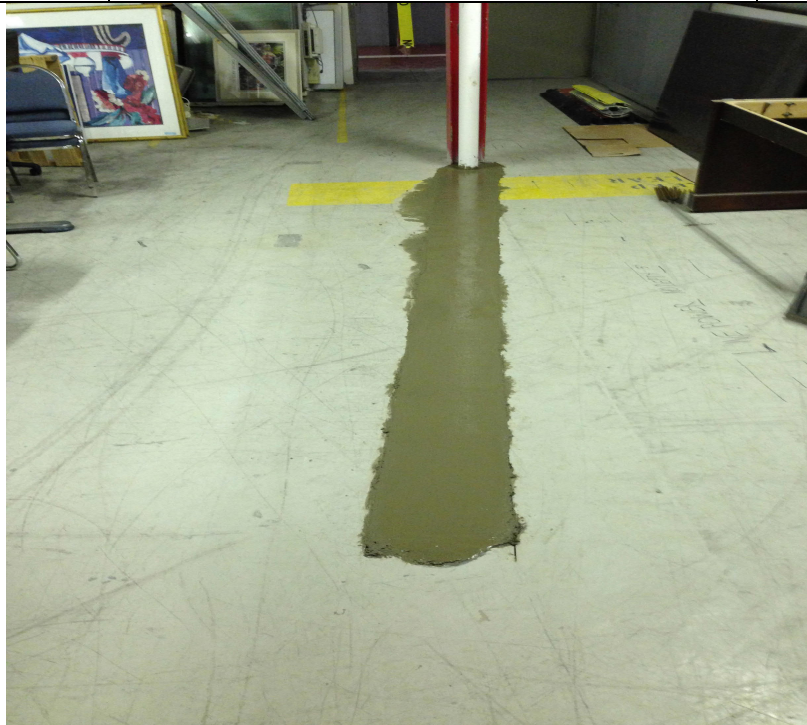
**Photo No.**  
**3**

EP-2 trench  
concreted.

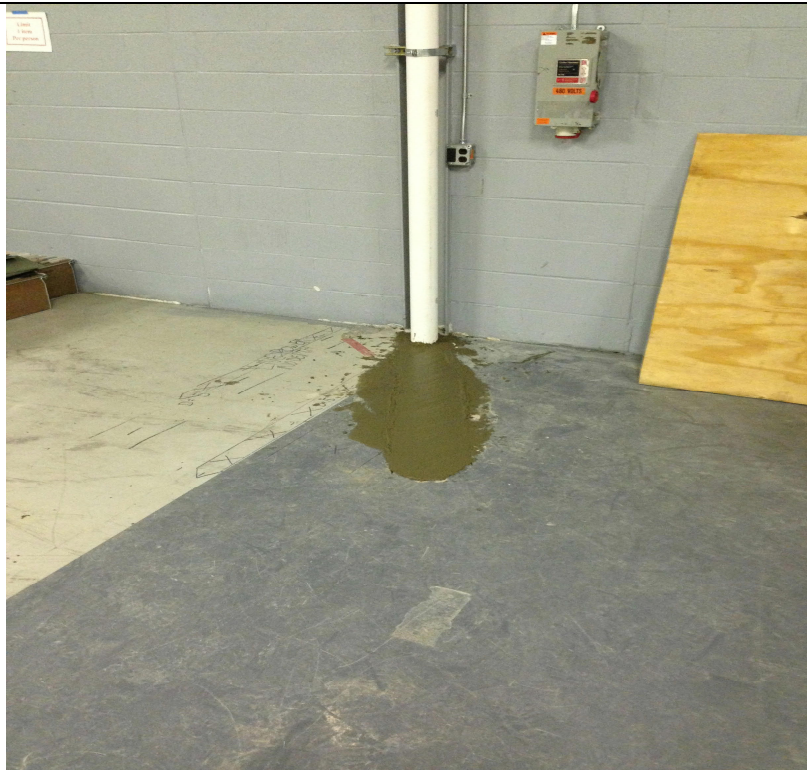
**Photo No.**  
**4**

EP-4 trench  
concreted.

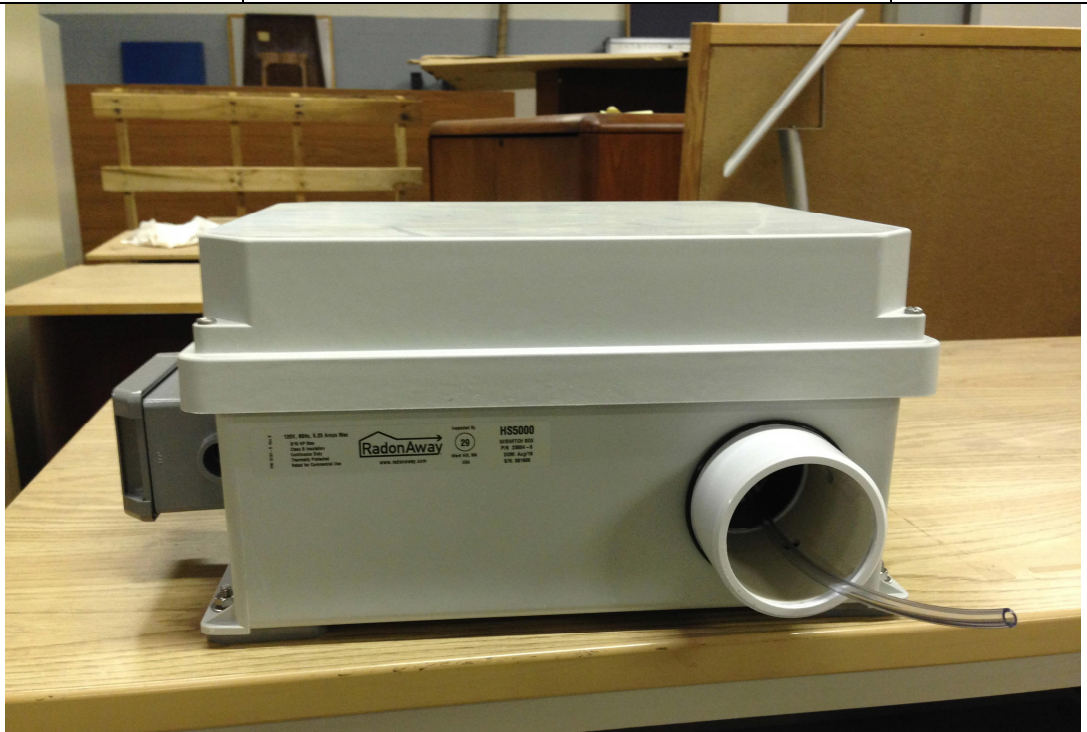
**Photo No.**  
**1**

RadonAway fan.

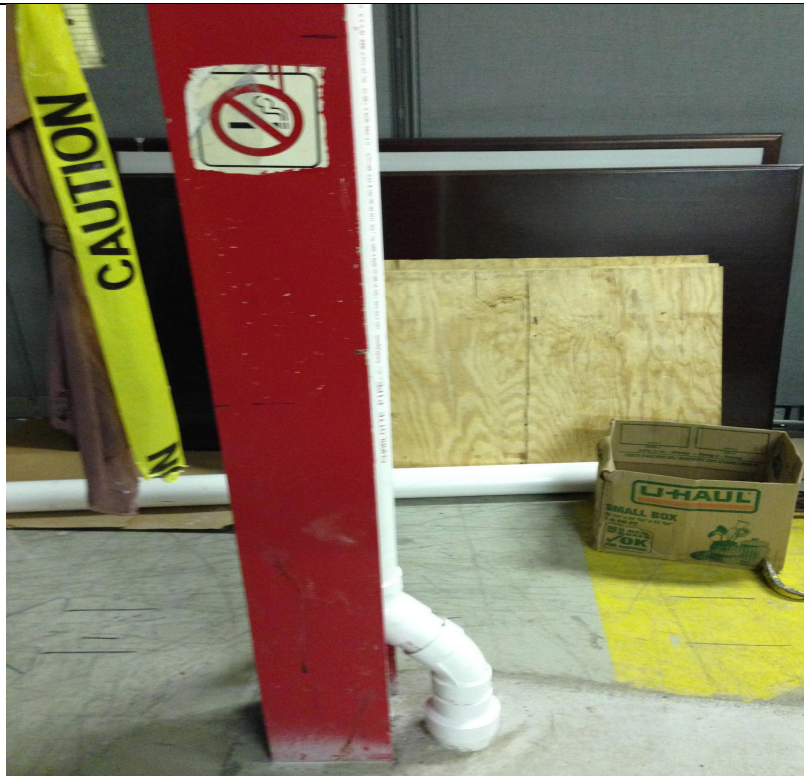
**Photo No.**  
**2**

Profile of PVC from slab of trench EP-2 along column U3.

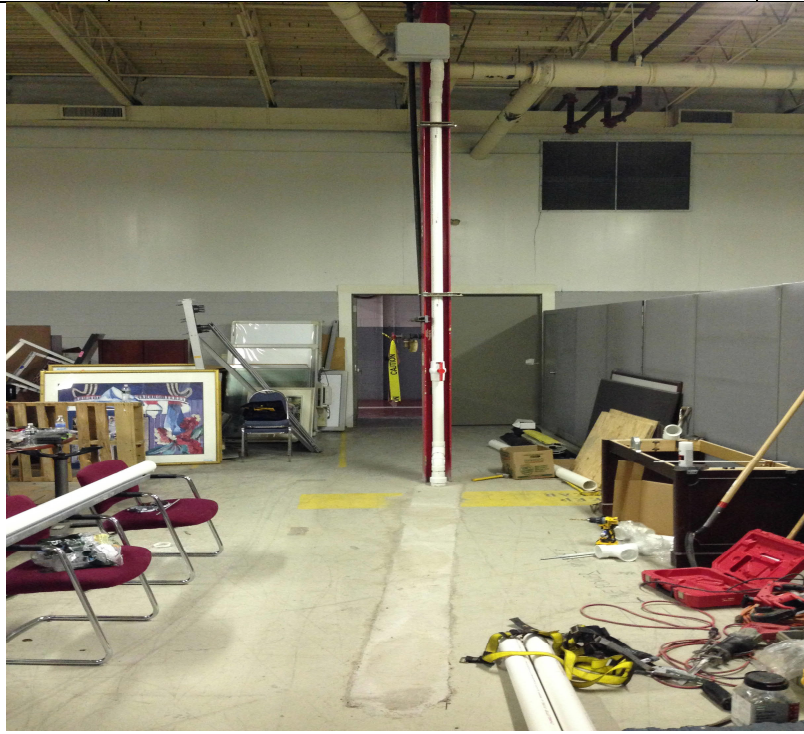
Trench, Piping,  
Blower at EP-2/U3.

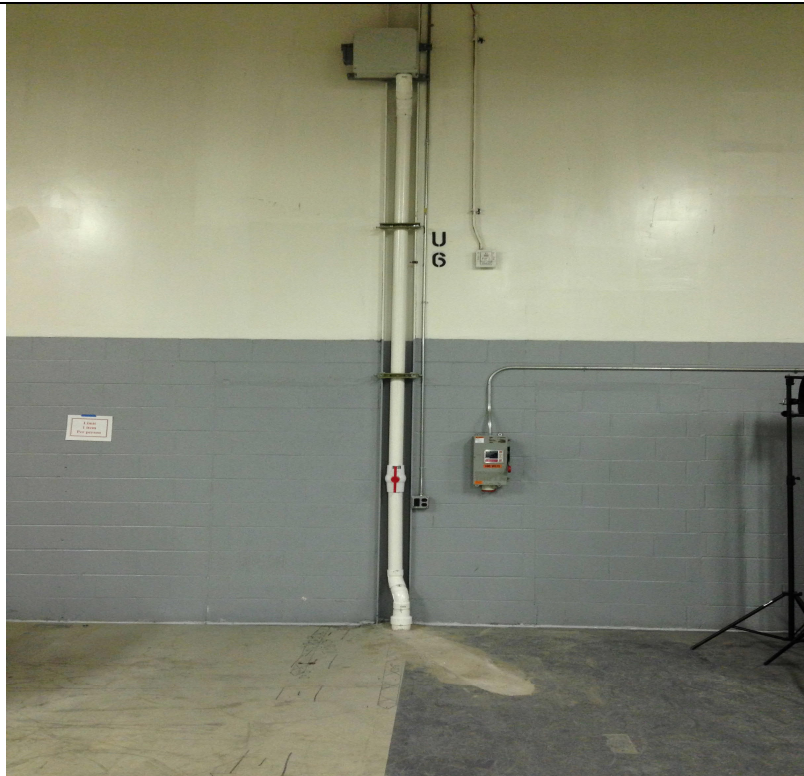
Trench, Piping,  
Blower at EP-4/U6.

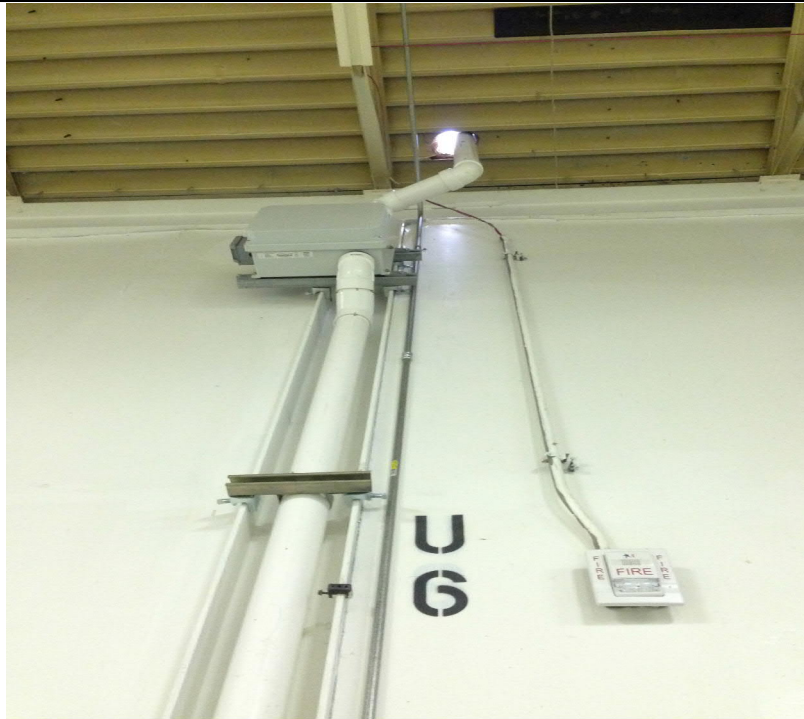
**Photo No.**  
**1**

Roof penetration at column U6.

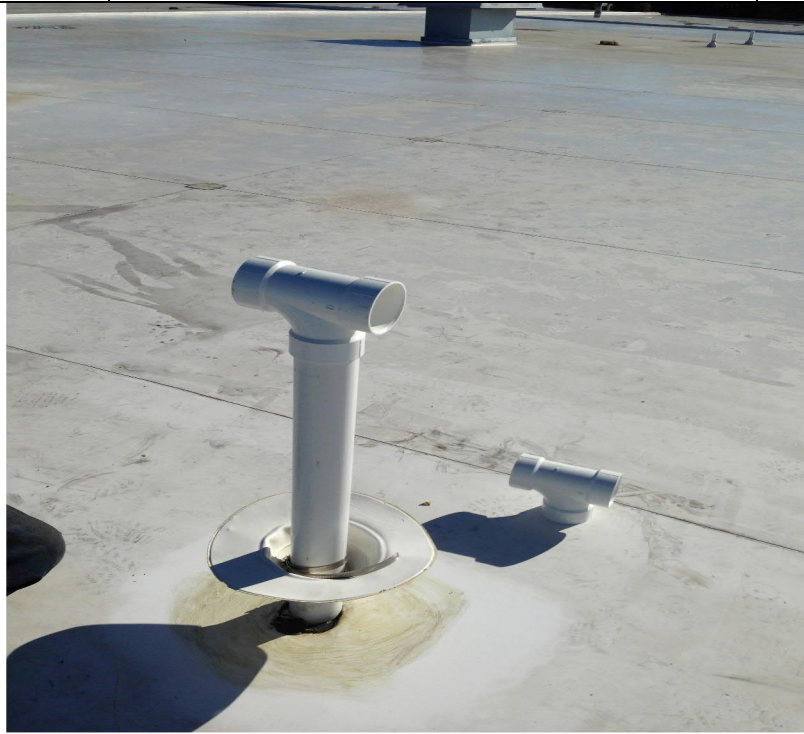
**Photo No.**  
**3**

In process of sealing rubber boot to rubber rooftop.

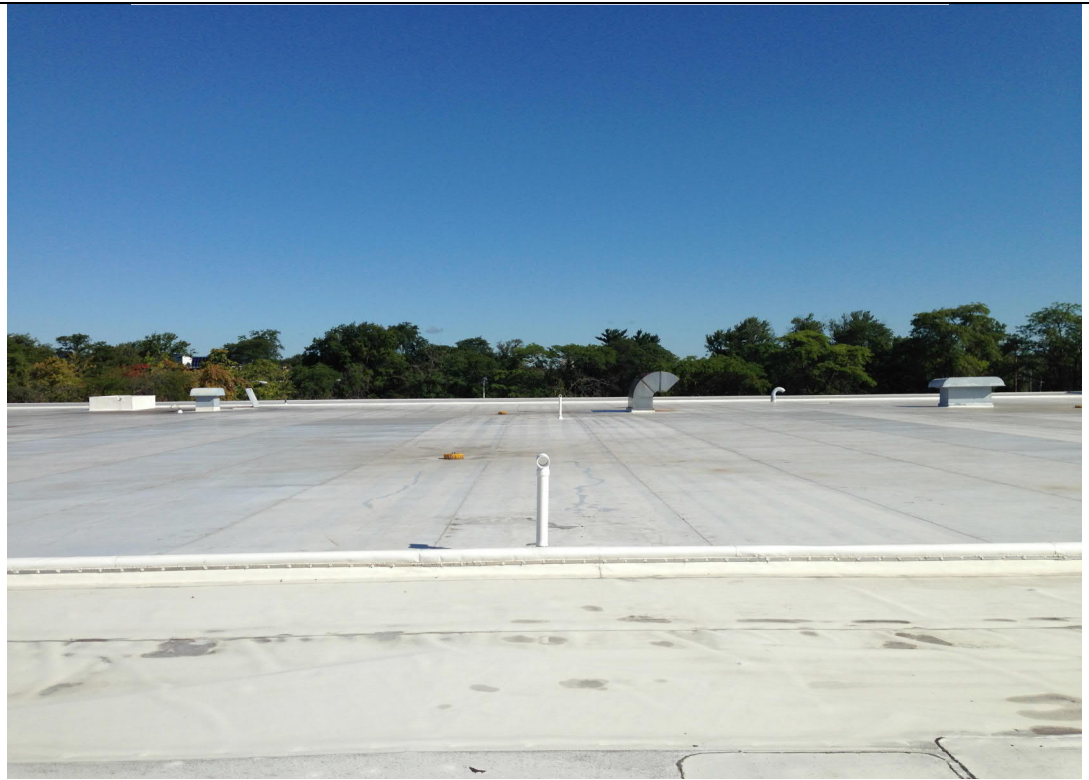
**Photo No.**  
**4**

EP-4 (foreground) and EP-2 (background). Nearest building exhaust = 30' NNE of EP-2. Nearest building intake = 65' ENE of EP-2.

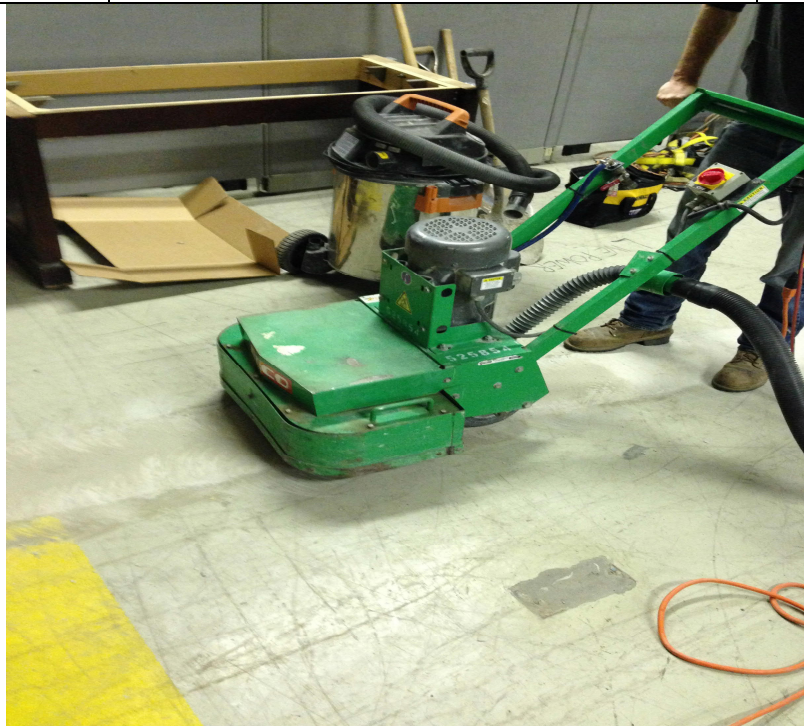
Concrete grinder with HEPA vacuum attachment.

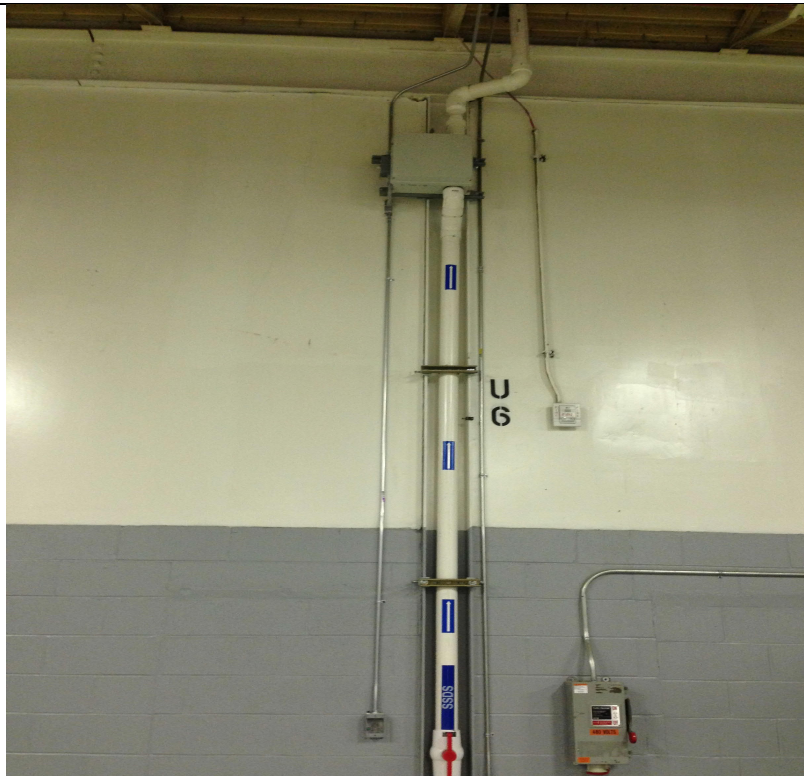
**Photo No.**  
**2**

Wiring/Conduit configuration along U6 column.

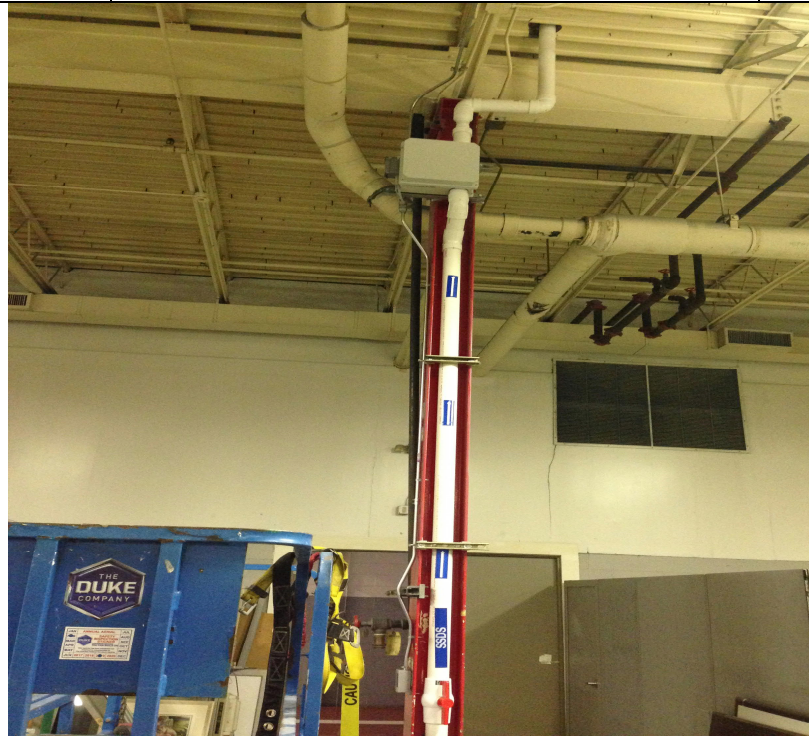
Wiring/Conduit configuration along U3 column.

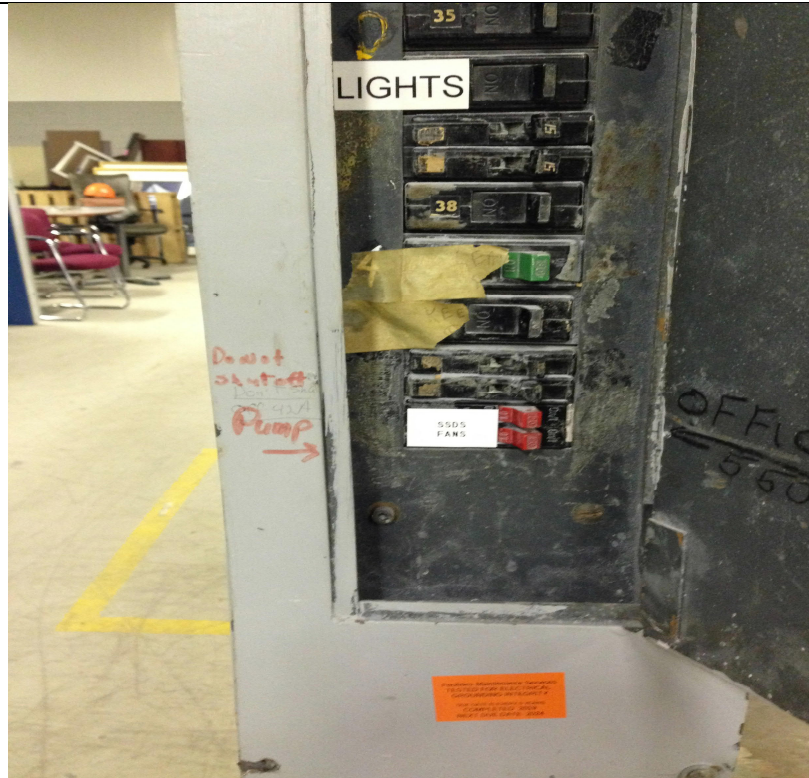
**Photo No.**  
**4**

Fuse box location of SSDS fans. Bottom breaker (red) on fuse box located on column U4.

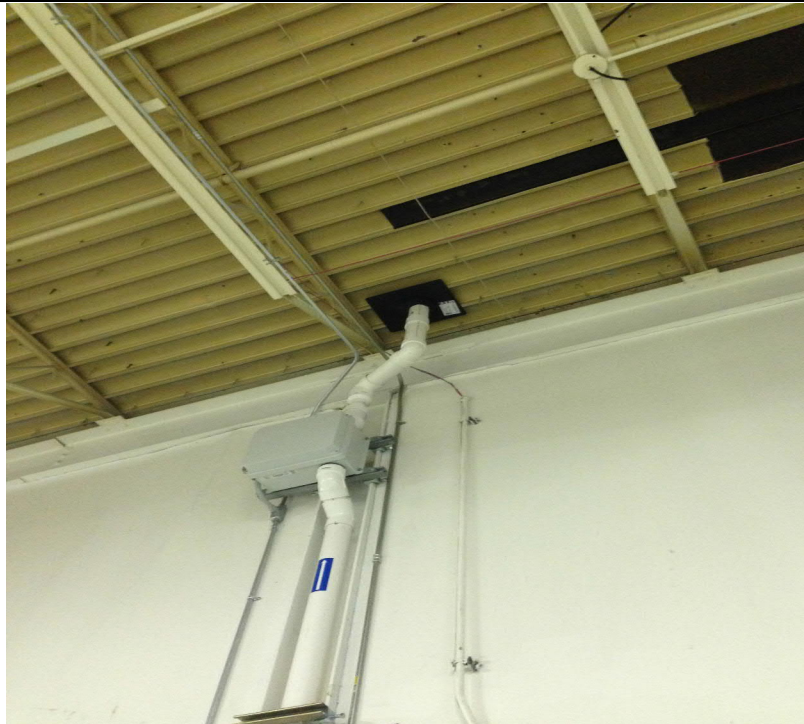
Roof penetration at column U6. Black plastic pipe flashing.

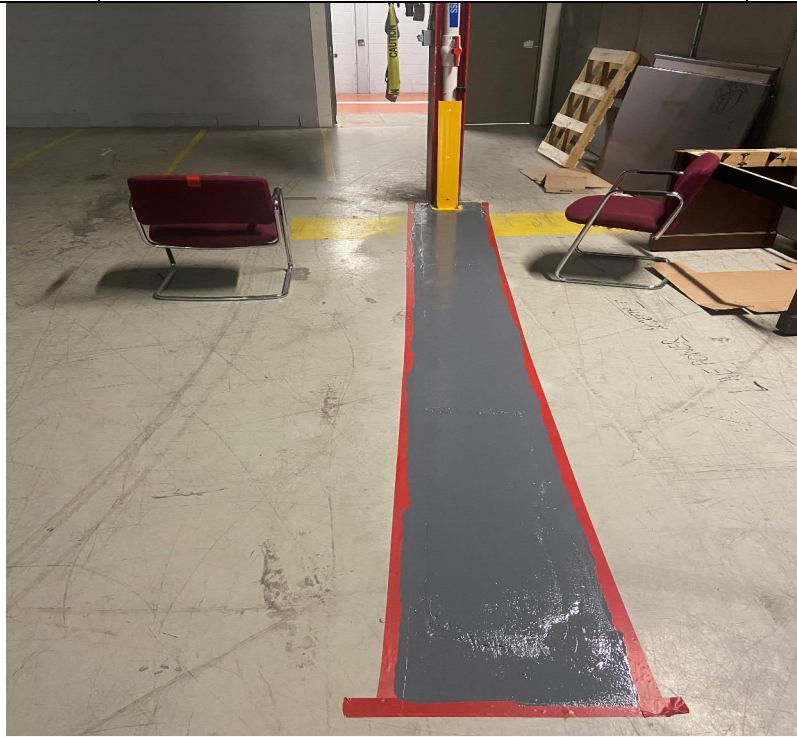
TR-20 EP-2 painted trench and bollard installation.

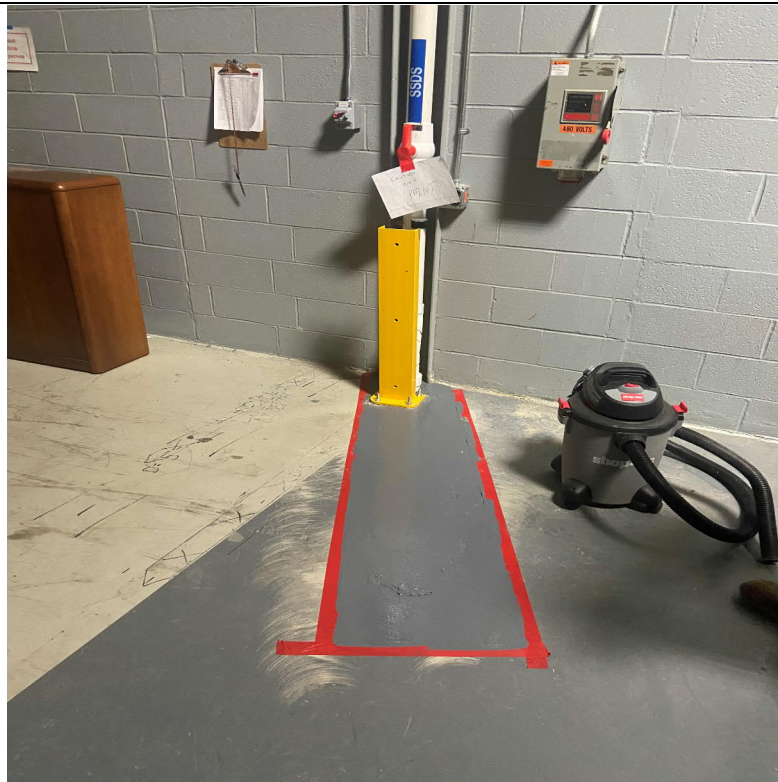
**Photo No.**  
**4**

TR-20 EP-4 painted trench and bollard installation.
