## Outfall Evaluation Report, Former Hampshire Chemical Corp Facility, Waterloo, New York

PREPARED FOR: Jerome Cibrik/Dow Remediation Leader

PREPARED BY: CH2M HILL Project Team

DATE: February 22, 2011

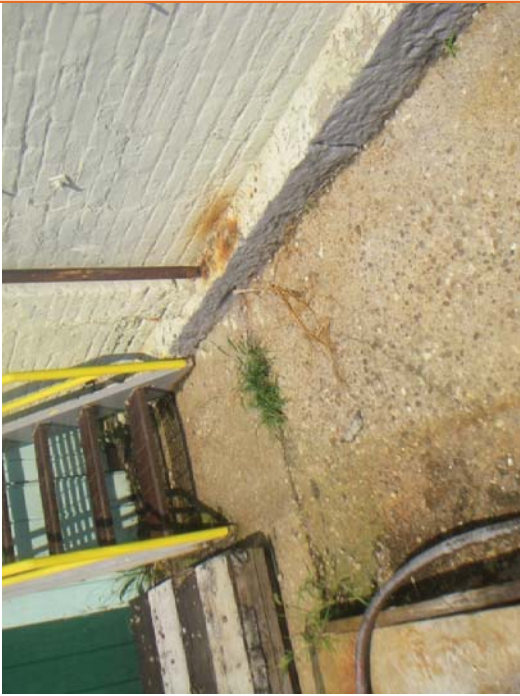
Photo 3. Outfall 001: No smoke observed northeast of 001-001A

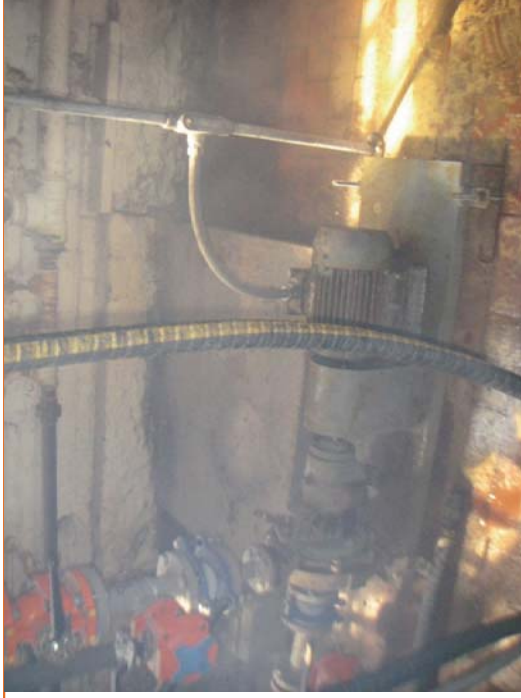
With the smoke blower placed on manhole opening 004-001, smoke was observed upgradient at two vertical pipes near 004-001A in Building 2-A, and at downgradient nodes 004-000A (Outfall 004 Shed) and 004-000 (Outfall 001 discharge point). These observations were consistent with site drawings (Attachment 3, Photographs 5 to 8).

Photo 5. Outfall 004: Smoke observed at former Hotwell 4B on east side of Building 4

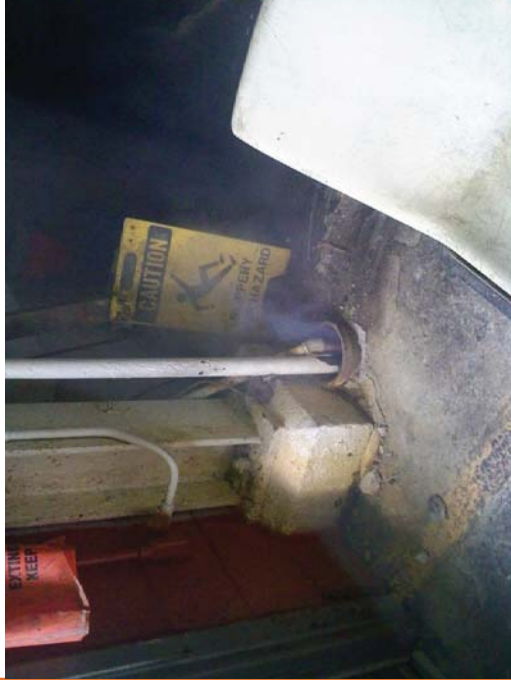
Photo 6. Outfall 004: Smoke observed at northernmost pipe in Building 2-A near 004-001A, north of Building 2-A entrance

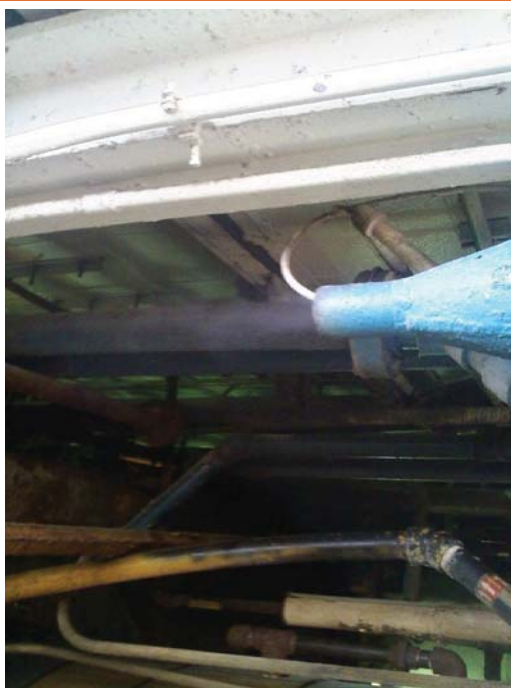
Photo 7. Outfall 004: Smoke observed at tap factory near 004-001A, south of Building 2-A entrance

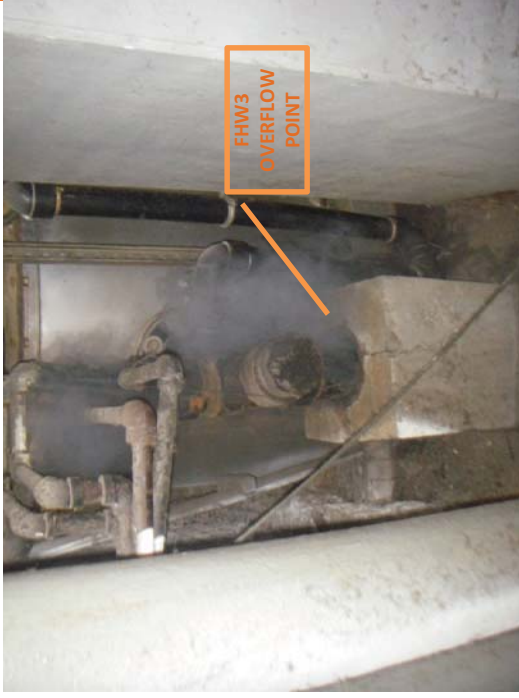
Photo 14. Outfall 005: Smoke observed at 005-001B near former Hotwell 3 overflow point

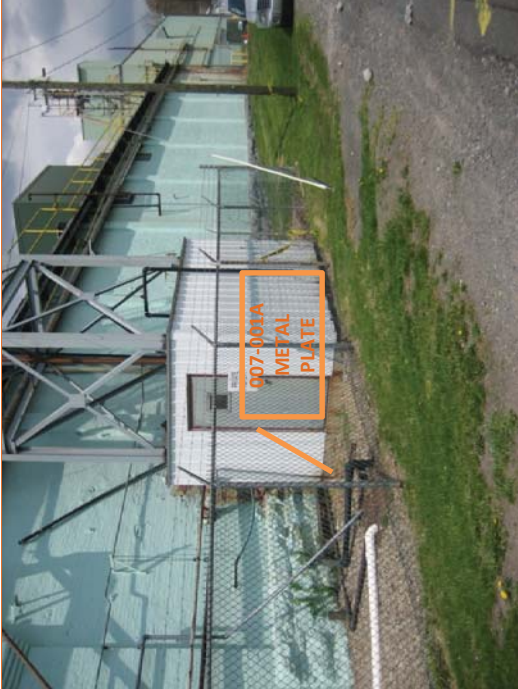
Photo 15 (Archive photo). Former Outfall 007 (Currently piped to Outfall 004): Perforated metal plate at 007-001A

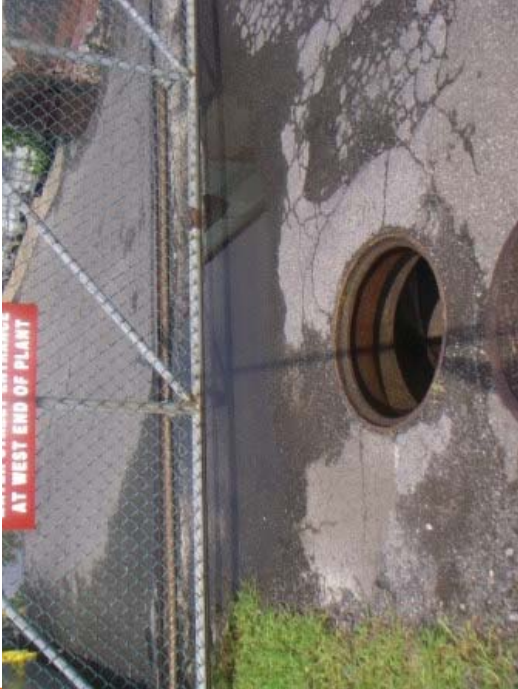
Photo 17. Former Outfall 007 (Currently piped to Outfall 004): Location for smoke blower at 007-001

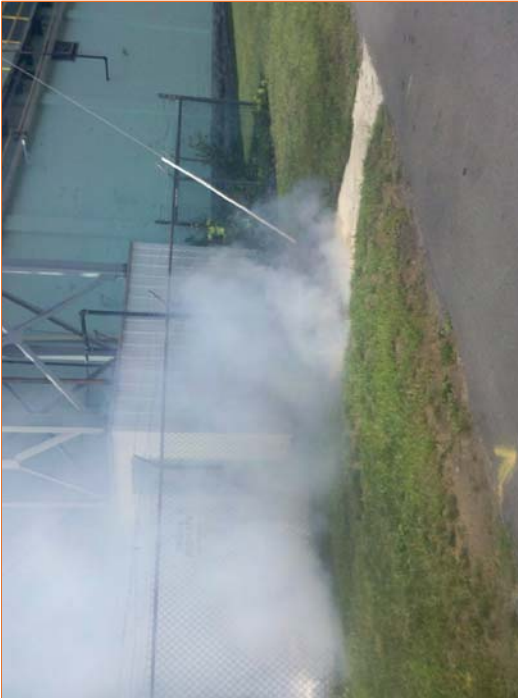
Photo 16. Former Outfall 007 (Currently piped to Outfall 004): Smoke observed at catch basin east of 007-001A

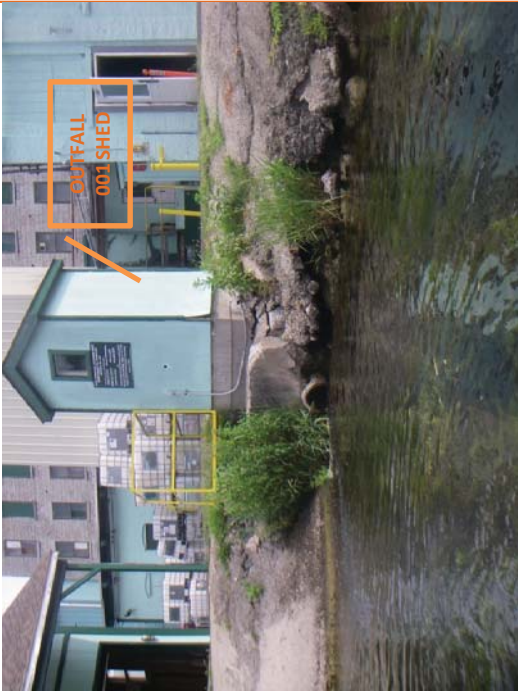
Photo 18. Outfall 001: Discharge point 001-000

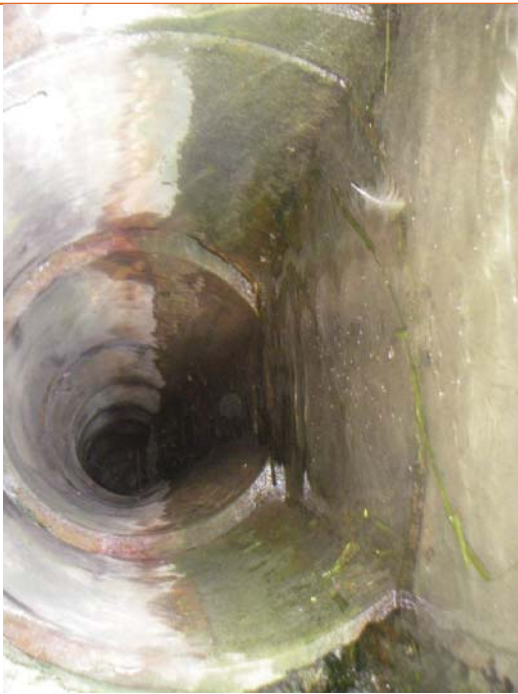
Photo 22. Interior of 21" diameter historical pipe No. 7 east of Outfall 002. See Figure 6.

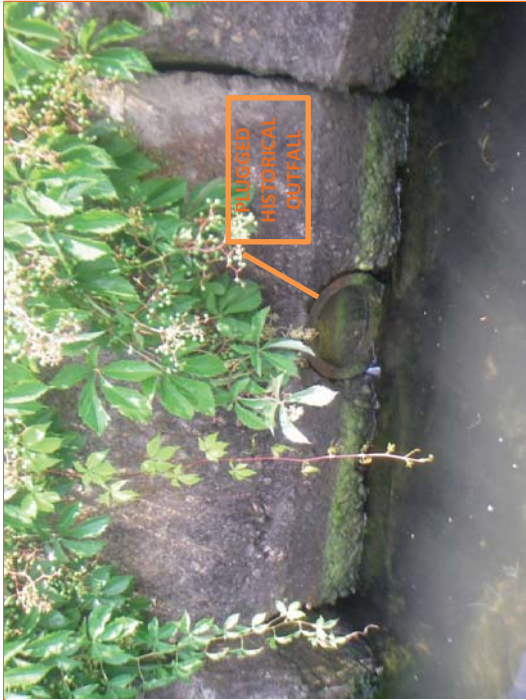
Photo 44. Abandoned 6" diameter historical outfall located between Outfalls 005 and 010. Plugged at discharge point. Seems to correspond to historical pipe No. 8.

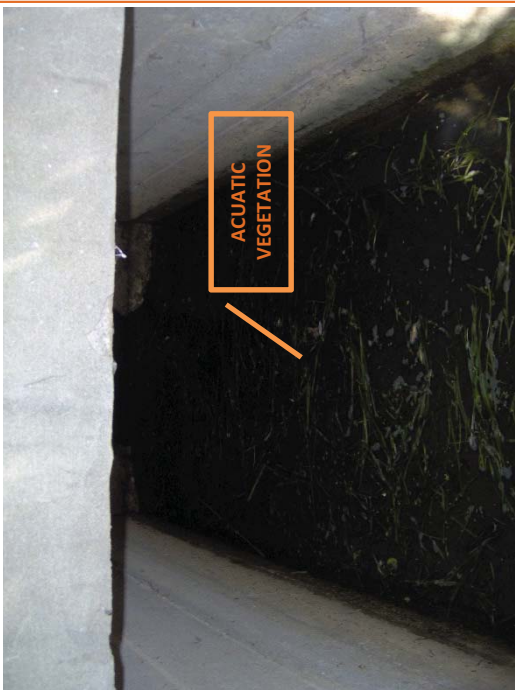
Site personnel opened the manhole upgradient of Outfall 008, which facility personnel had welded shut. This manhole did not connect to Outfall 008, but to a parallel underground conduit. This conduit is west of Building 4, and site personnel informed CH2M HILL that it was connected to a conduit under Building 14 and was used for discharge of noncontact cooling water to the canal. However, its current conditions are unknown (Attachment 3, Photographs 45 to 46).

Photo 46. North view of culvert west of Outfall 008

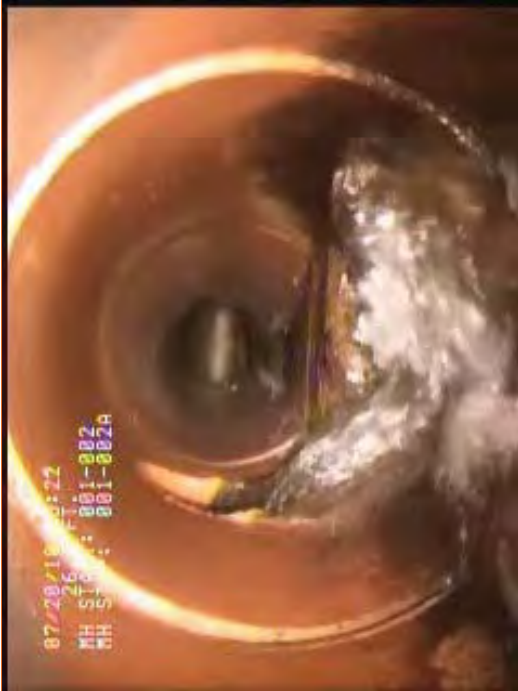
The piping interior between nodes 001-001 and 001-001B was found to be in good condition; no defects were documented. Water was observed flowing from 001D to 001C, then to 001-001 for discharge at 001-000. No water was observed flowing from 001B to 001D; however, accumulated water was seen in the piping interior at 001B. The node at 001B seems to correspond to abandoned Outfall 002 piping (Attachment 3, Photographs 47 to 49). Approximately 32 feet of piping was surveyed.

Photo 47. Outfall 001 (001-001B to 001-001): Noncontact cooling water discharged from active factory tap in Building 4 (001-001D to 001-001C)

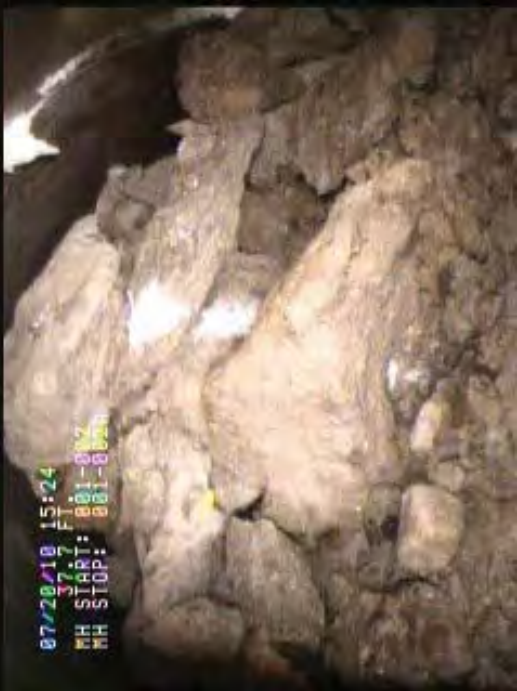
The outfall piping at 002-000 was identified without a plug at the discharge point. The upstream node 001-001B presented a concrete-like debris within the northern end of the piping and a concrete plug at the southern end. No defects were documented (Attachment 3, Photographs 48 and 49).

Photo 49. Outfall 001 (001-001B to 001-001): Cement debris in lateral to west of 001-001B which seems to correspond to Outfall 002

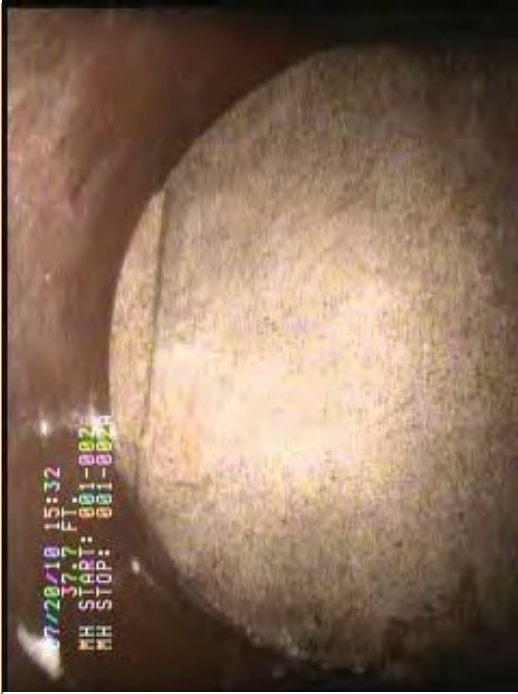
Photo 48. Outfall 001 (001-001B to 001-001): Cement plugged lateral south of 001-001B which seems to correspond to Outfall 002

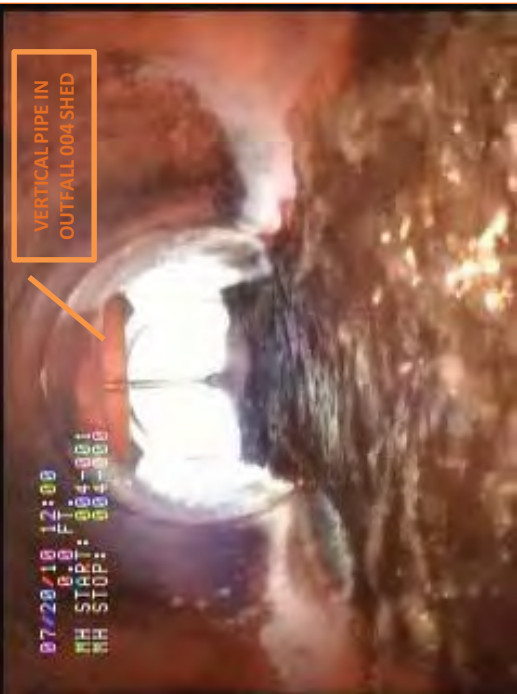
Photo 50. Outfall 004 (004-001 to 004-000): Looking downstream to Outfall 004-000

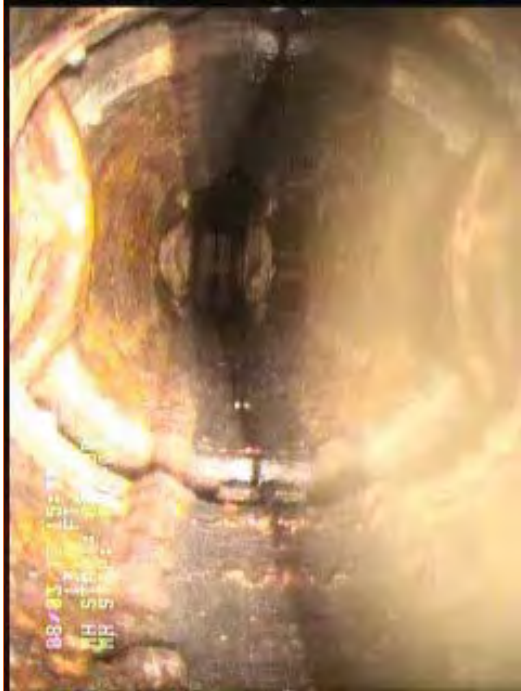
The discharge piping at 007-000 was not found. The area was heavily vegetated and riprap lined the canal bank area. Site personnel indicated the piping (007-000 to 007-001) could be submerged or may have been removed. Site personnel indicated the upstream section of Outfall 007 piping (007-001 to 007-001A) was rerouted to discharge through Outfall 004 via nodes 007-001 and 004-001. Approximately 8 feet of piping were surveyed because the CCTV equipment could not pass a gate valve structure located east of Building 1 (Attachment 3, Photographs 63 to 65).

Photo 63. Outfall 004 (007-001A to 007-001): Gate valve at 7ft upstream , north of 007-001

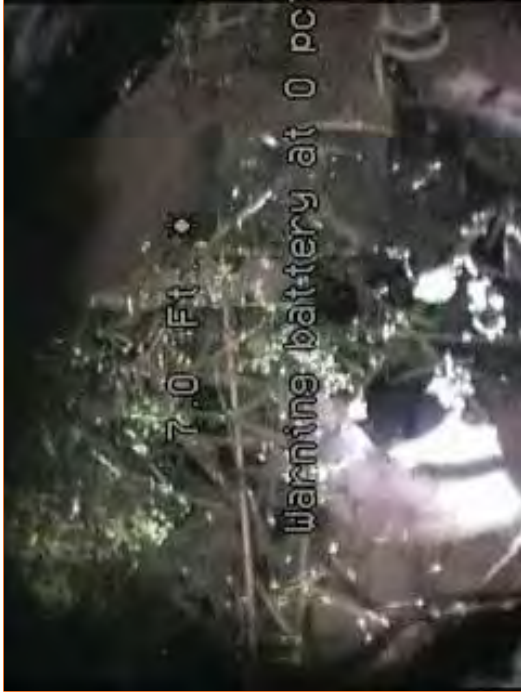
Photo 71. Outfall 005 (005-001A to 005-001): Aquatic weeds at 005-001

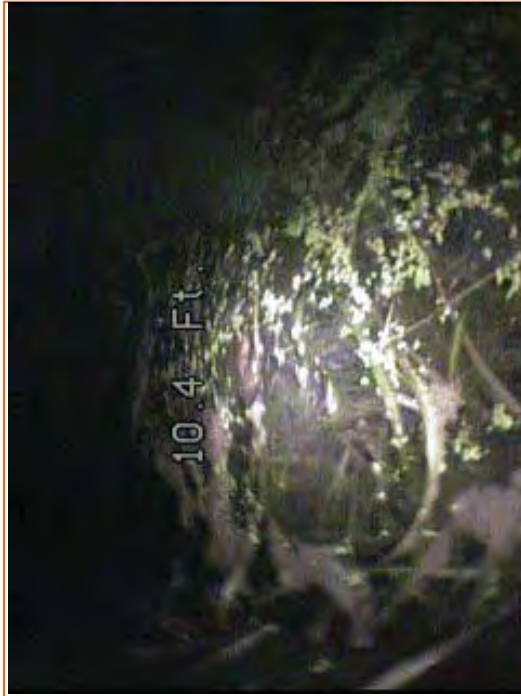
Photo 72. Outfall 005 (005-001A to 005-001): Roots and weeds at 10ft upstream of 005-001

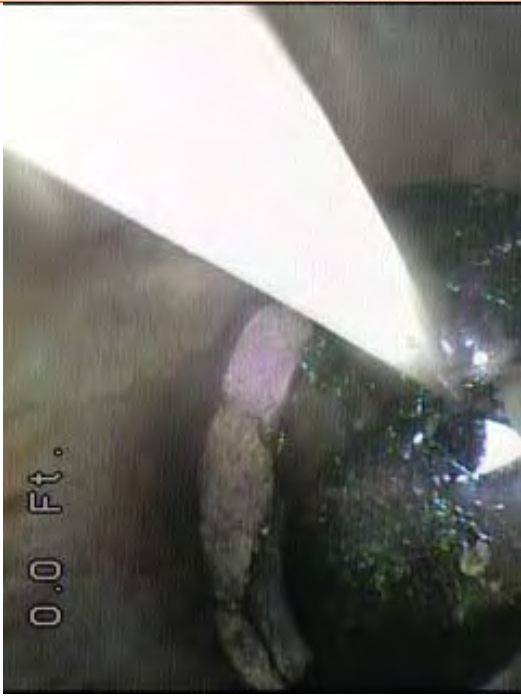
The outfall piping at 005-000 was submerged by canal water. Gravel debris in the submerged pipe impeded CCTV and push camera access, and the small diameter of piping at former hot well in Building 4 (FHW4) impeded push camera access (Attachment 3, Photographs 66 and 74). The perforated metal plate at 005-001 did not have enough area to guide the push camera through the piping. Approximately 39 feet of piping were surveyed from 005-000 to 005-001, and 4 feet of piping from 005-001A to 005-001.

Photo 74. Outfall 005 (005-001A to 005-001): Pipe partially submerged at 005-001

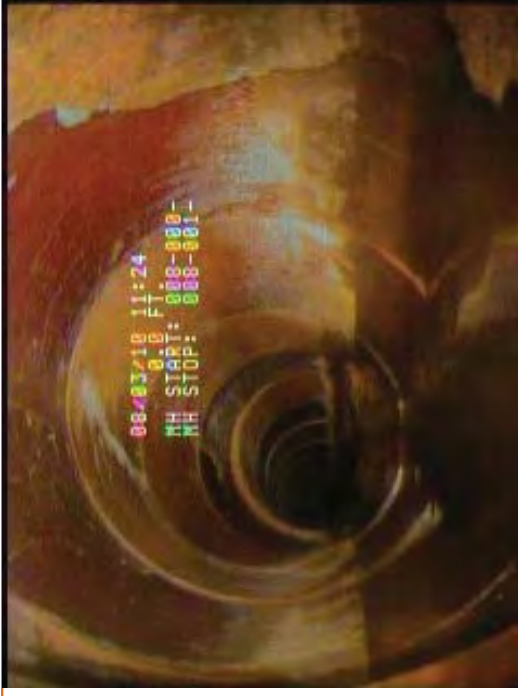
Photo 79. Outfall 008 (008-001 to 008-000): Mid-pipe 008-001 to 008-000 (facing south)

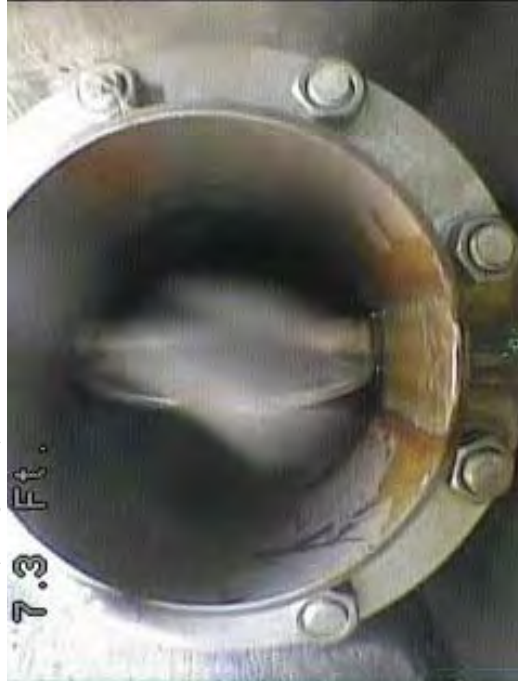
The outfall piping at 009-000 was above the water level in the canal and could not be accessed with the push camera because of the butterfly valve at the discharge point (Attachment 3, Photograph 81). Approximately 1 foot of piping was surveyed.

Photo 81. Outfall 009 (009-001 to 009-000): Outfall 009-000 gate valve from land side chamber (facing south)

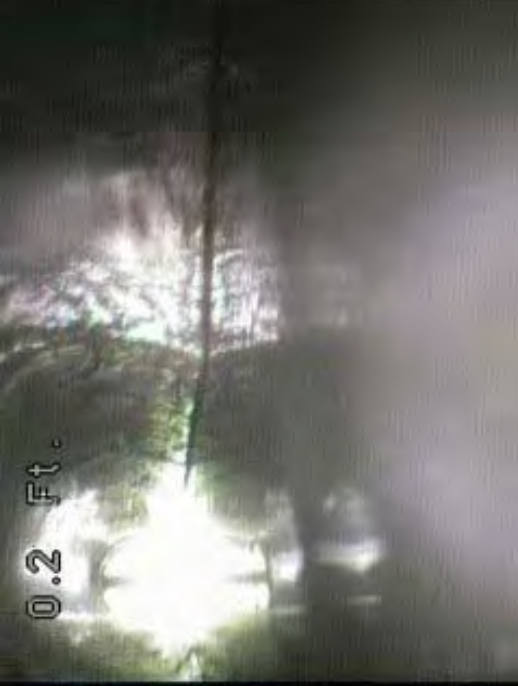
The outfall piping at 010-000 was above the water level in the canal and could not be accessed with the push camera because of the butterfly valve at the discharge point (Attachment 3, Photographs 82 to 84). Approximately 1 foot of piping was surveyed.

Photo 82. Outfall 010 (010-001 to 010-000): Facing south downstream from land side chamber

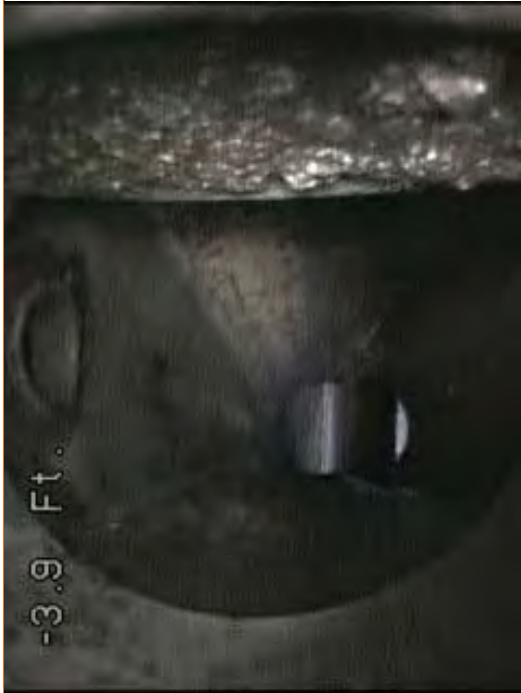
Photo 83. Outfall 010 (010-001 to 010-000): Facing north upstream from canal side chamber

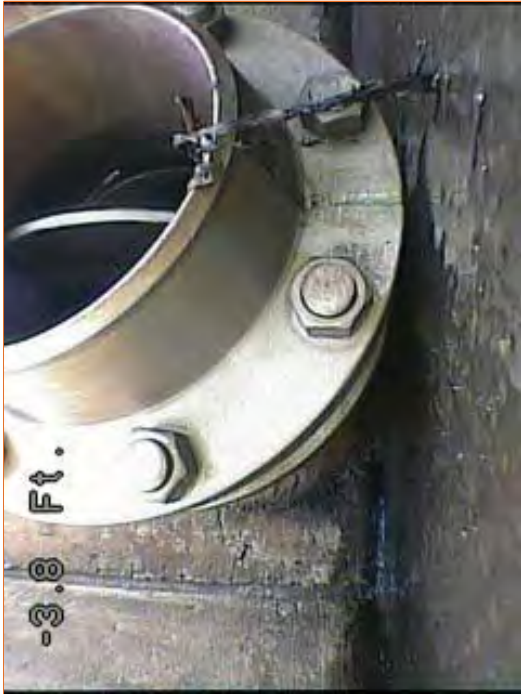
Photo 84. Outfall 010 (010-001 to 010-000): Outfall 010-000 gate valve from canal side chamber

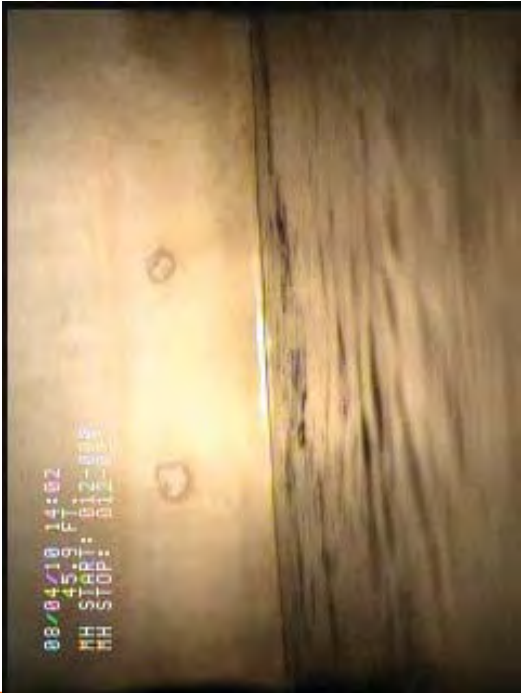
Photo 85. Outfall 012 (012-001 to 012-000): Facing north upstream to 012-001

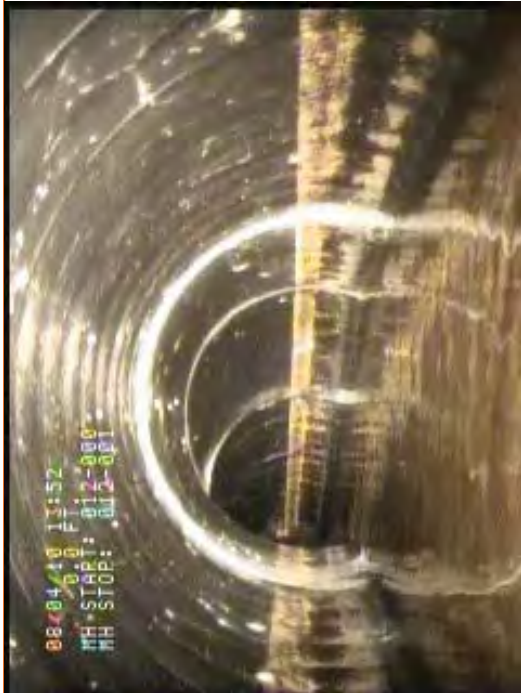
Photo 87. Outfall 012 (012-001 to 012-000): Piping interior facing north, upstream from 012-000

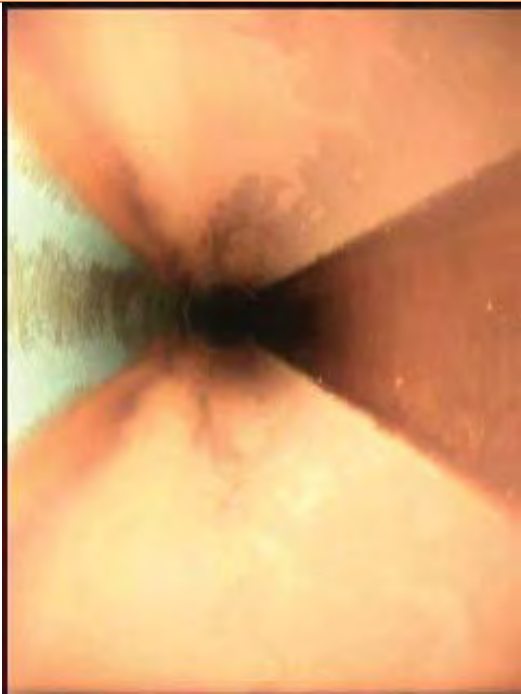
Photo 90. Outfall 013 (013-001 to 013-000): Facing north, upstream from 013-000

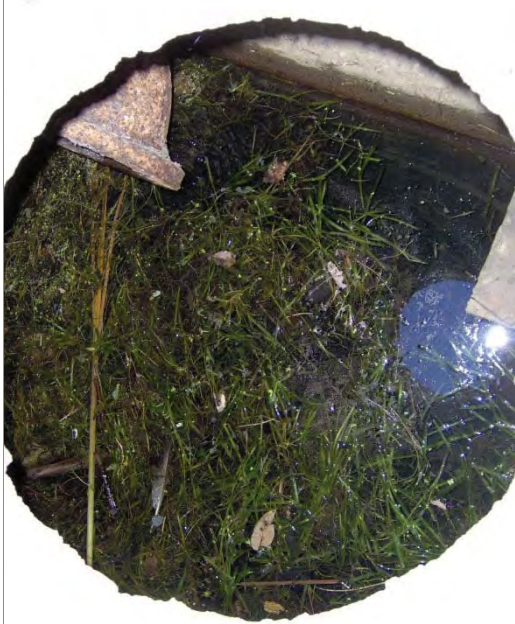
Photo 127. Manhole upgradient west of Outfall 008 which is not connected to the outfall

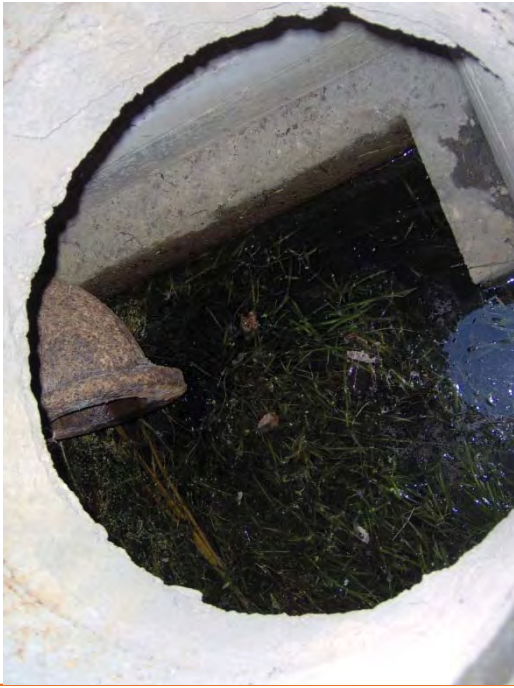
Photo 128. Manhole topside upgradient of Outfall 008 with discharge pipe from east wall

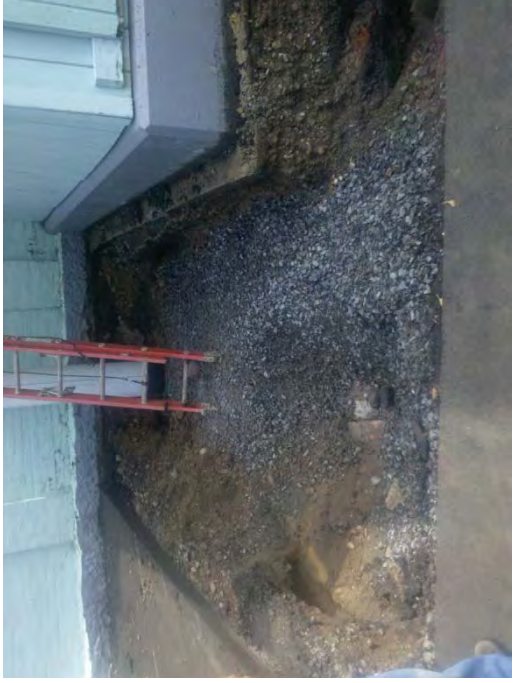
Photo 129. Manhole topside upgradient of Outfall 008 with discharge pipe from east wall; aquatic weeds

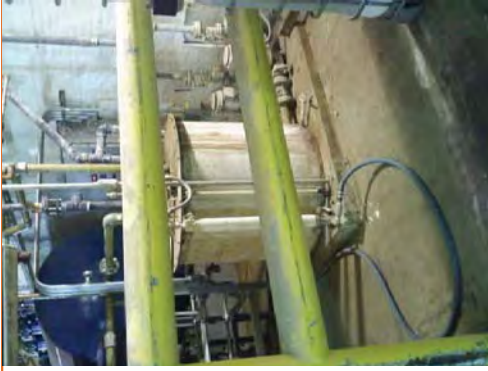
Photo 135. Location of former Hotwell 1B inside shed

Note: All former hot wells have either been paved over or replaced by aboveground storage tanks, and are no longer operational. Noncontact cooling water may be discharged at these locations.
