**DAILY INSPECTION REPORT - No. 001**  
**(Corning Post Creek) Site No. 851053**

NYSDEC Division of Environmental Remediation

Department of Environmental Conservation		<b>Contract No. D009811-29</b> <b>DEC Insp. –</b> <b>DEC PM – Robert Strang</b> <b>Contractor Supt. –</b> <b>Engineer PM – Matt Vetter</b> <b>Engineer Insp. – Joseph Moffitt</b>	
<b>Site Location: Corning, NY</b>					
<b>Weather Conditions</b>					
<b>General Description</b>	Cloudy	AM	Partly Cloudy	PM	
<b>Temperature</b>	31 F	AM	39 F	PM	
<b>Wind</b>	12 MPH W	AM	8 MPH WSW	PM	
<b>Health &amp; Safety</b> <b>If any box below is checked “Yes”, provide explanation under “Health &amp; Safety Comments”.</b>					
Were there any changes to the Health & Safety Plan?				*Yes	No X NA
Were there any exceedances of the perimeter air monitoring reported on this date?				*Yes	No X NA
Were there any nuisance issues reported/observed on this date?				*Yes	No X NA
<b>Health &amp; Safety Comments</b> Dash Card created for site. Integral conducted internal safety meeting with Parratt-Wolff No CAMP exceedances reported to Parsons by Integral

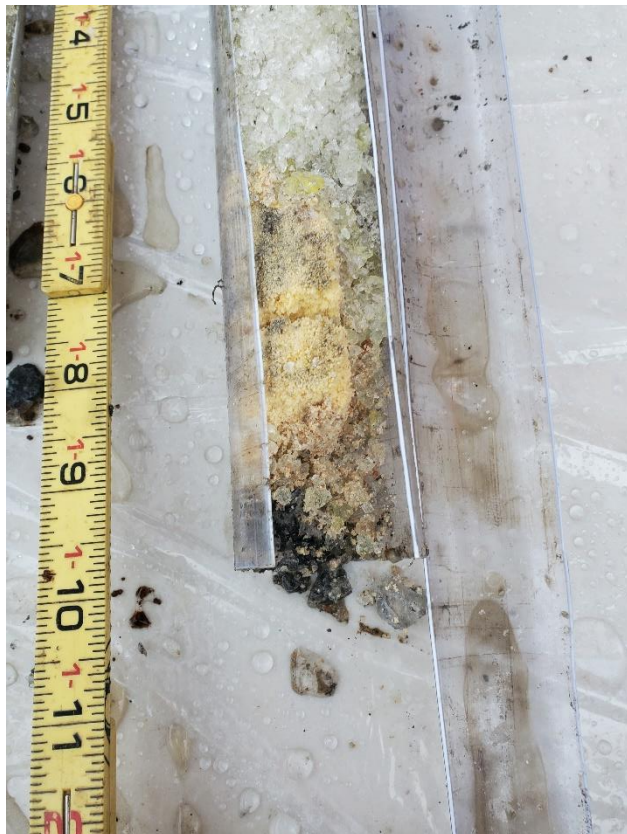
*Picture 3*

SS-39 3<sup>rd</sup> run. Brick fragments at bottom of run

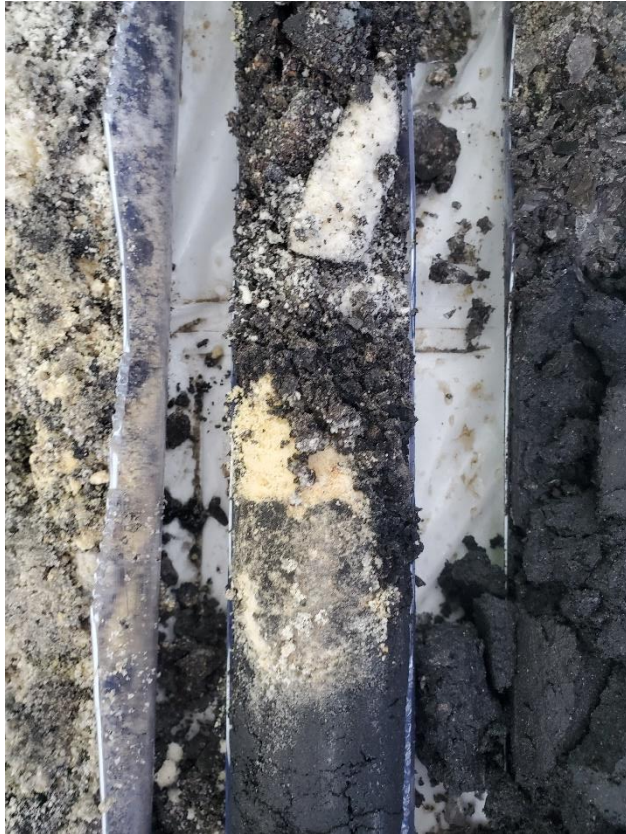
*Picture 5*

Close up SS-39 with brick fragments and ash at the bottom of run

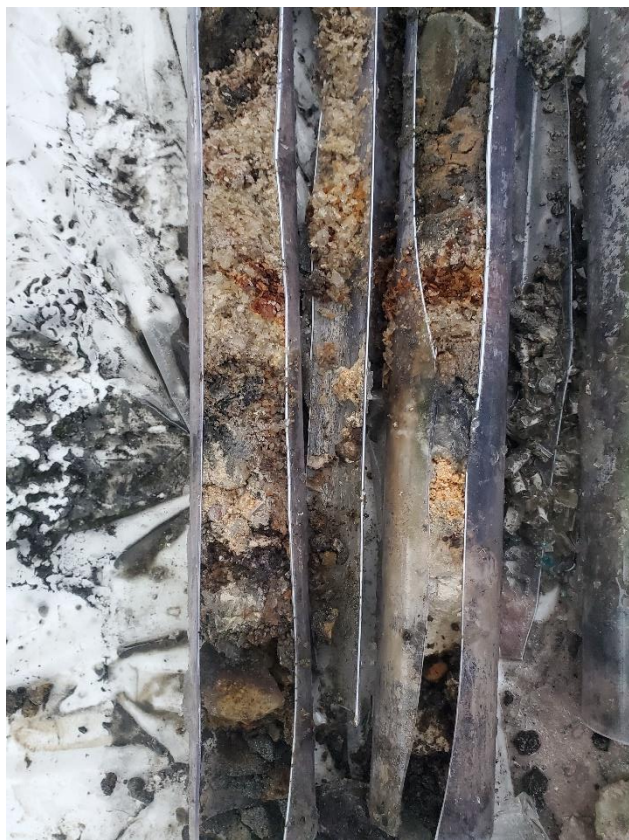
*Picture 7*

Close up of fill layer of SS-38

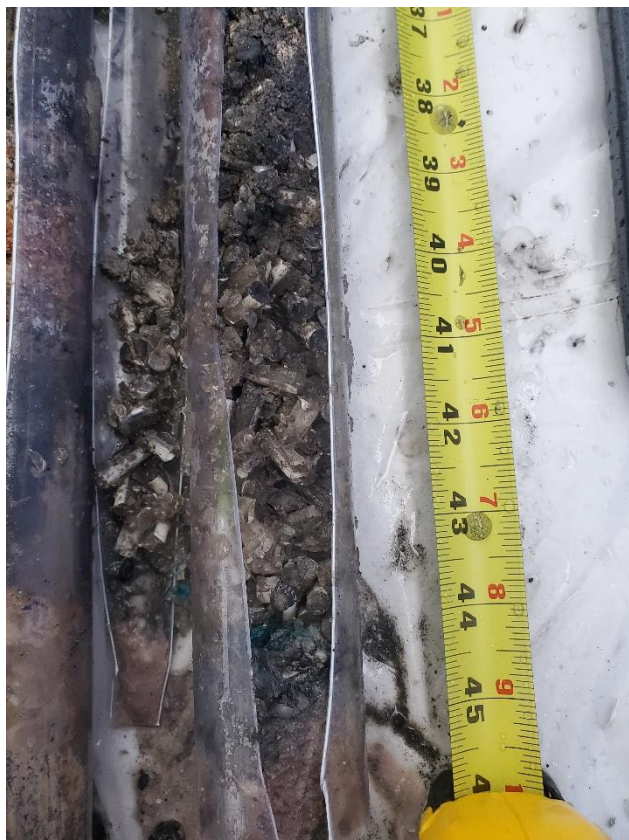
*Picture 9*

Thermometer tubing in SS-39

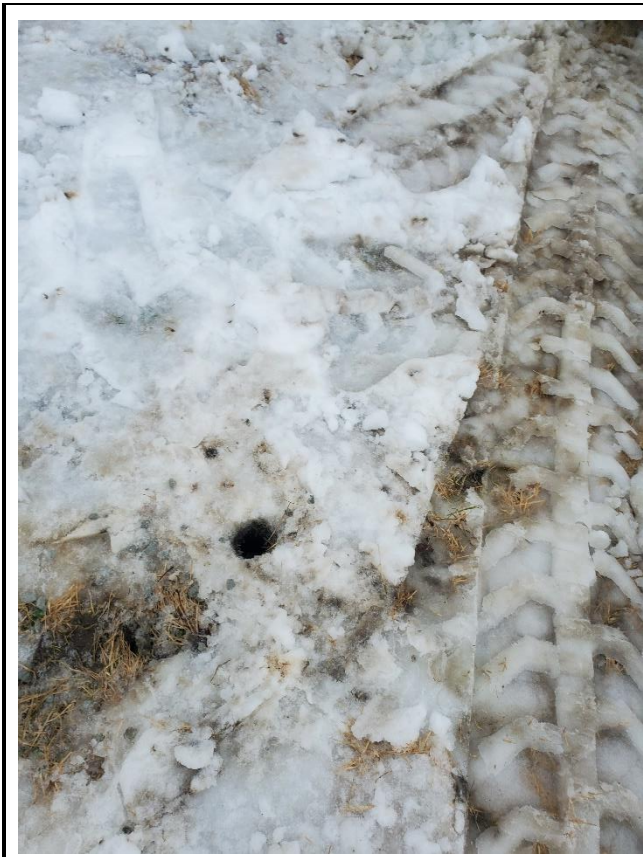
Picture 11  
SS-37 prior to backfilling

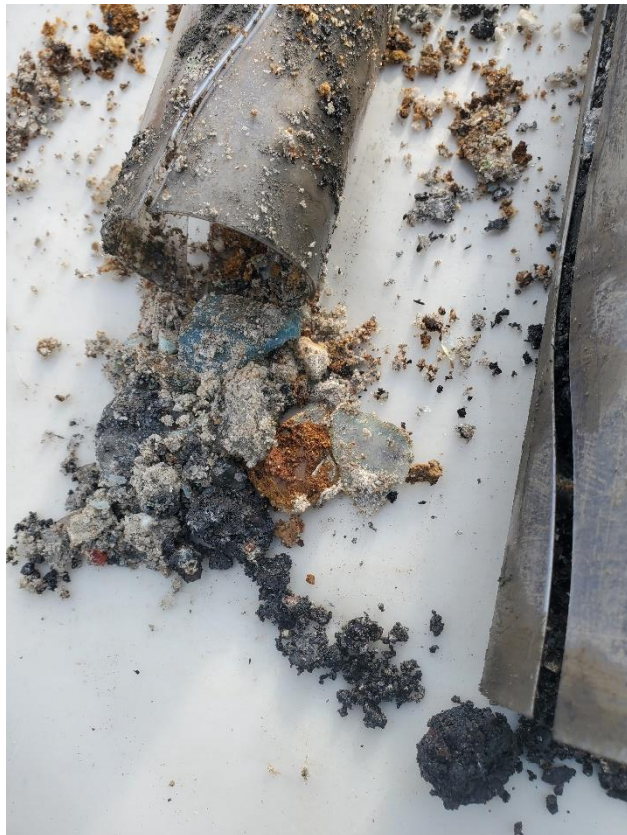
*Picture 5*

Close up of SB-19 8-12 FT BGS run, multiple colors of glass visible as well as white and gray ash.

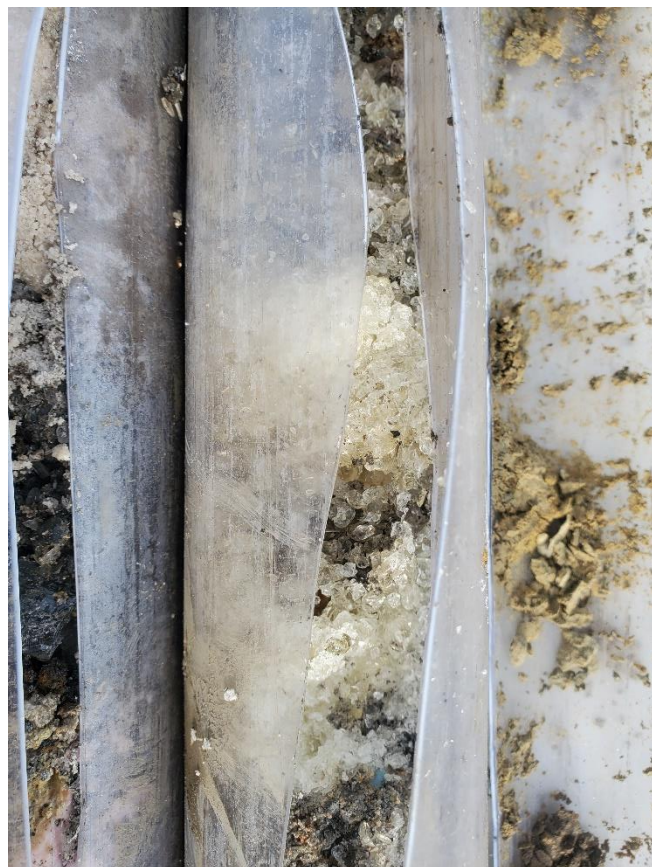
*Picture 6*

Close up of clear glass shards in SB-19

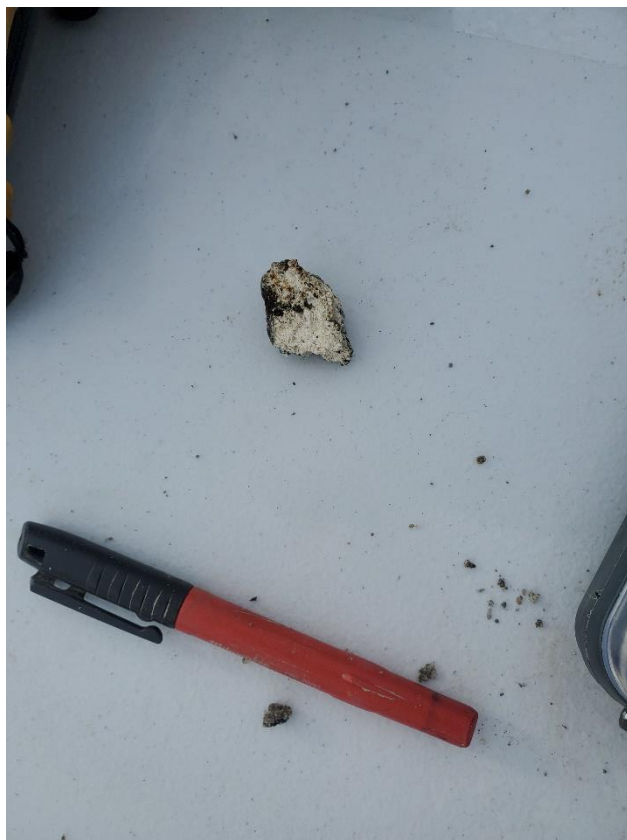
*Picture 7*

Close up of white furnace brick collected from SB-19.

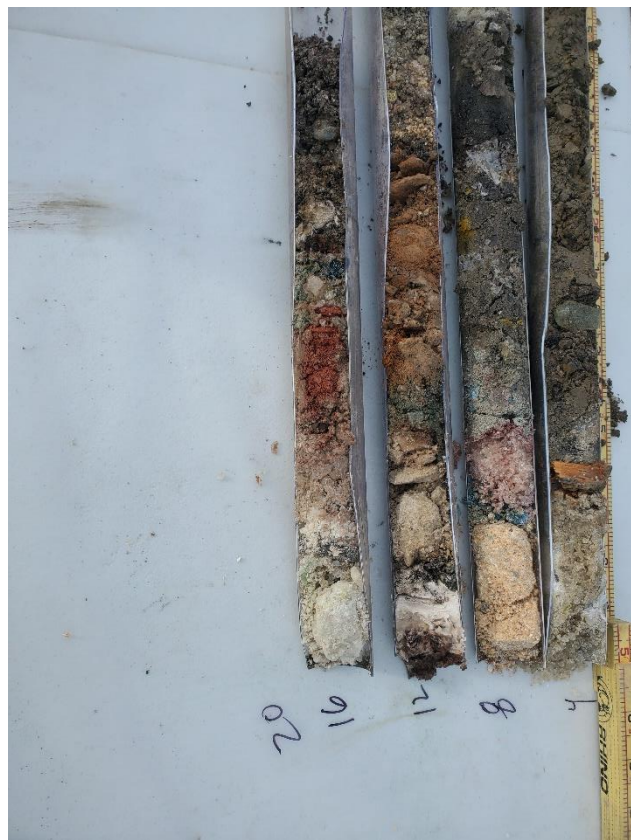
Picture 9

SB-17 firs run from 0-16 FT BGS, ABG fill starting at 2 FT BGS

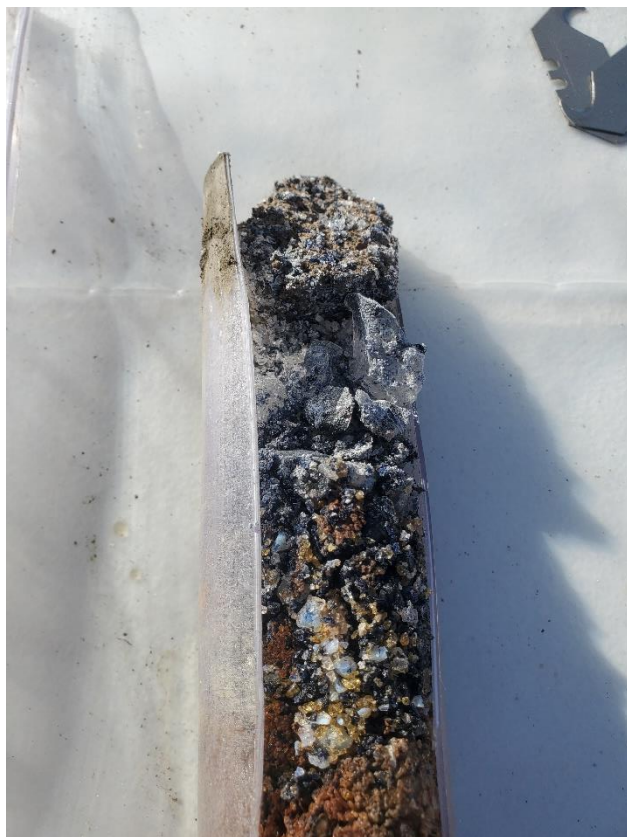
*Picture 13*

SB-17 offset, industrial slag, ash and glass visible

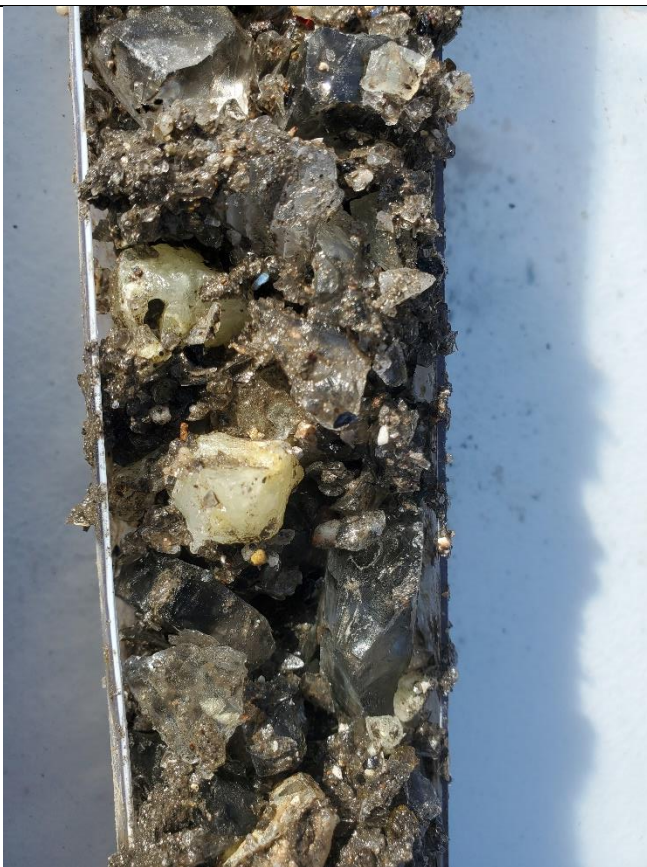
*Picture 14*

SB-17 offset, 24-28 FT core, glass shards and cullet visible.

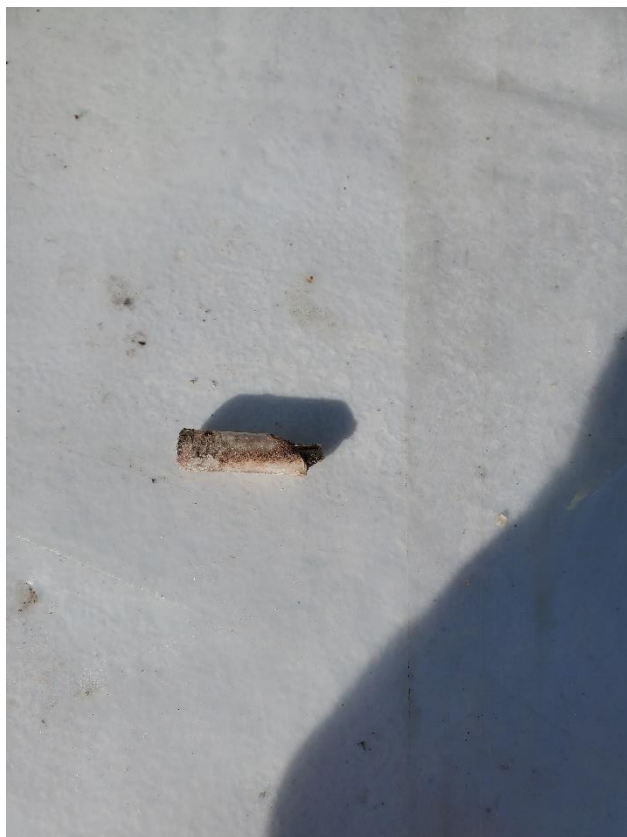
Picture 15

Clear hollow tubing collected as archive sample from SB-17

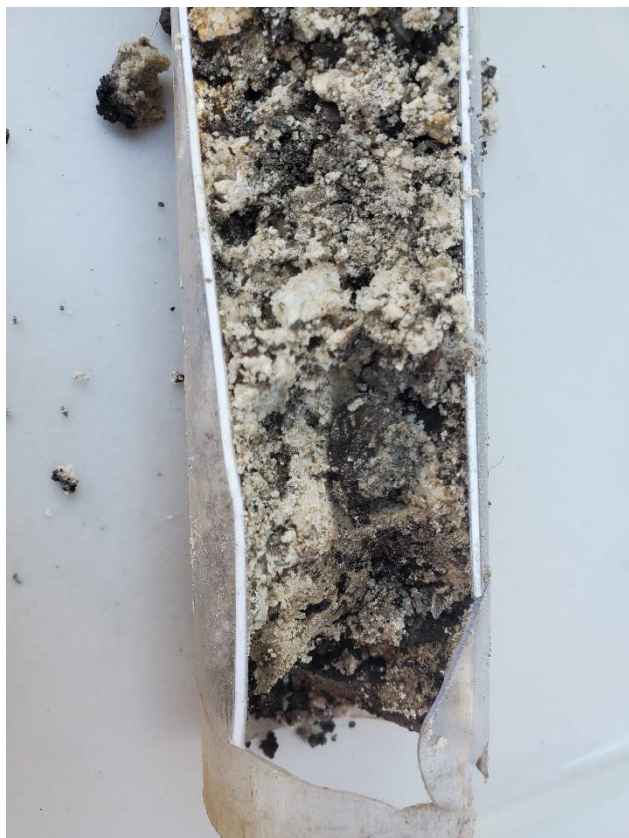
*Picture 3*

Close up of SS-35 showing white and black ash.

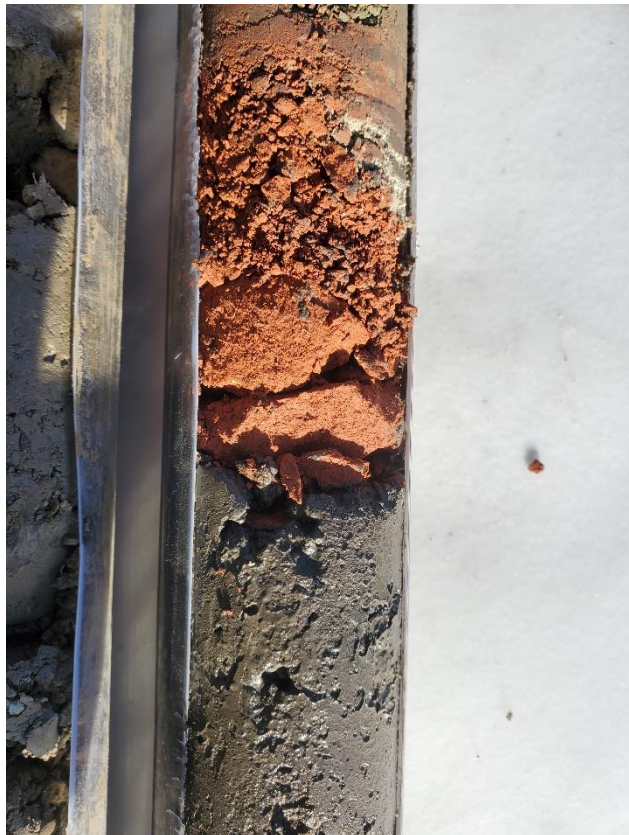
*Picture 5*

Close up of SB-18 4-8 FT BGS run, red brick.

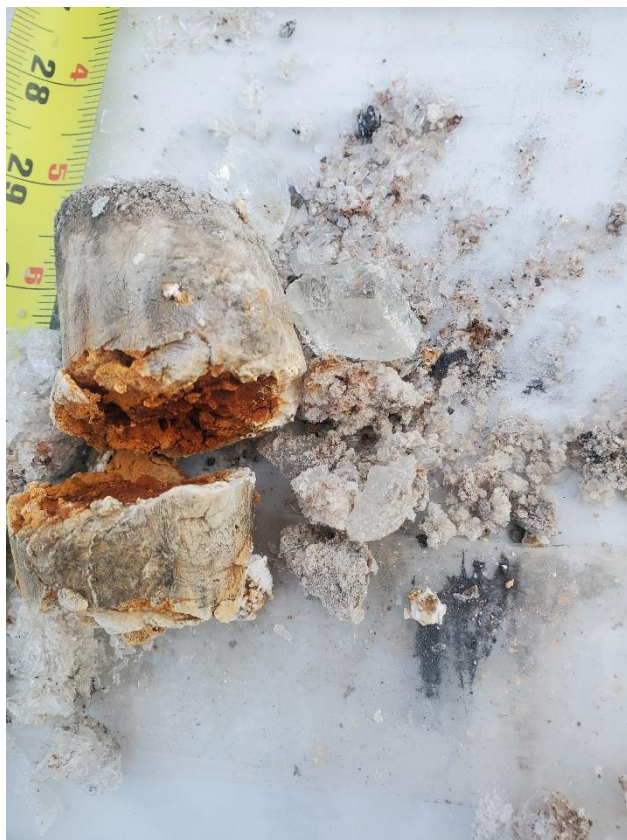
*Picture 7*

Close up of white and red ash, and clear cullet from Sb-18

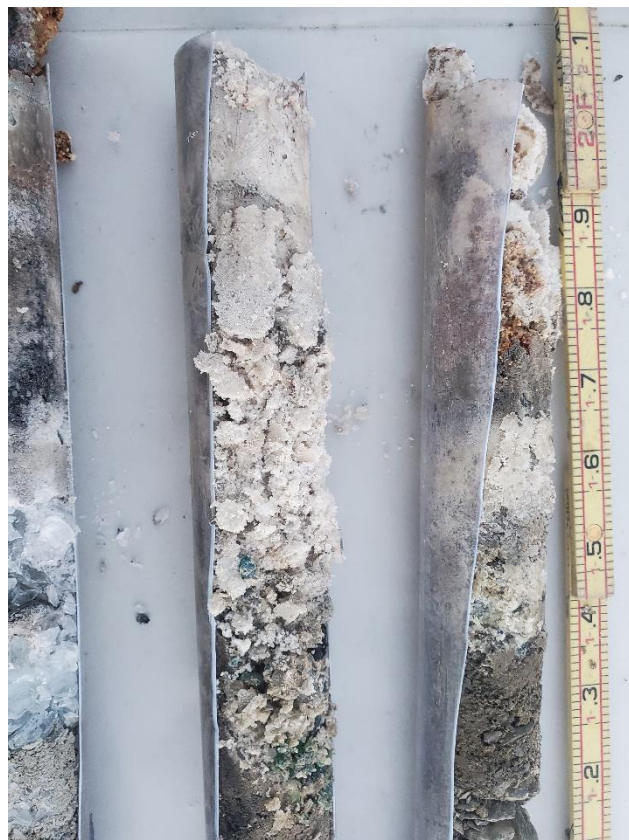
*Picture 9*

Close up of SS-33 showing white ash and blue glass cullet

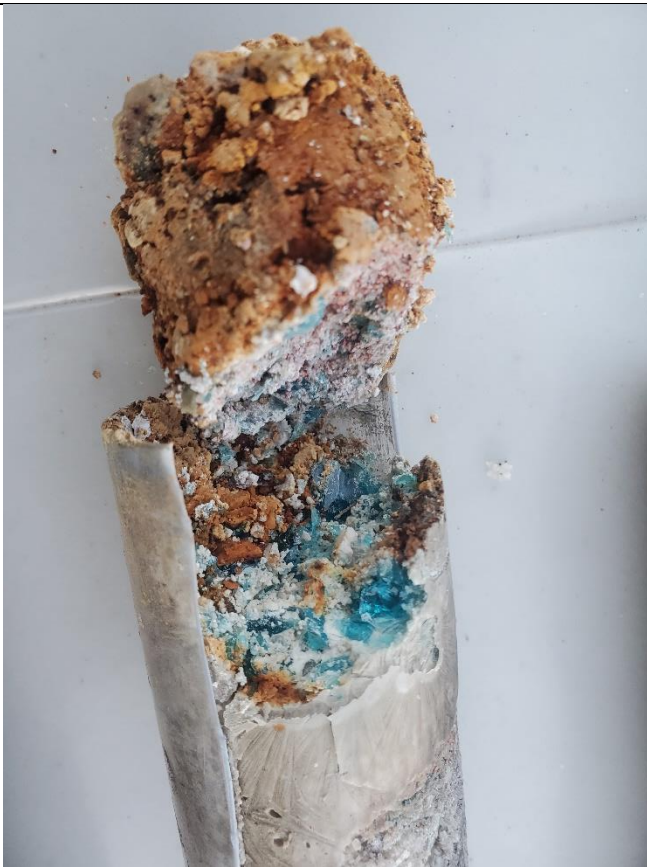
*Picture 10*

Close up of SS-33 showing blue glass cullet and white and red ash/brick

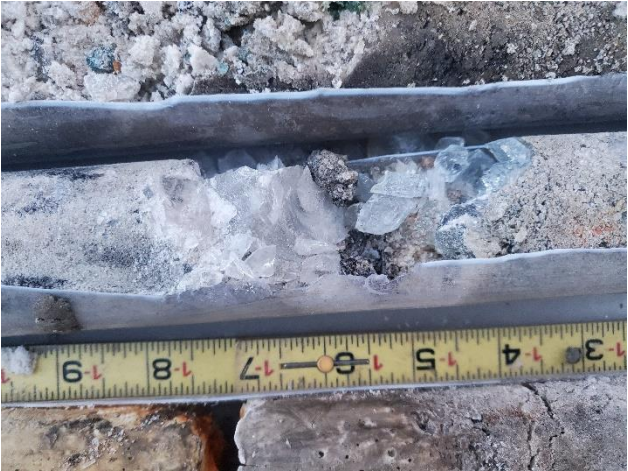
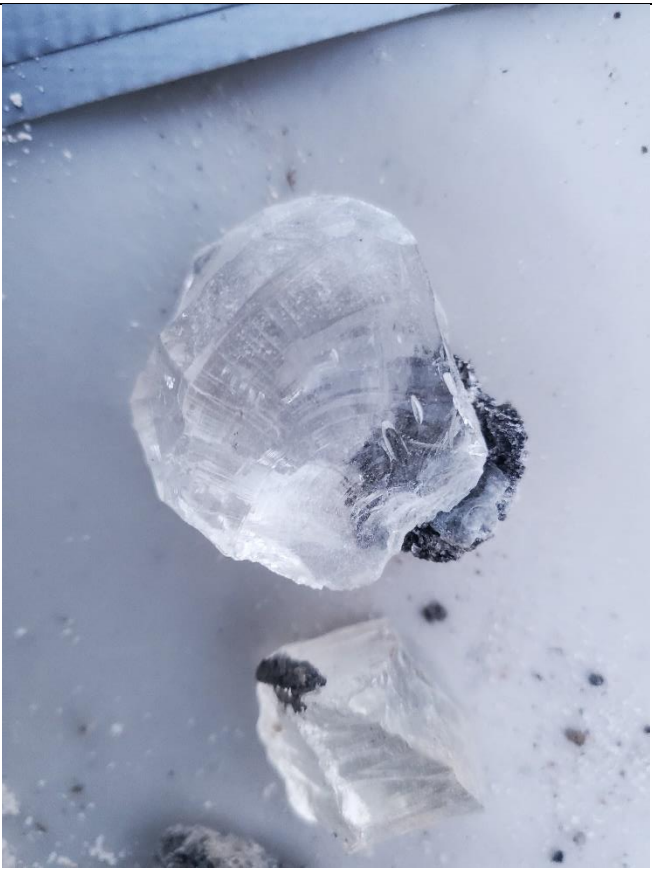
<p>Picture 11</p> <p>Close up of SS0-33 showing glass cullet and white ash.</p>	<p>Picture 12</p> <p>Close up of clear glass cullet with clear bubbles visible. Sample collected as archive sample.</p>

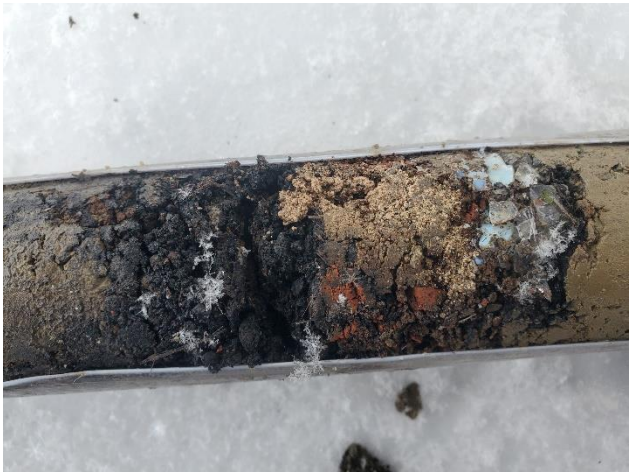
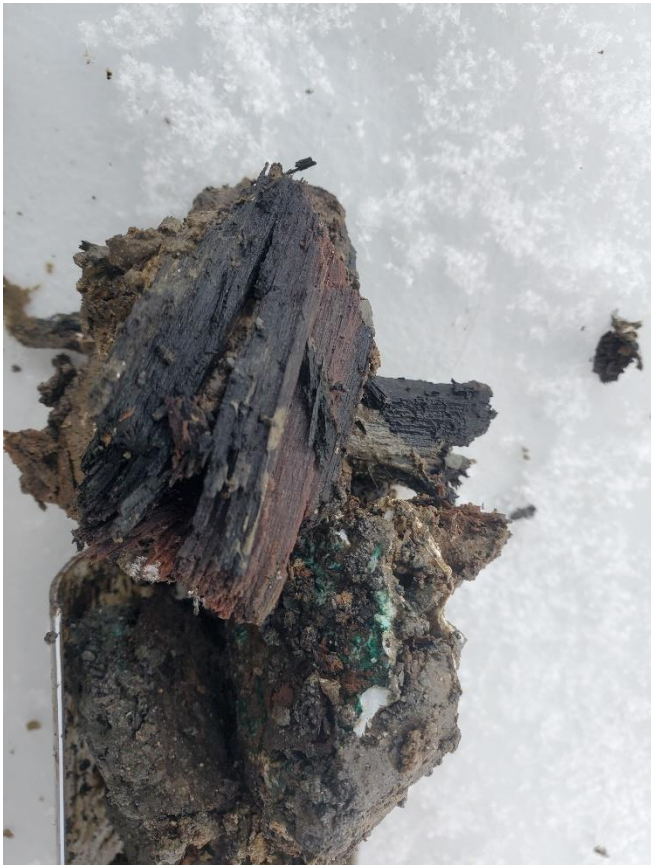
<p><i>Picture 1</i></p> <p>Close up of fill material from 4-8 FT core of SB-15. Black material, red brick, and blueish glass visible.</p>	<p><i>Picture 2</i></p> <p>Close up of wood recovered from SB-15</p>

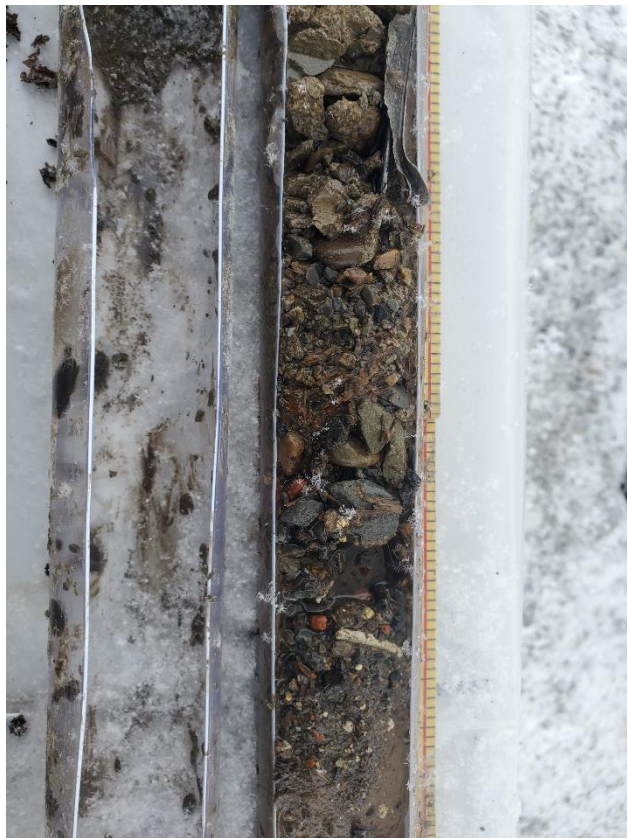
*Picture 3*

Close up of brick fragments and thin metal/plastic from SB-15

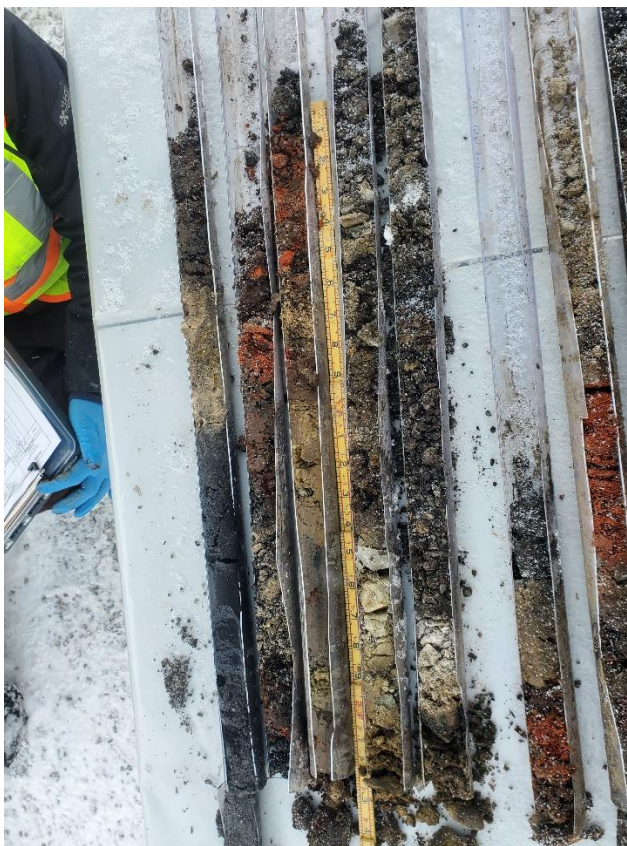
*Picture 4*

SB-16 and SB-16 offset runs to 15.5 FT BGS and 20 FT BGS respectively. Red brick and black soil visible.

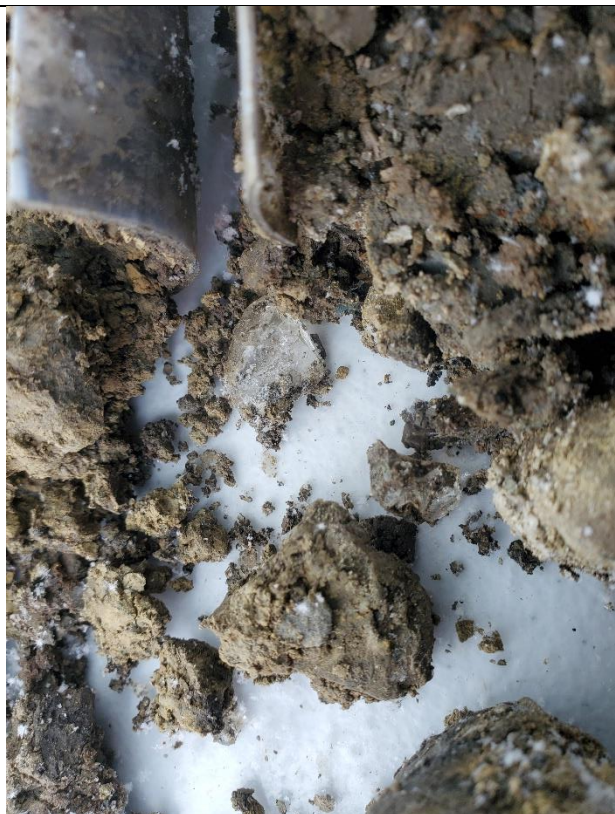
*Picture 5*

Close up of SB-16 at bottom of 8 FT core showing clear glass shard.

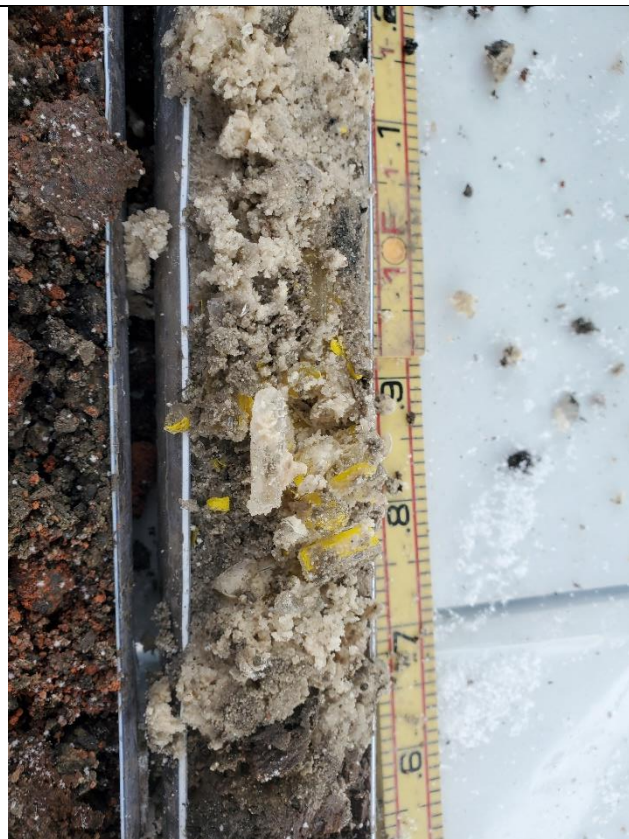
*Picture 7*

Close up of white ash/sand and yellow thermometer tubing from SB-16 16.6-17.1 FT BGS

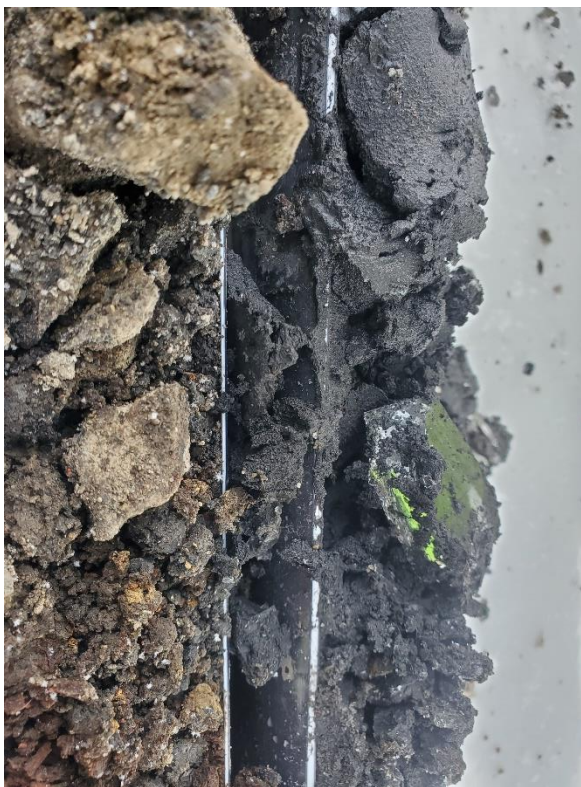
*Picture 8*

Close up of clear/greenish clear glass from bottom of SB-16 16-20 FT core.

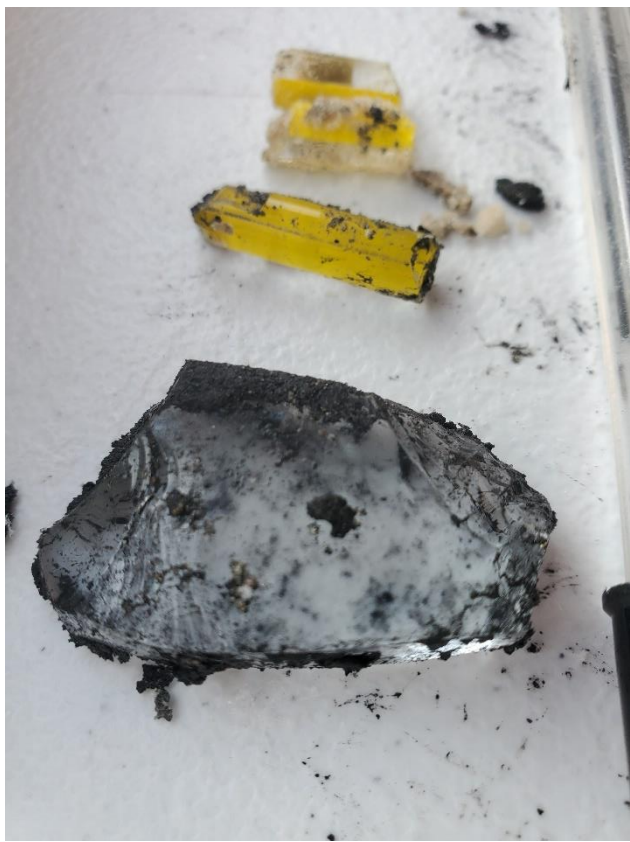
Picture 9

Glass recovered from SB-16

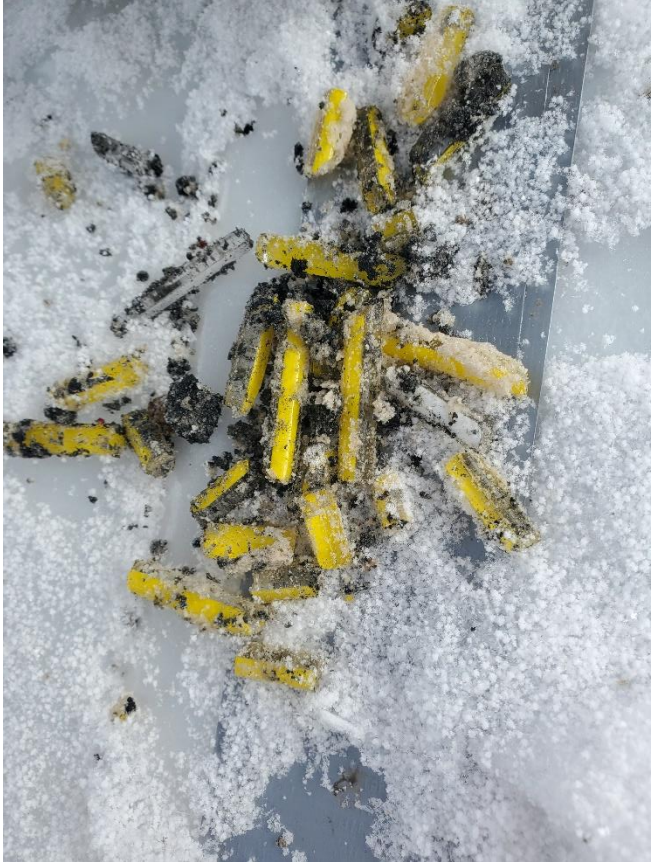
Picture 10

Thermometer tubing recovered from SB-16.

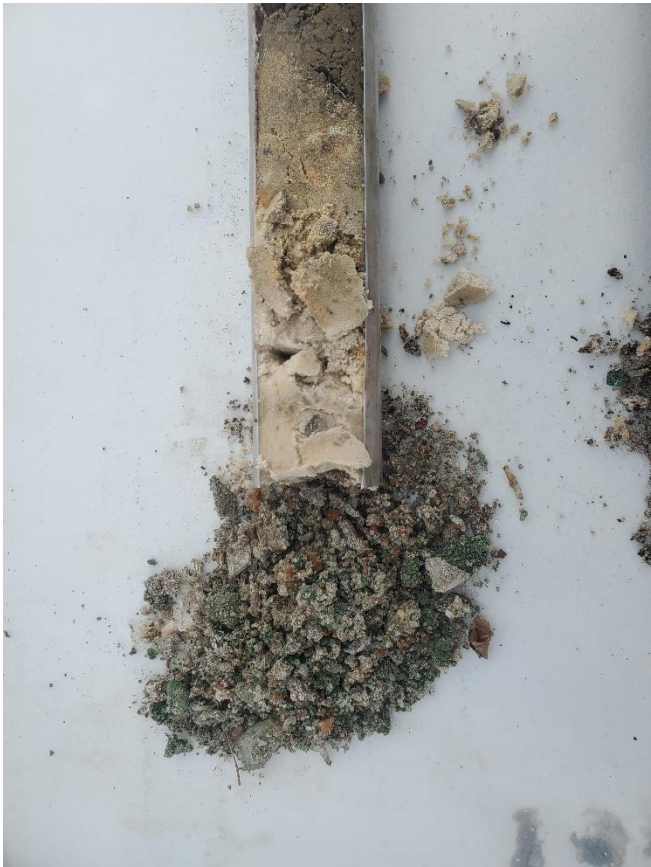
A close-up photograph of a sediment core. The core is held vertically, and a pile of sediment has fallen out from the bottom. The sediment is a mix of white ash/sand and dark, organic material.
<p><i>Picture 1</i></p> <p>SS-32 first 3 cores showing ABG fill layer in bottom 6-12 IN.</p>	<p><i>Picture 2</i></p> <p>Close up of white ash/sand at bottom of SS-32</p>

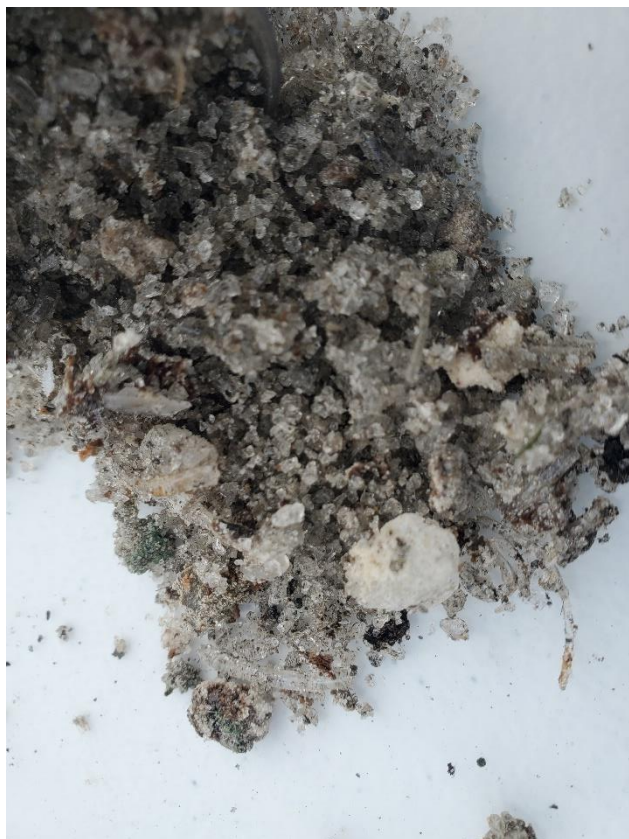
*Picture 3*

Close up of glass fill at bottom of SS-32.

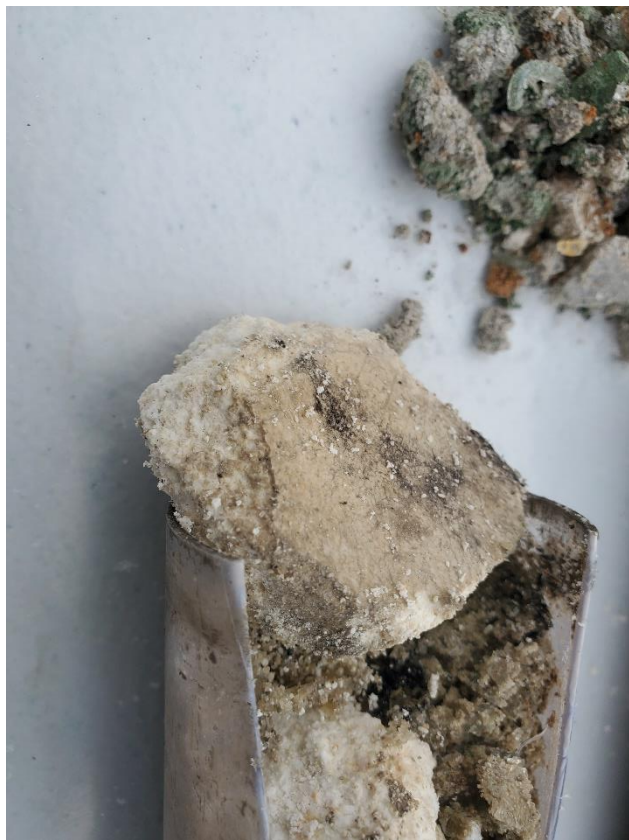
*Picture 5*

Close up of SS-32 white furnace brick at bottom of core.

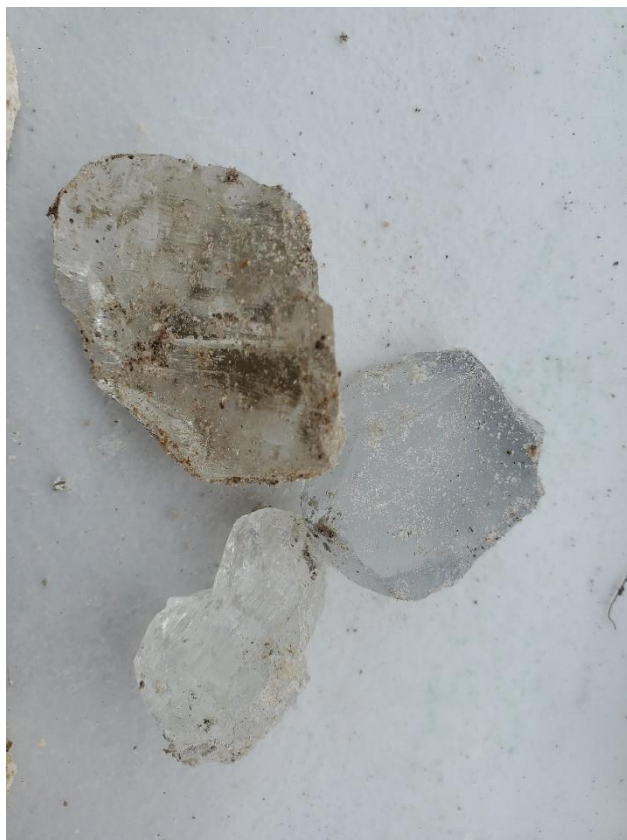
*Picture 7*

Close up of glass cullet recovered from SS-32.

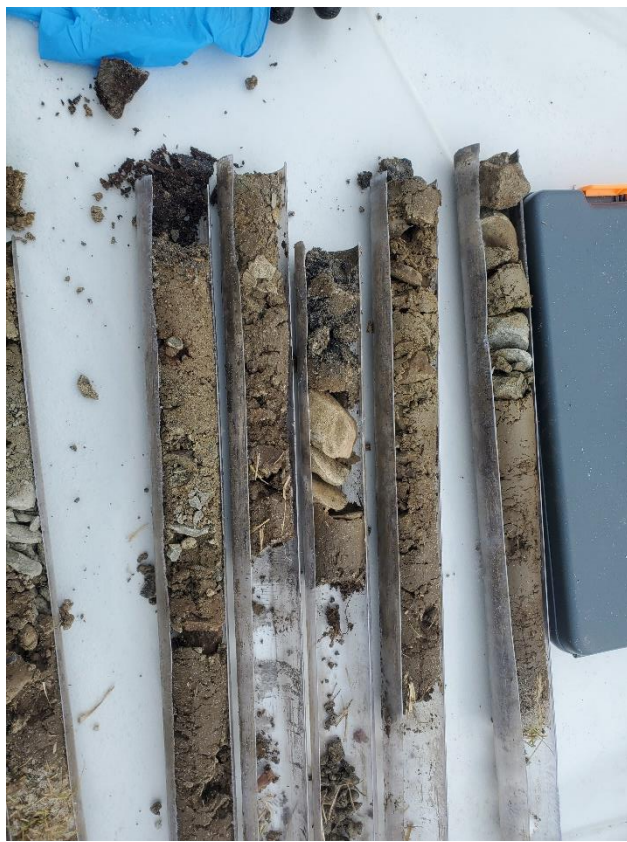
*Picture 9*

First six runs of SS-31, no ABG layer, non-native fill layer present in bottom half of runs.

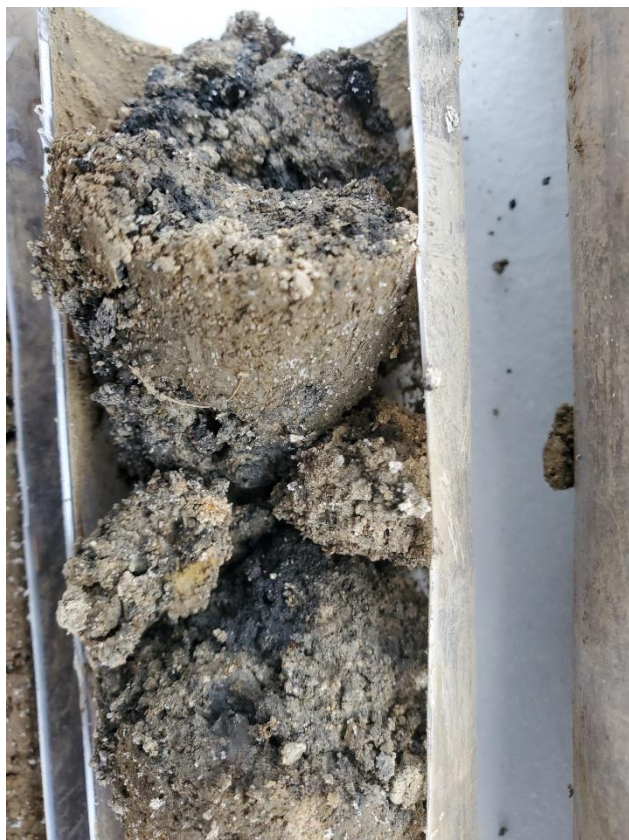
*Picture 9*

Close up of bottom of SS-31 showing industrial slag/ ash.

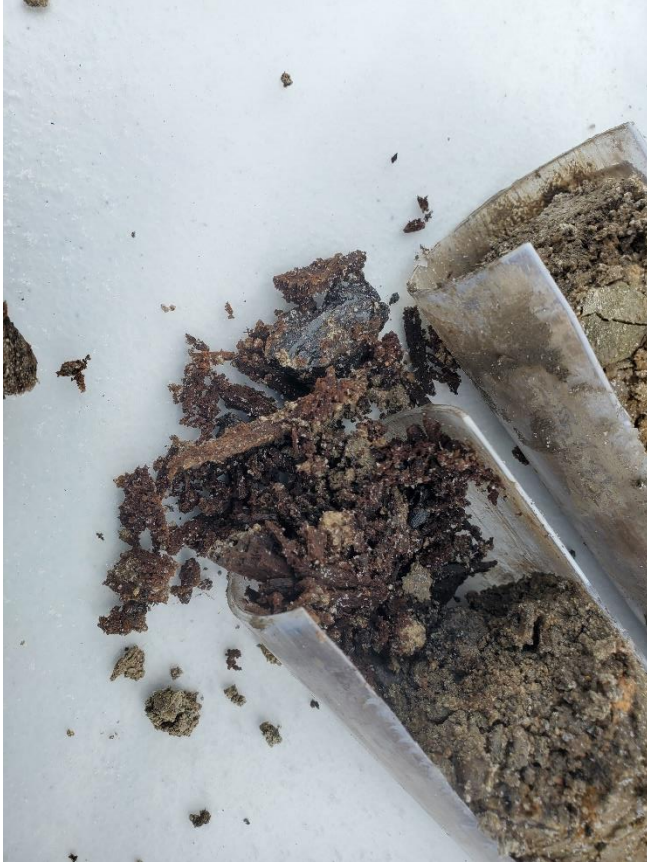
*Picture 10*

Close up of bottom of fSS-31 showing mulch/wood.

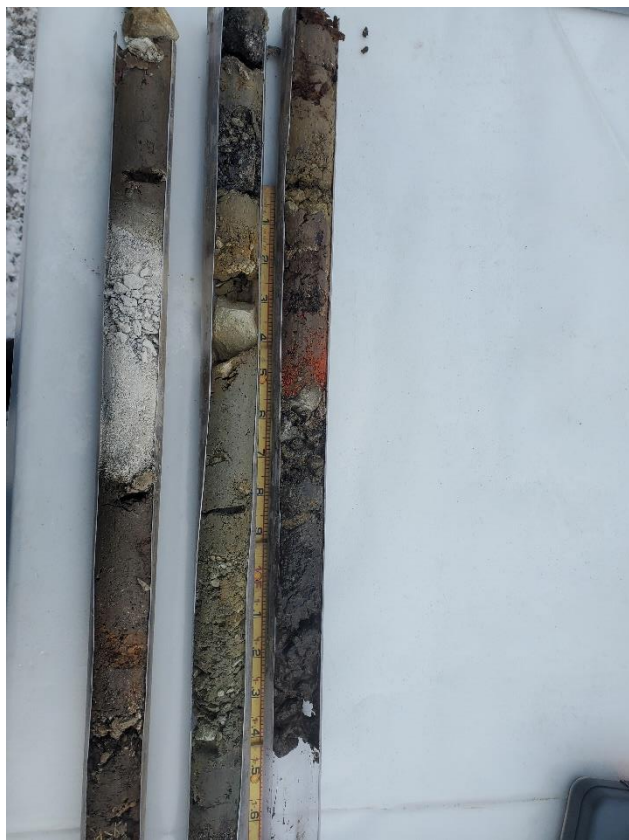
*Picture 11*

Start of fill in SB-14 in 8-12 FT core. Bottom at top.

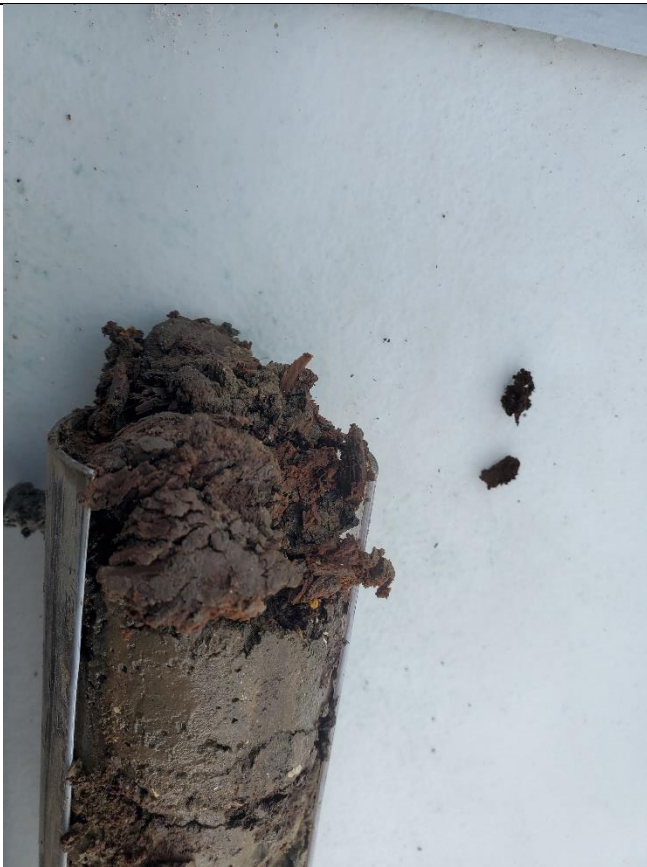
*Picture 12*

Close up of mulch/wood at 12 FT depth

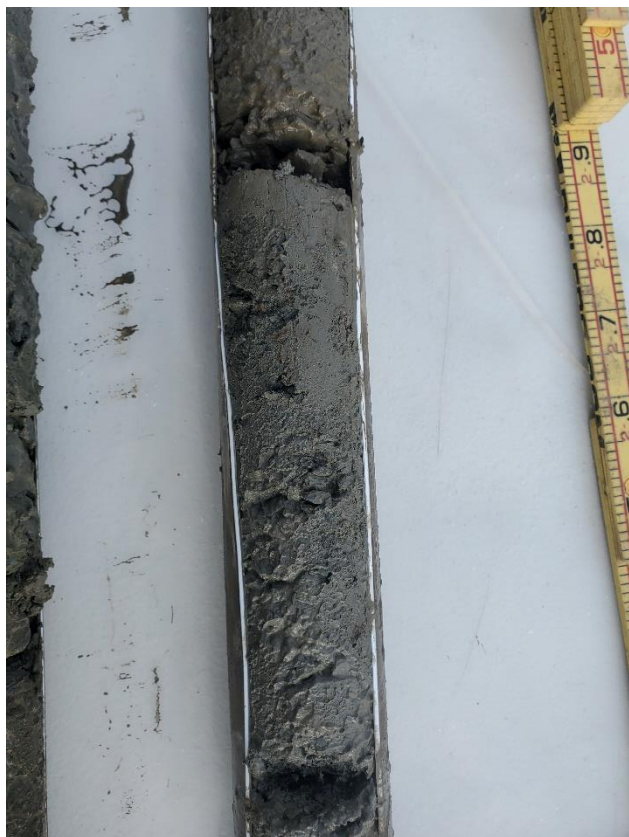
*Picture 15*

Gray material between from 20-24 FT core

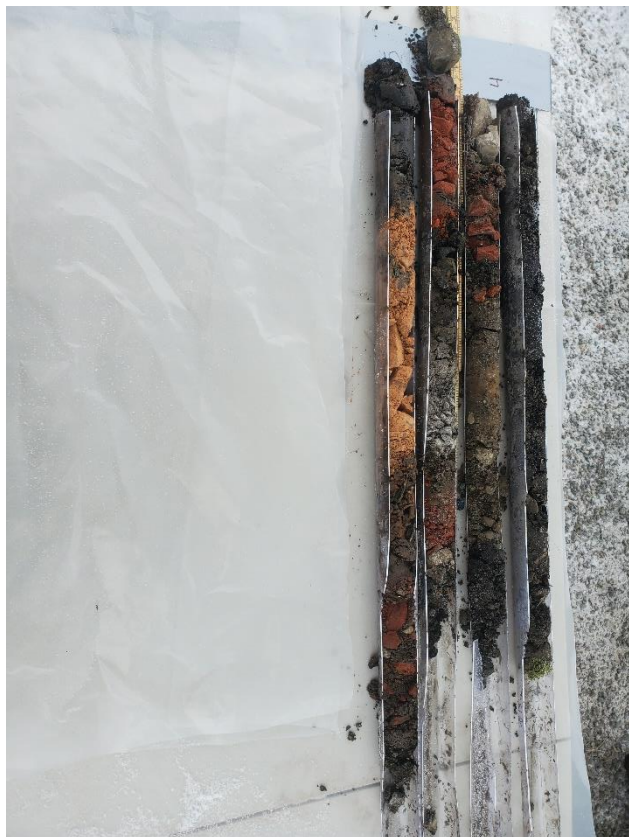
*Picture 1*

SB-13 0-15 FT showing red brick and orange furnace brick.

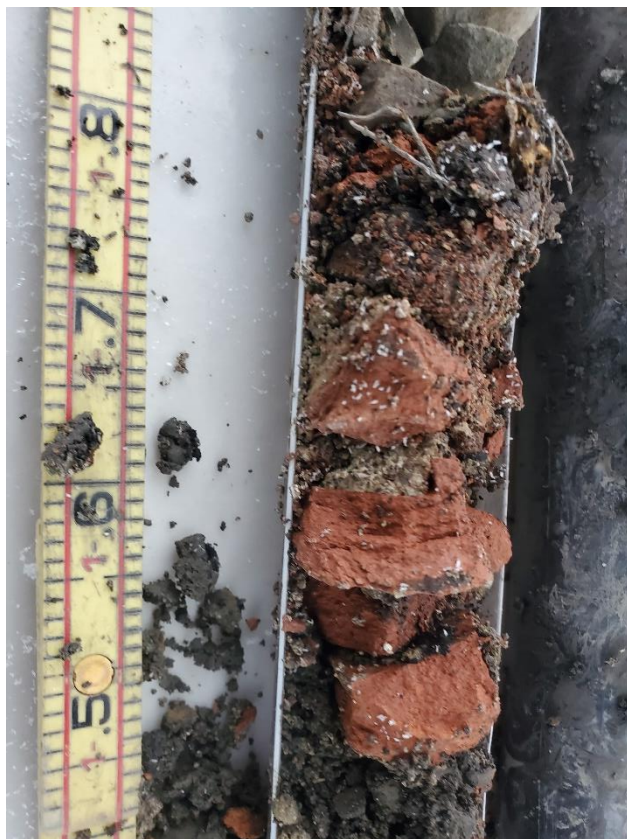
*Picture 3*

Close up of red brick from SB-13

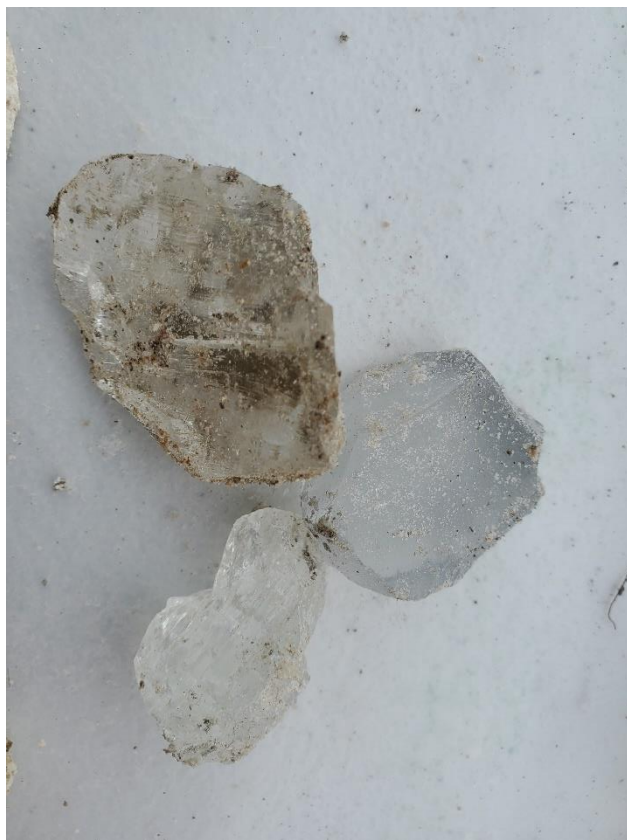
*Picture 7*

Close up of glass cullet recovered from SS-32.

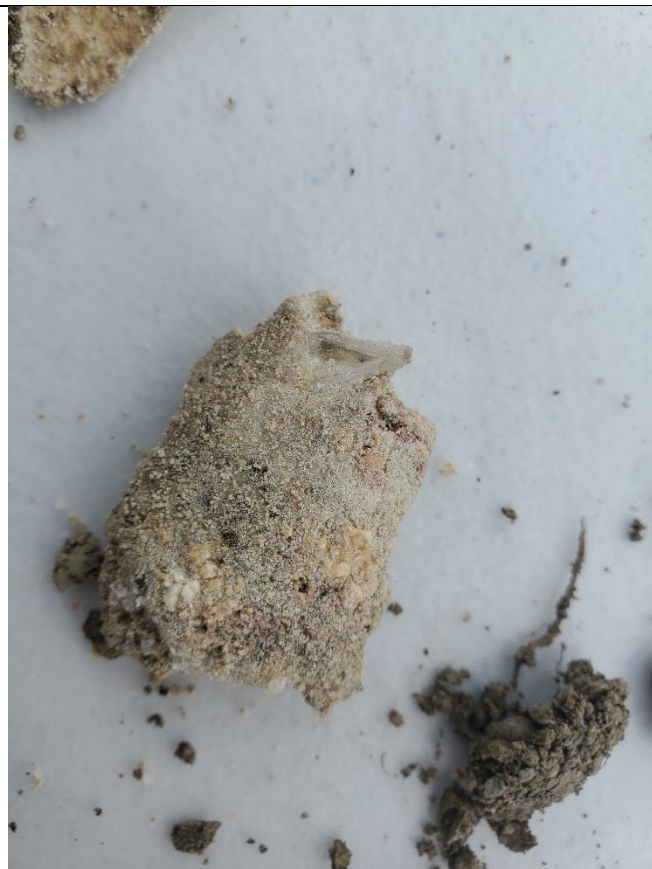
*Picture 8*

Close up of white furnace brick from SS-32.
