**DAILY INSPECTION REPORT - No. 001**  
**(Corning Post Creek) Site No. 851053**

NYSDEC Division of Environmental Remediation

Department of Environmental Conservation		<b>Contract No. D009811-29</b> <b>DEC Insp. –</b> <b>DEC PM – Robert Strang</b> <b>Contractor Supt. –</b> <b>Engineer PM – Matt Vetter</b> <b>Engineer Insp. – Joseph Moffitt</b>	
<b>Site Location: Corning, NY</b>					
<b>Weather Conditions</b>					
<b>General Description</b>	Cloudy	AM	Partly Cloudy	PM	
<b>Temperature</b>	31 F	AM	39 F	PM	
<b>Wind</b>	12 MPH W	AM	8 MPH WSW	PM	
<b>Health &amp; Safety</b> <b>If any box below is checked “Yes”, provide explanation under “Health &amp; Safety Comments”.</b>					
Were there any changes to the Health & Safety Plan?				*Yes	No X NA
Were there any exceedances of the perimeter air monitoring reported on this date?				*Yes	No X NA
Were there any nuisance issues reported/observed on this date?				*Yes	No X NA
<b>Health &amp; Safety Comments</b> Dash Card created for site. Integral conducted internal safety meeting with Parratt-Wolff No CAMP exceedances reported to Parsons by Integral

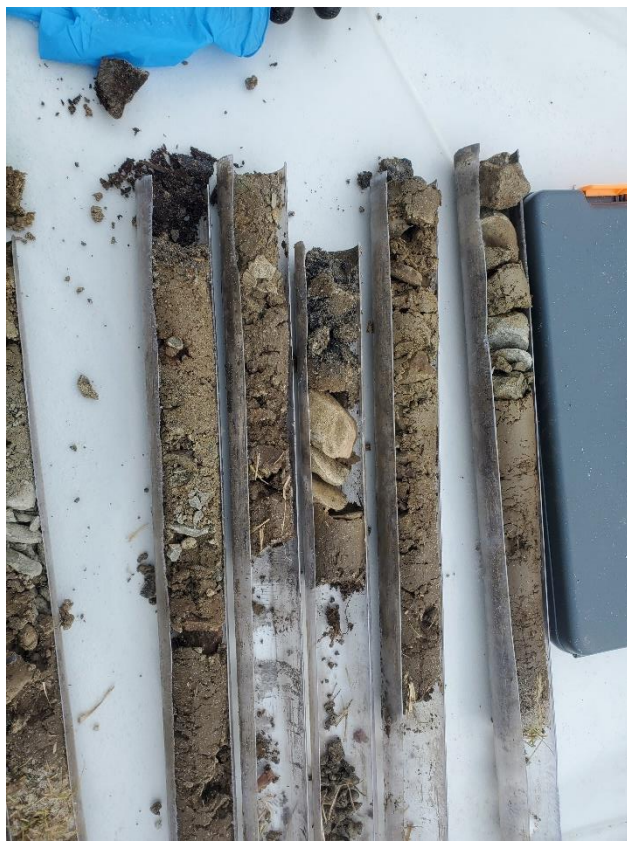
*Picture 9*

First six runs of SS-31, no ABG layer, non-native fill layer present in bottom half of runs.

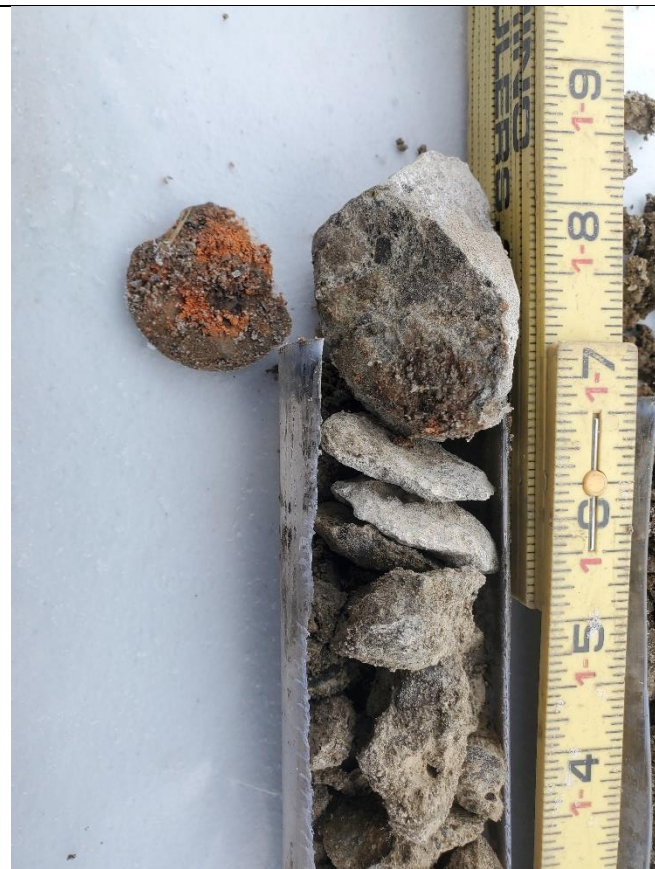
*Picture 10*

Close up of red brick and concrete fragments from bottom of SS-31.

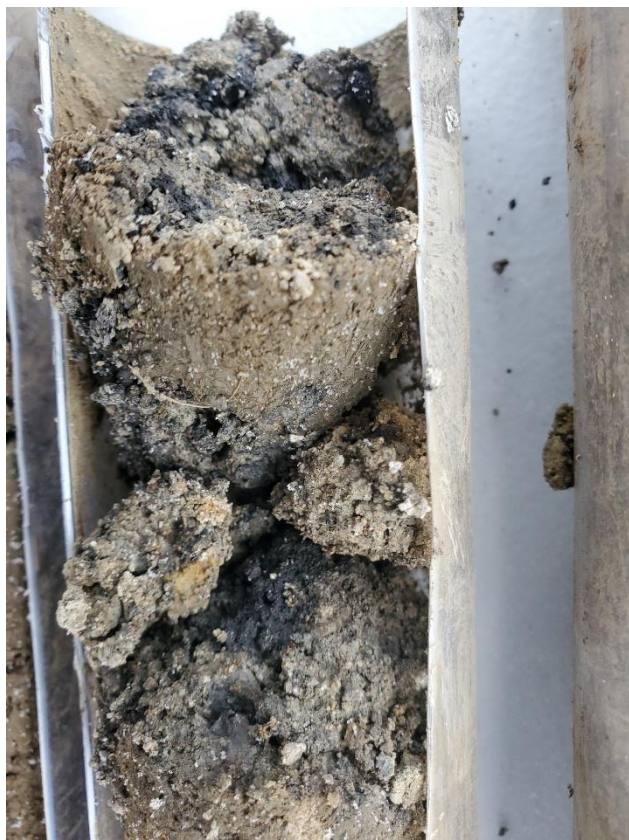
*Picture 9*

Close up of bottom of SS-31 showing industrial slag/ ash.

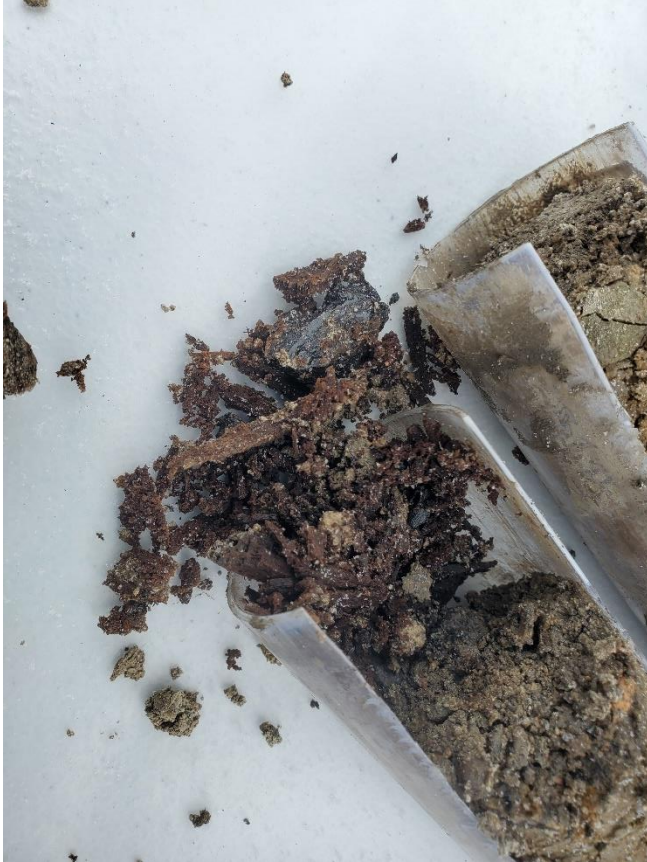
*Picture 10*

Close up of bottom of fSS-31 showing mulch/wood.

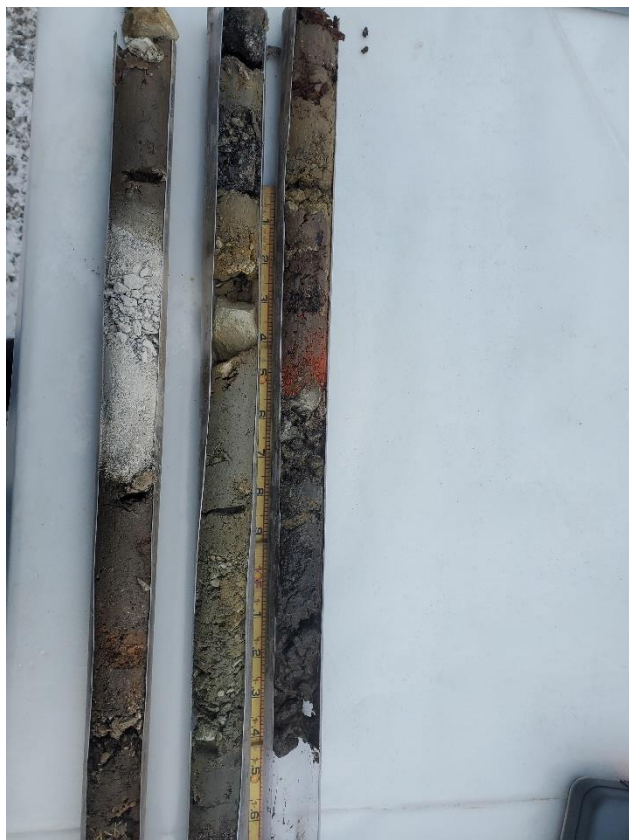
*Picture 11*

Start of fill in SB-14 in 8-12 FT core. Bottom at top.

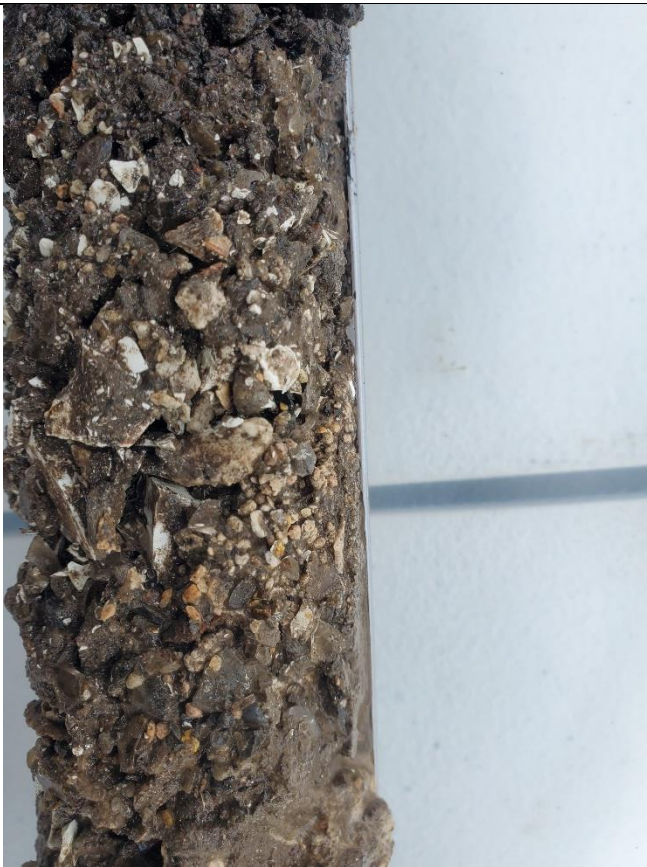
*Picture 14*

Close up white glass material from SB-14 from 16-20 FT BGS.

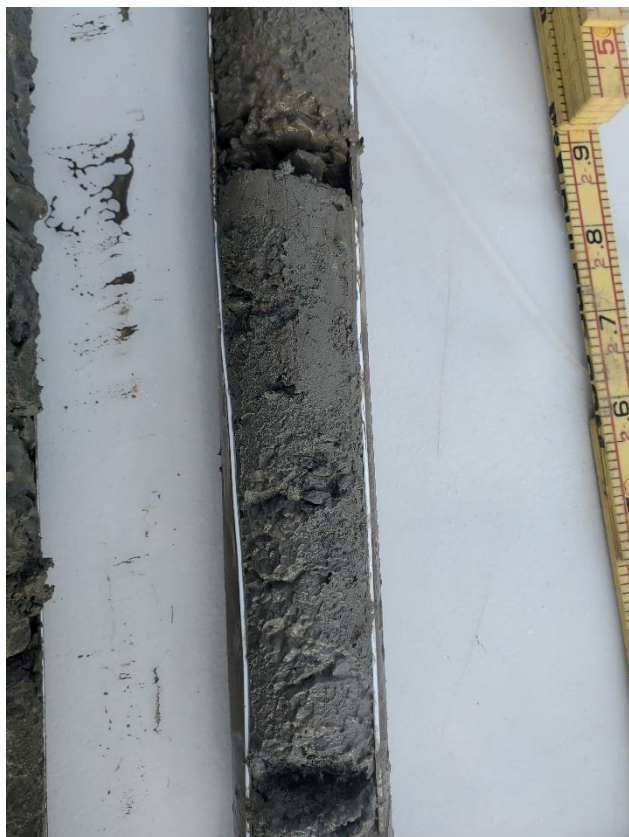
*Picture 15*

Gray material between from 20-24 FT core

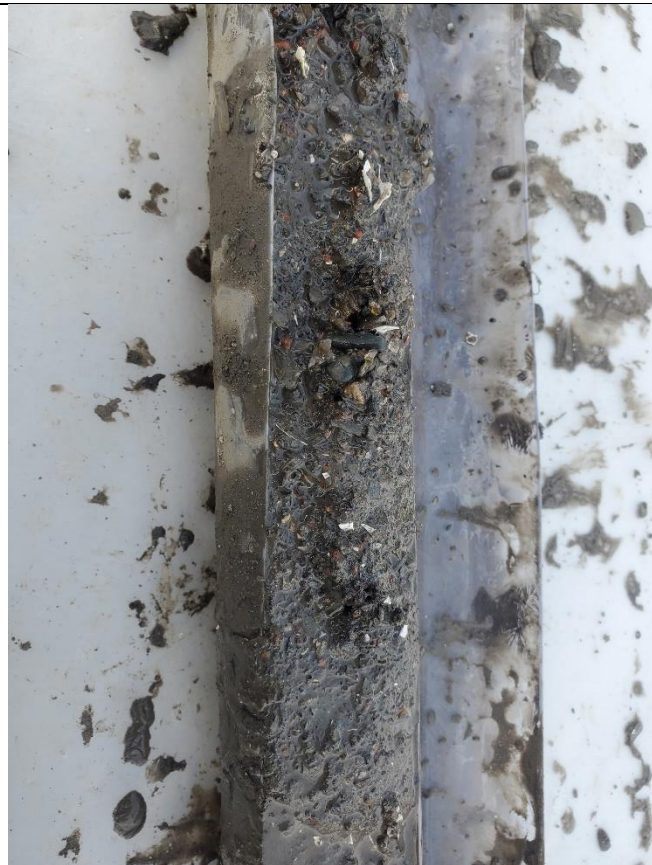
*Picture 16*

Close up of fill material from 24-30 FT section  
of SB-14

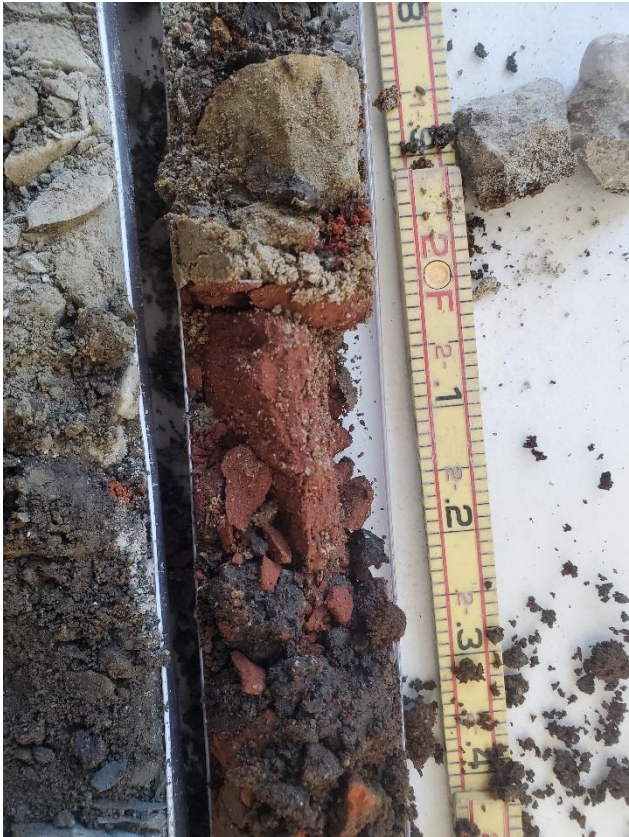
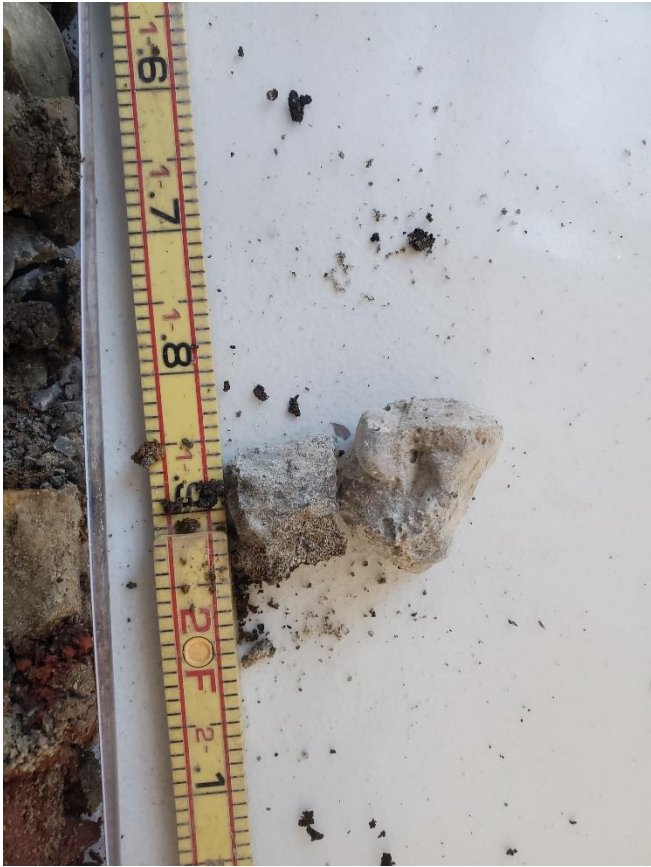
<p><i>Picture 1</i></p> <p>SB-09 6-6.5 FT showing red brick and possible tan brick</p>	<p><i>Picture 2</i></p> <p>Close up of possible concrete from SB-09 6-6.5 FT</p>

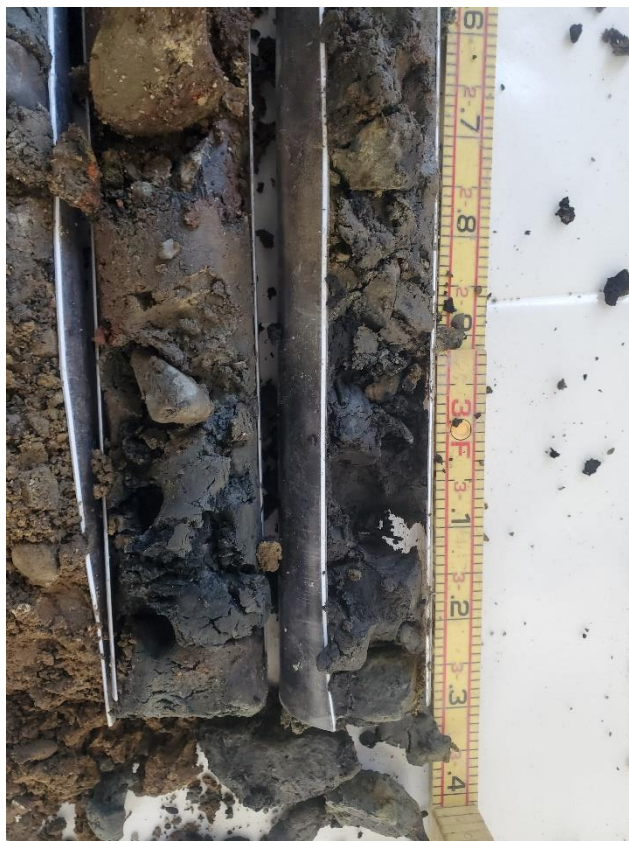
*Picture 3*

Sb-09 sandy silt at bottom of 8-12 FT BGS

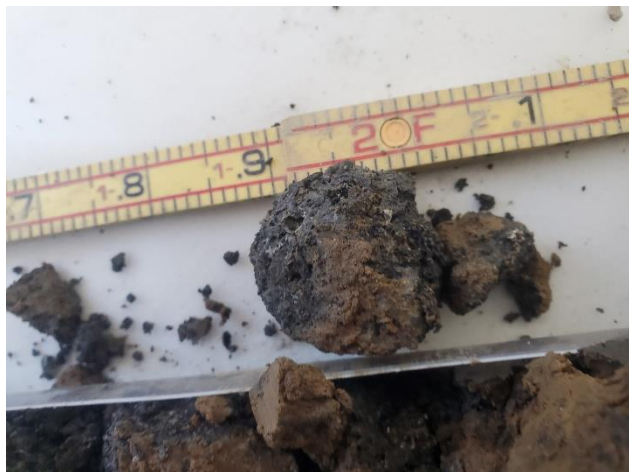
*Picture 5*

SB-10 slag recovered from 16 FT BGS.

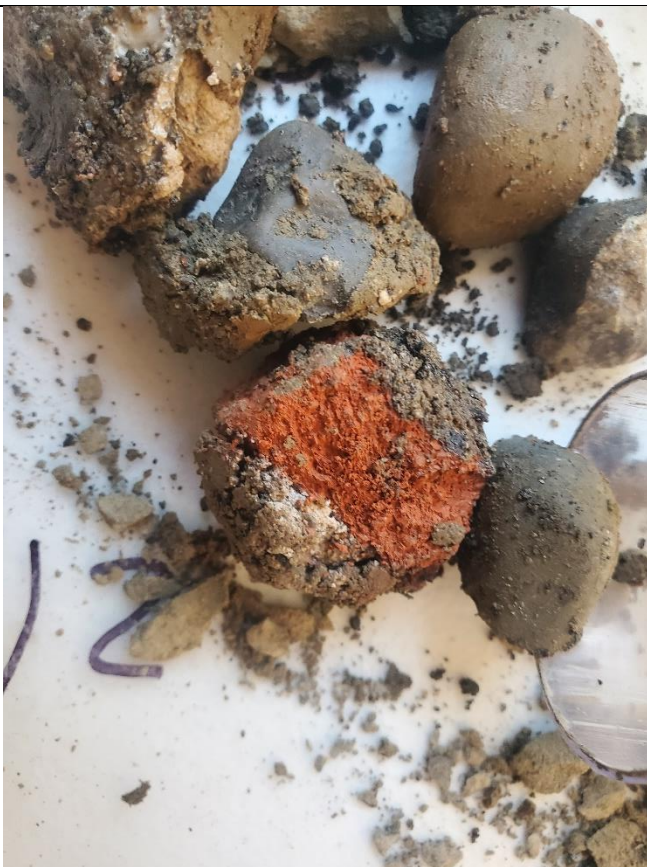
*Picture 6*

Red brick fragment recovered from SS-19.

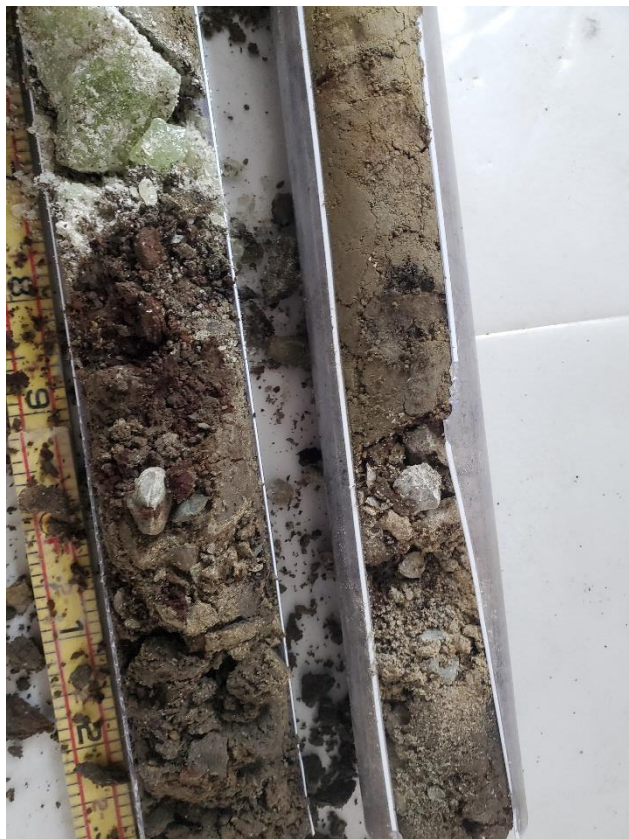
*Picture 1*

SS-17 Showing green glass cullet at ~21"  
 depth

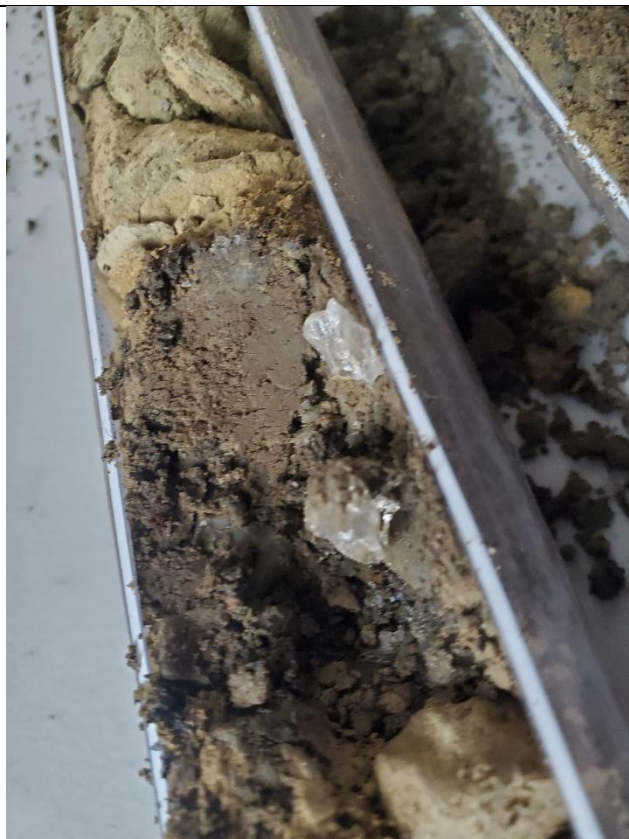
*Picture 3*

SS-17 Clear glass shards from ~21"

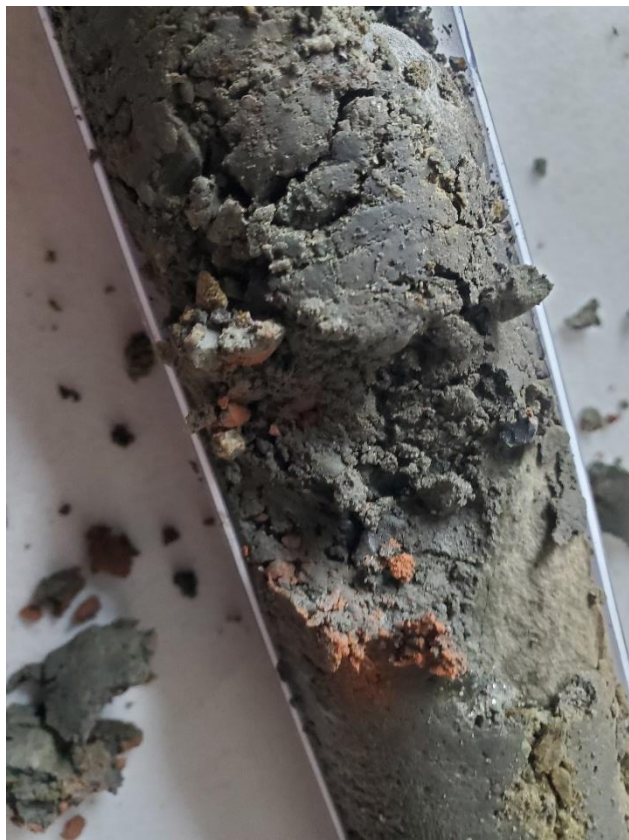
*Picture 5*

SS-16 Brick fragments at 2 FT BGS.

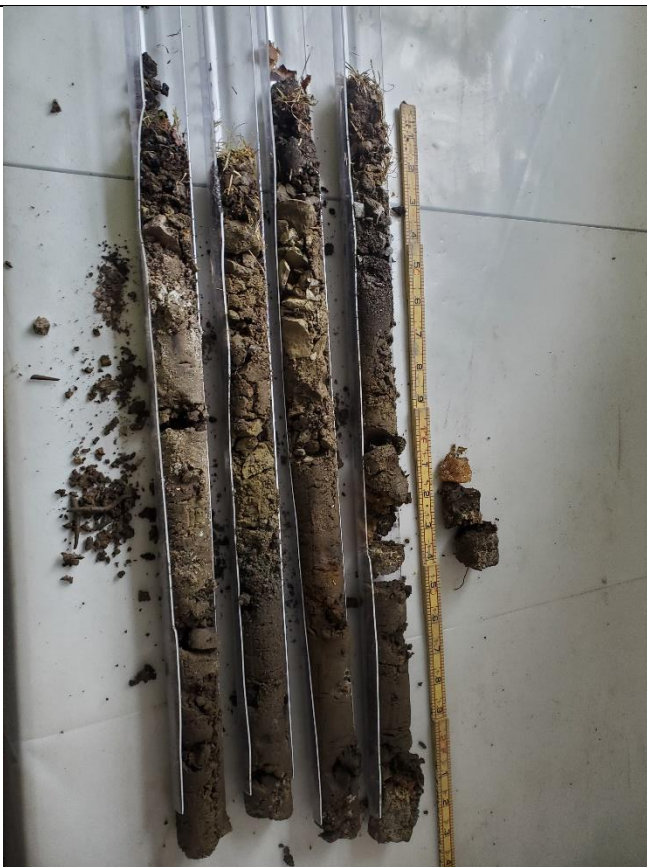
*Picture 6*

SS-15 cores

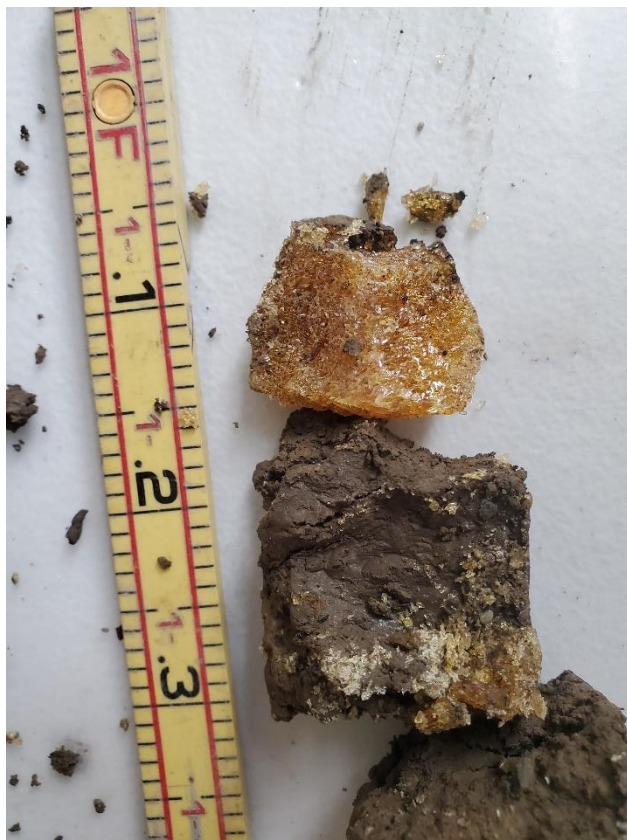
*Picture 7*

SS-15 close up of orange glass cullet.

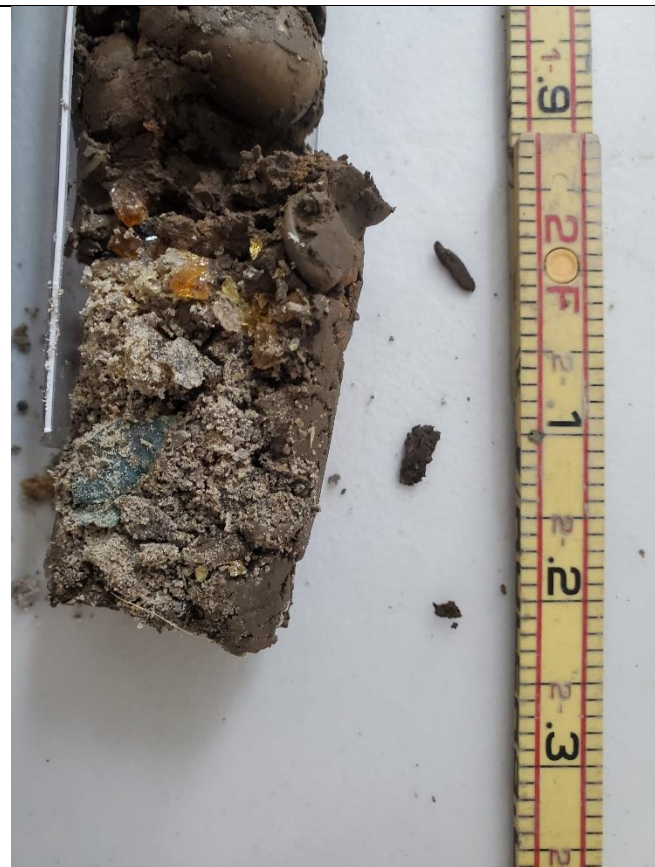
*Picture 8*

SS-15 orange and blue cullet shards and possible ash starting at 2 FT BGS.

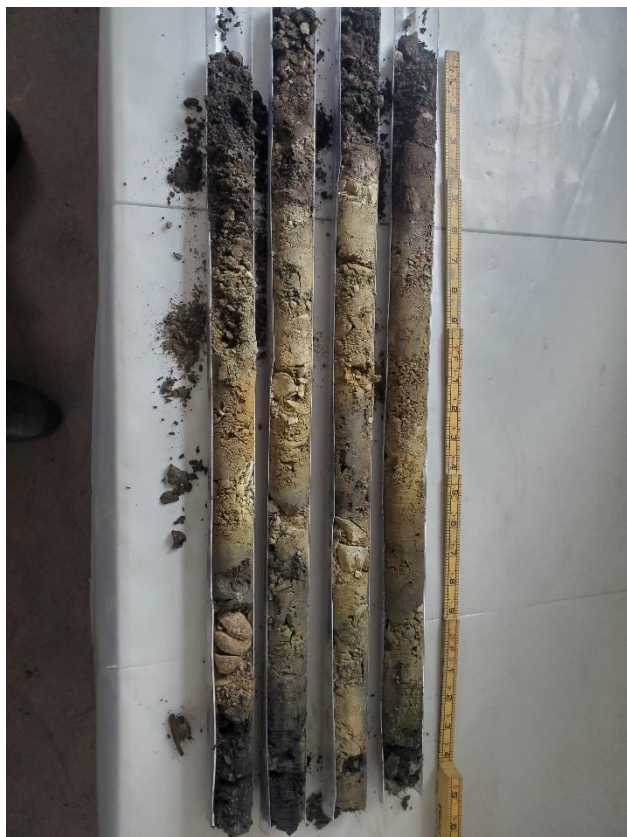
*Picture 9*

SS-14 cores, no visible ABG

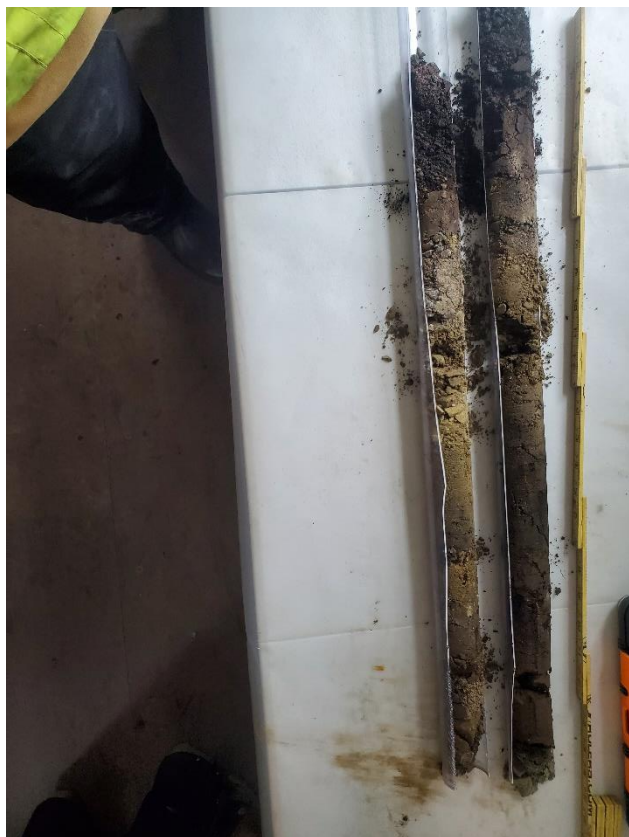
*Picture 11*

SS-12 cores with no visible ABG.

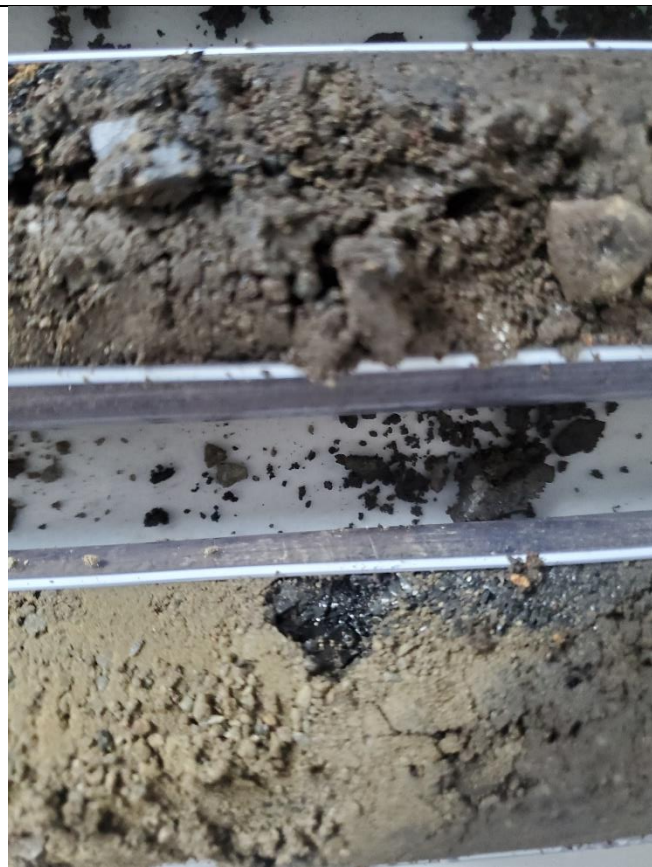
*Picture 12*

SS-12 close up of coal fragments at 1.3 FT BGS

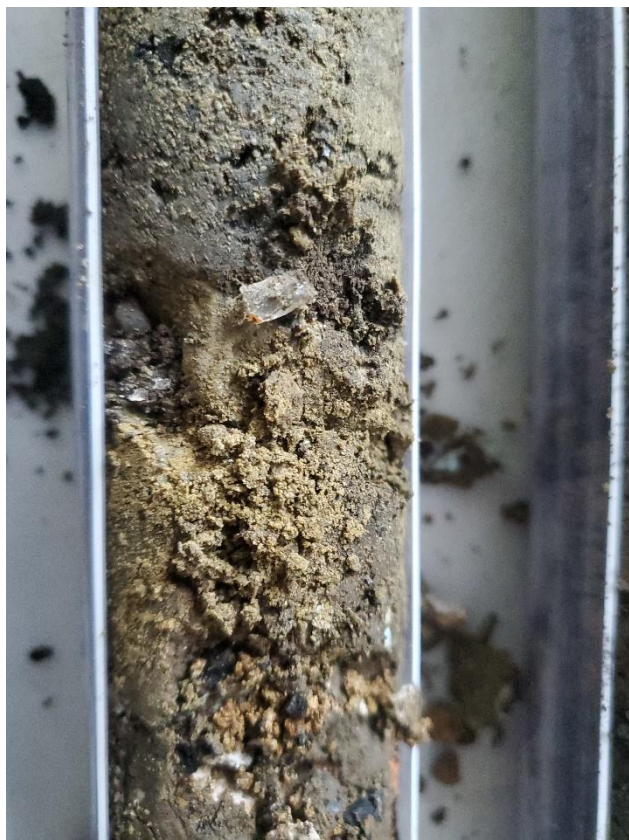
*Picture 13*

SS-12 Close up of clear glass shards at 1.3 FT BGS

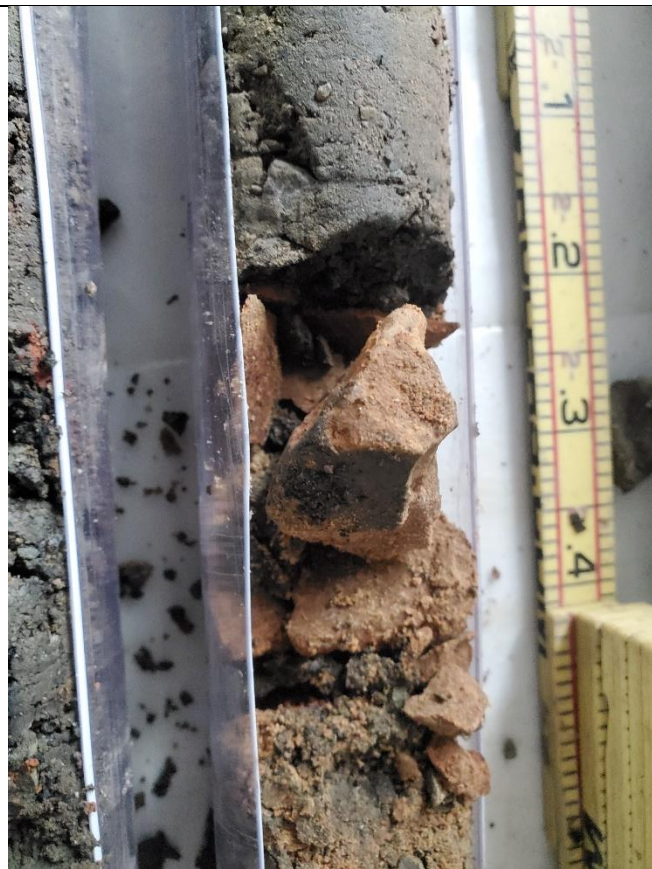
*Picture 14*

SS-11 tan brick fragments at 1.75 FT BGS.

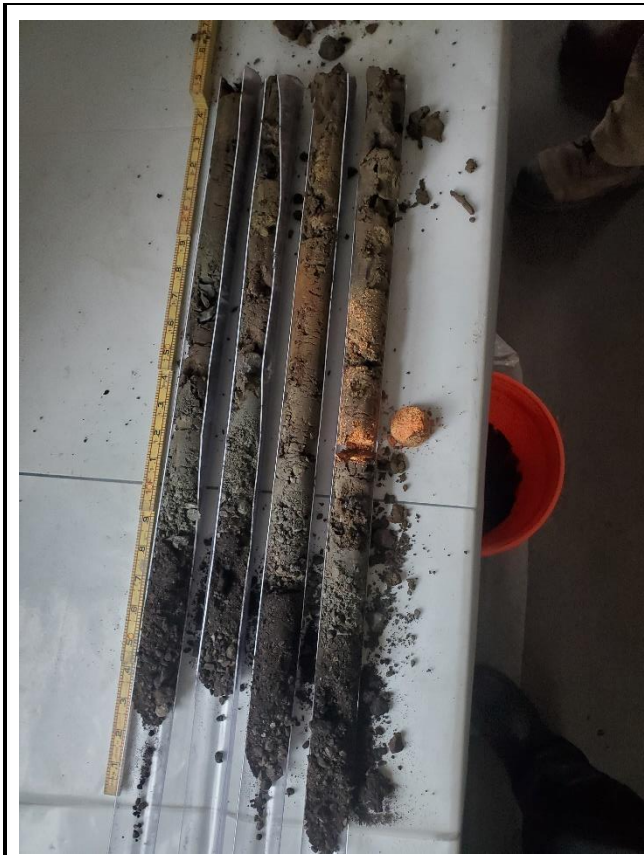
Picture 15

SS-10 cores with visible probable furnace brick from 1-1.3 FT BGS in one core.

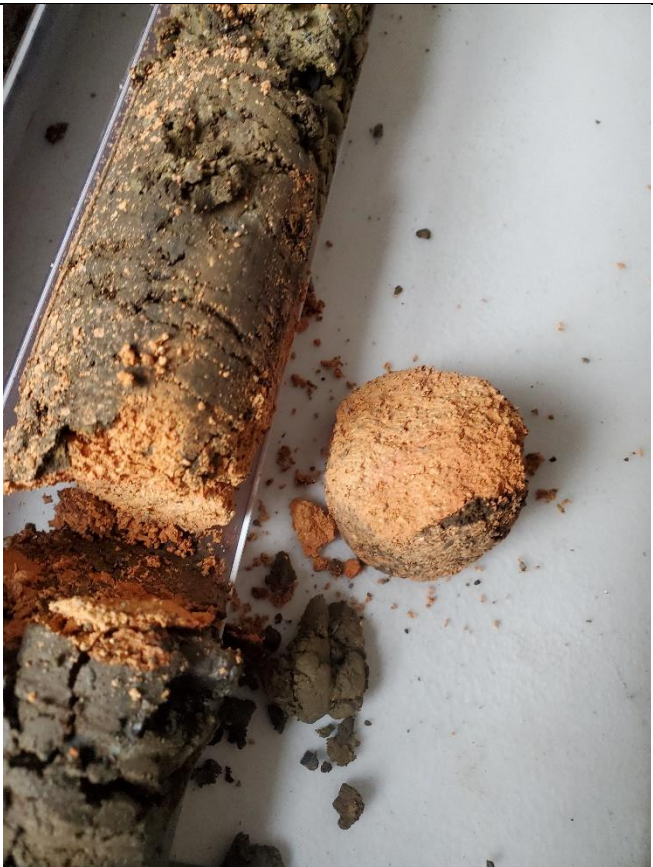
Picture 16

SS-10 close up of tan probable furnace brick

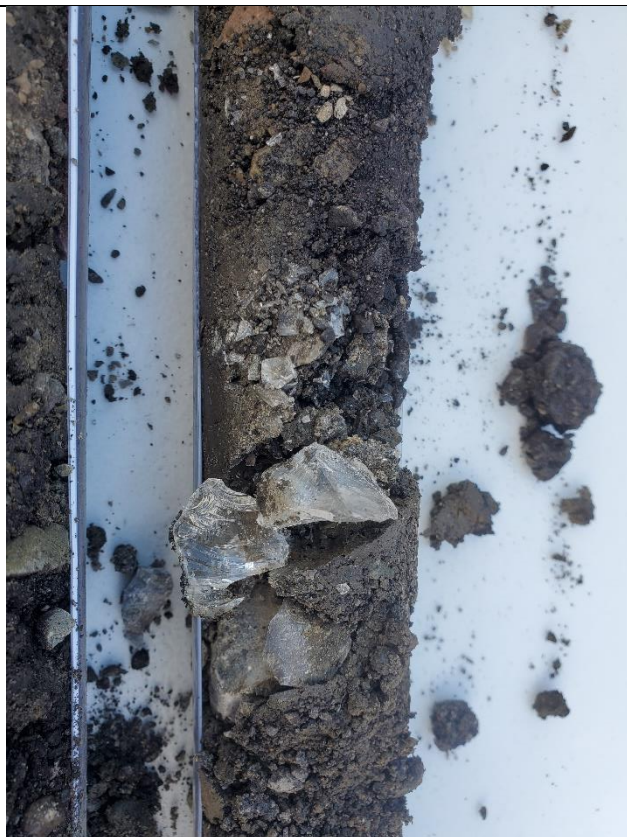
*Picture 3*

SS-09 close up of clear glass cullet from  
1.25-1.5 FT BGS

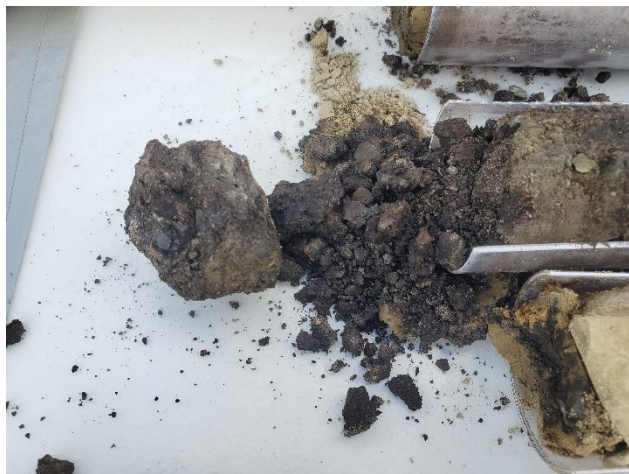
Picture 5

SS-08 close up of black material in bottom 6" with elevated PID readings.

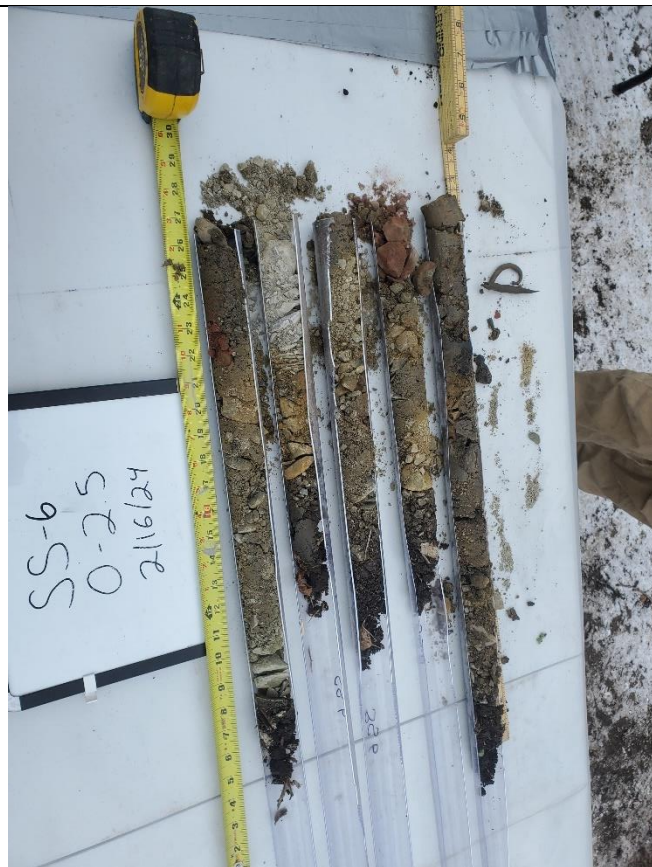
Picture 6

SS-06 cores

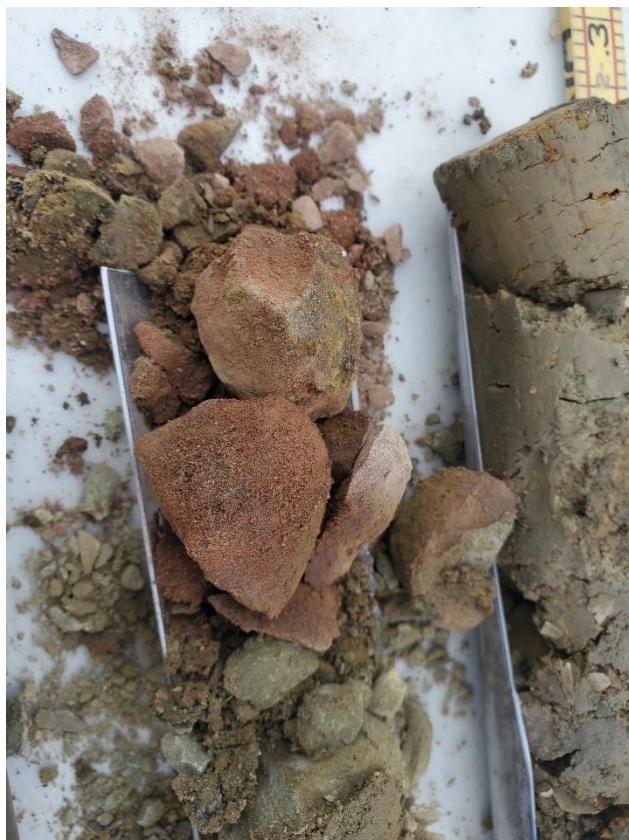
*Picture 7*

SS-06 close up brick fragments from bottom of interval.

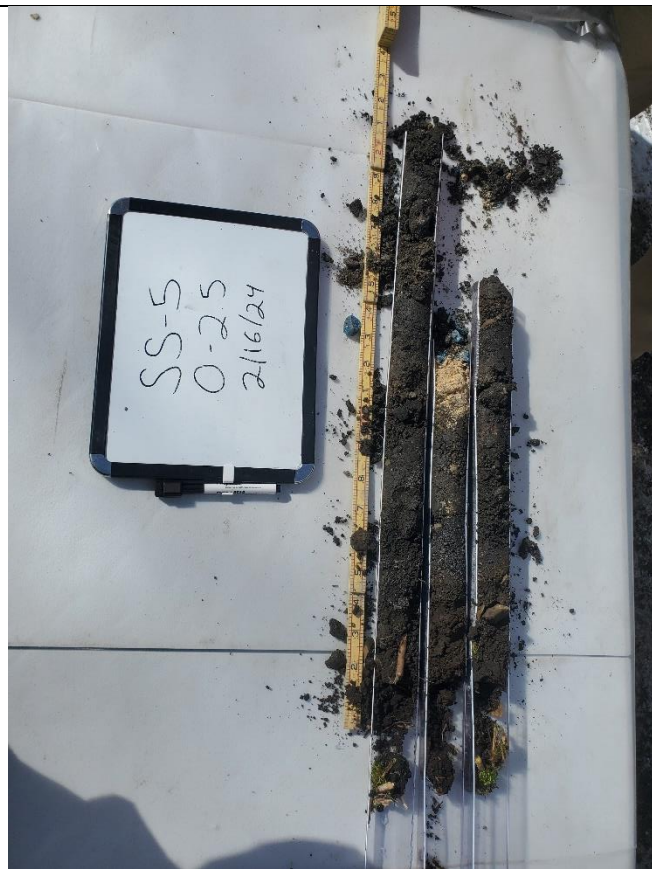
*Picture 8*

SS-05 cores with visible furnace brick.

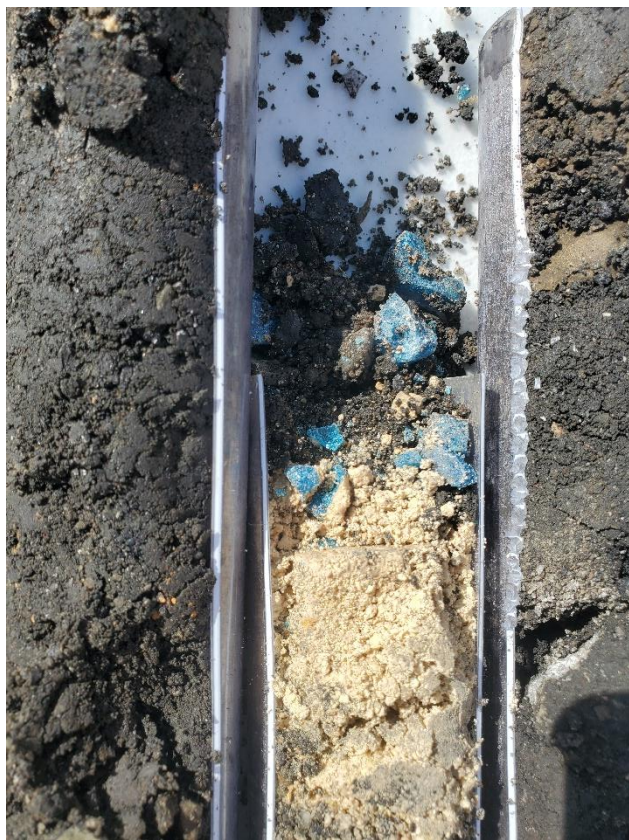
*Picture 9*

SS-05 furnace brick and blue cullet at bottom of interval.

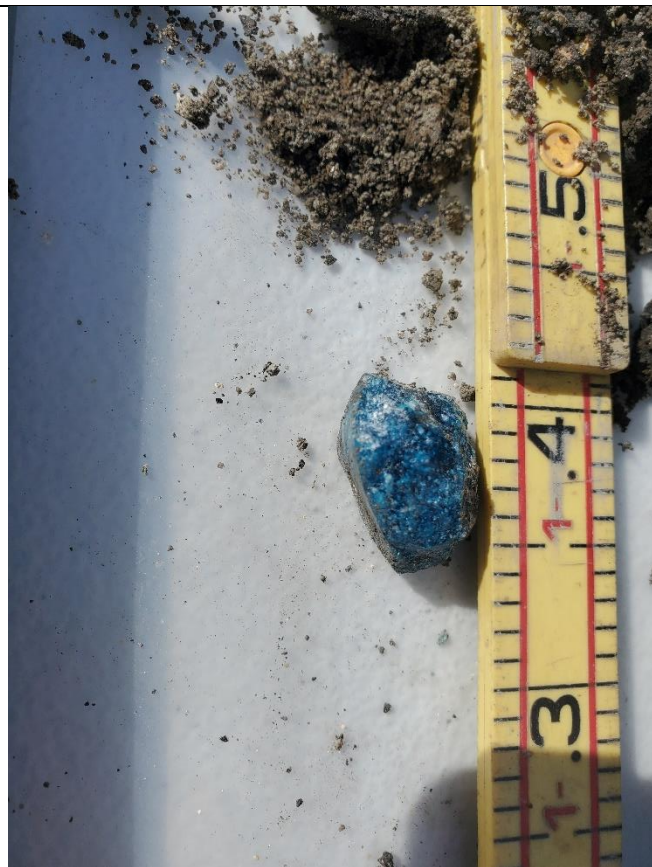
*Picture 10*

Blue cullet recovered from SS-05

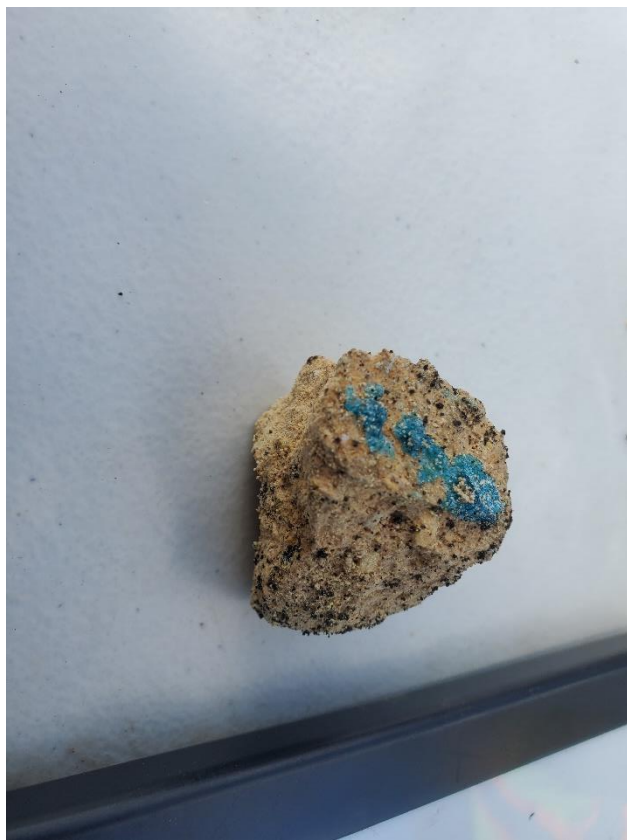
Picture 11

SS-05 glass fused to furnace brick.

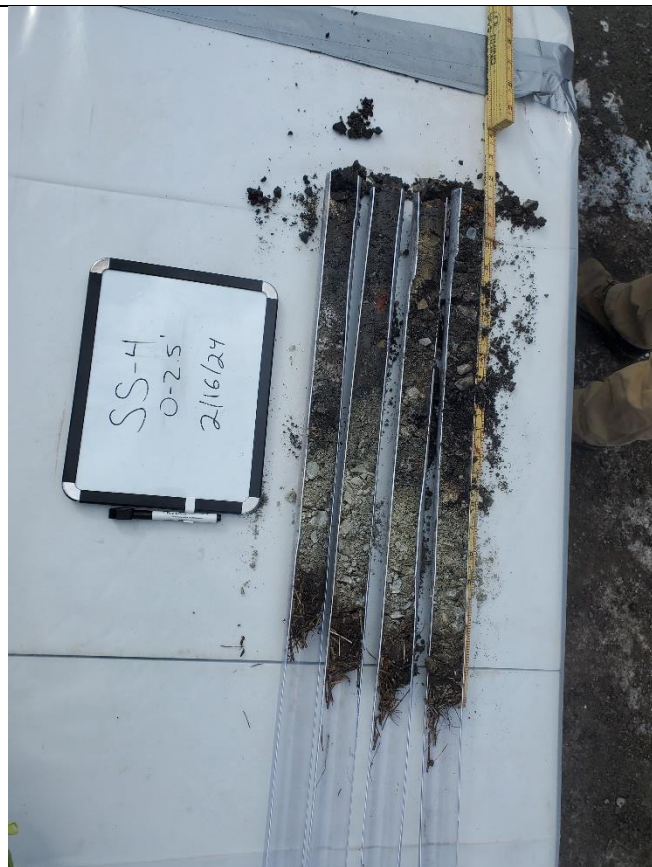
Picture 12

SS-04 cores

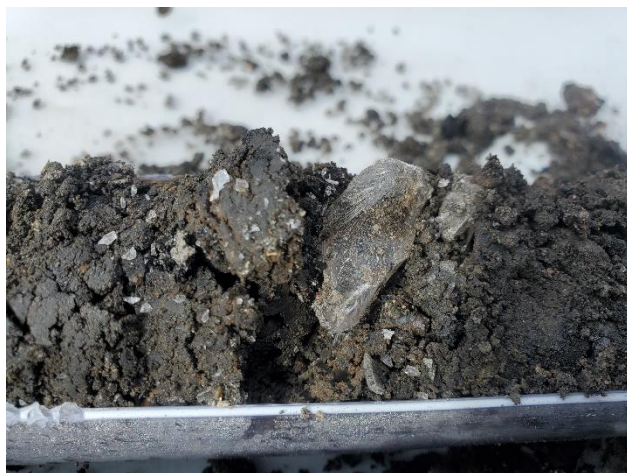
Picture 13

SS-04 Close up of clear glass cullet from 1-2.1 FT BGS interval.

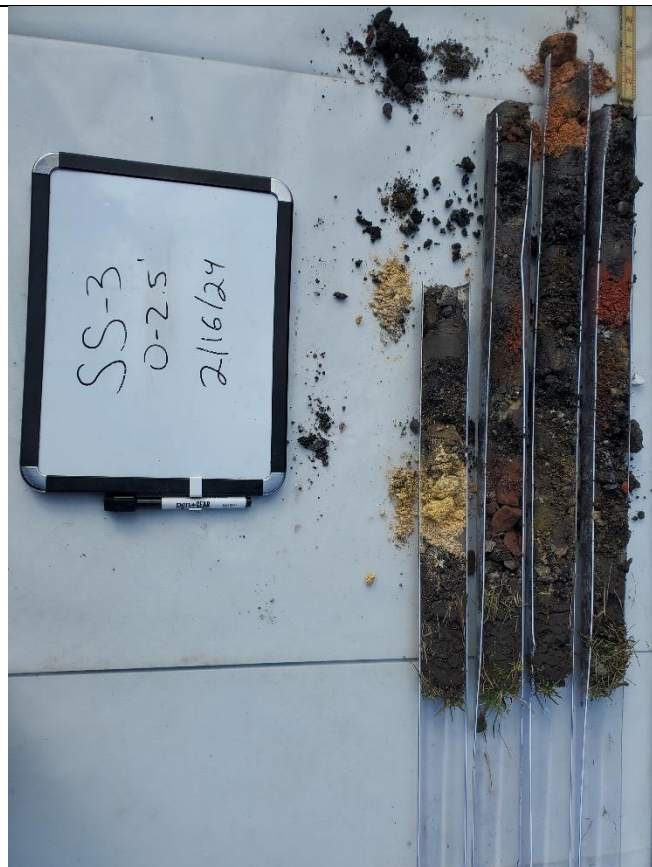
Picture 14

SS-03 cores with multiple colors of bricks visible.

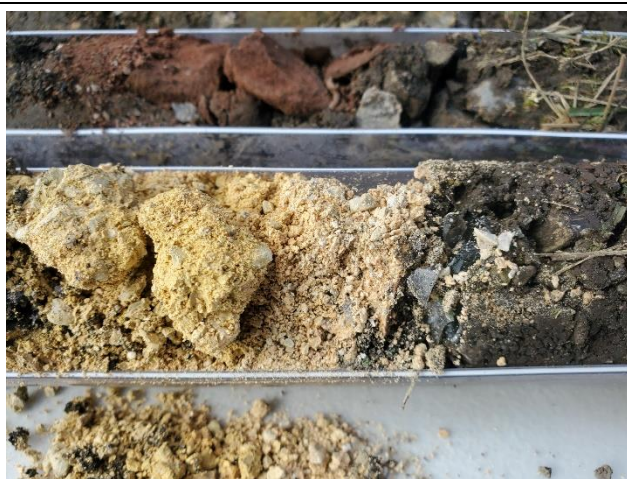
Picture 15

SS-03 close up of white brick and possible ceramics.

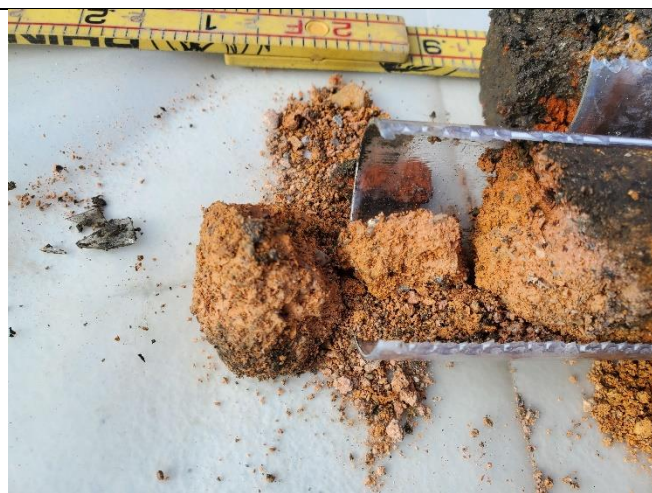
Picture 16

SS-03 orange brick at bottom of interval.

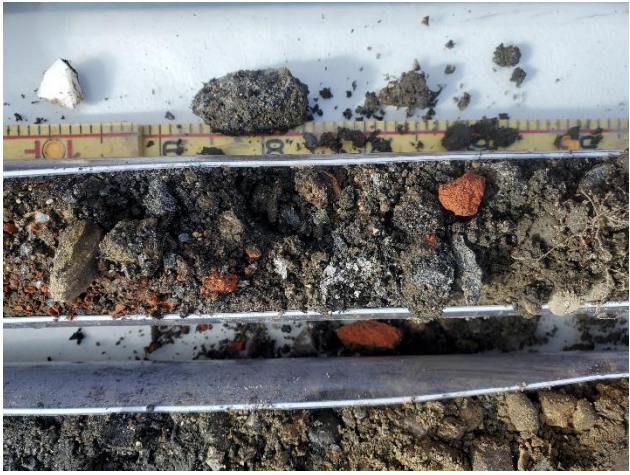
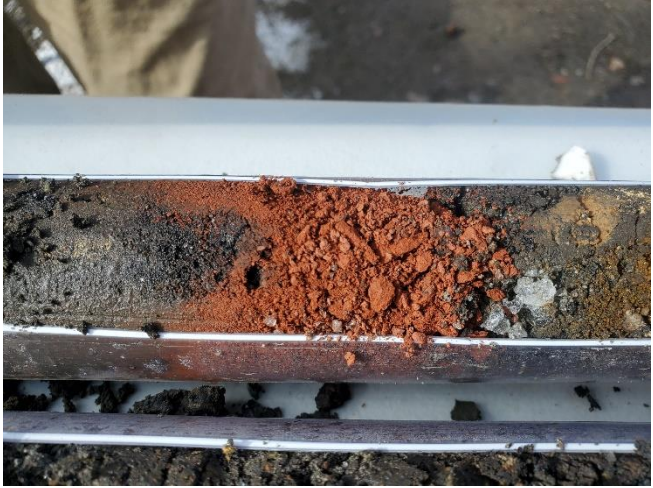
<p>Picture 17</p> <p>SS-03 close up of coal/ash layer with visible brick fragments in 1-2 FT BGS interval.</p>	<p>Picture 18</p> <p>SS-03 red brick fragments with clear glass cullet visible.</p>

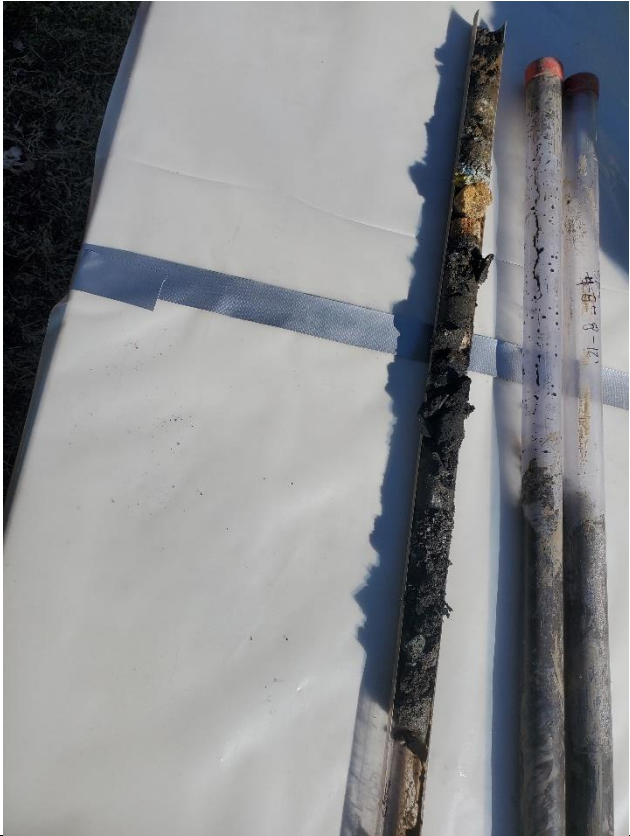
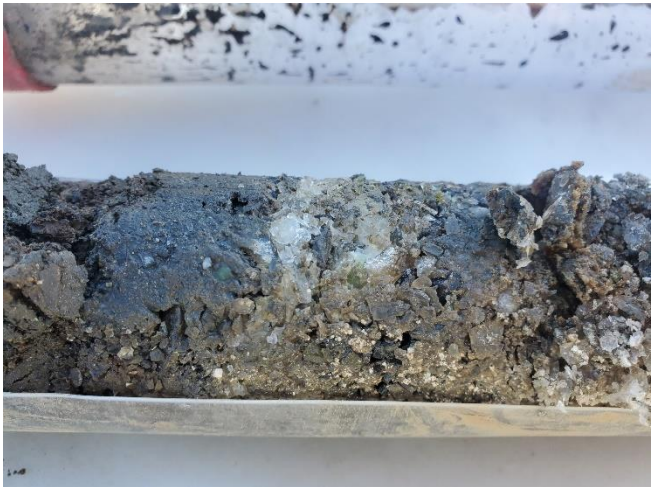
<p><i>Picture 1</i></p> <p>SB-05 4-8 FT with distinct ABG layer</p>	<p><i>Picture 2</i></p> <p>SB-05 glass shards and cullet visible in 5.9-6.7 FT interval.</p>

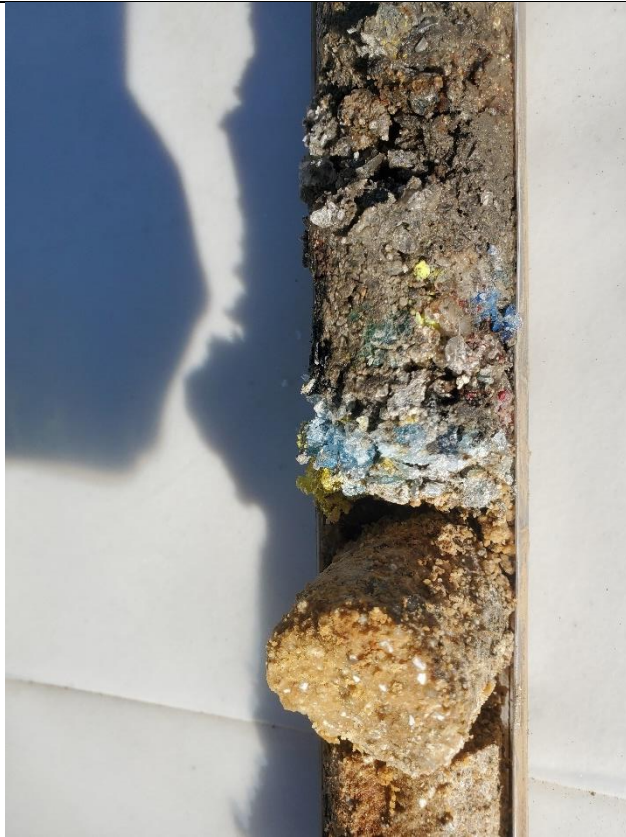
*Picture 3*

SB-05 with furnace brick and glass cullet visible from 5.9-6.7 FT interval.
