**DAILY INSPECTION REPORT - No. 001**  
**(Corning Post Creek) Site No. 851053**

NYSDEC Division of Environmental Remediation

Department of Environmental Conservation		<b>Contract No. D009811-29</b> <b>DEC Insp. –</b> <b>DEC PM – Robert Strang</b> <b>Contractor Supt. –</b> <b>Engineer PM – Matt Vetter</b> <b>Engineer Insp. – Joseph Moffitt</b>	
<b>Site Location: Corning, NY</b>					
<b>Weather Conditions</b>					
<b>General Description</b>	Cloudy	AM	Partly Cloudy	PM	
<b>Temperature</b>	31 F	AM	39 F	PM	
<b>Wind</b>	12 MPH W	AM	8 MPH WSW	PM	
<b>Health &amp; Safety</b> <b>If any box below is checked “Yes”, provide explanation under “Health &amp; Safety Comments”.</b>					
Were there any changes to the Health & Safety Plan?				*Yes	No X NA
Were there any exceedances of the perimeter air monitoring reported on this date?				*Yes	No X NA
Were there any nuisance issues reported/observed on this date?				*Yes	No X NA
<b>Health &amp; Safety Comments</b> Dash Card created for site. Integral conducted internal safety meeting with Parratt-Wolff No CAMP exceedances reported to Parsons by Integral

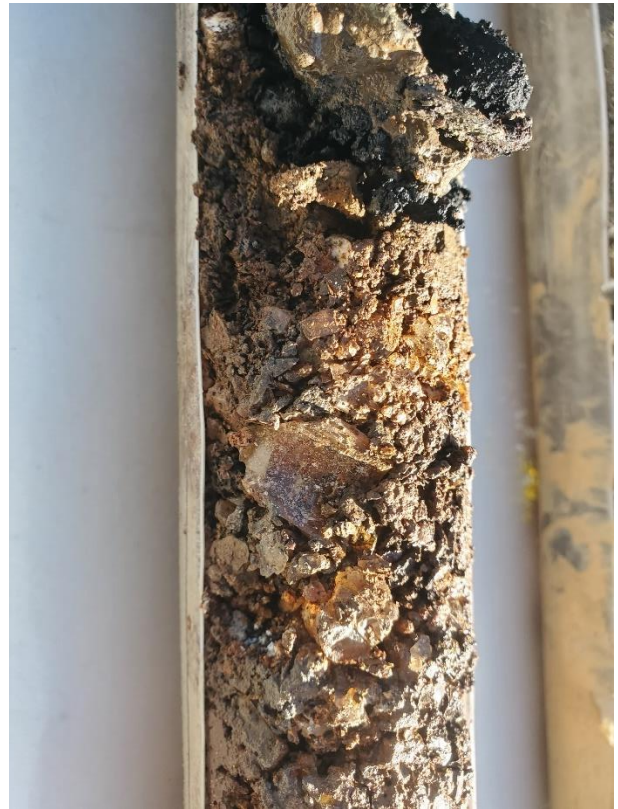
*Picture 4*

SB-05 orange glass shards and cullet from 5.9-6.7 FT interval.

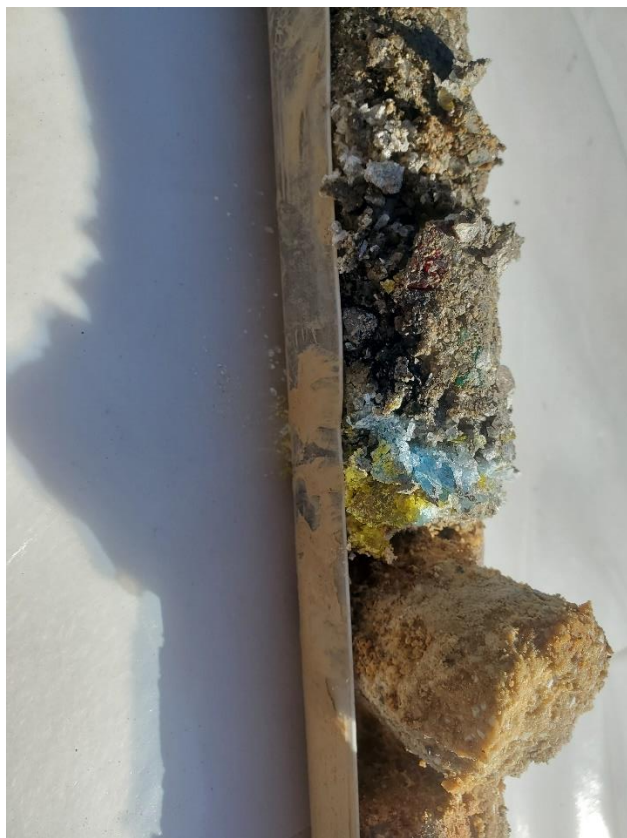
*Picture 5*

SB-05 close up of glass and brick from 5.9-6.7 FT interval.

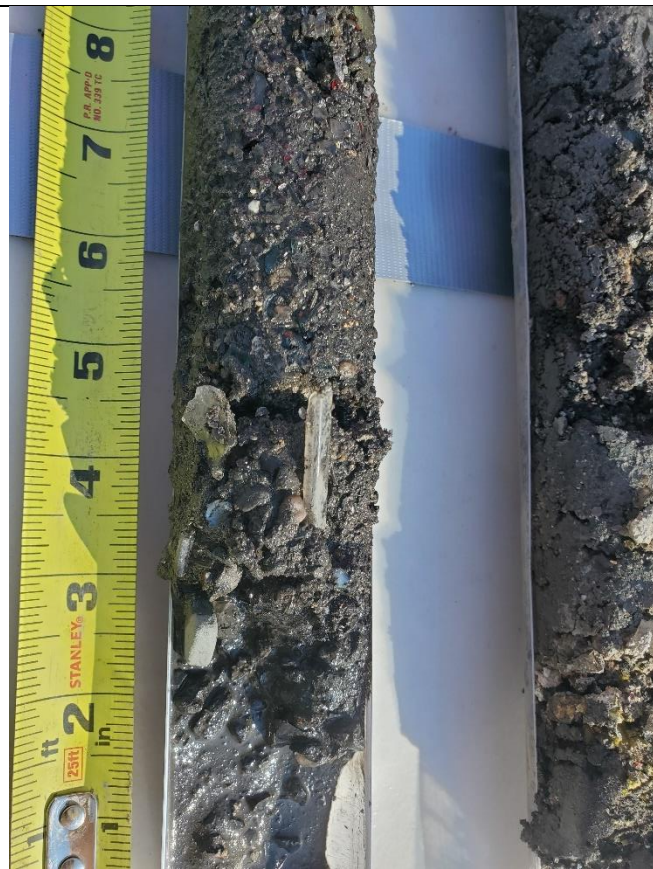
*Picture 6*

SB-05 thermometer tubing in 12-14 FT core

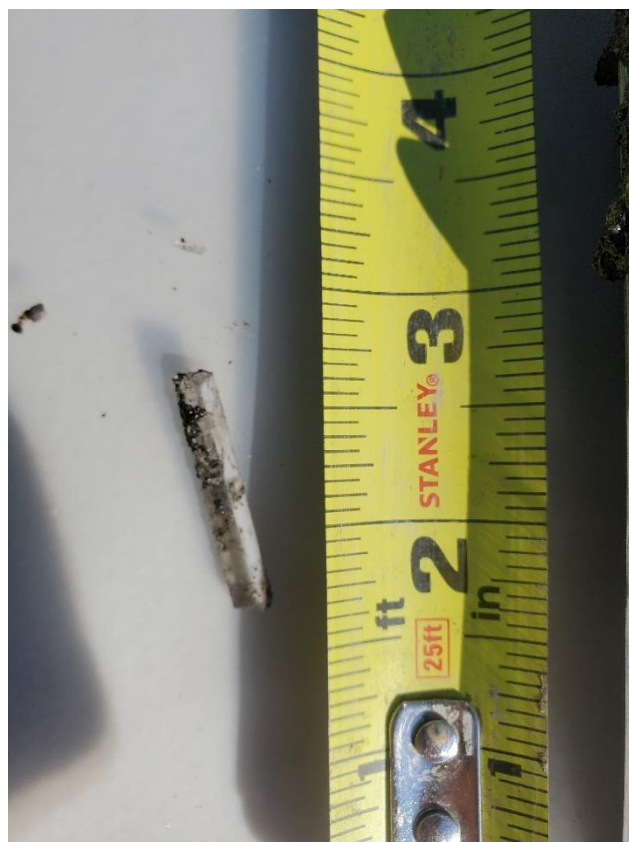
*Picture 7*

SB-05 close up of thermometer tubing from 12-14 FT core.

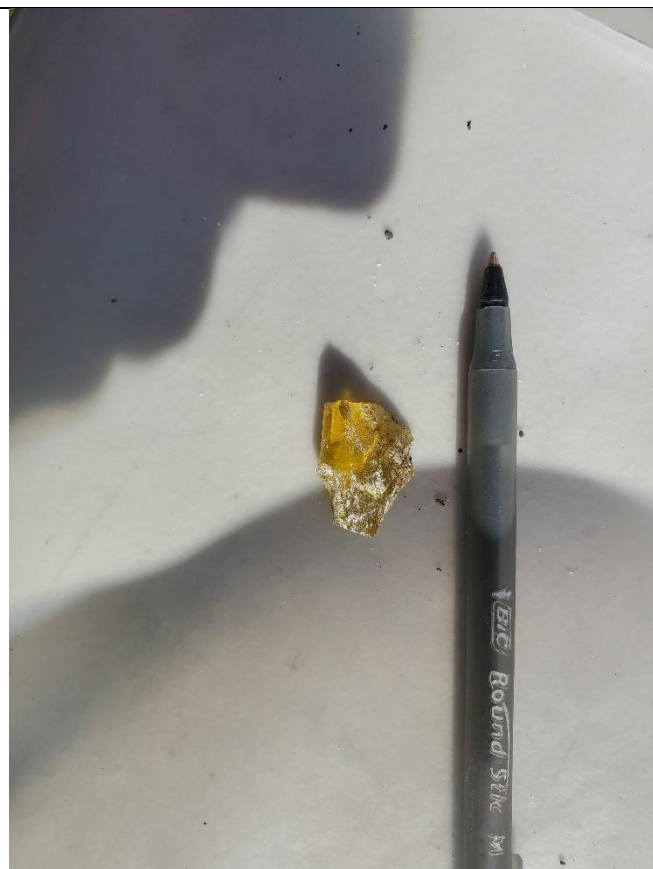
*Picture 8*

SB-05 yellow glass cullet recovered from 5.9-6.7 FT interval.

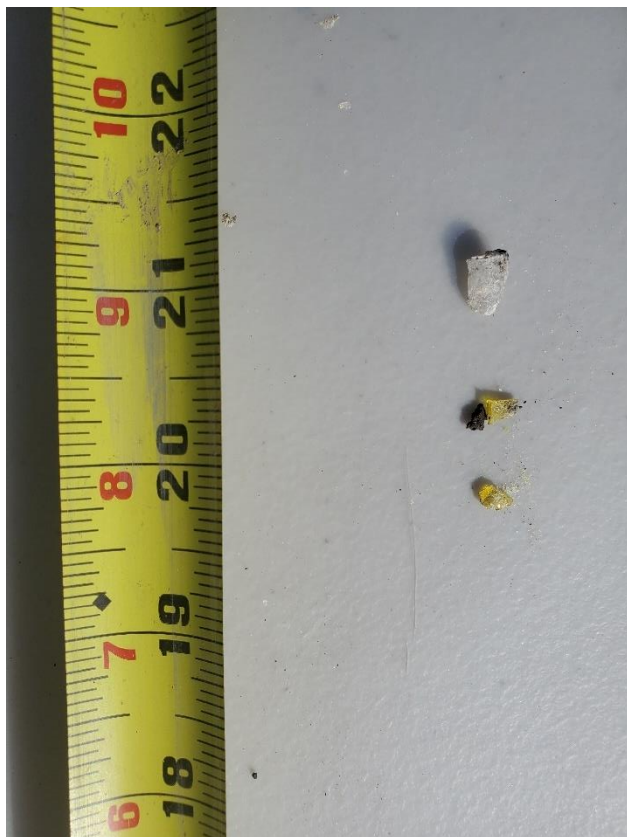
*Picture 9*

SB-05 Yellow and clear glass shards 5.9-6.7 FT interval.

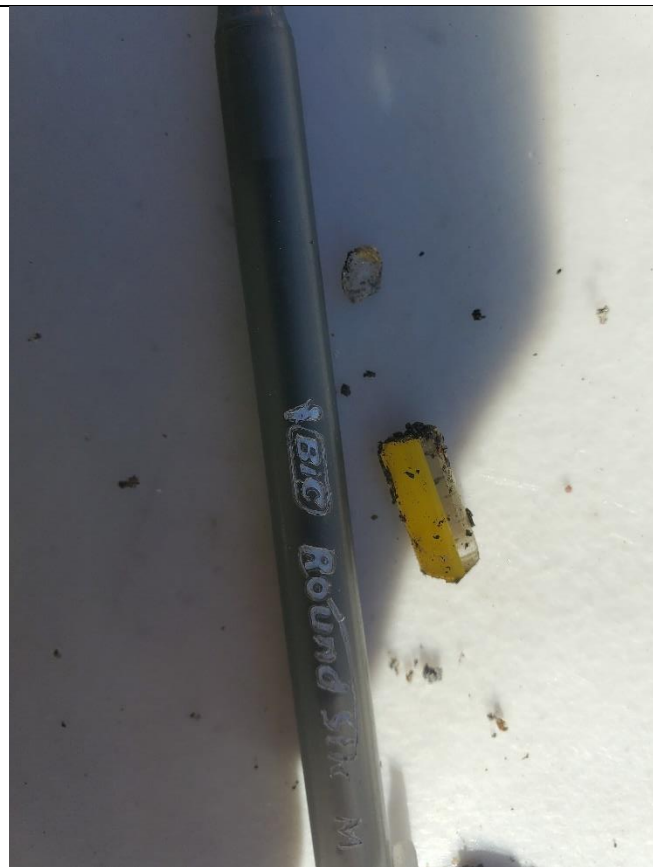
*Picture 10*

SB-05 yellow thermometer tubing 5.9-6.7 FT interval.

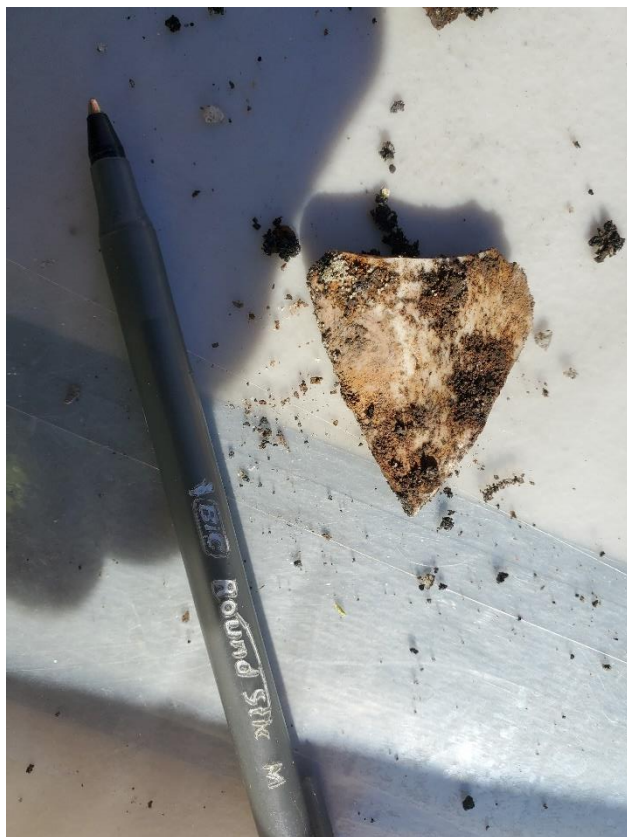
Picture 11

SB-05 white probable ceramic 10-12 FT interval.

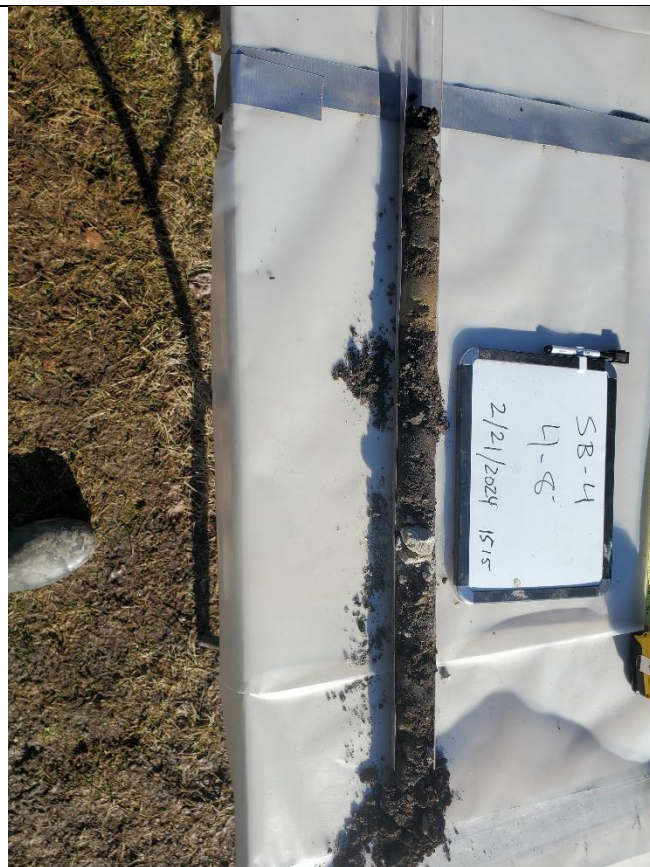
Picture 12

SB-04 4-8 FT core showing gravelly sand of location.

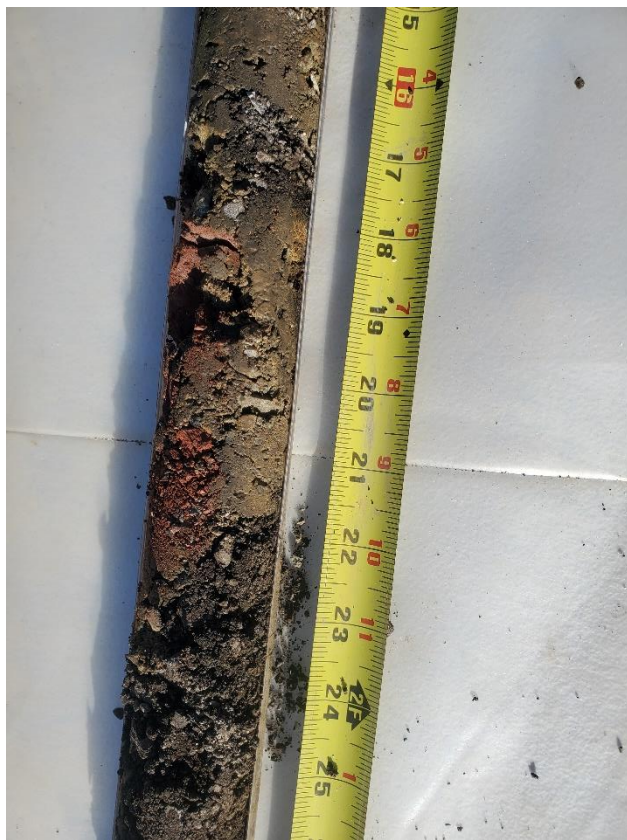
*Picture 13*

SB-04 8-12 FT interval with red brick fragments from 10 FT BGS.

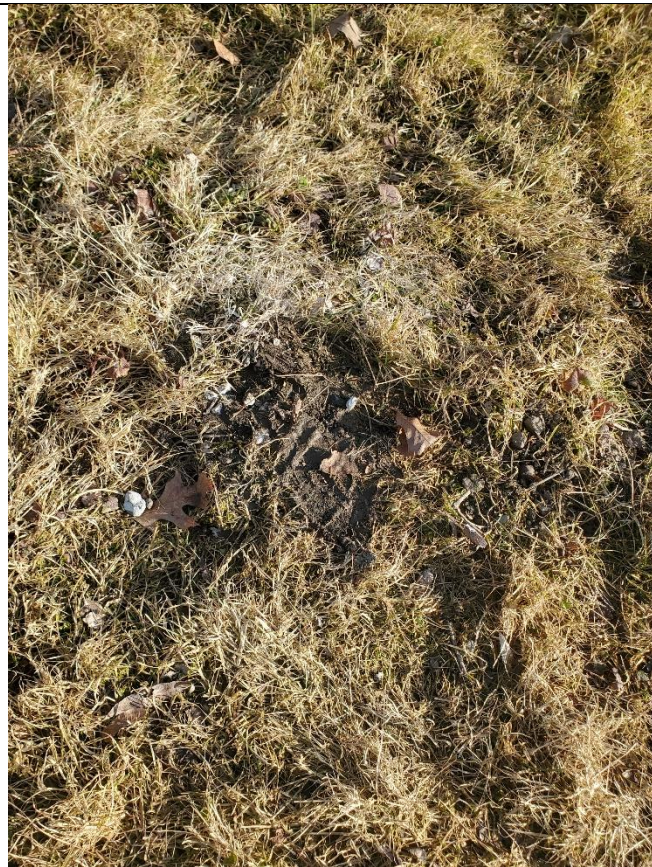
*Picture 14*

SS-04 location topped with topsoil after being backfilled with bentonite.

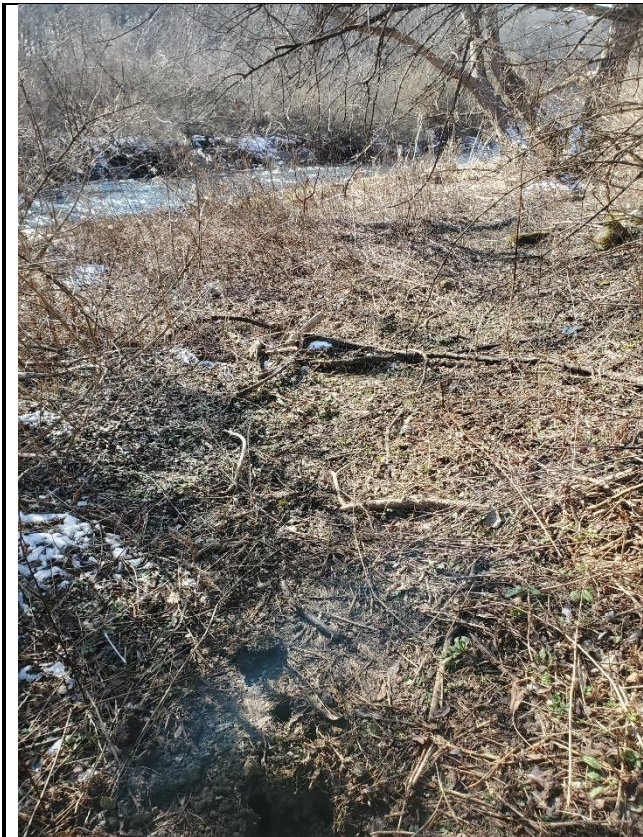
Picture 15  
View looking Southeast: SS-41 location relative to Post Creek.

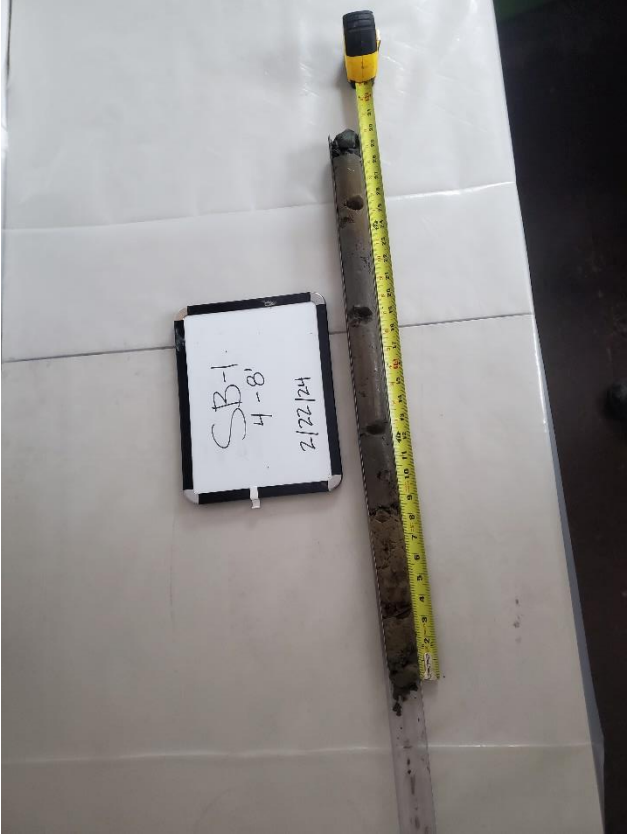
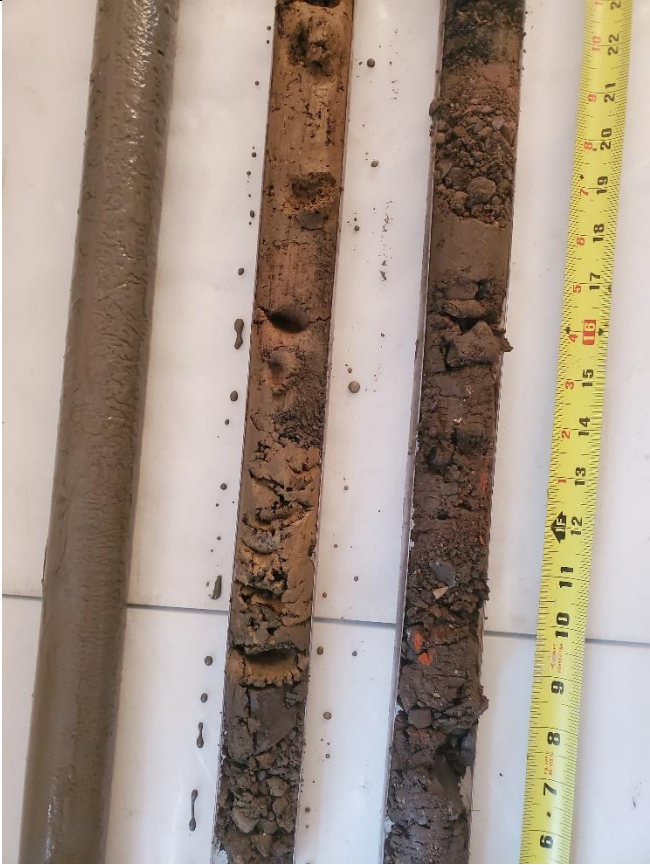
<p>A photograph showing two sediment cores side-by-side. The left core is a dark, silty material (SB-02, 4-8' core). The right core is a lighter, brownish material (SB-02, 0-4' core) containing numerous red brick fragments. A yellow measuring tape is visible on the right side of the cores.</p>
<p><i>Picture 1</i></p> <p>SB-01 0-4 FT core showing native silt material.</p>	<p><i>Picture 2</i></p> <p>SB-02 showing native silt layer (left) in 4-8 FT core, and red brick fragments (right) in 0-4 FT core.</p>

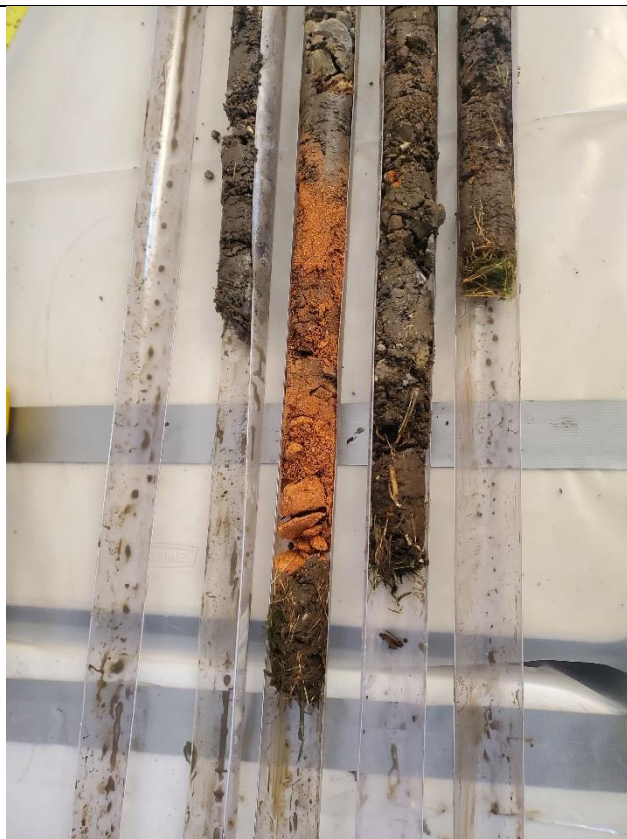
*Picture 3*

SB-02 orange brick in 0-4 FT core, ~1 FT long.

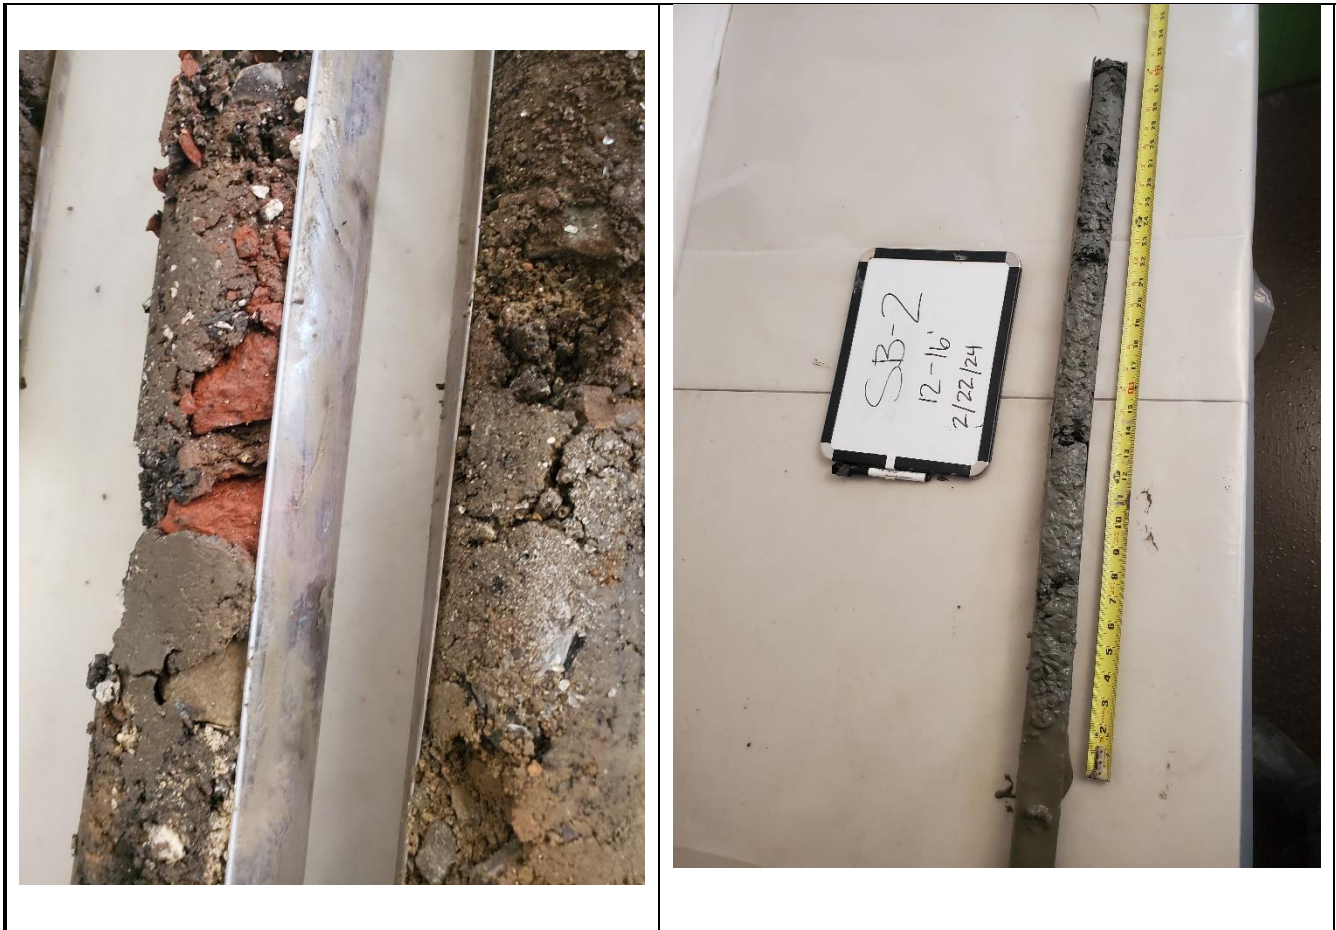
Picture 5

SB-02 close up of red brick from 0-4 FT core in separate core.

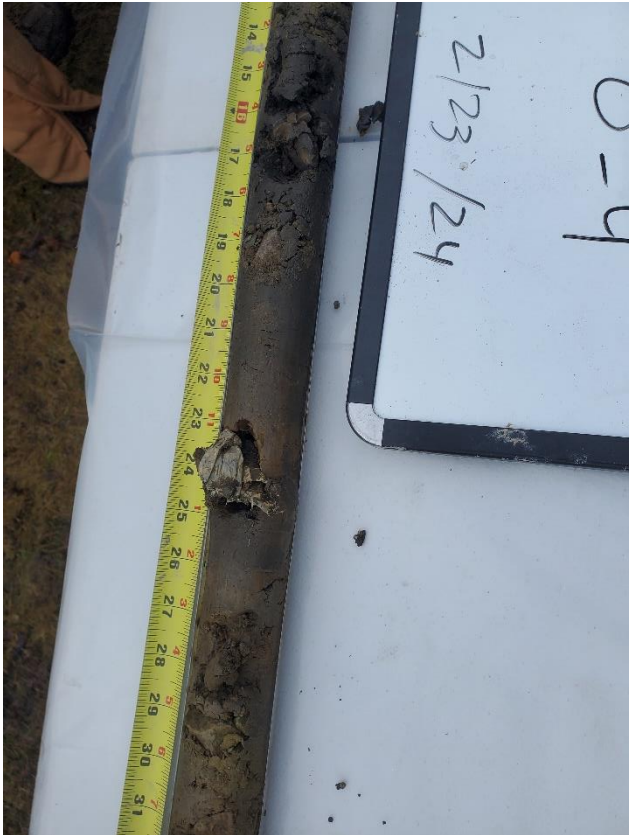
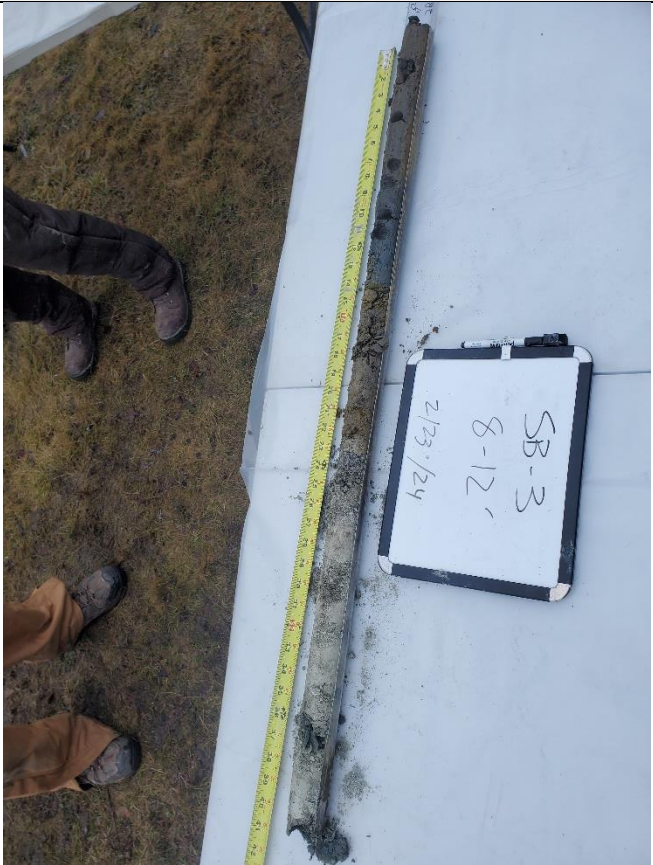
<p><i>Picture 1</i></p> <p>SB-03 paper waste at 2.5 FT BGS.</p>	<p><i>Picture 2</i></p> <p>SB-03 start of weathered bedrock at ~10 FT BGS.</p>

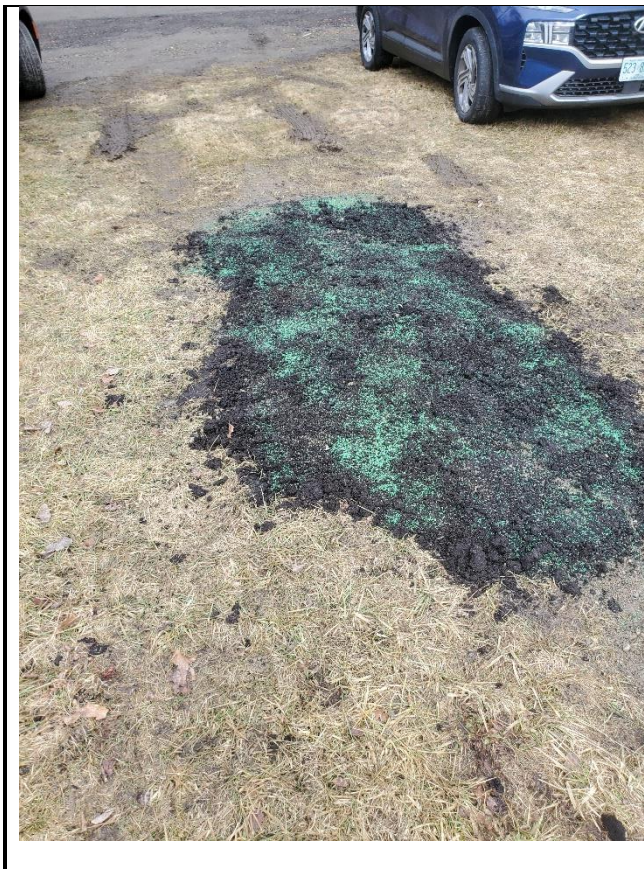
Picture 3  
View looking Northeast: grass seed on TP-TP-01.
