Division of Environmental Remediation

Site Investigation - Scope of Work

**Riverview Industrial Center
5335 River Road
Town of Tonawanda
Erie County, New York**

March 2009

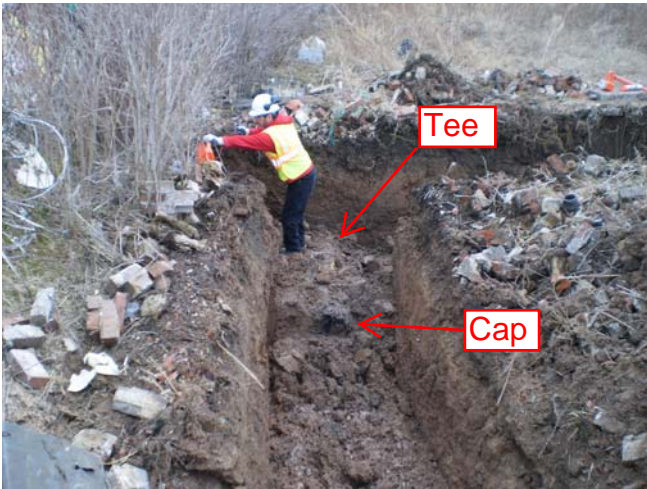
040510-05 Capped Tee.JPG

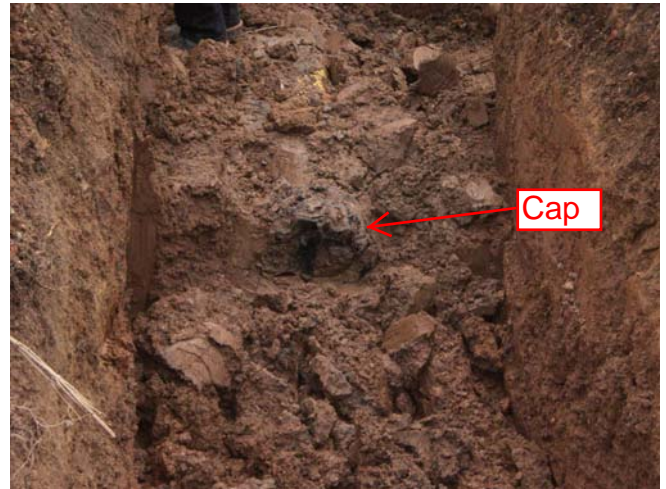
040510-06 Cap.JPG

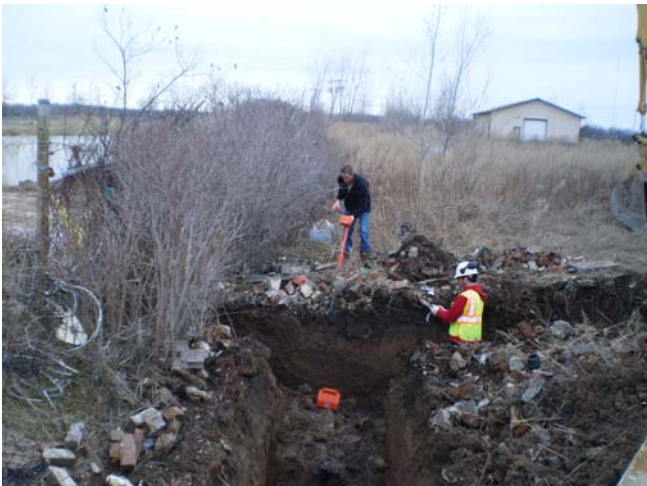
040510-07 Trace North.JPG
Riverview Industrial Center

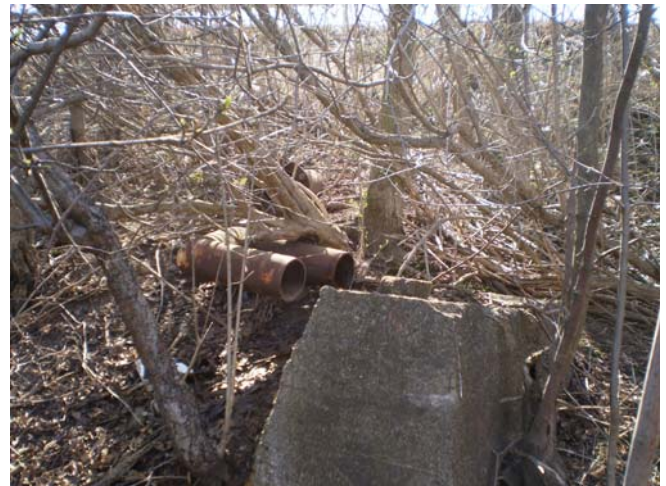
08 Abandoned Pipelines North of
Page 2

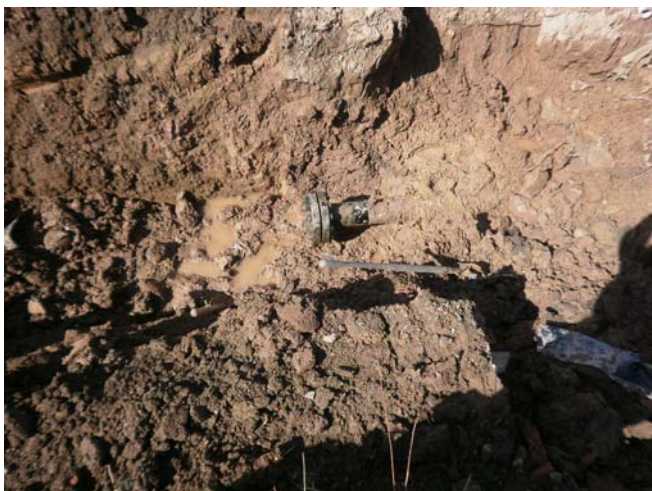
041410-01 Flange.JPG

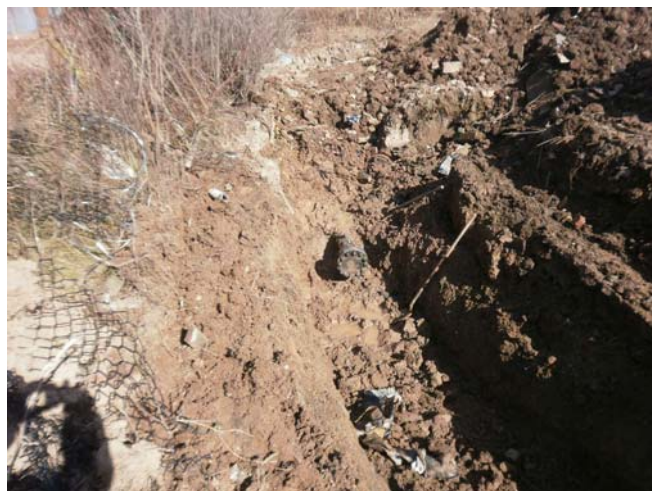
041410-02 Flange.JPG

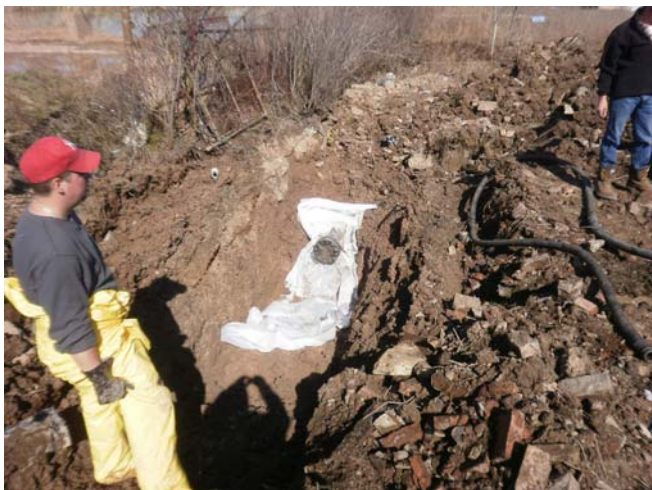
041410-03 Poly Containment.JPG
Riverview Industrial Center

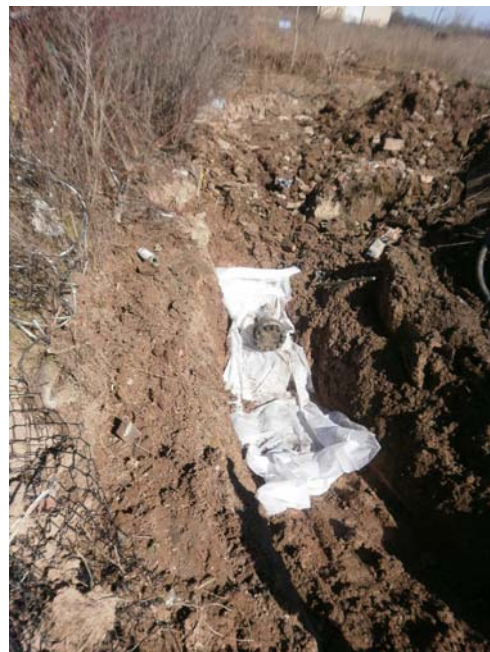
041410-04 Poly Containment.JPG
Page 1

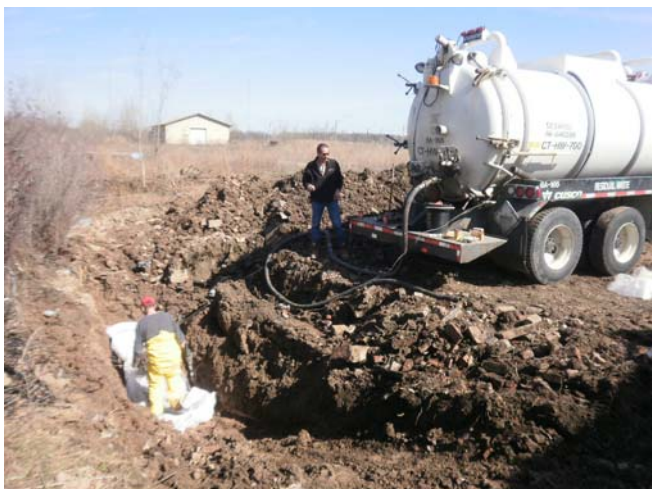
041410-05 Vac Truck.JPG

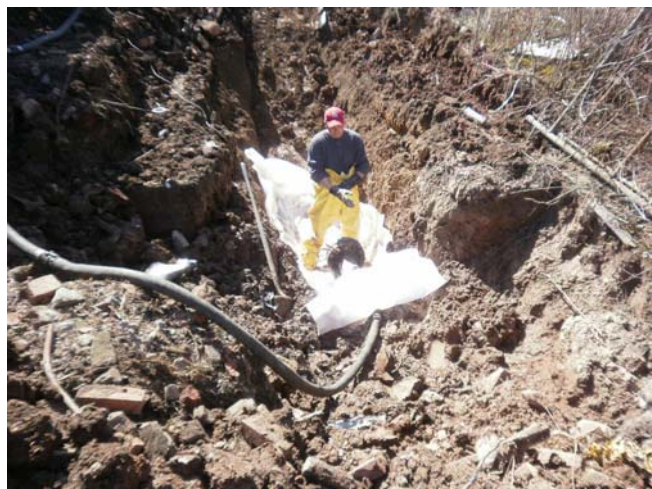
041410-06 Flange removal.JPG

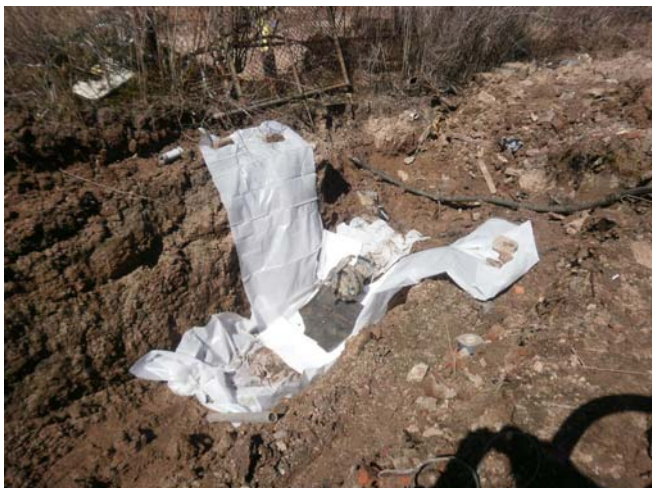
041410-07 Poly Containment Improvement
Riverview Industrial Center

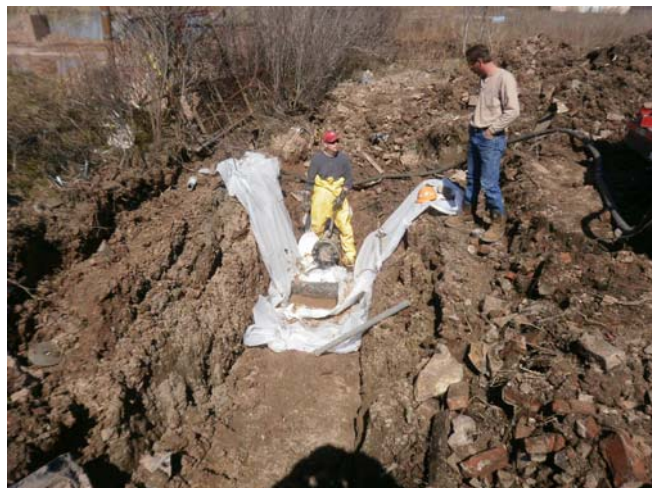
041410-08 Flange removal.JPG

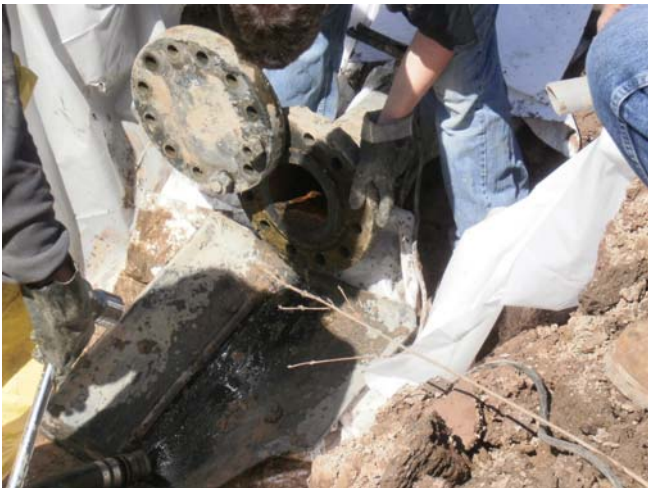
041410-11 Flange Removed.JPG
Riverview Industrial Center

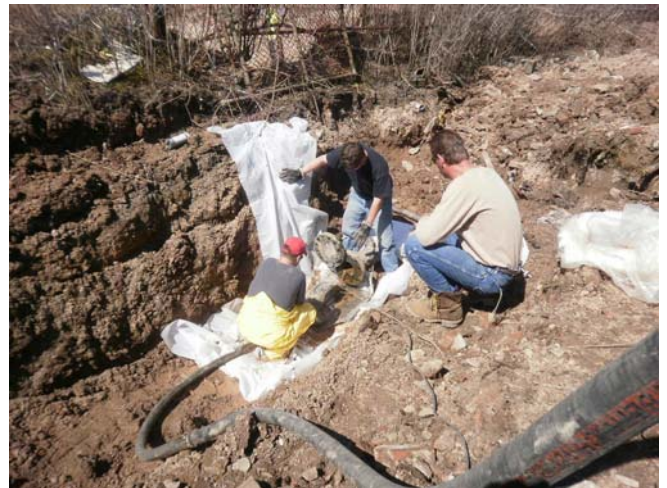
041410-12 Flange removed.JPG
Page 3

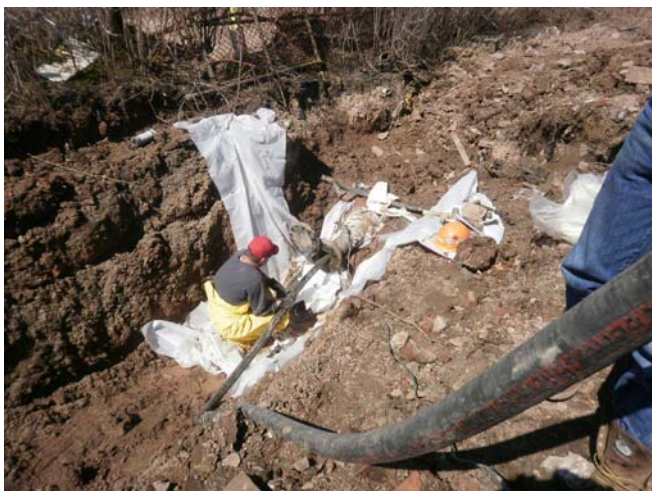
Flange removed at 1155 hrs - very little gasoline, mostly water removed approx 20 gallons max from pipe. Ran vac truck hose about 25' into pipe to remove product. None found

Op-Tech replaced flange (finger tight/snug), removed containment poly and backfilled excavation.

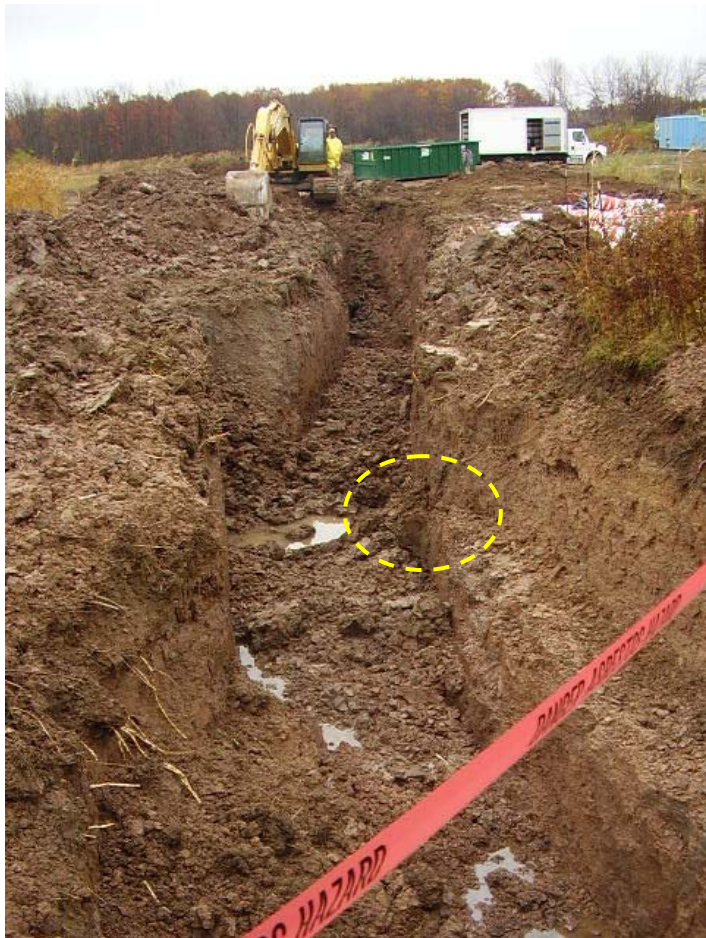
Location of unknown clay pipe with suspected petroleum contamination

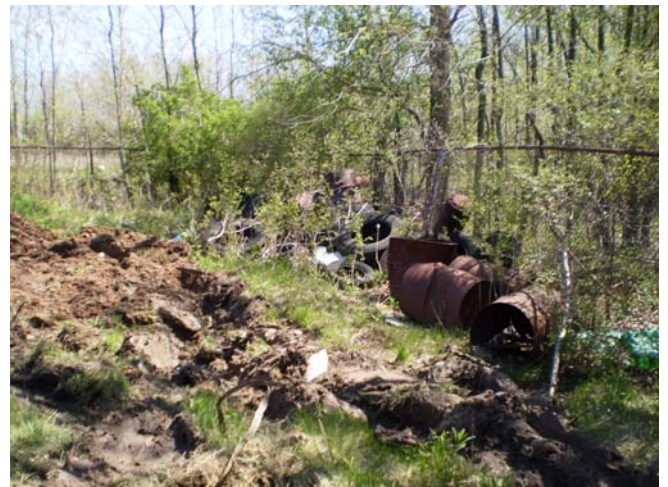
051109-04 Debris SE Corner.JPG

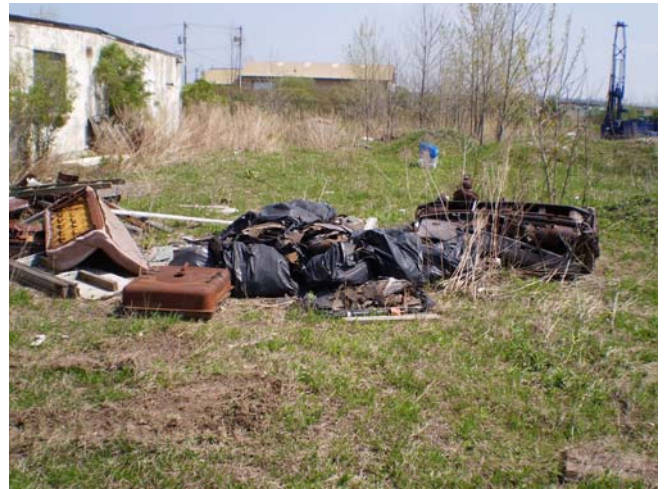
050809-02 Debris.JPG

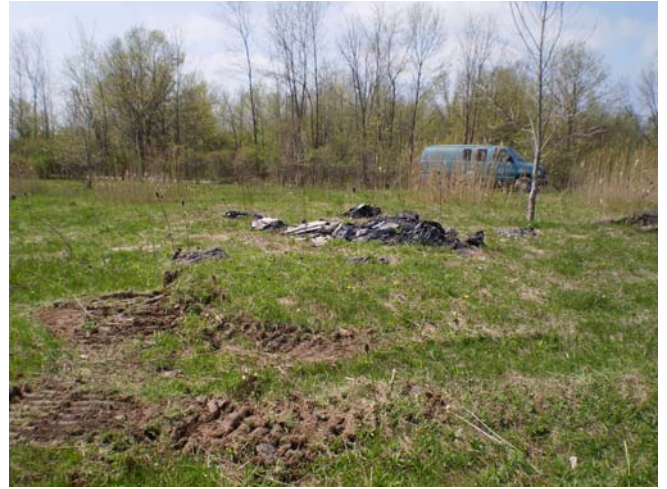
050809-06 Debris.JPG

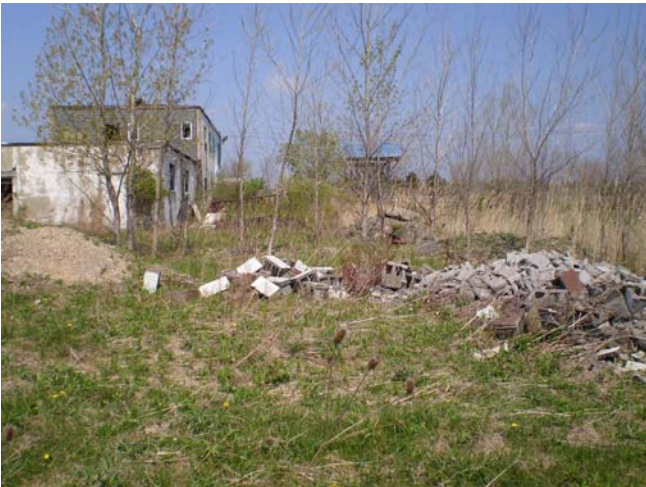
050809-07 Debris.JPG

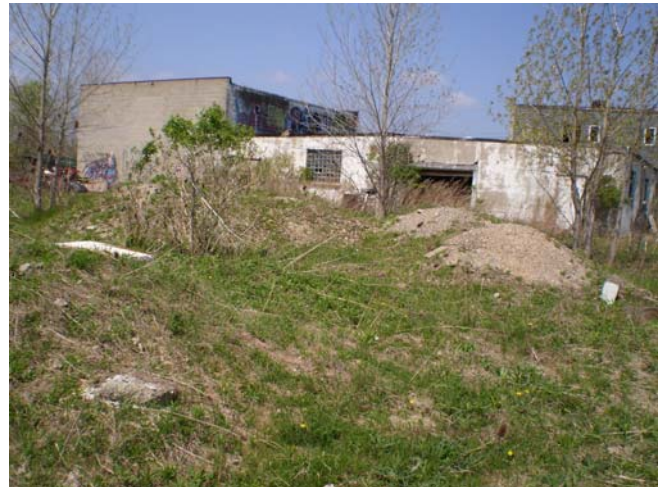
050809-08 Debris.JPG

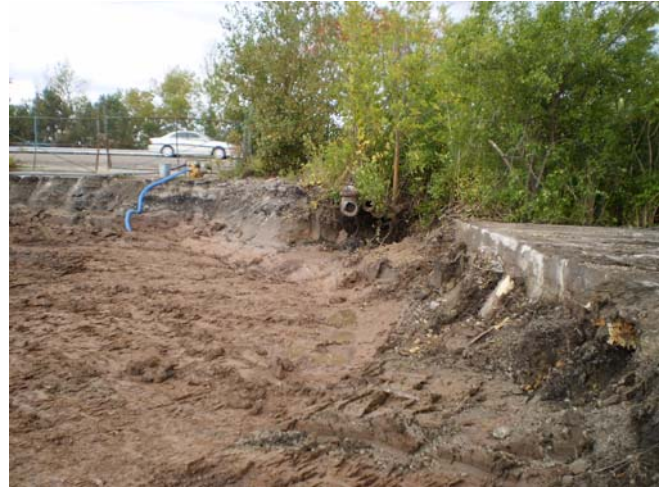
0109-01 East Side Excavation Old Pipe

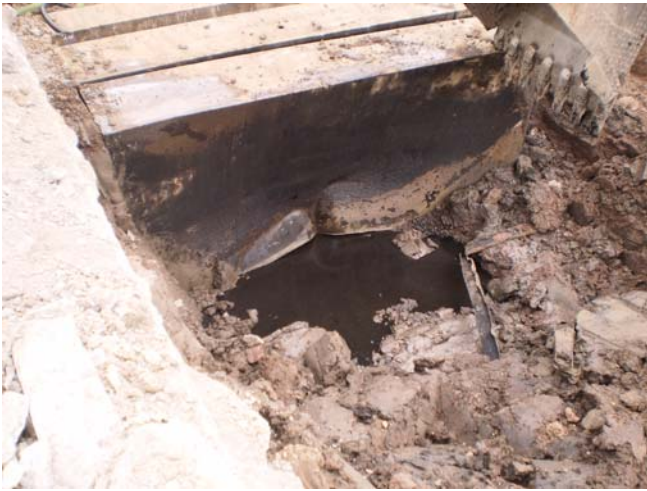
91809-01 T6 Oil in Excavation.JPG

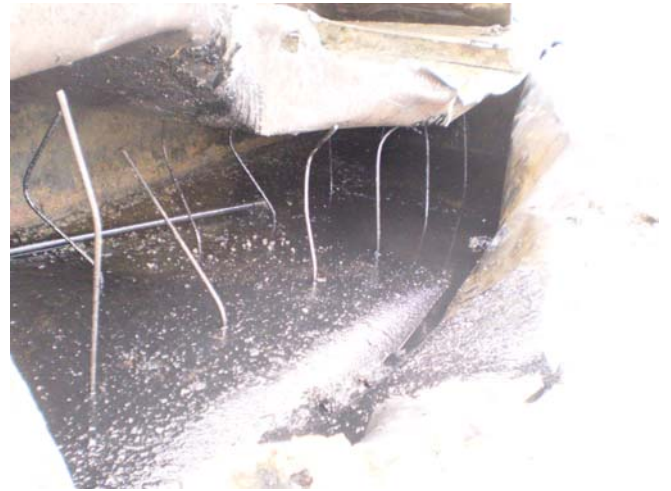
091809-02 Residual Oil in T6.JPG

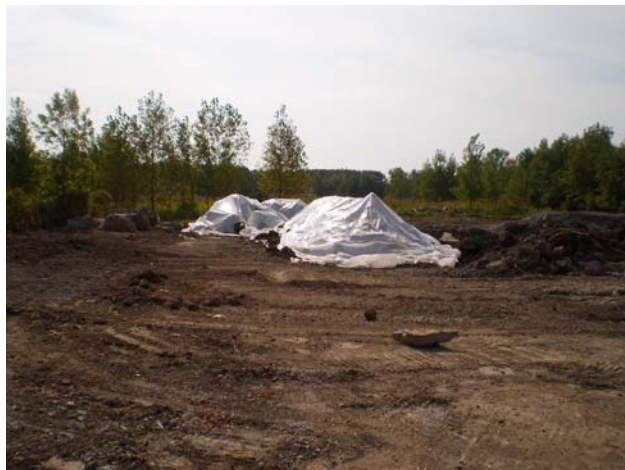
090909-03 Contaminated Soil Pile.JPG

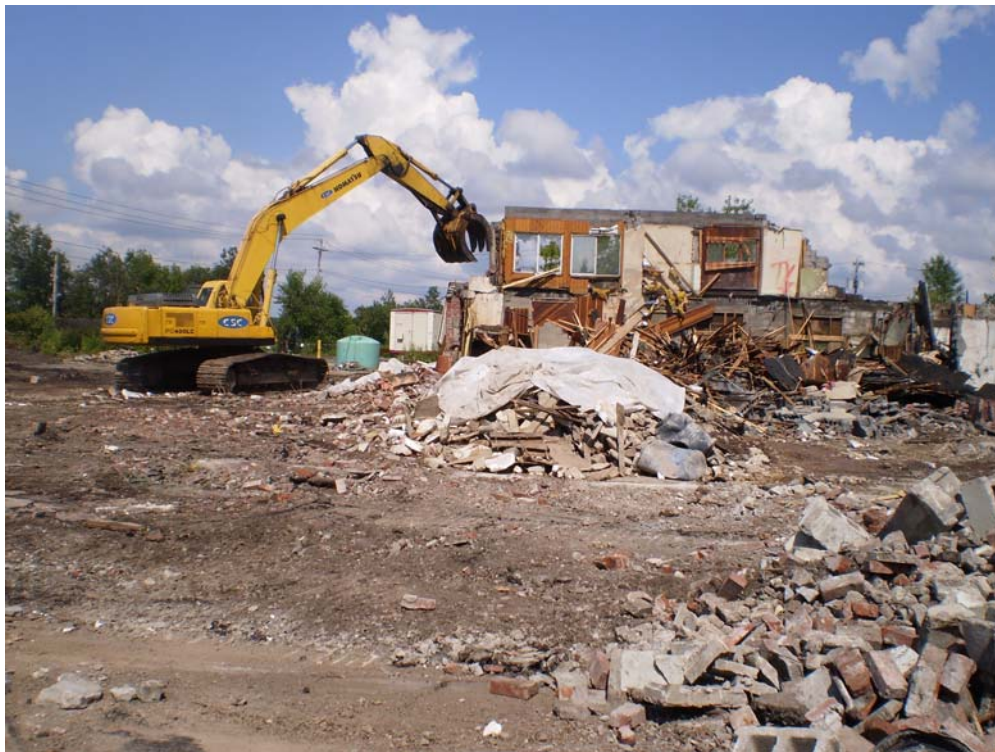
081209-01 Spill Area.JPG

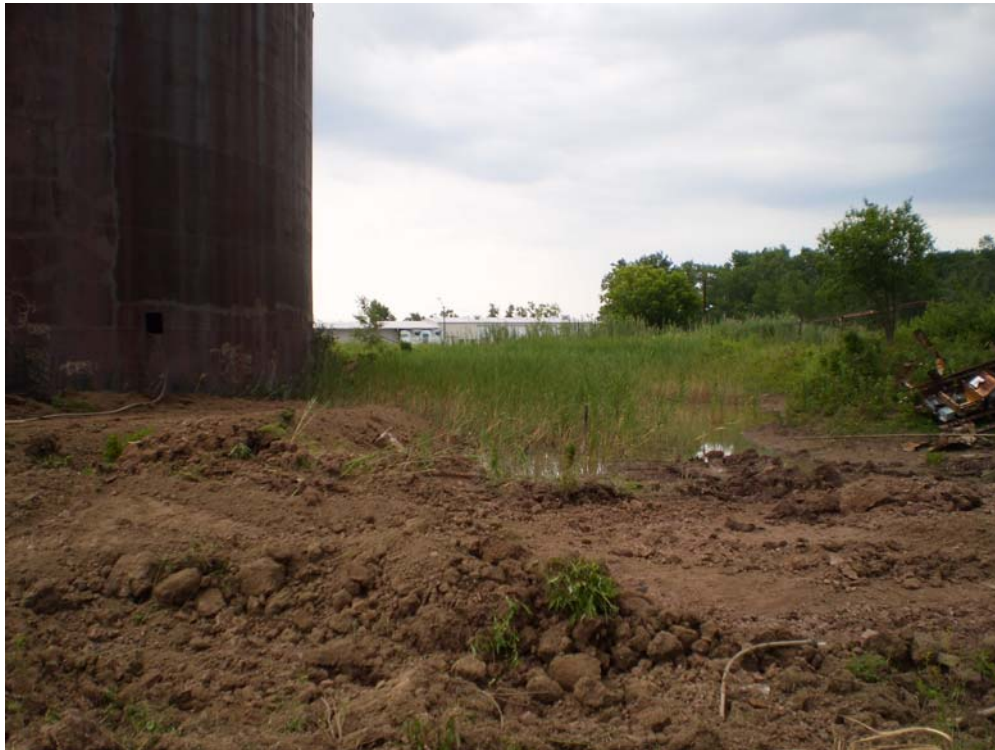
081209-02 Spill Area.JPG

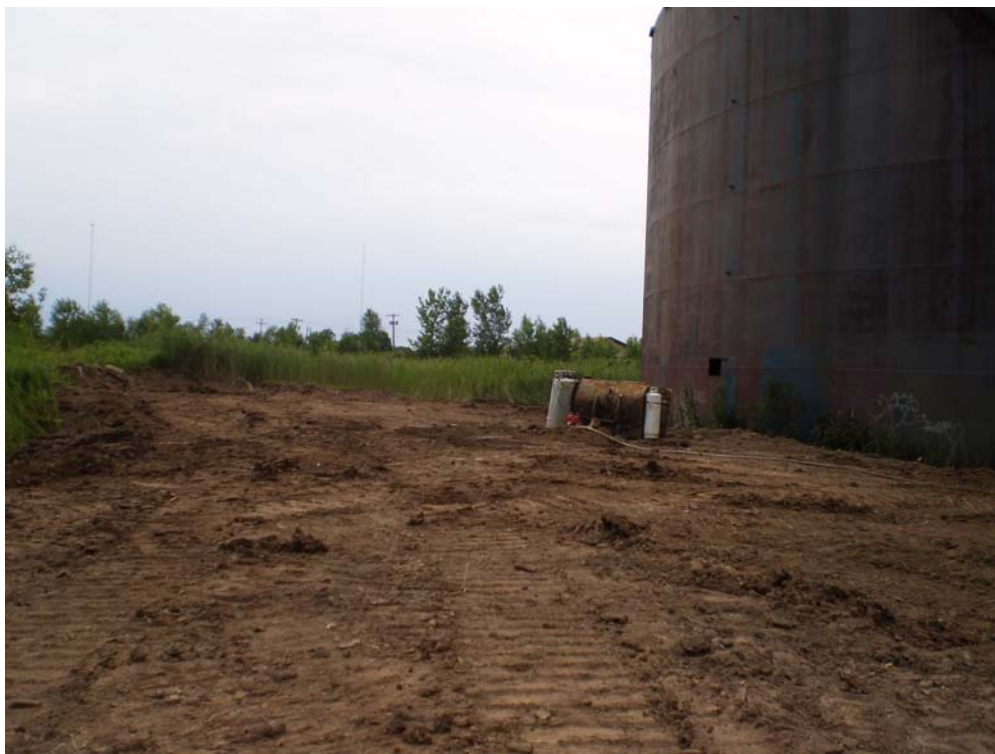
072109-01 Tank 4 South Side.JPG

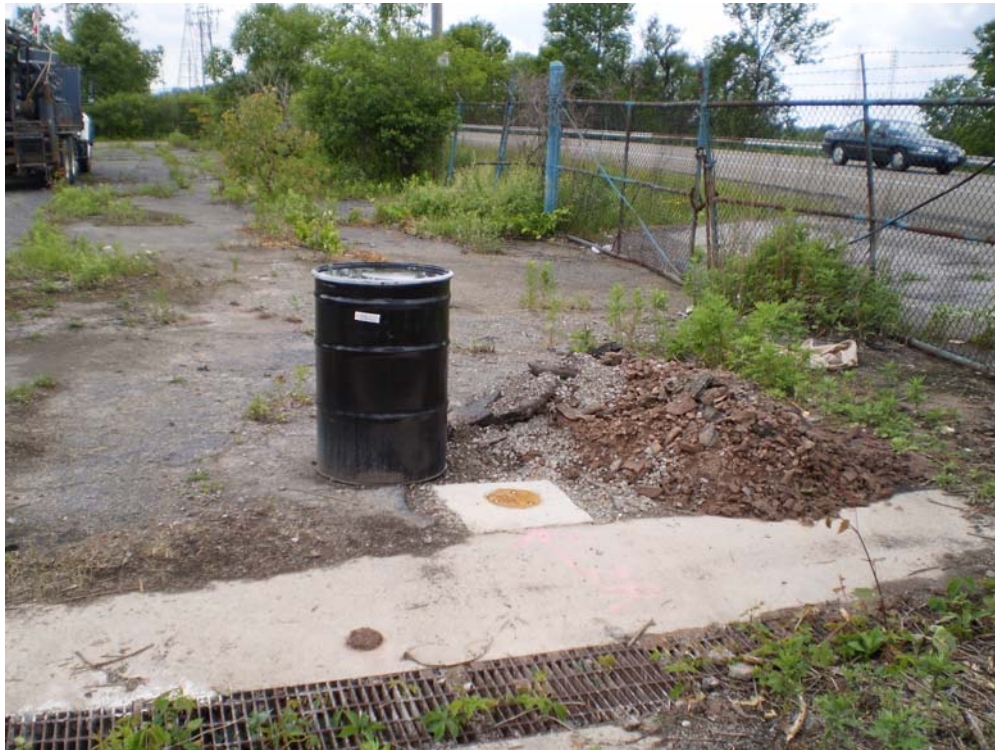
072109-02 Tank 4 Access Cut.JPG

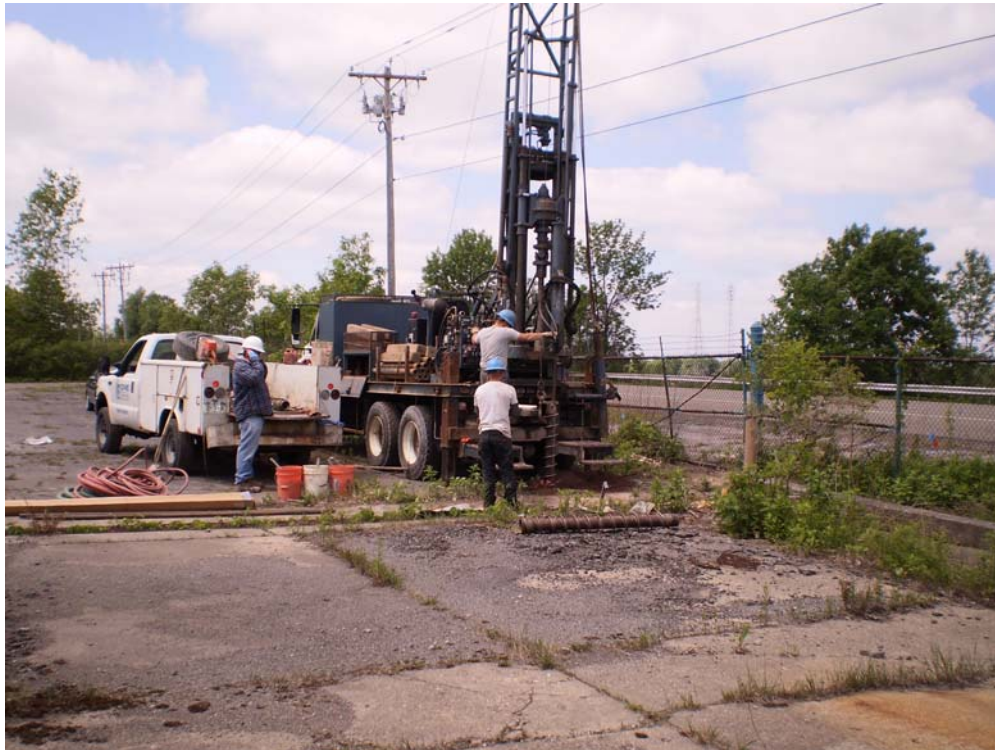
061309-02 UST T-3 cap.JPG

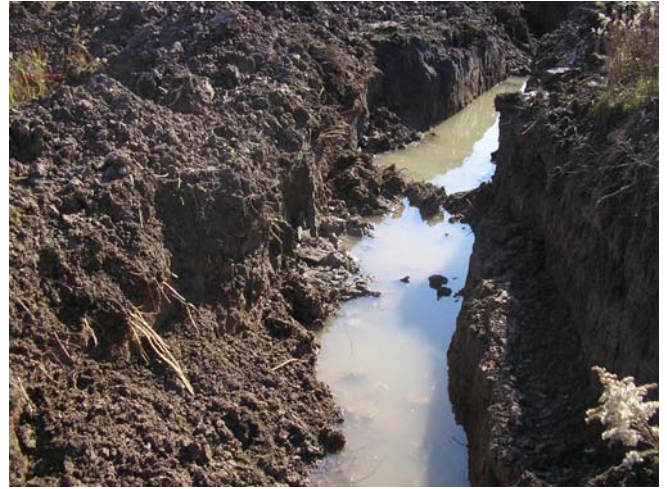
110209-01 10 inch clay tile.JPG

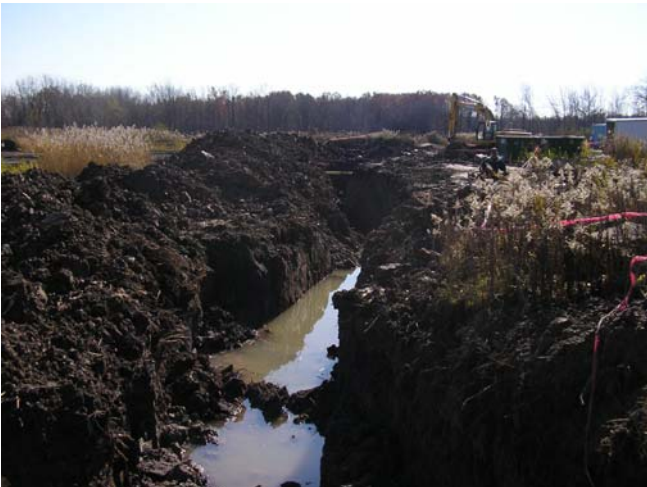
9-02 Sewer line removal - Asbesto

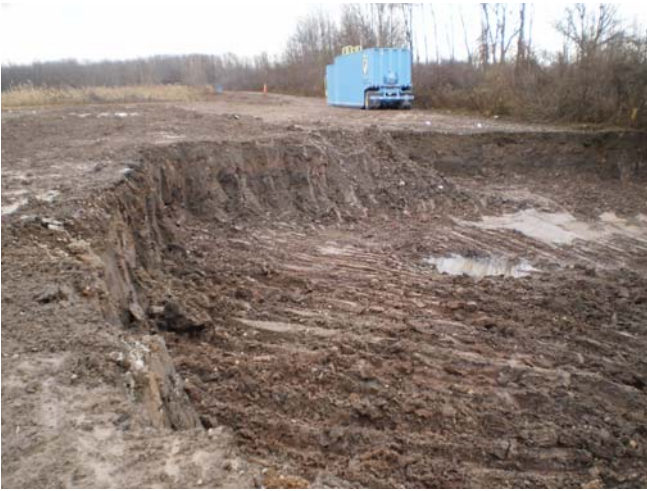
09-03 Sewer line removal Asbestos

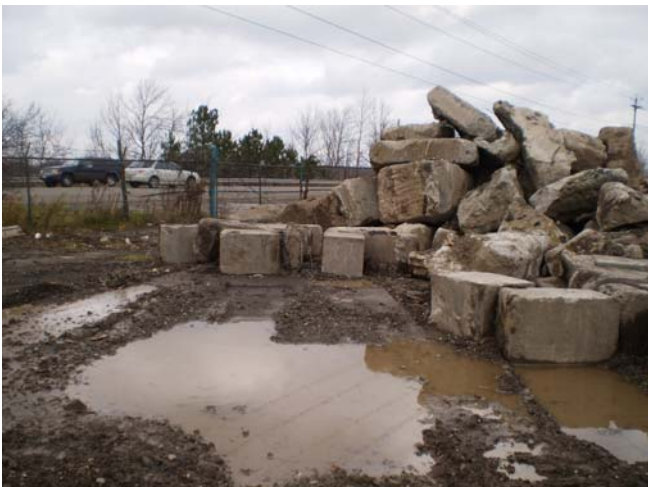
2009-10 Contaminated Concrete.Jl

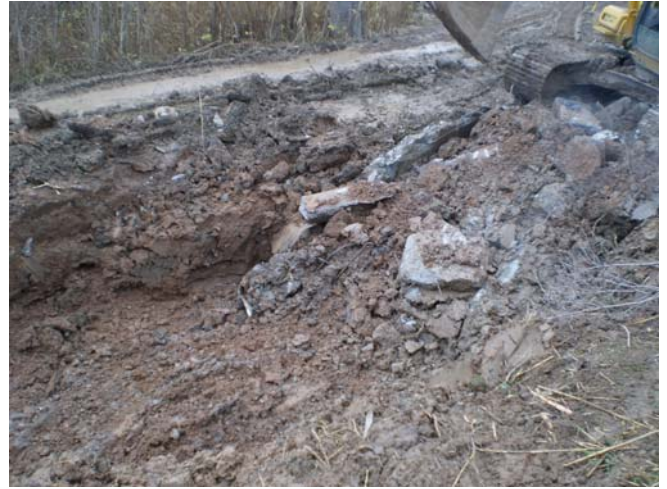
10609-03 Sewer line removal Asbestos
