Hooker-Hyde Park Landfill Gorge Inspection

DER Site Management, 06/08/2011

Report by Will Welling, NYSDEC

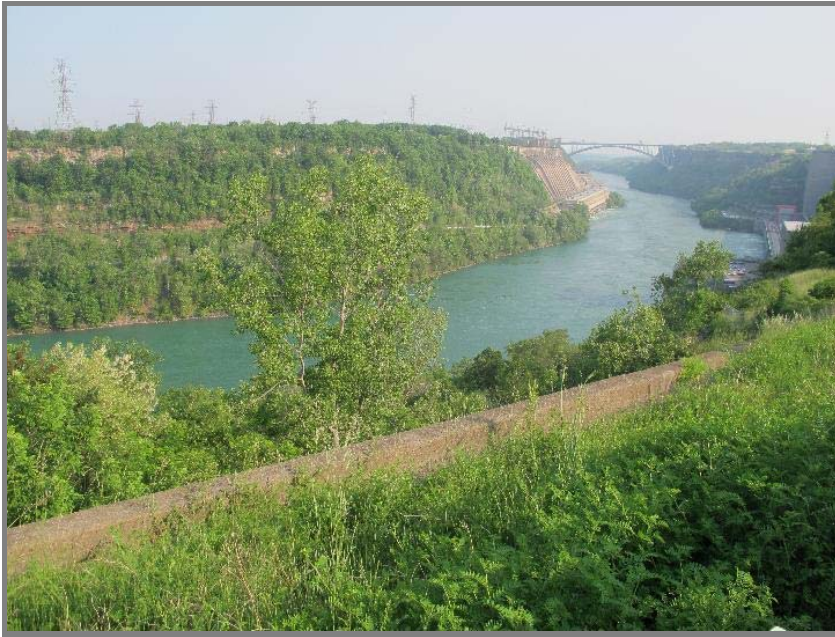
8:47 AM. Walk to Seep "3 Upper," the wing wall with seep holes, overlook. "3 Top" is overgrown. "3 Lower" - same as last time.

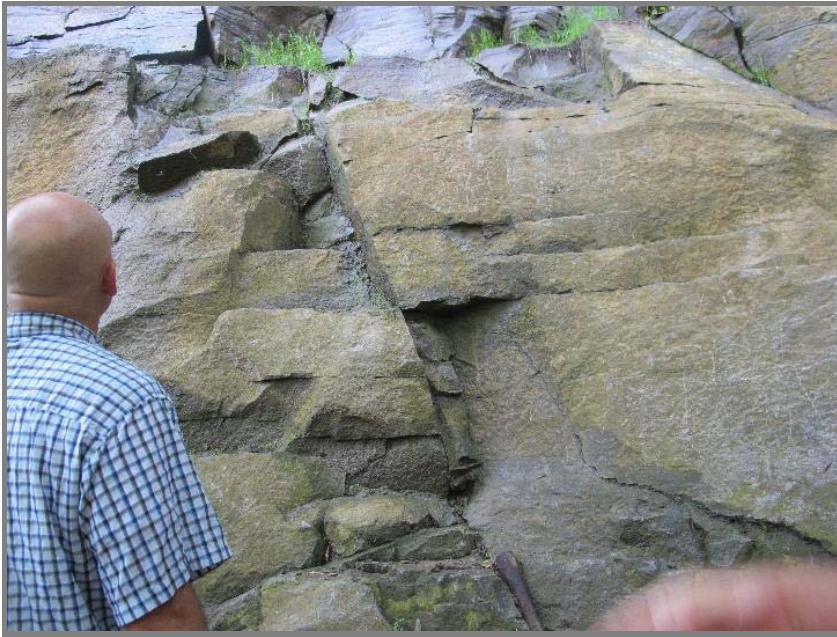
9:08 AM. Clint Babcock looks at the wall near Seep 6.

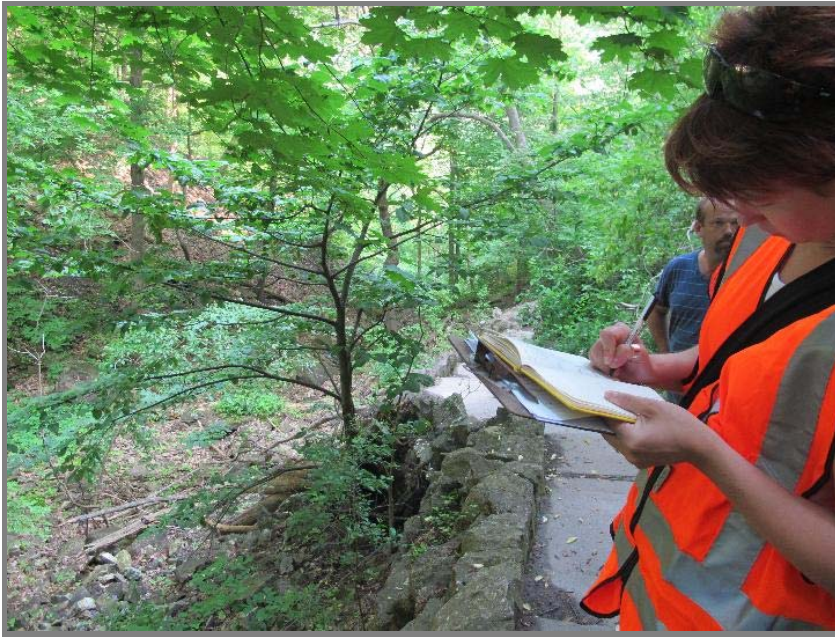
9:12 AM. Seeps of the #7-series follow the path down this ravine. Jane takes notes.

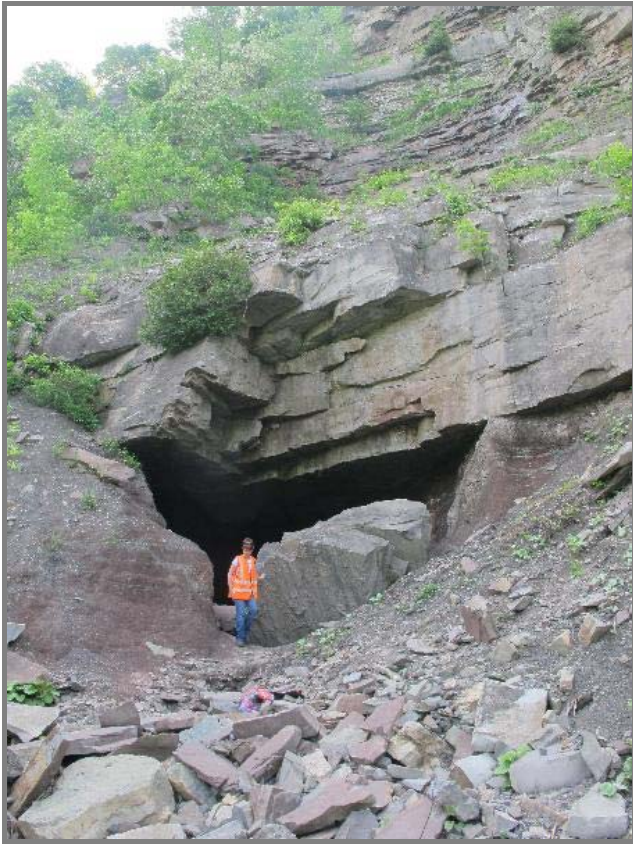
9:34 AM. Garfield Avenue Sewer. Seep # 21. We noted more fallen rx. than last visit. We walked into the cave. cool air flowing out; not too much smell.

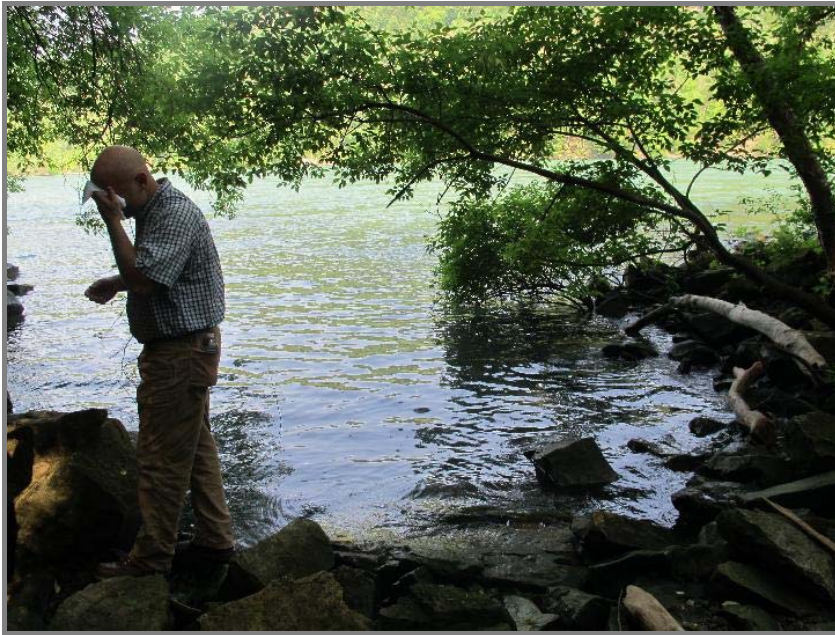
10:03 AM. Laid-up stone, a remnant of the narrow-gauge train that ran here many years ago. Seeps 11 A & B Inlet along the river bank at the laid-up stone.

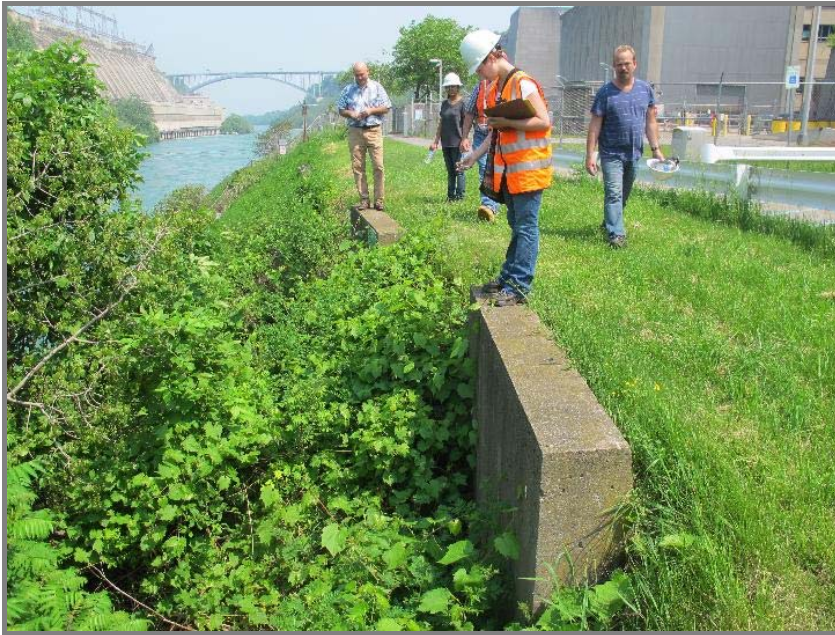
11:34 AM. The river. Finished inspection, hiked back up the road. Temperature in the '80s with high humidity.
